Expertise

Protocol number: 46371487  
Order No. / Reference: 26534020-1  
Inspection date: 30 Jun 2026

Manufacturer: Opel

Model: Zafira Life 2.0 D M Aut. Elegance

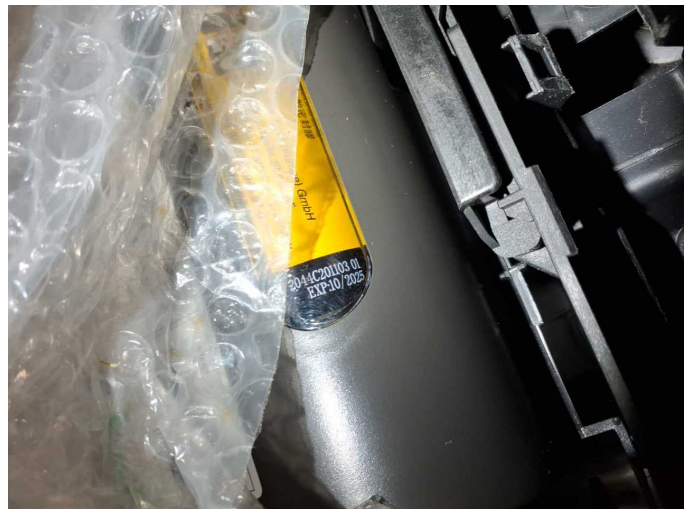
| No. | Component group | Description |
|---|---|---|
| 1 | Equipment | Tirefit filler - Expired - Replace |

**Damage 1:** Equipment: Tirefit filler - Expired - Replace

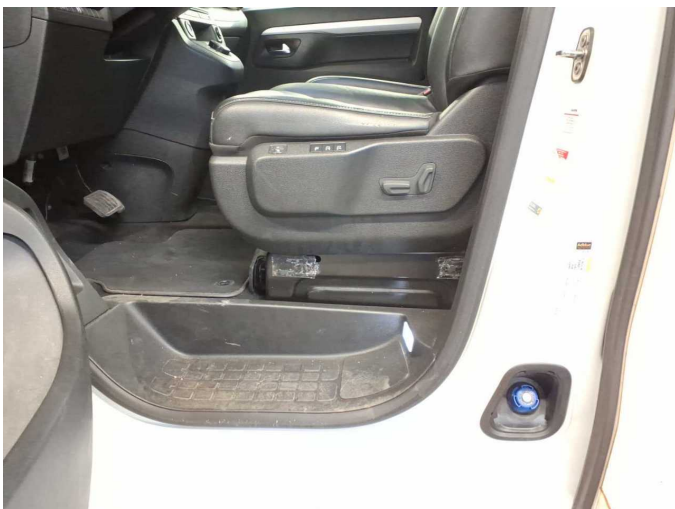
| No. | Component group | Description |
|---|---|---|
| 2 | Seat - front | Seat - left side - Glued / labelled - De-glue / neutralise |

**Damage 2:** Seat - front: Seat - left side - Glued / labelled - De-glue / neutralise

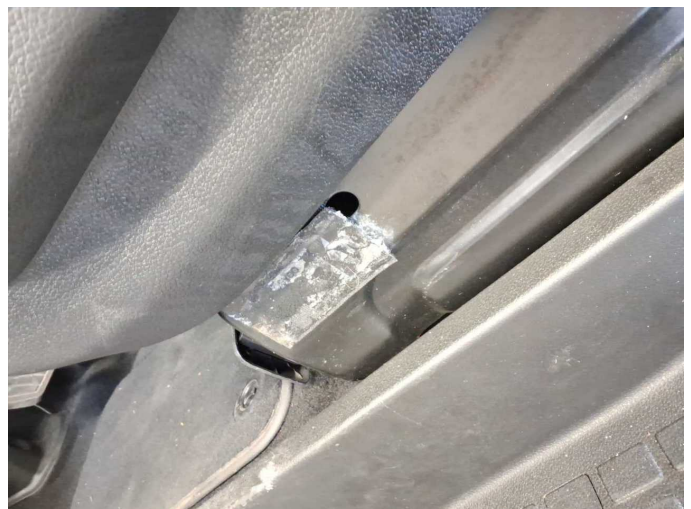
**Damage 2:** Seat - front: Seat - left side - Glued / labelled - De-glue / neutralise

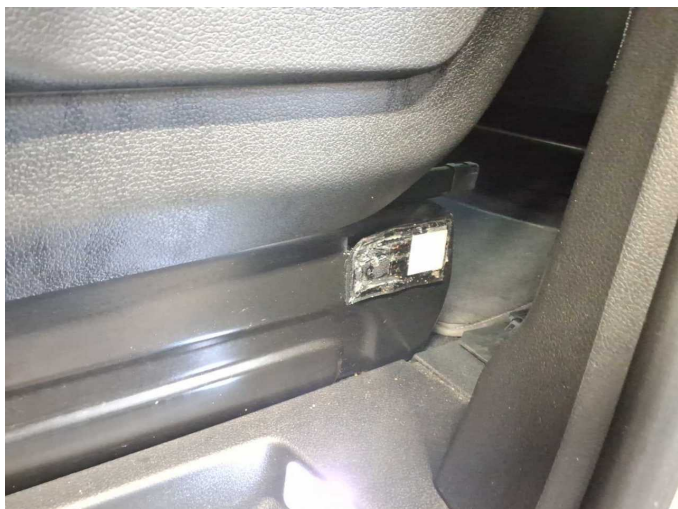
**Damage 2:** Seat - front: Seat - left side - Glued / labelled - De-glue / neutralise

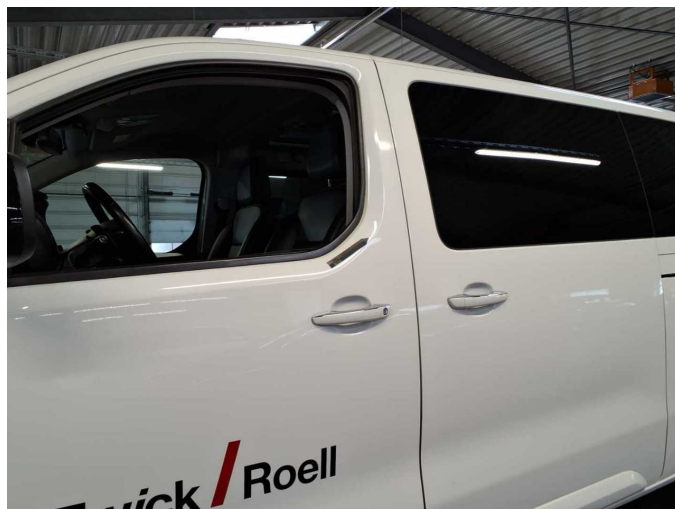
| No. | Component group | Description |
|---|---|---|
| 3 | Door - front left side | Door - Stone chips - Smart repair |

**Damage 3:** Door - front left side: Door - Stone chips - Smart repair

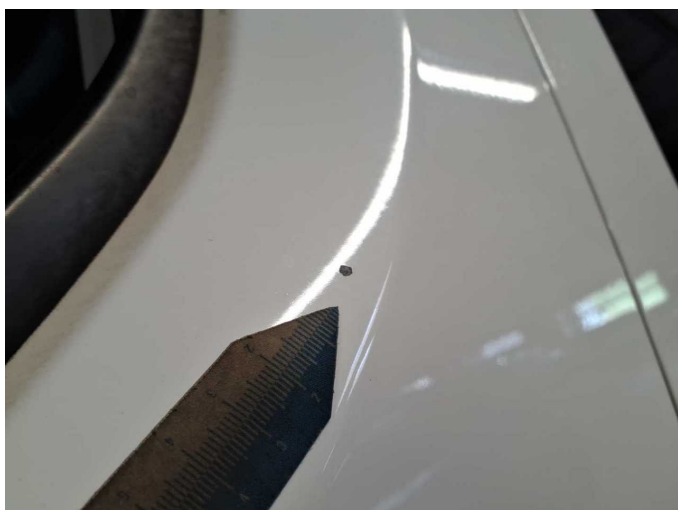
**Damage 3:** Door - front left side: Door - Stone chips - Smart repair

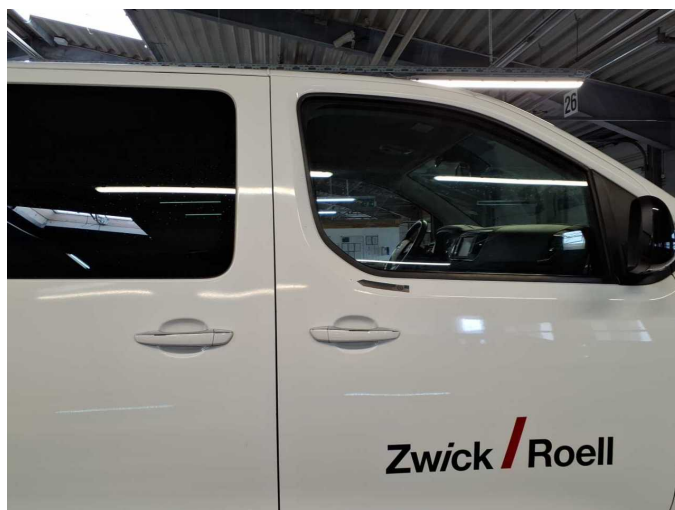
| No. | Component group | Description |
|---|---|---|
| 4 | Door - front right side | Door - Stone chips - Smart repair |

**Damage 4:** Door - front right side: Door - Stone chips - Smart repair

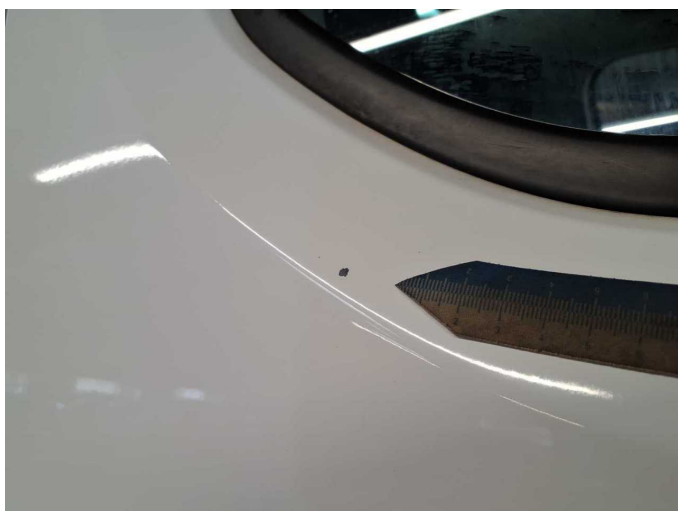
**Damage 4:** Door - front right side: Door - Stone chips - Smart repair

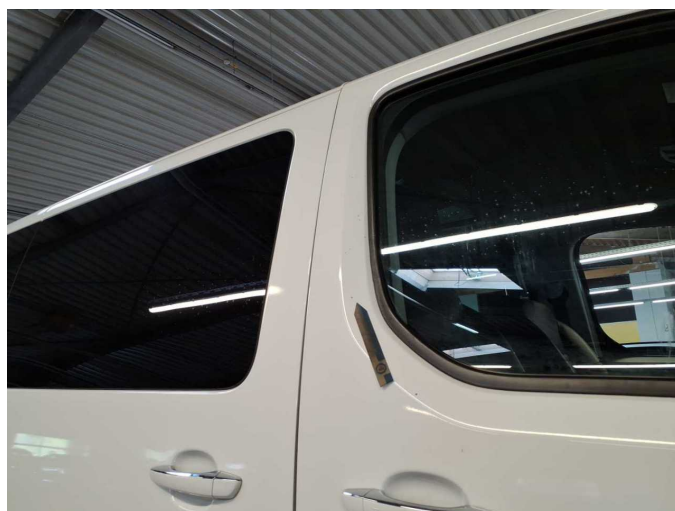
**Damage 4:** Door - front right side: Door - Stone chips - Smart repair

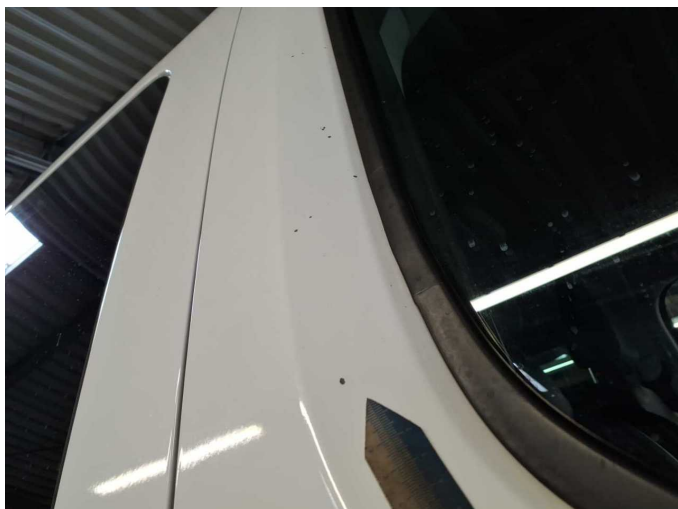
**Damage 4:** Door - front right side: Door - Stone chips - Smart repair

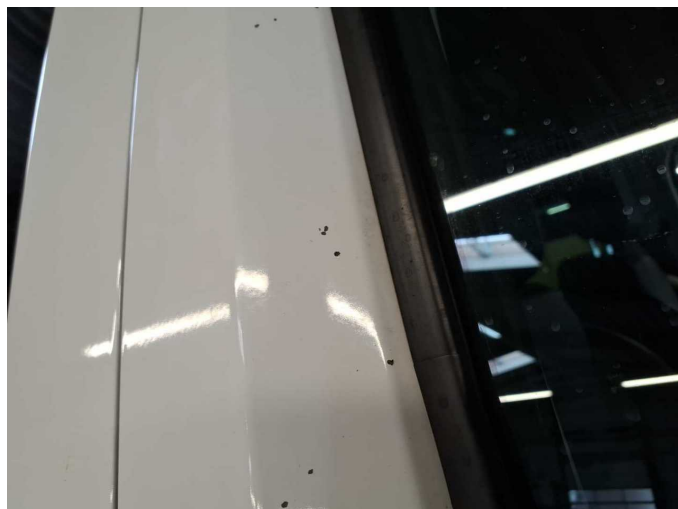
**Damage 4:** Door - front right side: Door - Stone chips - Smart repair

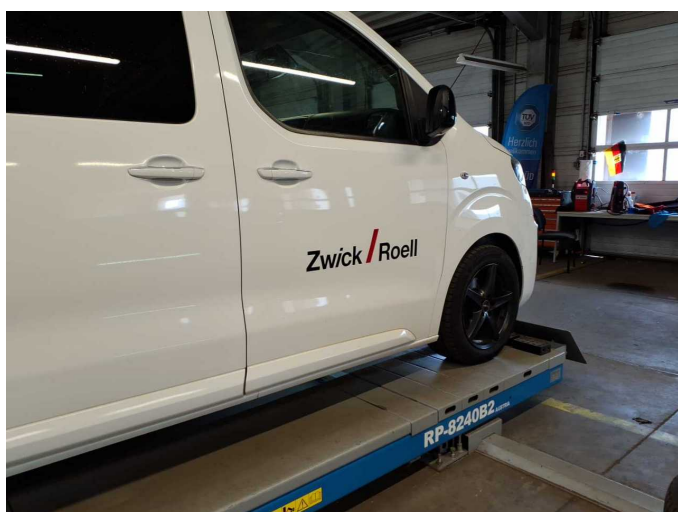
| No. | Component group | Description |
|---|---|---|
| 5 | Body | Body - Glued / labelled - De-glue / neutralise |

**Damage 5:** Body: Body - Glued / labelled - De-glue / neutralise

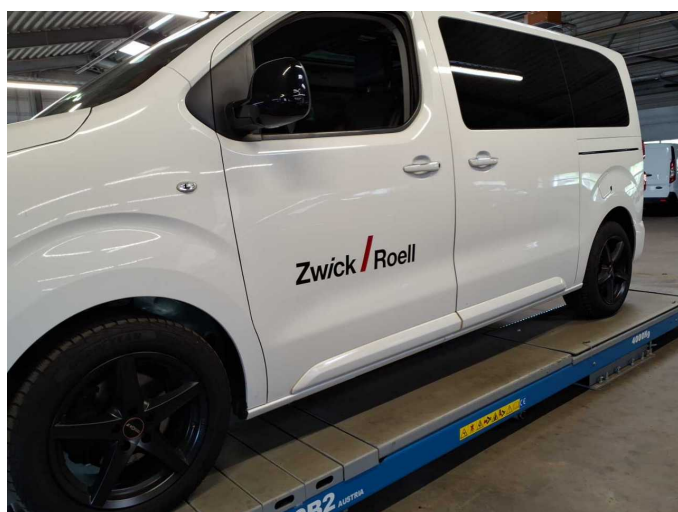
**Damage 5:** Body: Body - Glued / labelled - De-glue / neutralise

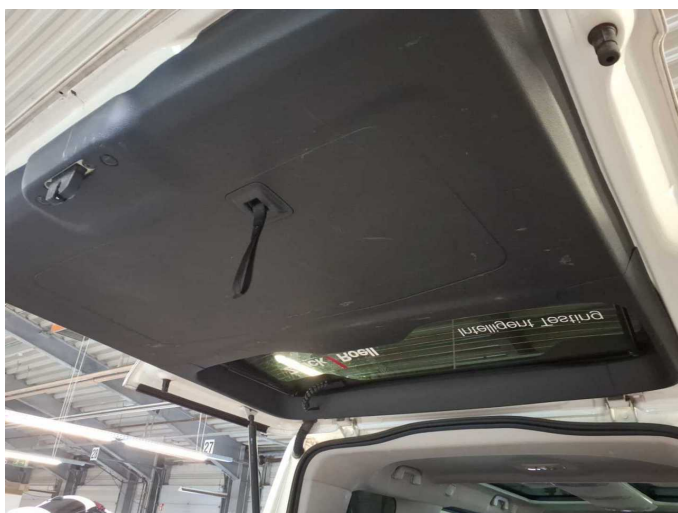
| No. | Component group | Description |
|---|---|---|
| 6 | Trim / covers | Boot lid - interior trim - Scratch(es) - Loss in value |

**Damage 6:** Trim / covers: Boot lid - interior trim - Scratch(es) - Loss in value

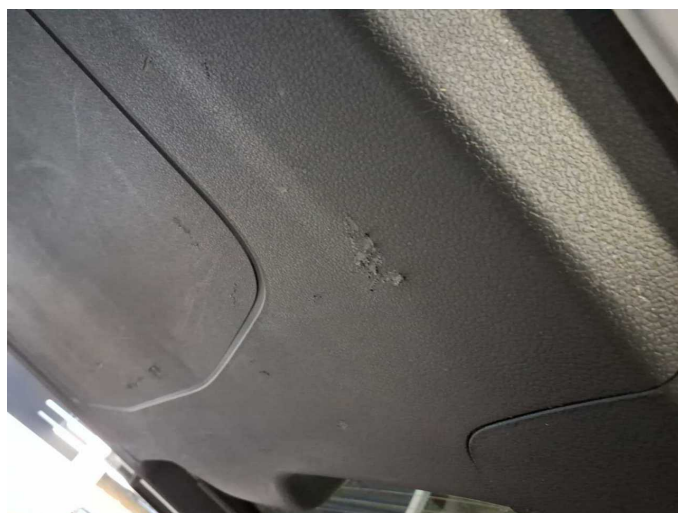
**Damage 6:** Trim / covers: Boot lid - interior trim - Scratch(es) - Loss in value

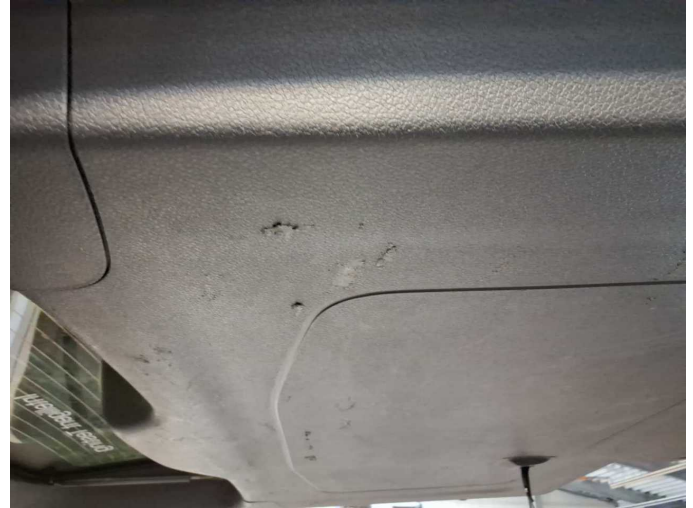
**Damage 6:** Trim / covers: Boot lid - interior trim - Scratch(es) - Loss in value

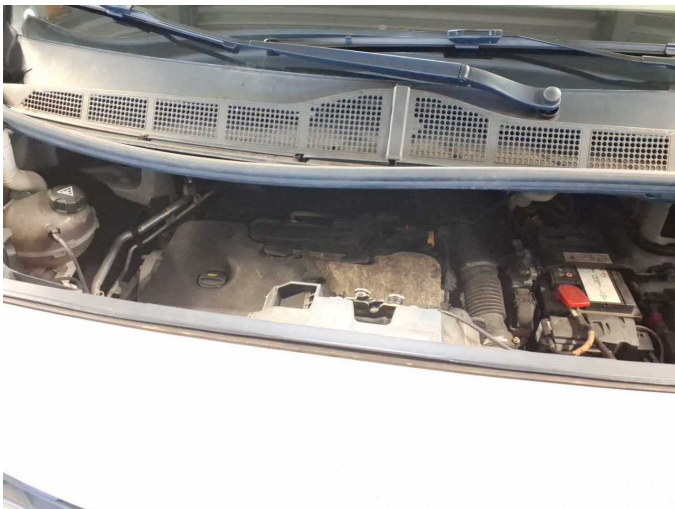
| No. | Component group | Description |
|---|---|---|
| 7 | Engine | Engine cover - Broken / torn - Replace |

**Damage 7:** Engine: Engine cover - Broken / torn - Replace

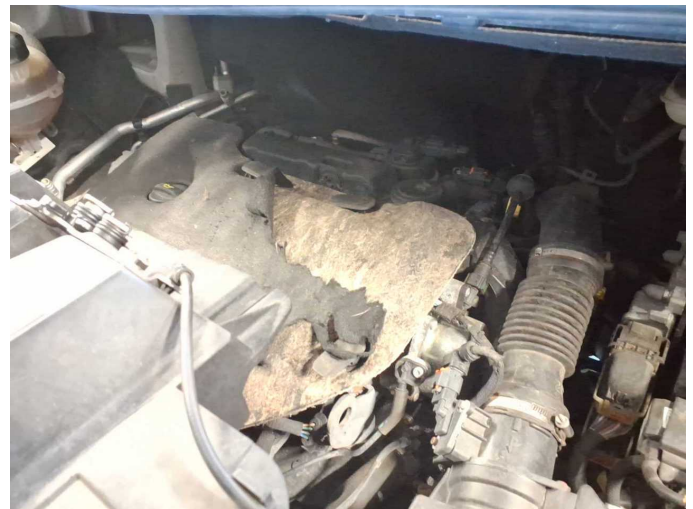
**Damage 7:** Engine: Engine cover - Broken / torn - Replace

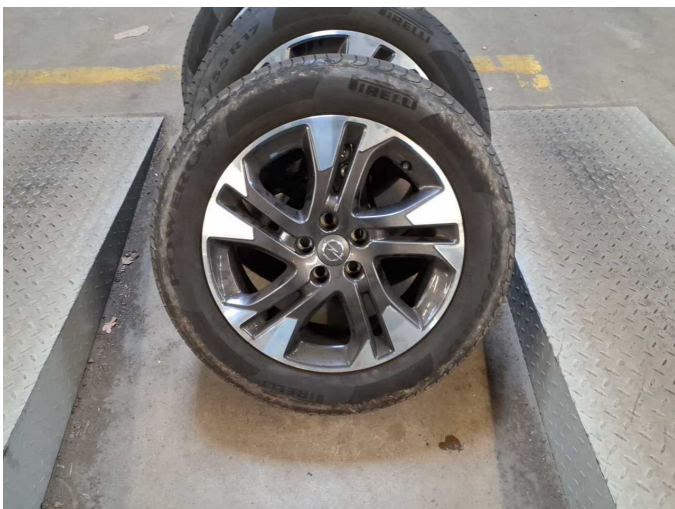
| No. | Component group | Description |
|---|---|---|
| 8 | 2nd wheel set | 1 alloy rim - Scratch(es) - Loss in value |

**Damage 8:** 2nd wheel set: 1 alloy rim - Scratch(es) - Loss in value

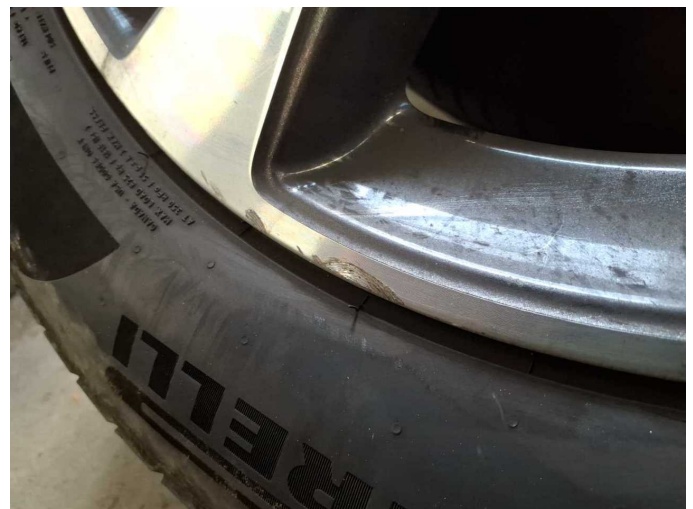
**Damage 8:** 2nd wheel set: 1 alloy rim - Scratch(es) - Loss in value

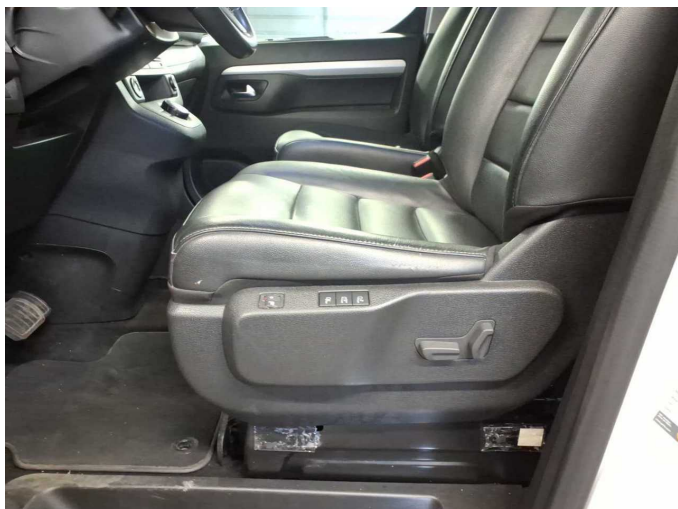
| No. | Component group | Description |
|---|---|---|
| 10 | Seat - front | Seat cover - left side (Wange) - Broken / torn - Smart repair |

**Damage 10:** Seat - front: Seat cover - left side (Wange) - Broken / torn - Smart repair

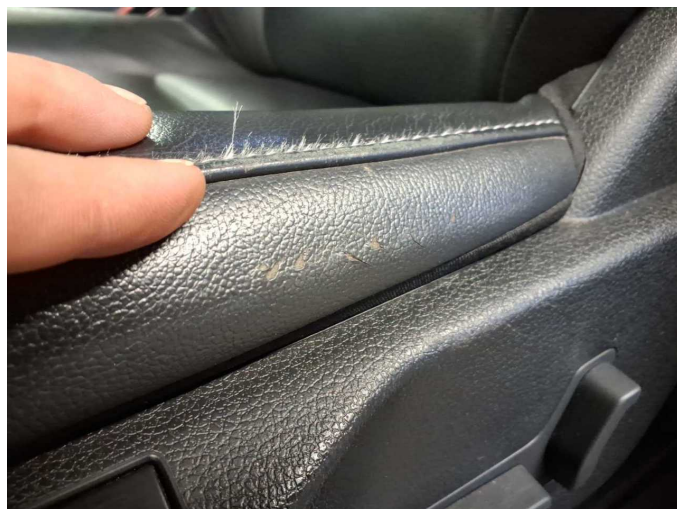
**Damage 10:** Seat - front: Seat cover - left side (Wange) - Broken / torn - Smart repair

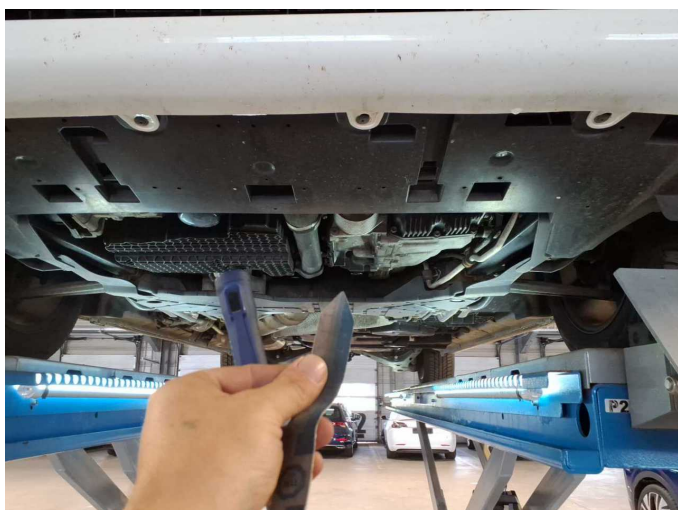
| No. | Component group | Description |
|---|---|---|
| 11 | Engine | Engine (+ Getriebe, Umweltbelastung) - Leaking - Perform diagnosis |

**Damage 11:** Engine: Engine (+ Getriebe, Umweltbelastung) - Leaking - Perform diagnosis

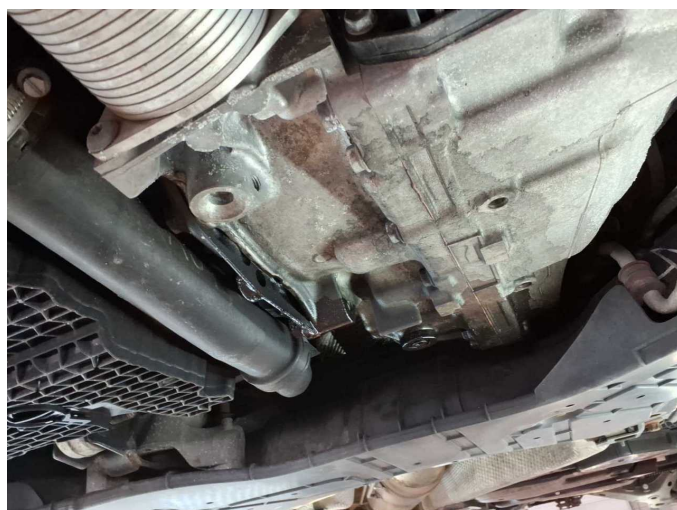
**Damage 11:** Engine: Engine (+ Getriebe, Umweltbelastung) - Leaking - Perform diagnosis

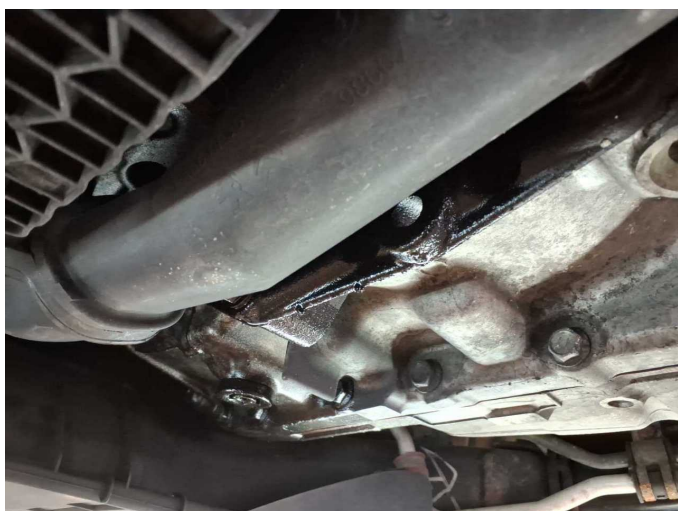
**Damage 11:** Engine: Engine (+ Getriebe, Umweltbelastung) - Leaking - Perform diagnosis

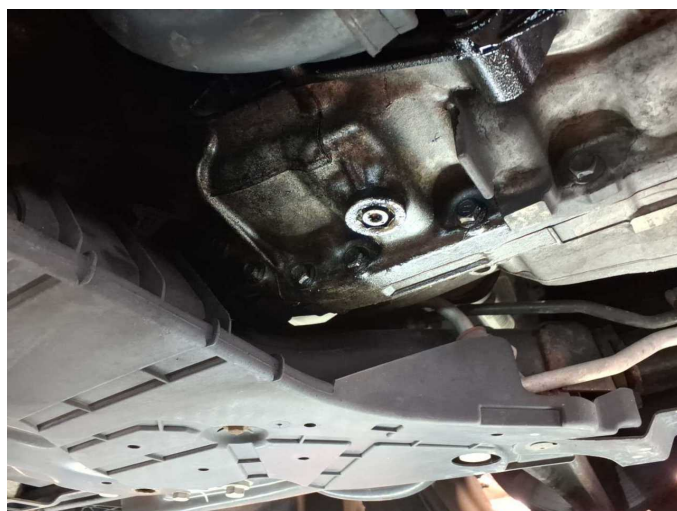
**Damage 11:** Engine: Engine (+ Getriebe, Umweltbelastung) - Leaking - Perform diagnosis

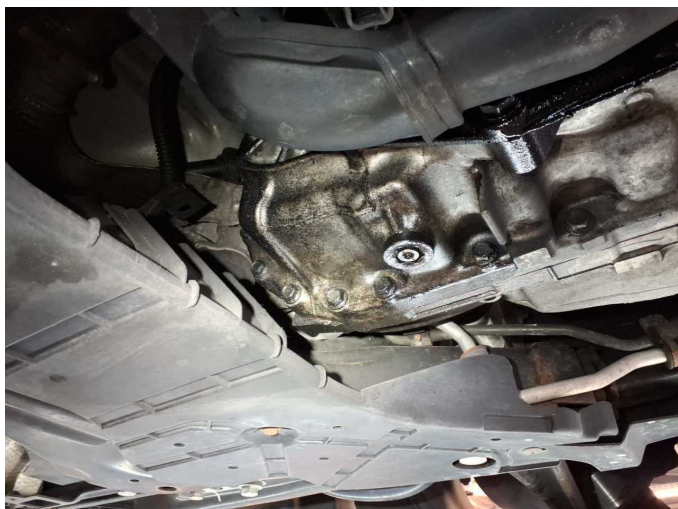
**Damage 11:** Engine: Engine (+ Getriebe, Umweltbelastung) - Leaking - Perform diagnosis

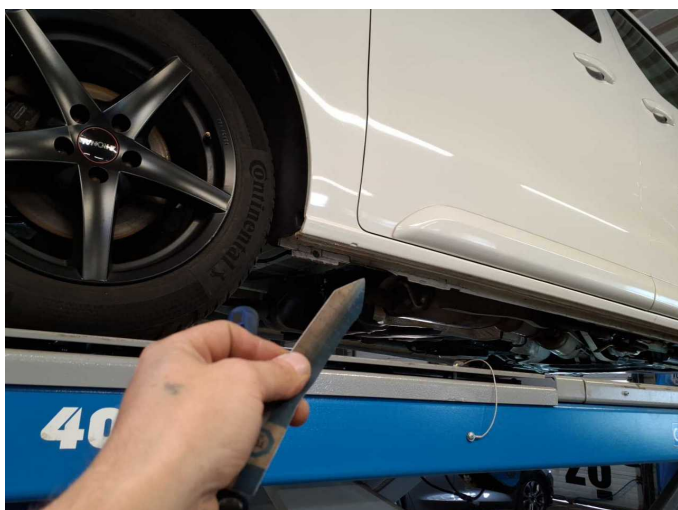
| No. | Component group | Description |
|---|---|---|
| 12 | Sill - right side | Sill - Deformed - Smart repair |

**Damage 12:** Sill - right side: Sill - Deformed - Smart repair

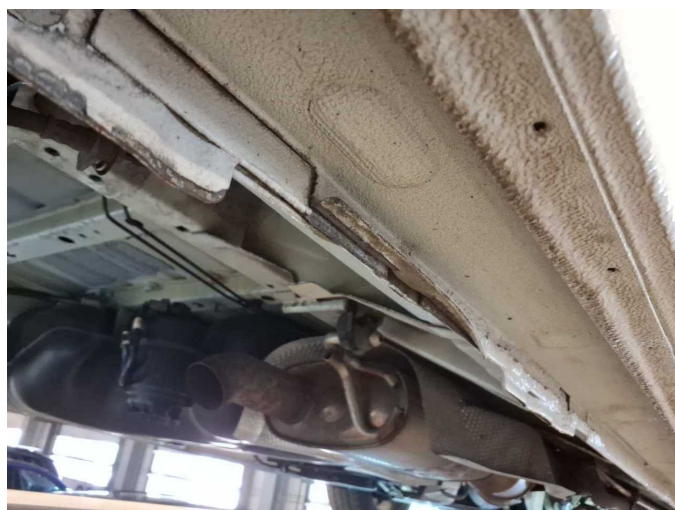
**Damage 12:** Sill - right side: Sill - Deformed - Smart repair

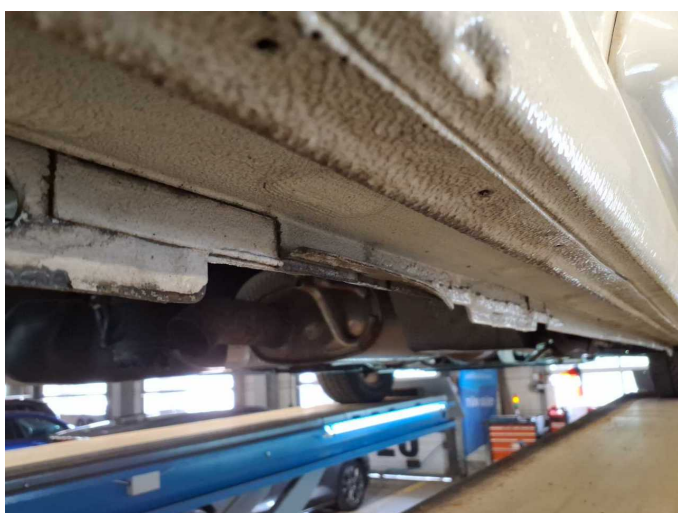
**Damage 12:** Sill - right side: Sill - Deformed - Smart repair

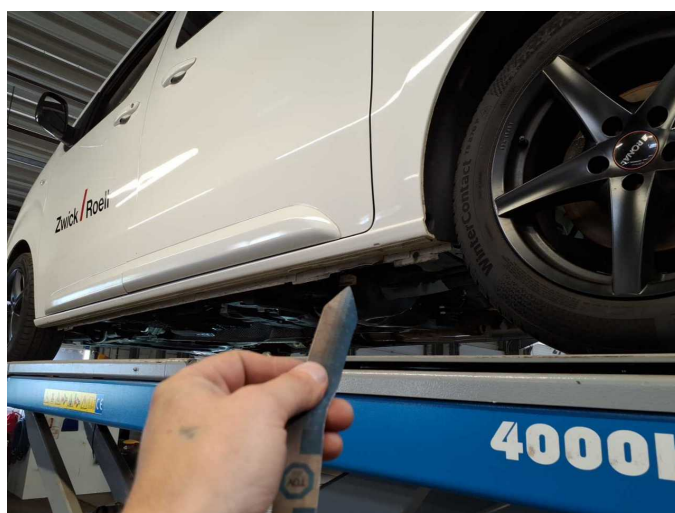
| No. | Component group | Description |
|---|---|---|
| 13 | Sill - left side | Sill - Deformed - Smart repair |

**Damage 13:** Sill - left side: Sill - Deformed - Smart repair

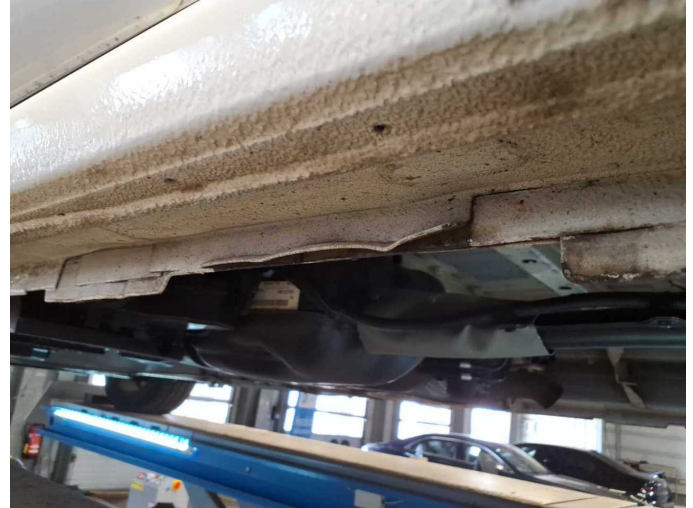
**Damage 13:** Sill - left side: Sill - Deformed - Smart repair

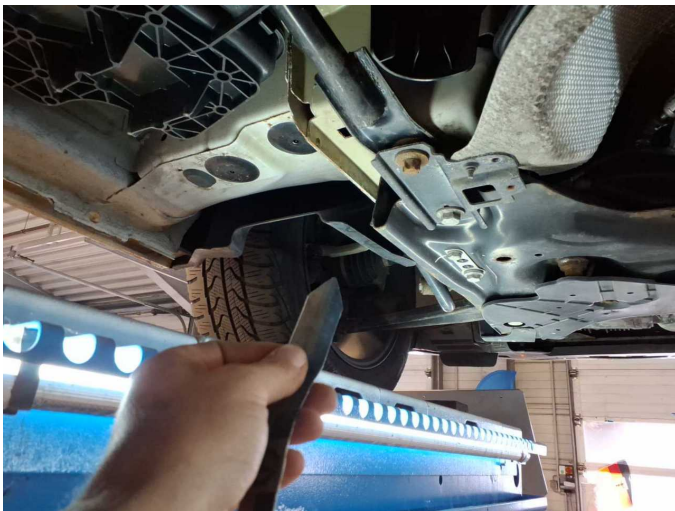
| No. | Component group | Description |
|---|---|---|
| 9 | Measurement | Front axle geometry (Spurstangekopf defekt.) - Perform |
| 14 | Steering system | Tie rod end (Links--> Achsvermessung) - Broken / torn - Replace |

**Damage 14:** Steering system: Tie rod end (Links--> Achsvermessung) - Broken / torn - Replace

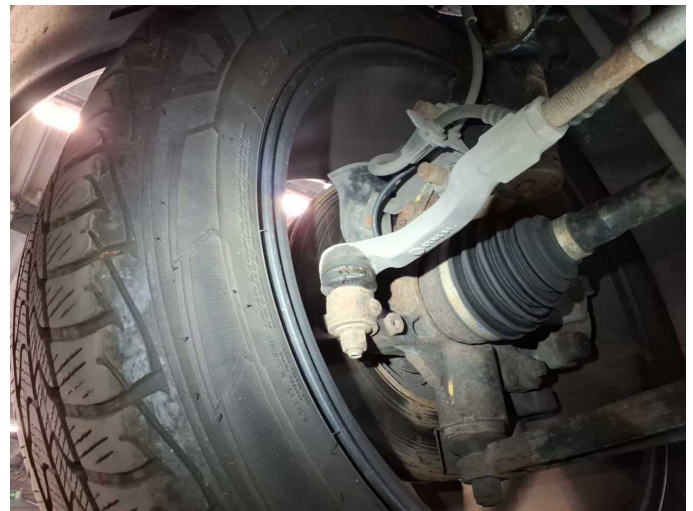
**Damage 14:** Steering system: Tie rod end (Links--> Achsvermessung) - Broken / torn - Replace

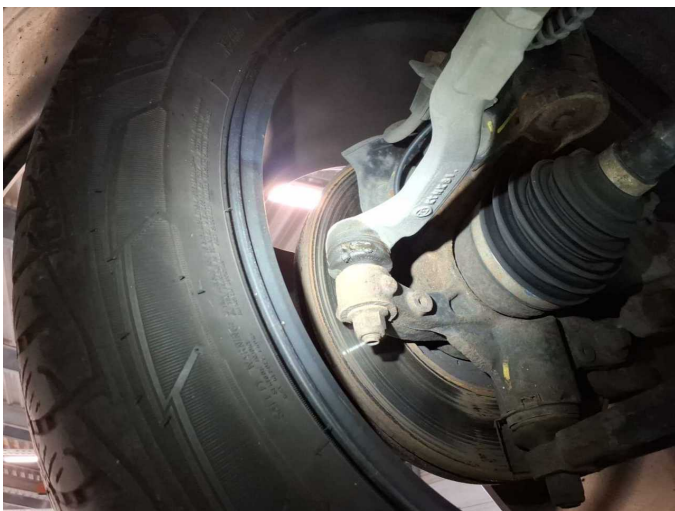
**Damage 14:** Steering system: Tie rod end (Links--> Achsvermessung) - Broken / torn - Replace

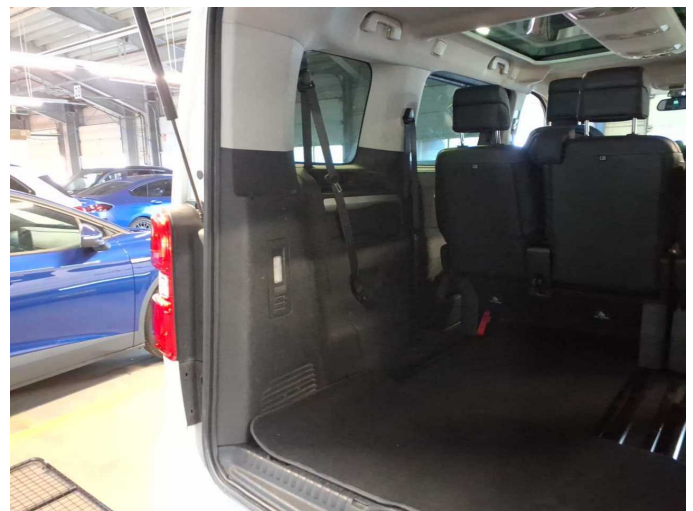
| No. | Component group | Description |
|---|---|---|
| 15 | Side panel - rear left side | Interior trim - Scratched - Loss in value |

**Damage 15:** Side panel - rear left side: Interior trim - Scratched - Loss in value

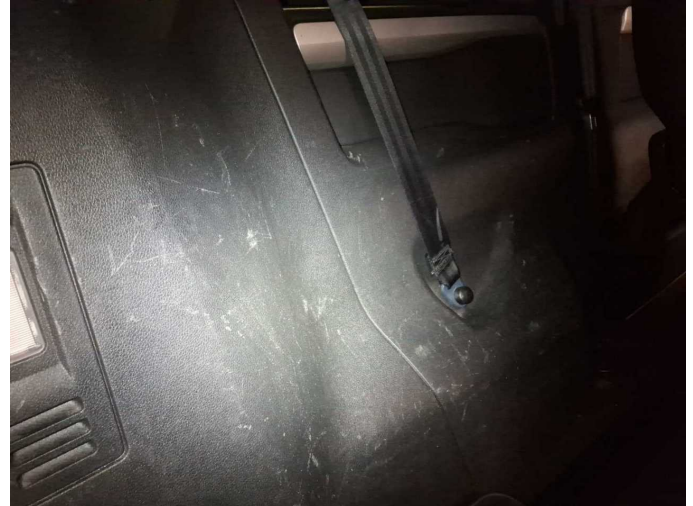
**Damage 15:** Side panel - rear left side: Interior trim - Scratched - Loss in value

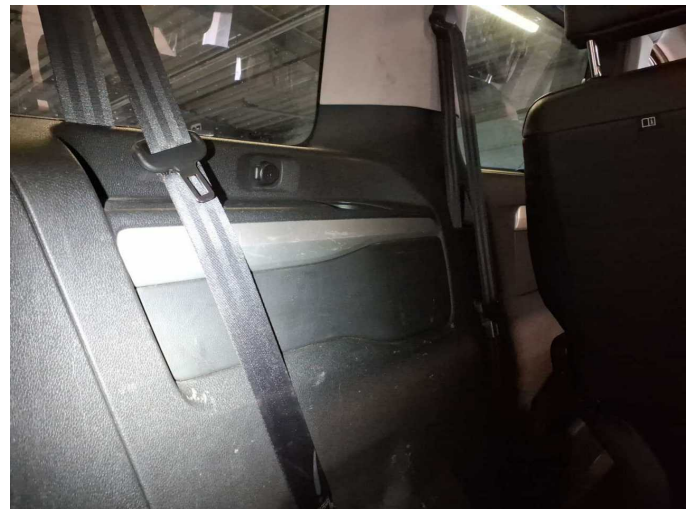
**Damage 15:** Side panel - rear left side: Interior trim - Scratched - Loss in value

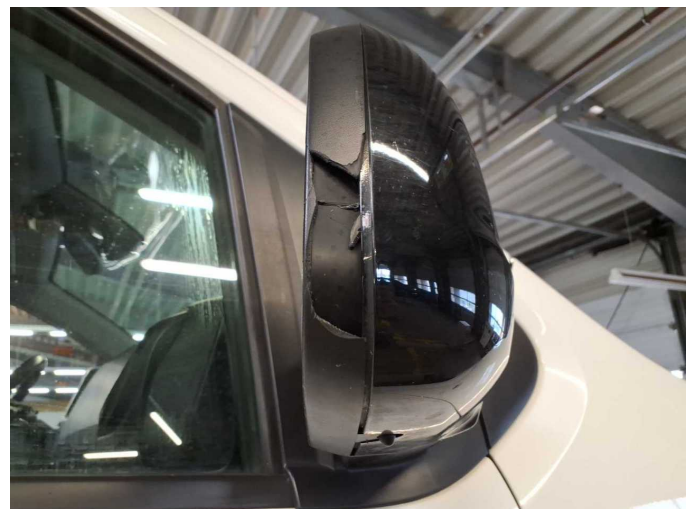
| No. | Component group | Description |
|---|---|---|
| 16 | Wing mirror - right side | Mirror housing (Rahmen) - Broken / torn - Replace |

**Damage 16:** Wing mirror - right side: Mirror housing (Rahmen) - Broken / torn - Replace

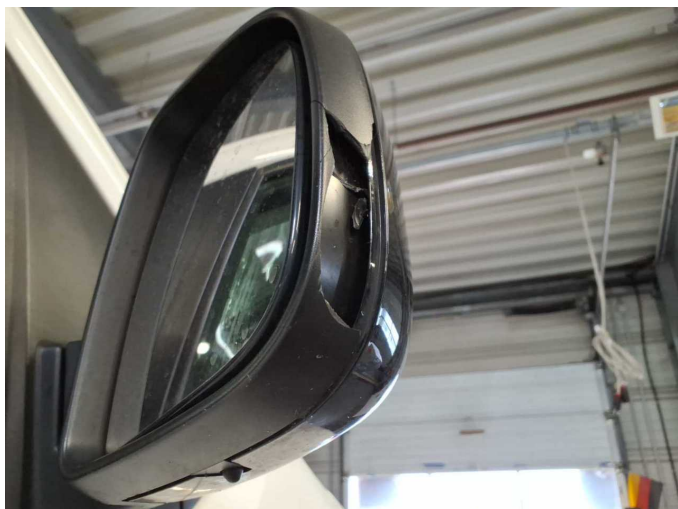
**Damage 16:** Wing mirror - right side: Mirror housing (Rahmen) - Broken / torn - Replace

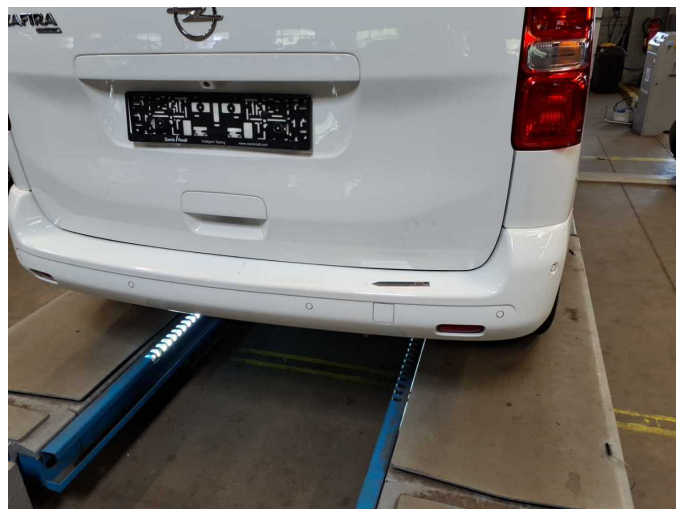
| No. | Component group | Description |
|---|---|---|
| 17 | Rear bumper | Rear bumper - Scratched - Paint |

**Damage 17:** Rear bumper: Rear bumper - Scratched - Paint

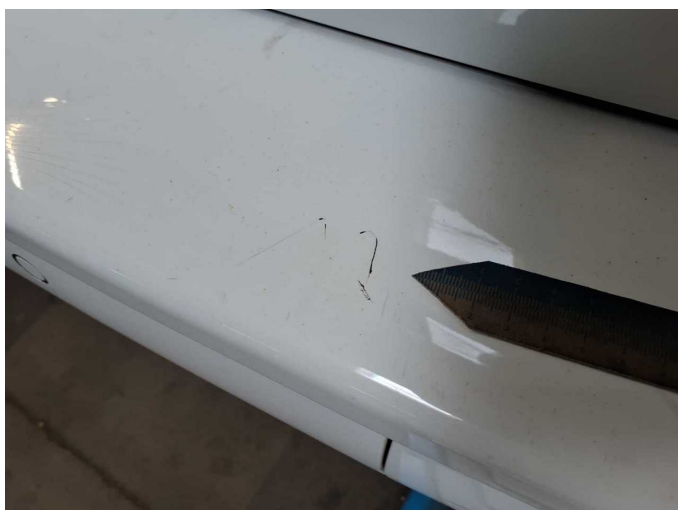
**Damage 17:** Rear bumper: Rear bumper - Scratched - Paint

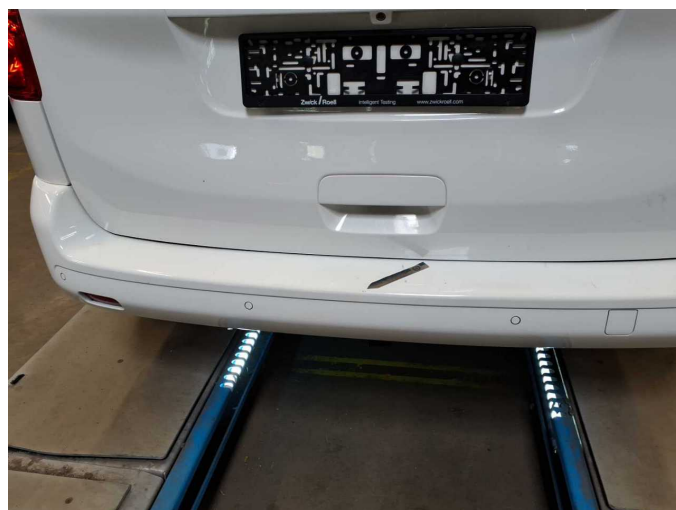
**Damage 17:** Rear bumper: Rear bumper - Scratched - Paint

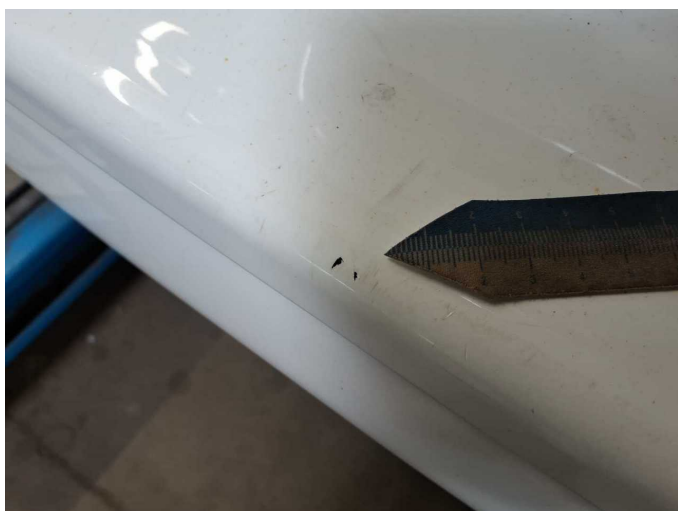
**Damage 17:** Rear bumper: Rear bumper - Scratched - Paint

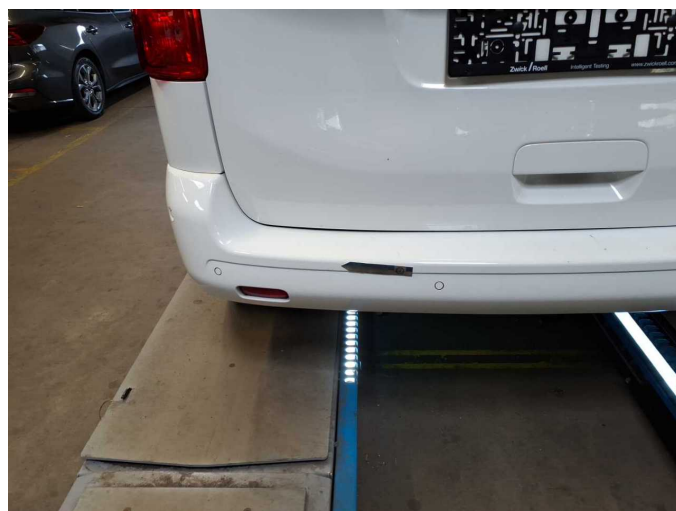
**Damage 17:** Rear bumper: Rear bumper - Scratched - Paint

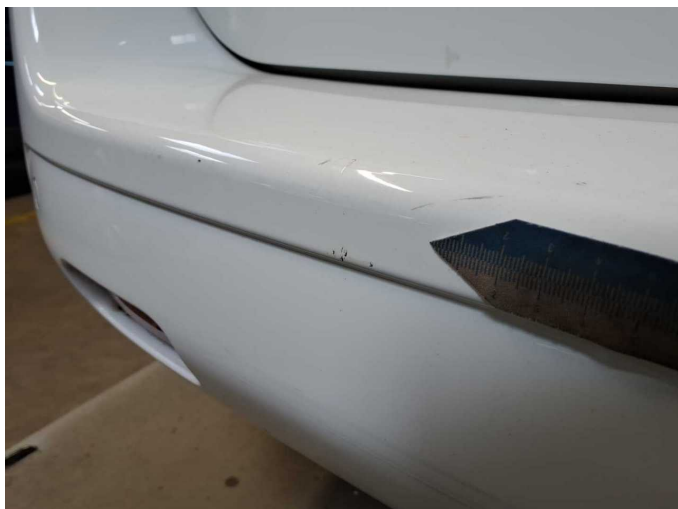
**Damage 17:** Rear bumper: Rear bumper - Scratched - Paint

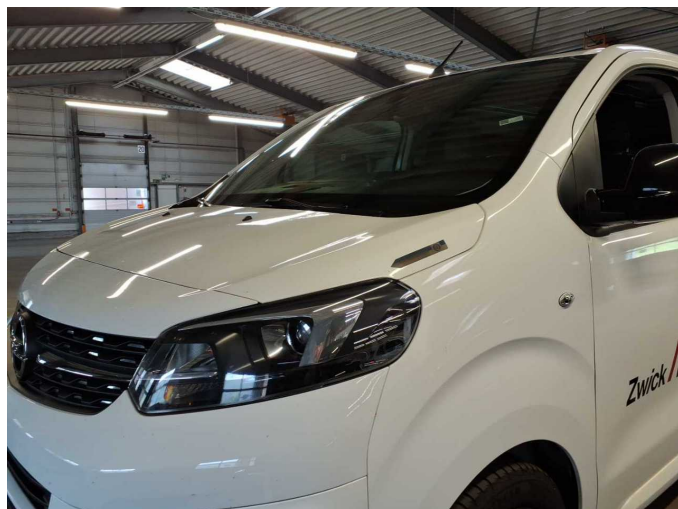
| No. | Component group | Description |
|---|---|---|
| 18 | Bonnet | Bonnet - Stone chips - Paint |

**Damage 18:** Bonnet: Bonnet - Stone chips - Paint

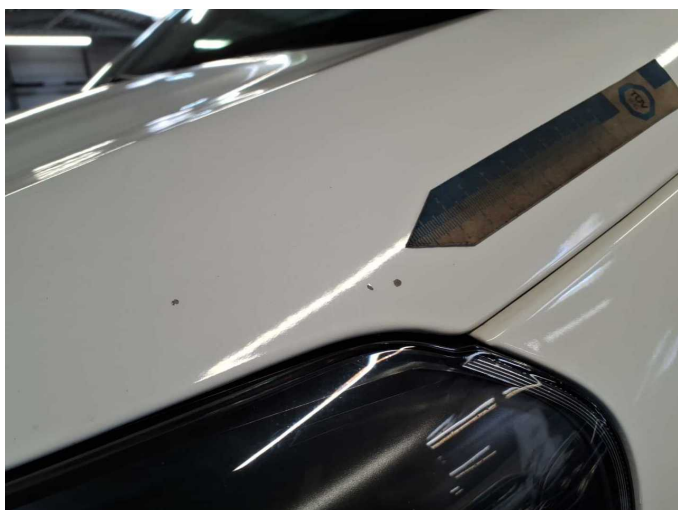
**Damage 18:** Bonnet: Bonnet - Stone chips - Paint

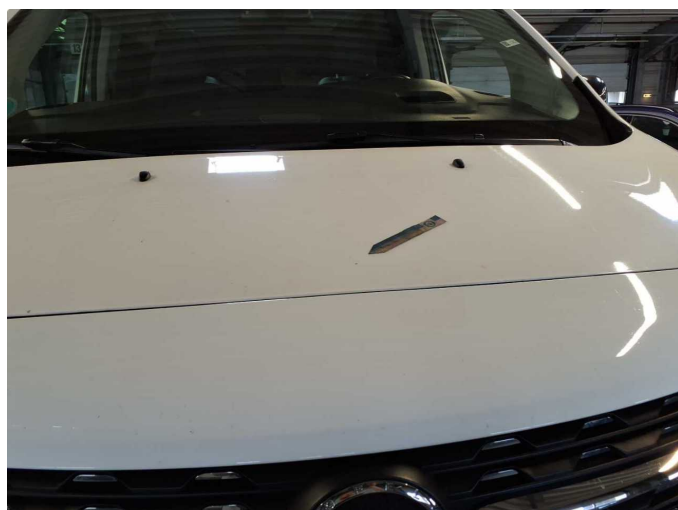
**Damage 18:** Bonnet: Bonnet - Stone chips - Paint

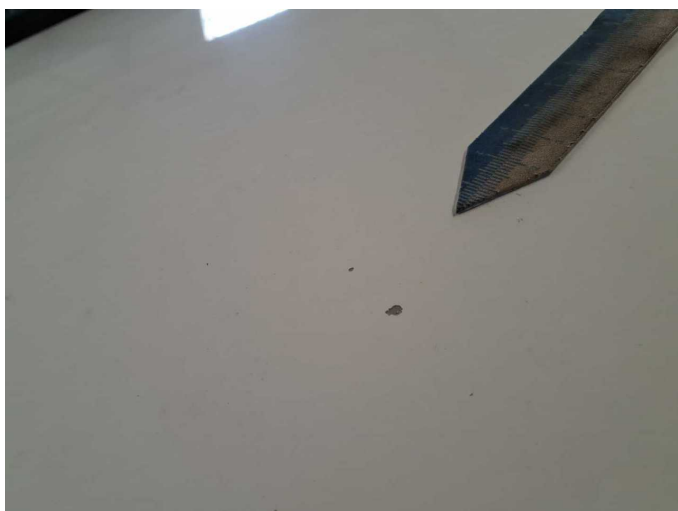
**Damage 18:** Bonnet: Bonnet - Stone chips - Paint

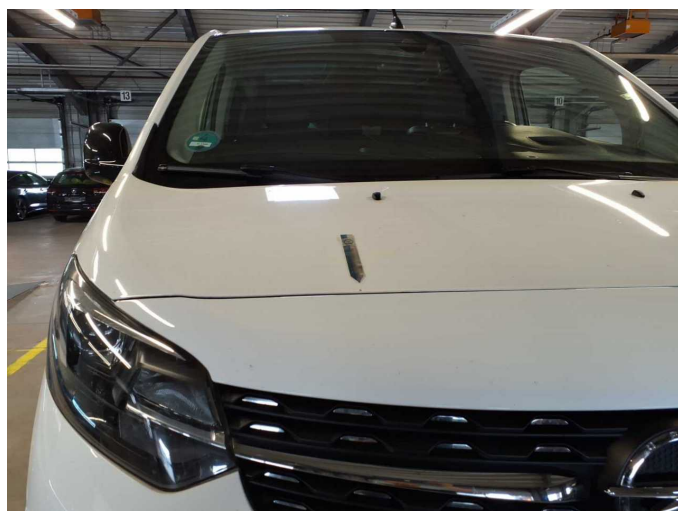
**Damage 18:** Bonnet: Bonnet - Stone chips - Paint

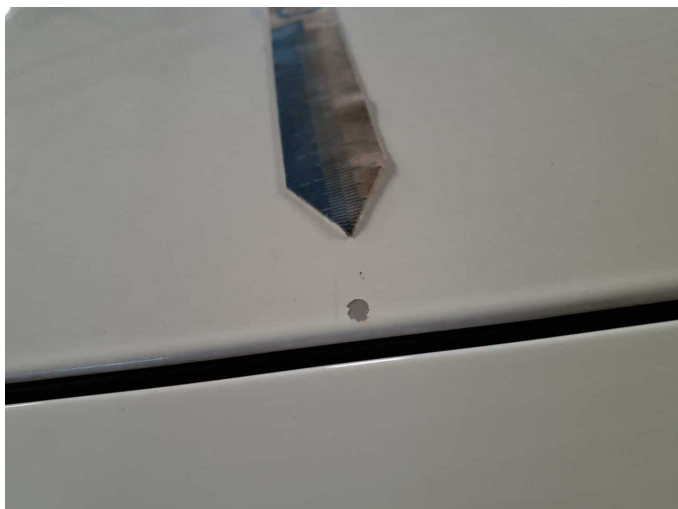
**Damage 18:** Bonnet: Bonnet - Stone chips - Paint

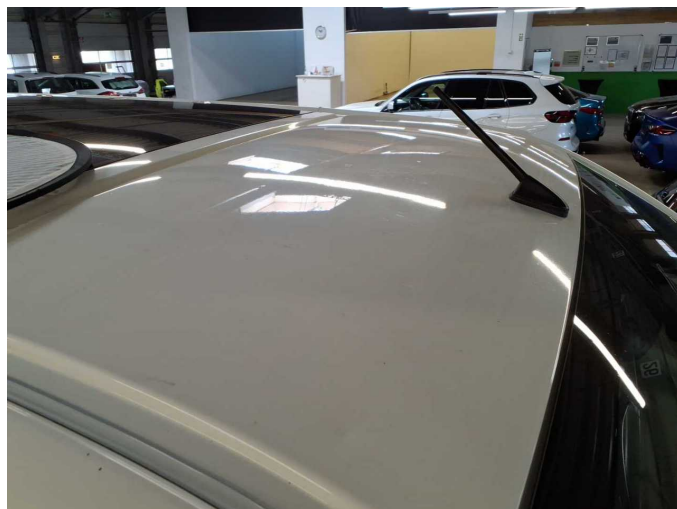
| No. | Component group | Description |
|---|---|---|
| 19 | Roof | Roof - Dent / paintcoat damage - Paint |

**Damage 19:** Roof: Roof - Dent / paintcoat damage - Paint

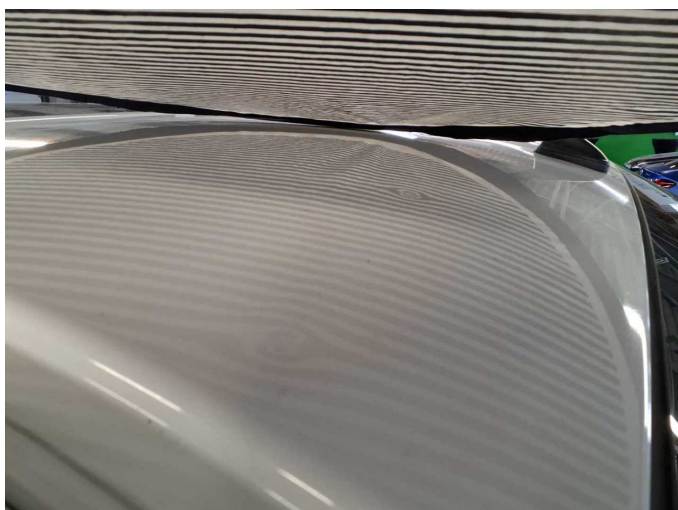
**Damage 19:** Roof: Roof - Dent / paintcoat damage - Paint

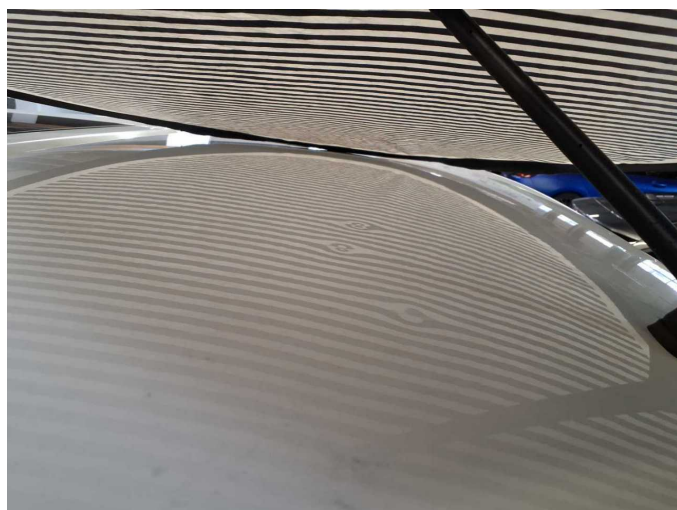
**Damage 19:** Roof: Roof - Dent / paintcoat damage - Paint

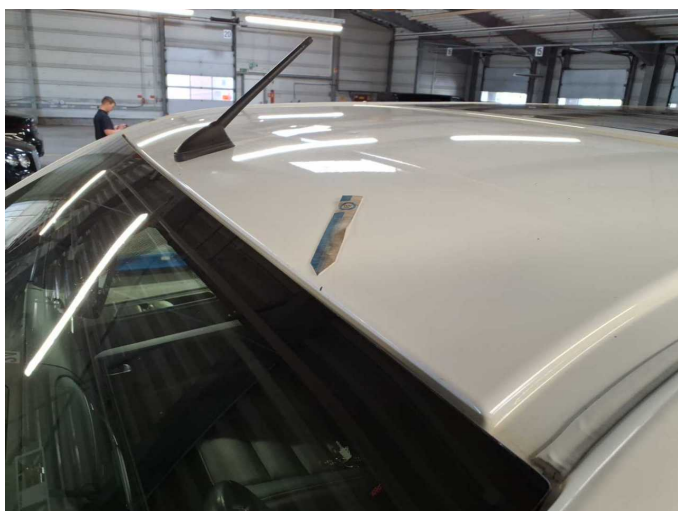
**Damage 19:** Roof: Roof - Dent / paintcoat damage - Paint

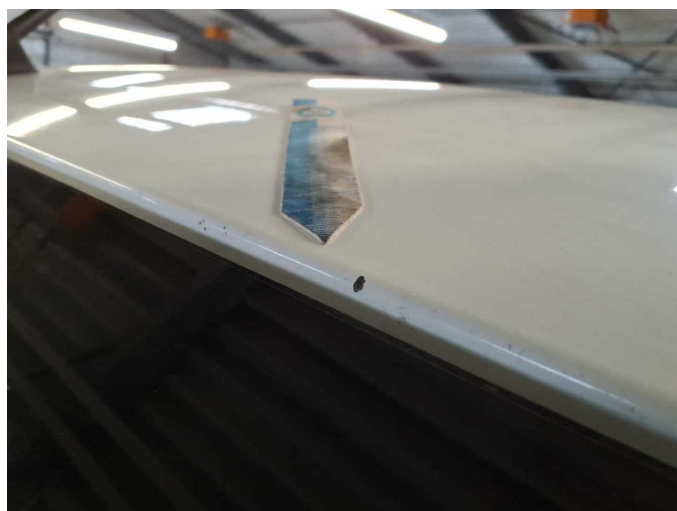
**Damage 19:** Roof: Roof - Dent / paintcoat damage - Paint

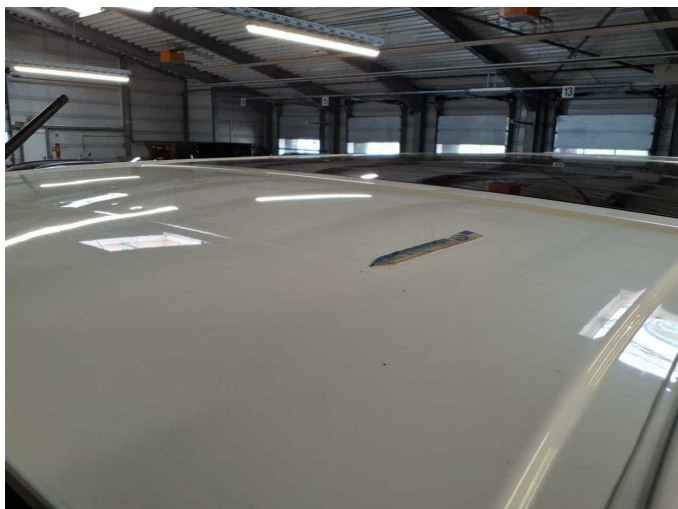
**Damage 19:** Roof: Roof - Dent / paintcoat damage - Paint

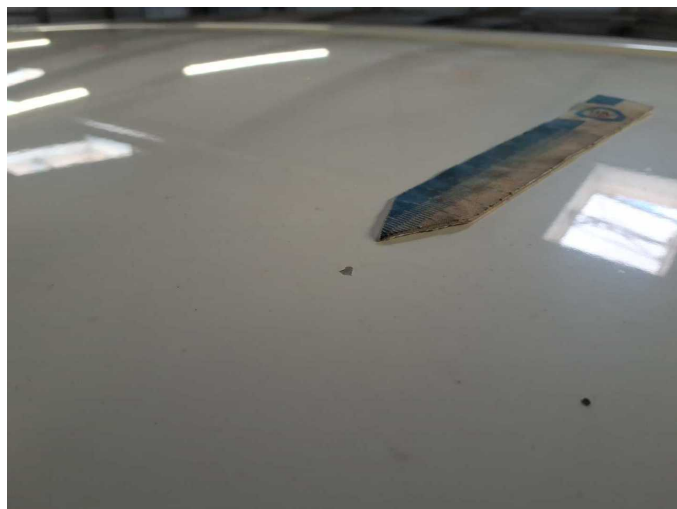
**Damage 19:** Roof: Roof - Dent / paintcoat damage - Paint

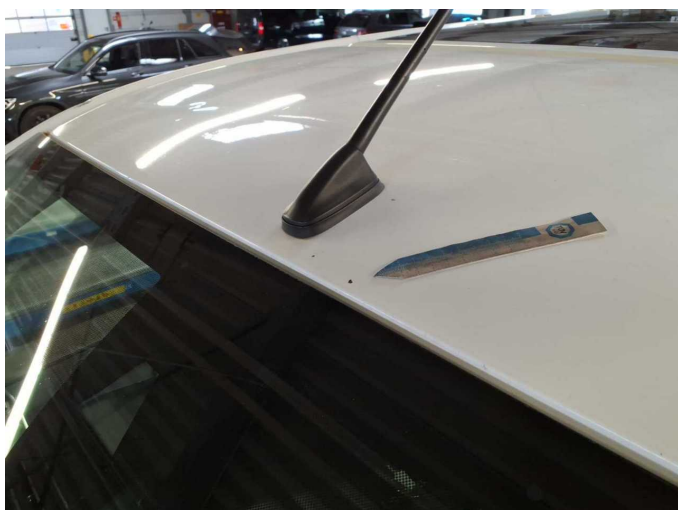
**Damage 19:** Roof: Roof - Dent / paintcoat damage - Paint

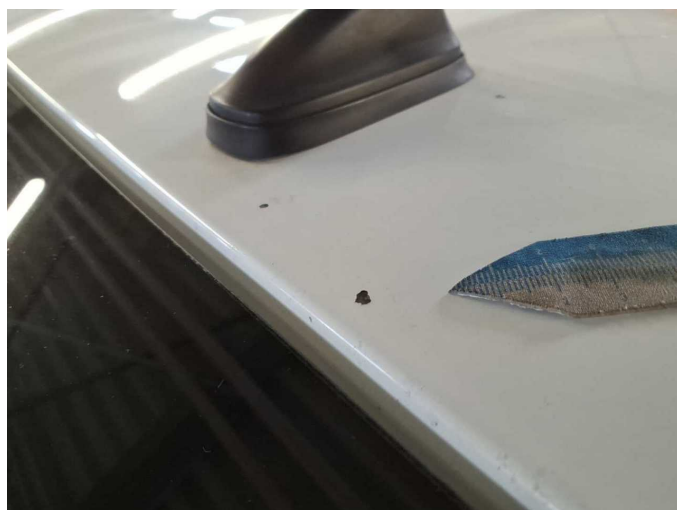
**Damage 19:** Roof: Roof - Dent / paintcoat damage - Paint
