Expertise

Protocol number: 46371487  
Order No. / Reference: 26534020-1  
Inspection date: 30 Jun 2026

Manufacturer: Opel

Model: Zafira Life 2.0 D M Aut. Elegance

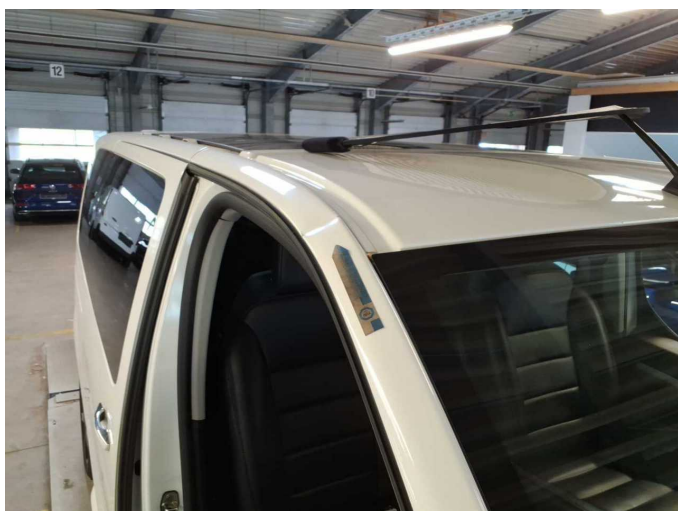
| No. | Component group | Description |
|---|---|---|
| 20 | Body | A-pillar - right side - Deformed - Paint |

**Damage 20:** Body: A-pillar - right side - Deformed - Paint

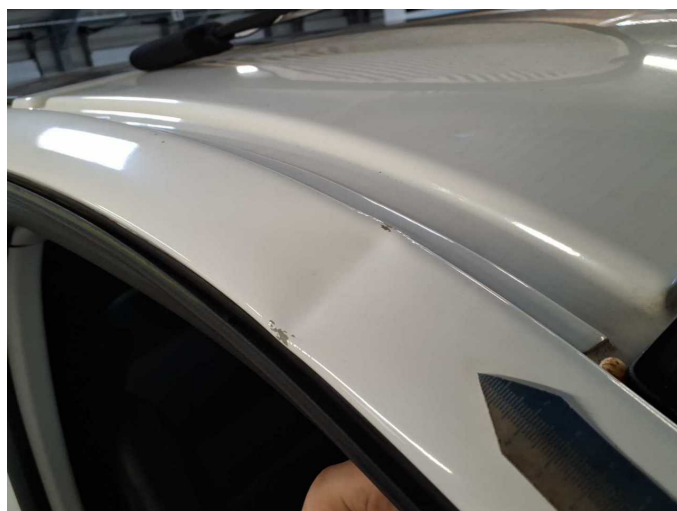
**Damage 20:** Body: A-pillar - right side - Deformed - Paint

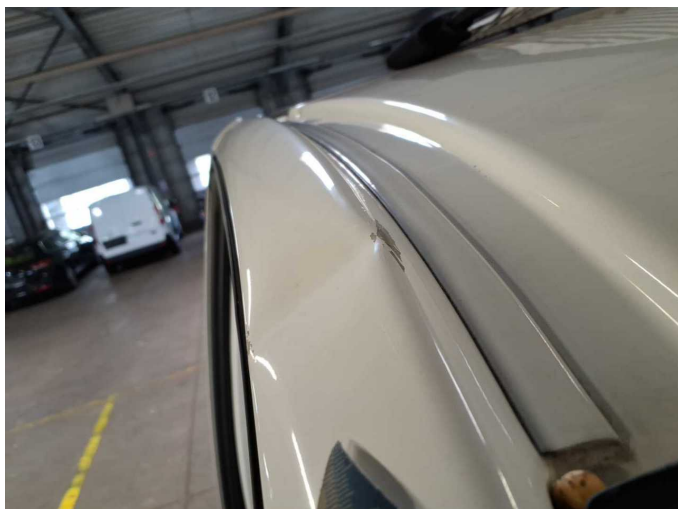
**Damage 20:** Body: A-pillar - right side - Deformed - Paint

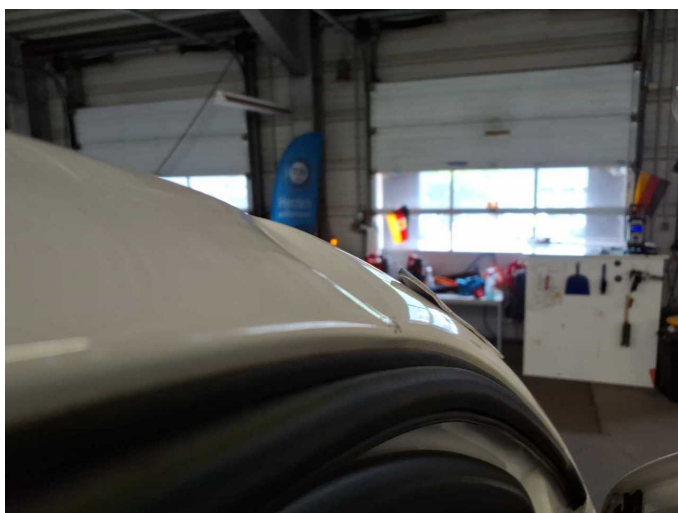
**Damage 20:** Body: A-pillar - right side - Deformed - Paint

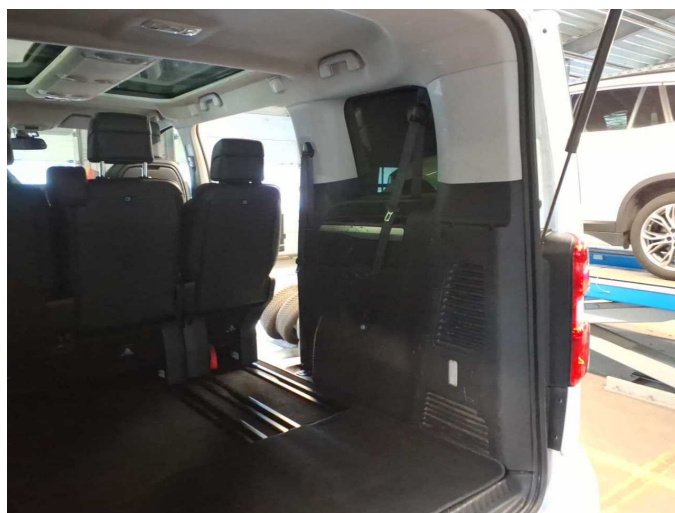
| No. | Component group | Description |
|---|---|---|
| 21 | Side panel - rear right side | Interior trim - Scratched - Replace |

**Damage 21:** Side panel - rear right side: Interior trim - Scratched - Replace

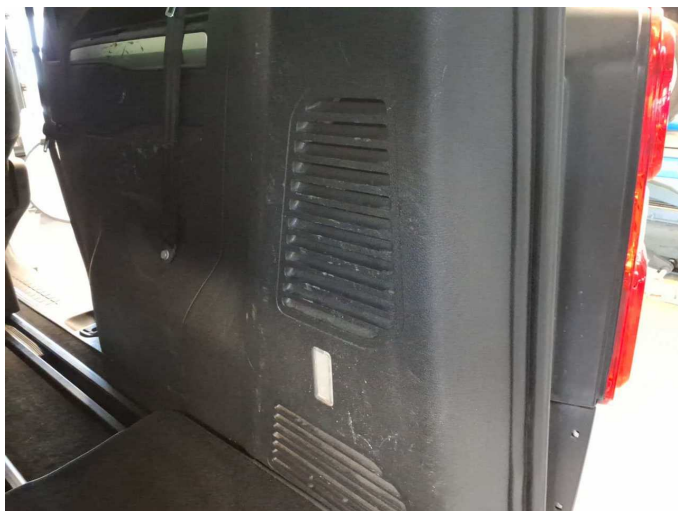
**Damage 21:** Side panel - rear right side: Interior trim - Scratched - Replace

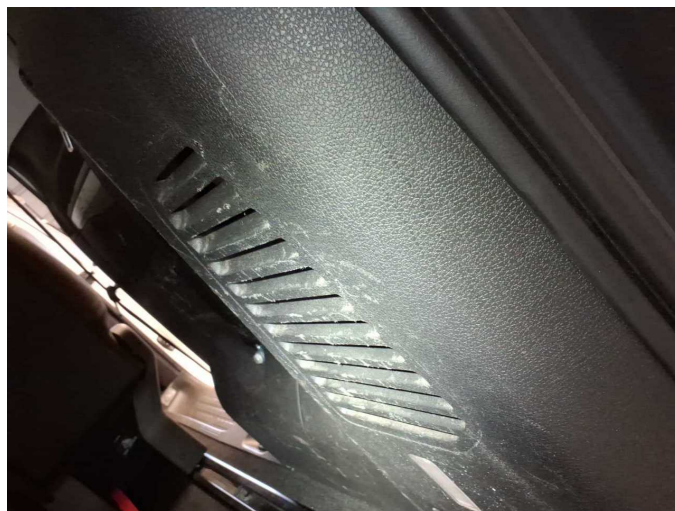
**Damage 21:** Side panel - rear right side: Interior trim - Scratched - Replace

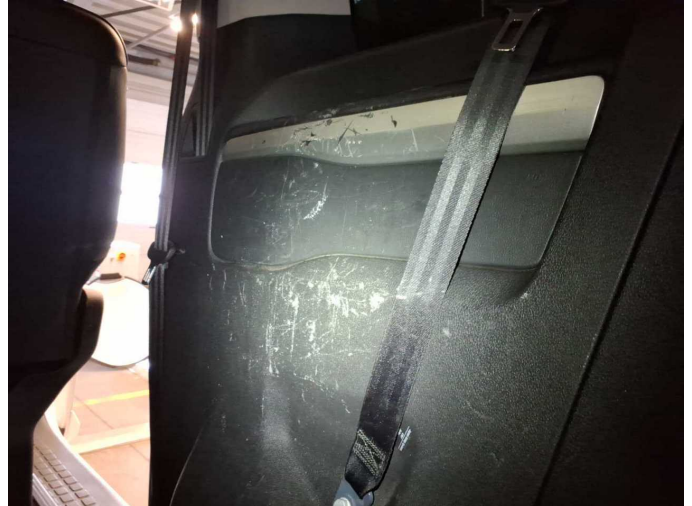
**Damage 21:** Side panel - rear right side: Interior trim - Scratched - Replace

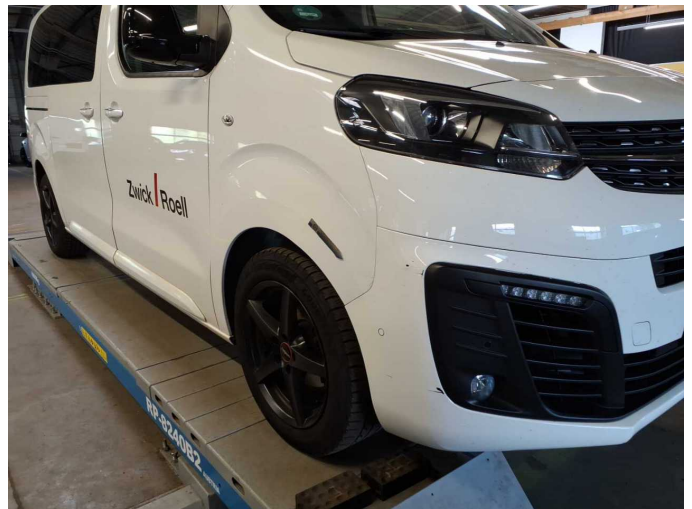
| No. | Accident |
|---|---|
| 1 | Front, Side right |

**Accident 1:** Front, Side right
