## Expertise

Protocol number: 45868473  
Order No. / Reference: 25933197  
Inspection date: 29 May 2026

Manufacturer: Mercedes-Benz

Model: Vito 116 CDI Lang HA PRO

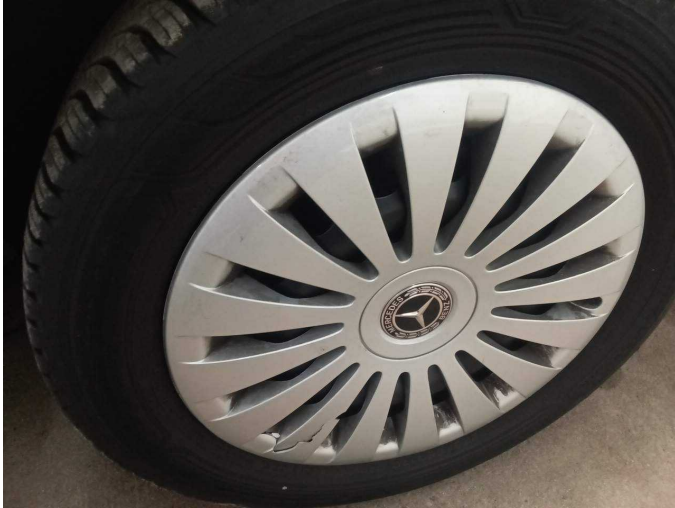
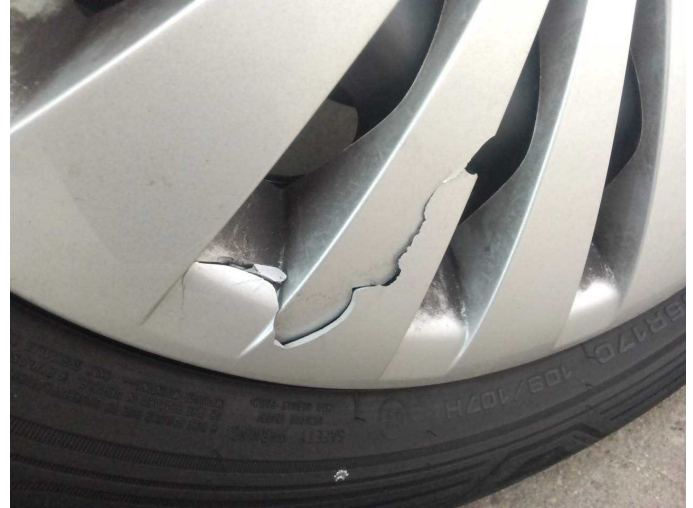
No.	Component group	Description
1	Misc.	Inspection / maintenance - No evidence - No deduction
2	Wheel / tyres	Wheel cover - rear left side - Broken / torn - Replace
3	Rear bumper	Rear bumper - Scratched - Smart repair

**Damage 2:** Wheel / tyres: Wheel cover - rear left side - Broken / torn - Replace

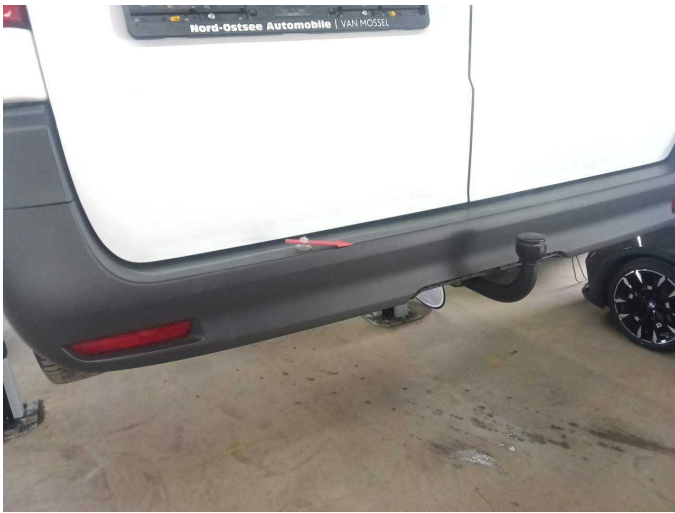
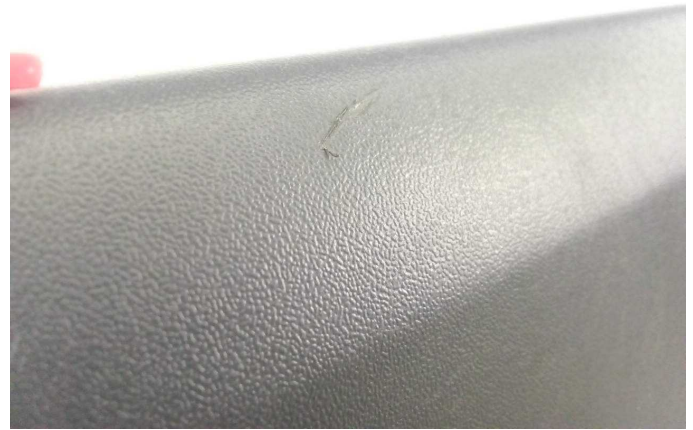
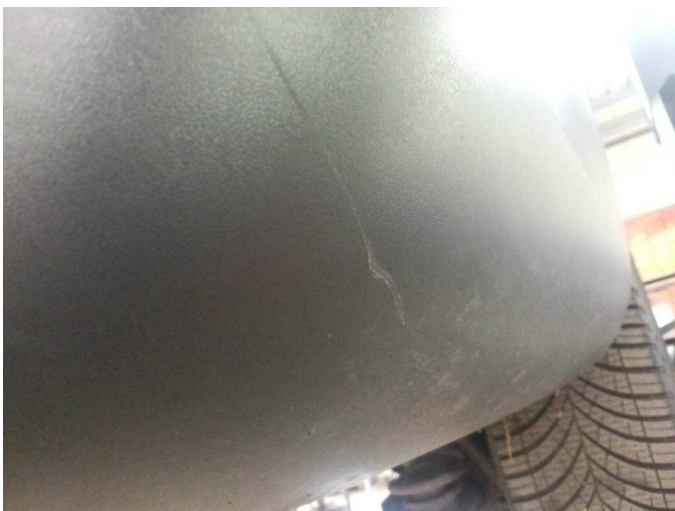
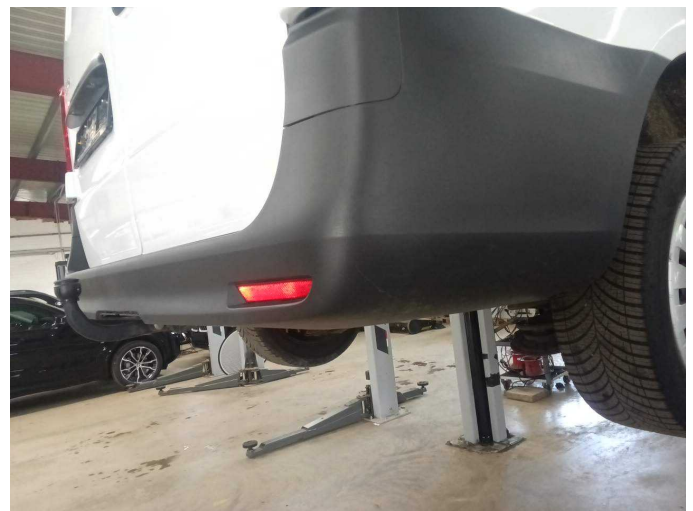
**Damage 3:** Rear bumper: Rear bumper - Scratched - Smart repair
