Expertise

Protocol number: 46702610  
Order No. / Reference: 26809236  
Inspection date: 23 Jul 2026

Manufacturer: Volkswagen

Model: Touran 2.0 TDI SCR DSG Comfortline

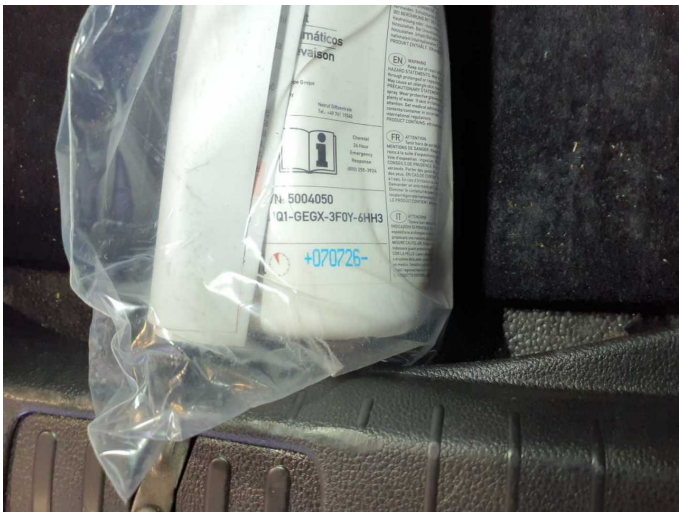
| No. | Component group | Description |
|---|---|---|
| 1 | Equipment | Tirefit filler - Expired - Replace |

Damage 1: Equipment: Tirefit filler - Expired - Replace

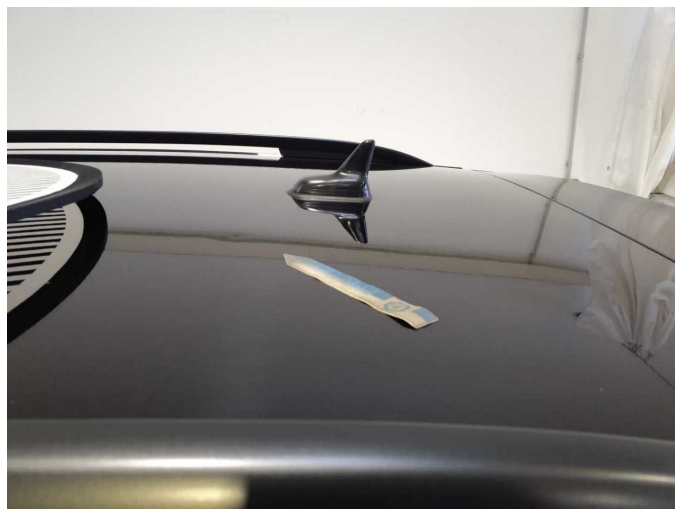
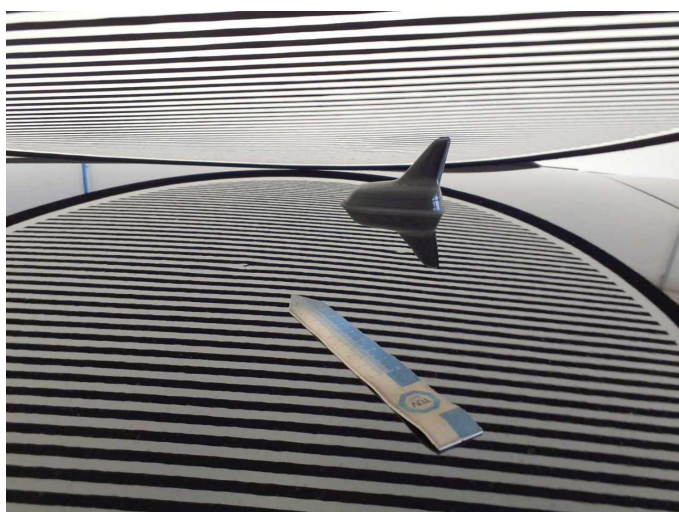
| No. | Component group | Description |
|---|---|---|
| 3 | Roof | Roof - dent(s) - Smooth repair work |

**Damage 3:** Roof: Roof - dent(s) - Smooth repair work

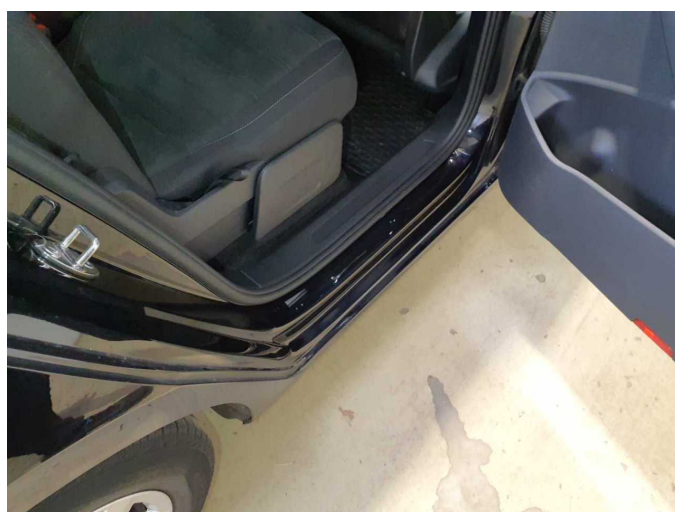
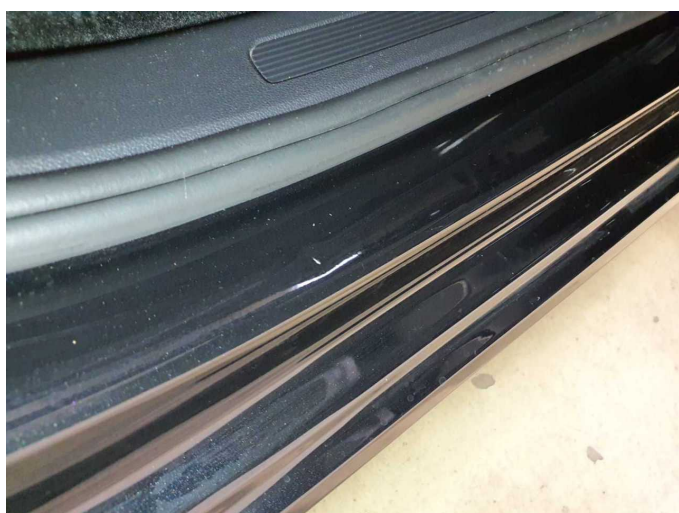
| No. | Component group | Description |
|---|---|---|
| 4 | Side panel - rear right side | Sill - Dent / paintcoat damage - Smart repair |

**Damage 4:** Side panel - rear right side: Sill - Dent / paintcoat damage - Smart repair

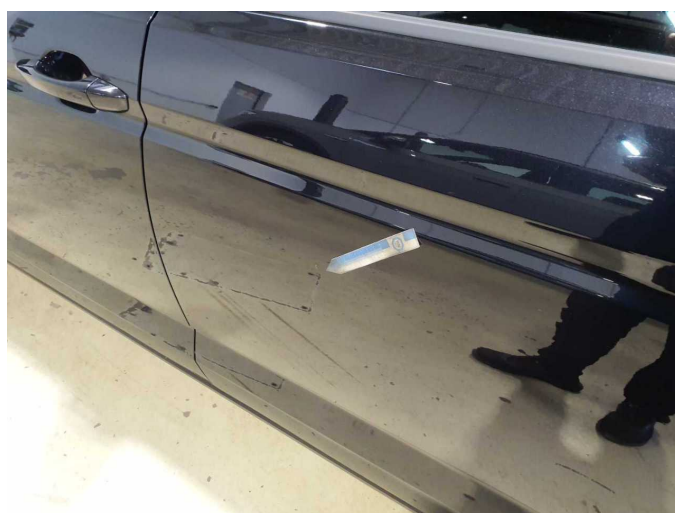
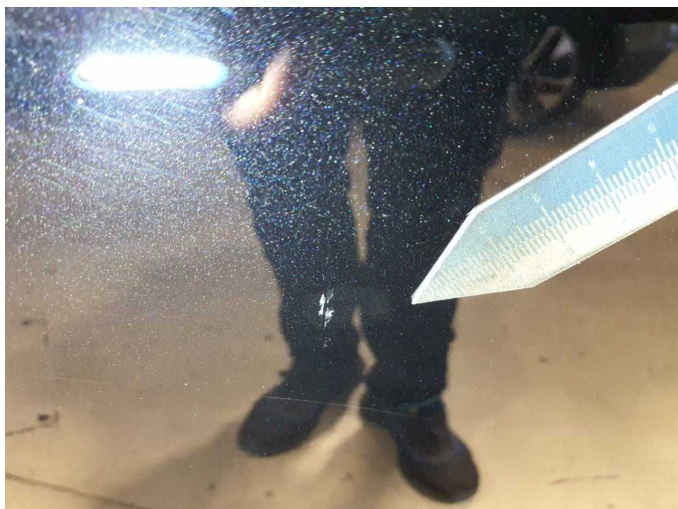
| No. | Component group | Description |
|---|---|---|
| 5 | Door - rear left side | Door - Scratch(es) - Smart repair |

**Damage 5:** Door - rear left side: Door - Scratch(es) - Smart repair

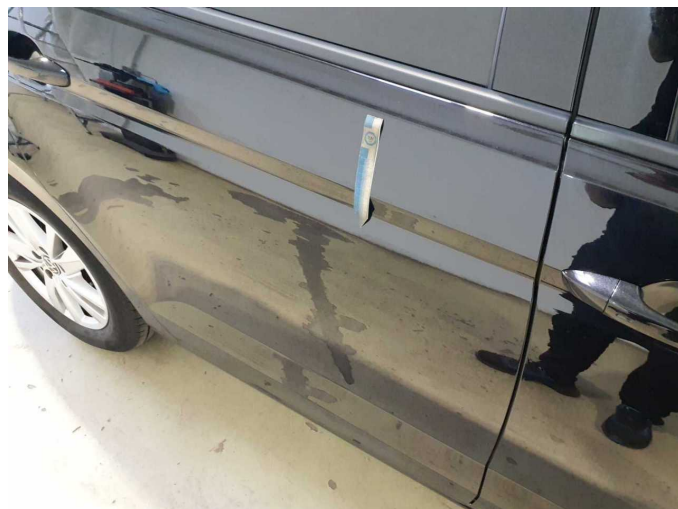
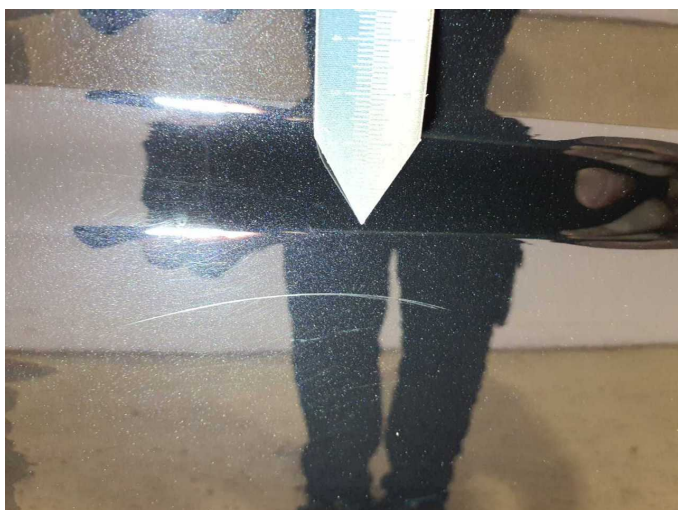
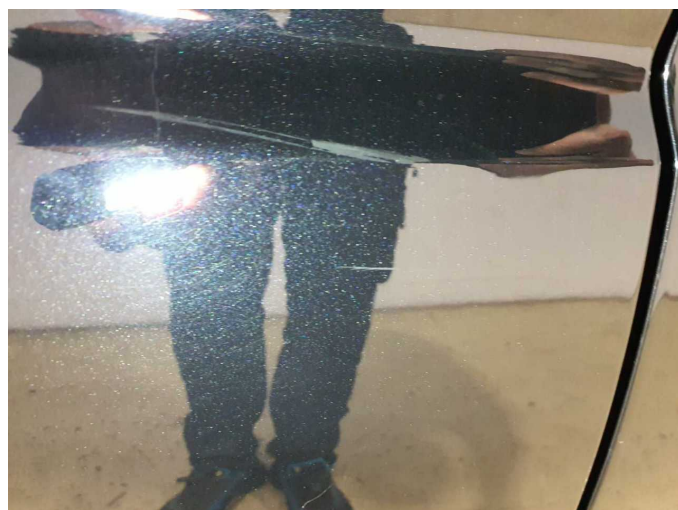
| No. | Component group | Description |
|---|---|---|
| 6 | Door - rear right side | Door - Scratch(es) - Paint |

**Damage 6:** Door - rear right side: Door - Scratch(es) - Paint

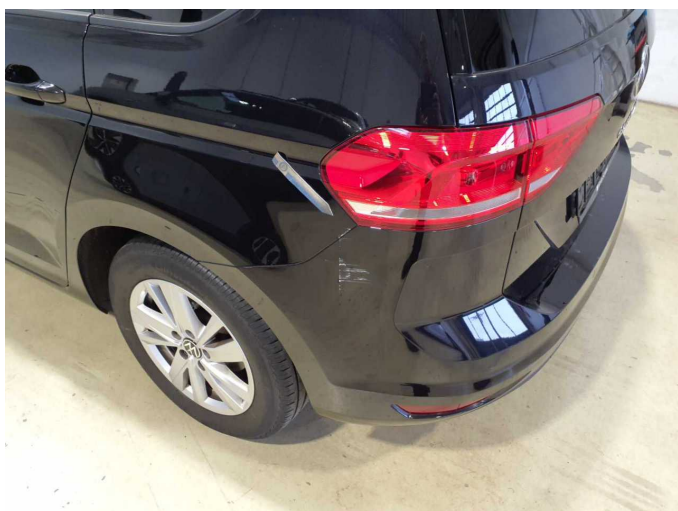
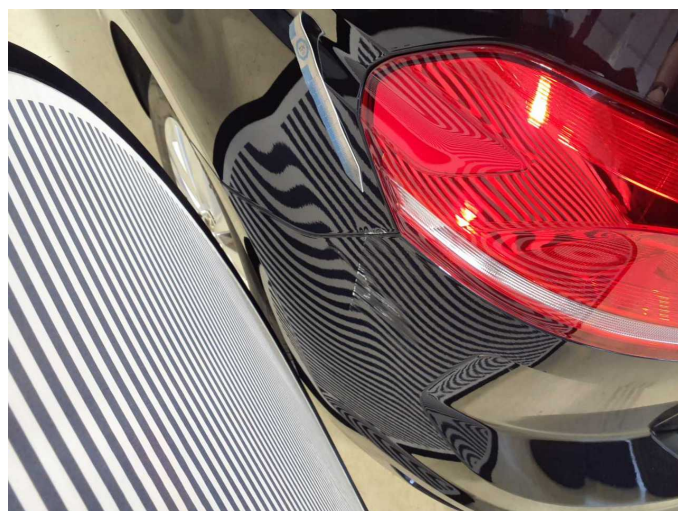
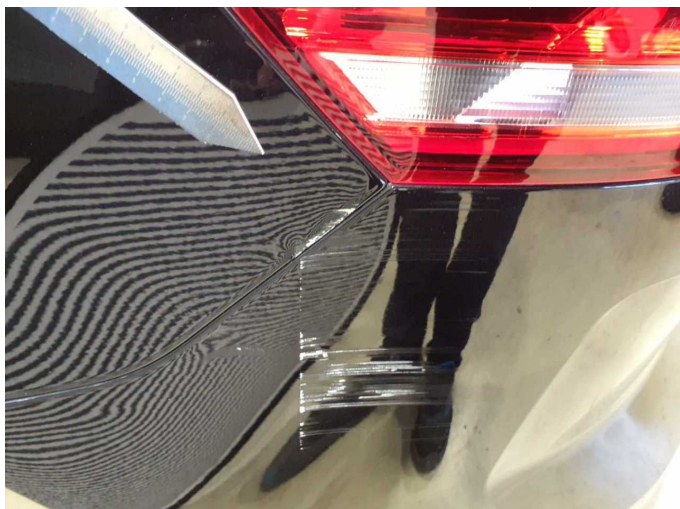
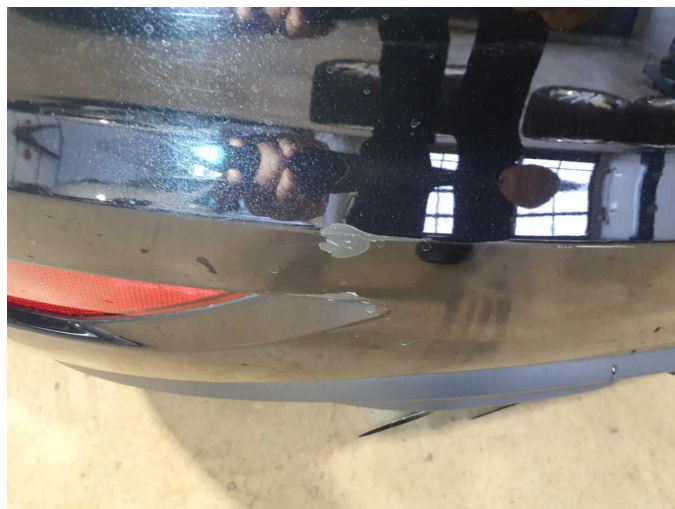
| No. | Accident |
|---|---|
| 1 | Side - left |

**Accident 1:** Side - left

**Accident 1: Side - left**

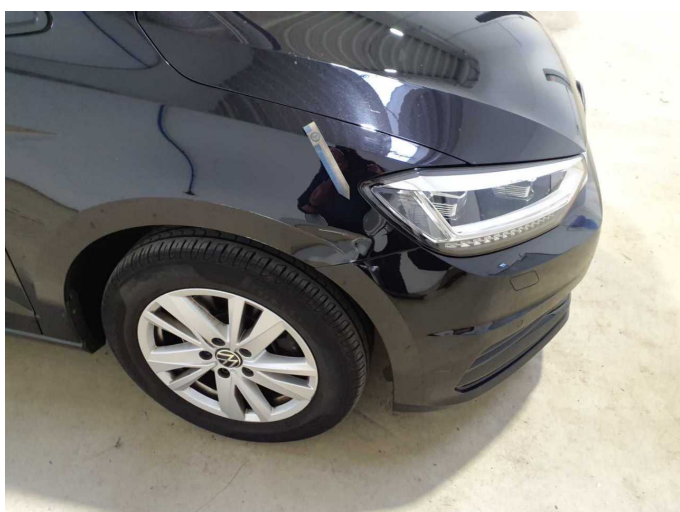
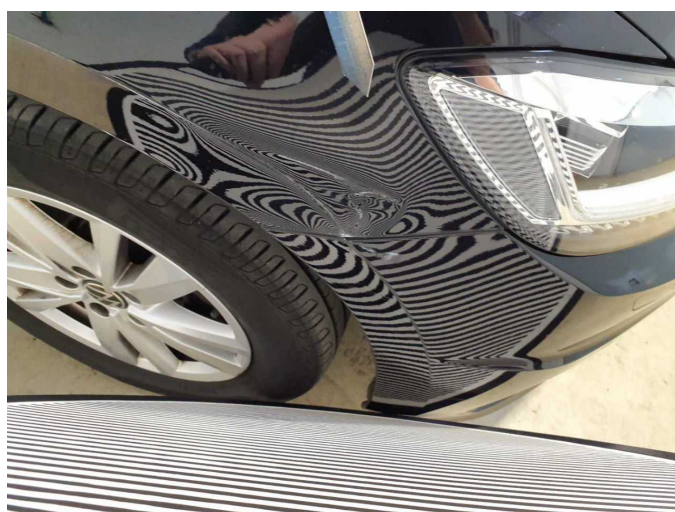
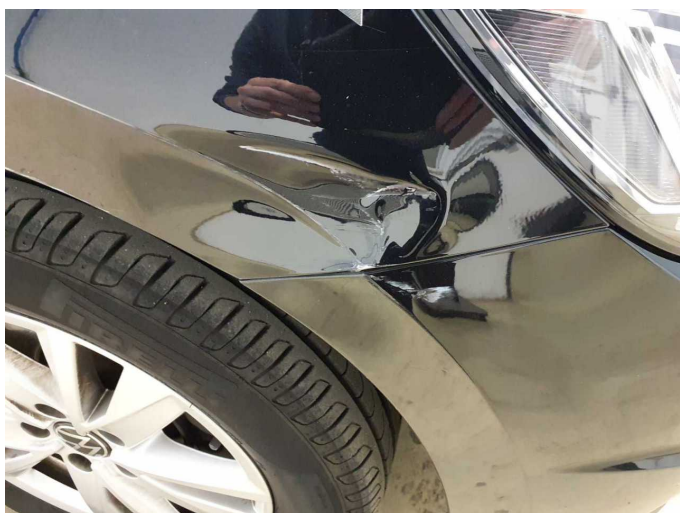
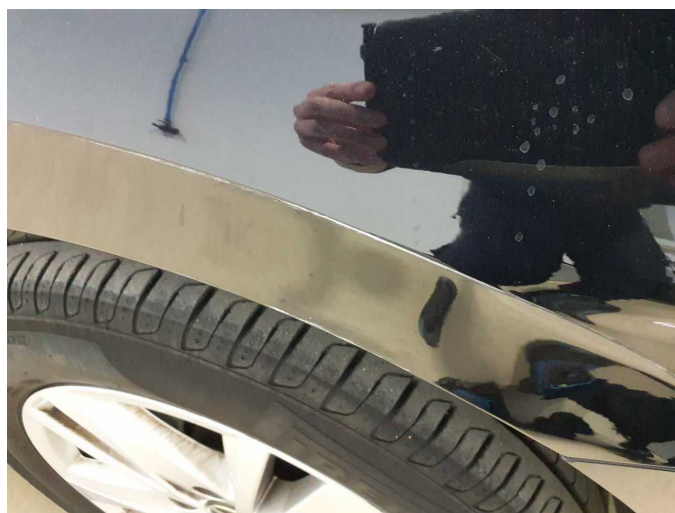
| No. | Accident |
|---|---|
| 2 | Side right |

**Accident 2: Side right**
