## Expertise

Protocol number: 46304782  
Order No. / Reference: 26577844  
Inspection date: 30 Jun 2026

Model: Transit 350 L3 VA Trend

VIN: WF0AXXTTRALC57376

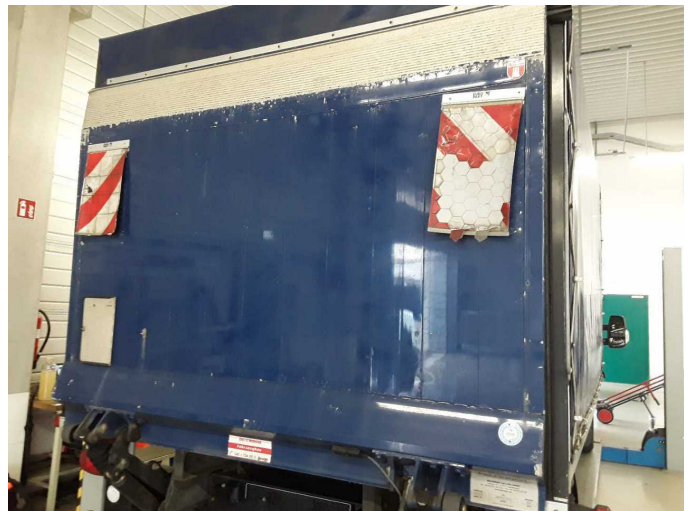
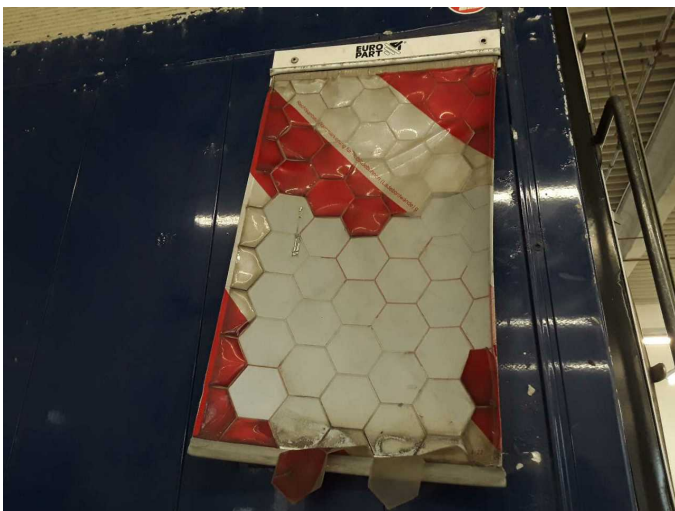
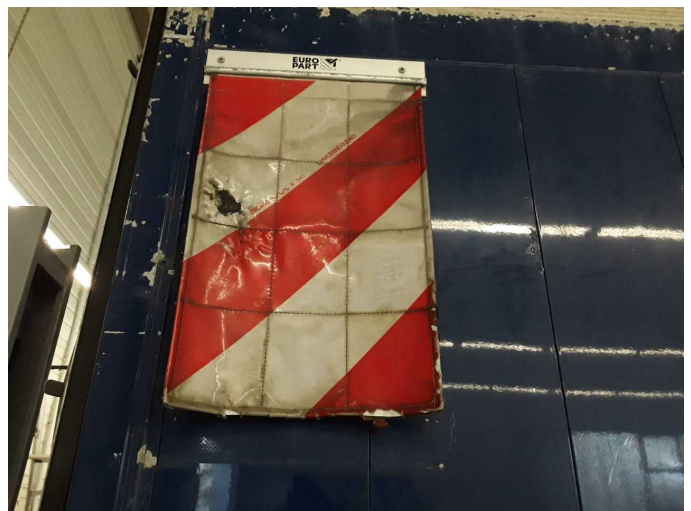
Damage 1: Misc.: Misc. (2x Warnwimpel) - Broken / torn - Replace

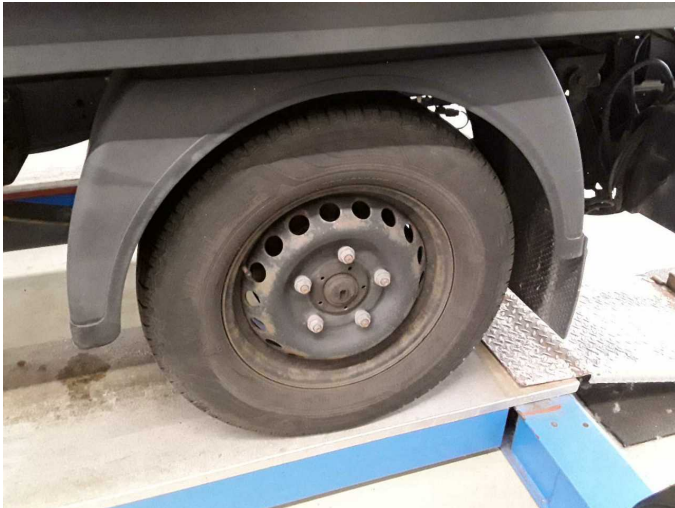
**Damage 2:** Wheel / tyres: Wheel cover - rear left side - Missing - Replace

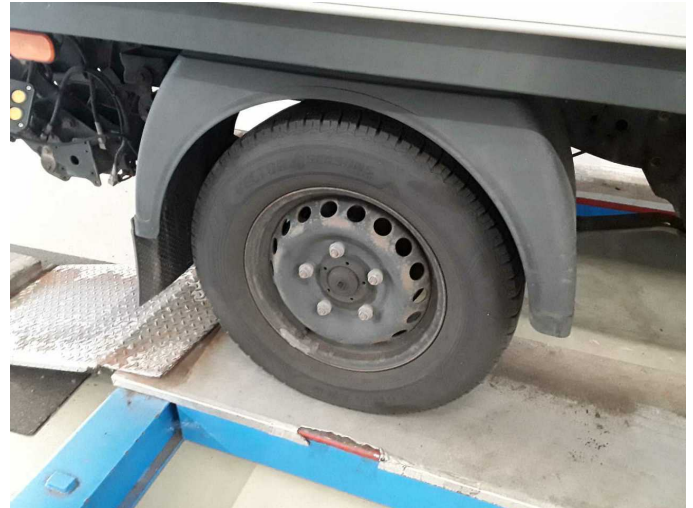
**Damage 3:** Wheel / tyres: Wheel cover - rear right side - Missing - Replace

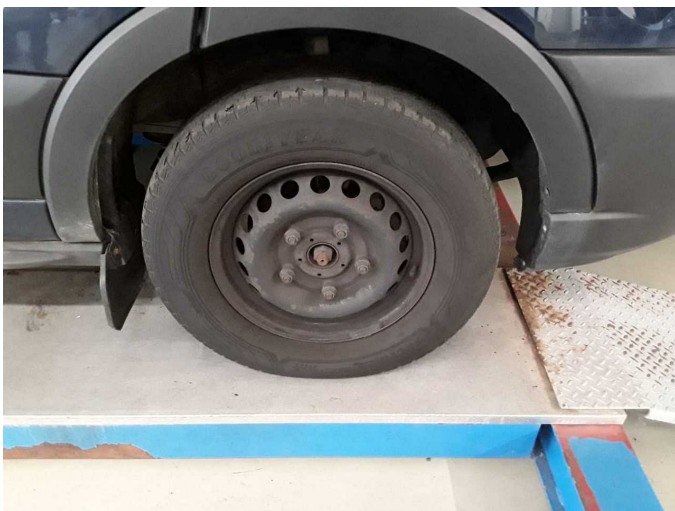
**Damage 4:** Wheel / tyres: Wheel cover - front right side - Missing - Replace

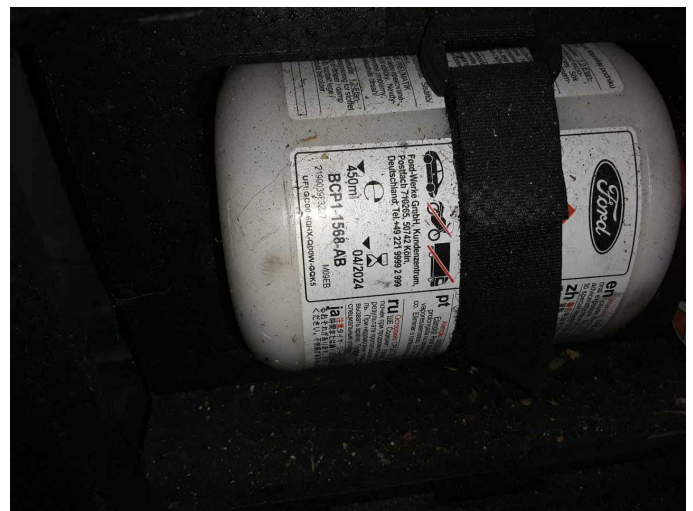
**Damage 5:** Equipment: Tirefiller - Expired - Replace

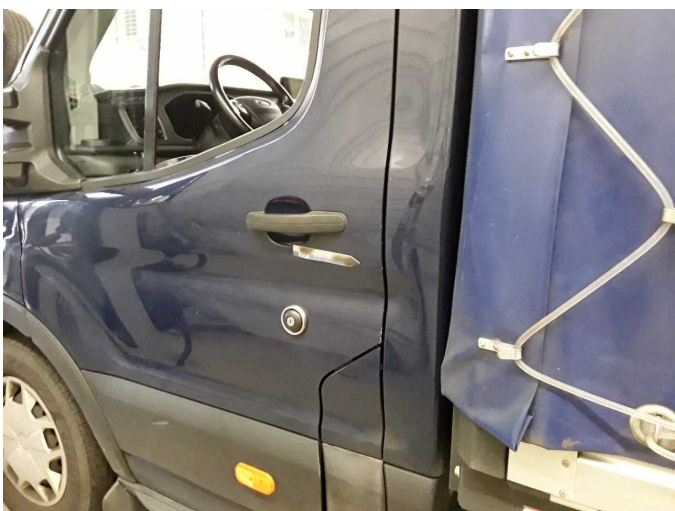
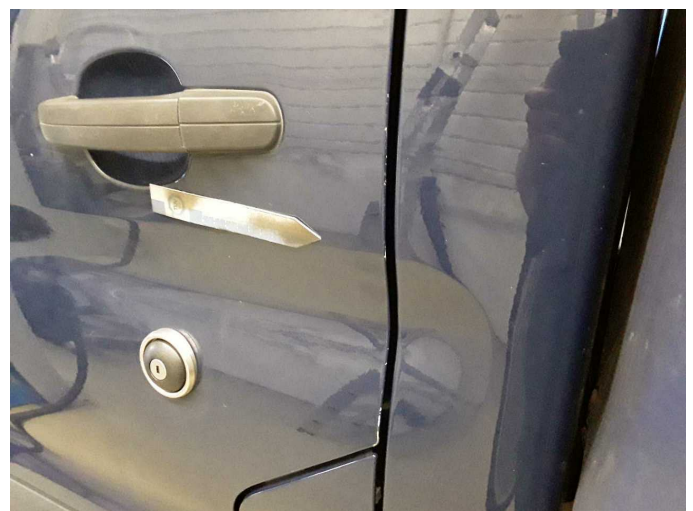
**Damage 6:** Door - front left side: Door edge - Scratch(es) - Smart repair

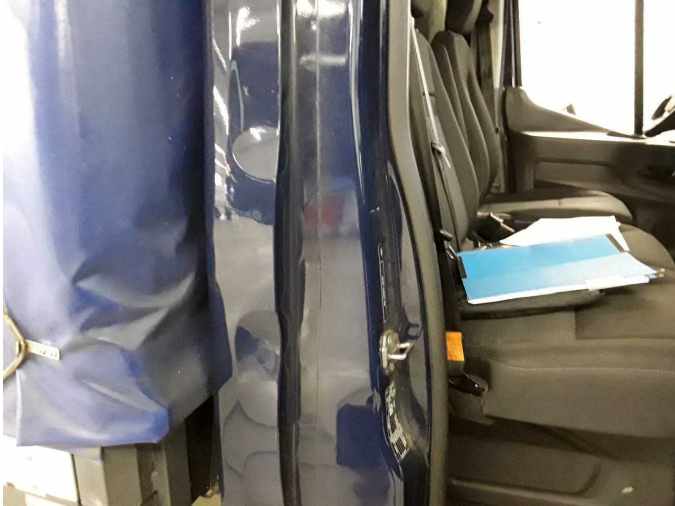
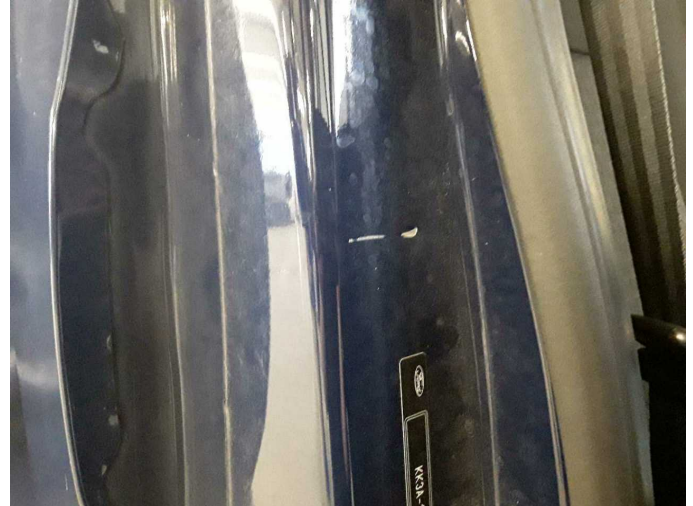
**Damage 7:** Body: B-pillar - right side - Scratch(es) - Smart repair

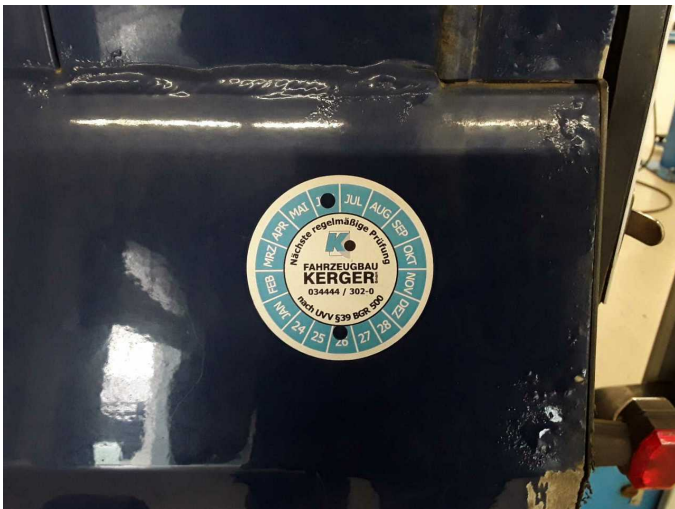
**Damage 8:** Misc.: Safety test (Ladebordwand 06/2026) - Due - Perform

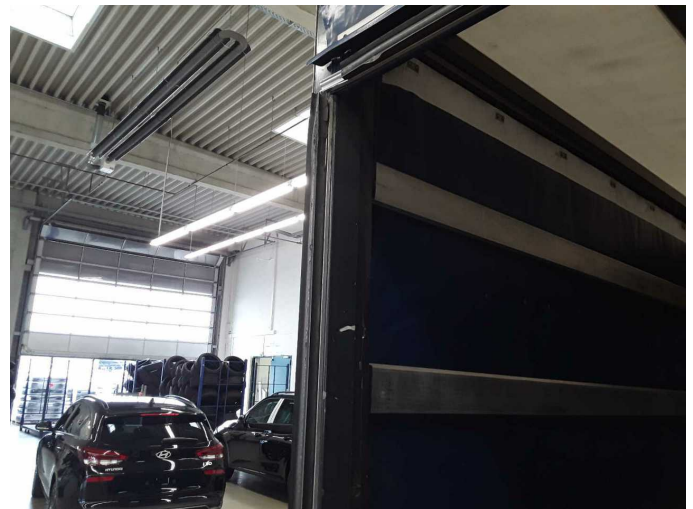
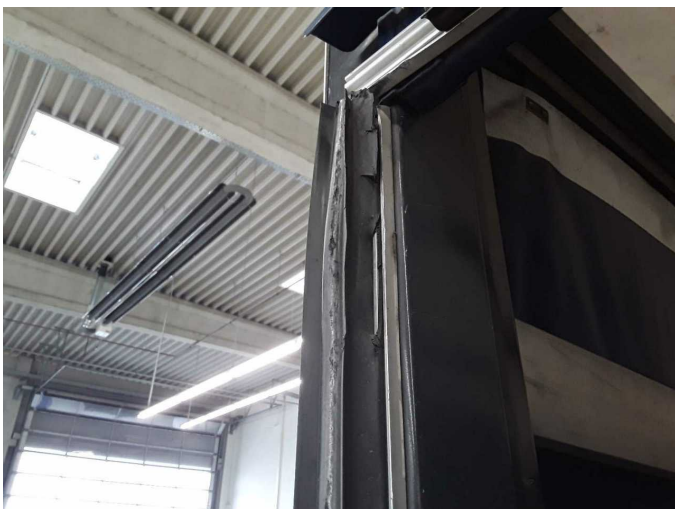
**Damage 9:** Misc.: Misc. (Portaldichtung links) - Broken / torn - Replace

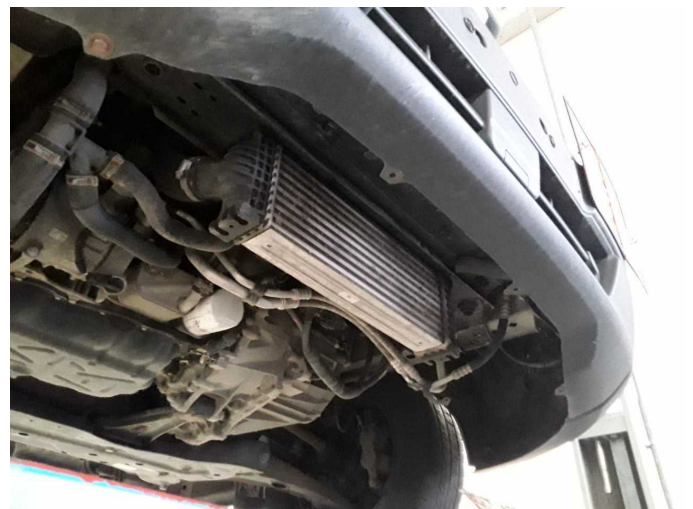
**Damage 10:** Front bumper: Spoiler (Luftabweiser) - Missing - Replace

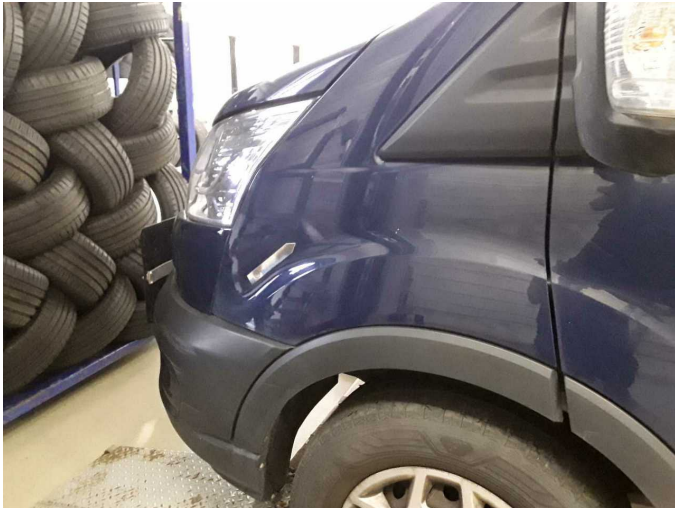
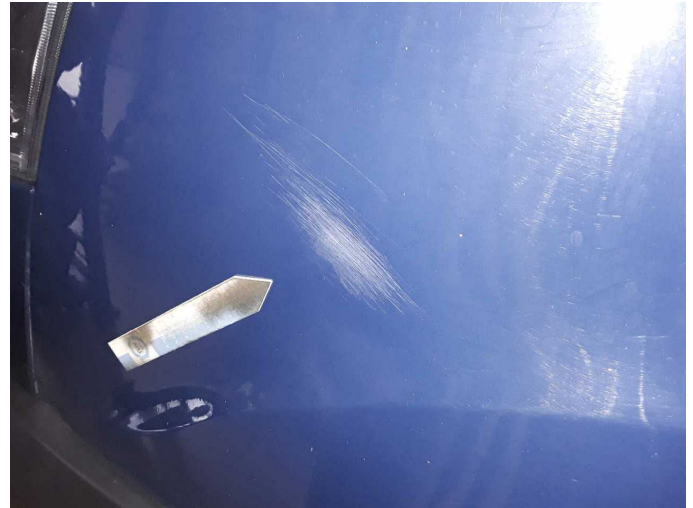
**Damage 11:** Mudguard - left side: Mudguard - left side - Scratch(es) - Smart repair

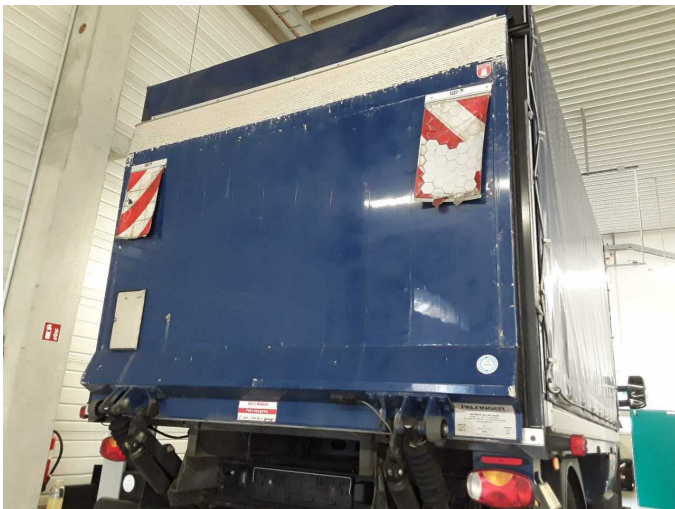
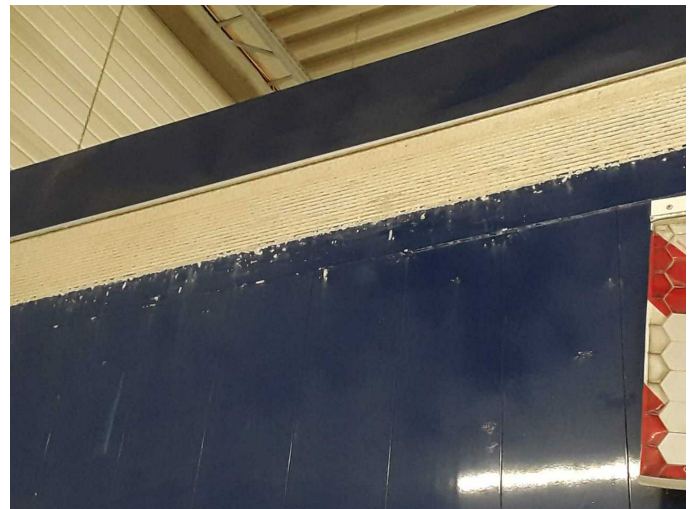
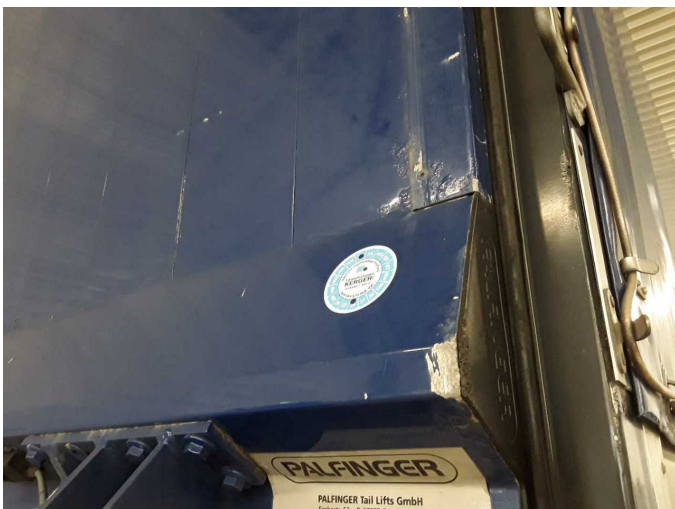
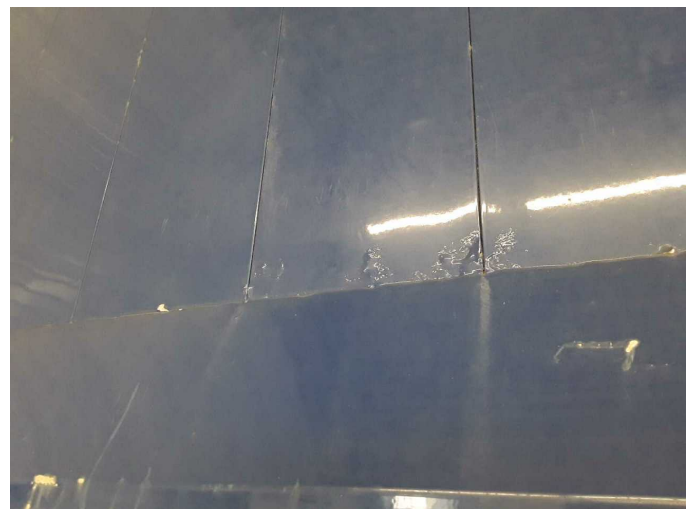
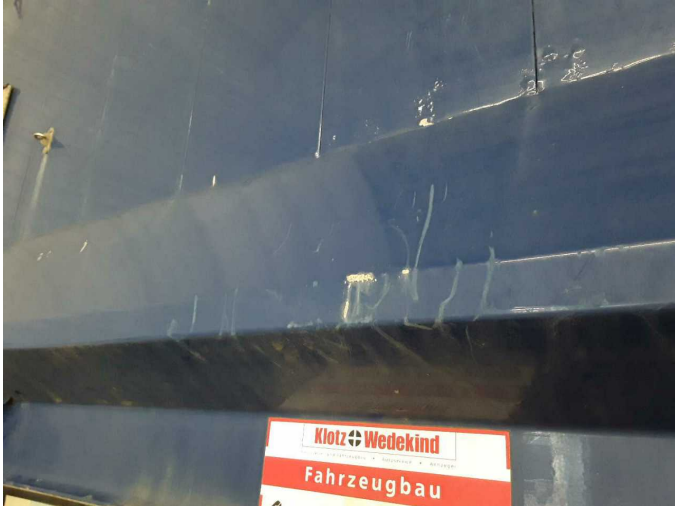
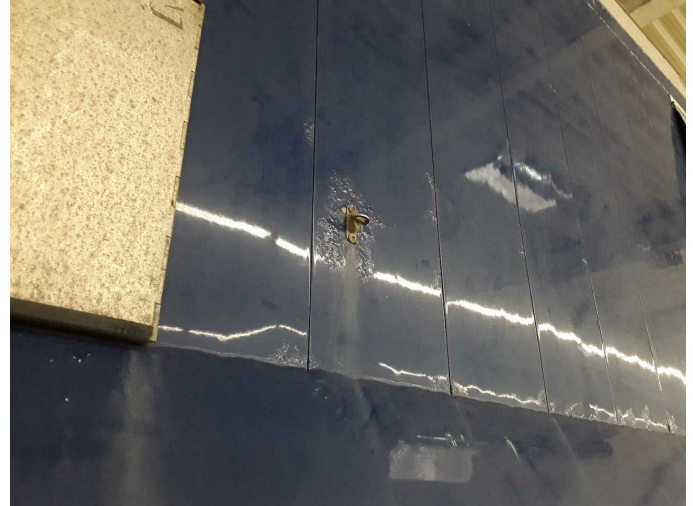
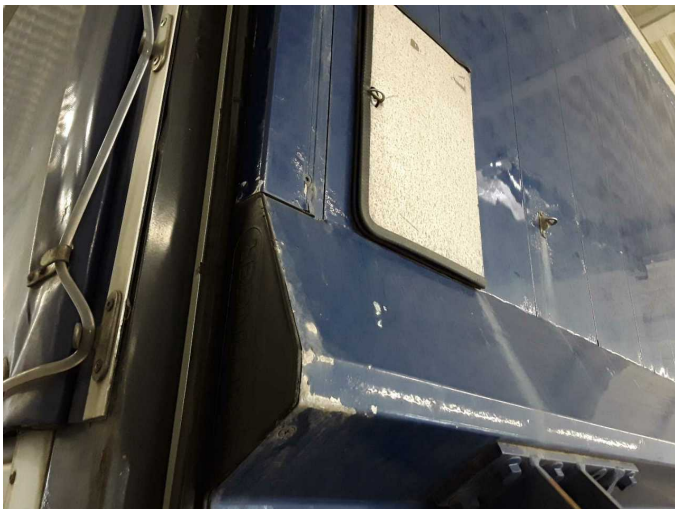
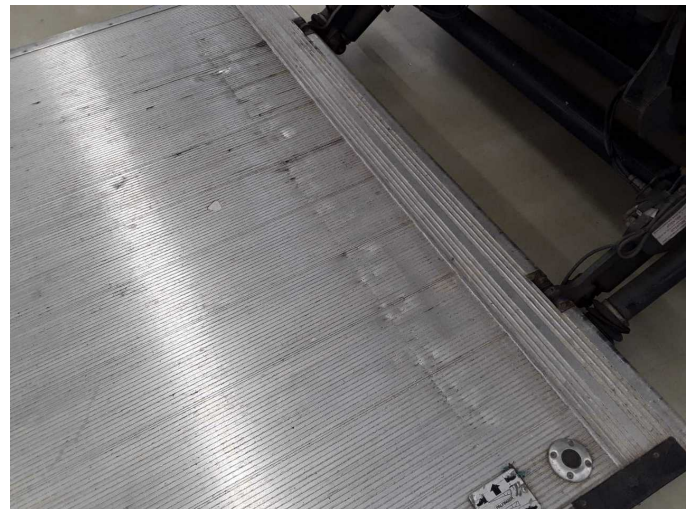
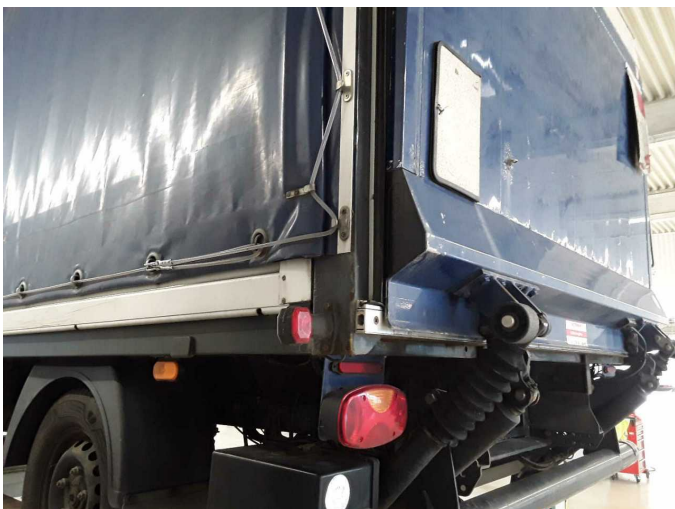
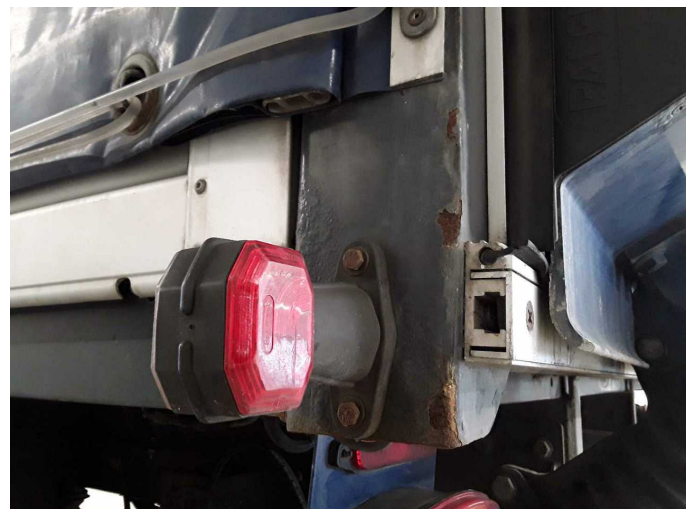
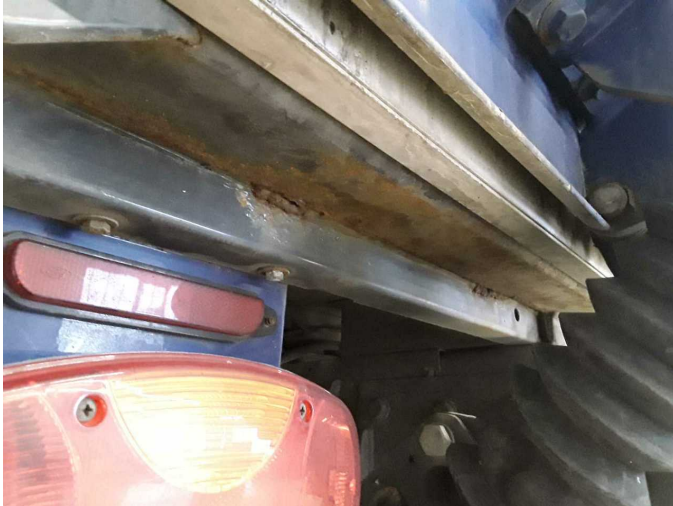
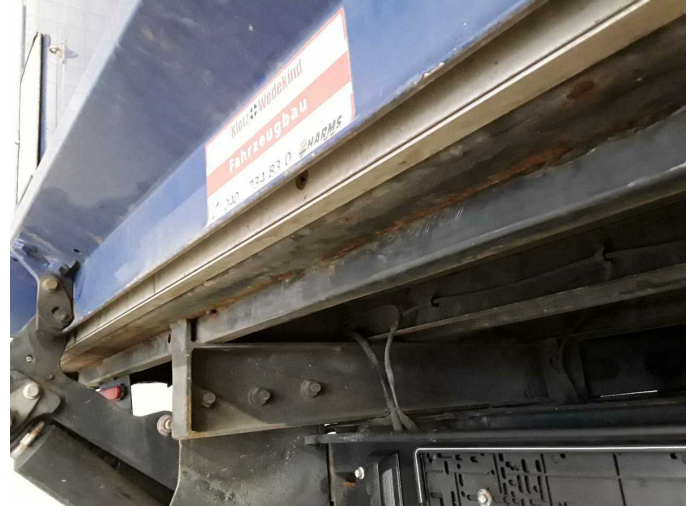
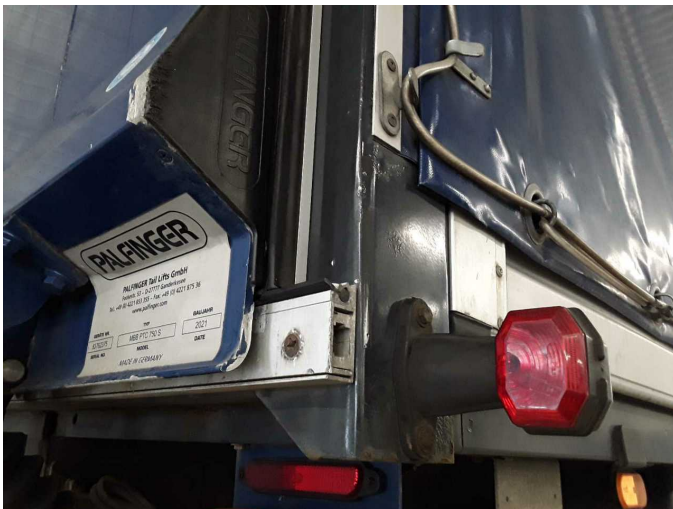
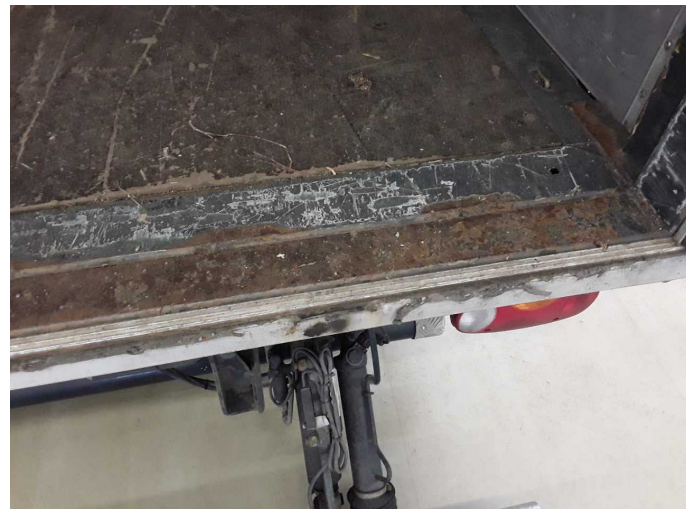
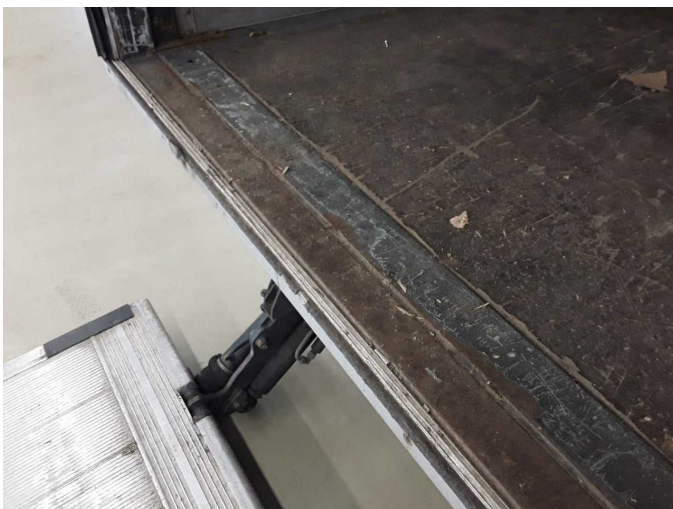
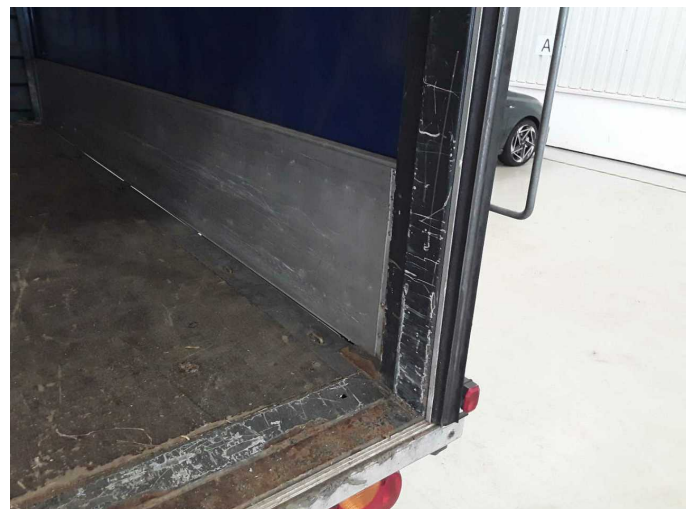
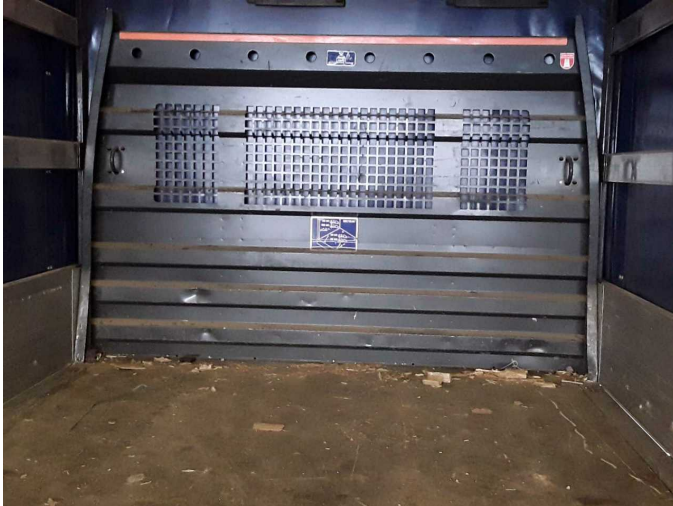
**Damage 12:** Misc.: Misc. (Planen-/Kofferaufbau) - Corrosion - Loss in value

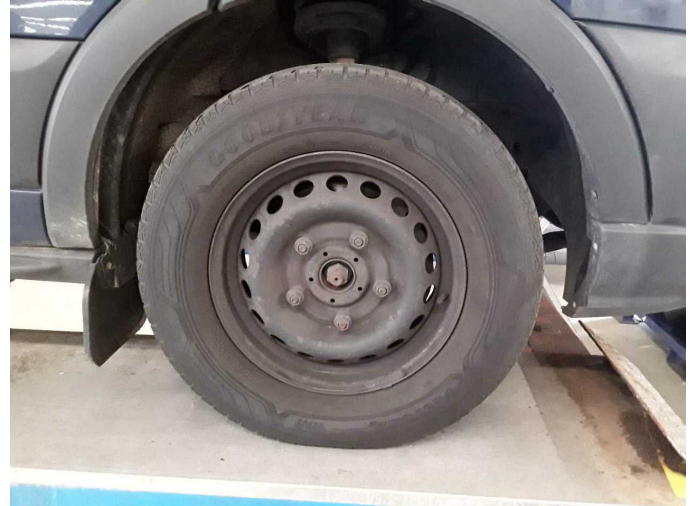
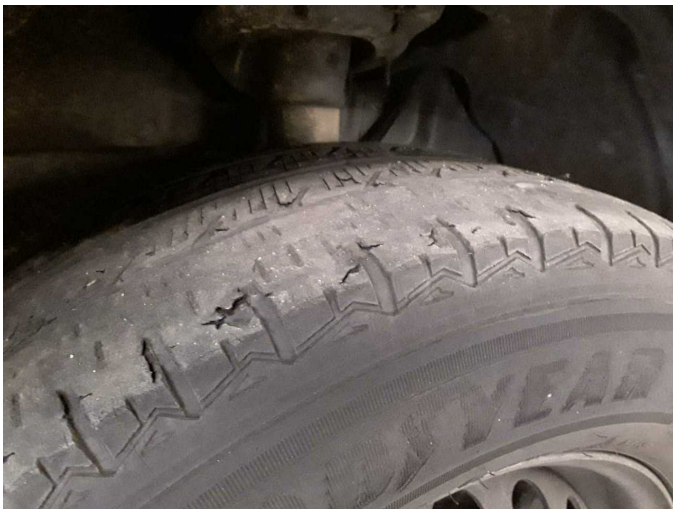
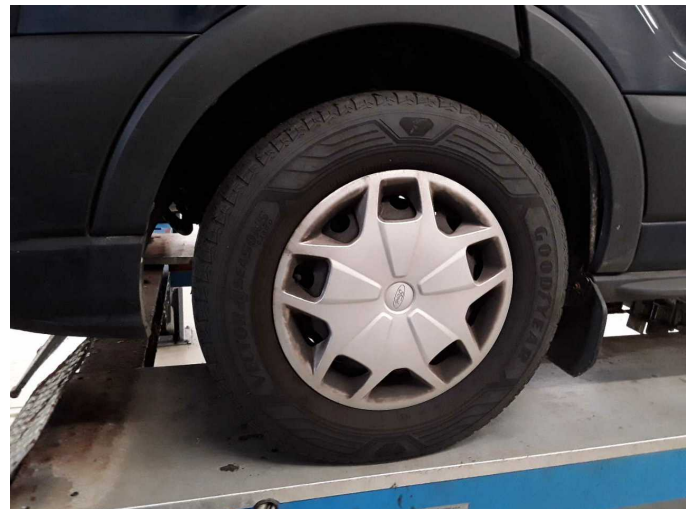
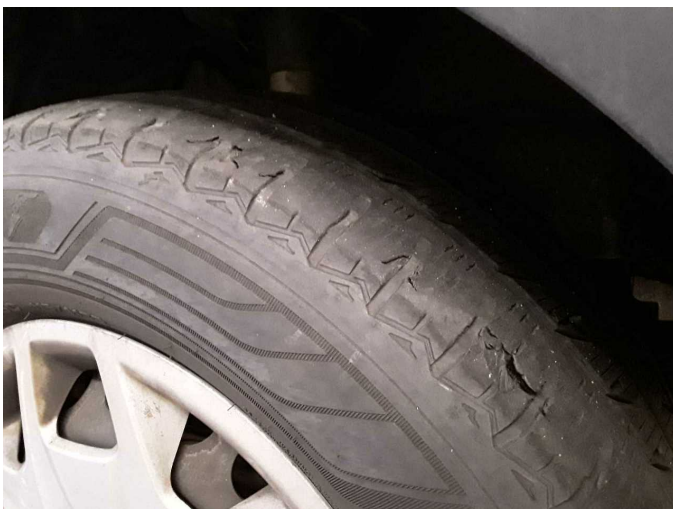
**Damage 13:** Wheel / tyres: Tyre - front - Broken / torn - Replace

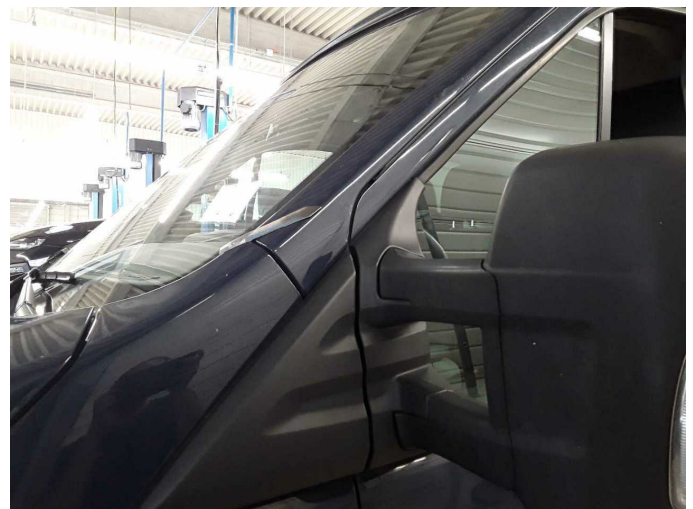
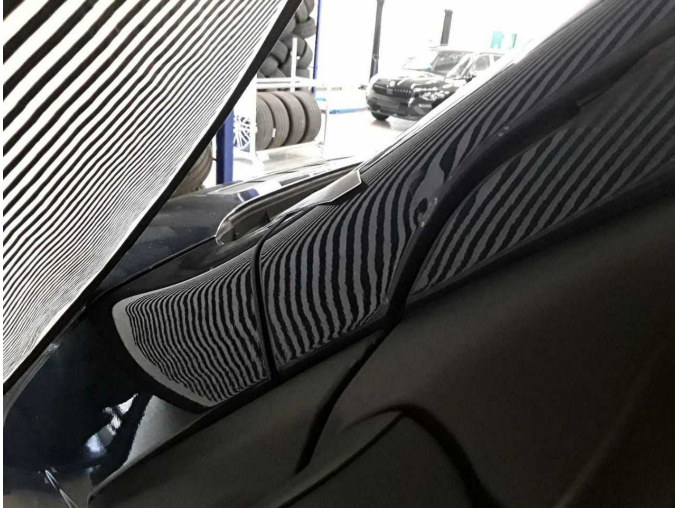
**Damage 14:** Body: A-pillar - left side - Dent / paintcoat damage - Repair and paint

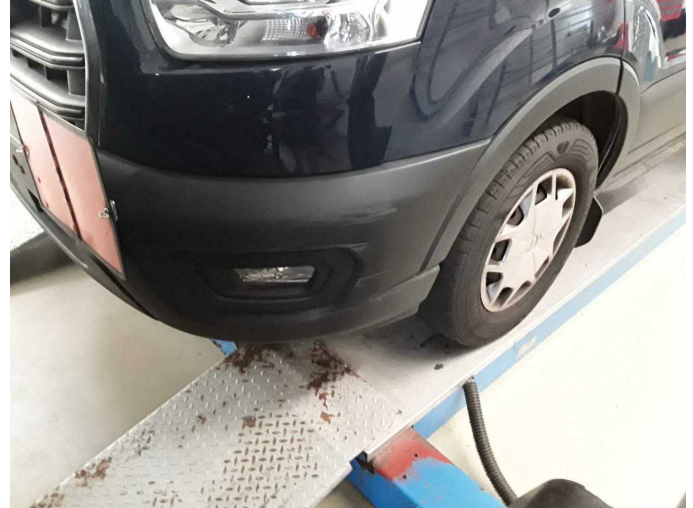
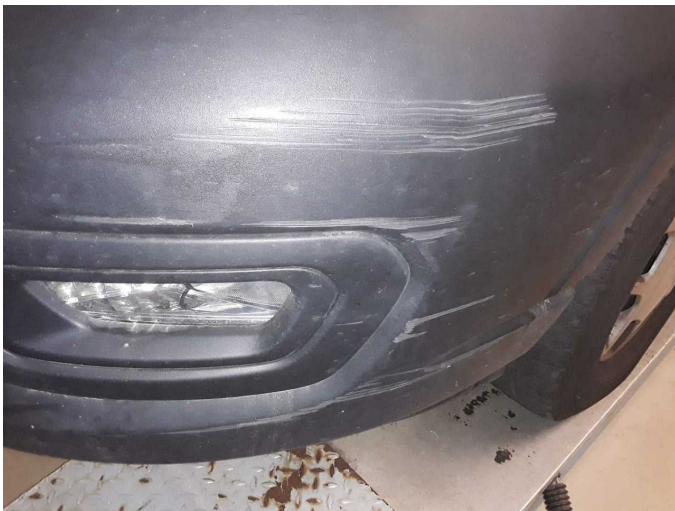
**Damage 15:** Front bumper: Front bumper (Unterteil) - Scratched - Replace

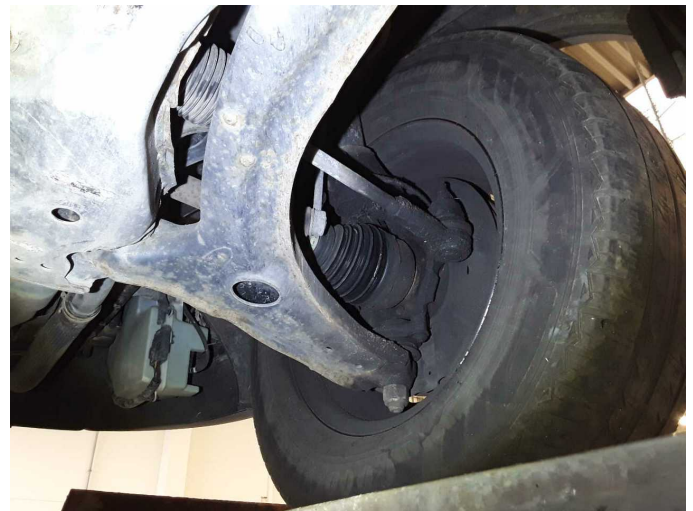
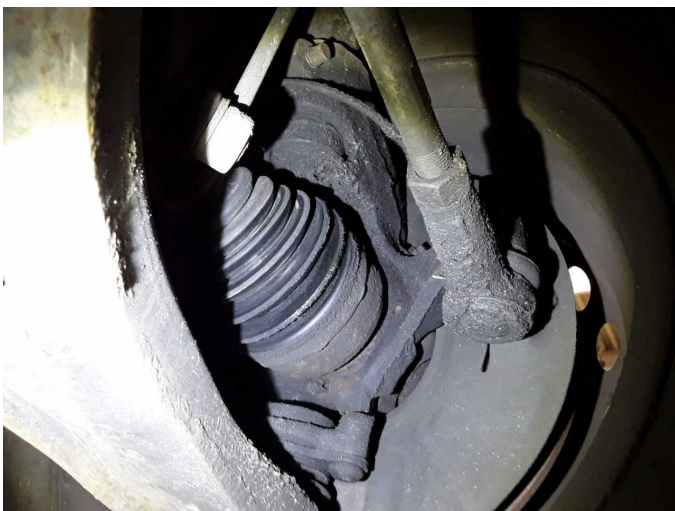
**Damage 16:** Drive train: Sleeve prop shaft - front right side - Leaking - Replace

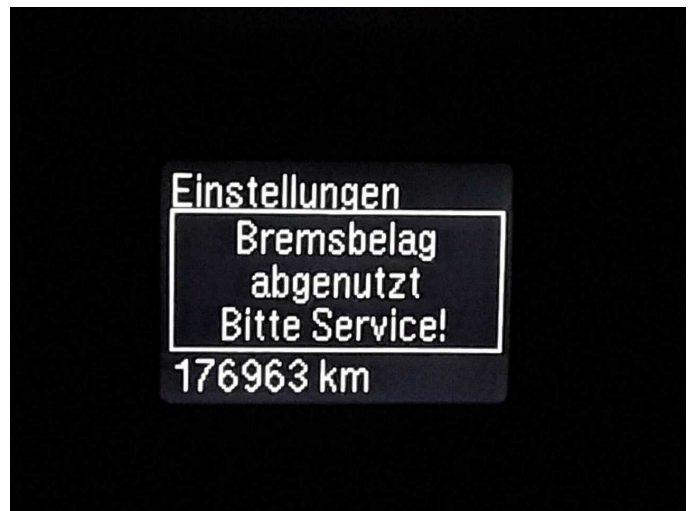
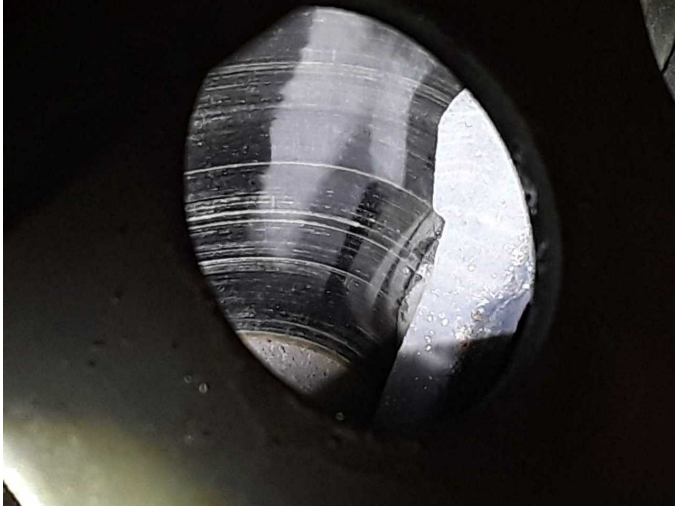
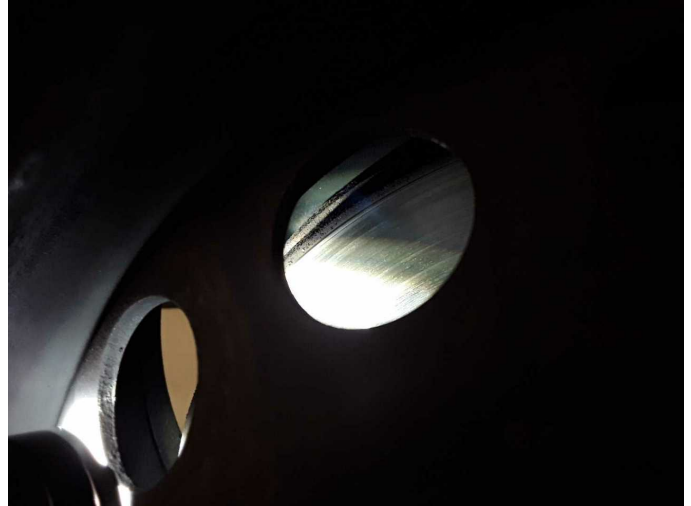
**Damage 17:** Braking system: Brake discs and brake pads - front - Worn - Replace

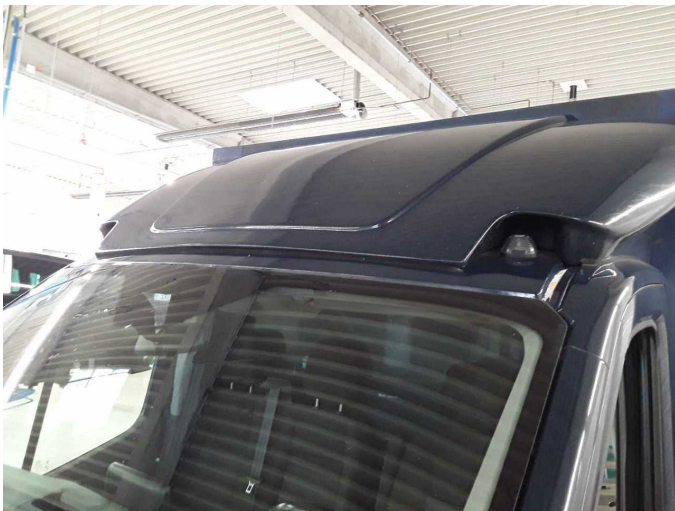
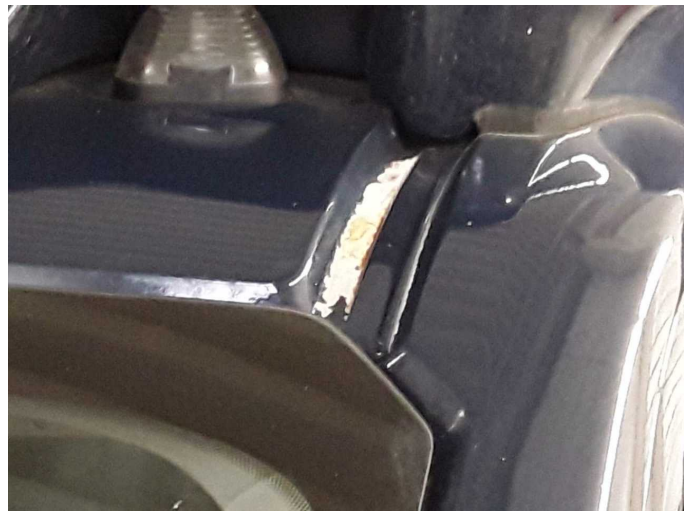
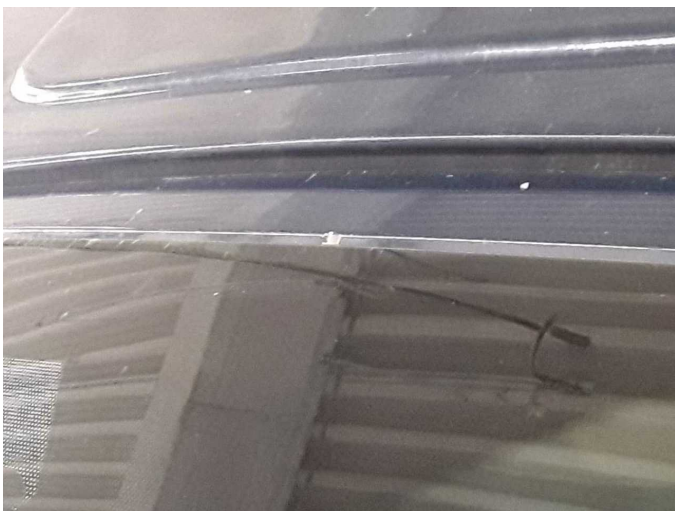
**Damage 18:** Roof: Roof - Paint defect - Paint

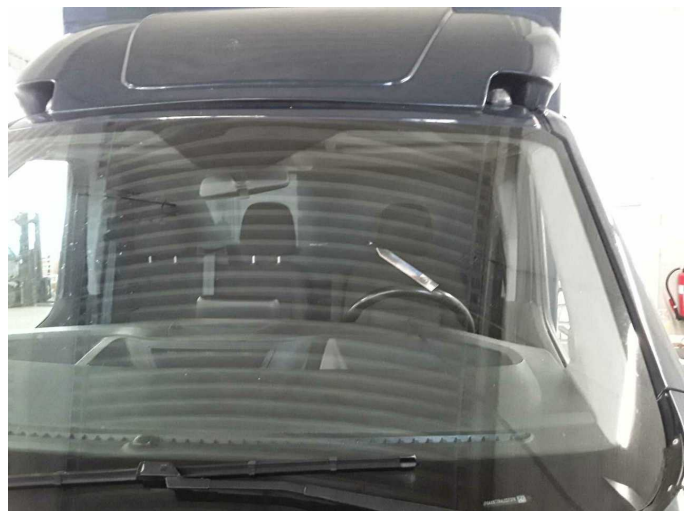
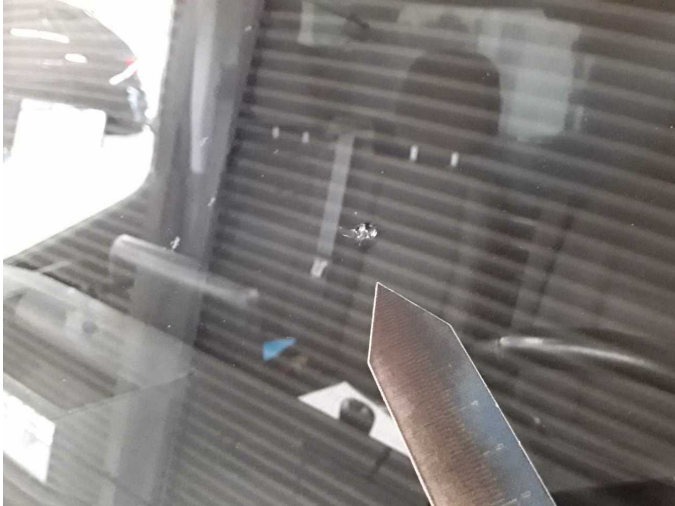
**Damage 19:** Vehicle glazing: Windscreen - Stone chips - Replace

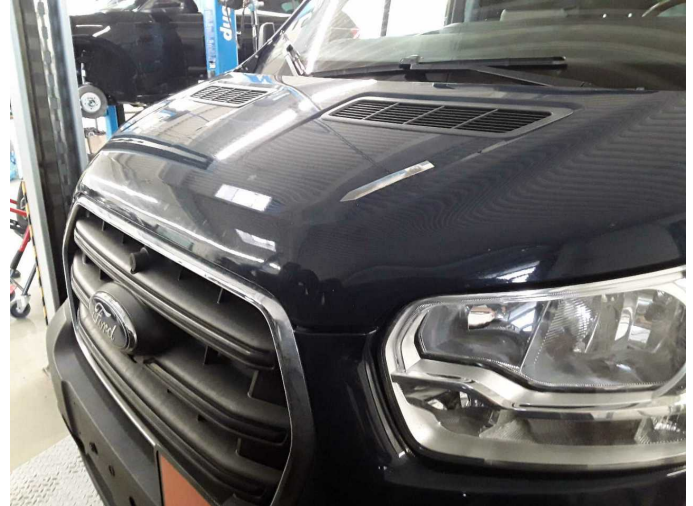
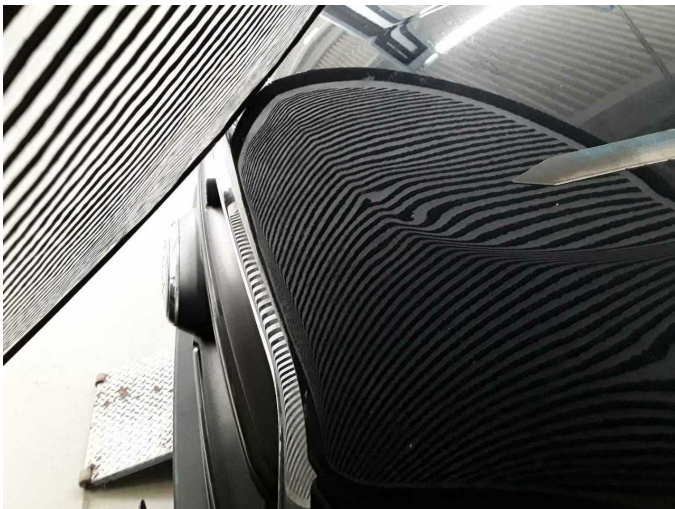
**Wear and tear 1:** Bonnet: Bonnet (weiche) - dent(s) - No deduction

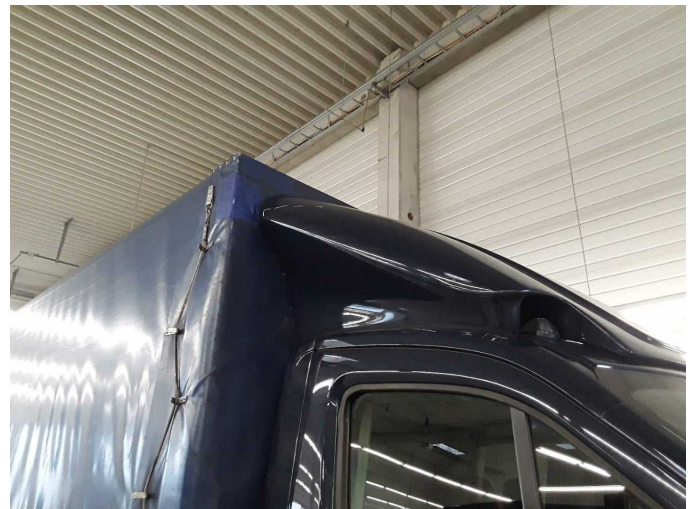
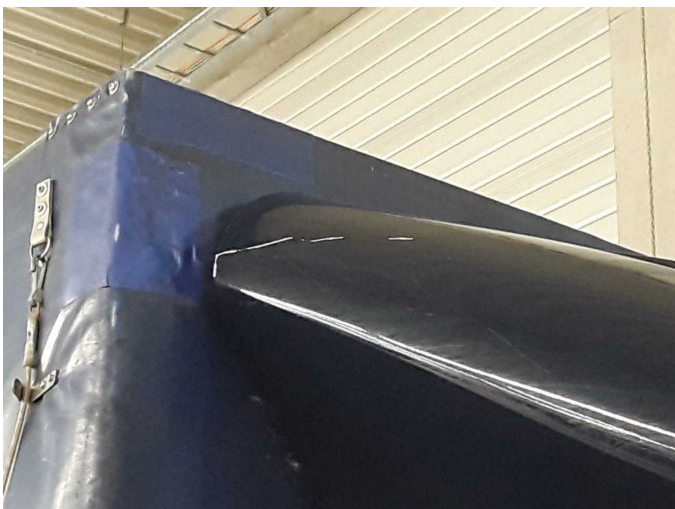
**Wear and tear 2:** Misc.: Vehicle (Windabweiser Dach) - Scratch(es) - No deduction

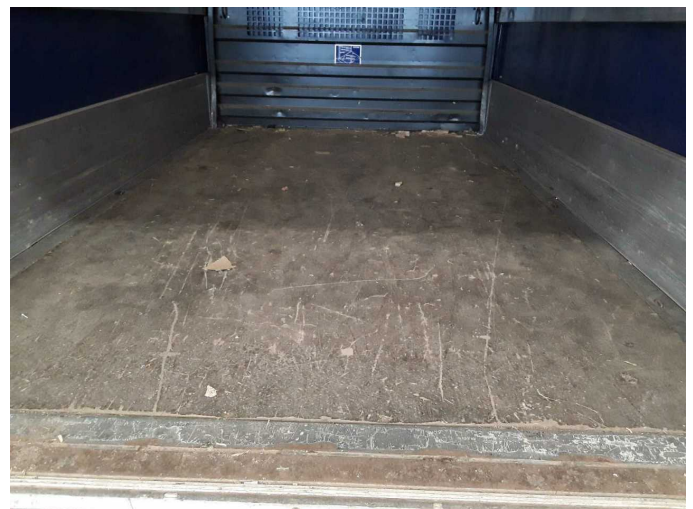
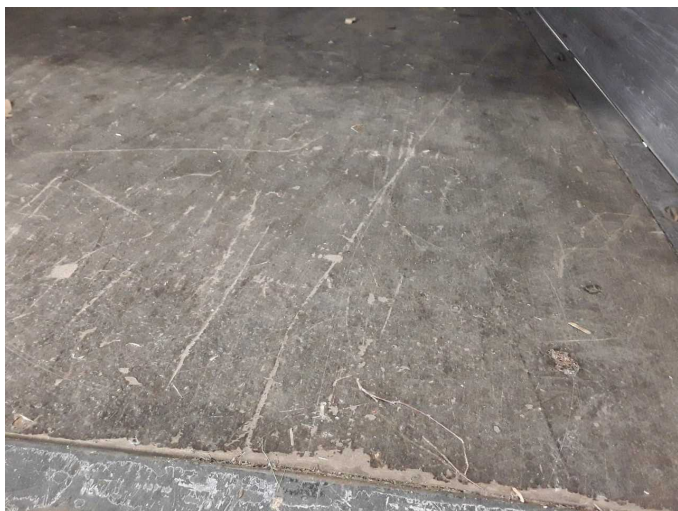
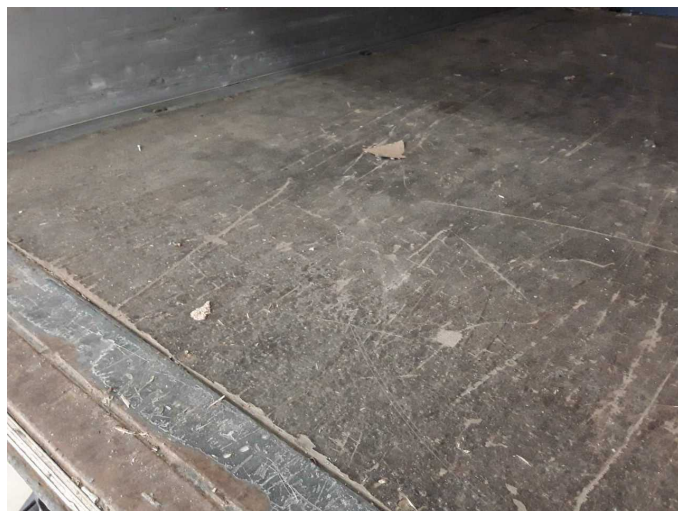
**Wear and tear 3:** Interior: Cargo area floor (Pritsche) - Scratched - No deduction
