Expertise

Protocol number: 46553099  
Order No. / Reference: 26577045  
Inspection date: 16 Jul 2026

Manufacturer: MAN  
VIN: WMA03VUYXP9012685

Model: TGE 3.140 4X2F SB

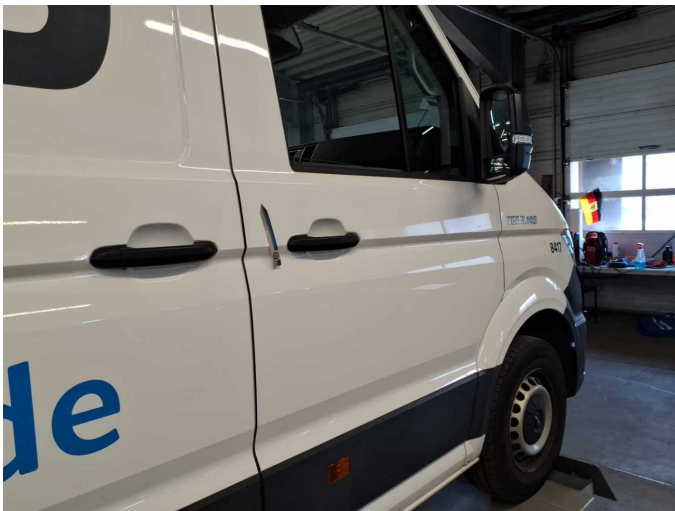
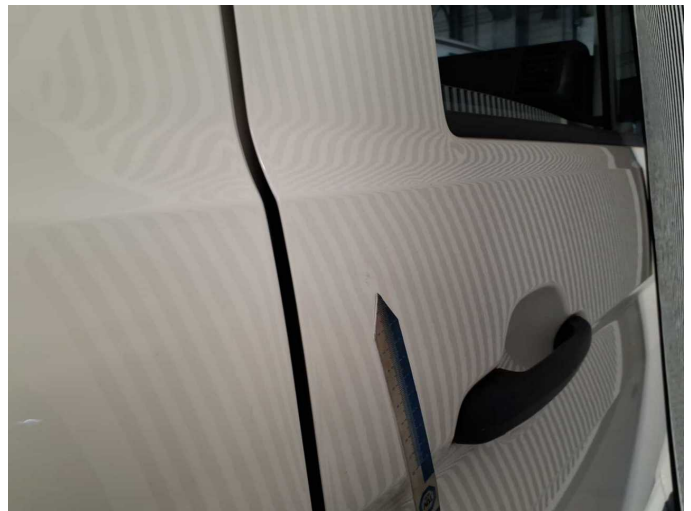
| No. | Component group | Description |
|---|---|---|
| 1 | Door - front right side | Door - dent(s) - Smart repair |

**Damage 1:** Door - front right side: Door - dent(s) - Smart repair

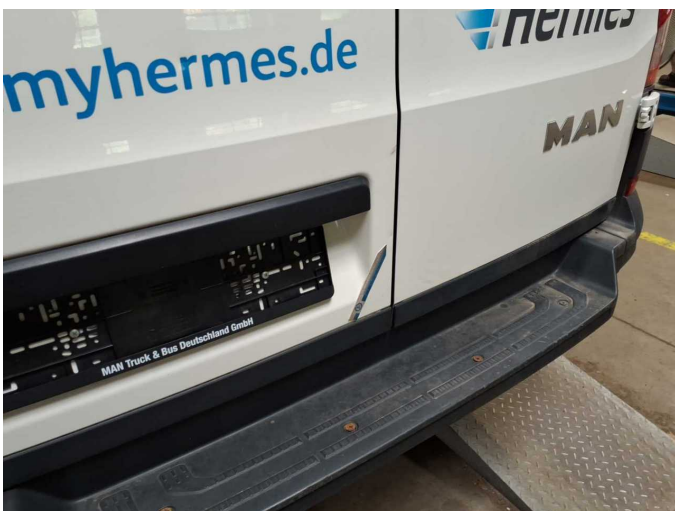
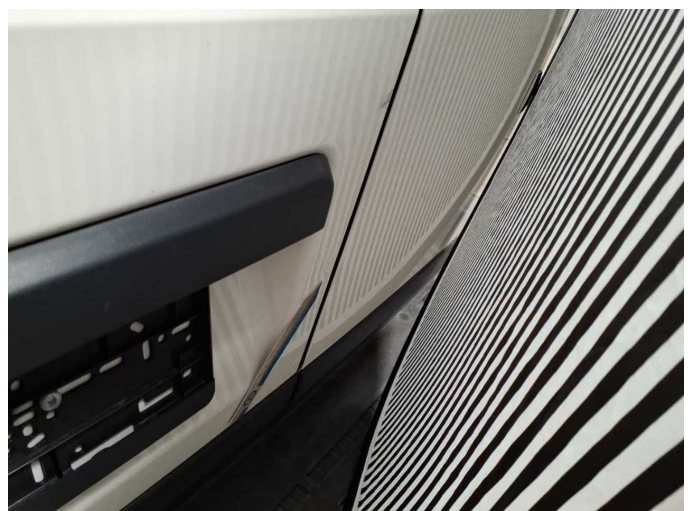
| No. | Component group | Description |
|---|---|---|
| 2 | Boot lid / rear door | Rear door - left side - dent(s) - Smooth repair work |

**Damage 2:** Boot lid / rear door: Rear door - left side - dent(s) - Smooth repair work

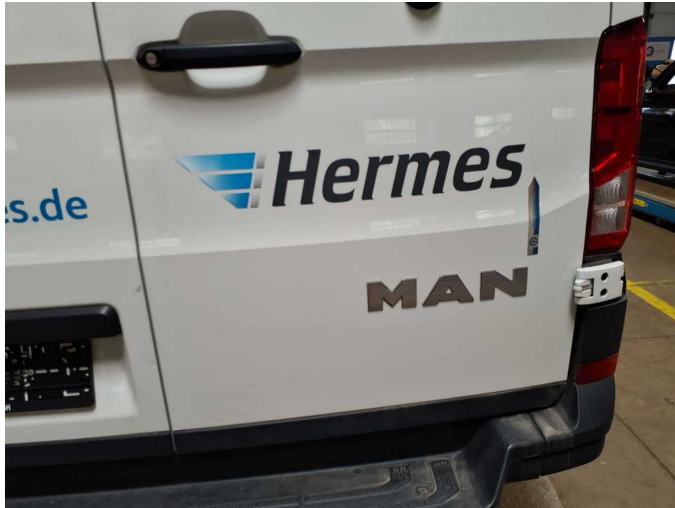
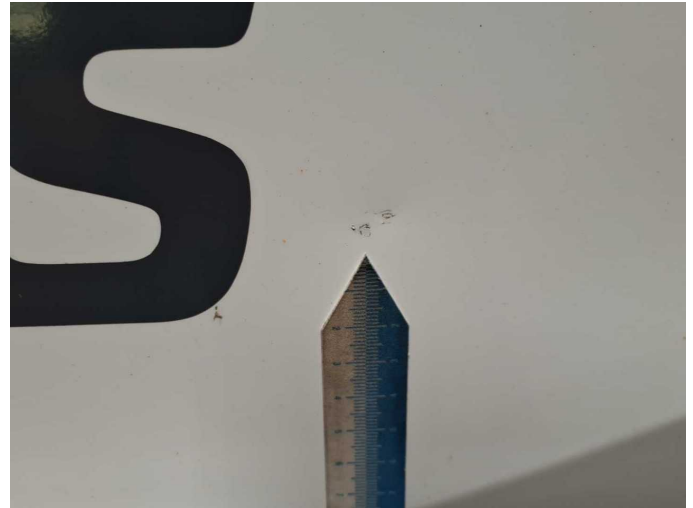
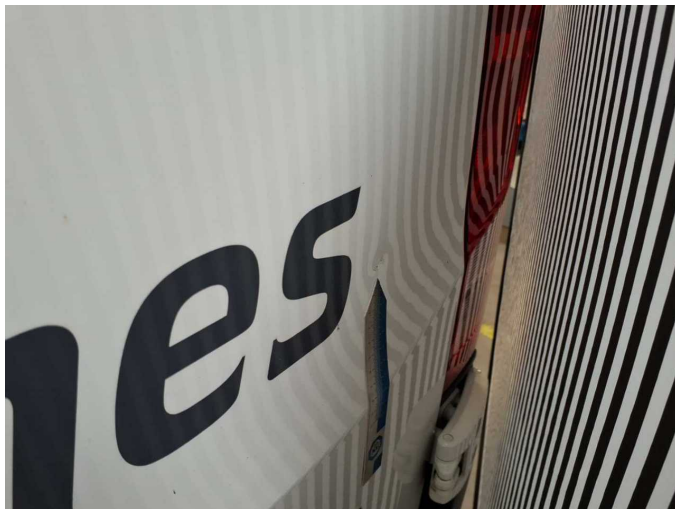
| No. | Component group | Description |
|---|---|---|
| 3 | Boot lid / rear door | Rear door - right side - Dent / paintcoat damage - Smart repair |

**Damage 3:** Boot lid / rear door: Rear door - right side - Dent / paintcoat damage - Smart repair

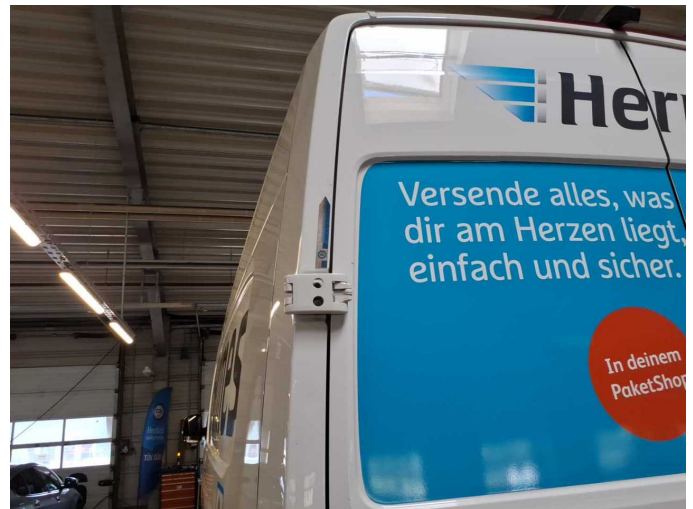
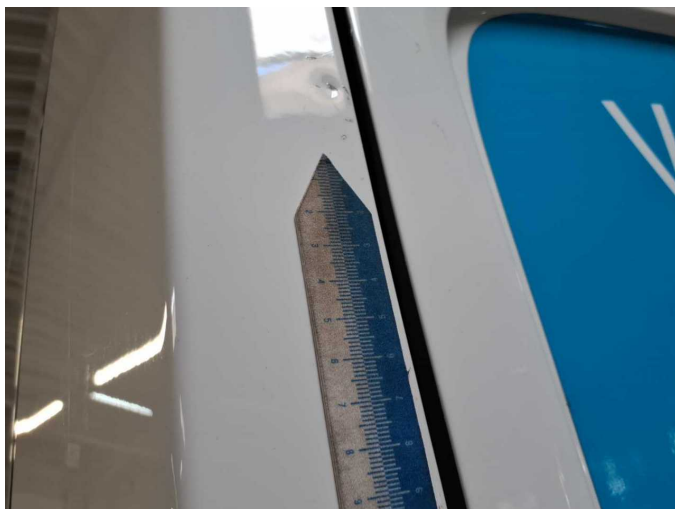
| No. | Component group | Description |
|---|---|---|
| 4 | Body | C-pillar - left side - Dent / paintcoat damage - Smart repair |

**Damage 4:** Body: C-pillar - left side - Dent / paintcoat damage - Smart repair

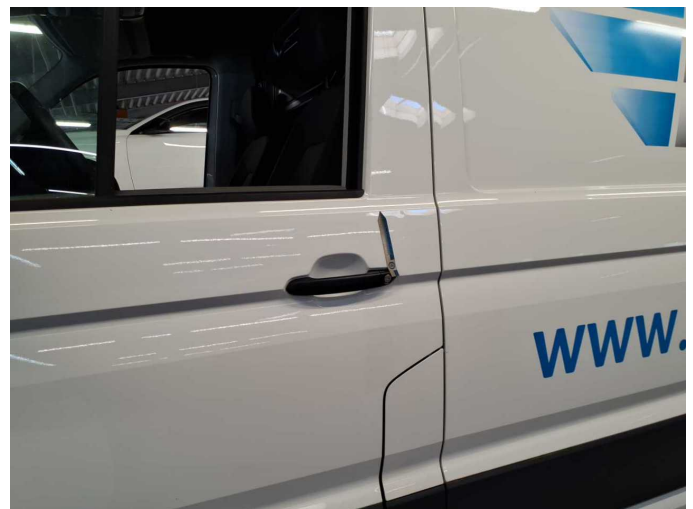
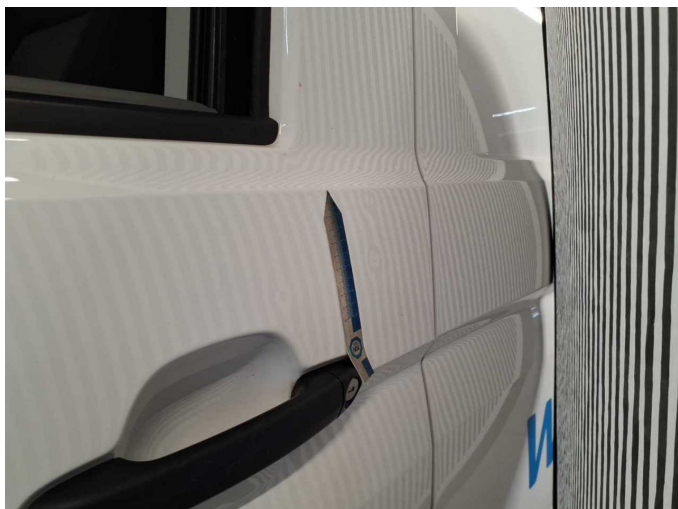
| No. | Component group | Description |
|---|---|---|
| 5 | Door - front left side | Door - dent(s) - Smooth repair work |

**Damage 5:** Door - front left side: Door - dent(s) - Smooth repair work

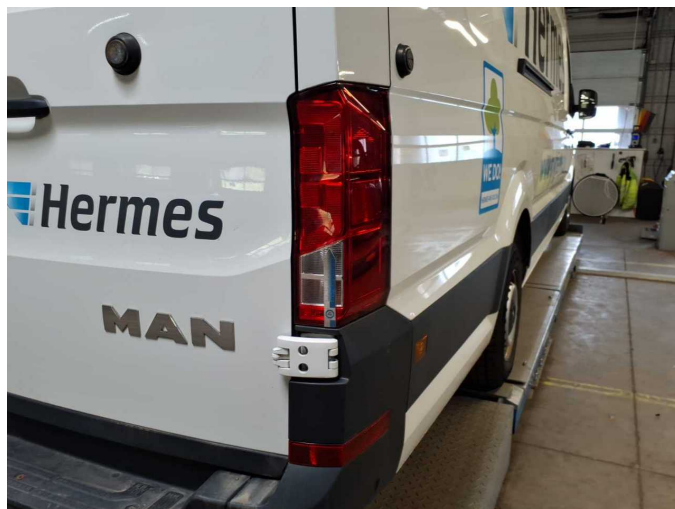
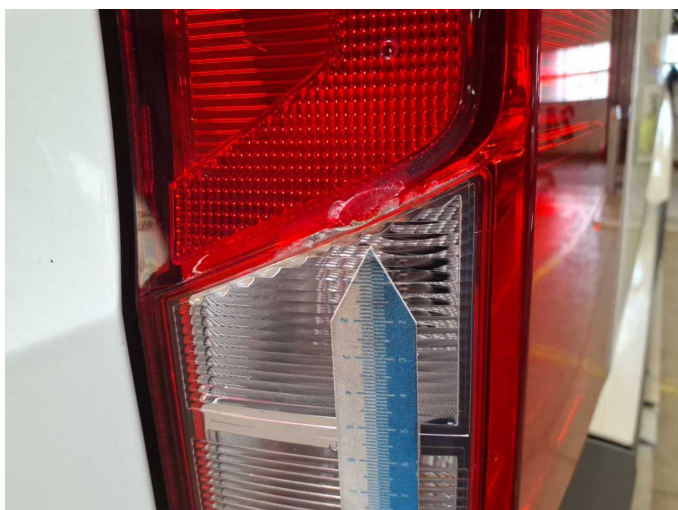
| No. | Component group | Description |
|---|---|---|
| 6 | Tail light | Tail lamp - right side - Damaged - Replace |

**Damage 6:** Tail light: Tail lamp - right side - Damaged - Replace

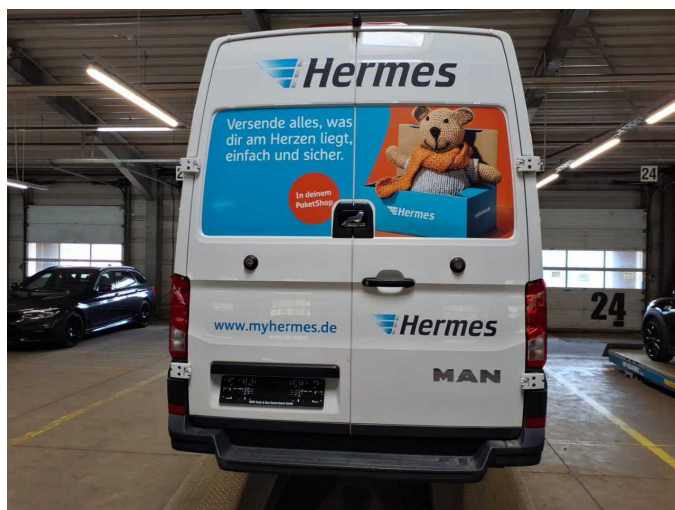
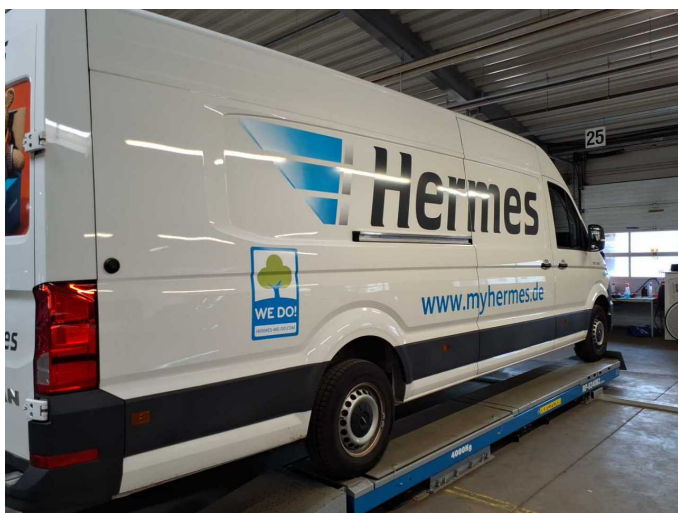
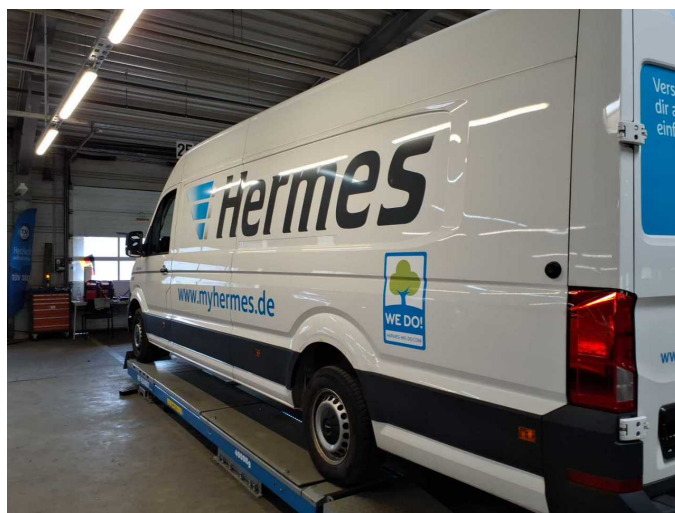
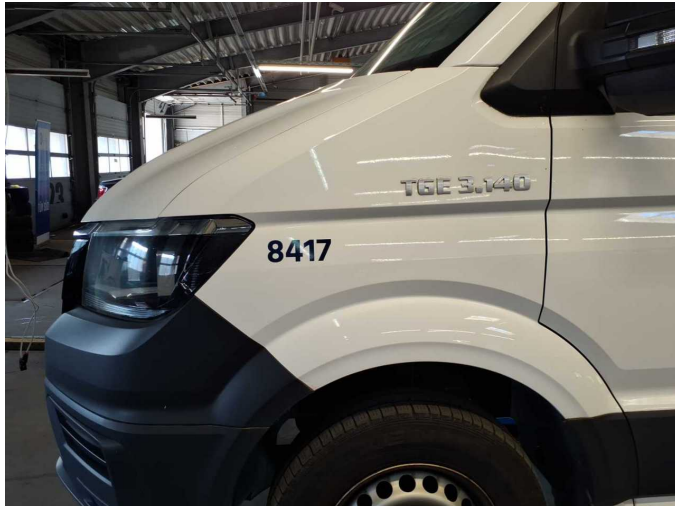
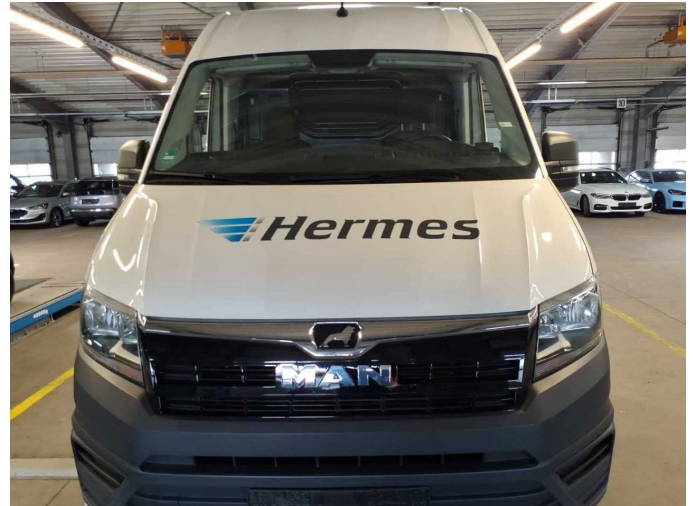
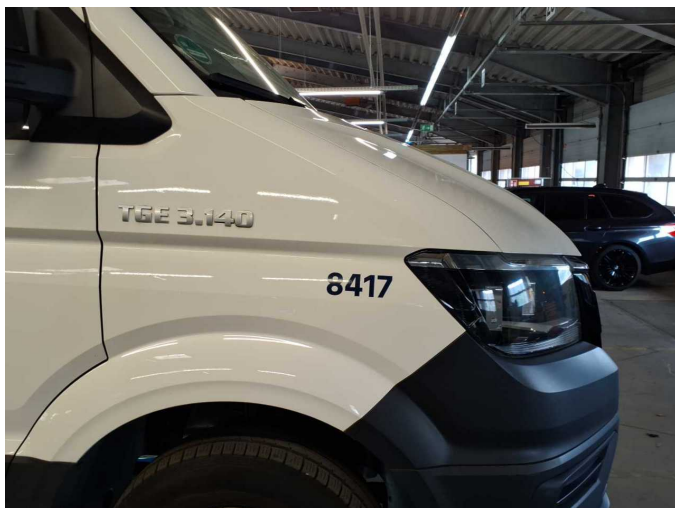
| No. | Component group | Description |
|---|---|---|
| 7 | Body | Body - Glued / labelled - De-glue / neutralise |

**Damage 7:** Body: Body - Glued / labelled - De-glue / neutralise

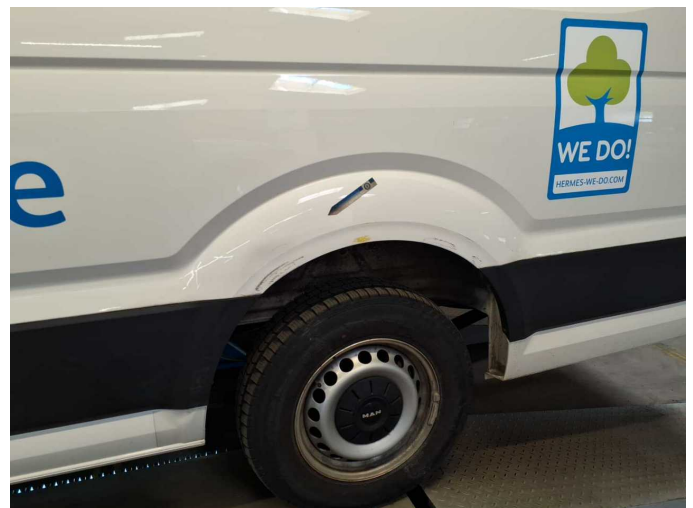
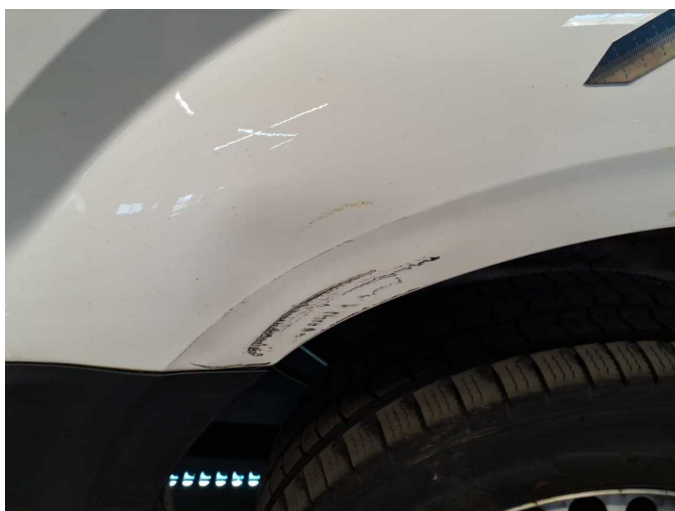
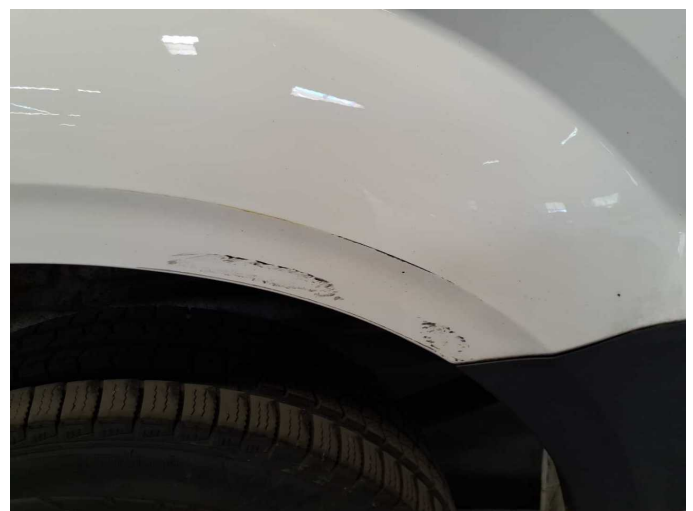
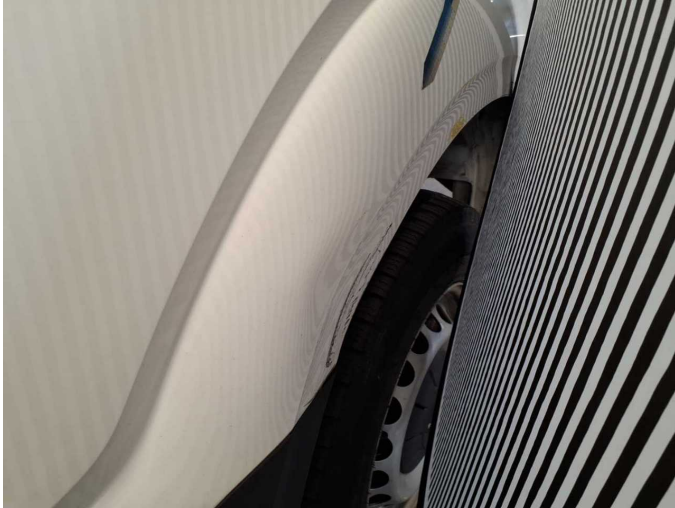
| No. | Component group | Description |
|---|---|---|
| 8 | Side panel - rear left side | Wheel arch - Damaged - Repair and paint |

**Damage 8:** Side panel - rear left side: Wheel arch - Damaged - Repair and paint
