**Model / version:** C4 Space Tourer  
**Vin:** VF73AHNS4NJ616019  
**Mileage:** 65517  
**First registration:** 20/05/2022  
**Color:** BLEU FOREST

#### DAMAGES SUMMARY

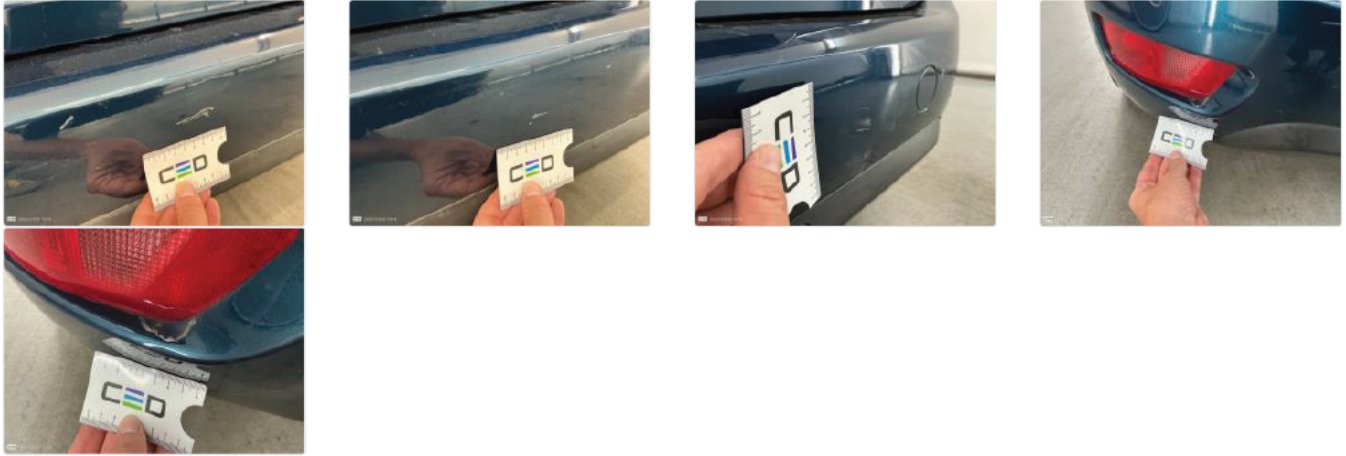
### 5 - Bumper R - Scratch(es)

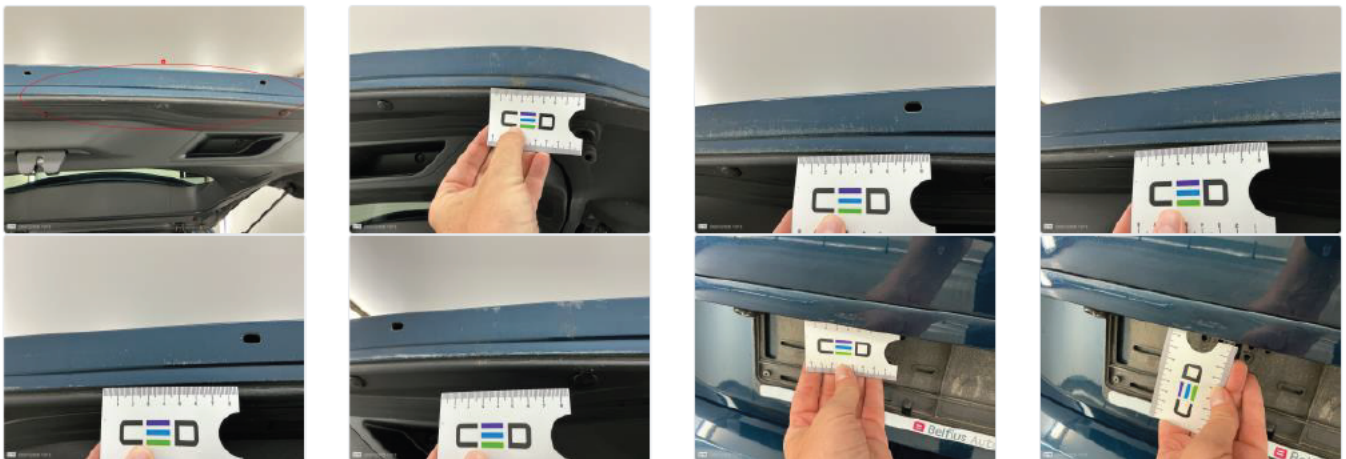
6 - Tailgate / Boot - Scratch(es)

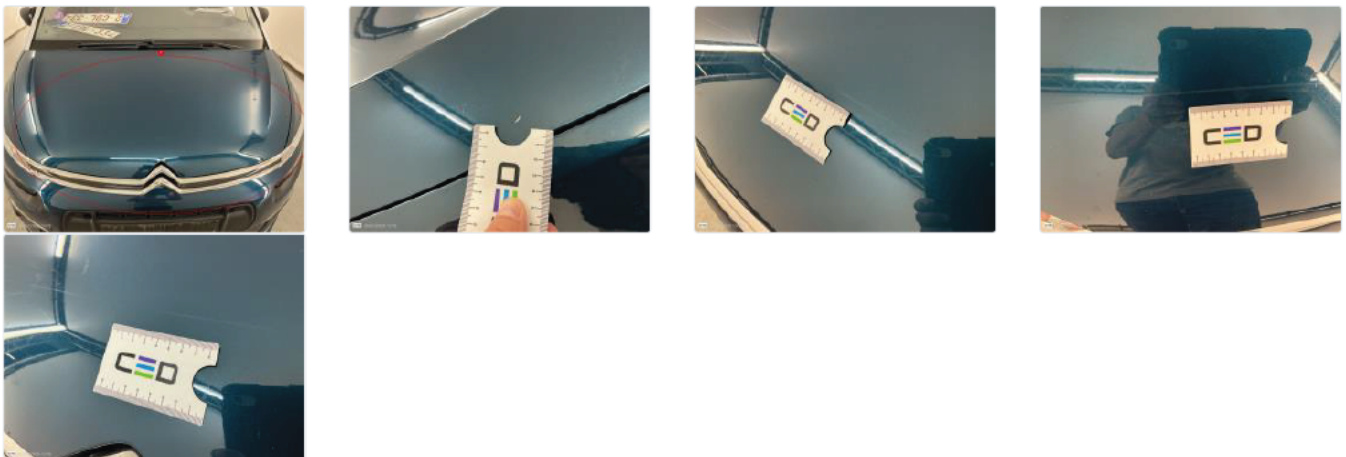
7 - Bonnet - Scratch(es)

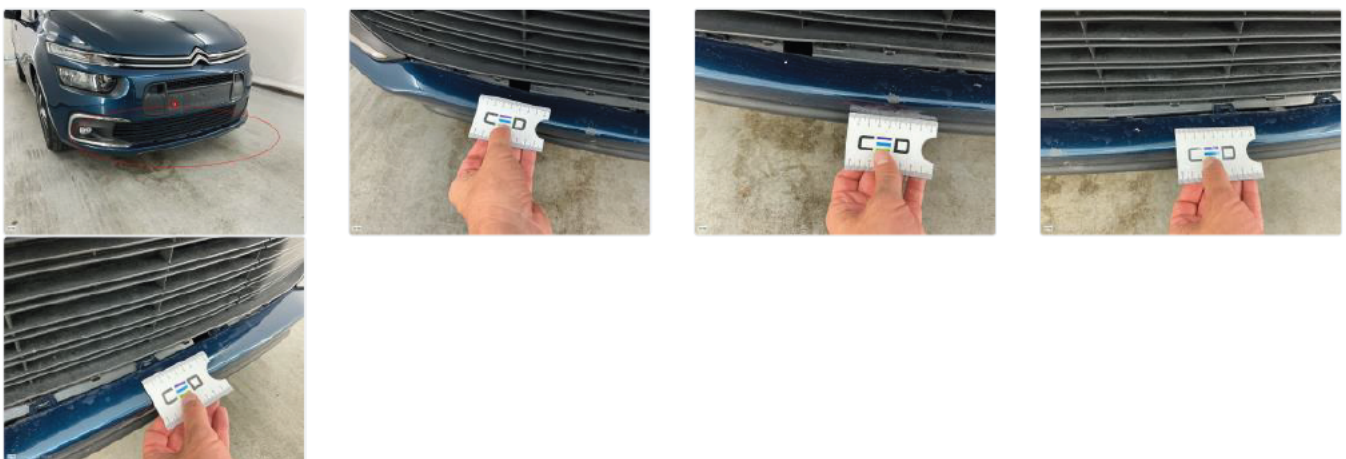
8 - Bumper F - Damaged

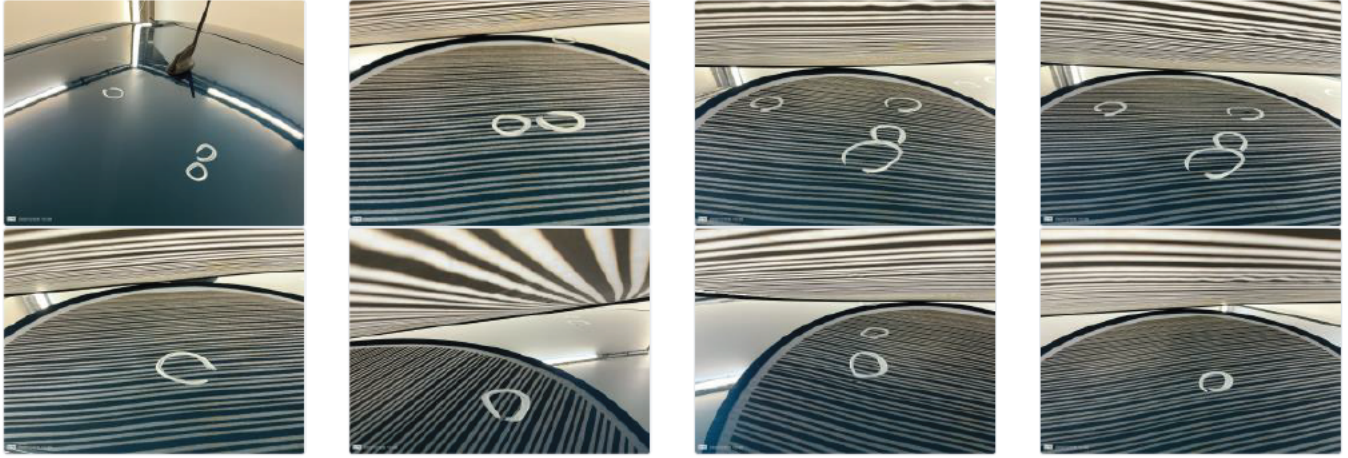
14 - Roof - Hail damage

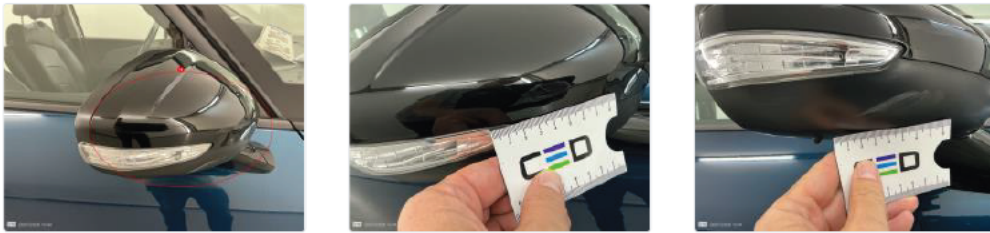
15 - Outside rear-view mirror housing R - Dent(s) and scratch(es)

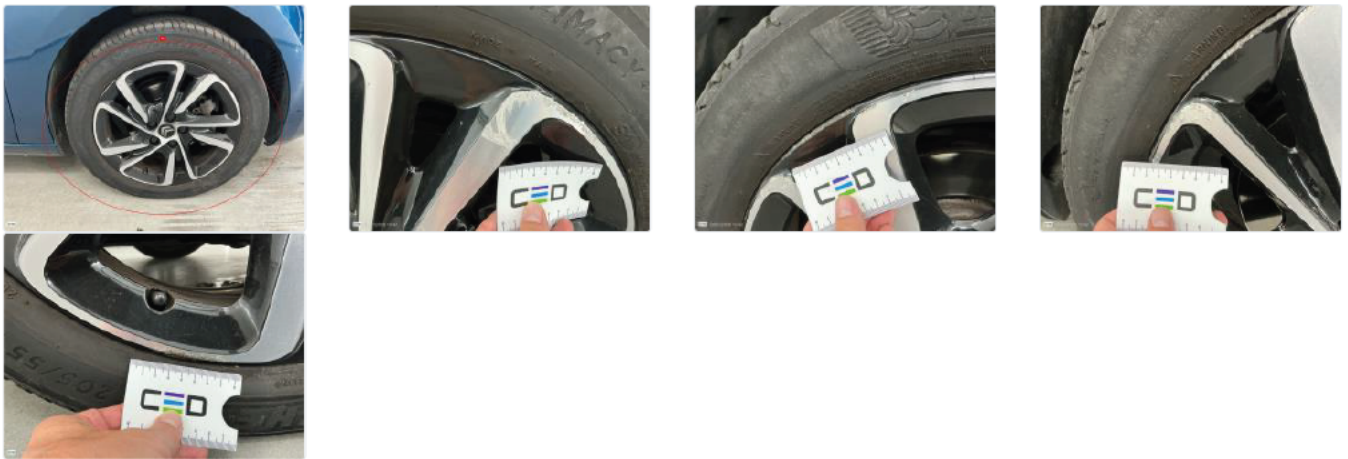
16 - Alloy rim FR polished - Dent(s) and scratch(es)

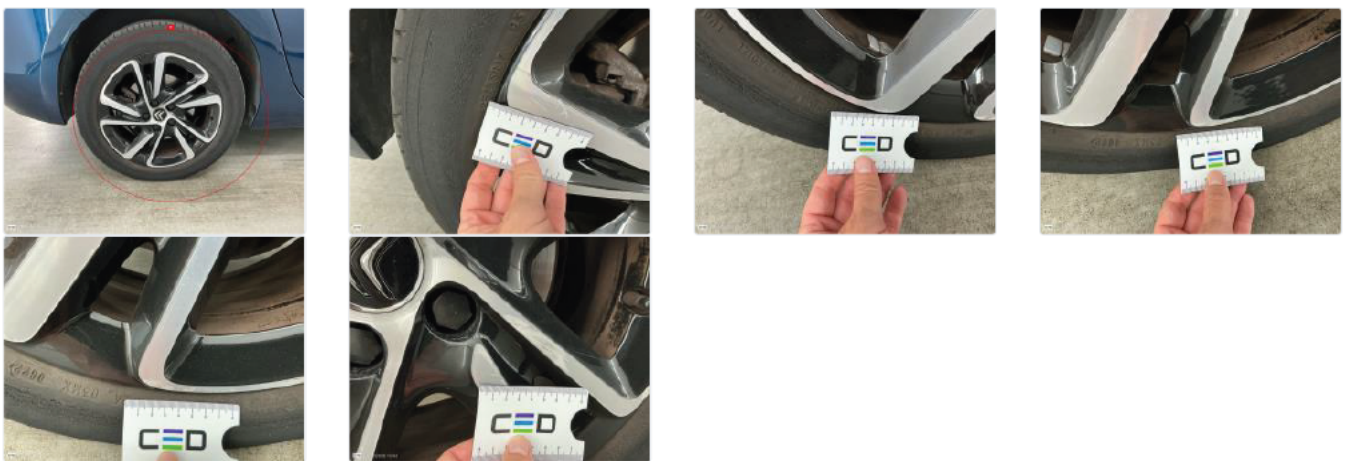
17 - Alloy rim RL polished - Dent(s) and scratch(es)

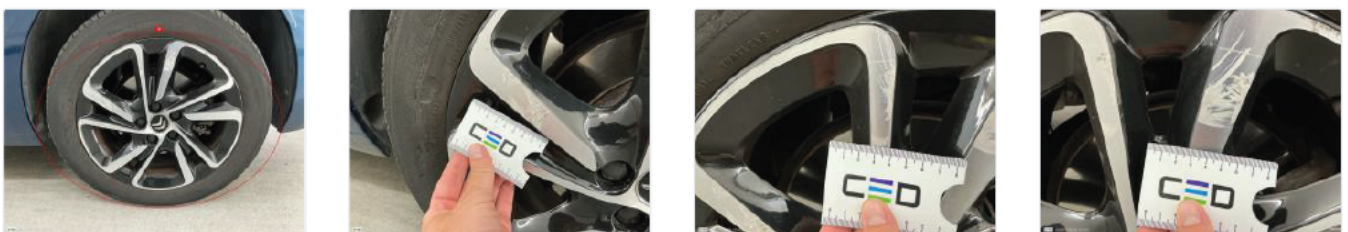
18 - Alloy rim RL polished - Dent(s) and scratch(es)

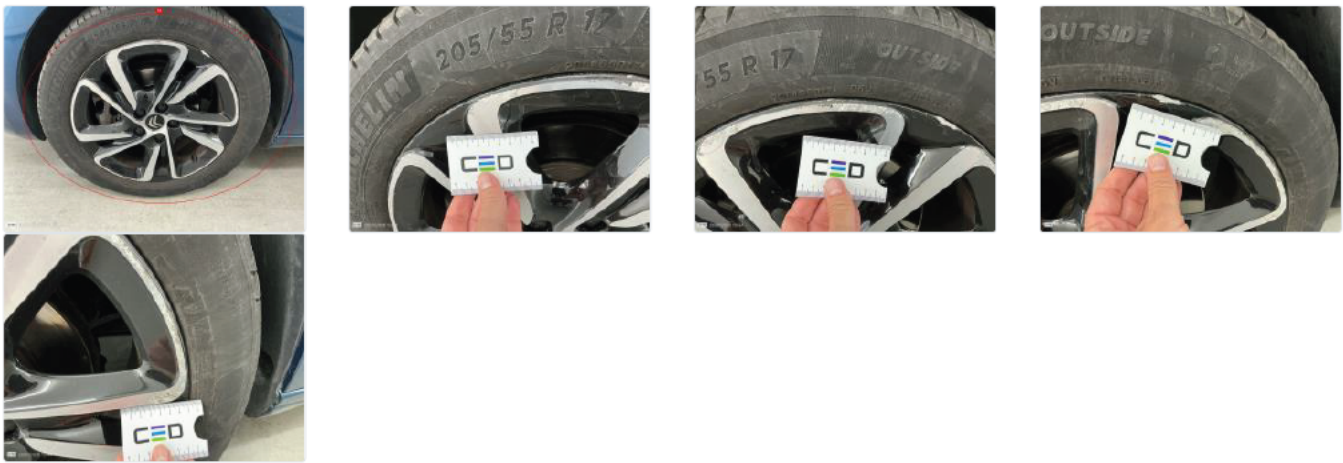
19 - Alloy rim FL polished - Dent(s) and scratch(es)

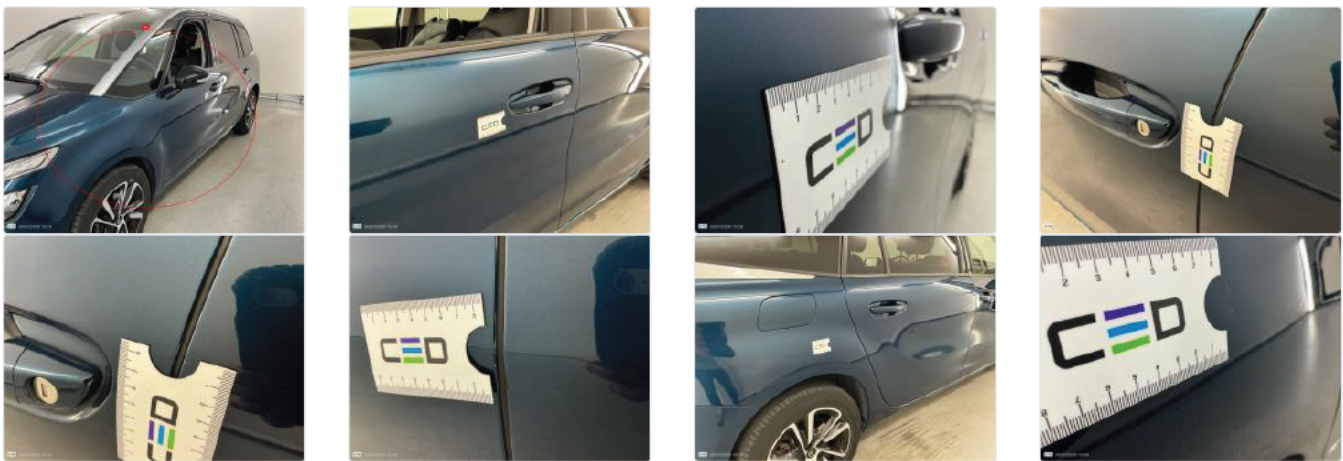
10 - Bodywork - Dent(s) and scratch(es) - Renta®
