Expertise

Protocol number: 46230954  
Order No. / Reference: 26555137  
Inspection date: 25 Jun 2026

| Manufacturer: Opel | Model: Insignia Sports Tourer 2.0 Diesel Aut. Business |
| VIN: W0VZT8EP7N1042028 | |

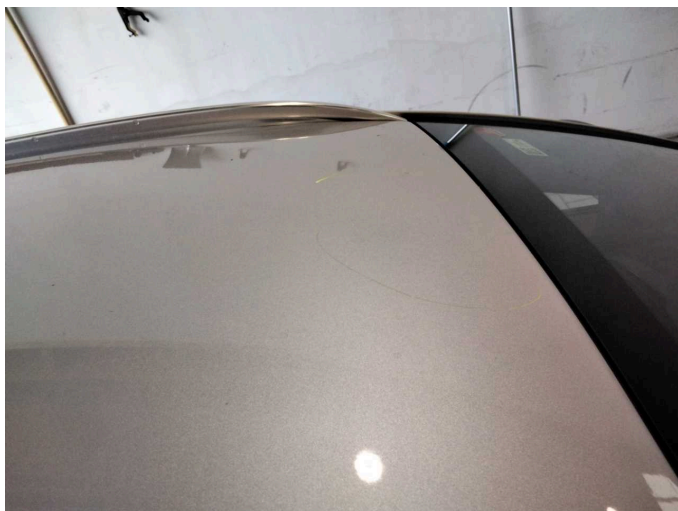
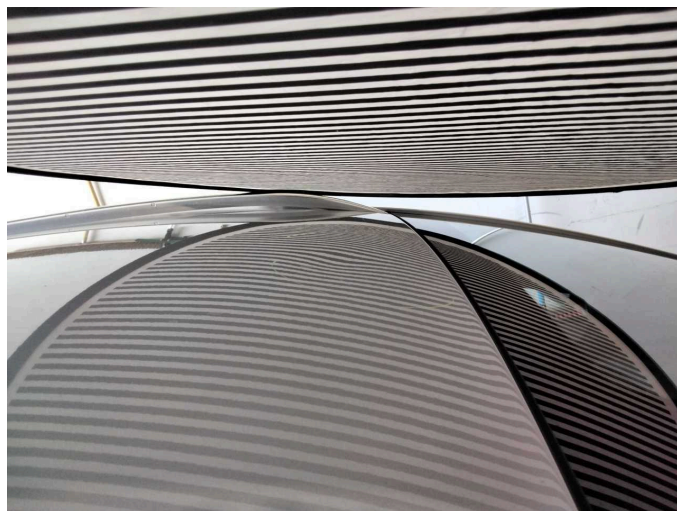
| No. | Component group | Description |
|---|---|---|
| 1 | Roof | Roof - dent(s) - Smooth repair work |

**Damage 1:** Roof: Roof - dent(s) - Smooth repair work

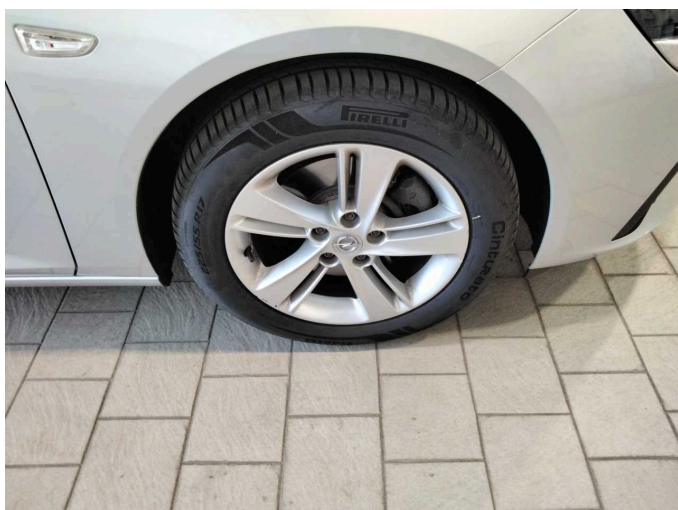
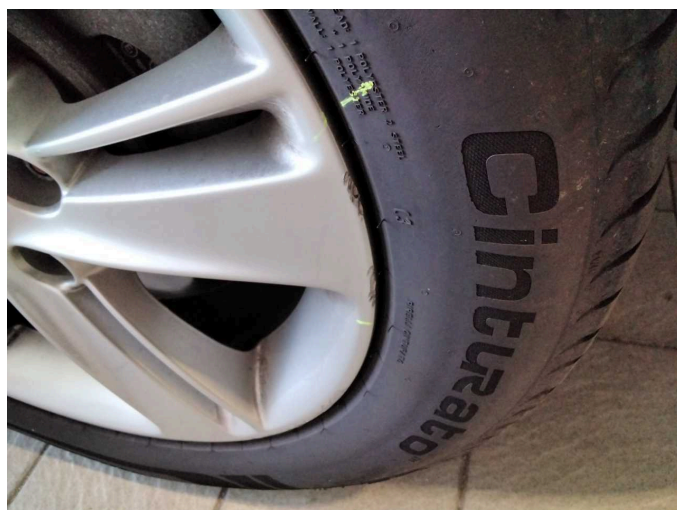
| No. | Component group | Description |
|---|---|---|
| 2 | Wheel / tyres | Alloy rim - front right side - Scratch(es) - Loss in value |

**Damage 2:** Wheel / tyres: Alloy rim - front right side - Scratch(es) - Loss in value

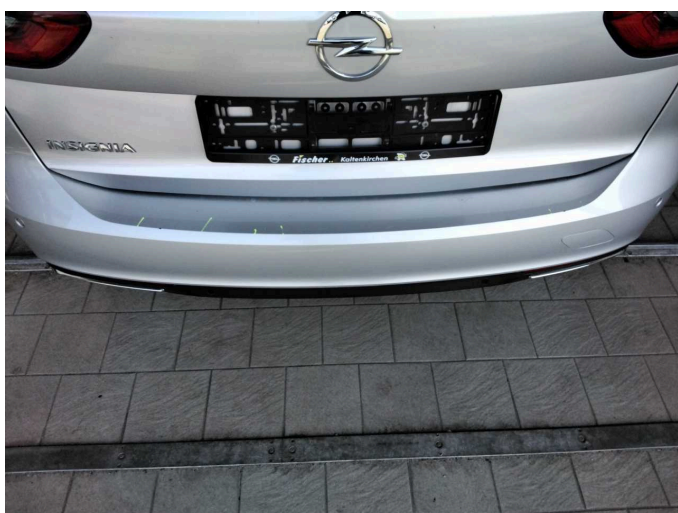
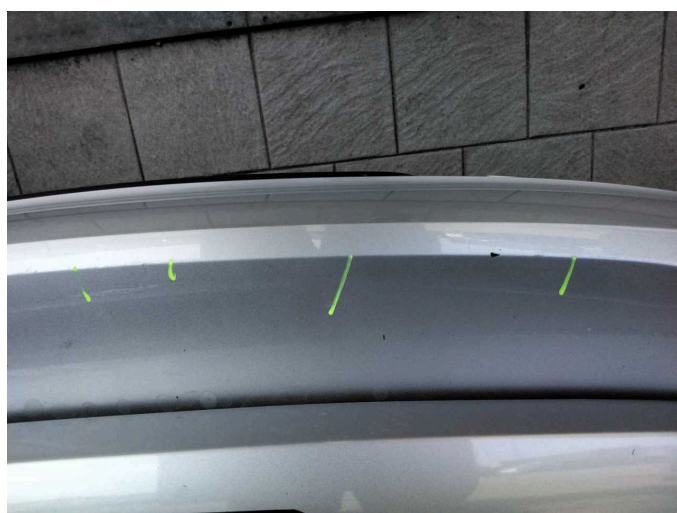
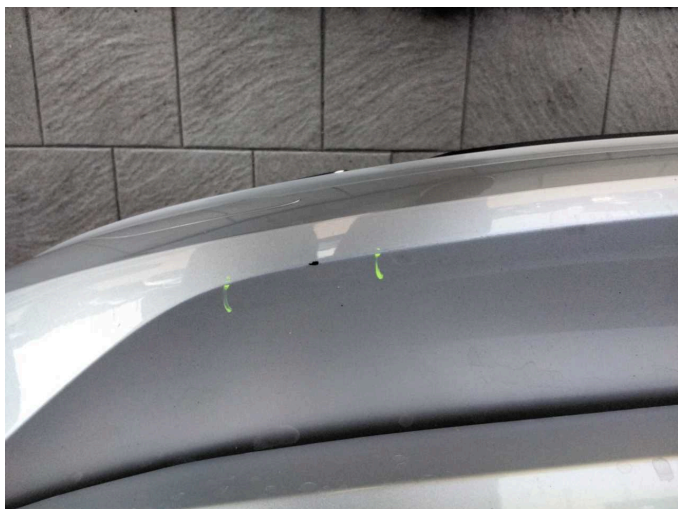
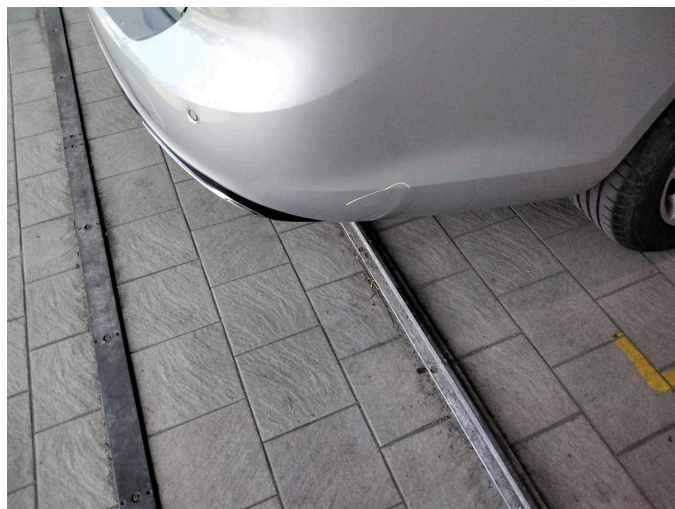
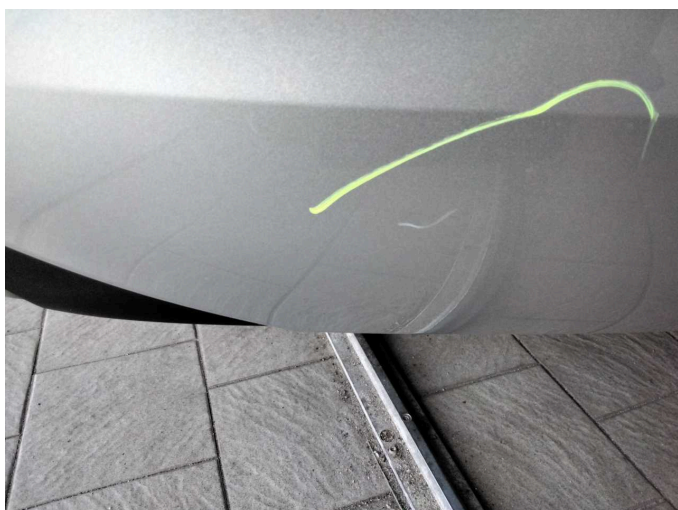
| No. | Component group | Description |
|---|---|---|
| 3 | Rear bumper | Rear bumper - Scratch(es) - Paint |

**Damage 3:** Rear bumper: Rear bumper - Scratch(es) - Paint

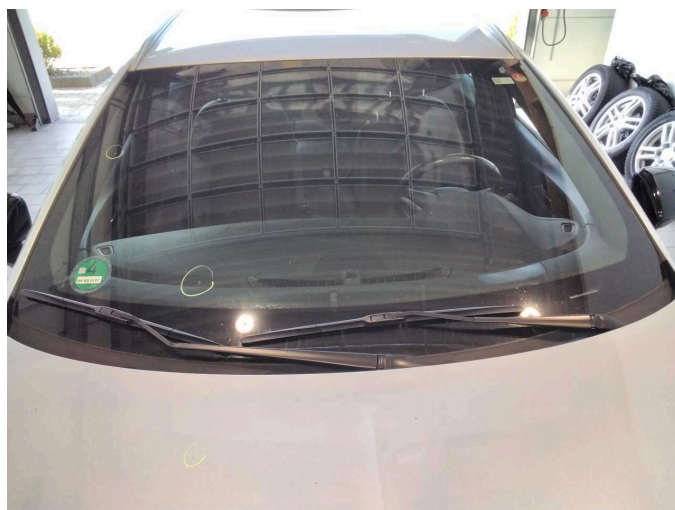
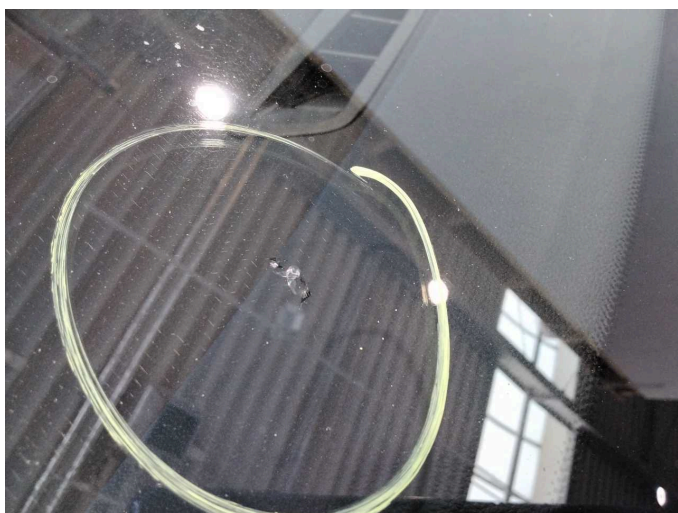
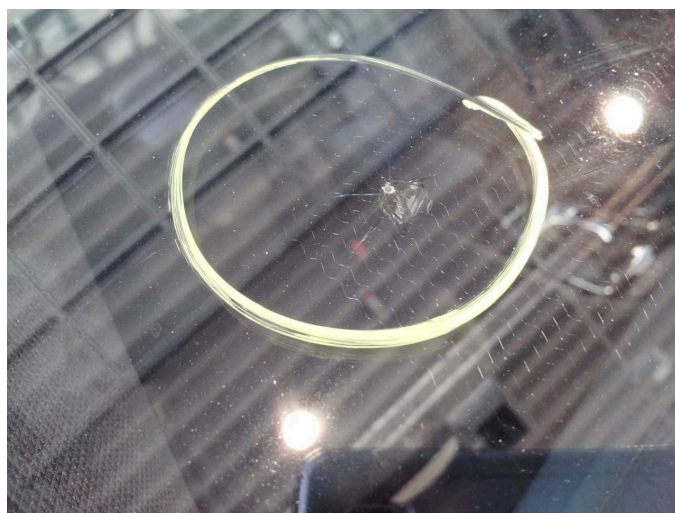
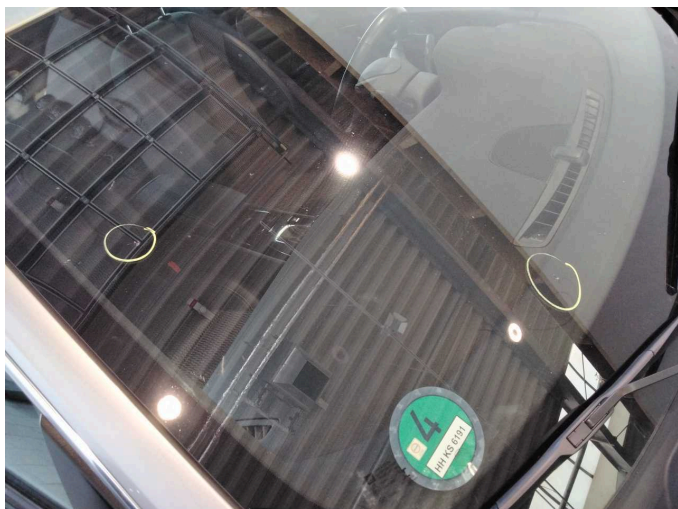
| No. | Component group | Description |
|---|---|---|
| 4 | Vehicle glazing | Windscreen - Stone chips - Replace |

**Damage 4:** Vehicle glazing: Windscreen - Stone chips - Replace

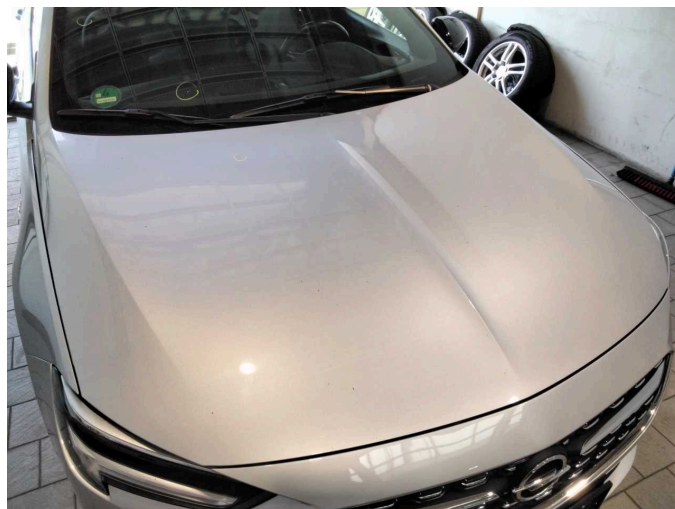
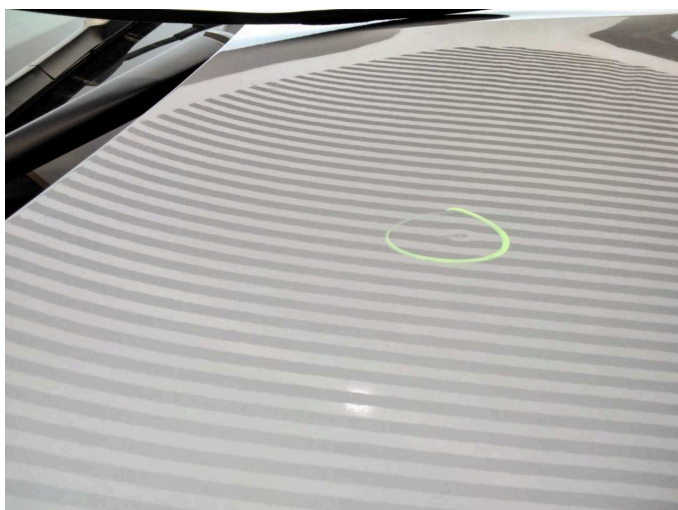
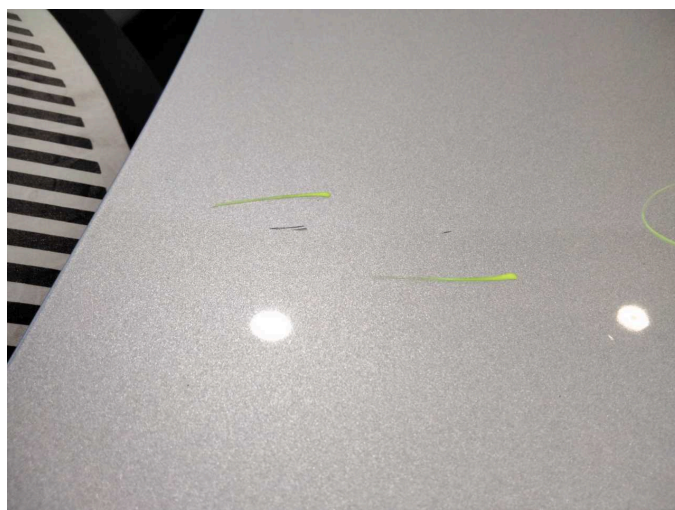
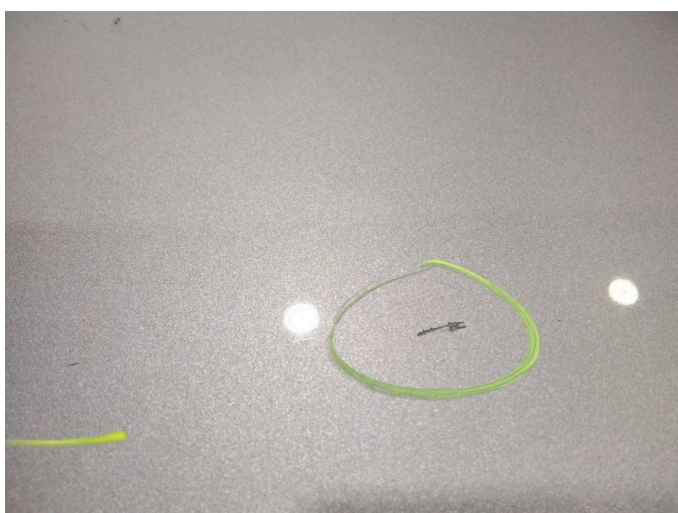
| No. | Component group | Description |
|---|---|---|
| 5 | Bonnet | Bonnet - Dent / paintcoat damage - Paint |

**Damage 5:** Bonnet: Bonnet - Dent / paintcoat damage - Paint

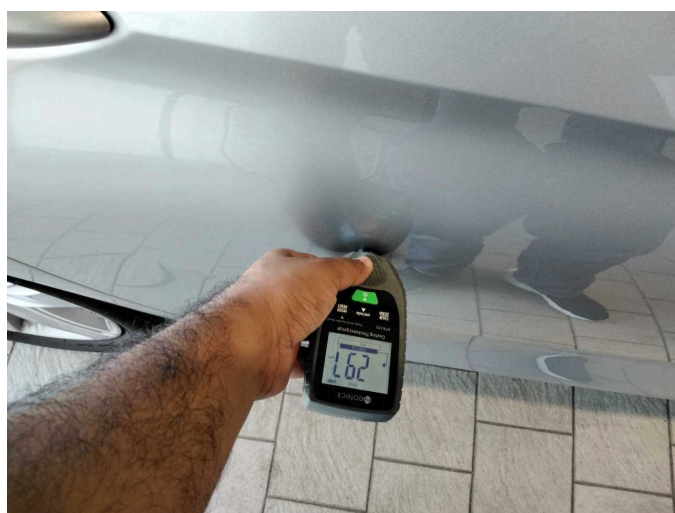
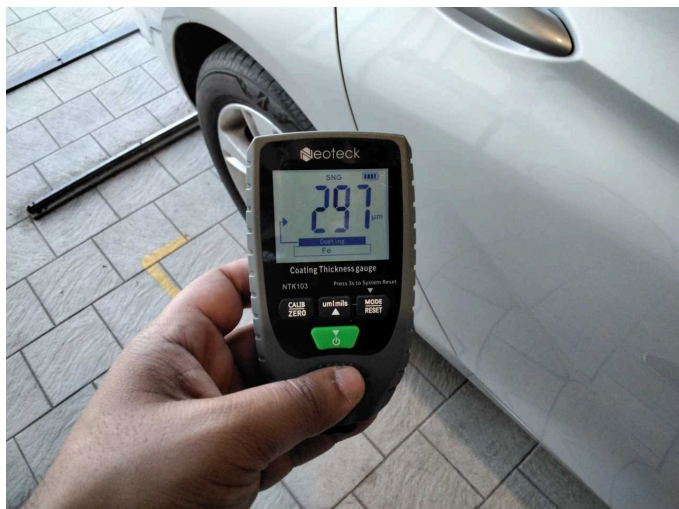
**Door - rear right side:** 297 µm

Door - rear right side: 297 µm

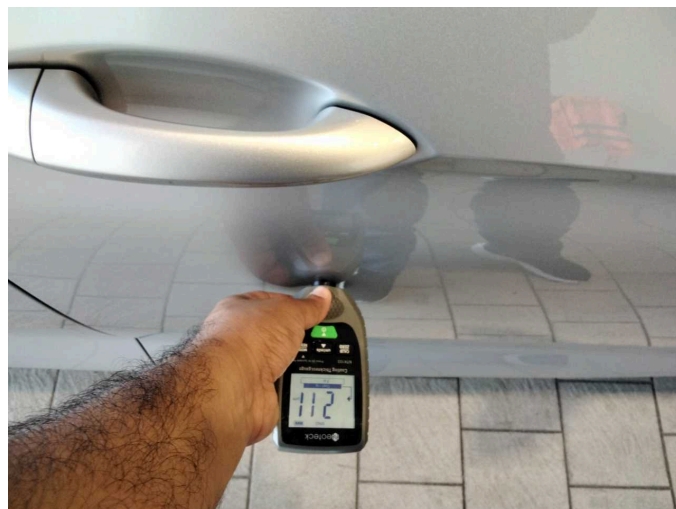
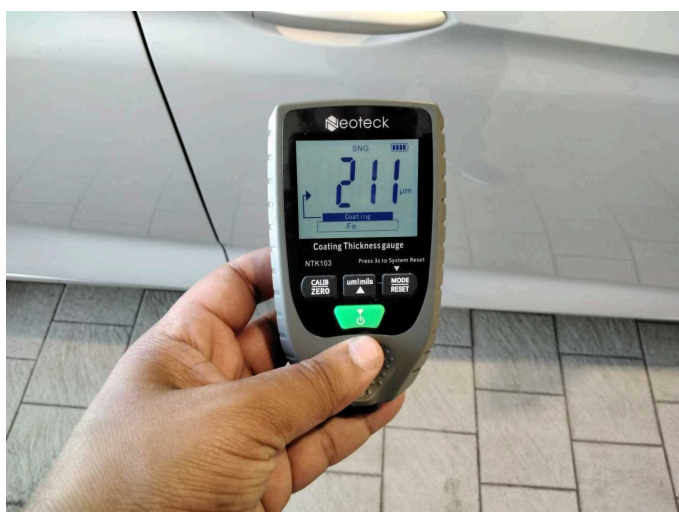
Door - front right side: 211 µm
