Expertise

Protocol number: 46511175  
Order No. / Reference: 26029354  
Inspection date: 13 Jul 2026

Manufacturer: Mercedes-Benz

Model: Vito 116 CDI Tourer Lang Aut. PRO

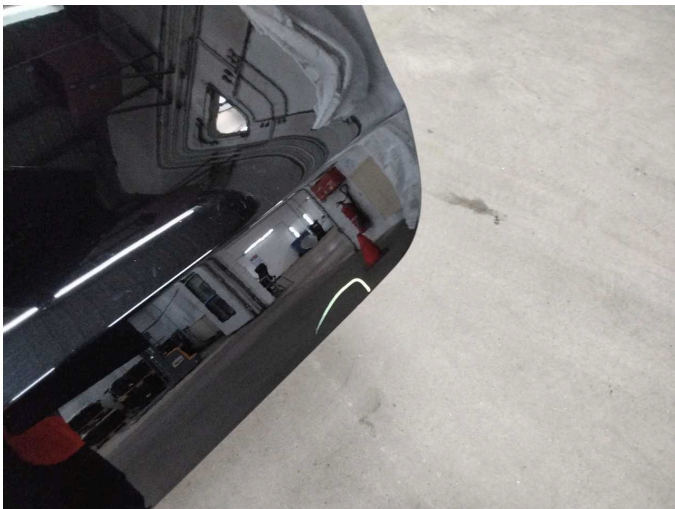
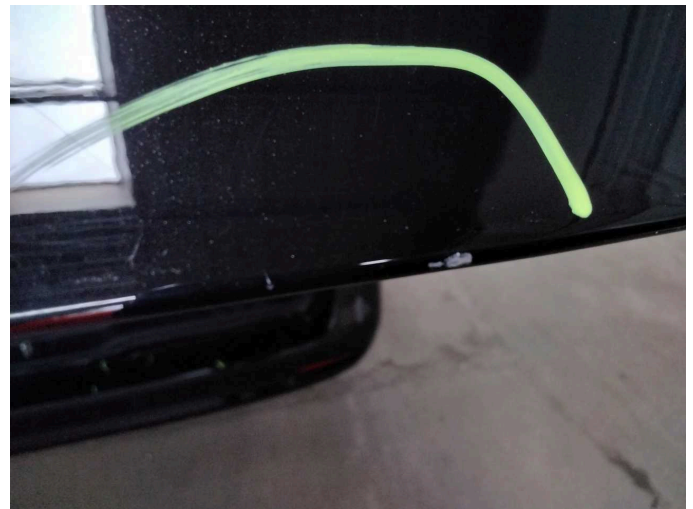
| No. | Component group | Description |
|---|---|---|
| 1 | Boot lid / rear door | Boot lid - Scratch(es) - Smart repair |

**Damage 1:** Boot lid / rear door: Boot lid - Scratch(es) - Smart repair

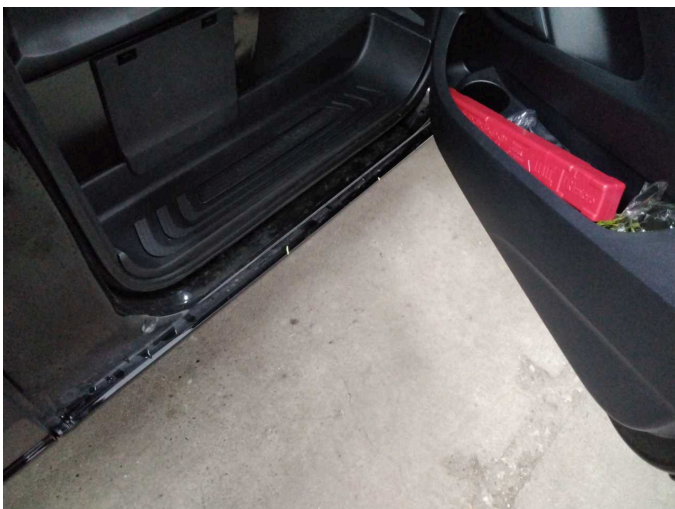
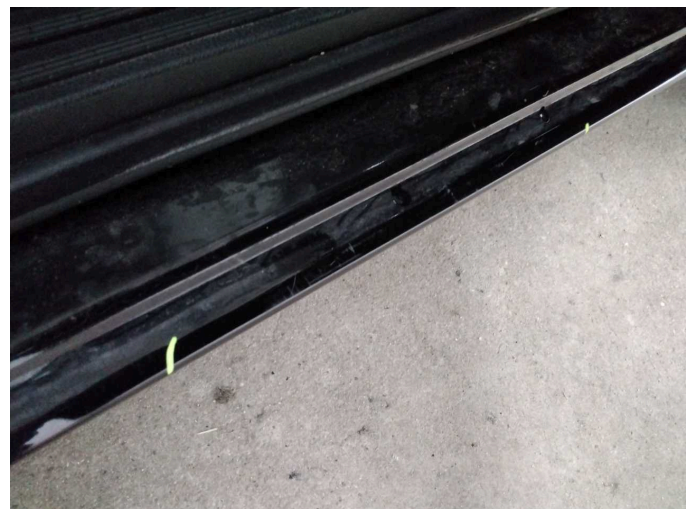
| No. | Component group | Description |
|---|---|---|
| 2 | Sill - right side | Sill - Scratch(es) - Smart repair |

**Damage 2:** Sill - right side: Sill - Scratch(es) - Smart repair

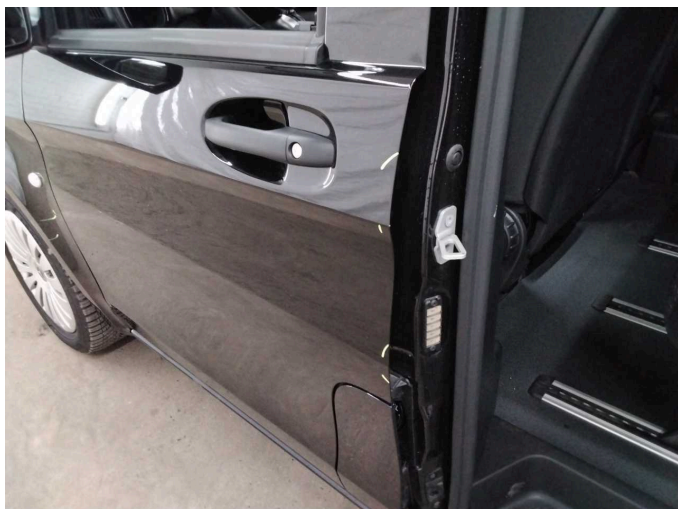
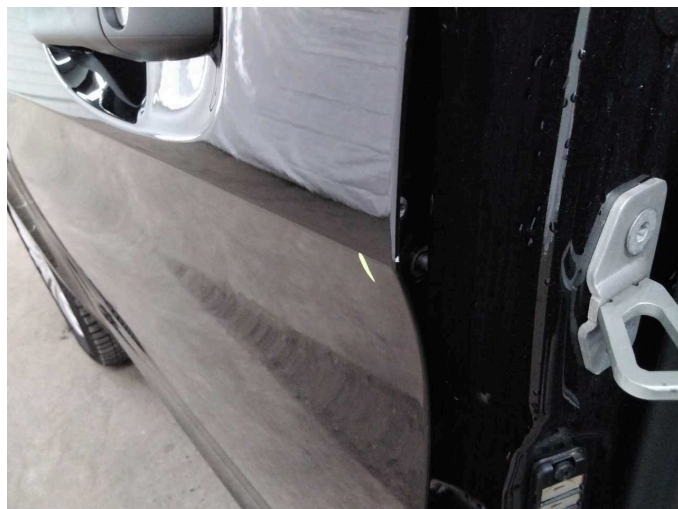
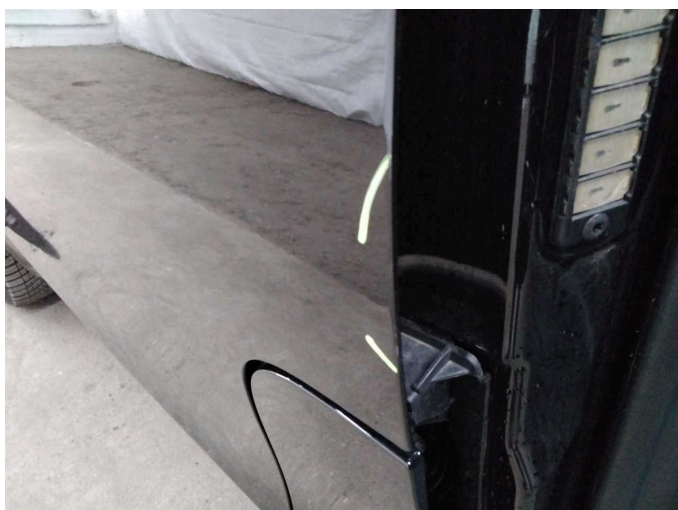
| No. | Component group | Description |
|---|---|---|
| 3 | Door - front left side | Door edge - Scratch(es) - Smart repair |

**Damage 3:** Door - front left side: Door edge - Scratch(es) - Smart repair

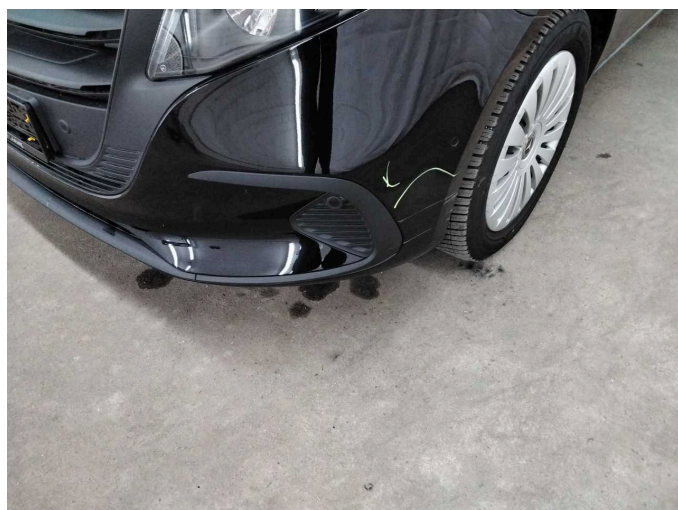
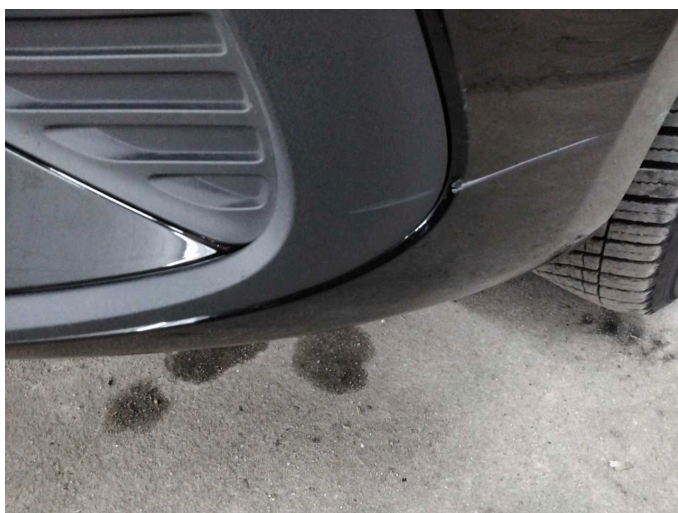
| No. | Component group | Description |
|---|---|---|
| 4 | Front bumper | Spoiler (Linke seite) - Scratch(es) - Replace |

**Damage 4:** Front bumper: Spoiler (Linke Seite) - Scratch(es) - Replace

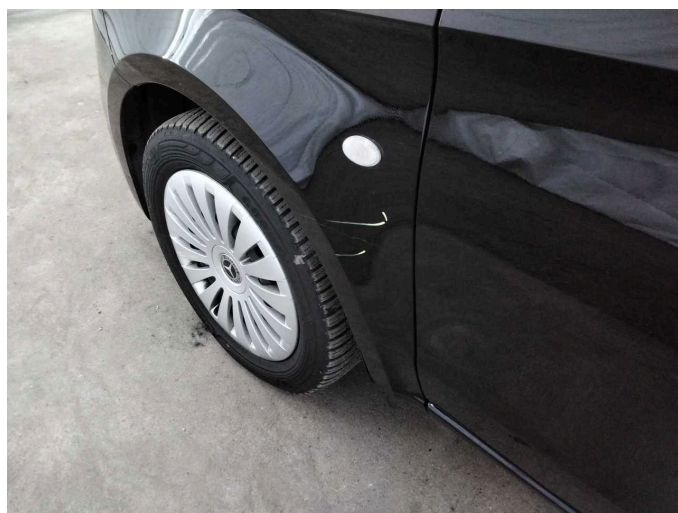
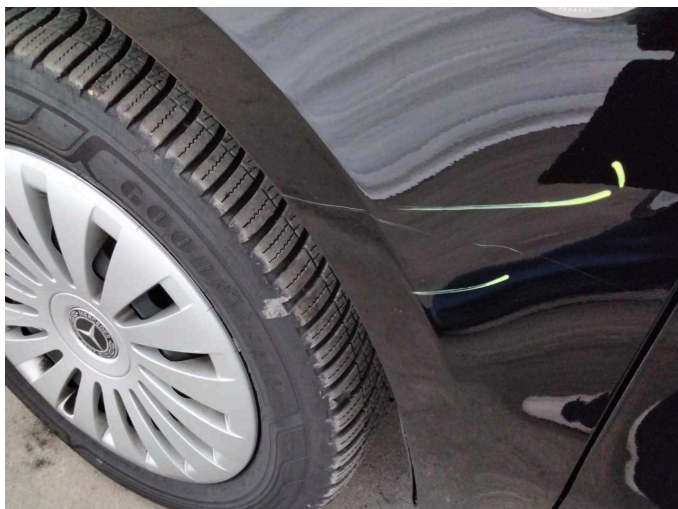
| No. | Component group | Description |
|---|---|---|
| 5 | Mudguard - left side | Mudguard - left side - Scratch(es) - Paint |

**Damage 5:** Mudguard - left side: Mudguard - left side - Scratch(es) - Paint

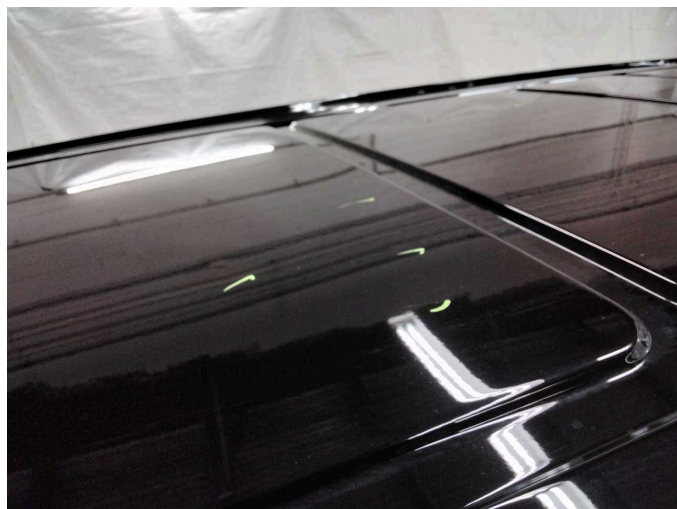
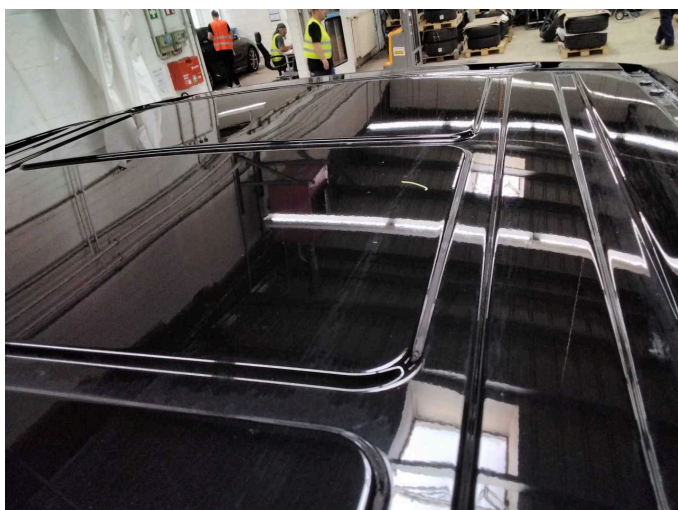
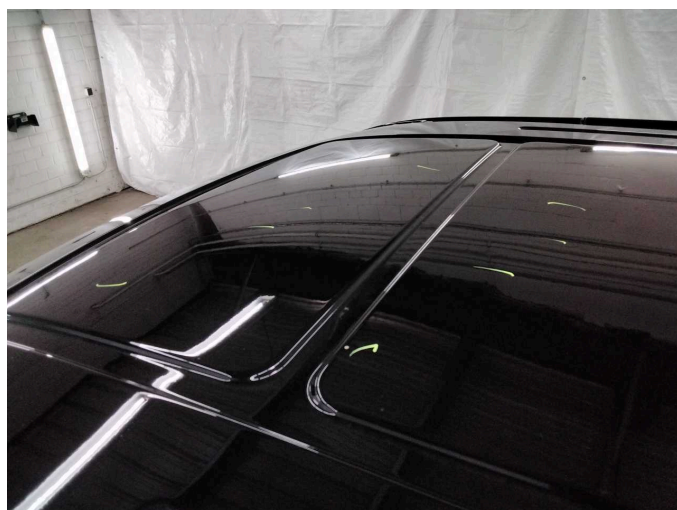
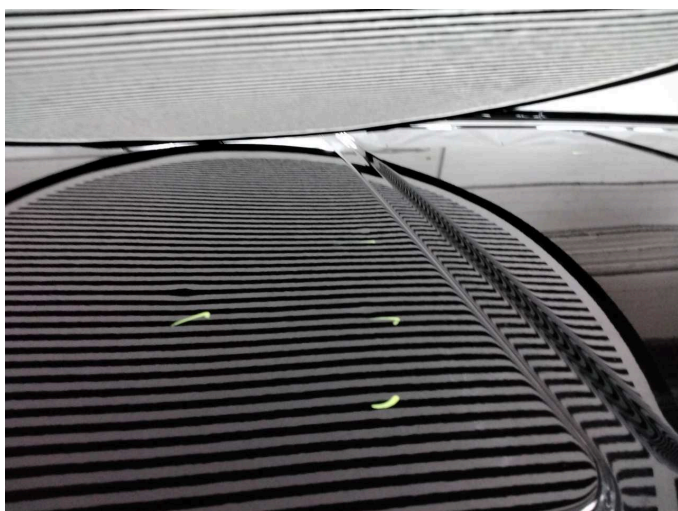
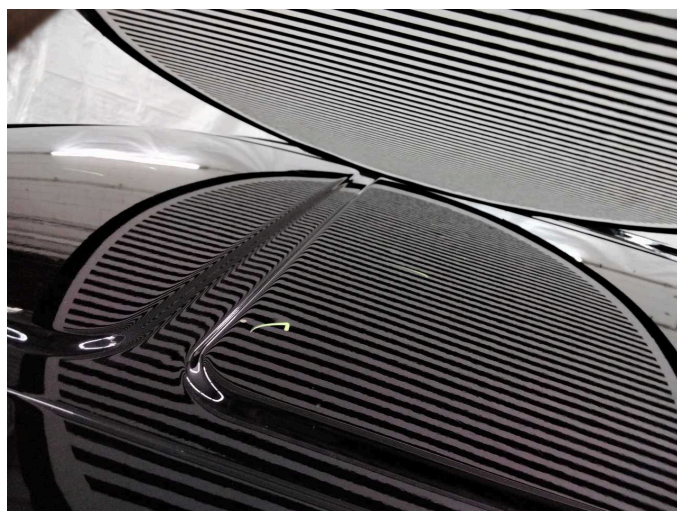
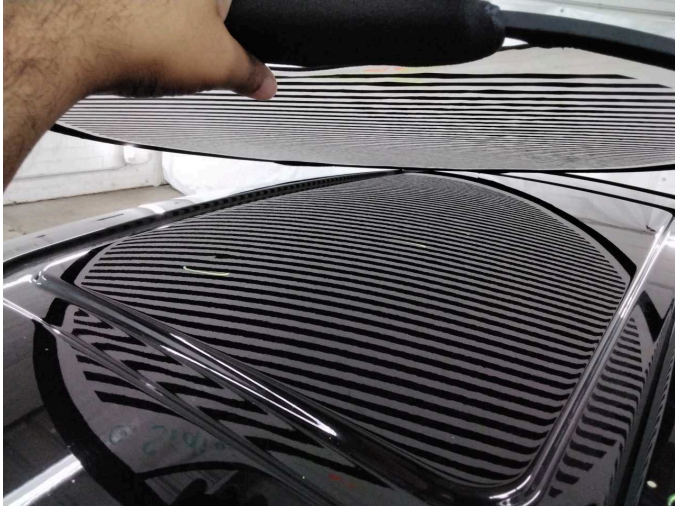
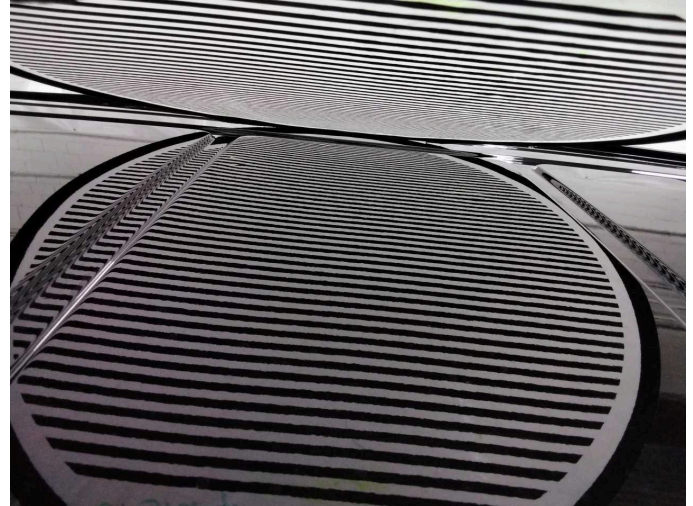
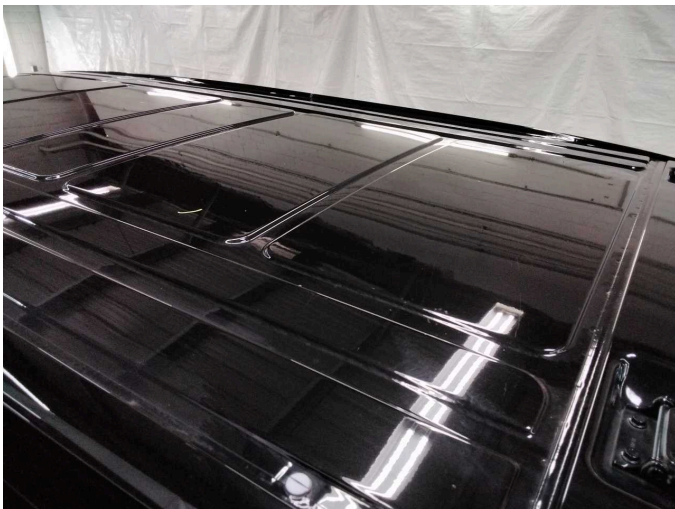
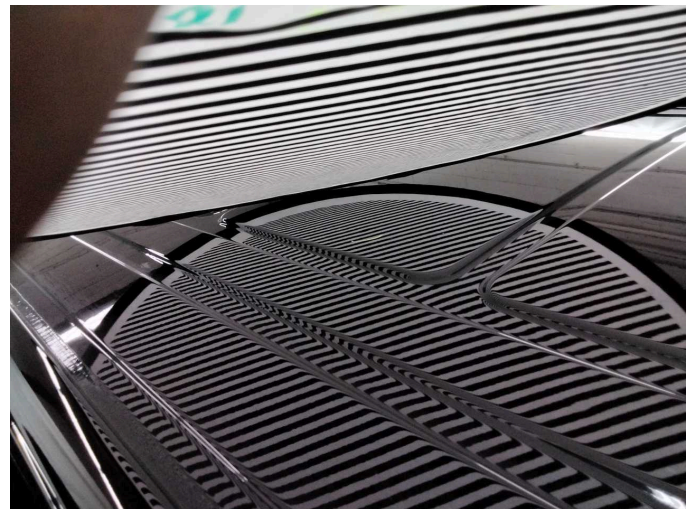
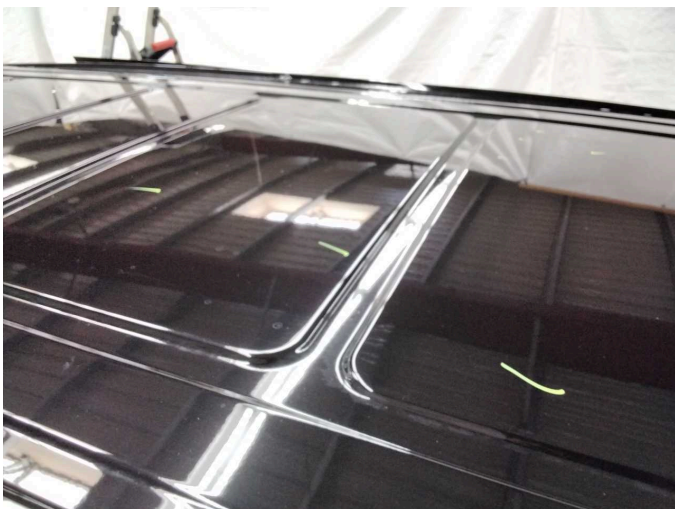
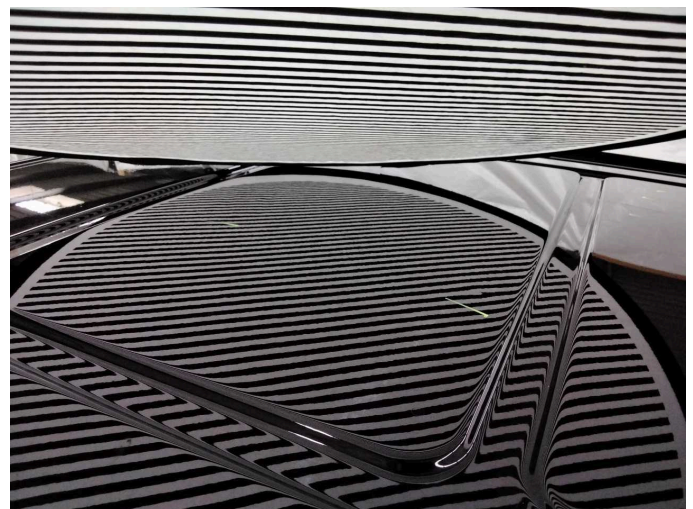
| No. | Component group | Description |
|---|---|---|
| 6 | Roof | Roof - Damage by hail - Smooth repair work |

**Damage 6:** Roof: Roof - Damage by hail - Smooth repair work

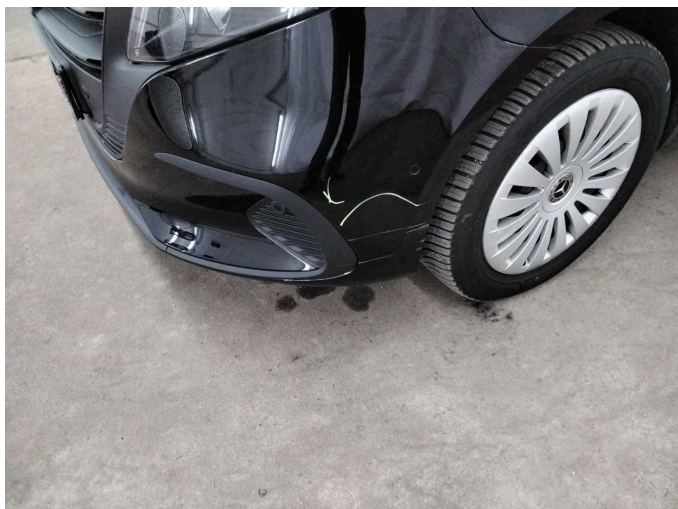
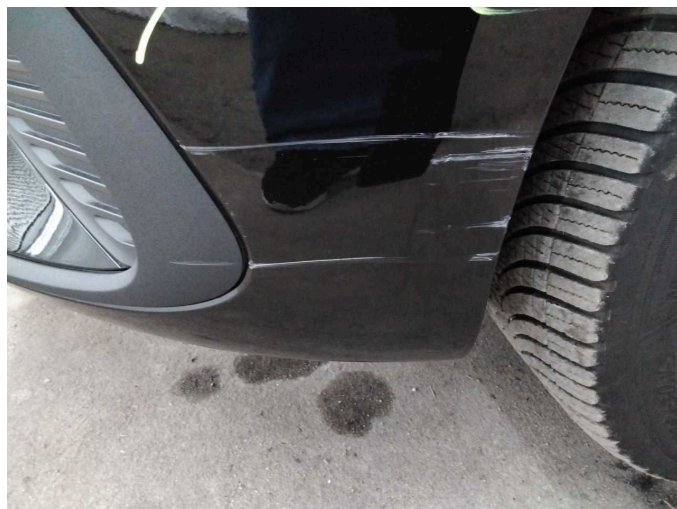
| No. | Component group | Description |
|---|---|---|
| 7 | Front bumper | Front bumper - Scratch(es) - Paint |

**Damage 7:** Front bumper: Front bumper - Scratch(es) - Paint

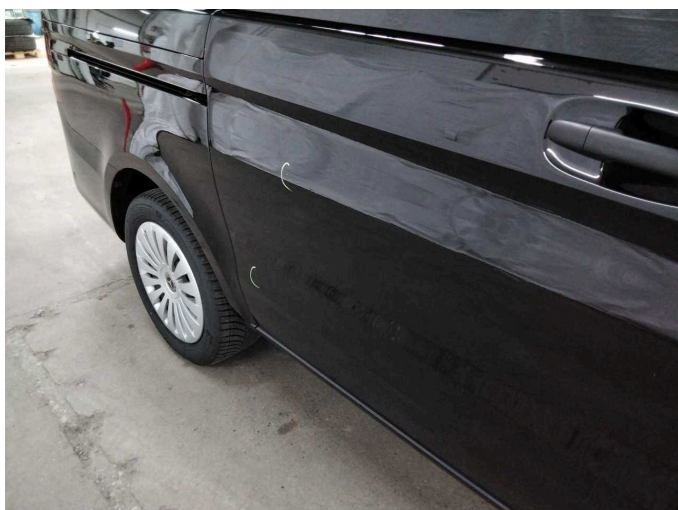
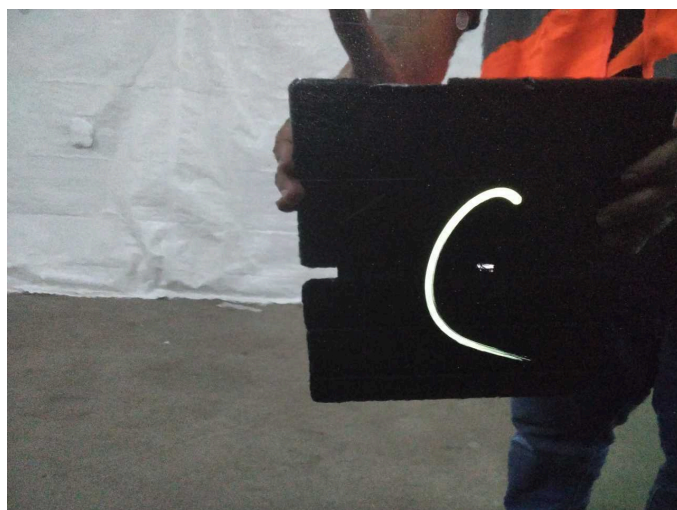
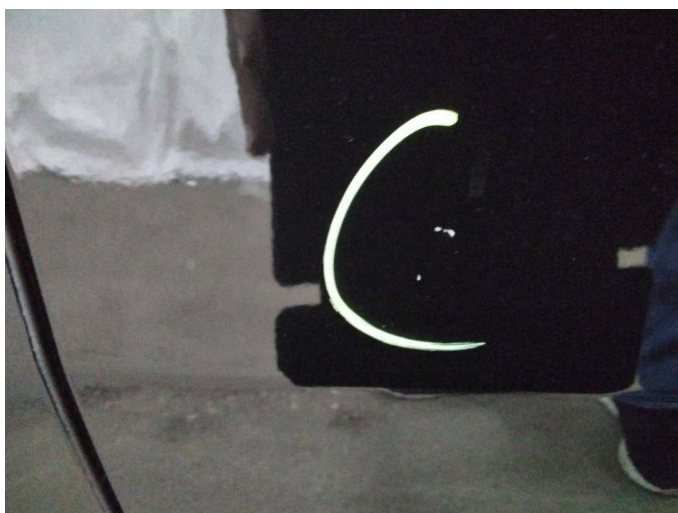
| No. | Component group | Description |
|---|---|---|
| 8 | Sliding door, right | Sliding door with glass panel - Scratch(es) - Paint |

**Damage 8:** Sliding door, right: Sliding door with glass panel - Scratch(es) - Paint

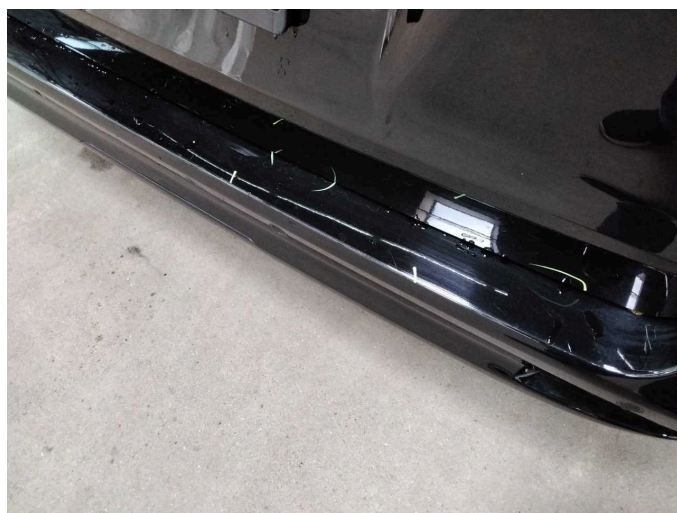
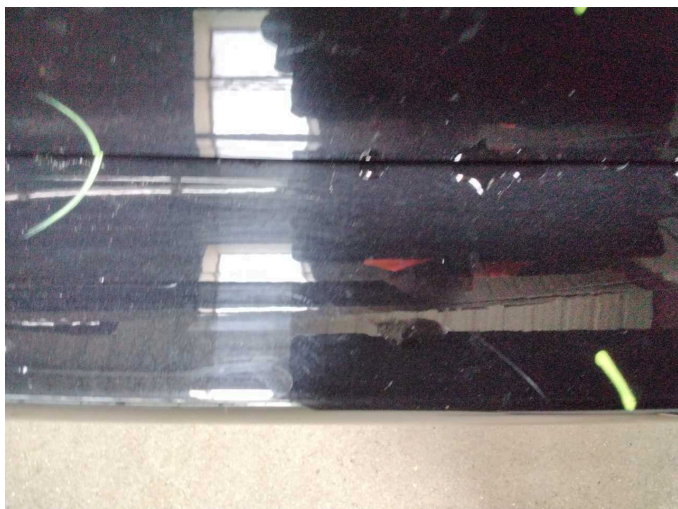
| No. | Component group | Description |
|---|---|---|
| 4 | Rear bumper | Rear bumper (Verlade- / Einstiegsbereich) - Scratch(es) - No deduction |

**Wear and tear 4:** Rear bumper: Rear bumper (Verlade- / Einstiegsbereich) - Scratch(es) - No deduction
