Expertise

Protocol number: 46187564
Order No. / Reference: 26622867
Inspection date: 25 Jun 2026

Model: Transit Connect Kombi 230 L2 S&S Trend

VIN: WF07XXWPG7LY86098

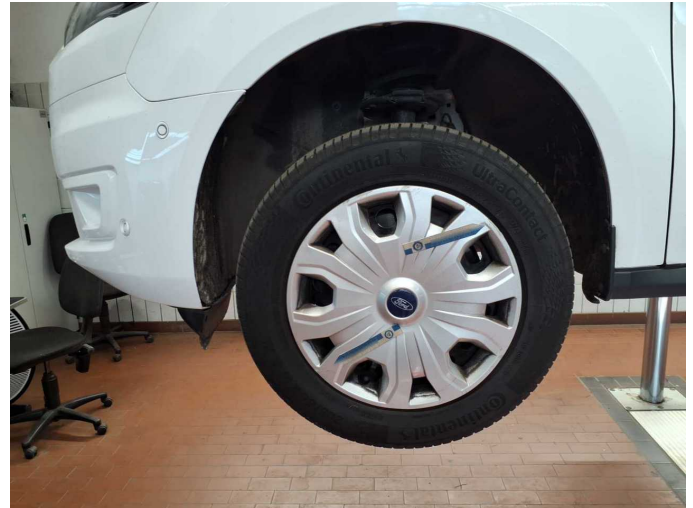
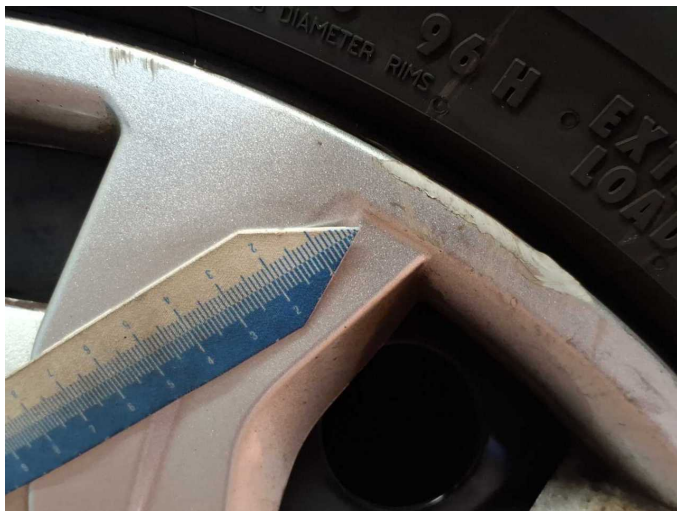
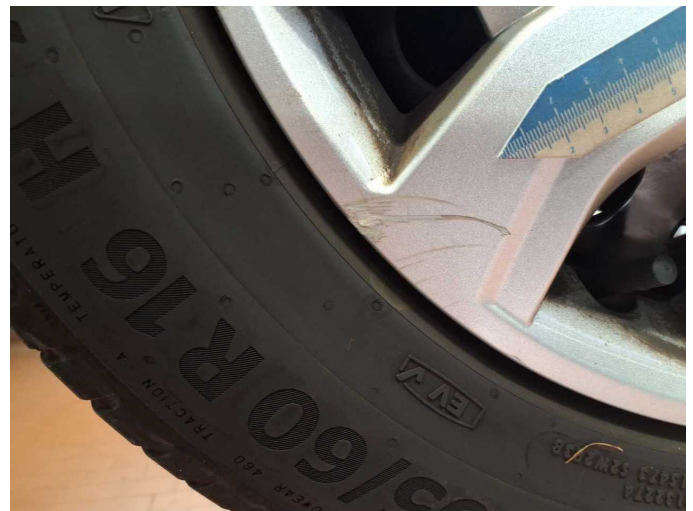
Damage 1: Wheel / tyres: Wheel cover - front left side - Scratched - Replace

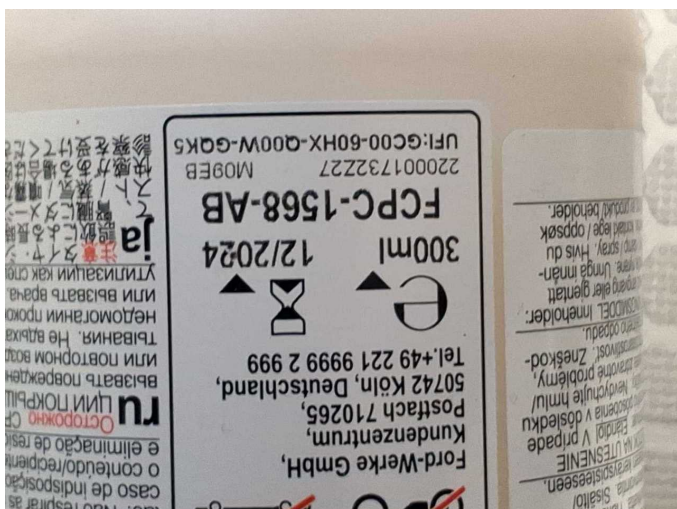
Damage 2: Equipment: Tirefit filler - Expired - Replace

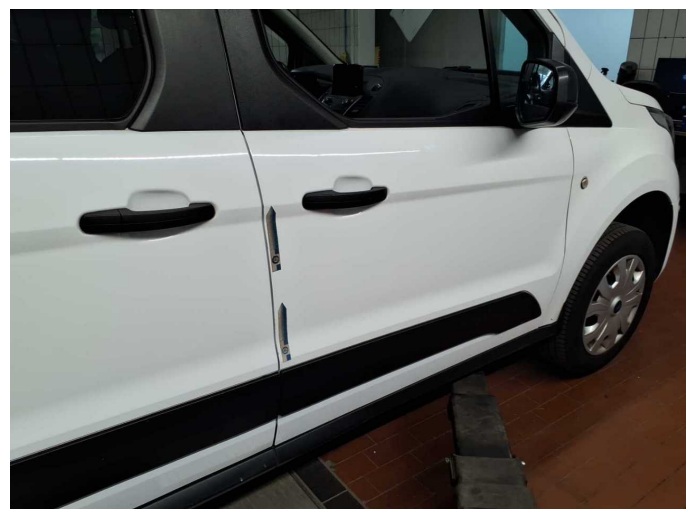
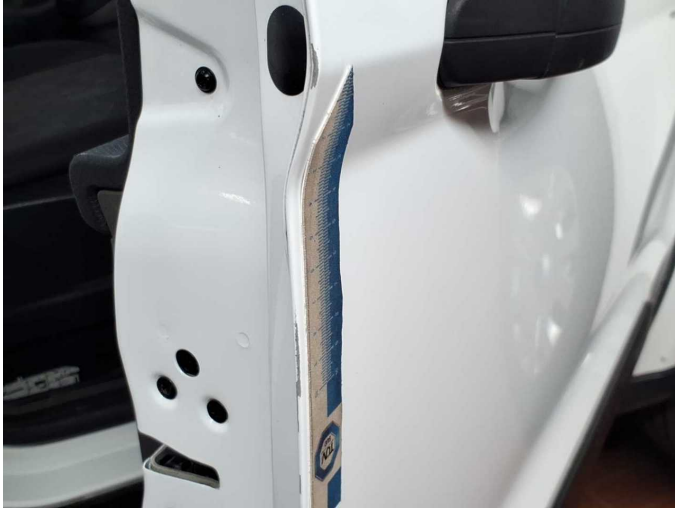
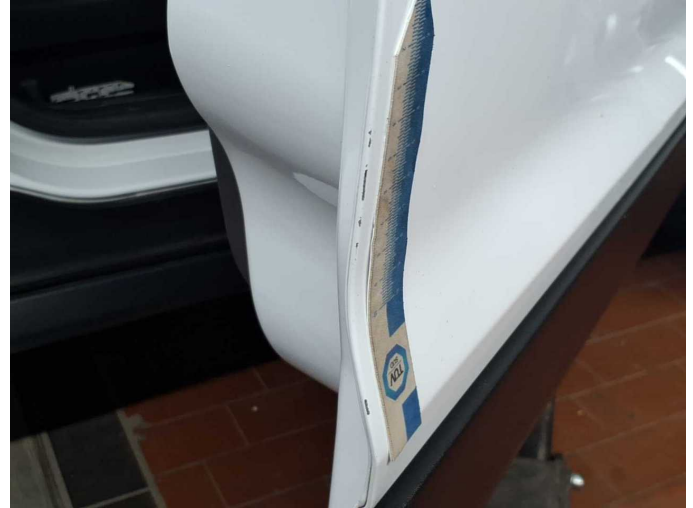
Damage 3: Door - front right side: Door edge - Scratch(es) - Smart repair

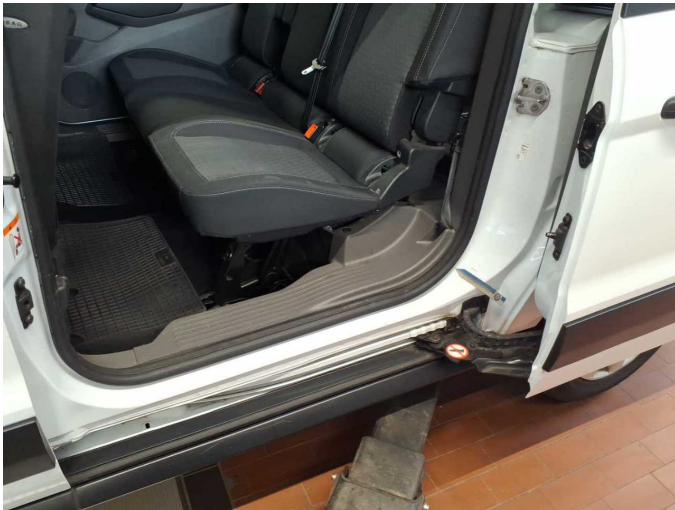
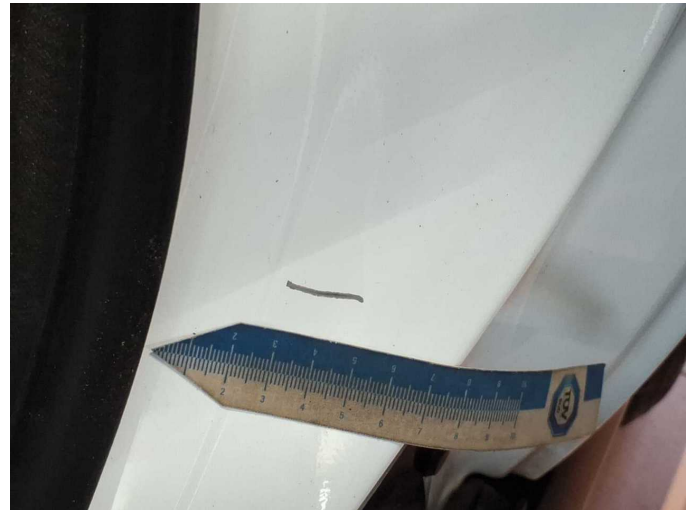
Damage 4: Side panel - rear left side: Sill - Scratch(es) - Smart repair

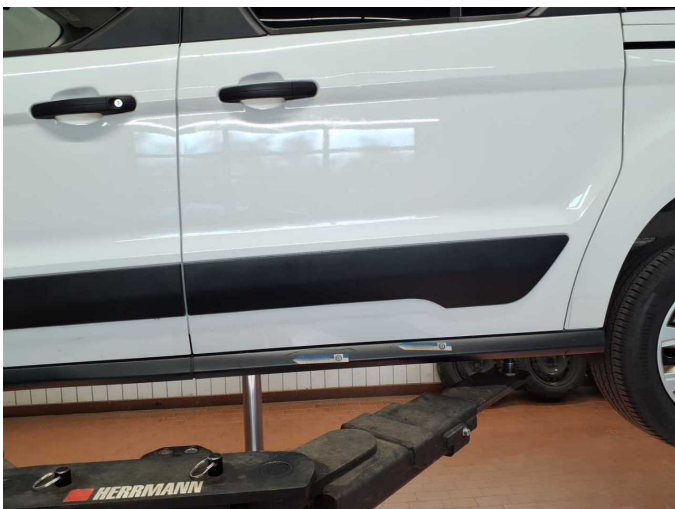
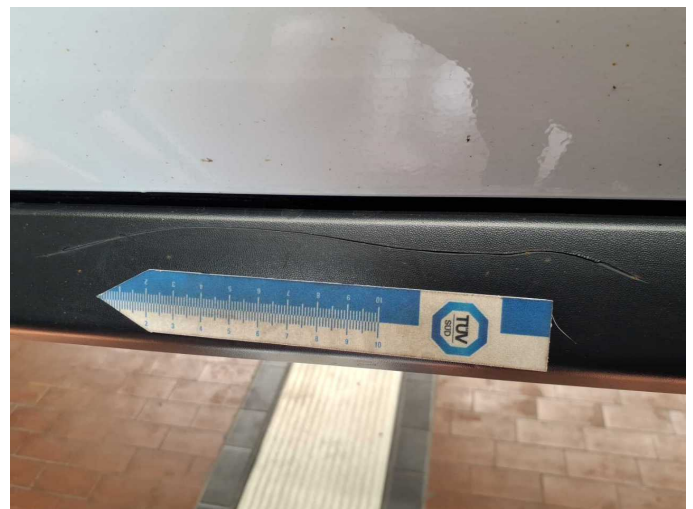
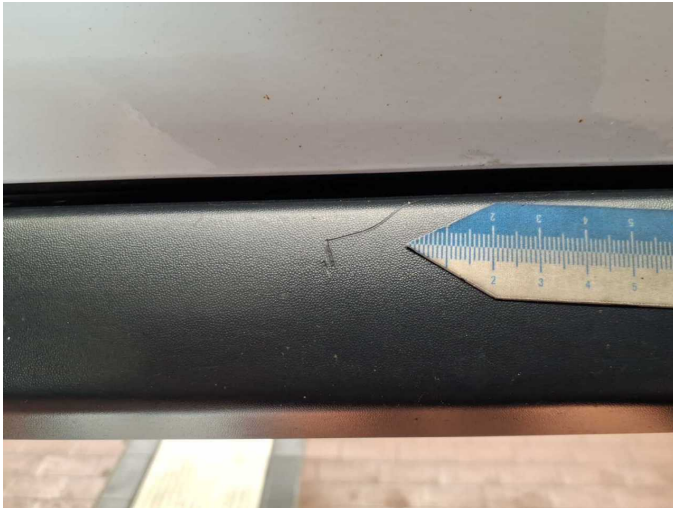
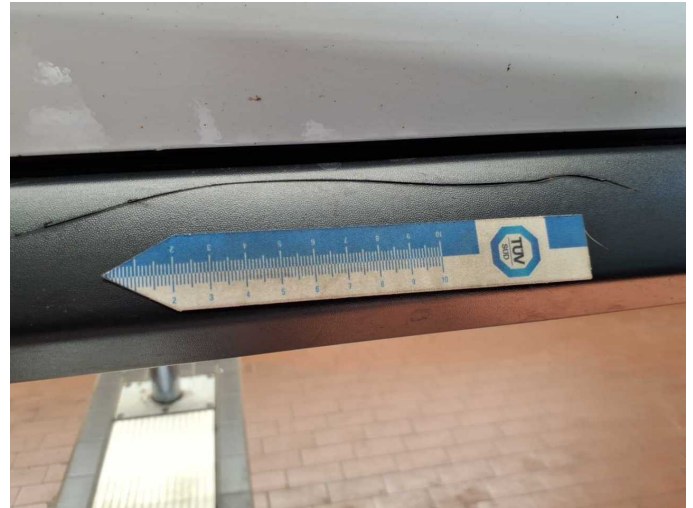
Damage 5: Sill - left side: Trim (Hinten) - Scratched - Replace

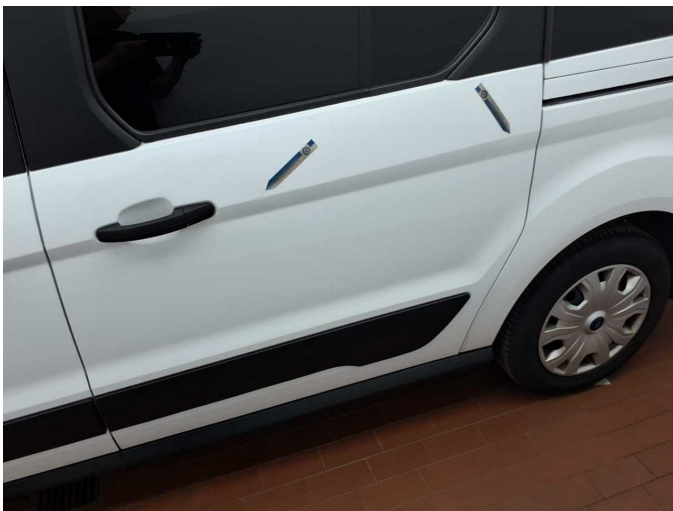
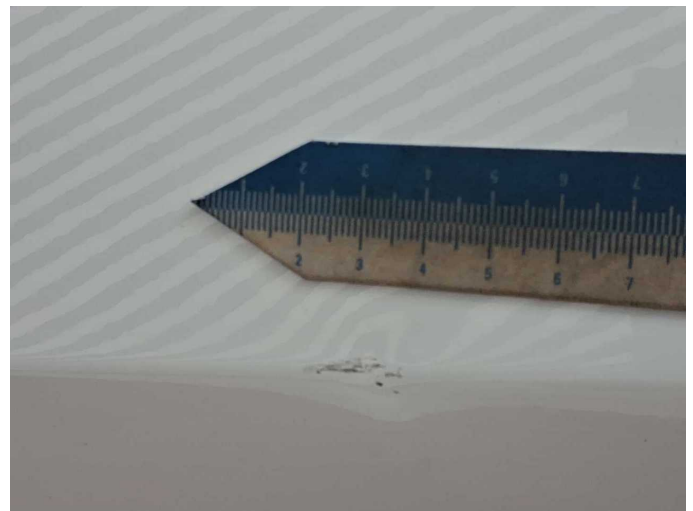
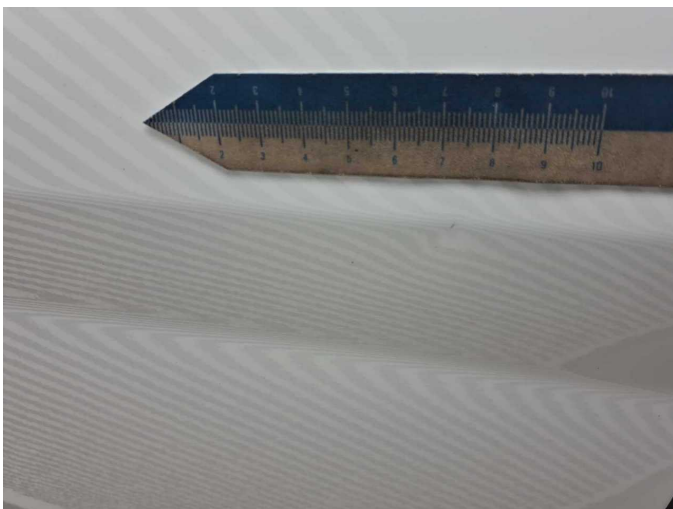
Damage 6: Sliding door - left side: Sliding door with glass panel - Dent / paintcoat damage - Smart repair

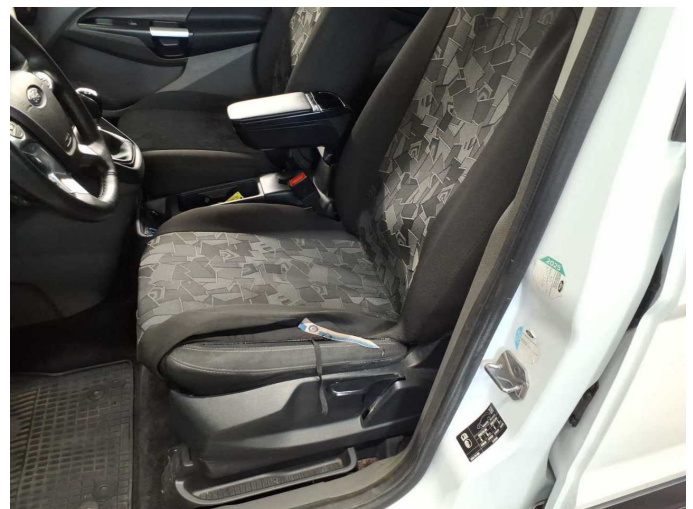
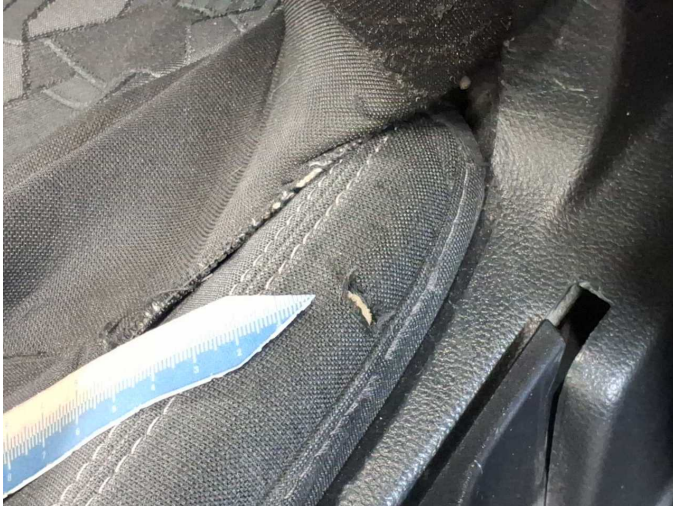
Damage 7: Seat - front: Seat cover - left side - Porous / cracked - Replace

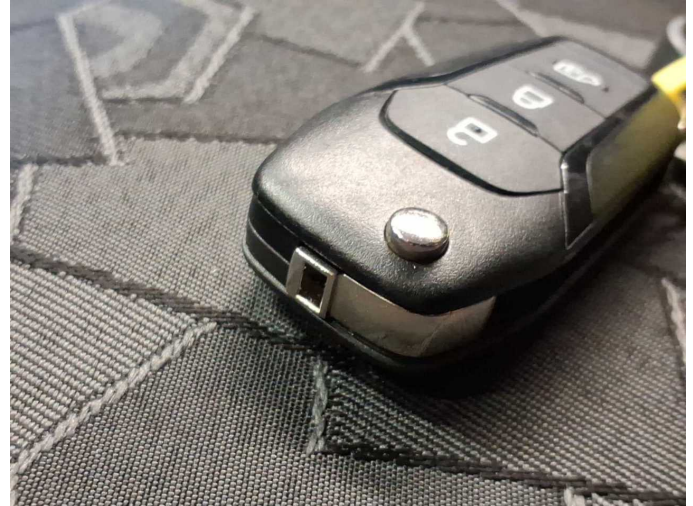
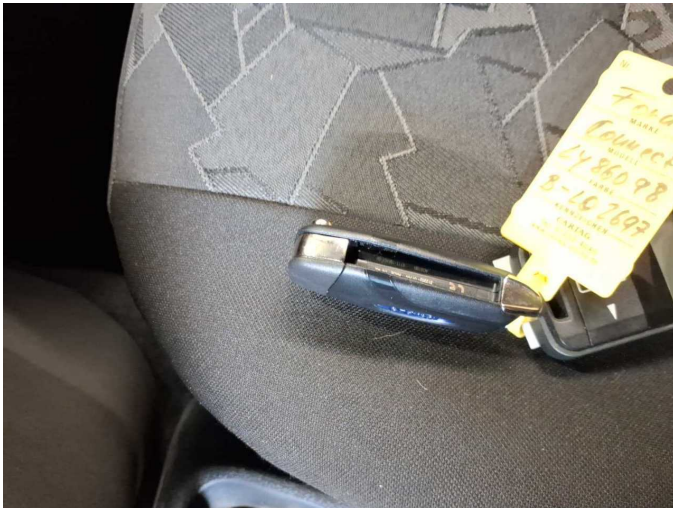
Damage 8: Equipment: Vehicle key with remote control (Schlüsselbart fehlt) - Sub-function - Replace

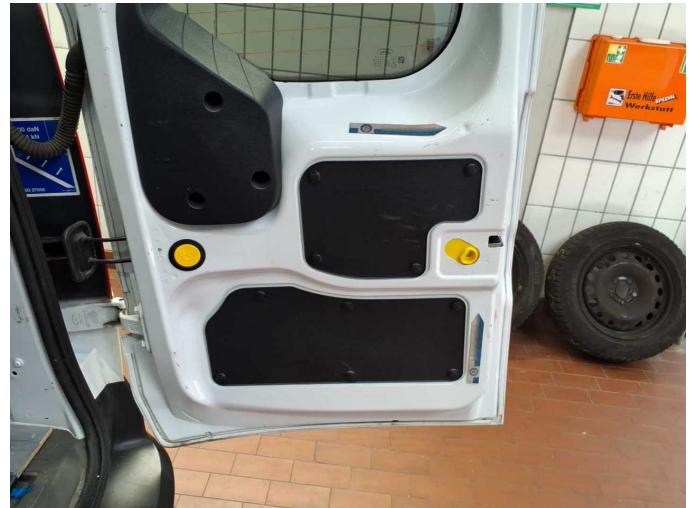
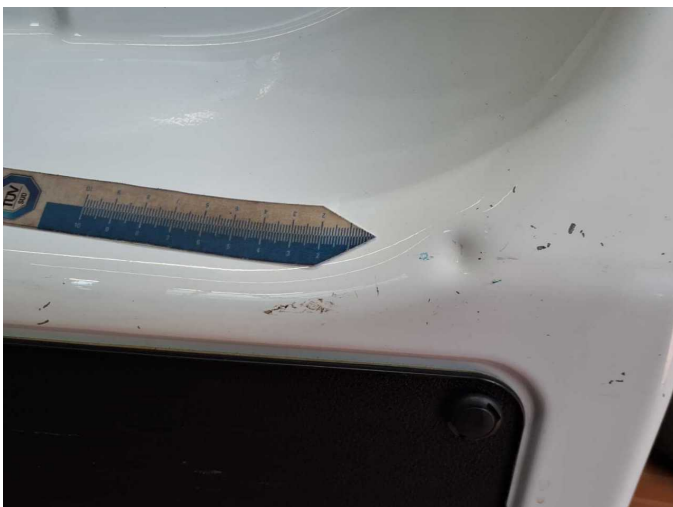
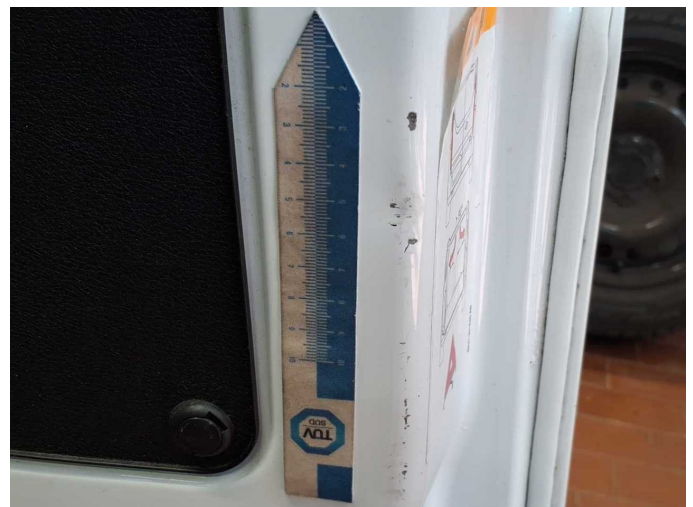
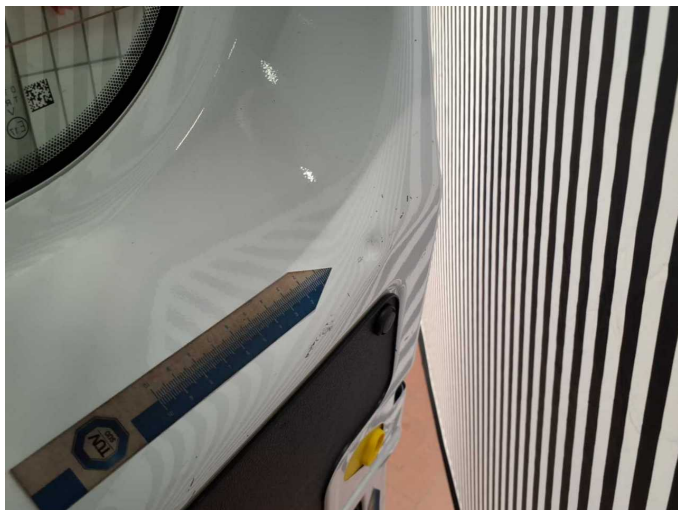
Wear and tear 7: Boot lid / rear door: Rear door - right side (innen) - Dent / paintcoat damage - No deduction

Wear and tear 7: Boot lid / rear door: Rear door - right side (innen) -
Dent / paintcoat damage - No deduction
