## Expertise

Protocol number: 45478507  
Order No. / Reference: 26274862  
Inspection date: 11 May 2026

Manufacturer: Ford

Model: Kuga 2.5 Duratec PHEV TITANIUM X

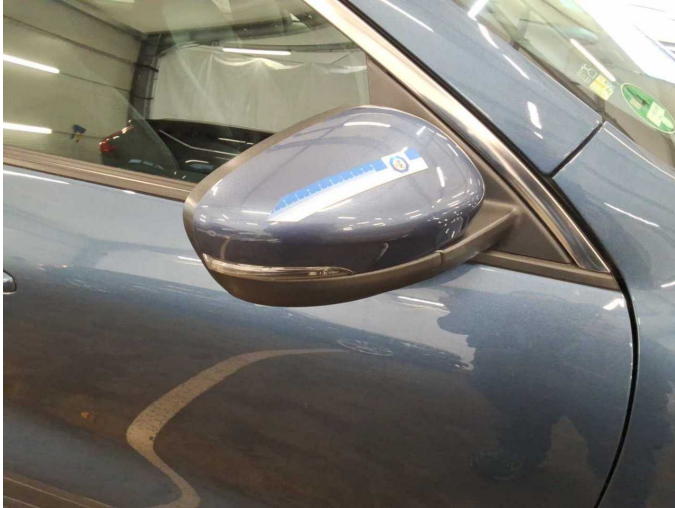
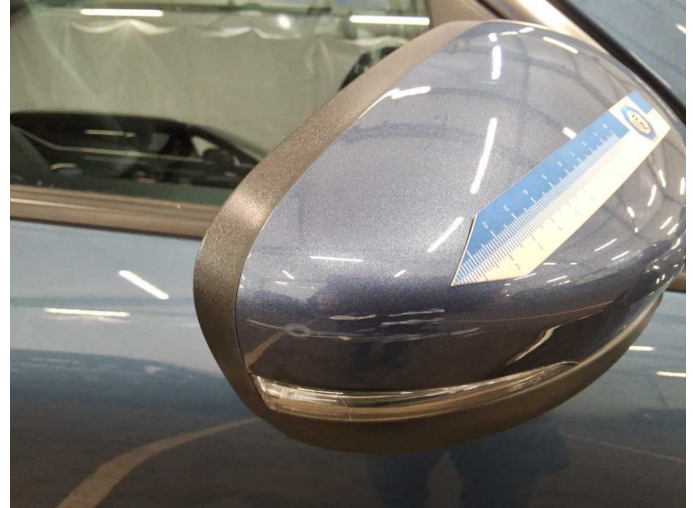
**Damage 1:** Wing mirror - right side: Cap - Scratch(es) - Smart repair

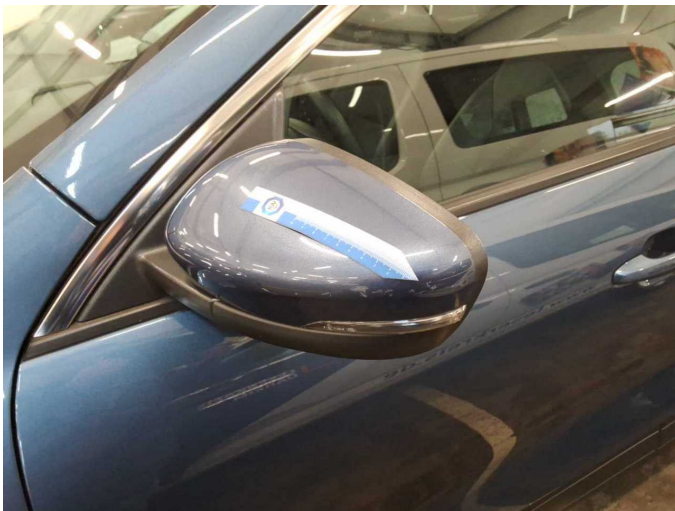
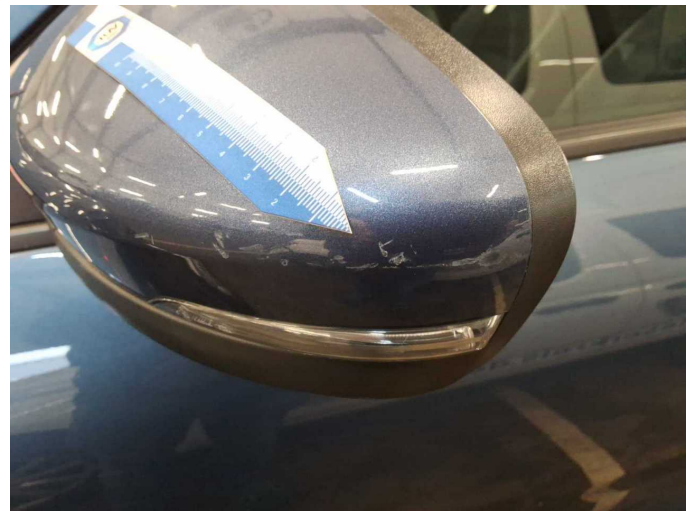
**Damage 2:** Wing mirror - left side: Cap - Scratch(es) - Smart repair

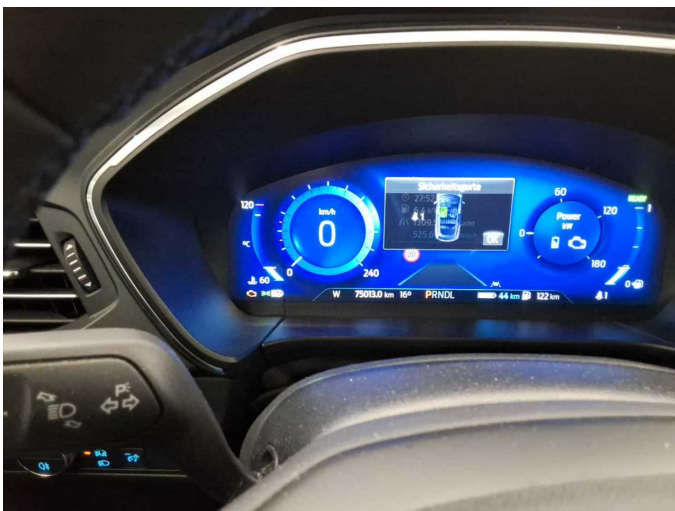
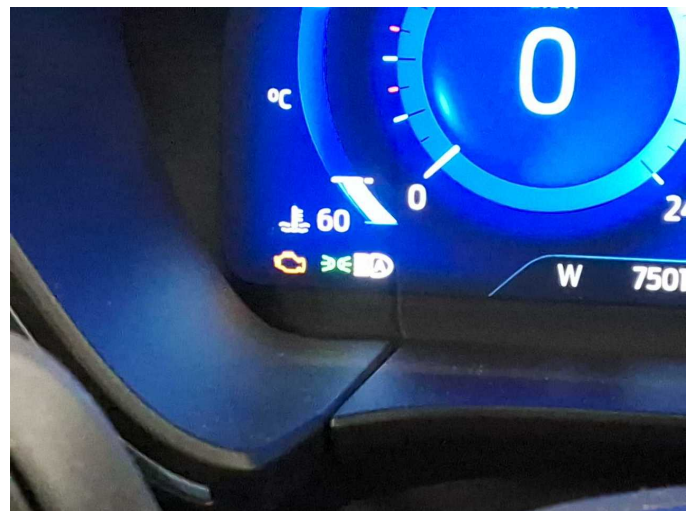
Documents submitted	At the time of the inspection, the vehicle registration certificate Part 2 (title) was available, but the vehicle registration certificate Part 1 (document) was not. (Copy)
VIN comparison	The vehicle identification number (VIN) was read from the vehicle and its conformity with the submitted documents was confirmed by the undersigned during the inspection.
Inspection	The inspection conditions were sufficient for the assessment of the vehicle. No lifting equipment or pit was available for inspecting the vehicle. Therefore, inspection of the vehicle's underside was only possible to a limited extent.
Test drive	No test drive/shunting maneuver was carried out during the inspection of the vehicle.
Engine function test	An engine test run was performed, problem has been detected This is due to the following reason.: Motorkontrolleuchte aktiv, Fehlerursache nicht genauer Identifizierbar

**Damage 3:** Instrument panel: Indicator light (Motorkontrolle) - on - Perform diagnosis

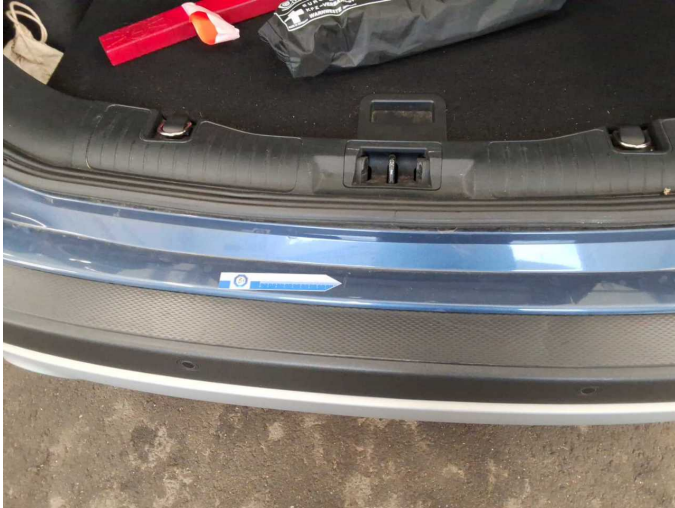
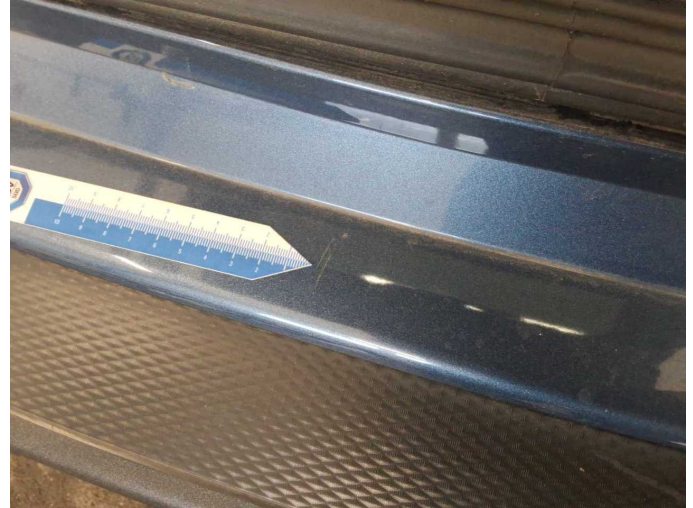
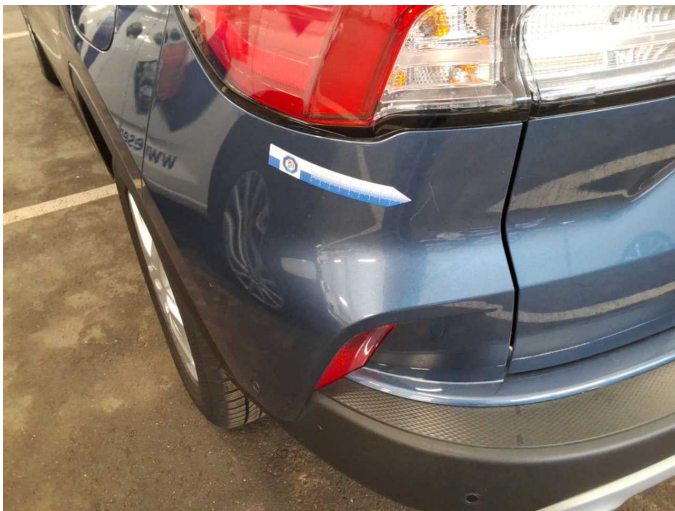
**Damage 4:** Rear bumper: Rear bumper - Scratch(es) - Paint

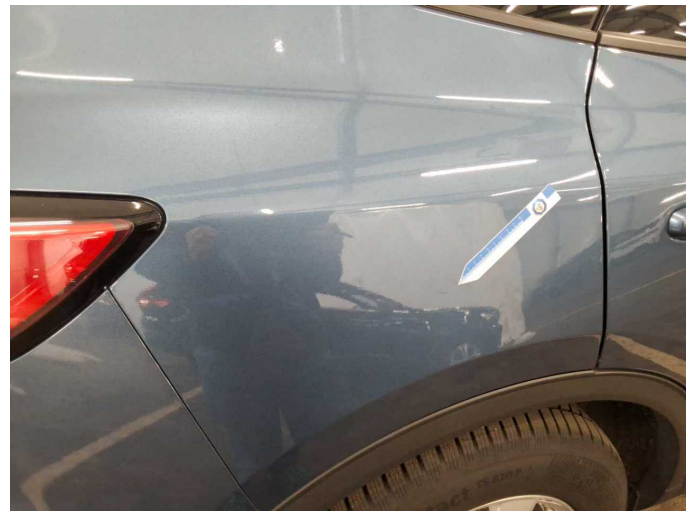
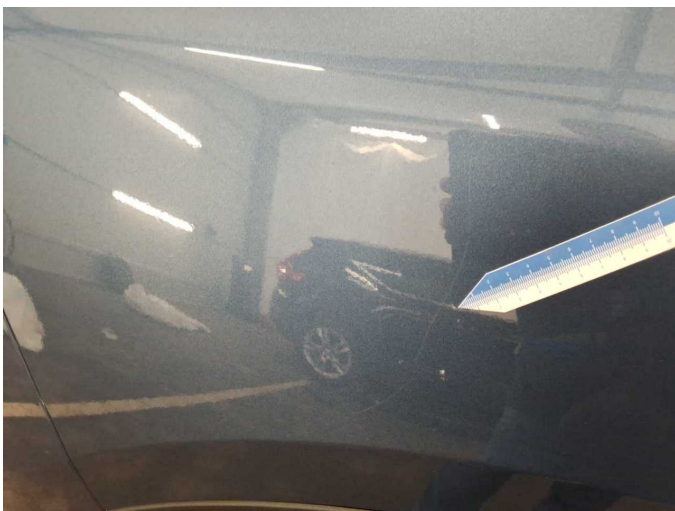
**Wear and tear 2:** Side panel - rear right side: Side panel - Scratch(es) - No deduction

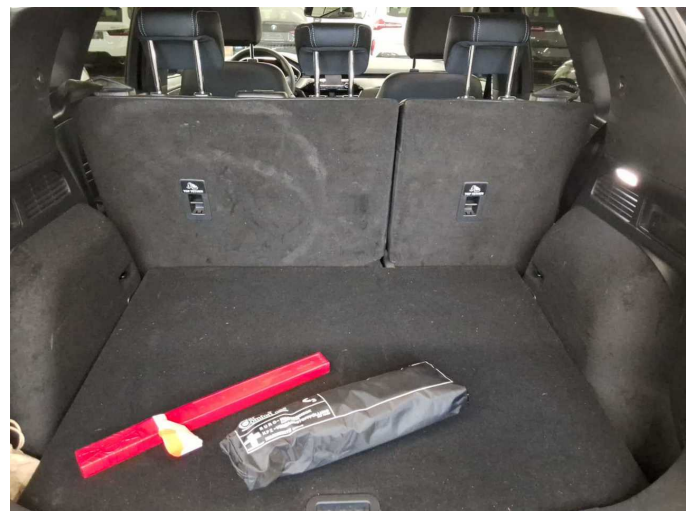
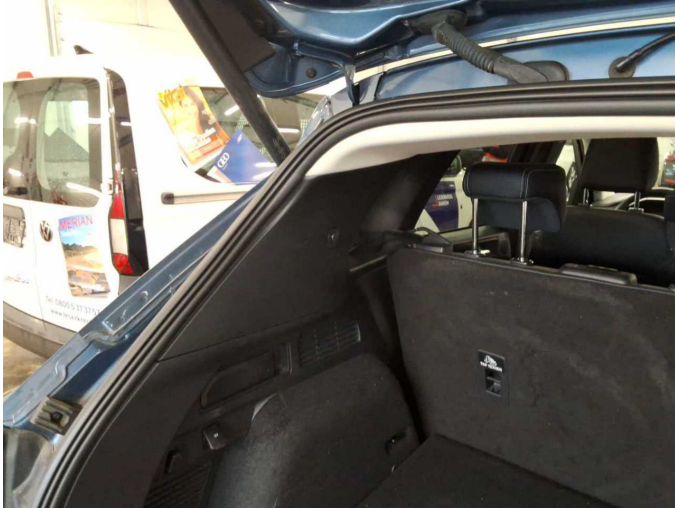
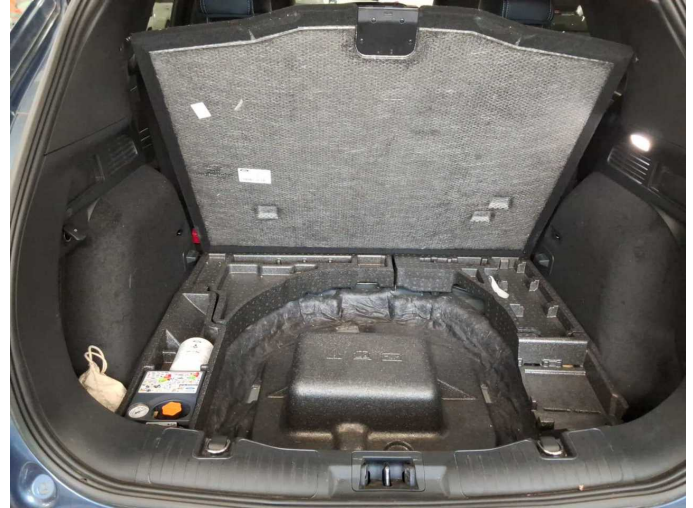
**Missing part 1:** Interior: Boot cover / roller cover - Missing - Replace

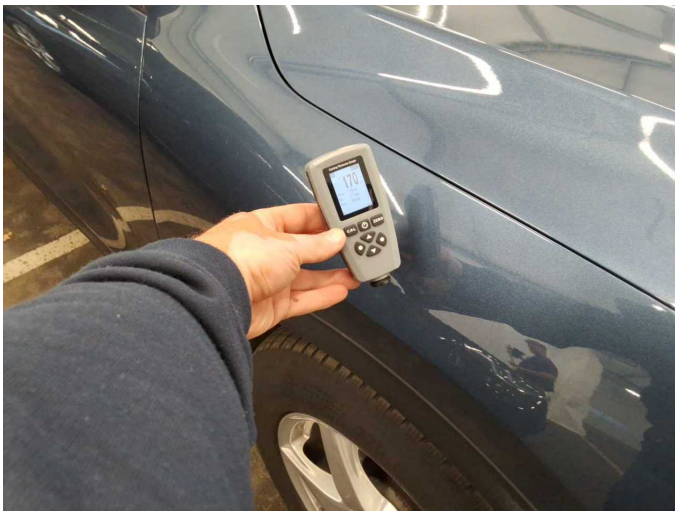
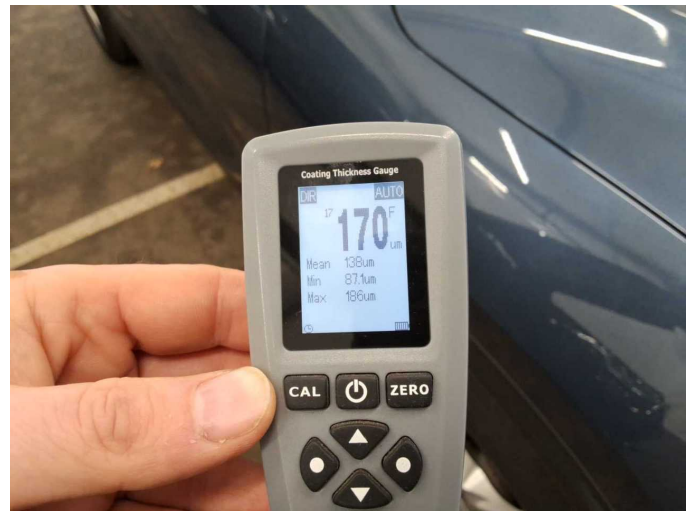
**Repainting 1:** Mudguard - right side

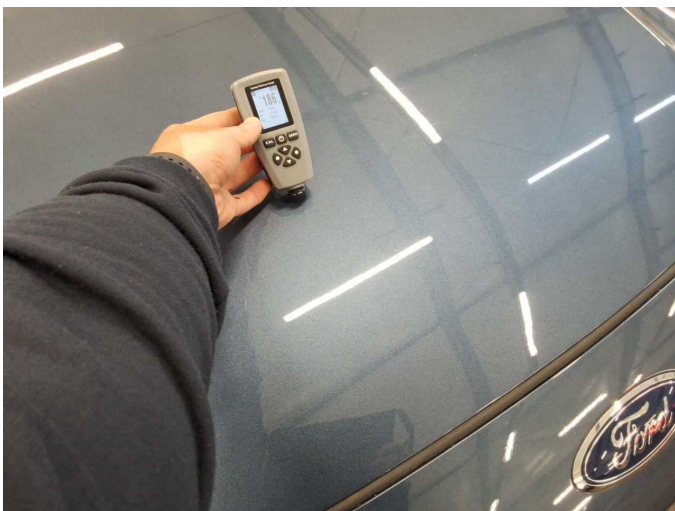
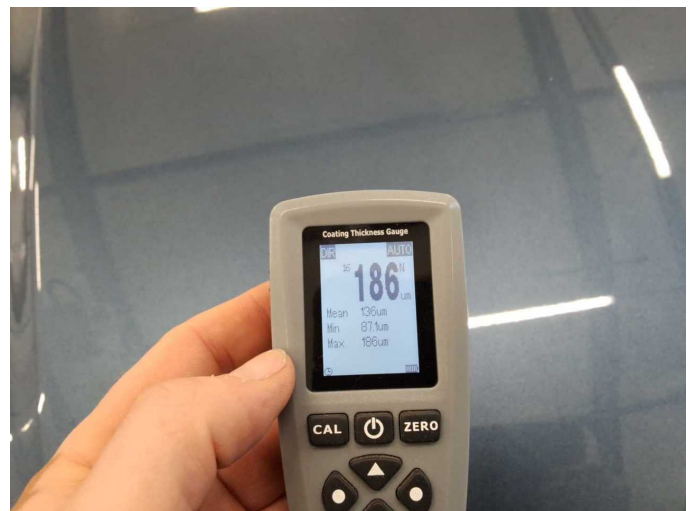
**Repainting 2:** Bonnet

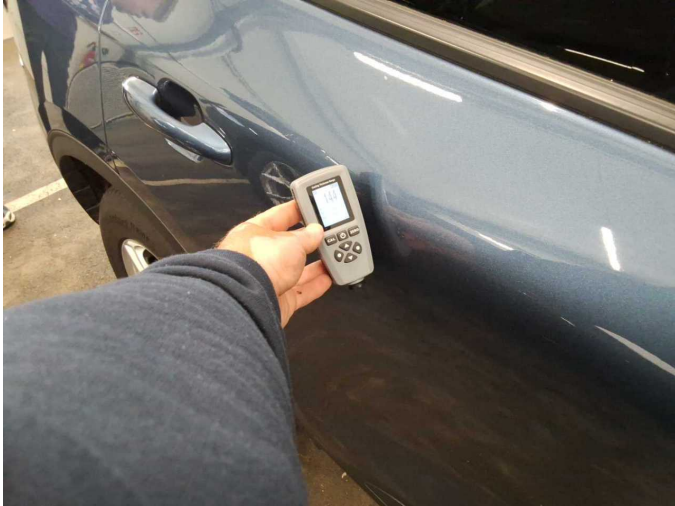
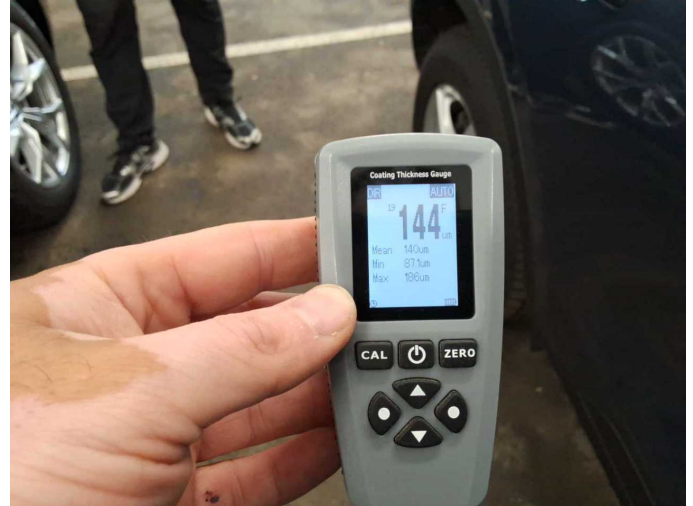
Repainting 3: Door - rear right side

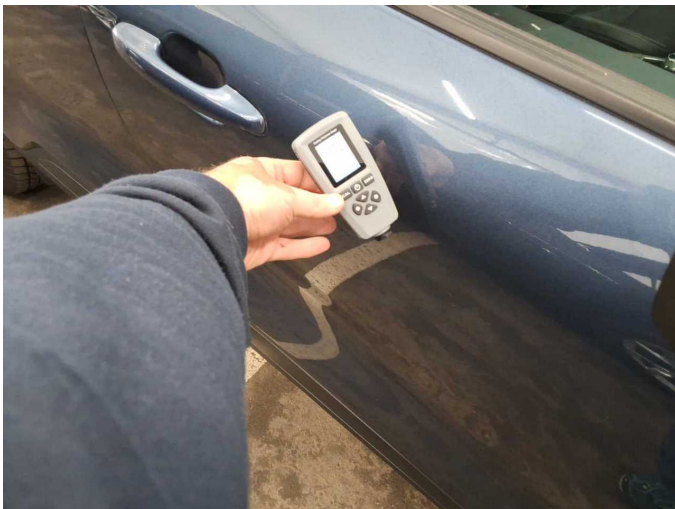
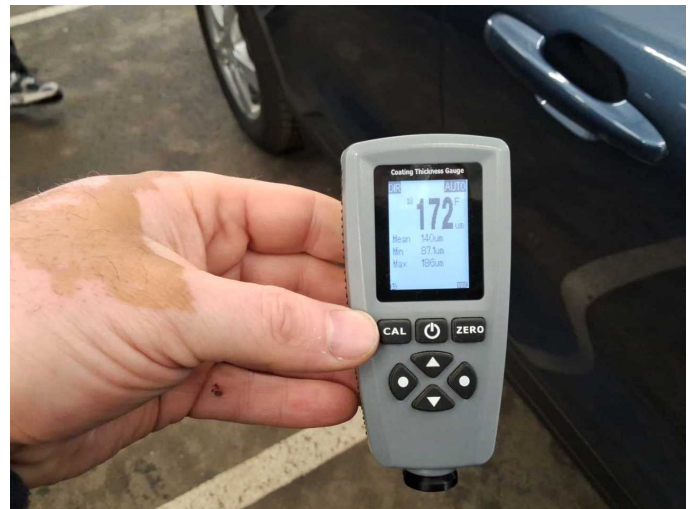
Repainting 4: Door - front right side
