Expertise

Protocol number: 46865918  
Order No. / Reference: 26805376  
Inspection date: 3 Aug 2026

Manufacturer: Skoda  
VIN: TMBJR7NX1MY132331

Model: Octavia Combi 1.5 TSI ACT Clever

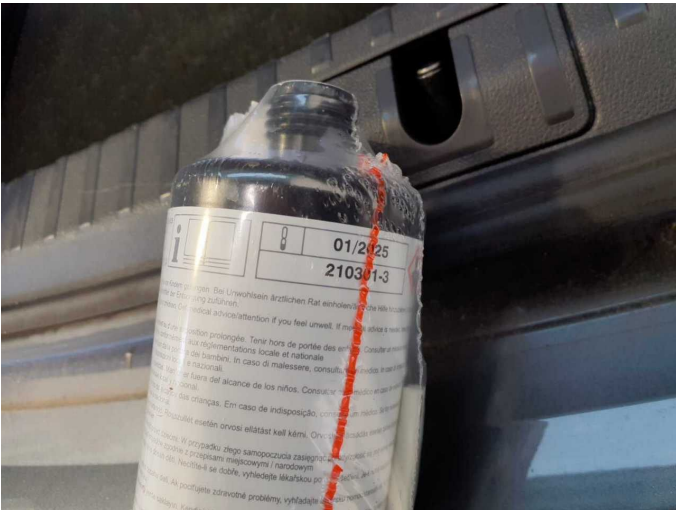
| No. | Component group | Description |
|---|---|---|
| 2 | Equipment | Tirefit filler - Expired - Replace |

Damage 2: Equipment: Tirefit filler - Expired - Replace

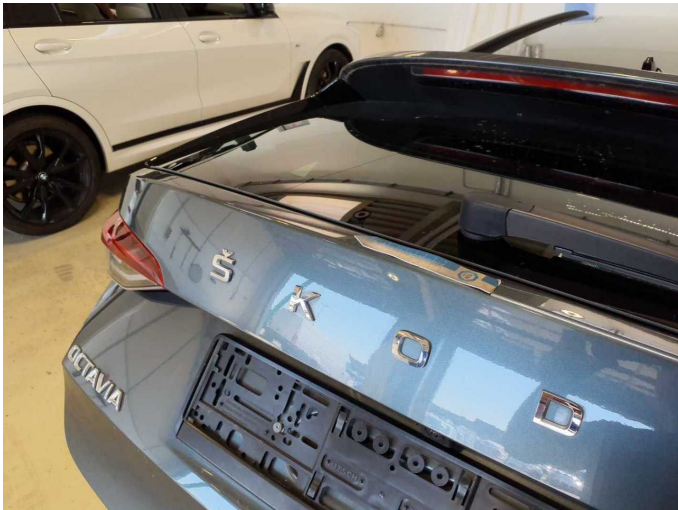
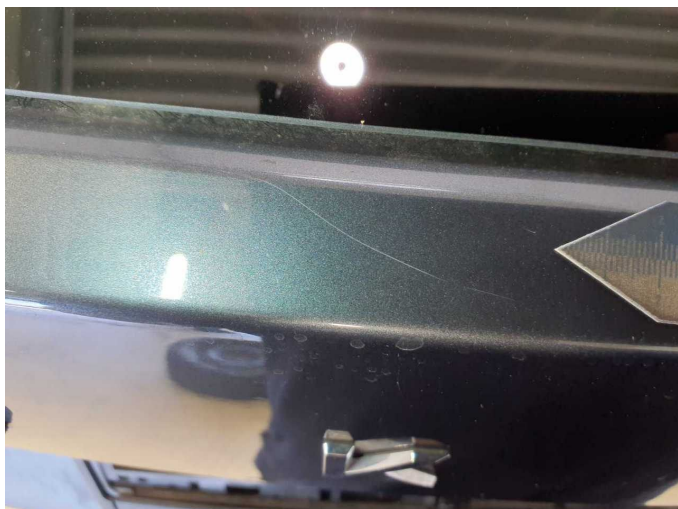
| No. | Component group | Description |
|---|---|---|
| 3 | Boot lid / rear door | Boot lid - Scratch(es) - Smart repair |

Damage 3: Boot lid / rear door: Boot lid - Scratch(es) - Smart repair

**Damage 3:** Boot lid / rear door: Boot lid - Scratch(es) - Smart repair

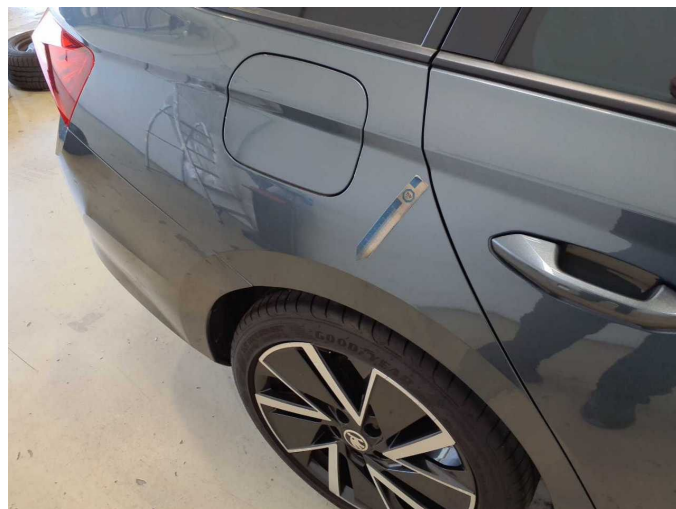
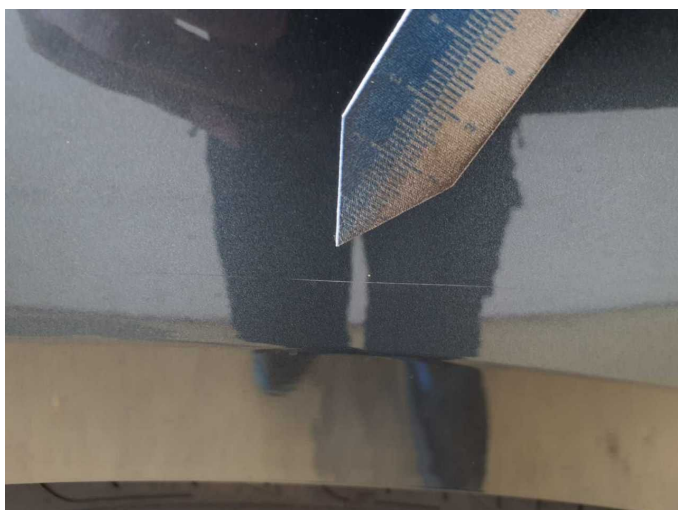
| No. | Component group | Description |
|---|---|---|
| 4 | Side panel - rear right side | Side panel - Scratch(es) - Smart repair |

**Damage 4:** Side panel - rear right side: Side panel - Scratch(es) - Smart repair

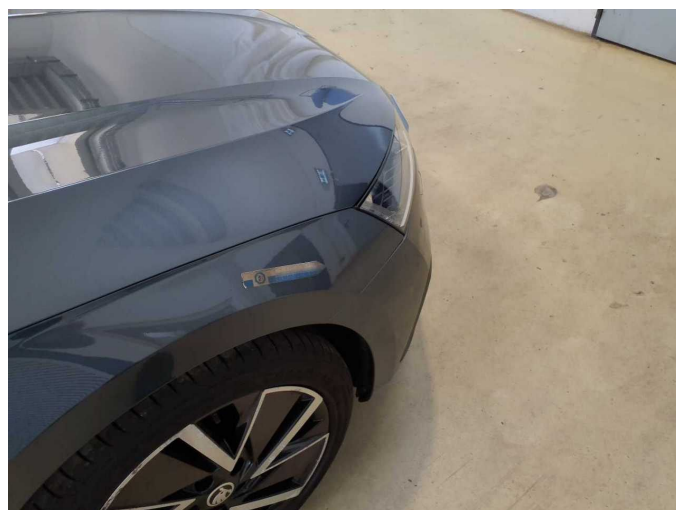
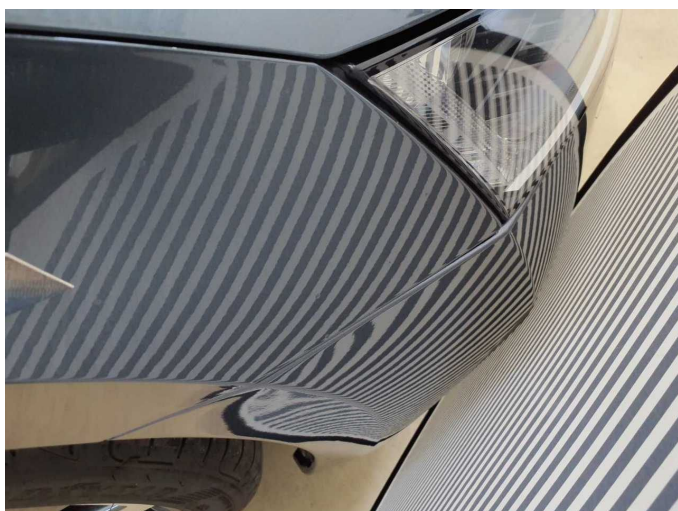
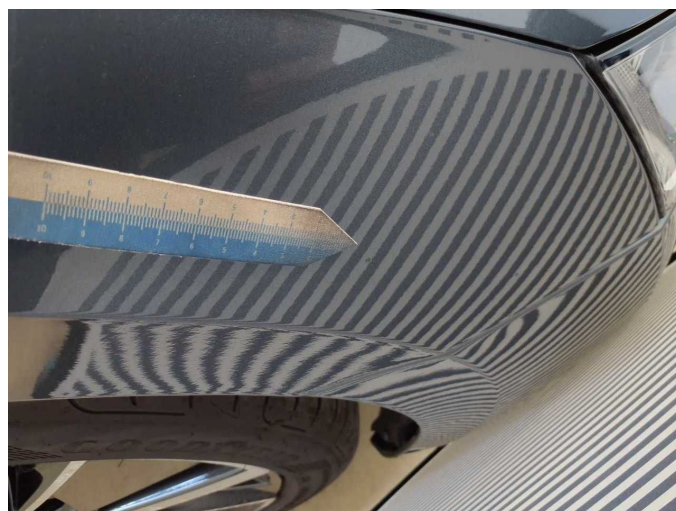
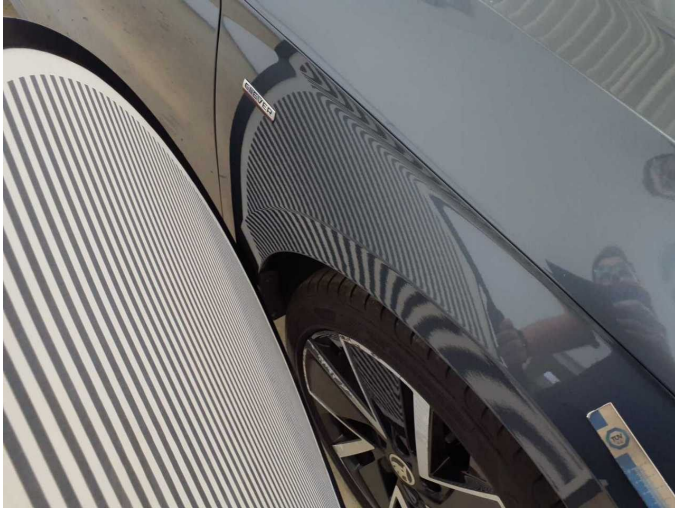
| No. | Component group | Description |
|---|---|---|
| 5 | Mudguard - right side | Mudguard - right side (Einschlüsse-Mehrkosten möglich) - Unprofessionally repaired - Conditioning |

1 Mudguard - right side, Unprofessionally carried out

**Damage 5:** Mudguard - right side: Mudguard - right side (Einschlüsse-Mehrkosten möglich) - Unprofessionally repaired - Conditioning

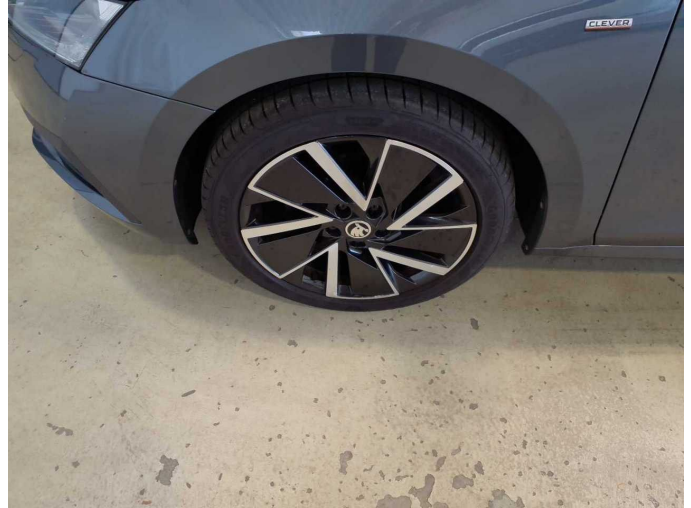
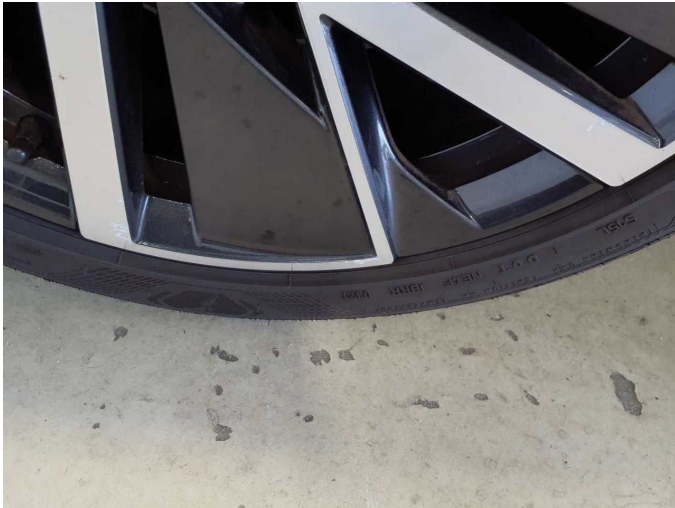
| No. | Component group | Description |
|---|---|---|
| 6 | Wheel / tyres | Alloy rim - front left side - Scratch(es) - Loss in value |

**Damage 6:** Wheel / tyres: Alloy rim - front left side - Scratch(es) - Loss in value

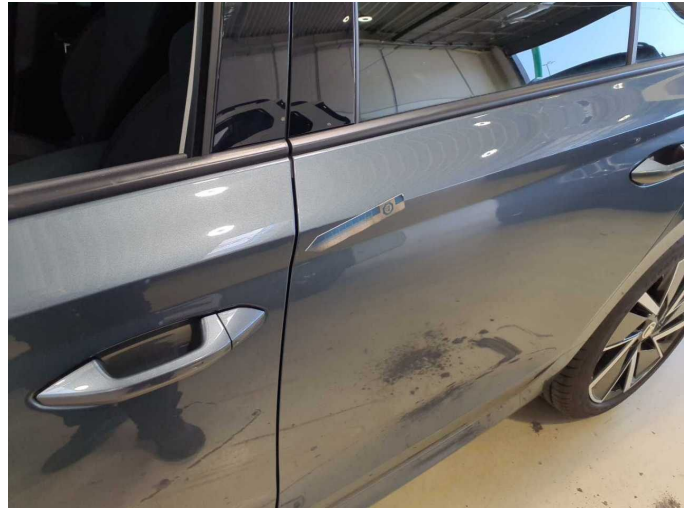
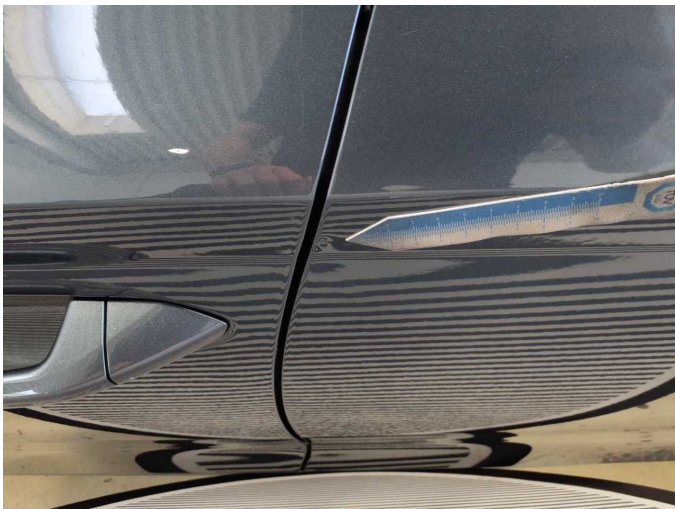
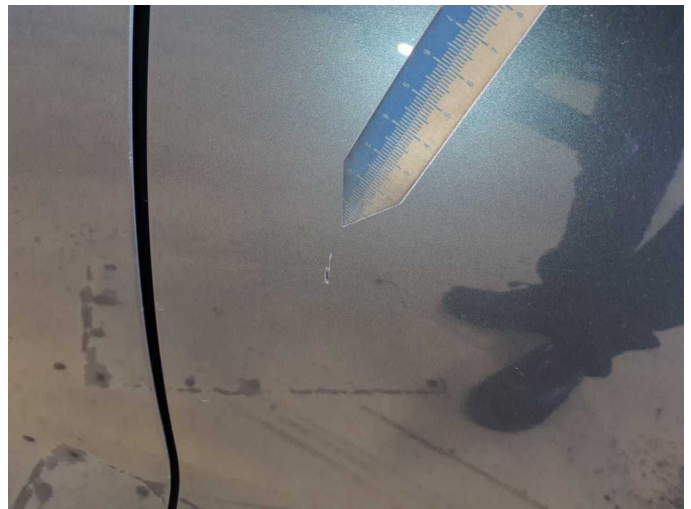
| No. | Component group | Description |
|---|---|---|
| 7 | Door - rear left side | Door - Dent / paintcoat damage - Smart repair |

**Damage 7:** Door - rear left side: Door - Dent / paintcoat damage - Smart repair

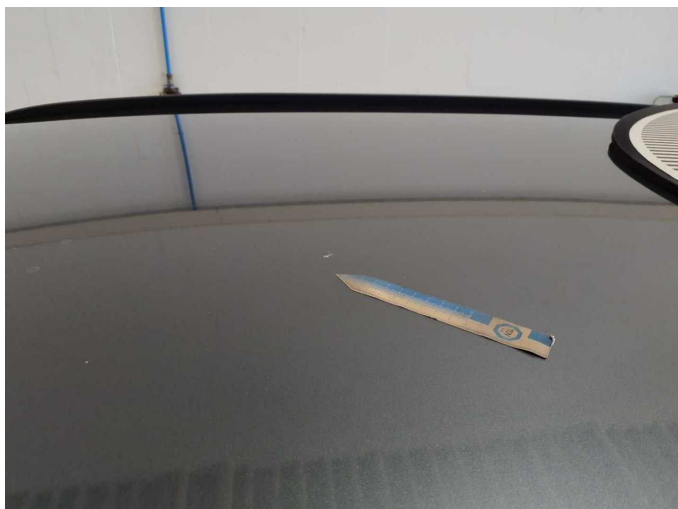
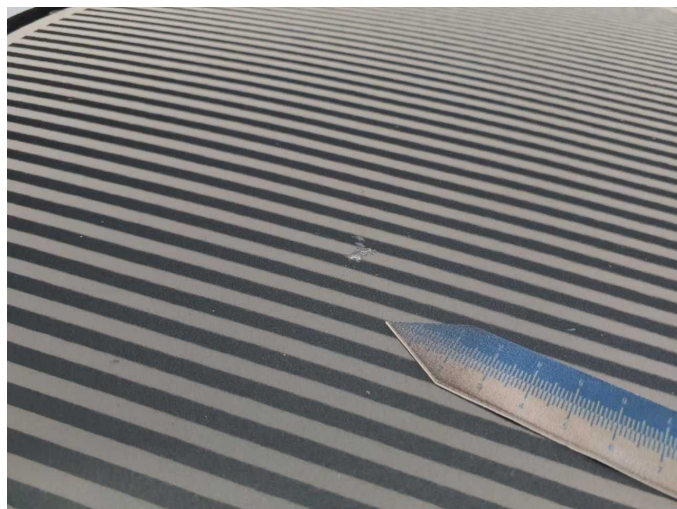
| No. | Component group | Description |
|---|---|---|
| 8 | Roof | Roof (Mehrkosten möglich) - Paint defect - Conditioning |

**Damage 8:** Roof: Roof (Mehrkosten möglich) - Paint defect - Conditioning

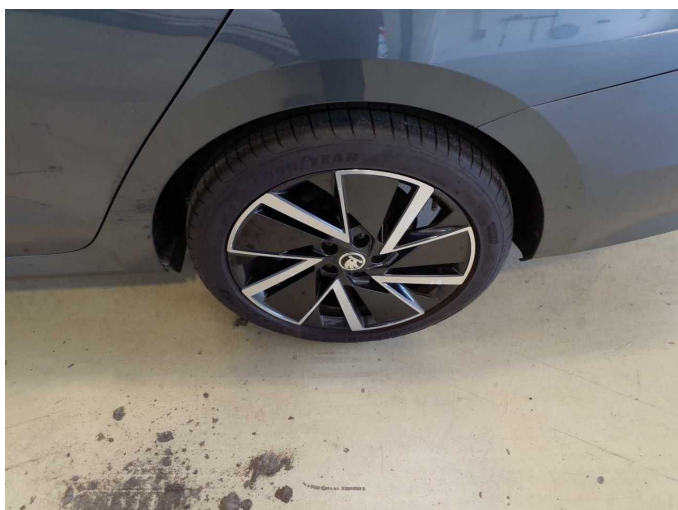
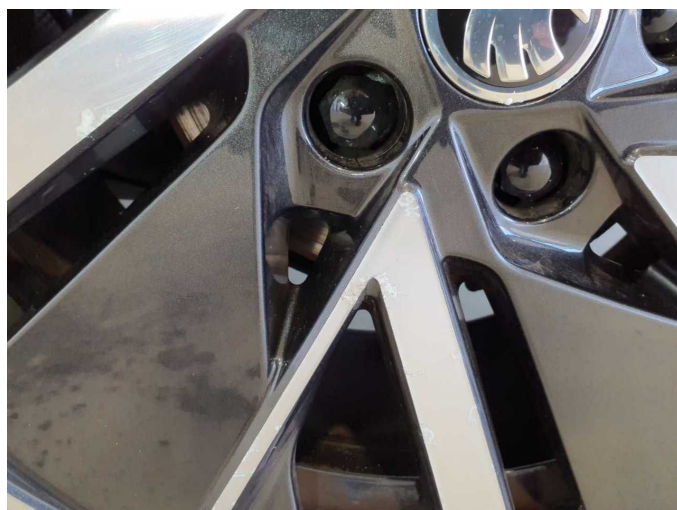
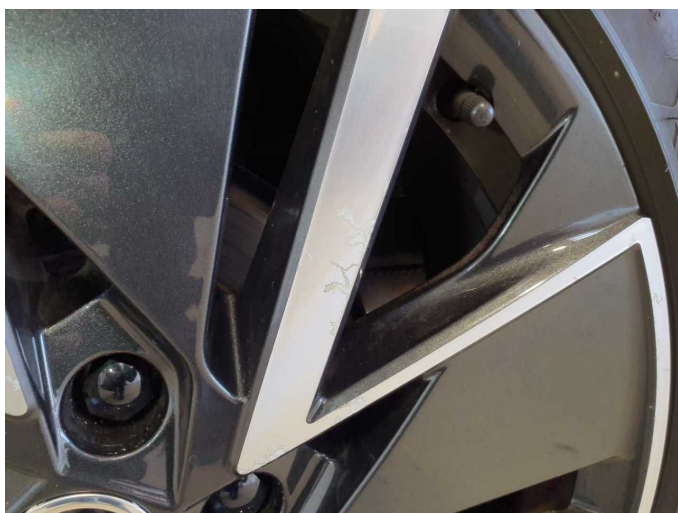
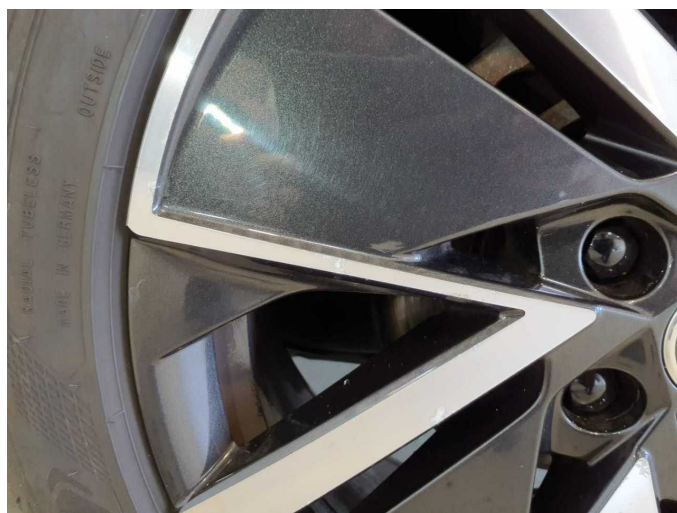
| No. | Component group | Description |
|---|---|---|
| 9 | Wheel / tyres | Alloy rim - rear left side - Scratch(es) - Loss in value |

**Damage 9:** Wheel / tyres: Alloy rim - rear left side - Scratch(es) - Loss in value

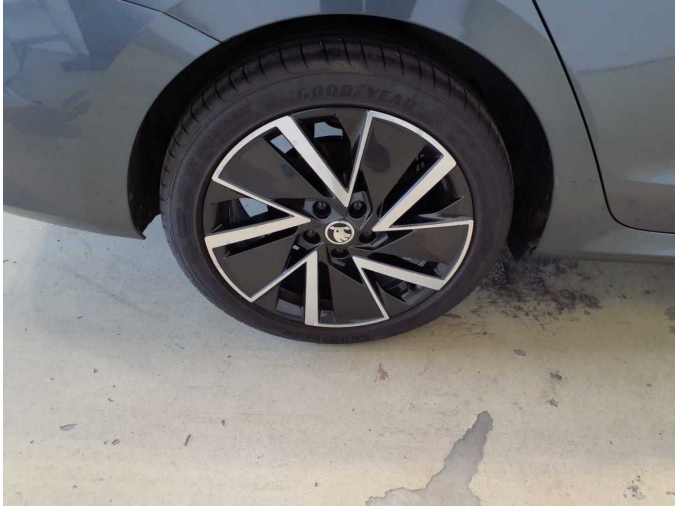
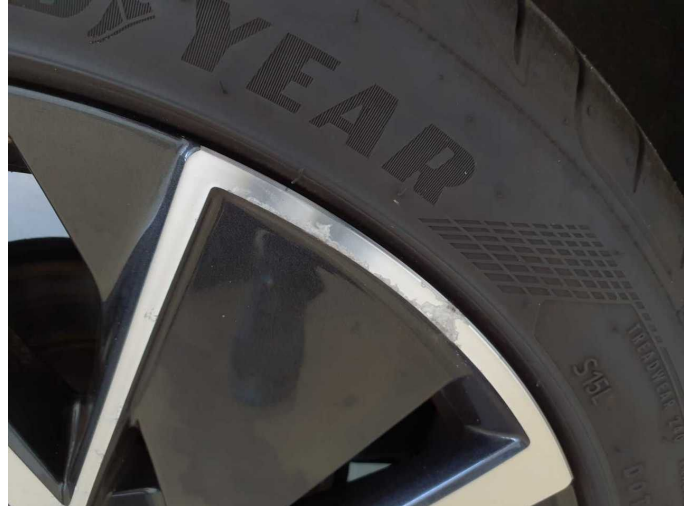
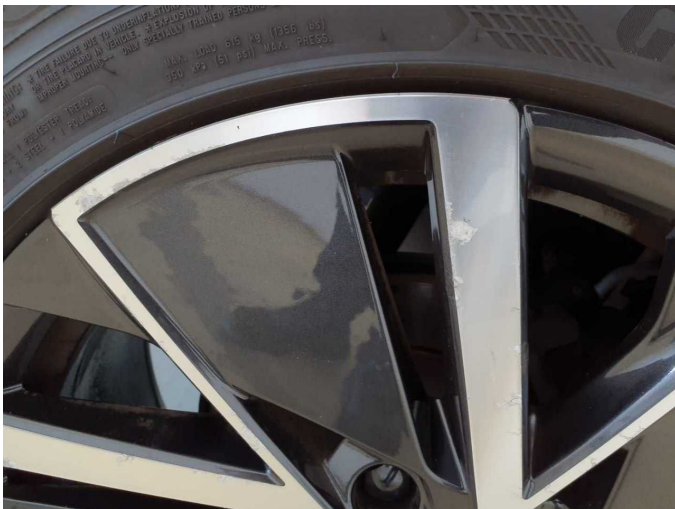
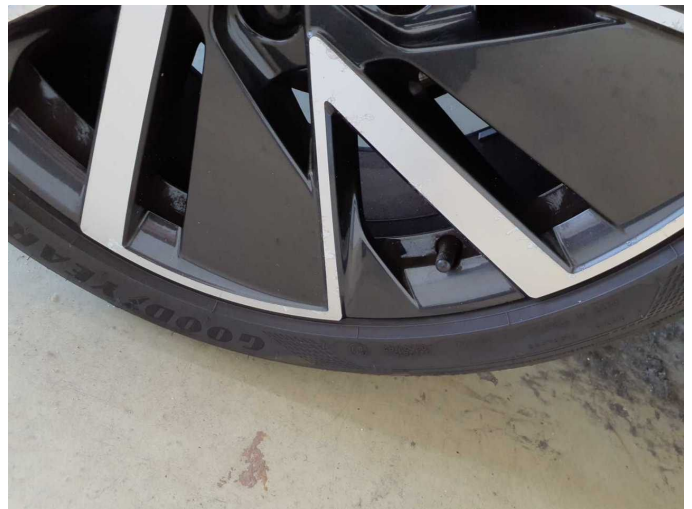
| No. | Component group | Description |
|---|---|---|
| 10 | Wheel / tyres | Alloy rim - rear right side - Scratch(es) - Loss in value |

**Damage 10:** Wheel / tyres: Alloy rim - rear right side - Scratch(es) - Loss in value

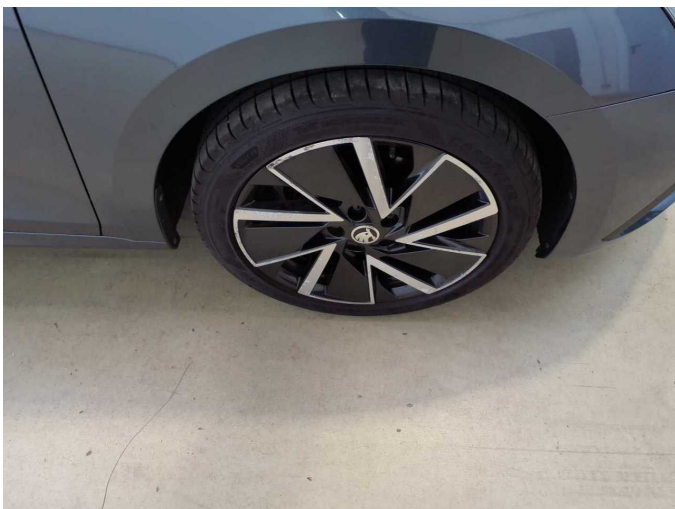
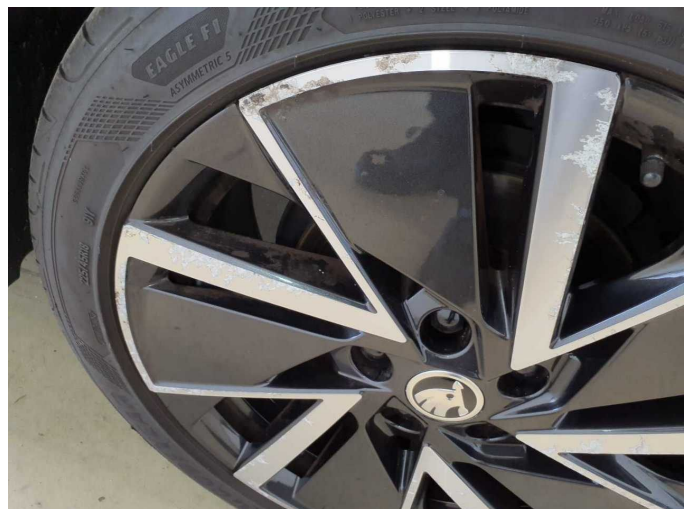
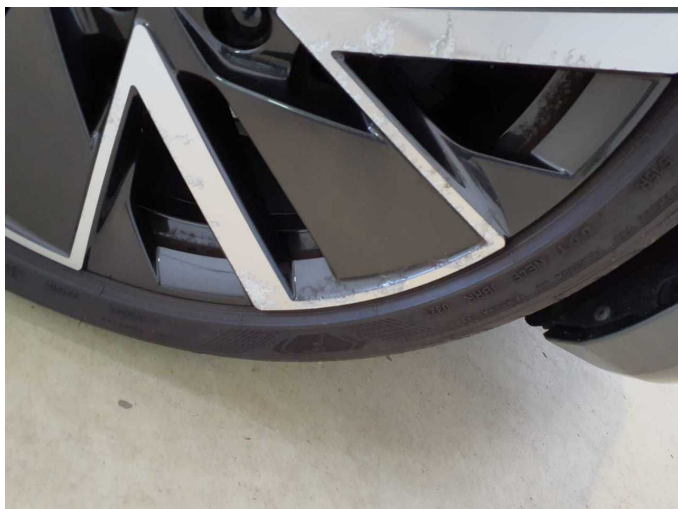
| No. | Component group | Description |
|---|---|---|
| 11 | Wheel / tyres | Alloy rim - front right side - Scratch(es) - Loss in value |

**Damage 11:** Wheel / tyres: Alloy rim - front right side - Scratch(es) - Loss in value

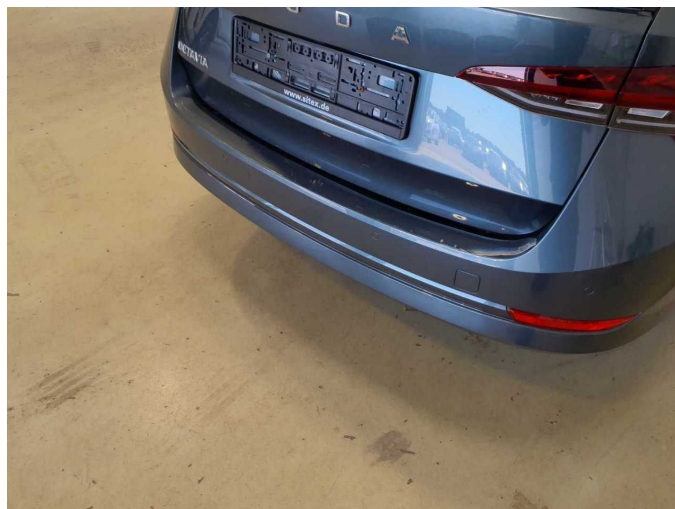
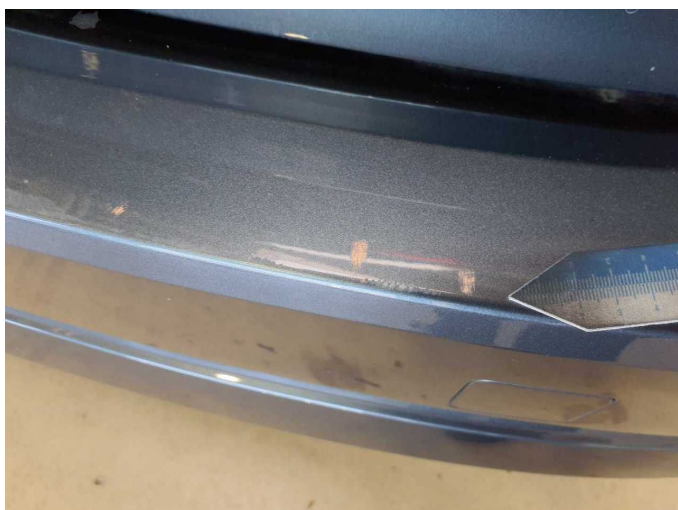
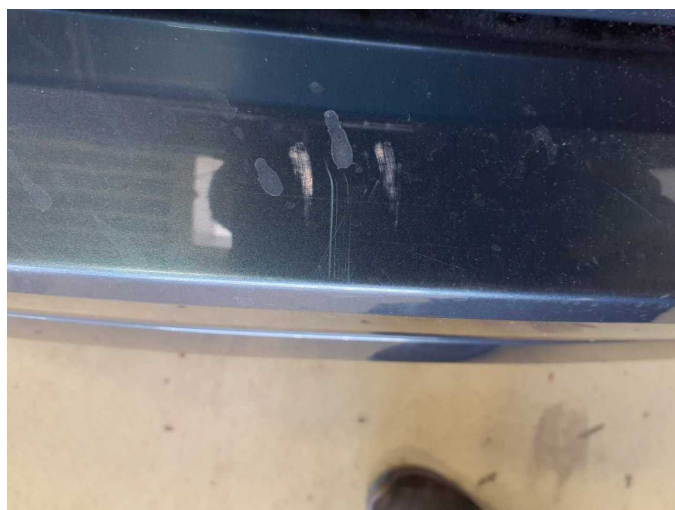
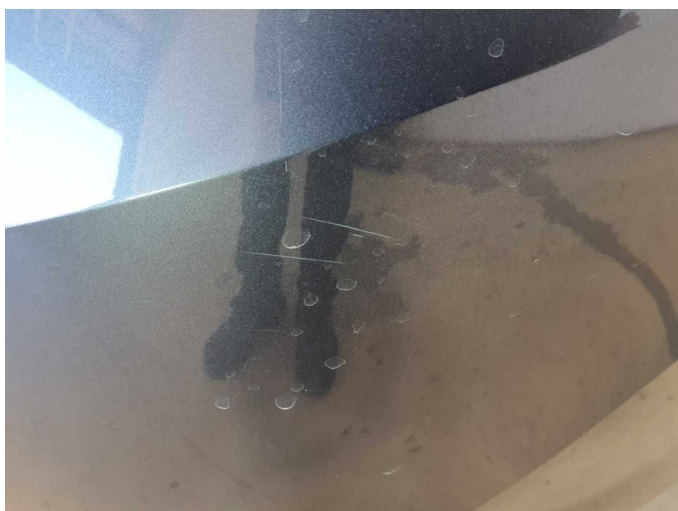
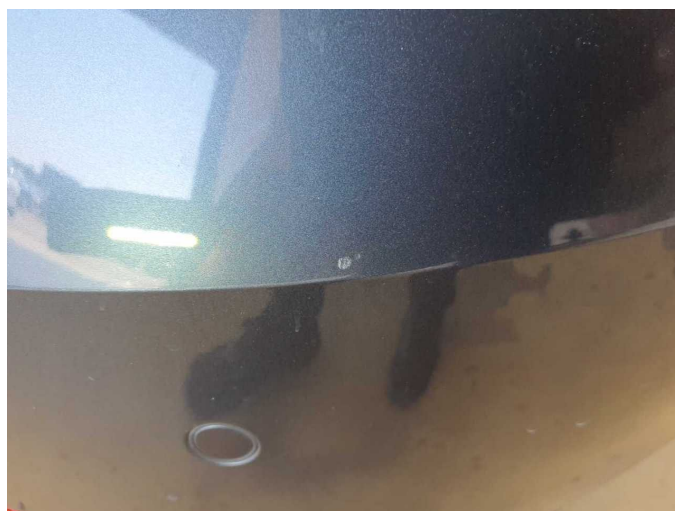
| No. | Component group | Description |
|---|---|---|
| 12 | Rear bumper | Rear bumper - Scratch(es) - Paint |

**Damage 12:** Rear bumper: Rear bumper - Scratch(es) - Paint

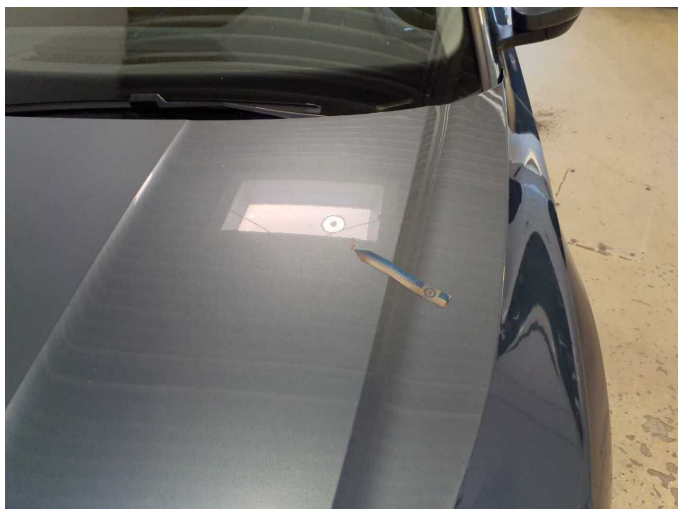
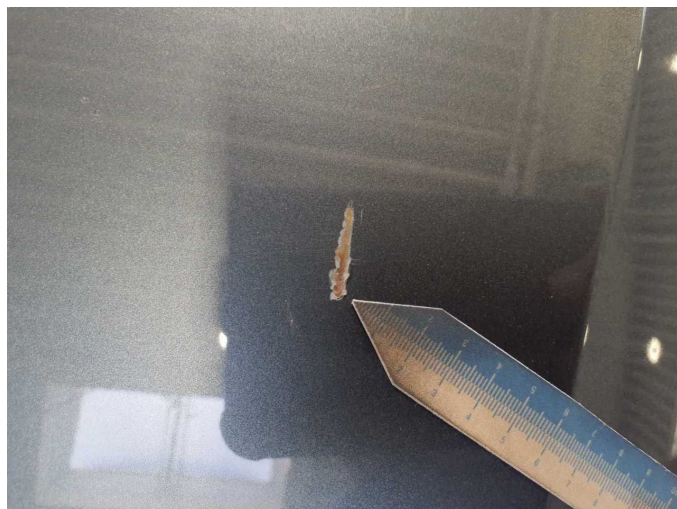
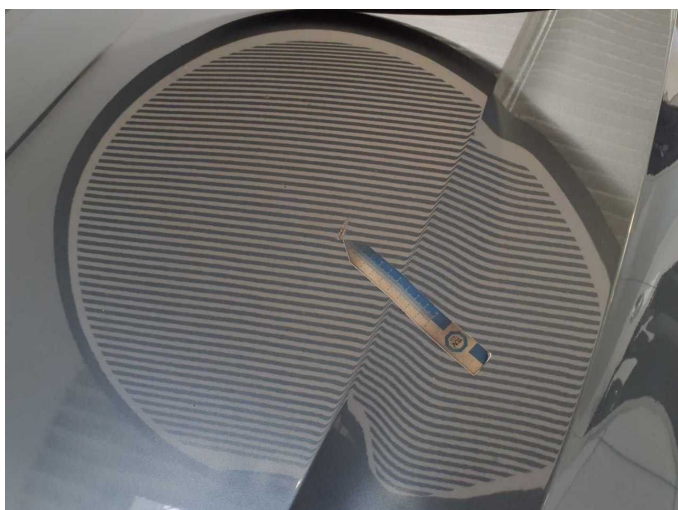
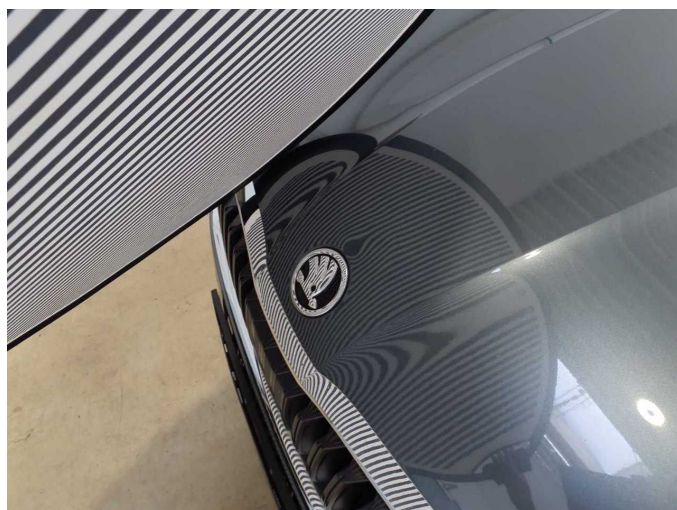
| No. | Component group | Description |
|---|---|---|
| 13 | Bonnet | Bonnet - Corrosion - Repair and paint |

**Damage 13:** Bonnet: Bonnet - Corrosion - Repair and paint

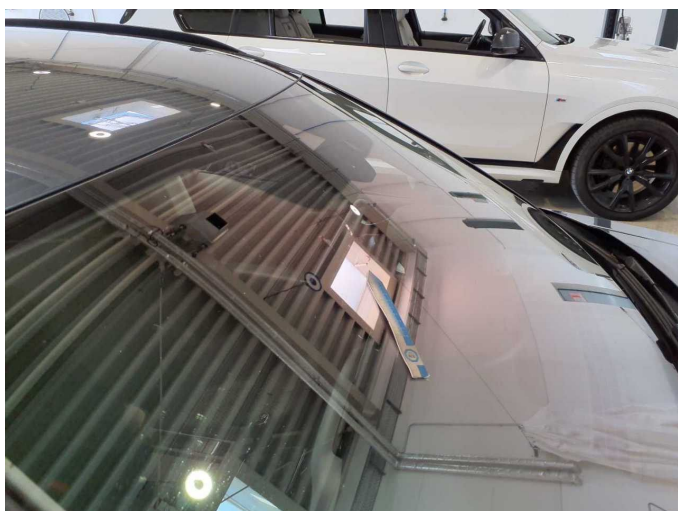
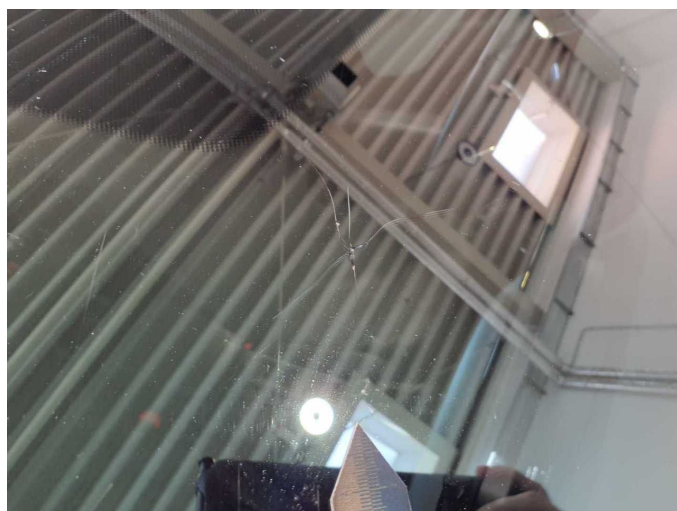
| No. | Component group | Description |
|---|---|---|
| 14 | Vehicle glazing | Windscreen - Broken / torn - repair according to calculation |

**Damage 14:** Vehicle glazing: Windscreen - Broken / torn - repair according to calculation

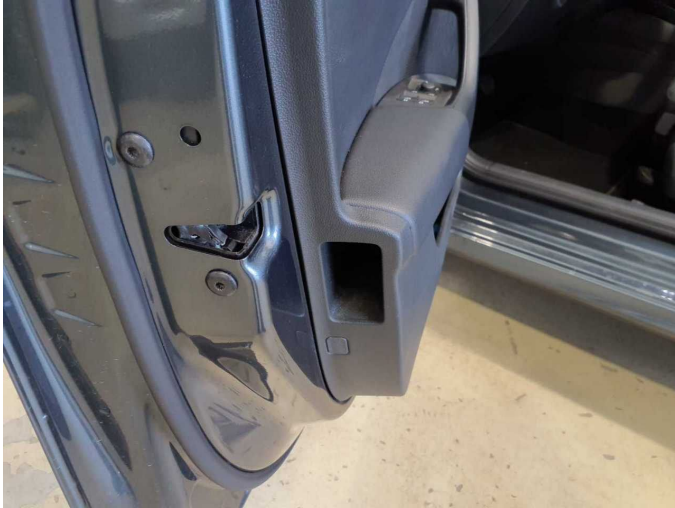
Equipment - Umbrella

**Missing part 1:** Equipment: Umbrella - Missing - Replace
