Expertise

Protocol number: 46103260
Order No. / Reference: 26496030
Inspection date: 23 Jun 2026

Manufacturer: Volkswagen

Model: Multivan Kurz 1,4 OPF eHybrid Life

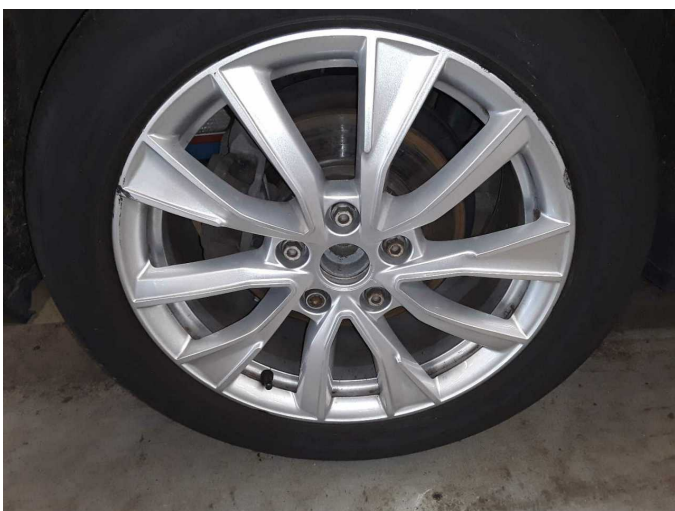
Damage 1: Wheel / tyres: Wheel cover - rear right side - Missing - Replace

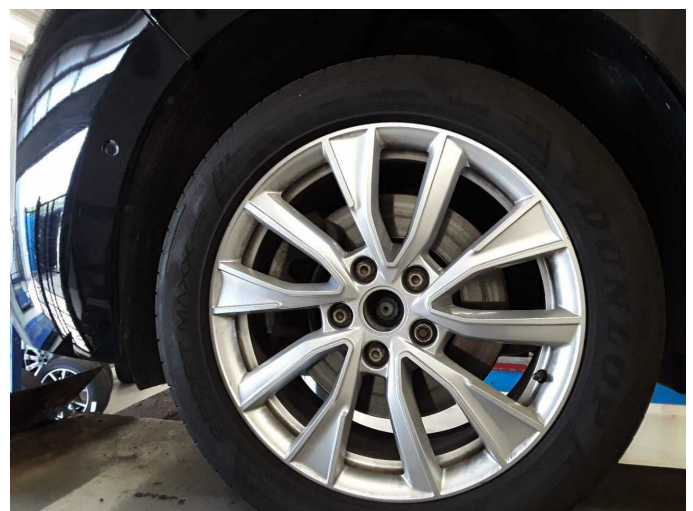
Damage 2: Wheel / tyres: Wheel cover - front left side - Missing - Replace

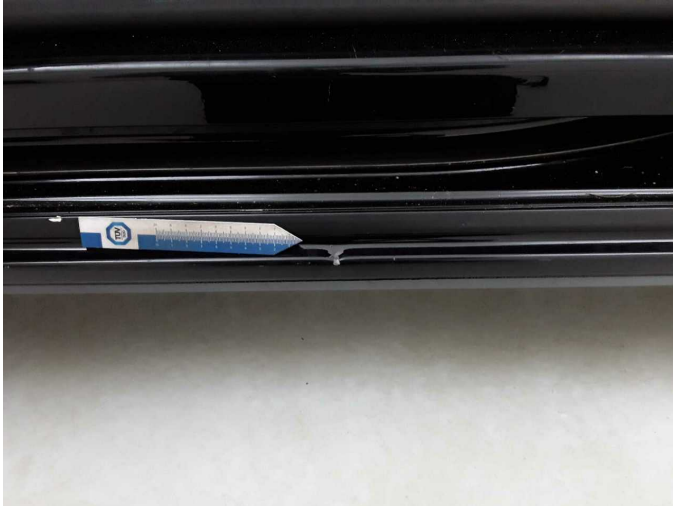
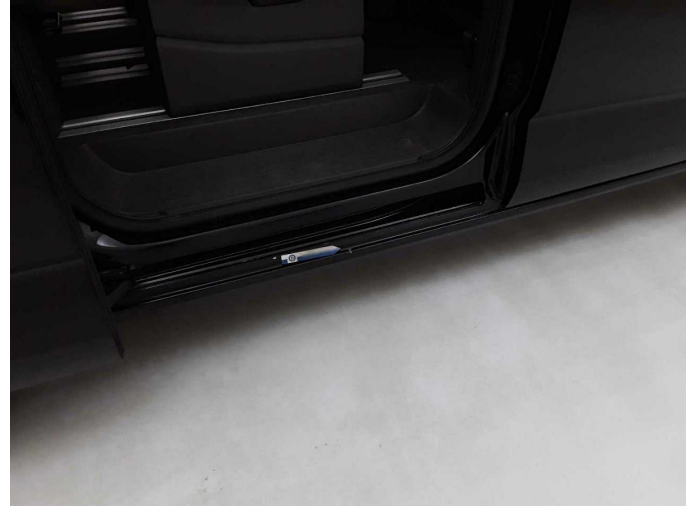
Damage 3: Sill - right side: Sill (Hinten) - Dent / paintcoat damage - Smart repair

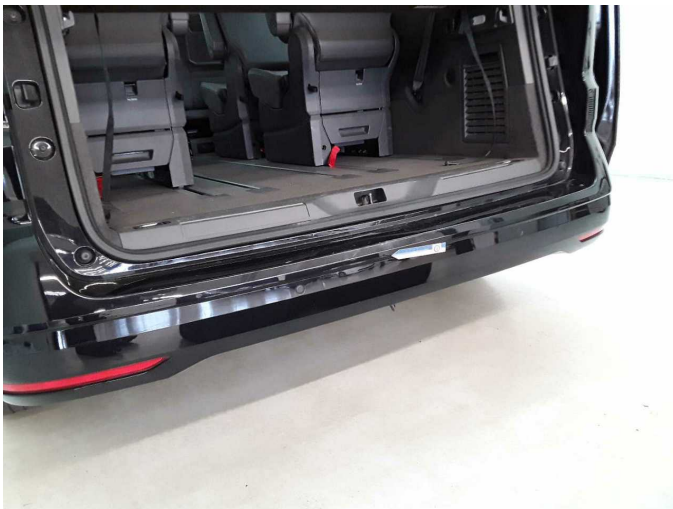
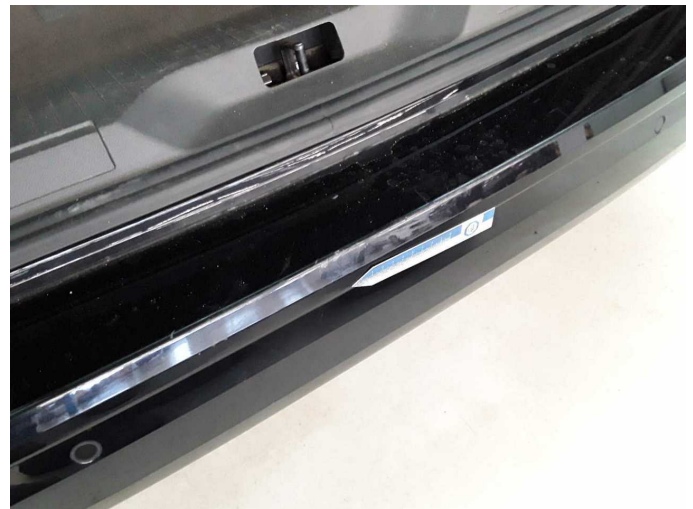
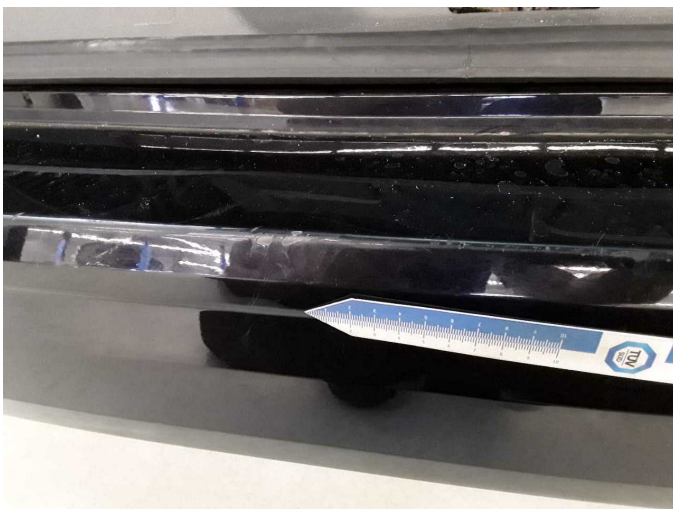
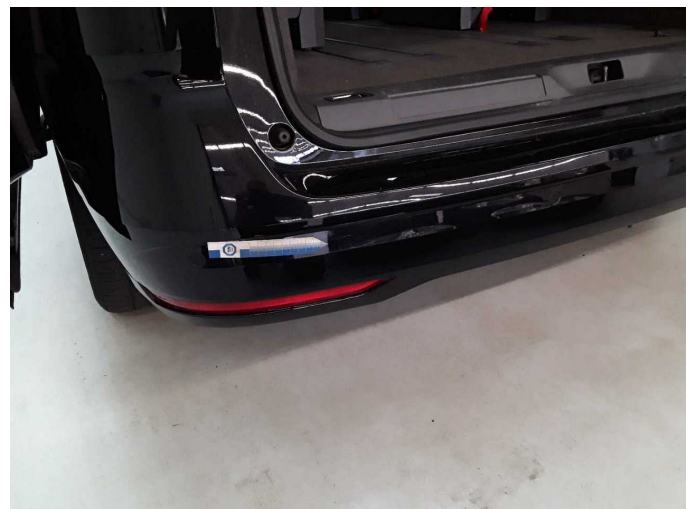
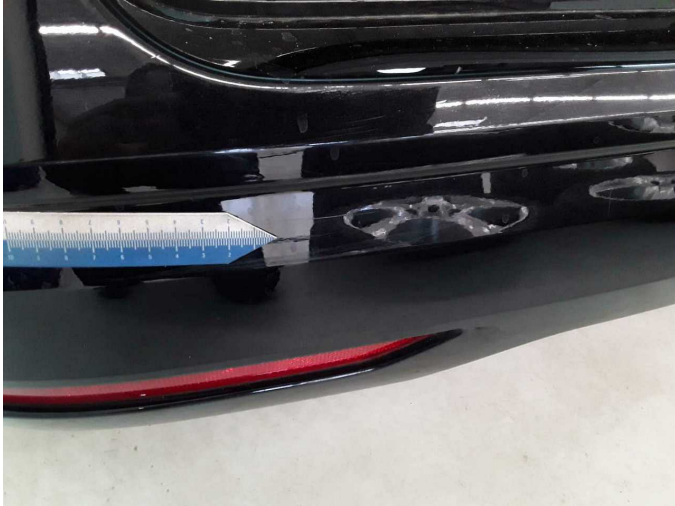
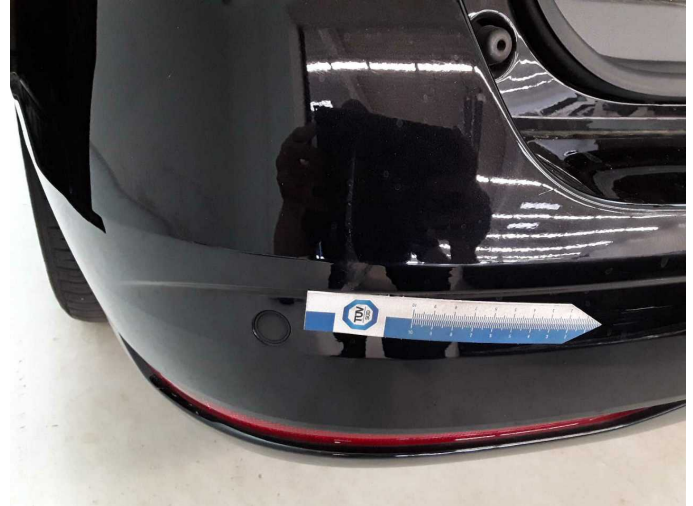
Damage 4: Rear bumper: Rear bumper - Scratched - Repair and paint

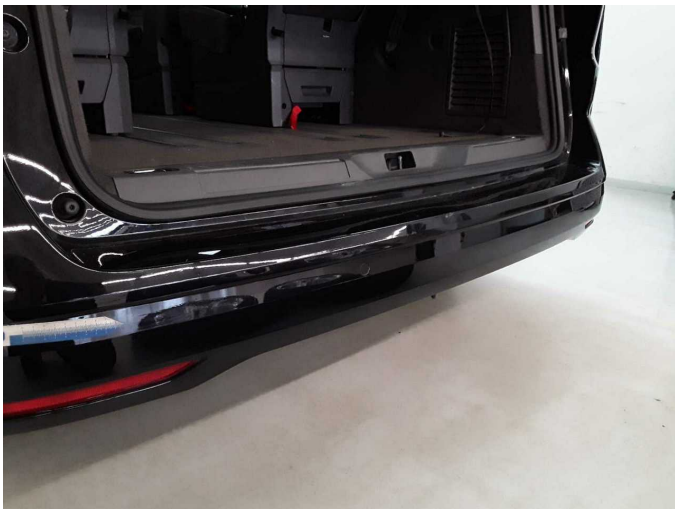
Damage 4: Rear bumper: Rear bumper - Scratched - Repair and paint

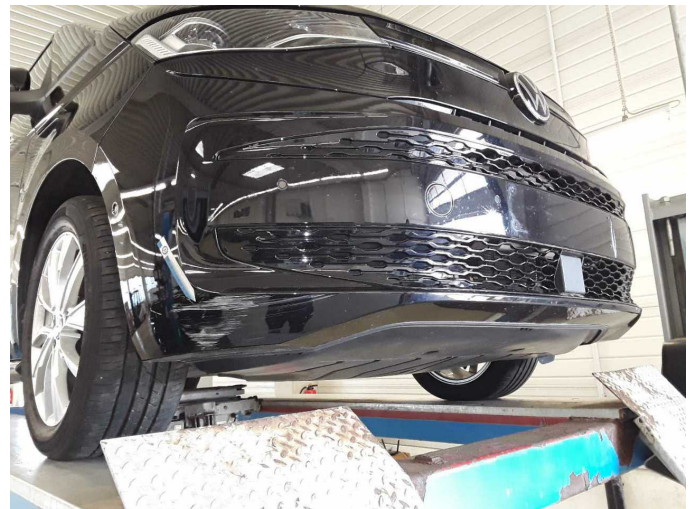
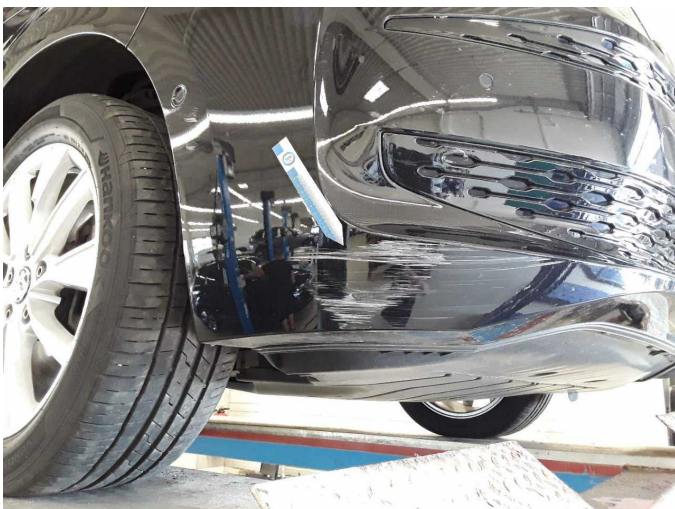
Damage 5: Front bumper: Front bumper - Scratched - Repair and paint

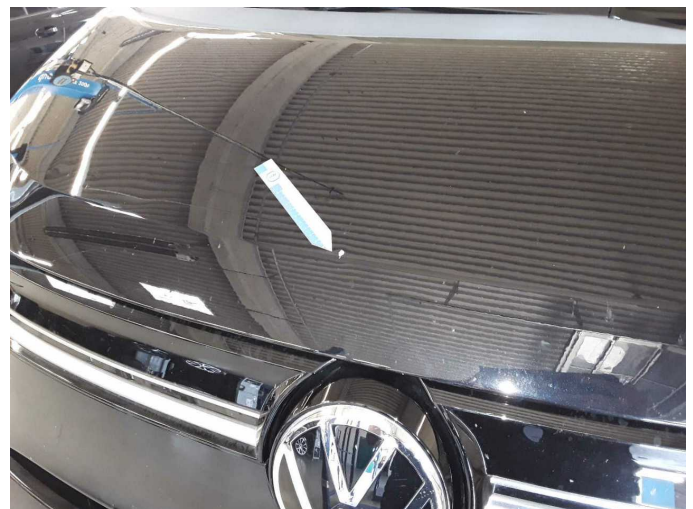
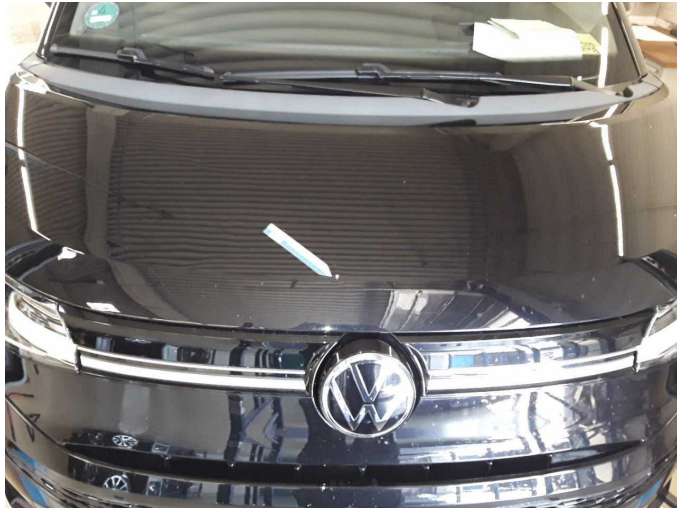
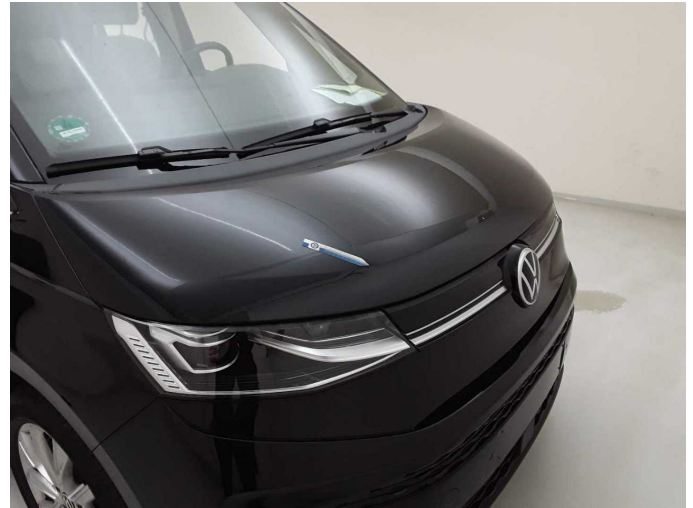
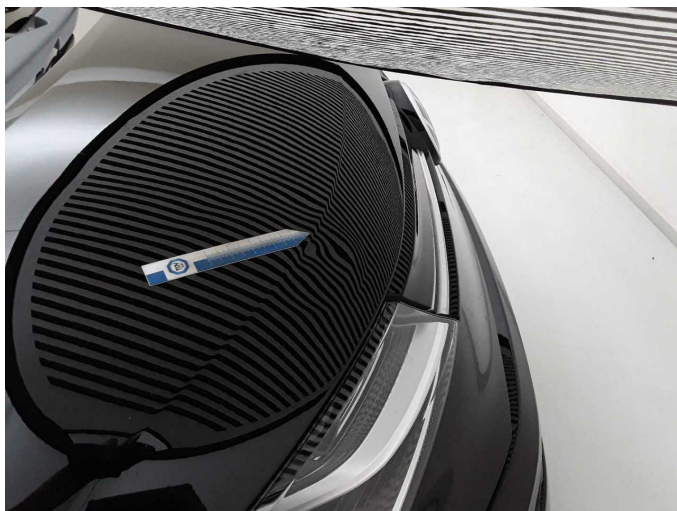
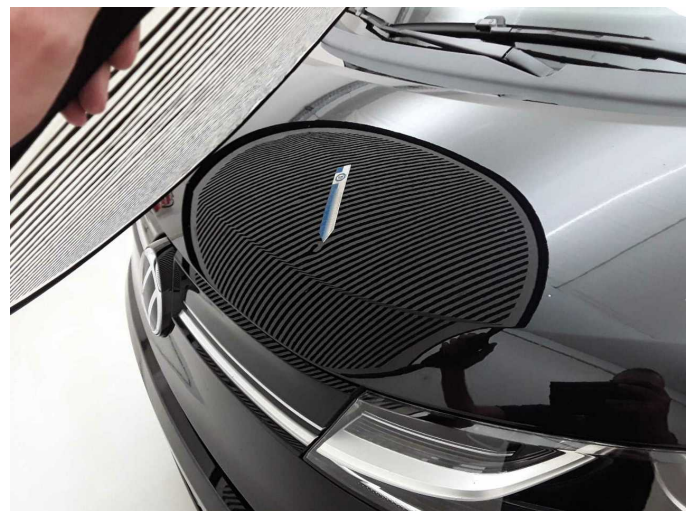
Damage 6: Bonnet: Bonnet - Dent / paintcoat damage - Repair and paint

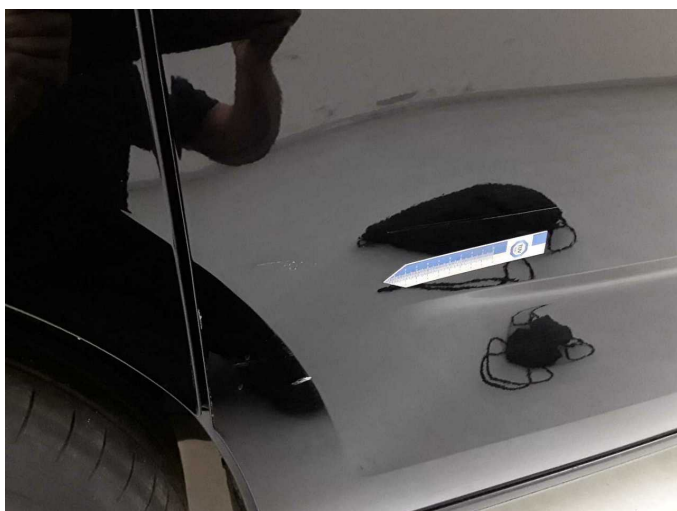
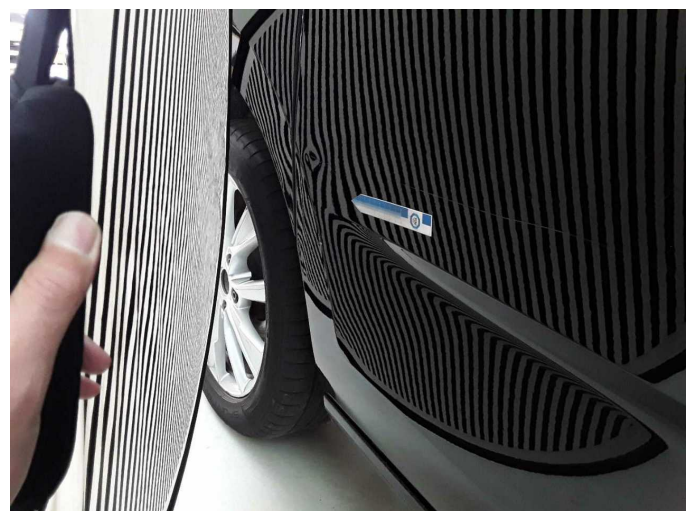
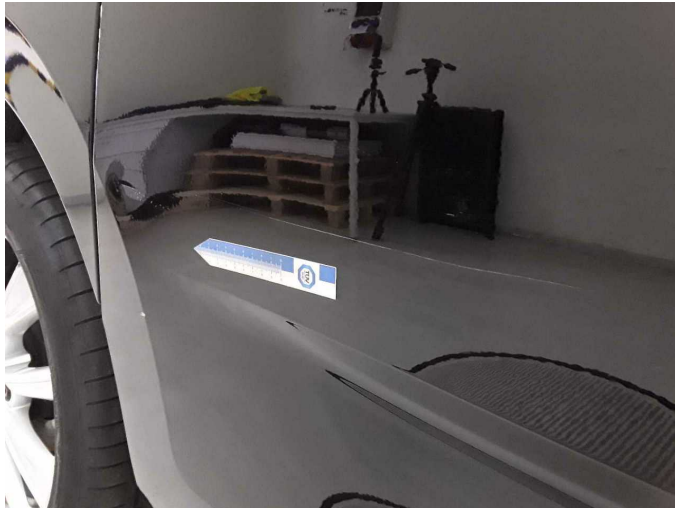
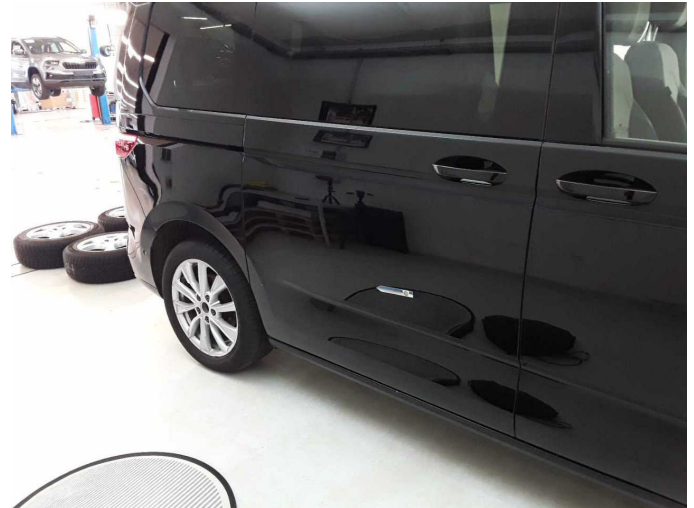
Damage 7: Sliding door, right: Sliding door - Dent / paintcoat damage - Repair and paint

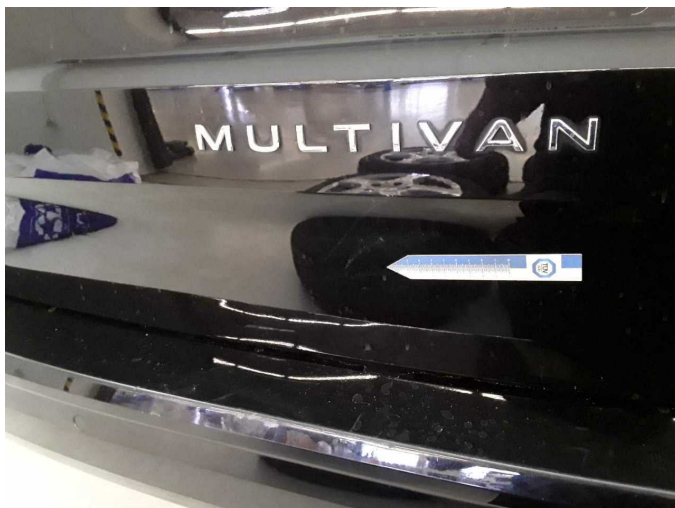
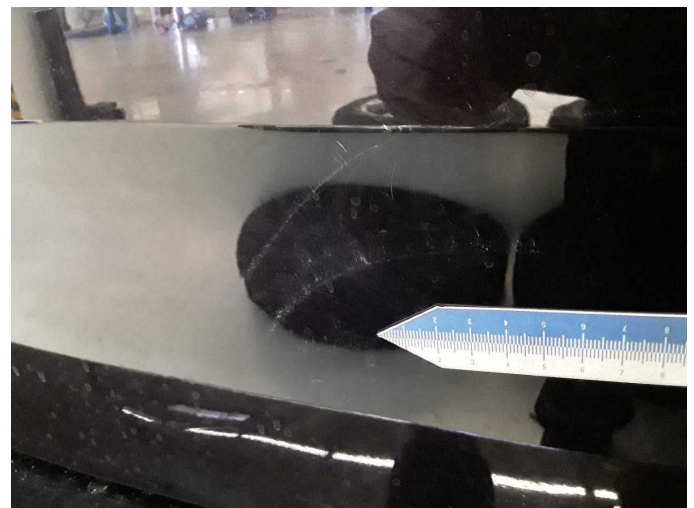
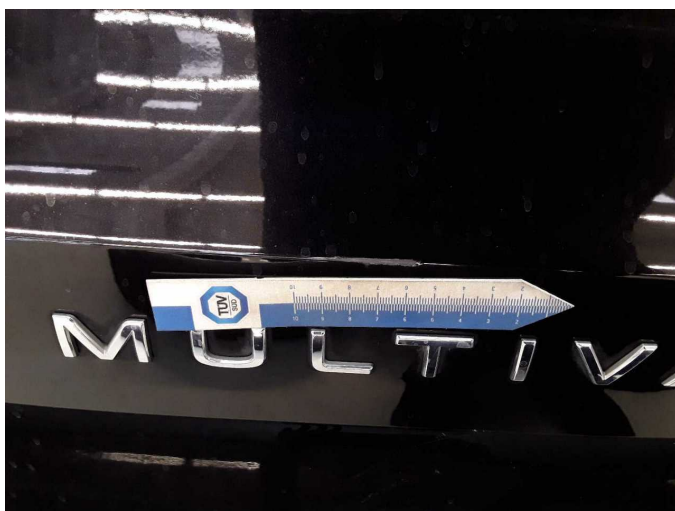
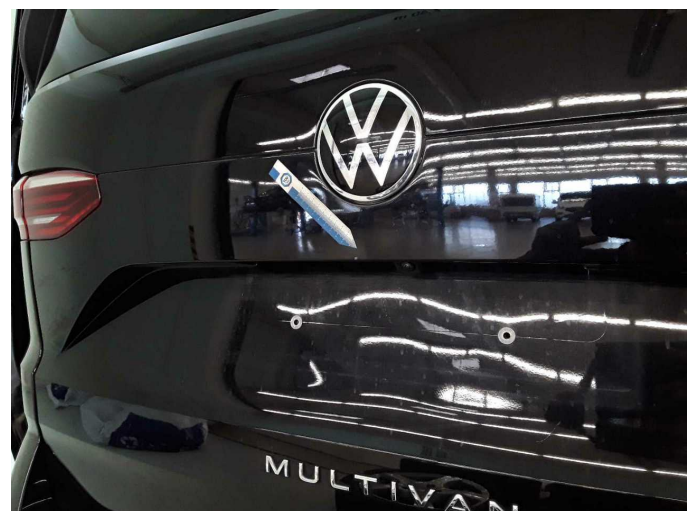
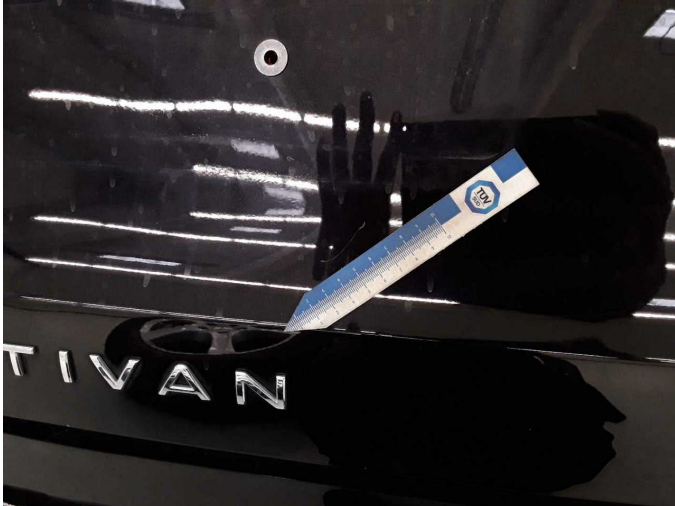
Damage 8: Boot lid / rear door: Boot lid (Unterteil) - Scratch(es) - Repair and paint

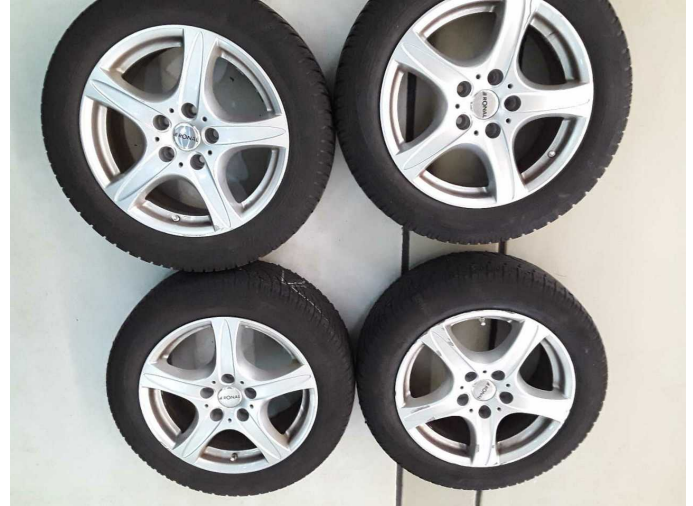
Wear and tear 1: 2nd wheel set: Alloy rim set - complete - Scratched - No deduction

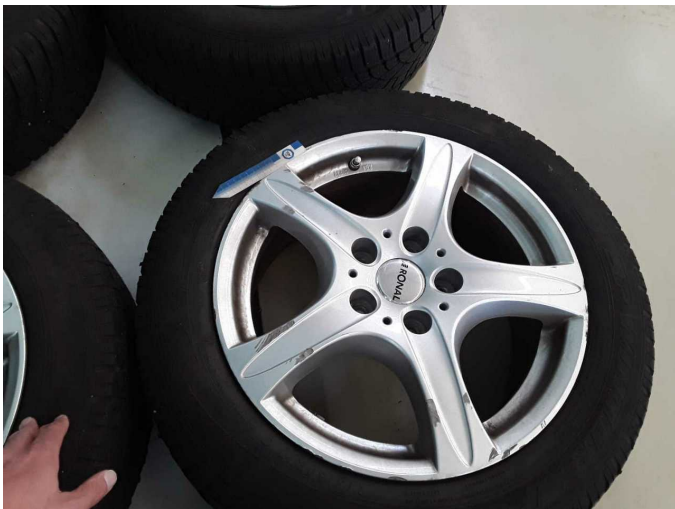
Wear and tear 3: 2nd wheel set: 1 tyre - Broken / torn - No deduction

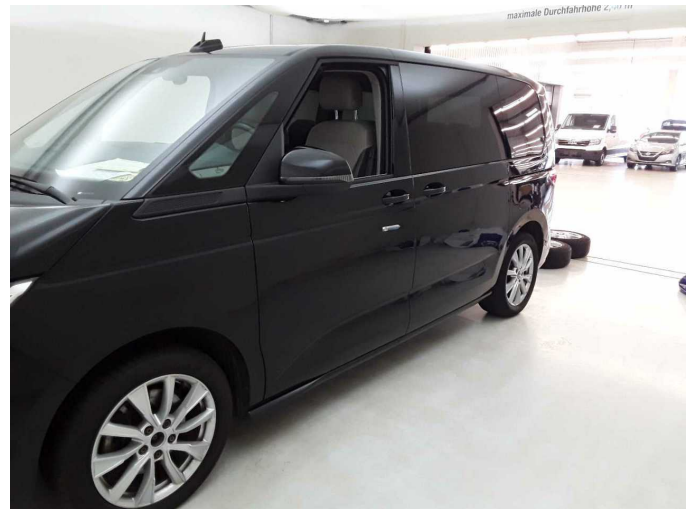
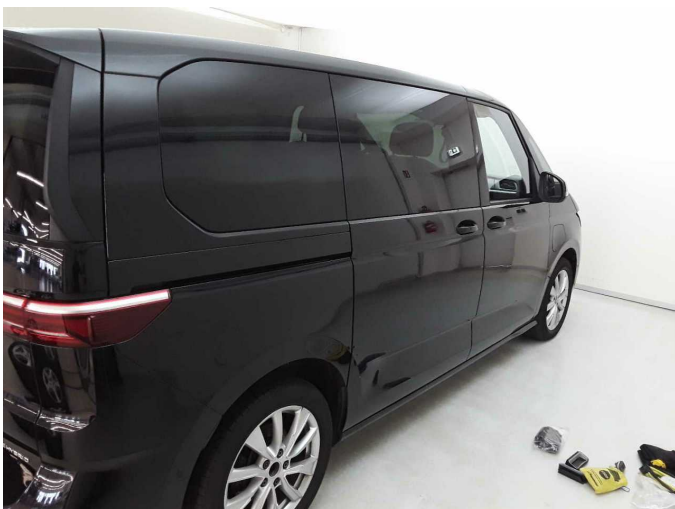
Wear and tear 4: Body: Body - dent(s) - No deduction

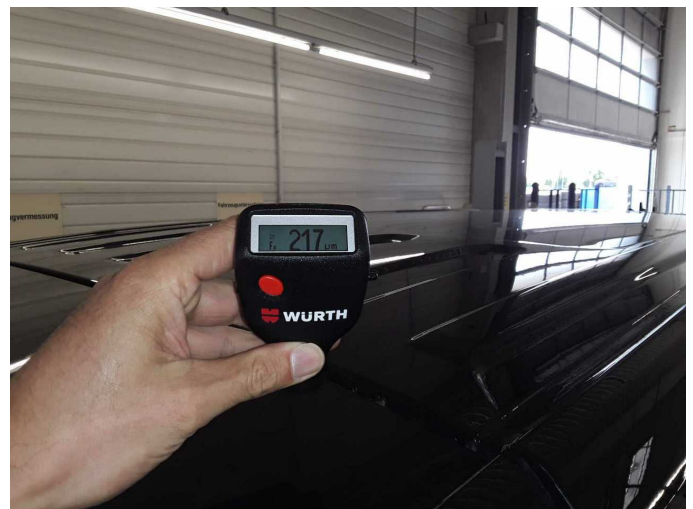
Roof: 269 µm

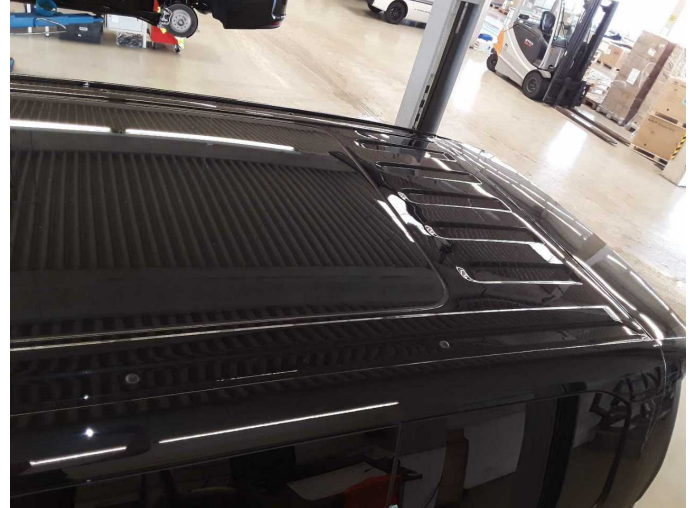
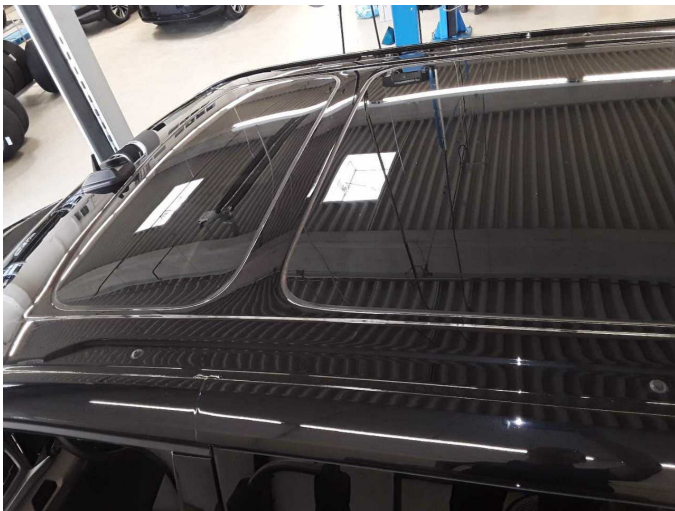
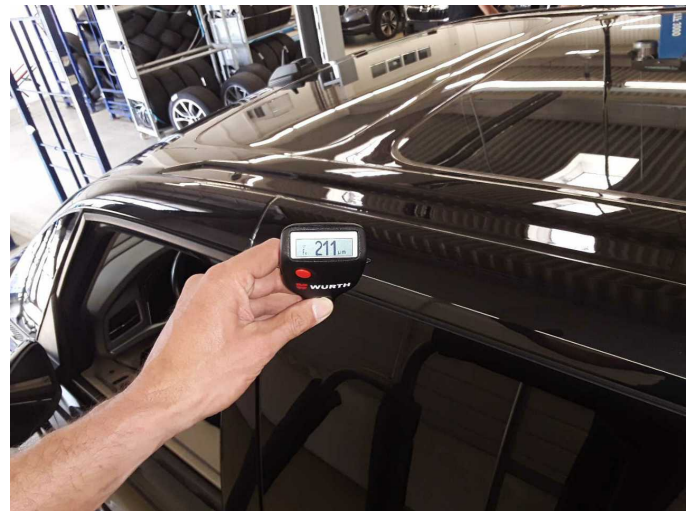
Roof: 269 µm

Roof rail - left side: 211 µm

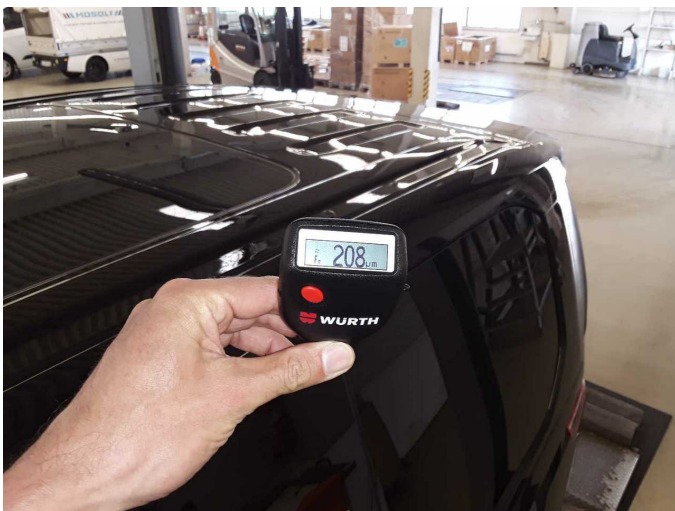
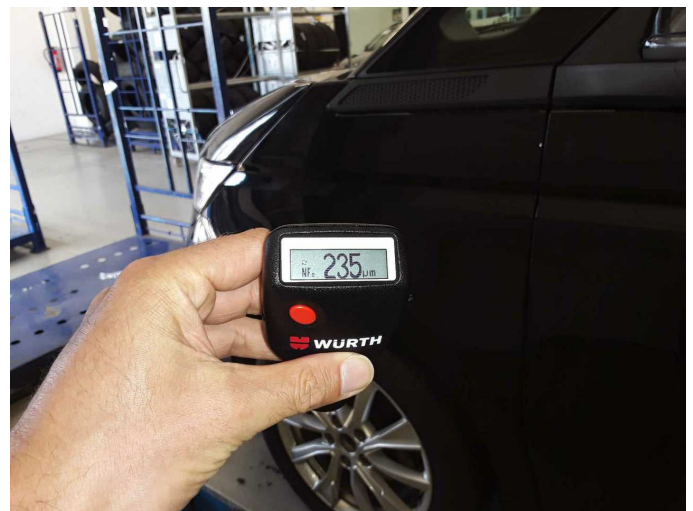
Roof rail - left side: 211 µm

Mudguard - left side: 235 µm

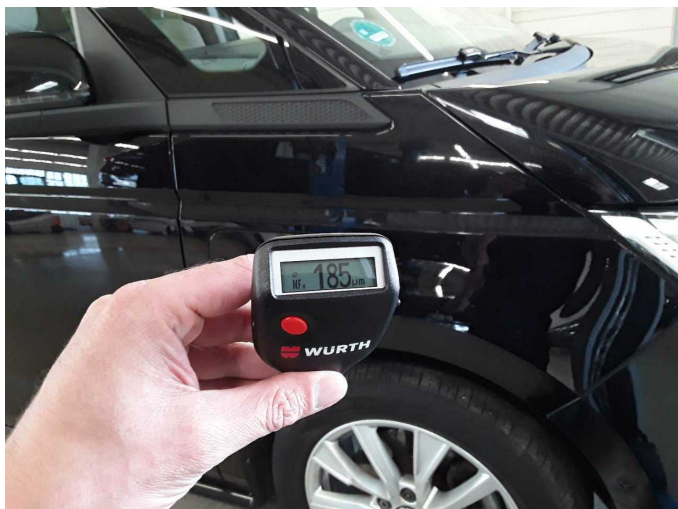
Mudguard - right side: 185 µm
