Expertise

Protocol number: 46377225  
Order No. / Reference: 26397414  
Inspection date: 7 Jul 2026

Manufacturer: Volkswagen

Model: Tiguan Allspace 2.0 TDI SCR DSG Life

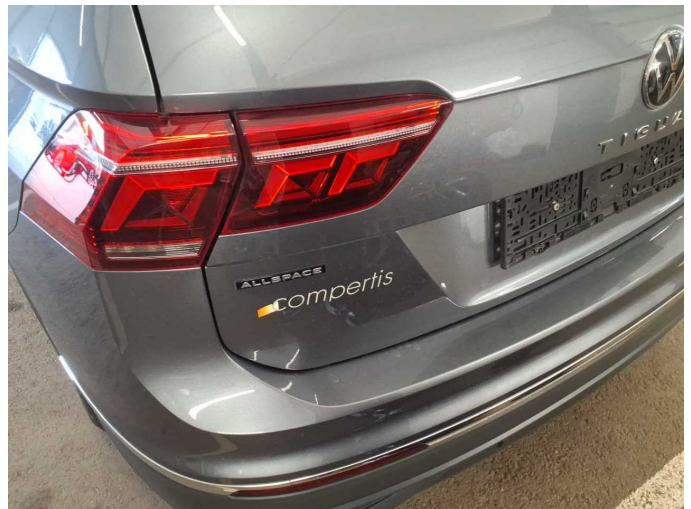
| No. | Component group | Description |
|---|---|---|
| 1 | Boot lid / rear door | Boot lid - Glued / labelled - De-glue / neutralise |

**Damage 1:** Boot lid / rear door: Boot lid - Glued / labelled - De-glue / neutralise

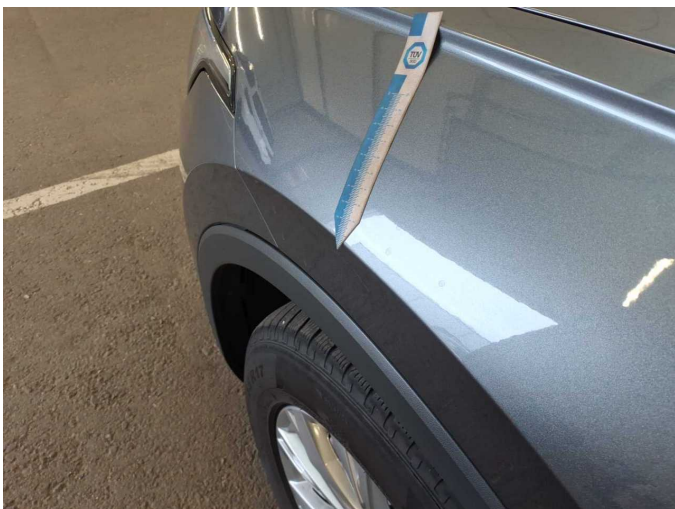
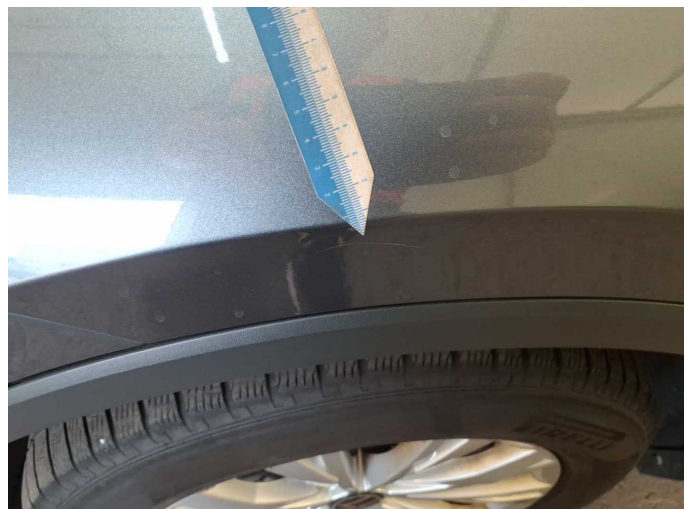
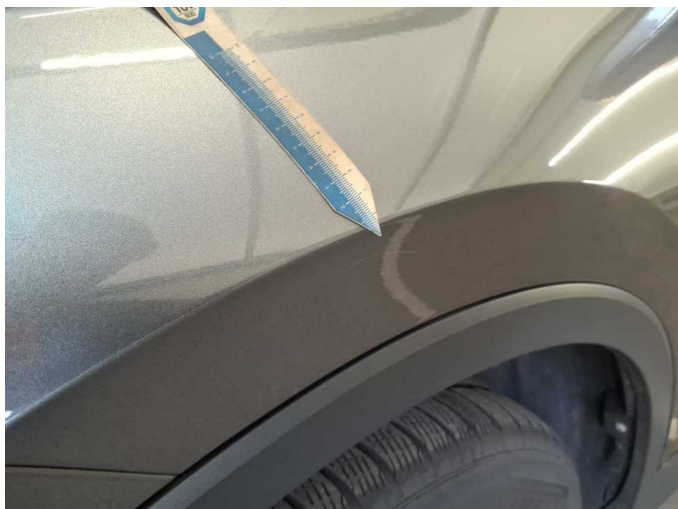
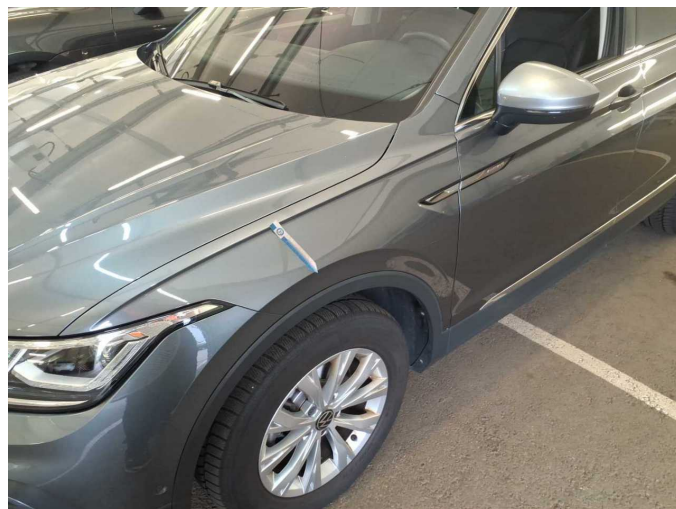
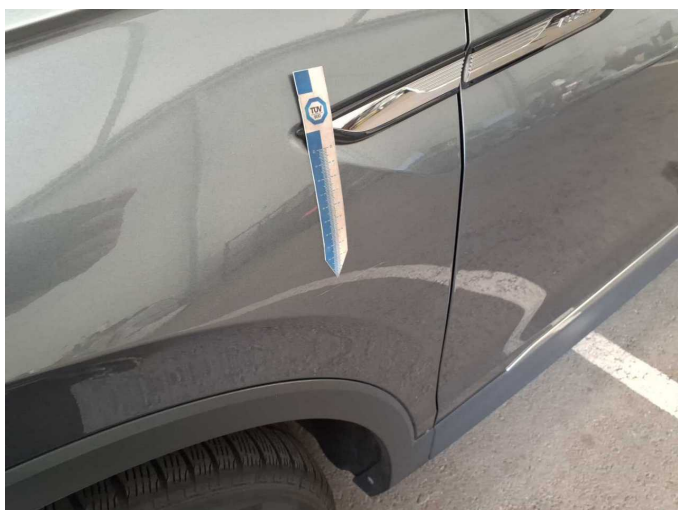
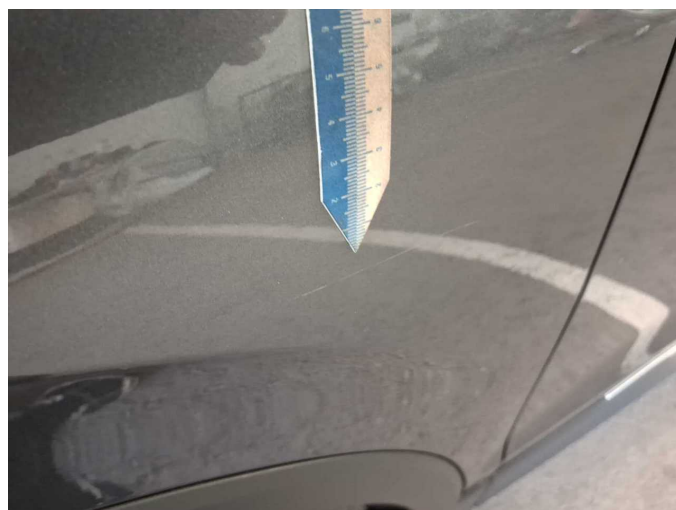
| No. | Component group | Description |
|---|---|---|
| 2 | Mudguard - left side | Mudguard - left side - Scratch(es) - Smart repair |

**Damage 2:** Mudguard - left side: Mudguard - left side - Scratch(es) - Smart repair

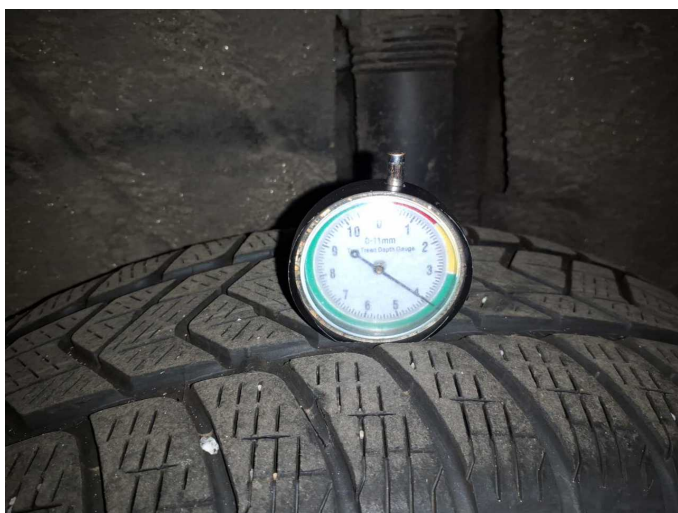
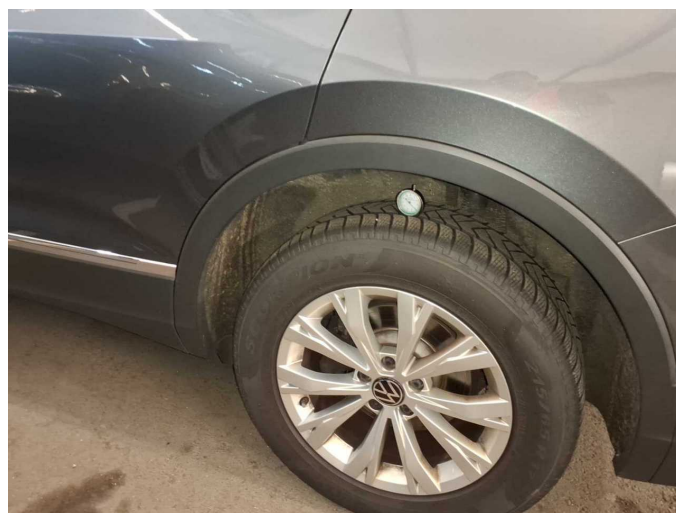
| No. | Component group | Description |
|---|---|---|
| 3 | Wheel / tyres | Tyre - rear left side - Does not meet the leasing specifications - Replace |

**Damage 3:** Wheel / tyres: Tyre - rear left side - Does not meet the leasing specifications - Replace

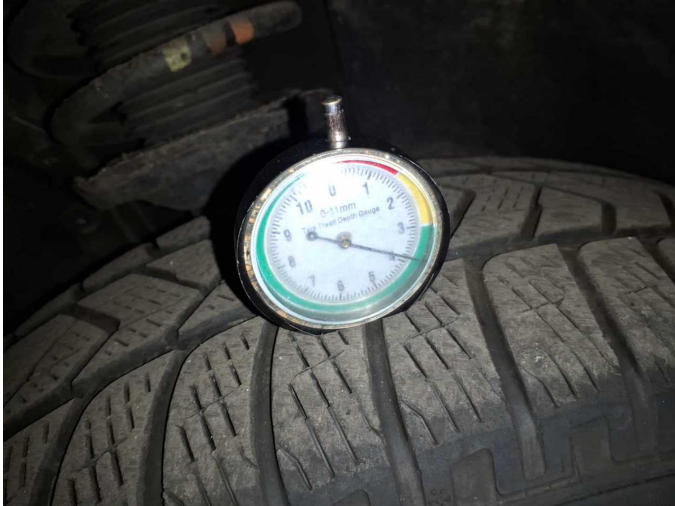
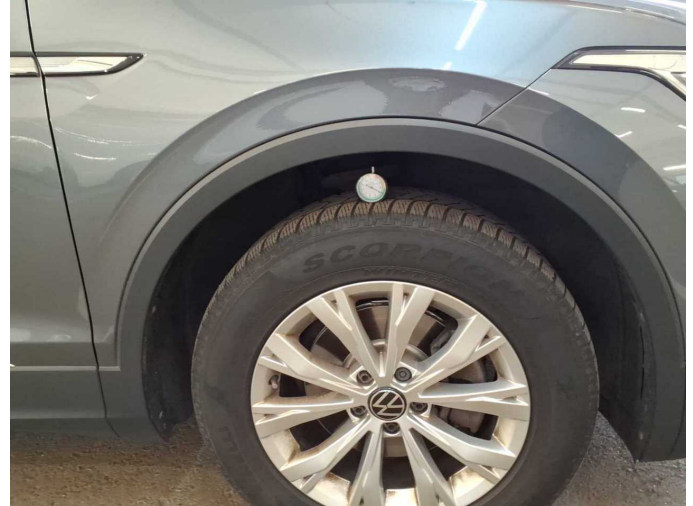
| No. | Component group | Description |
|---|---|---|
| 4 | Wheel / tyres | Tyre - front right side - Does not meet the leasing specifications - Replace |

**Damage 4:** Wheel / tyres: Tyre - front right side - Does not meet the leasing specifications - Replace

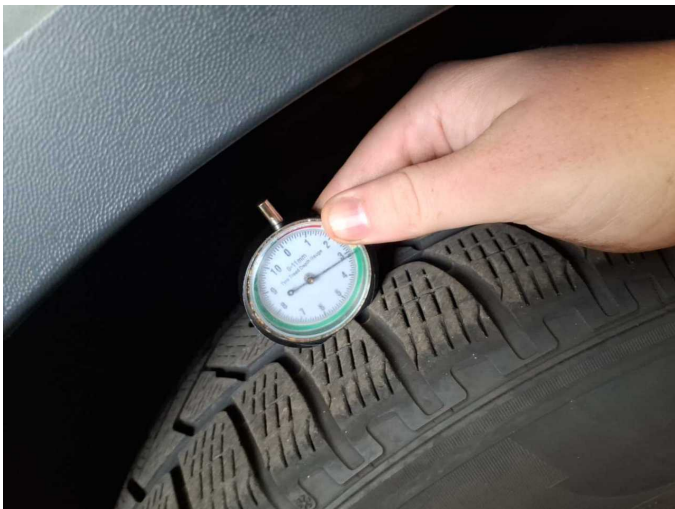
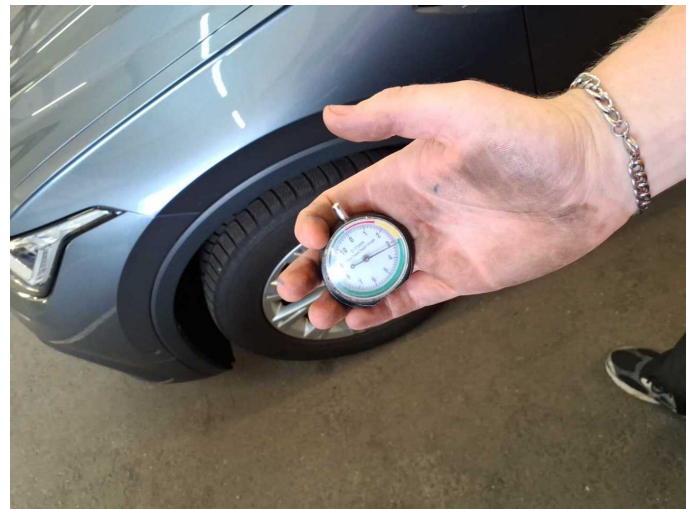
| No. | Component group | Description |
|---|---|---|
| 5 | Wheel / tyres | Tyre - front left side - Does not meet the leasing specifications - Replace |

**Damage 5:** Wheel / tyres: Tyre - front left side - Does not meet the leasing specifications - Replace

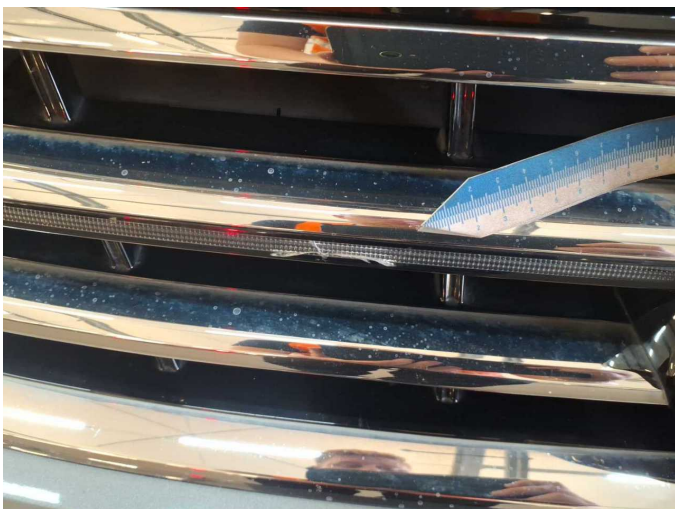
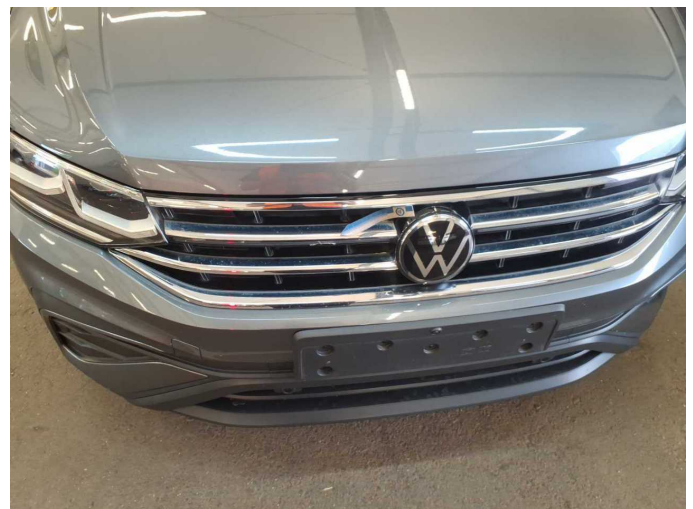
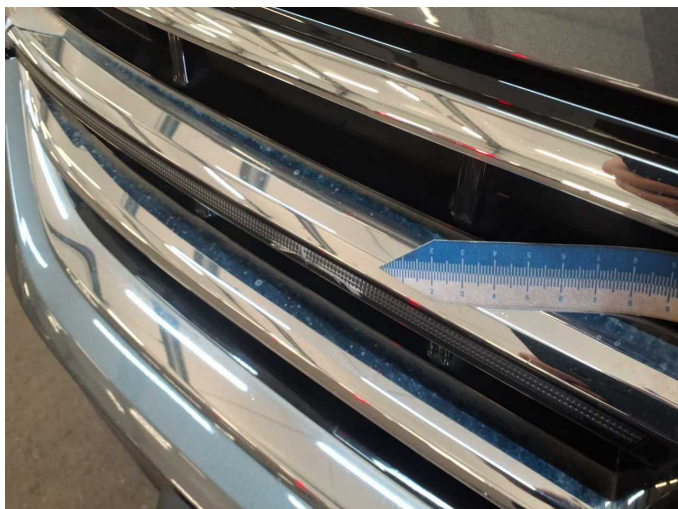
| No. | Component group | Description |
|---|---|---|
| 6 | Bonnet | Air grille - Broken / torn - Replace |

**Damage 6:** Bonnet: Air grille - Broken / torn - Replace

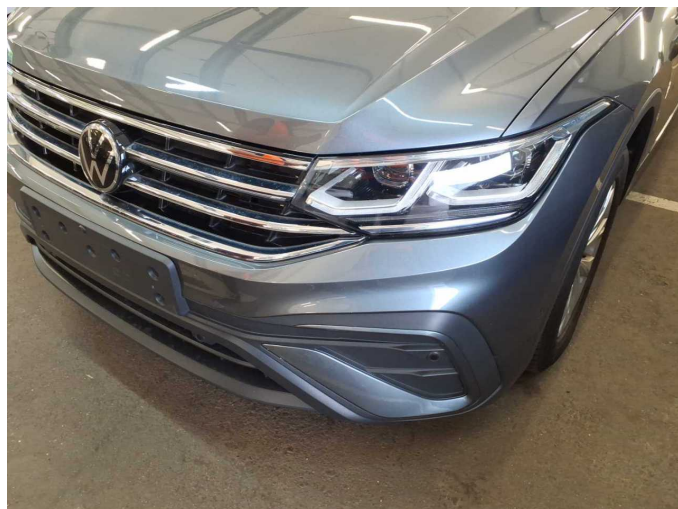
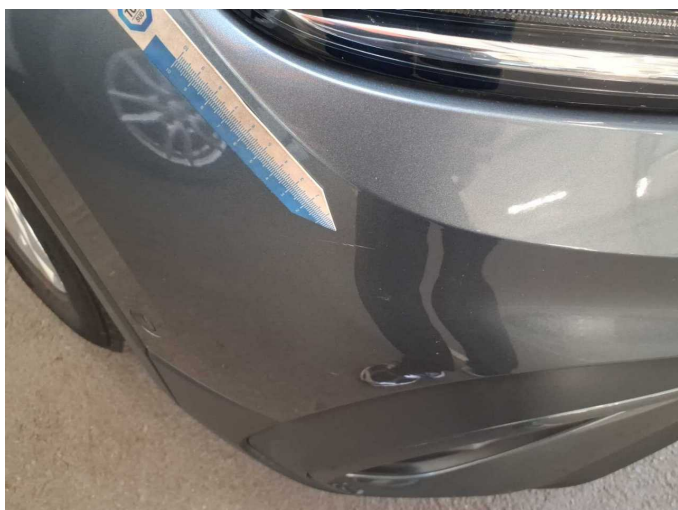
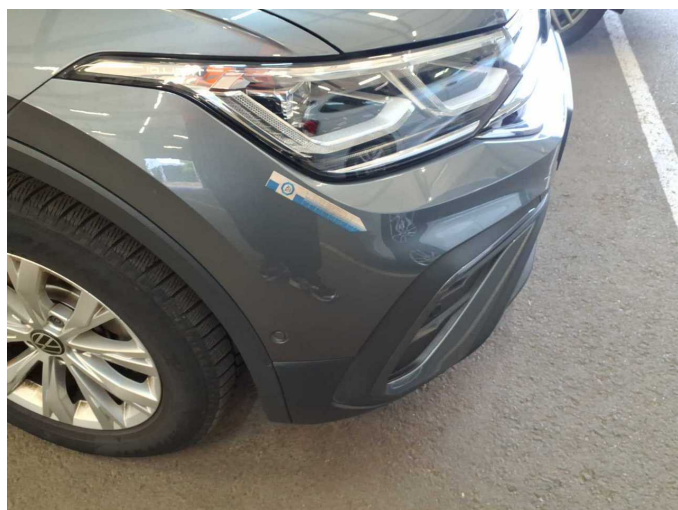
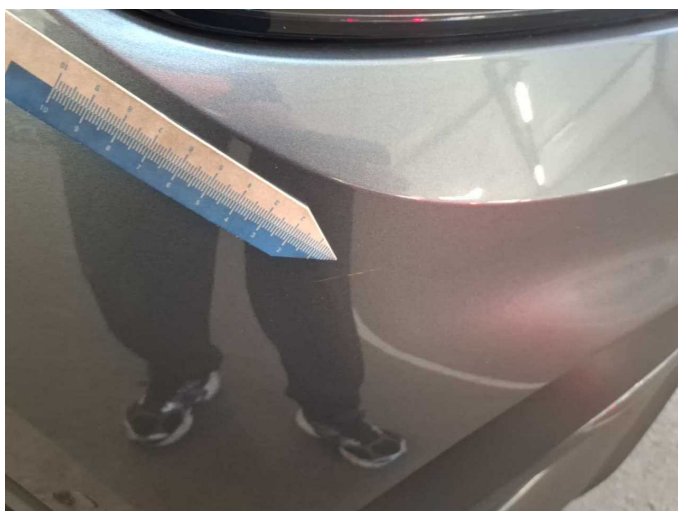
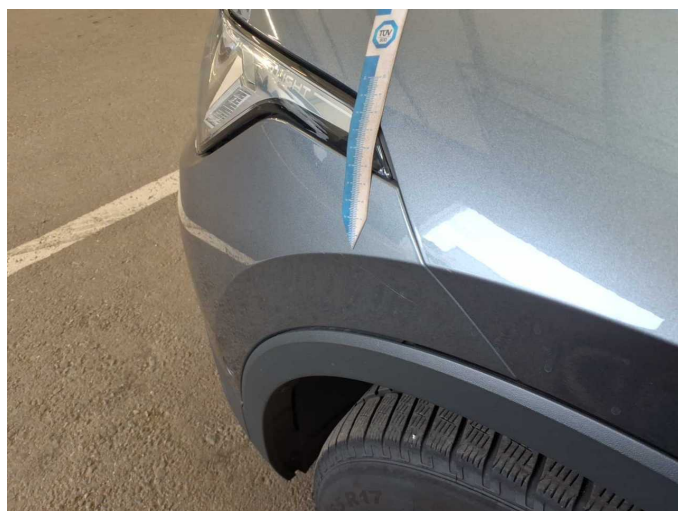
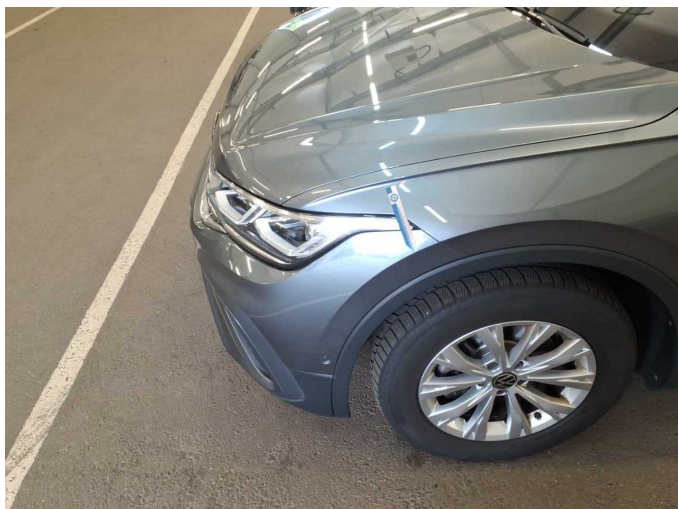
| No. | Component group | Description |
|---|---|---|
| 7 | Front bumper | Front bumper - Scratch(es) - Paint |

**Damage 7:** Front bumper: Front bumper - Scratch(es) - Paint

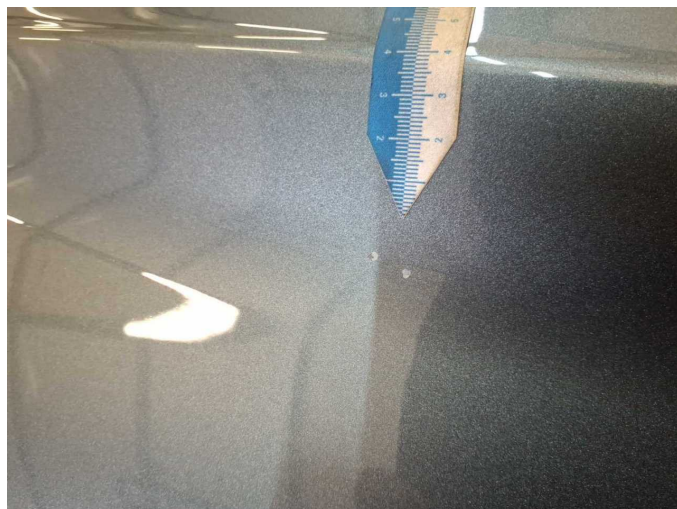
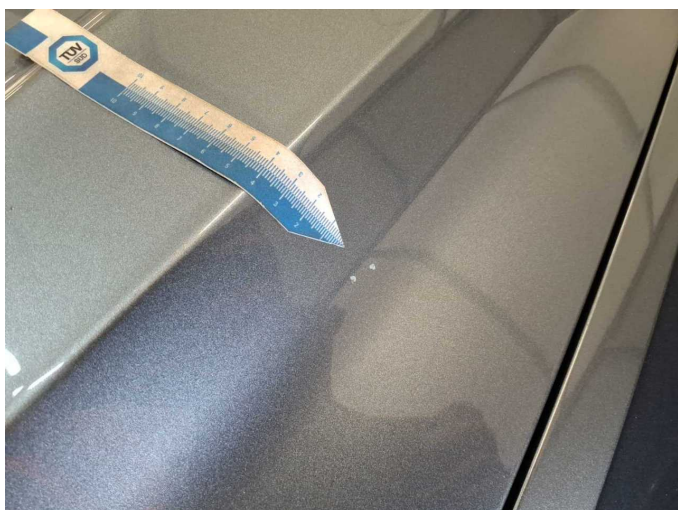
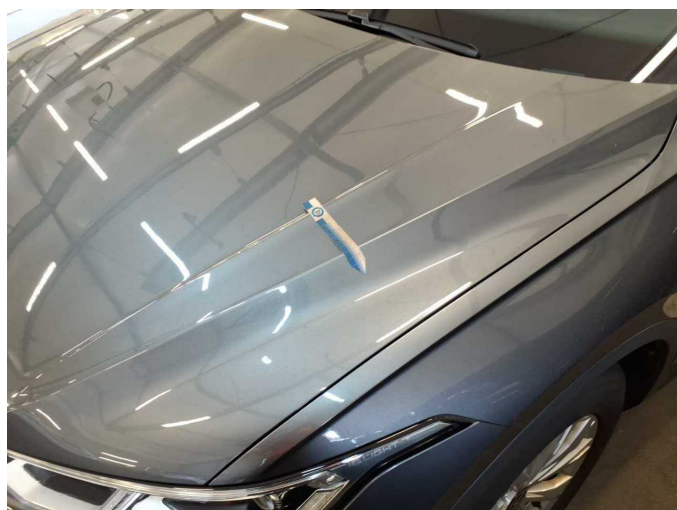
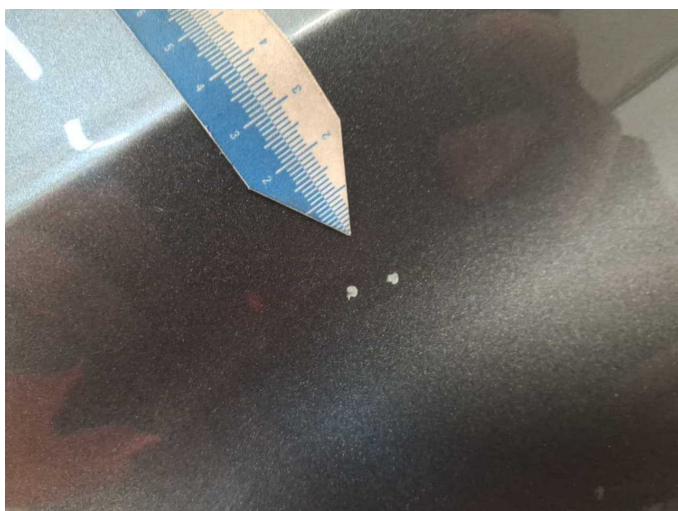
| No. | Component group | Description |
|---|---|---|
| 8 | Bonnet | Bonnet (Steinschlag mit Korrosion) - Stone chips - Repair and paint |

**Damage 8:** Bonnet: Bonnet (Steinschlag mit Korrosion) - Stone chips - Repair and paint

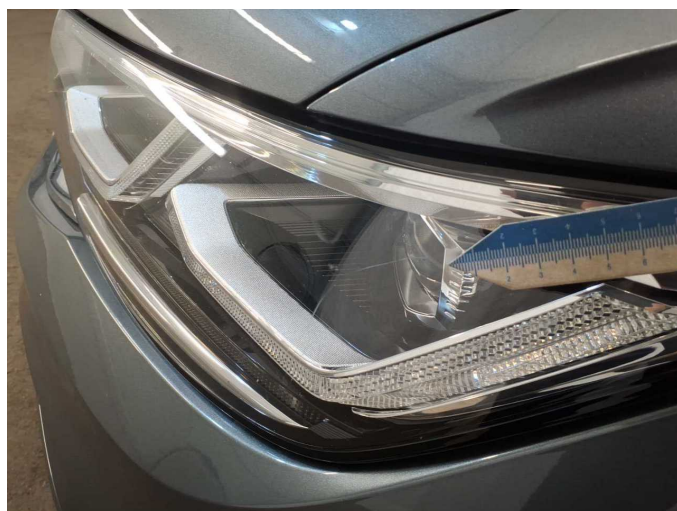
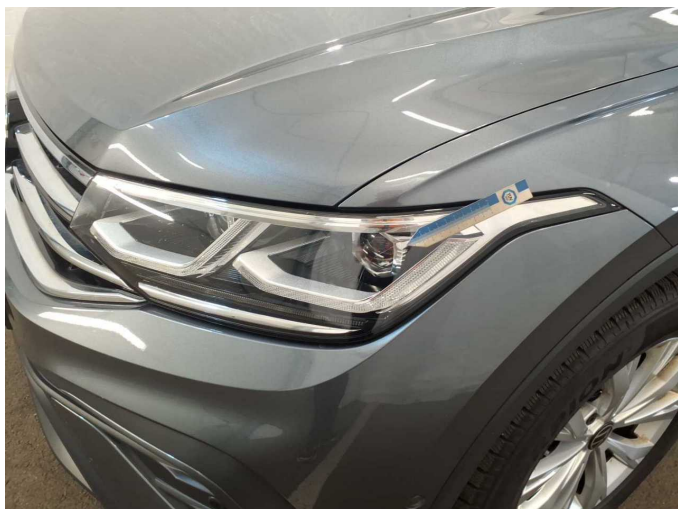
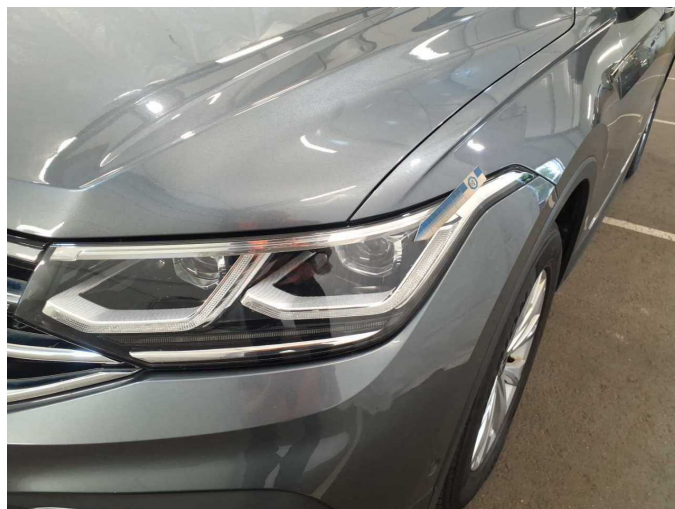
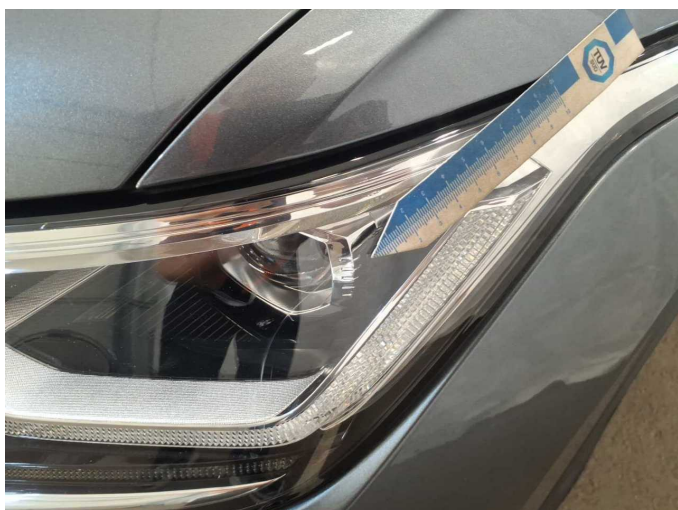
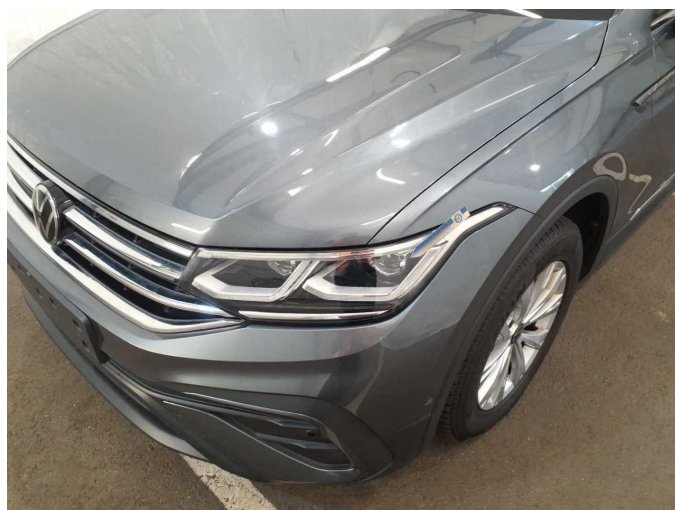
| No. | Component group | Description |
|---|---|---|
| 9 | Headlight | Headlight - left side - Scratch(es) - Replace |

Der Scheinwerfer wurde aufgrund des Alters und der Laufleistung gemindert

**Damage 9:** Headlight: Headlight - left side - Scratch(es) - Replace

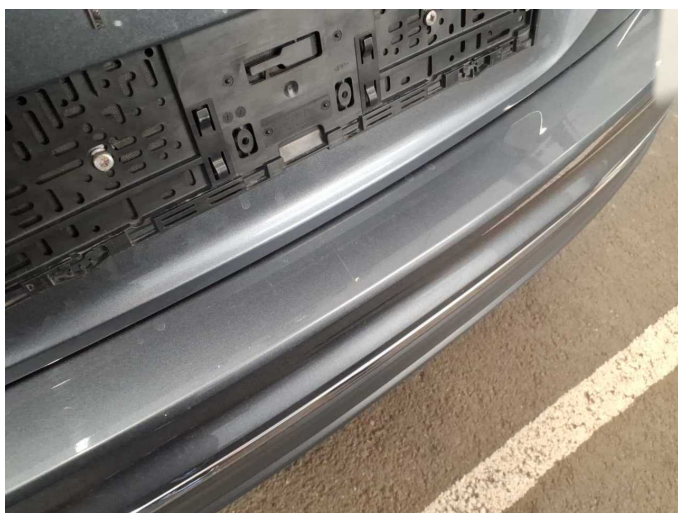
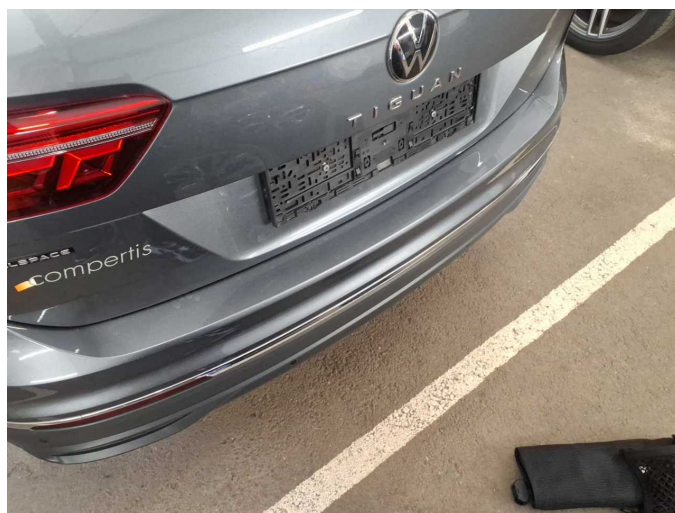
| No. | Component group | Description |
|---|---|---|
| 2 | Rear bumper | Rear bumper - Scratch(es) - No deduction |

**Wear and tear 2:** Rear bumper: Rear bumper - Scratch(es) - No deduction

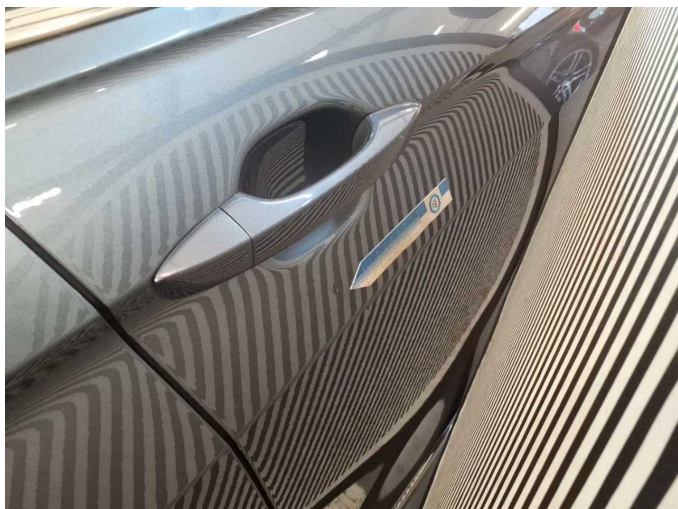
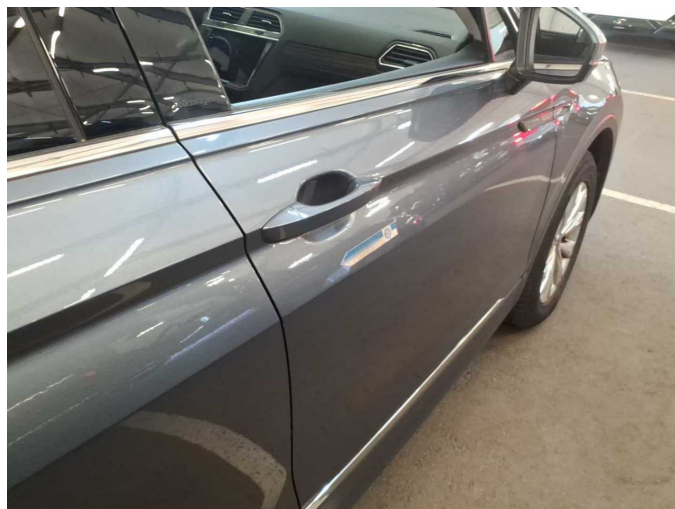
| No. | Component group | Description |
|---|---|---|
| 3 | Door - front right side | Door - dent(s) - Smooth repair work |

**Wear and tear 3:** Door - front right side: Door - dent(s) - Smooth repair work

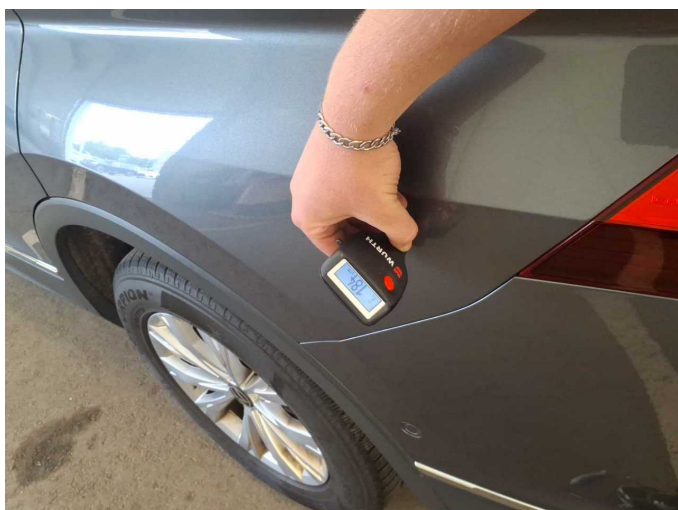
| No. | Repainting |
|---|---|
| 1 | Side panel - rear left side |

| Side panel - rear left side | 184 µm | Side panel - rear right side | 170 µm |

**Repainting 1:** Side panel - rear left side

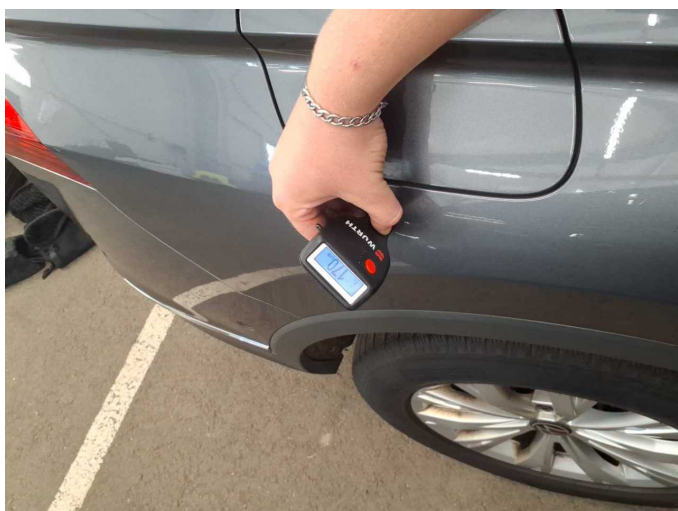
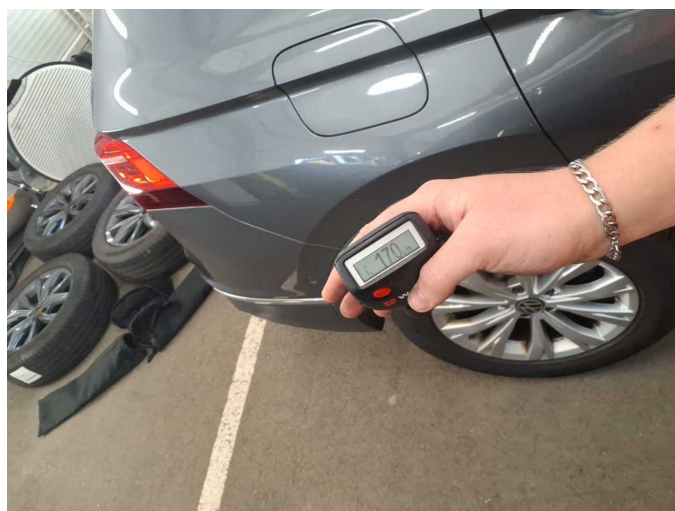
| No. | Repainting |
|---|---|
| 2 | Side panel - rear right side |

**Repainting 2:** Side panel - rear right side
