Expertise

Protocol number: 46320784  
Order No. / Reference: 26673537  
Inspection date: 3 Jul 2026

Manufacturer: MAN  
VIN: WMA03VUY0P9018964

Model: TGE 3.140 4X2F SB

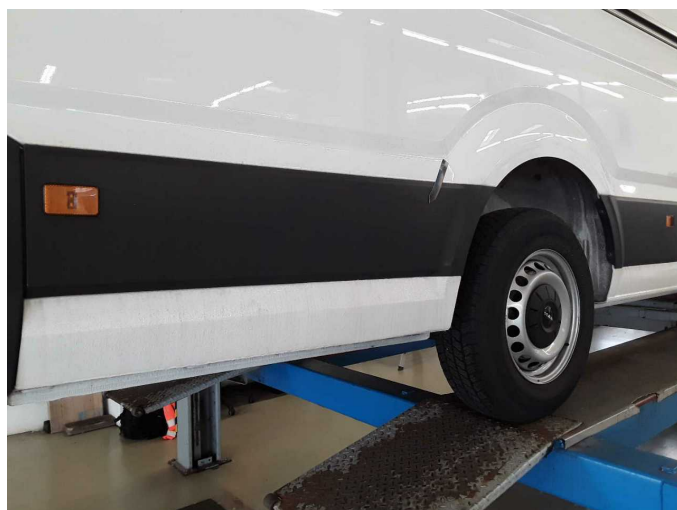
| No. | Component group | Description |
|---|---|---|
| 1 | Side panel - rear right side | Protection strip (hinten) - Scratched - Loss in value |

**Damage 1:** Side panel - rear right side: Protection strip (hinten) - Scratched - Loss in value

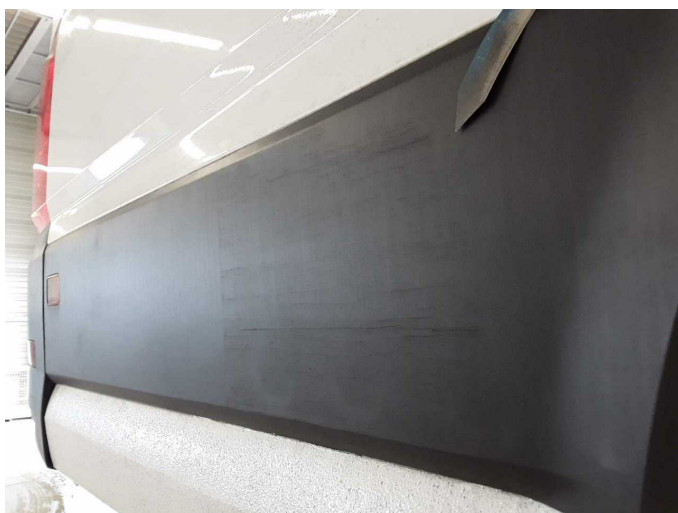
**Damage 1:** Side panel - rear right side: Protection strip (hinten) - Scratched - Loss in value

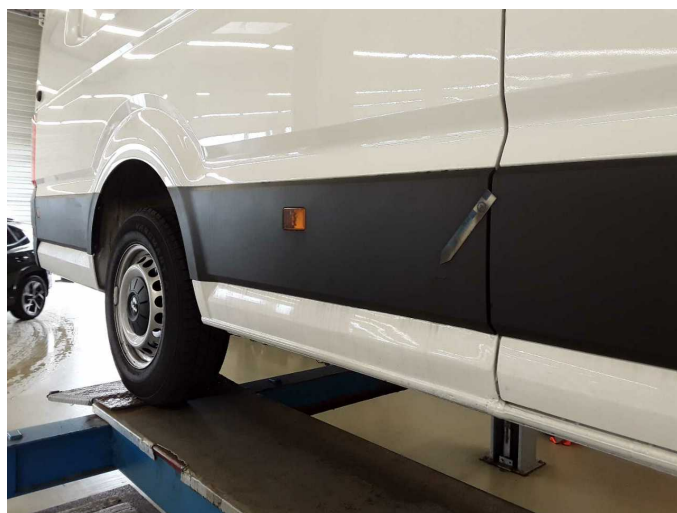
| No. | Component group | Description |
|---|---|---|
| 2 | Side panel - rear right side | Protection strip (vorn) - Deformed - Loss in value |

**Damage 2:** Side panel - rear right side: Protection strip (vorn) - Deformed - Loss in value

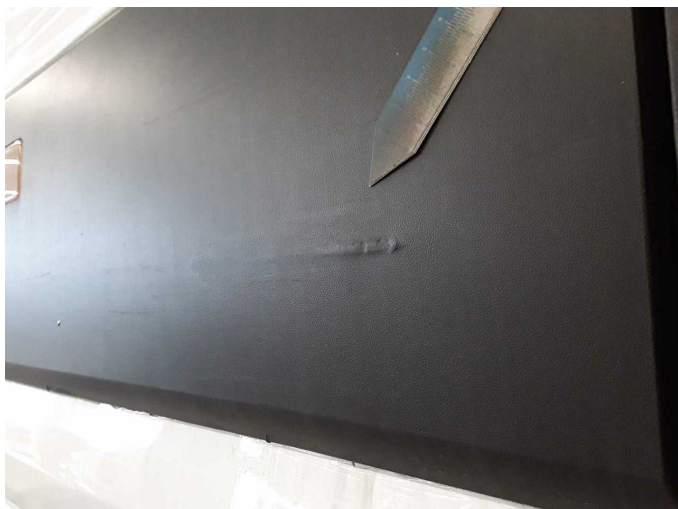
**Damage 2:** Side panel - rear right side: Protection strip (vorn) - Deformed  
- Loss in value

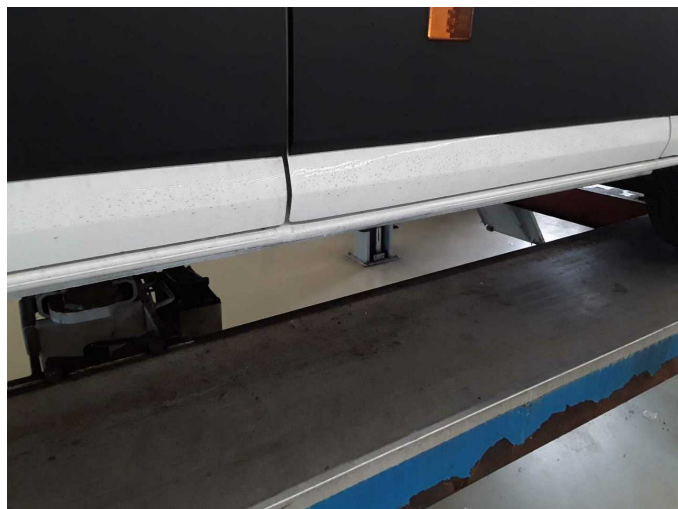
| No. | Component group | Description |
|---|---|---|
| 3 | Sill - right side | Sill (verformt nicht gerade) - Unprofessionally repaired - Repair and paint |

| Boot lid / rear door | 284 µm | Sill - right side | 435 µm |

**Damage 3:** Sill - right side: Sill (verformt nicht gerade) - Unprofessionally repaired - Repair and paint

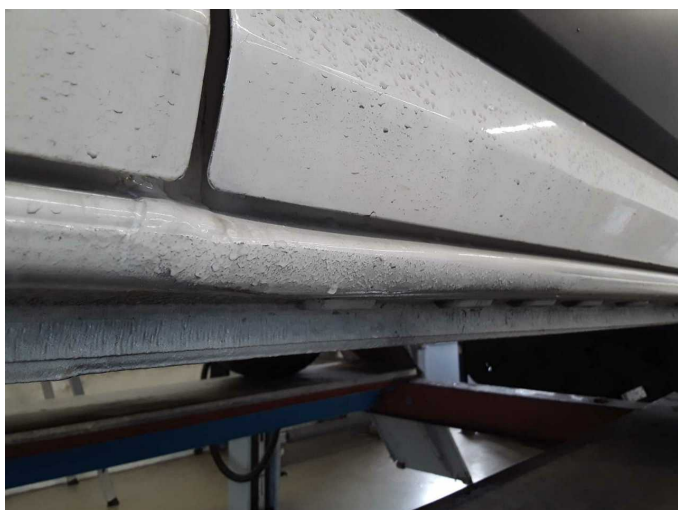
**Damage 3:** Sill - right side: Sill (verformt nicht gerade) - Unprofessionally repaired - Repair and paint

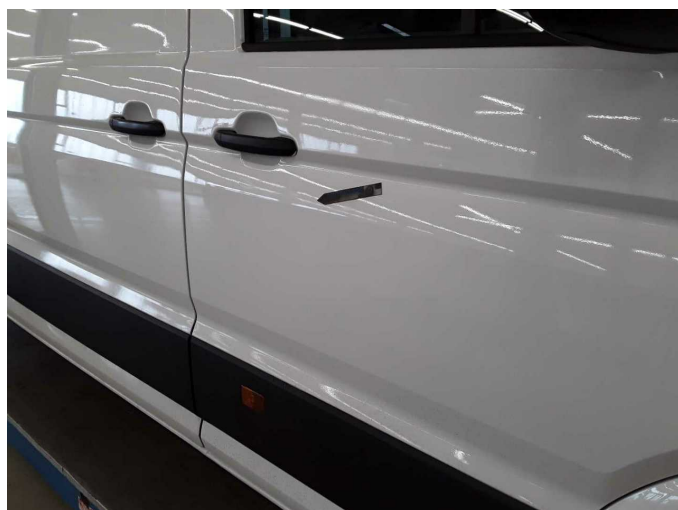
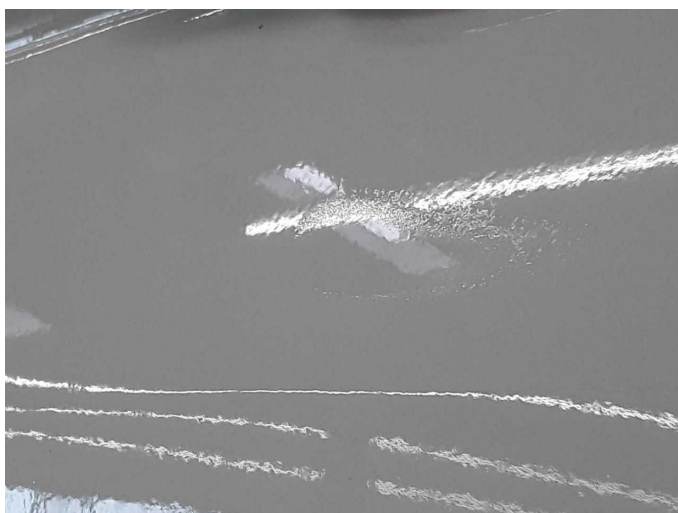
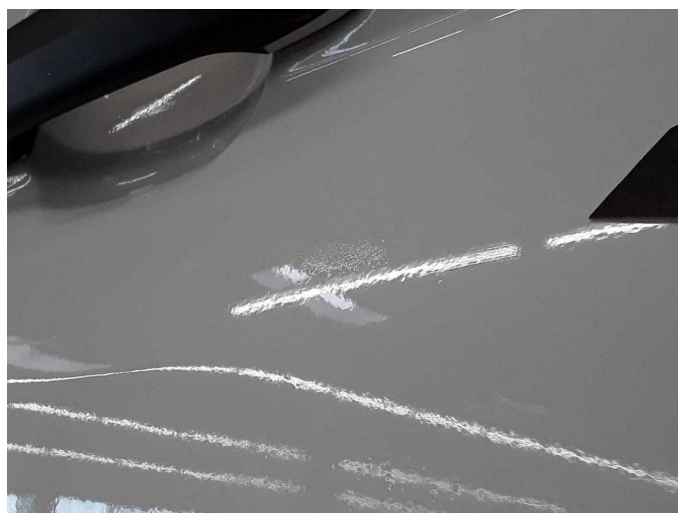
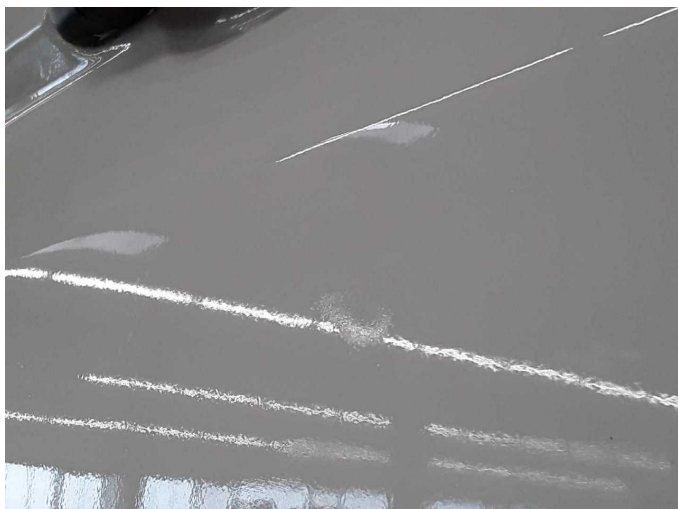
| No. | Component group | Description |
|---|---|---|
| 4 | Door - front right side | Door (Schleifspuren, Orangenhaut) - Unprofessionally repaired - Paint |

**Damage 4:** Door - front right side: Door (Schleifspuren, Orangenhaut) - Unprofessionally repaired - Paint

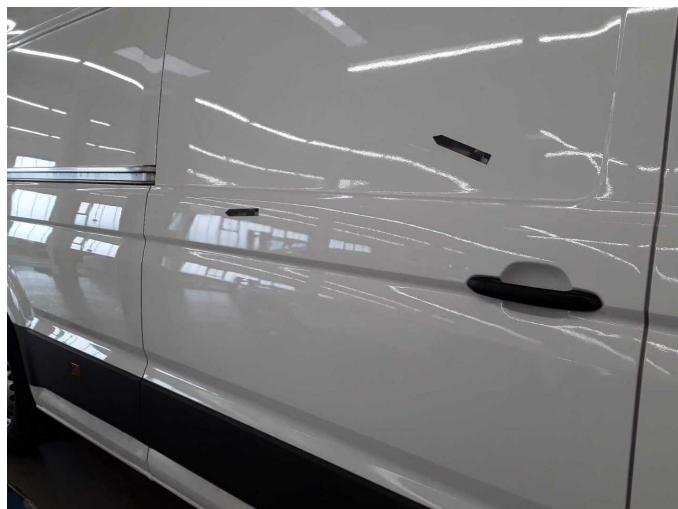
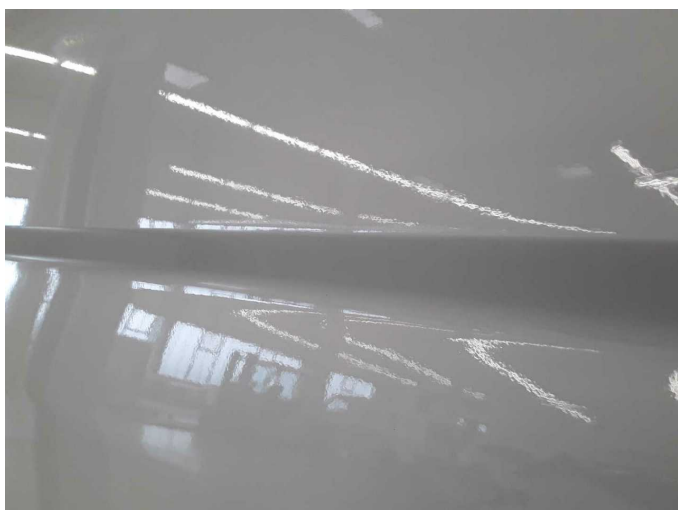
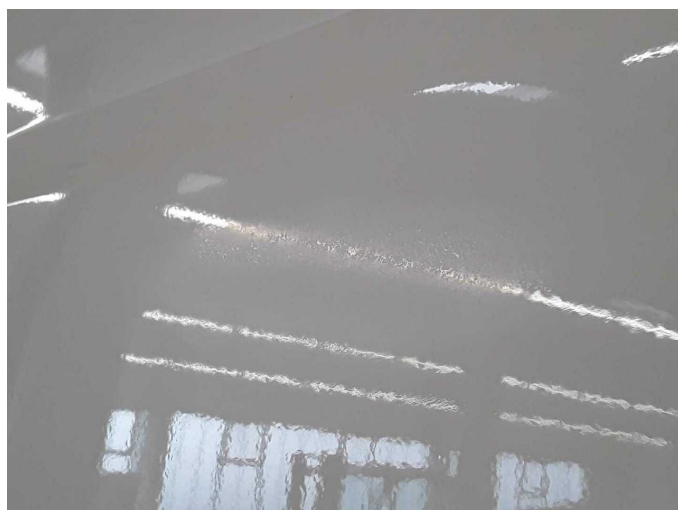
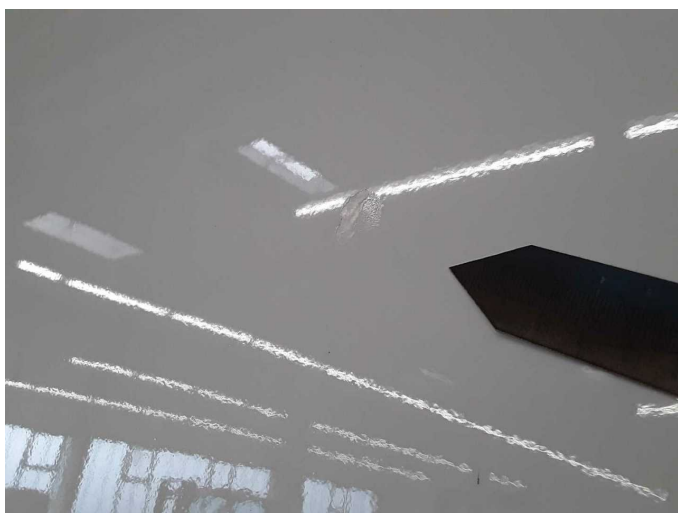
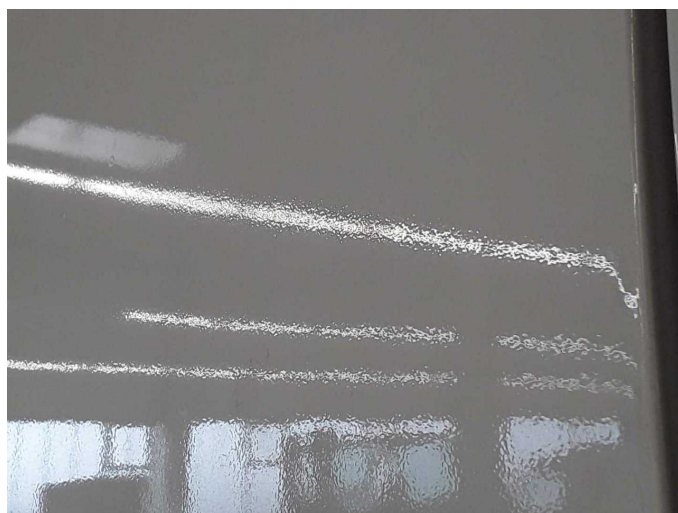
| No. | Component group | Description |
|---|---|---|
| 5 | Sliding door, right | Sliding door (Orangenhaut, Schleifspuren) - Unprofessionally repaired - Paint |

**Damage 5:** Sliding door, right: Sliding door (Orangenhaut, Schleifspuren) - Unprofessionally repaired - Paint

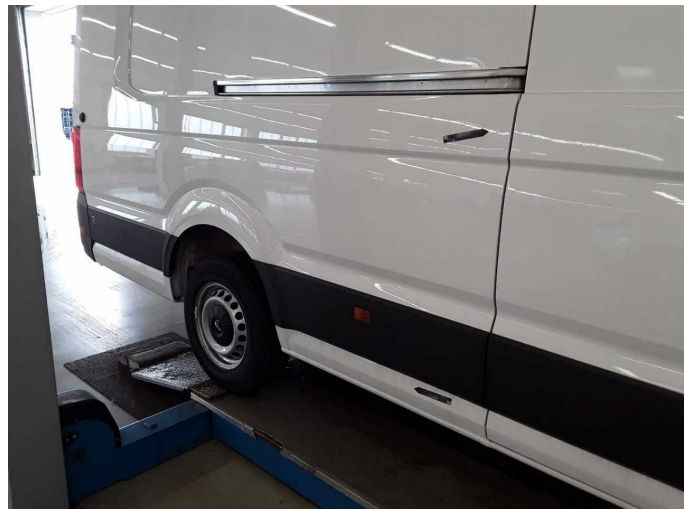
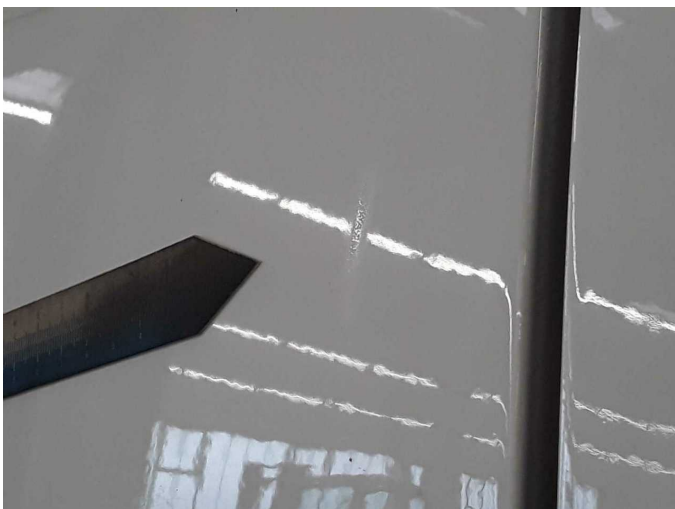
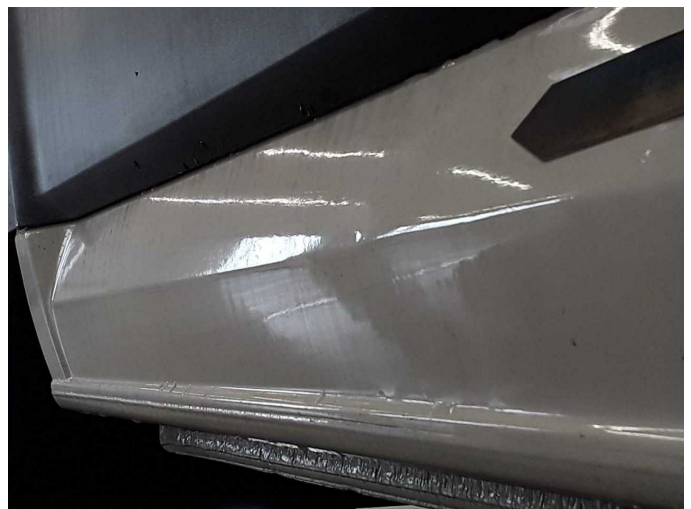
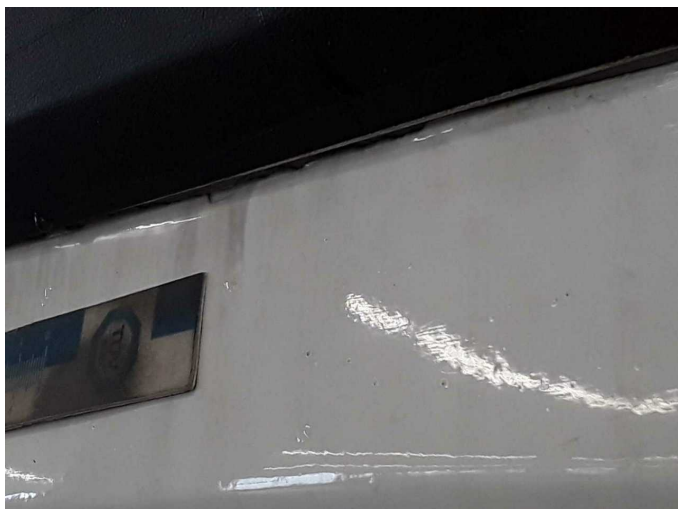
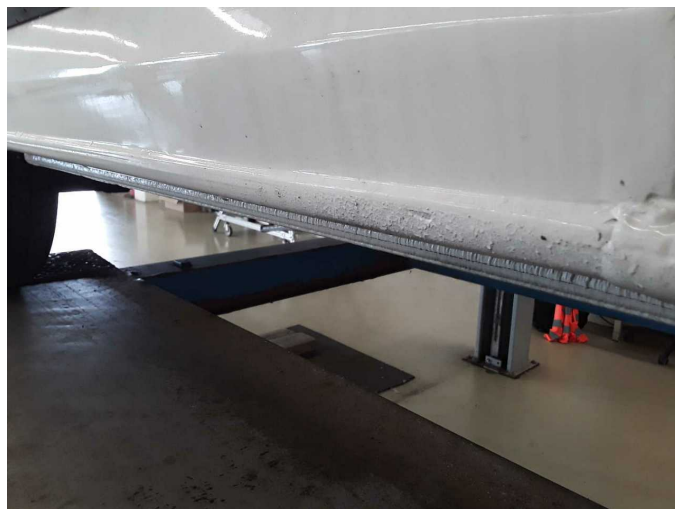
| No. | Component group | Description |
|---|---|---|
| 7 | Side panel - rear right side | Side panel (Schleifspuren, Orangenhaut) - Unprofessionally repaired - Repair and paint |

**Damage 7:** Side panel - rear right side: Side panel (Schleifspuren, Orangenhaut) - Unprofessionally repaired - Repair and paint

**Damage 7:** Side panel - rear right side: Side panel (Scleifspuren, Orangenhaut) - Unprofessionally repaired - Repair and paint

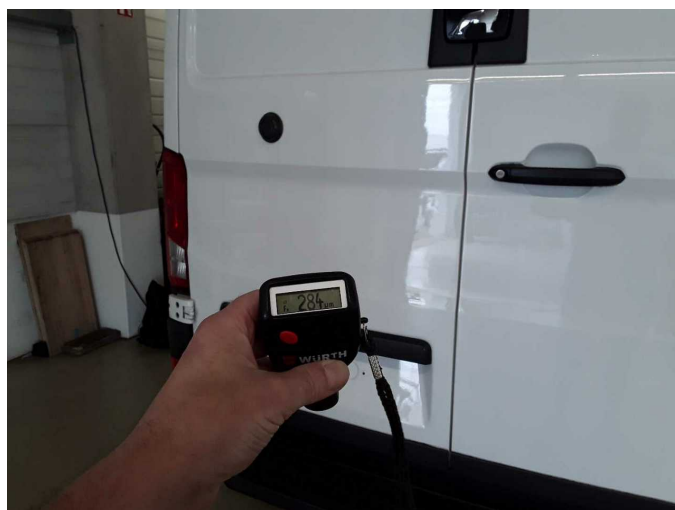
**Boot lid / rear door:** 284 µm

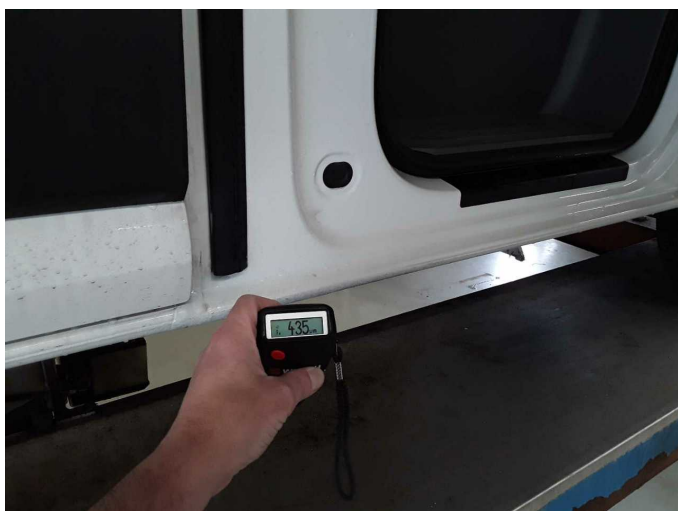
**Sill - right side:** 435 µm

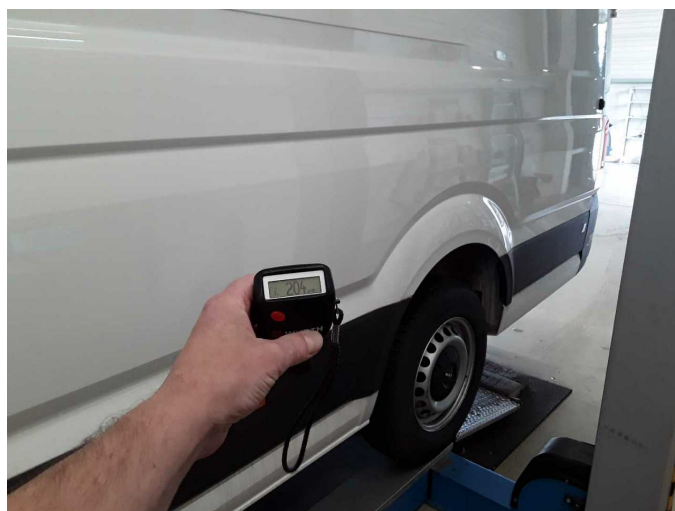
**Side panel - rear left side:** 204 µm

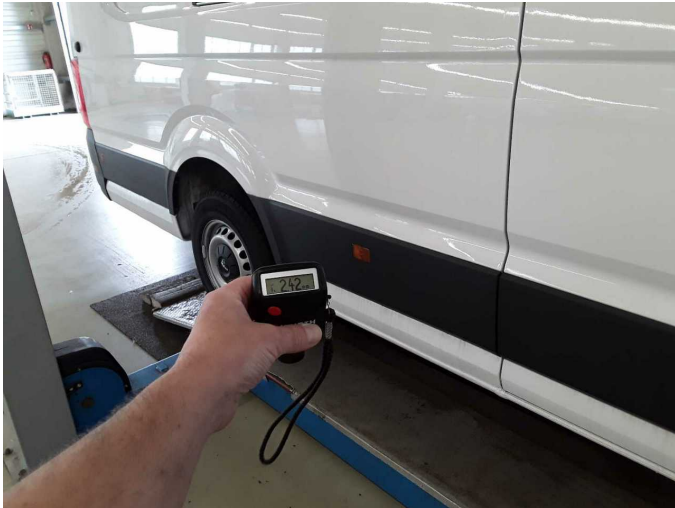
**Side panel - rear right side: 2,420 µm**

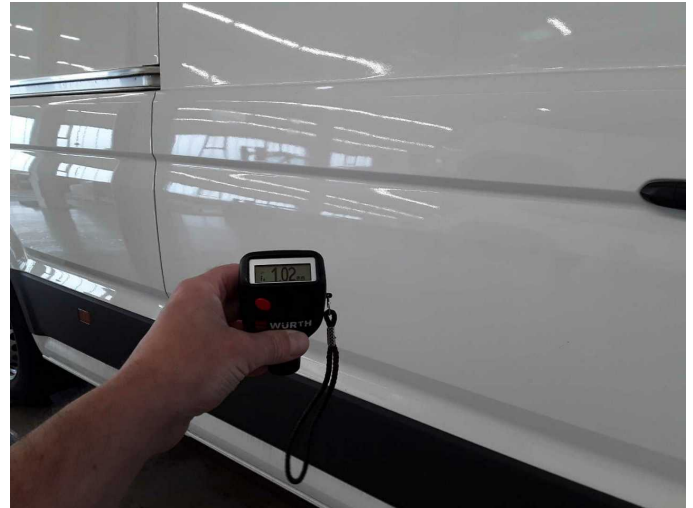
**Door - rear right side: 1,020 µm**

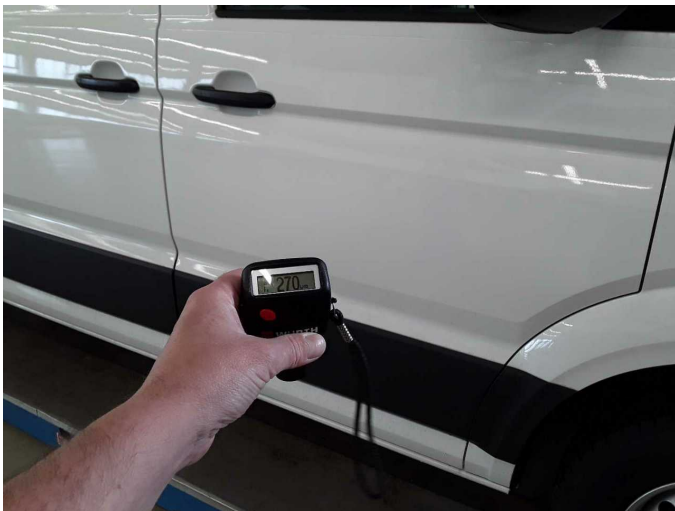
**Door - front right side: 270 µm**
