Expertise

Protocol number: 45606042
Order No. / Reference: 26284736
Inspection date: 12 May 2026

Manufacturer: Skoda

Model: Kodiaq 2.0 TDI 4x4 DSG Sportline

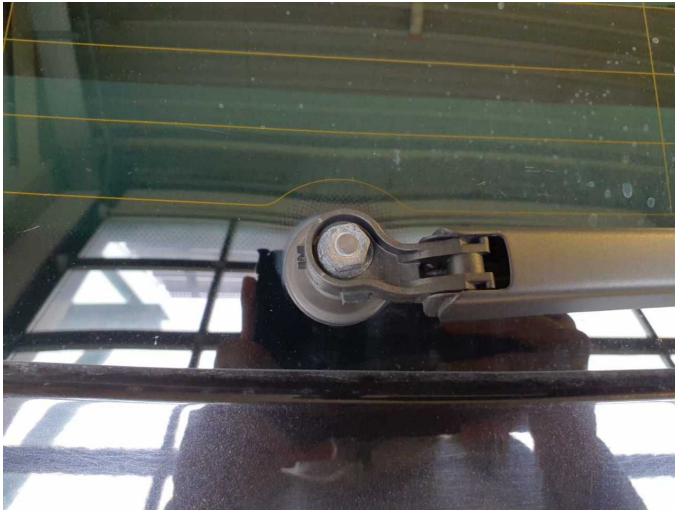
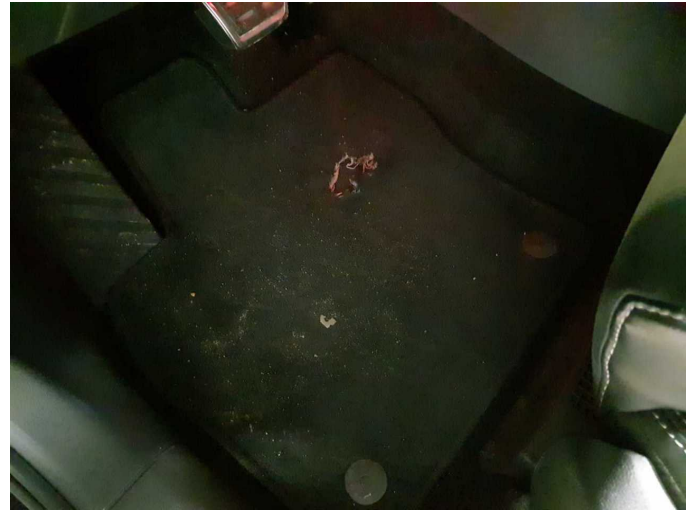
| No. | Component group | Description |
|---|---|---|
| 1 | Screen cleaning | Wiper arm - rear (Abdeckkappe) - Missing - Replace |

Damage 1: Screen cleaning: Wiper arm - rear (Abdeckkappe) - Missing - Replace

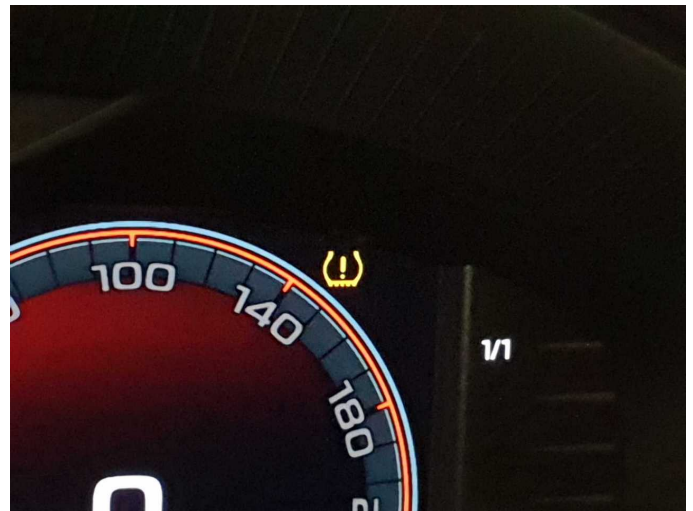
| No. | Component group | Description |
|---|---|---|
| 2 | Trim / covers | Floor mats - Holes - Replace |

Damage 2: Trim / covers: Floor mats - Holes - Replace

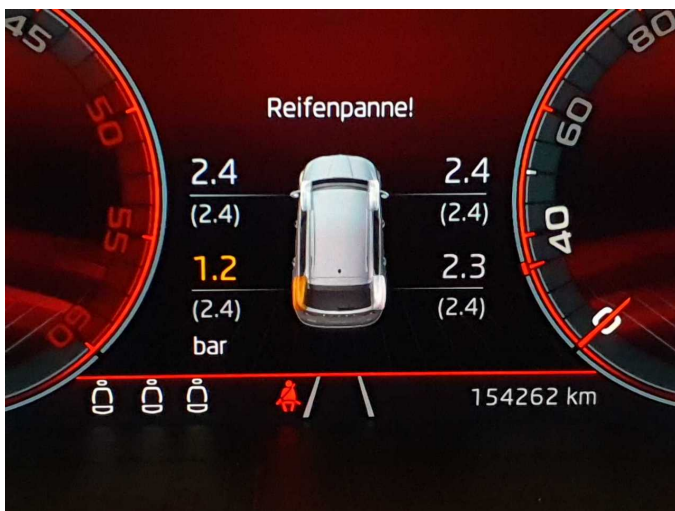
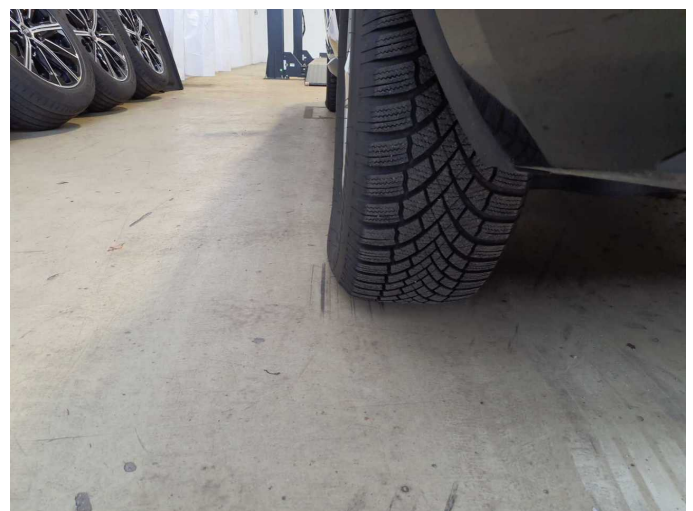
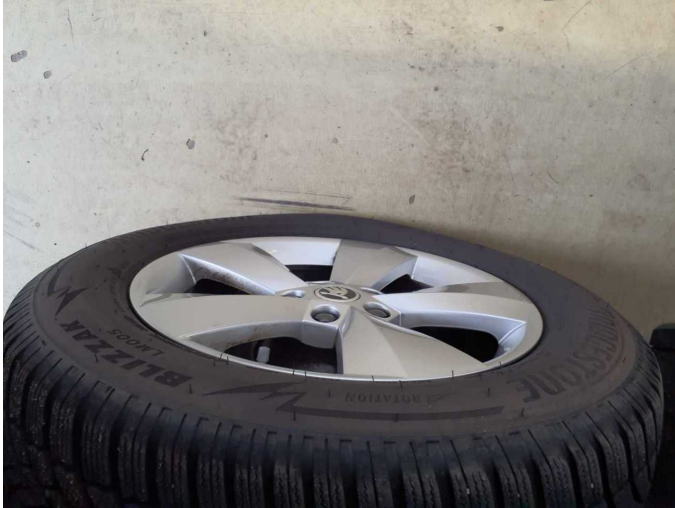
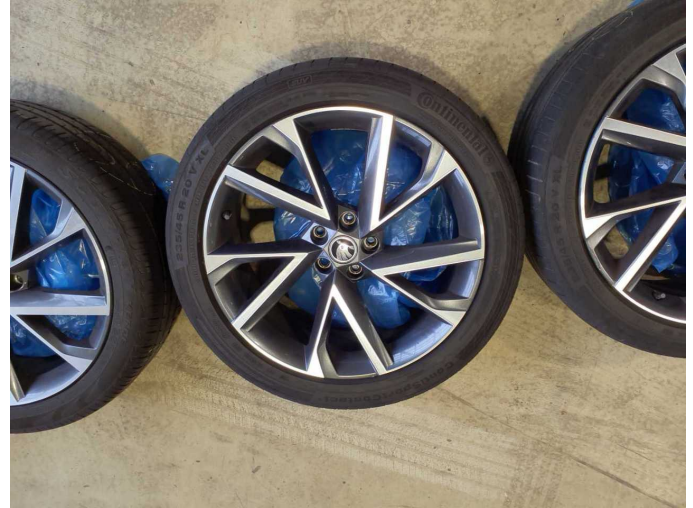
| No. | Component group | Description |
|---|---|---|
| 3 | Instrument panel | Indicator light (Reifendruck) - on - Perform diagnosis |

Damage 3: Instrument panel: Indicator light (Reifendruck) - on - Perform diagnosis

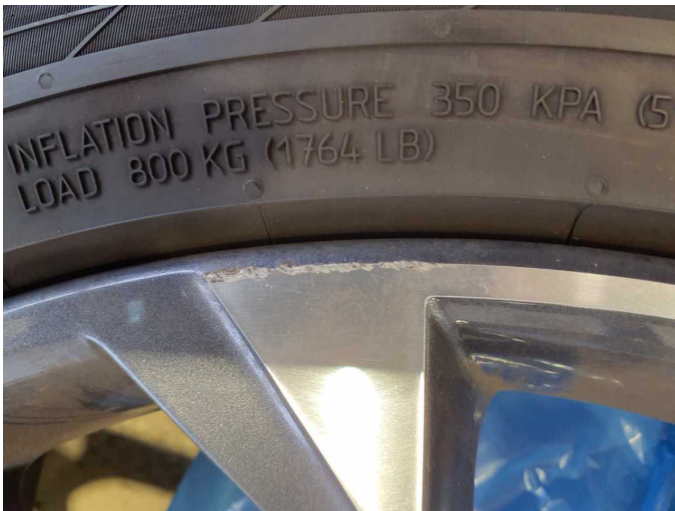
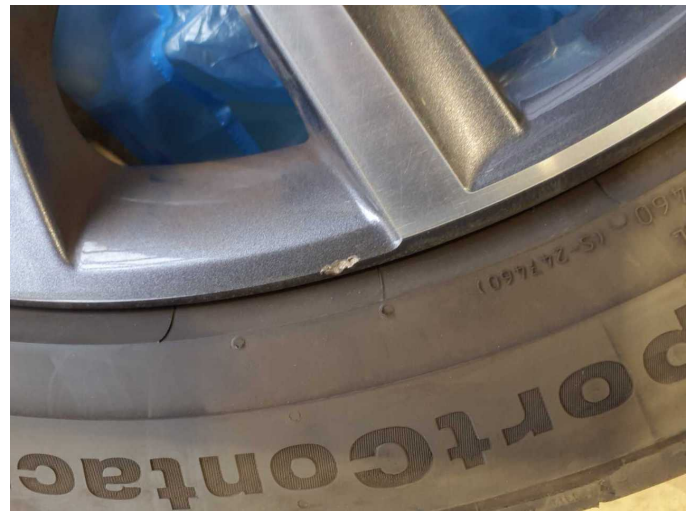
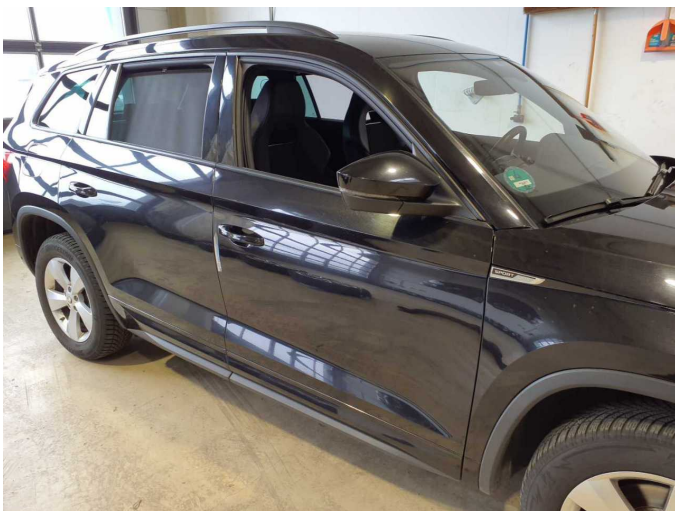
| No. | Component group | Description |
|---|---|---|
| 4 | 2nd wheel set | 1 alloy rim - Scratch(es) - Loss in value |

Damage 4: 2nd wheel set: 1 alloy rim - Scratch(es) - Loss in value

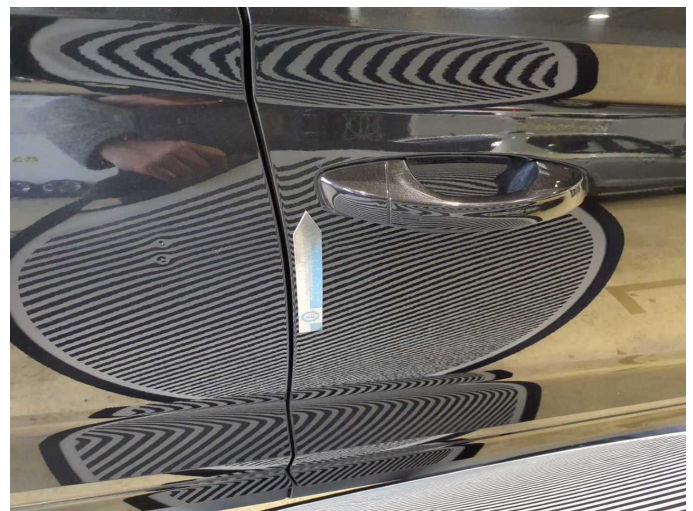
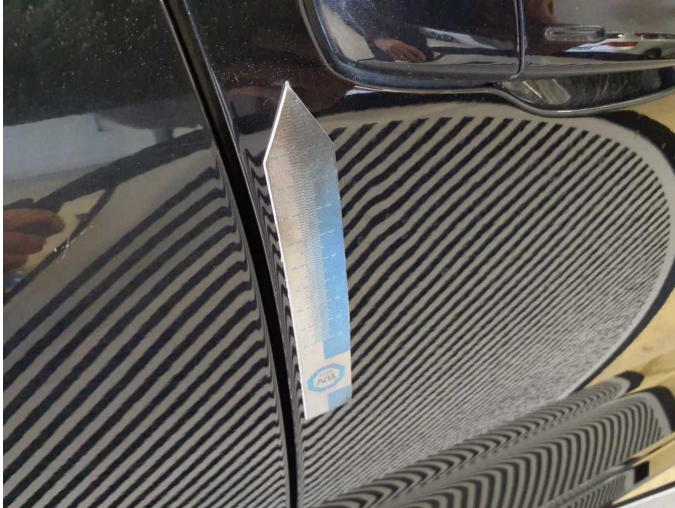
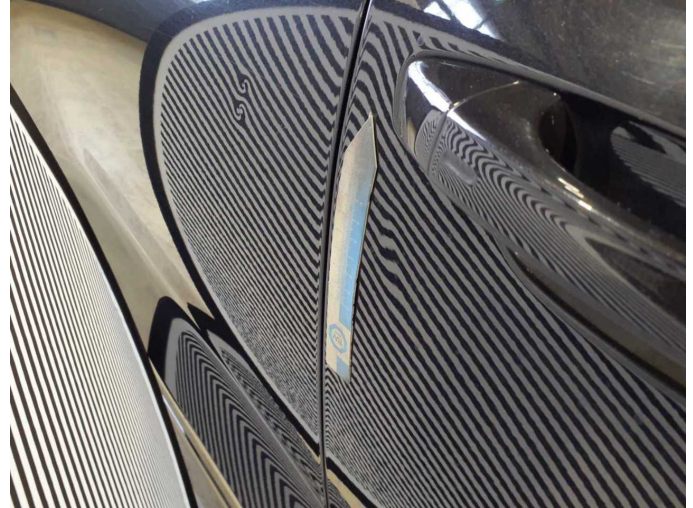
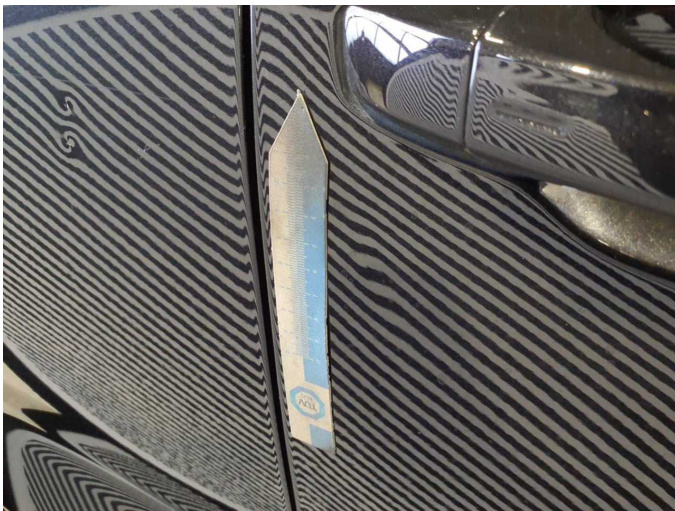
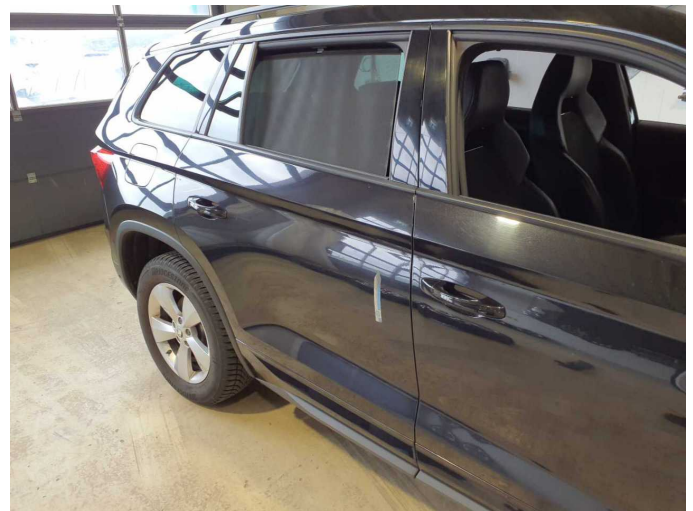
| No. | Component group | Description |
|---|---|---|
| 5 | Door - front right side | Door - dent(s) - Smart repair |

Damage 5: Door - front right side: Door - dent(s) - Smart repair

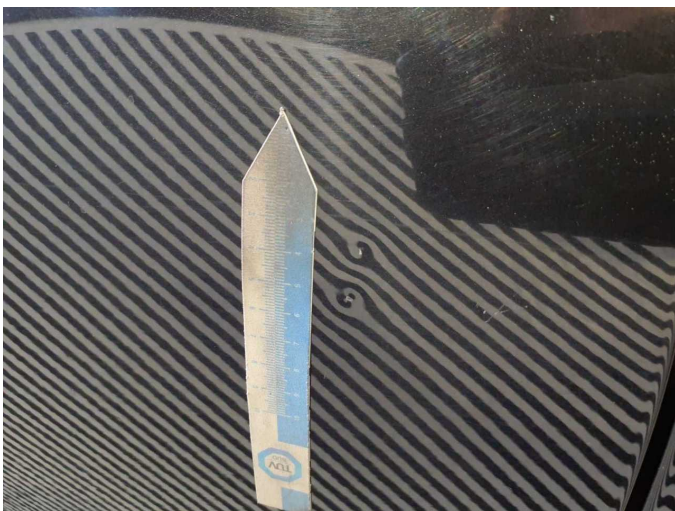
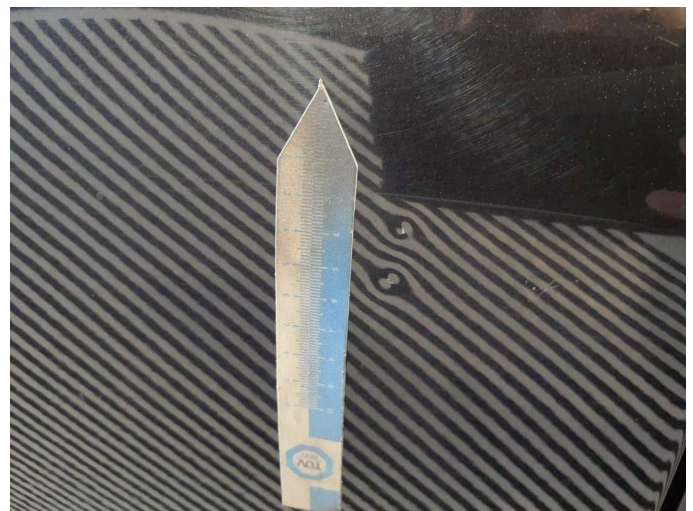
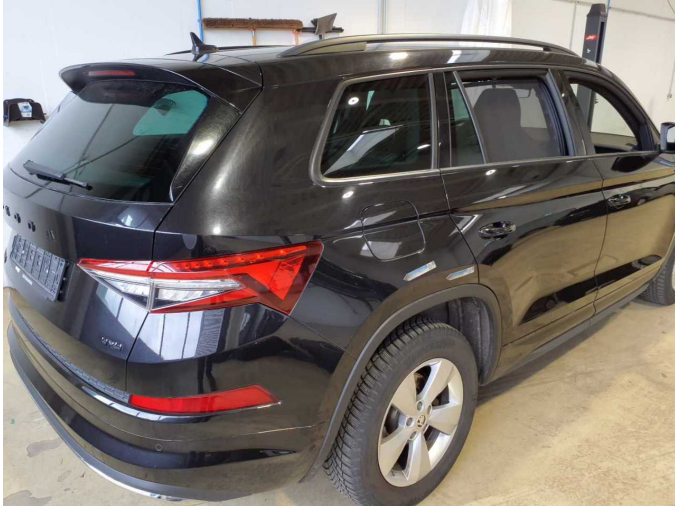
| No. | Component group | Description |
|---|---|---|
| 6 | Door - rear right side | Door - Dent / paintcoat damage - Smart repair |

Damage 6: Door - rear right side: Door - Dent / paintcoat damage - Smart repair

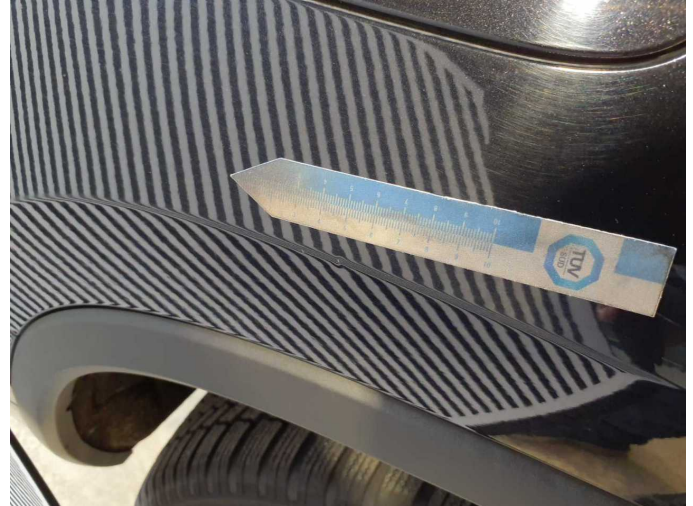
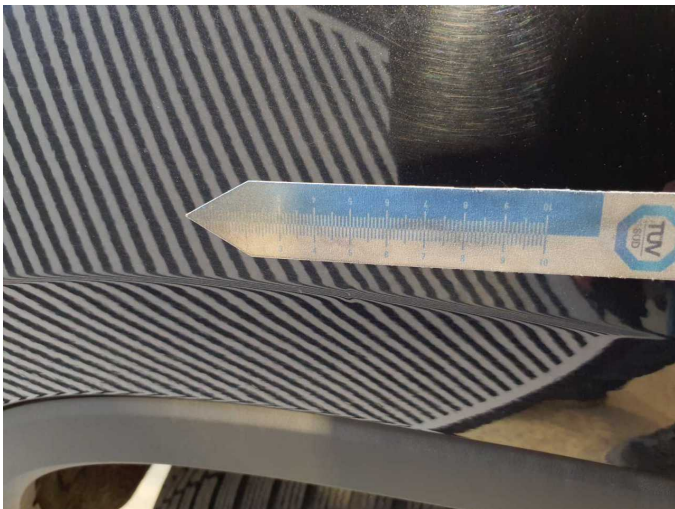
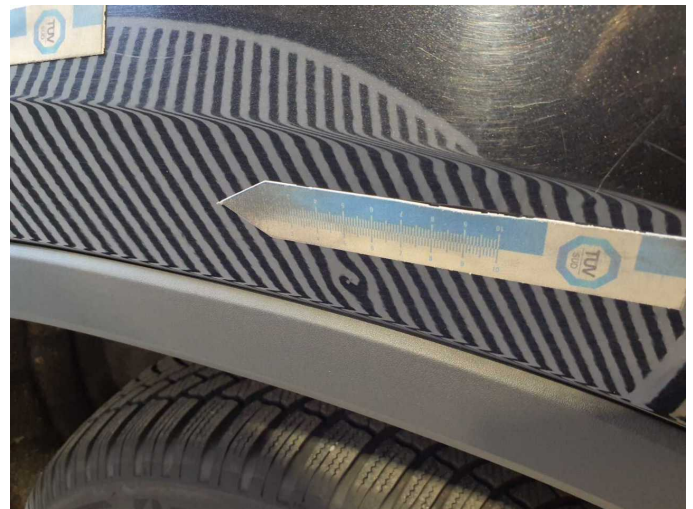
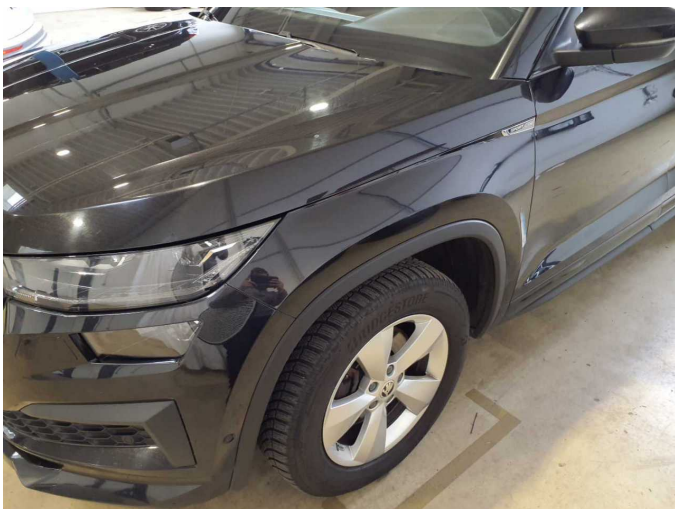
| No. | Component group | Description |
|---|---|---|
| 7 | Side panel - rear right side | Side panel - dent(s) - Smart repair |

Damage 7: Side panel - rear right side: Side panel - dent(s) - Smart repair

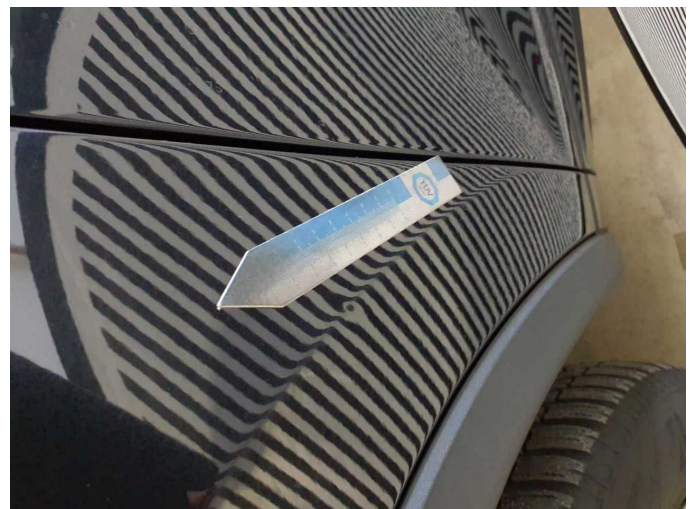
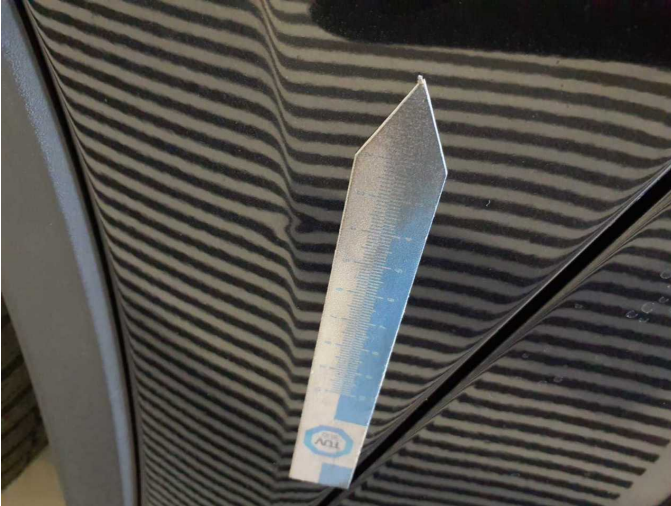
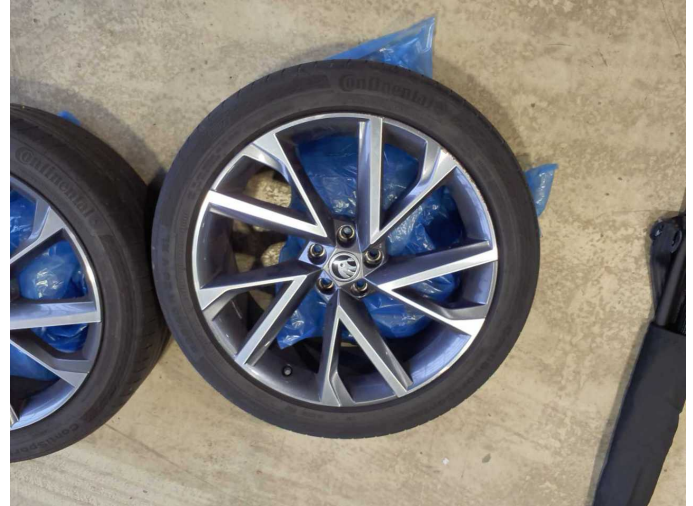
| No. | Component group | Description |
|---|---|---|
| 8 | Mudguard - left side | Mudguard - left side - dent(s) - Smart repair |

Damage 8: Mudguard - left side: Mudguard - left side - dent(s) - Smart repair

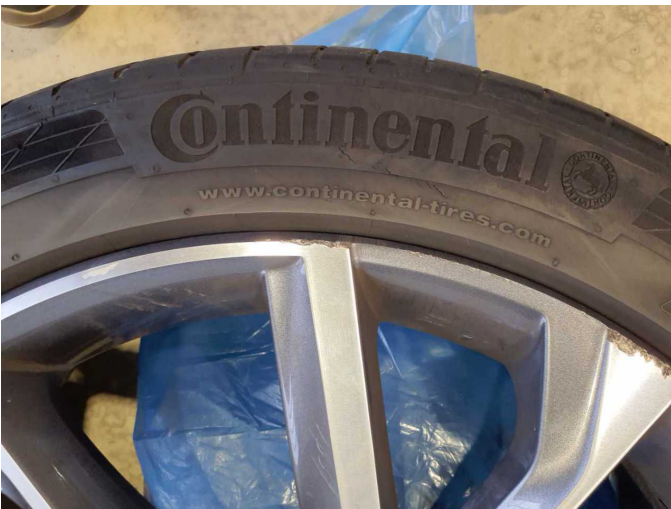
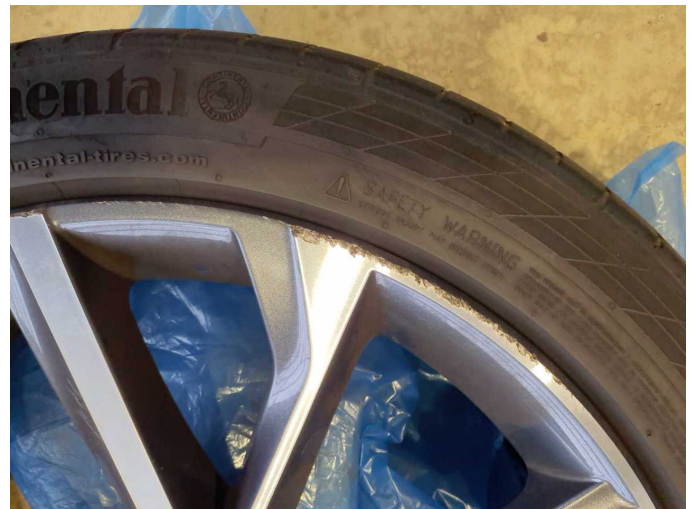
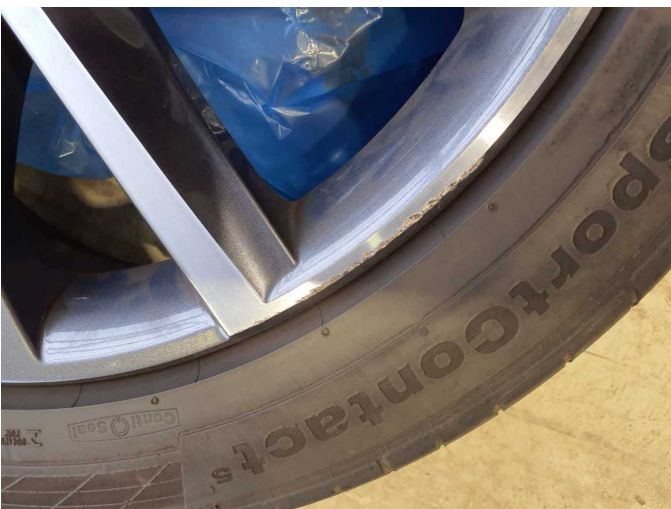
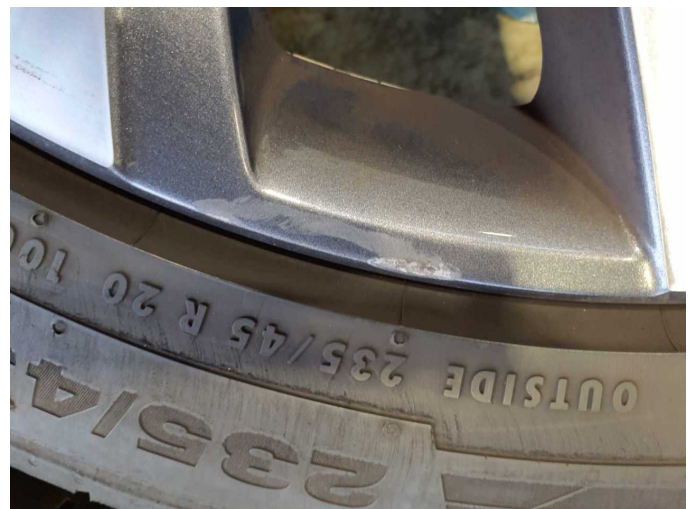
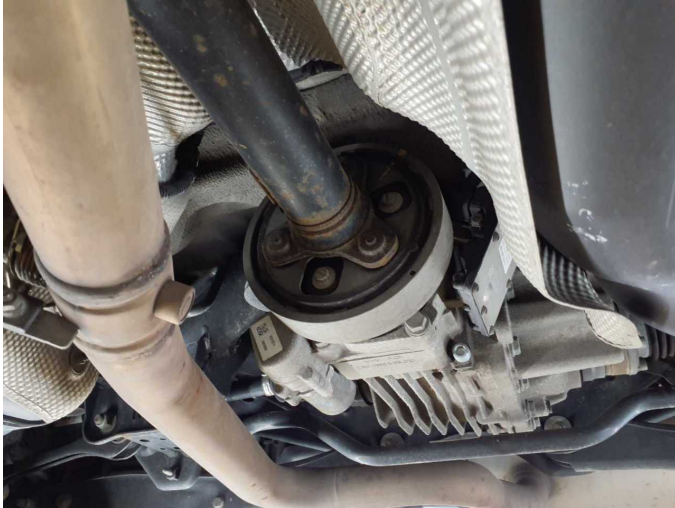
| No. | Component group | Description |
|---|---|---|
| 9 | 2nd wheel set | 1 alloy rim - Scratch(es) - Replace |

Damage 9: 2nd wheel set: 1 alloy rim - Scratch(es) - Replace

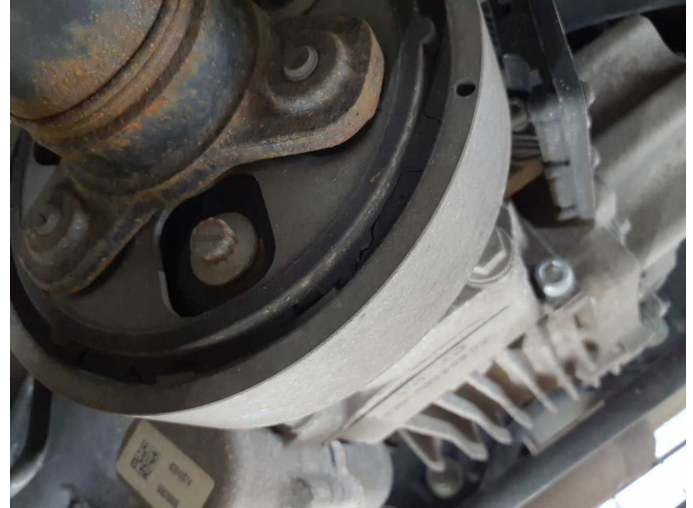
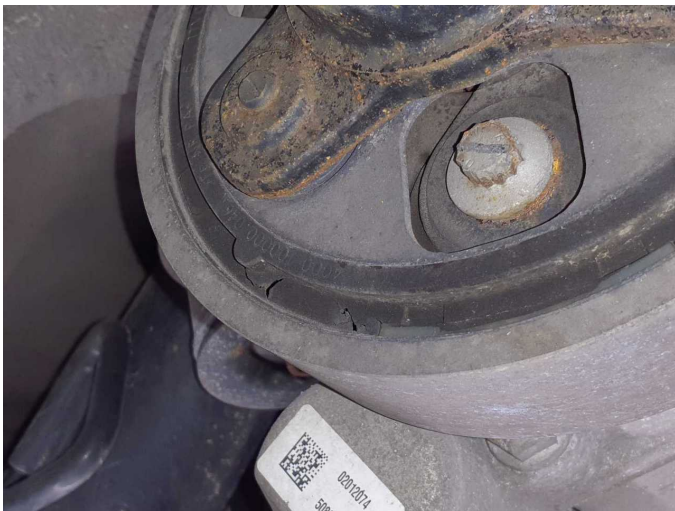
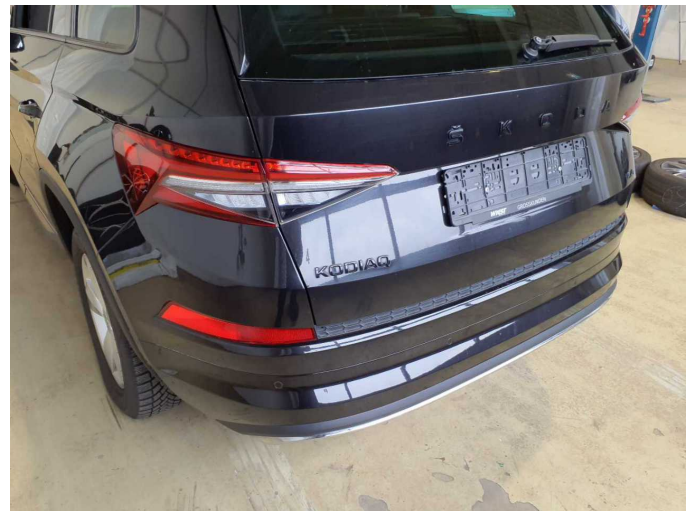
| No. | Component group | Description |
|---|---|---|
| 10 | Drive train | Drive train (Hardichscheibe) - Porous / cracked - Replace |

Damage 10: Drive train: Drive train (Harddichscheibe) - Porous / cracked - Replace

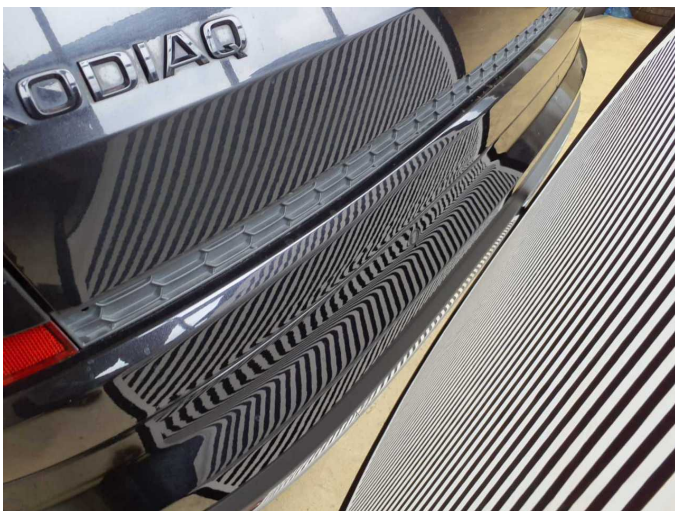
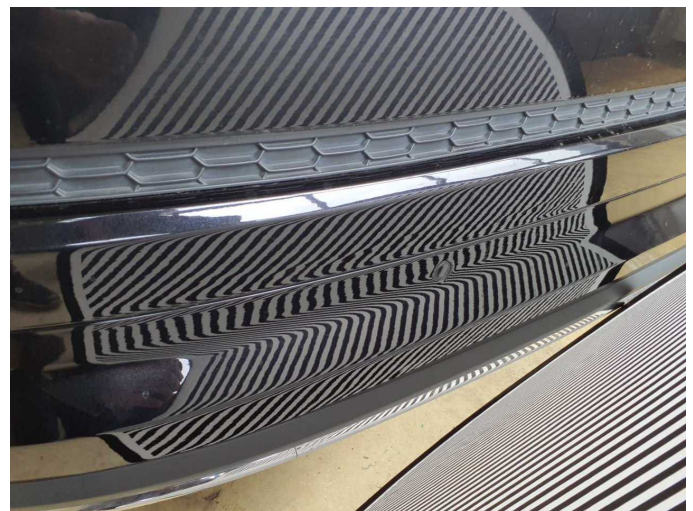
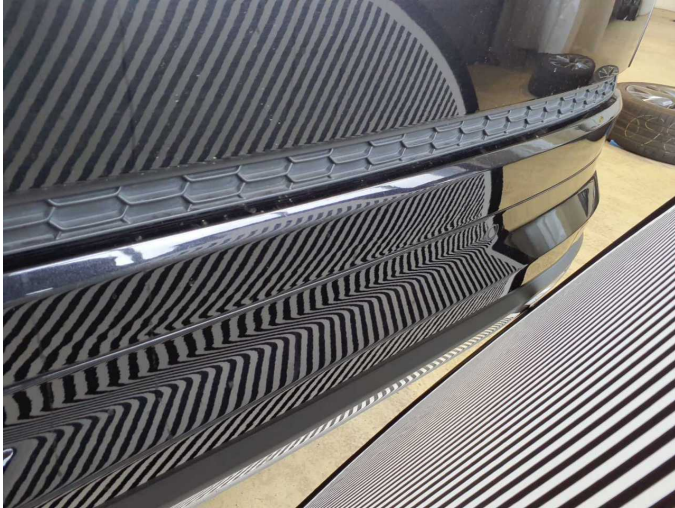
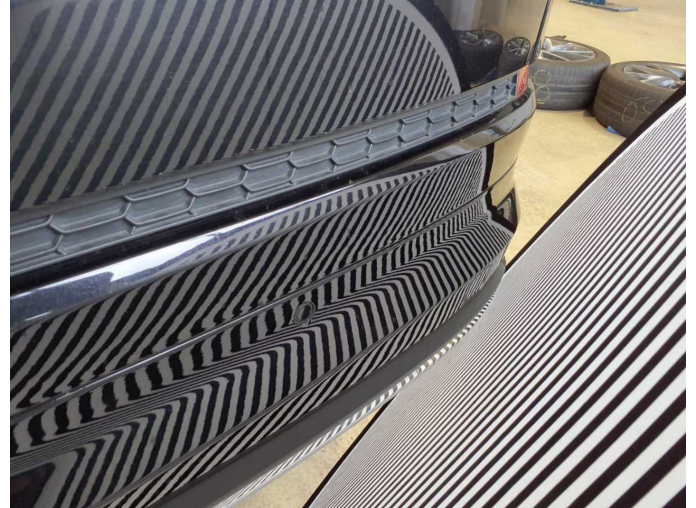
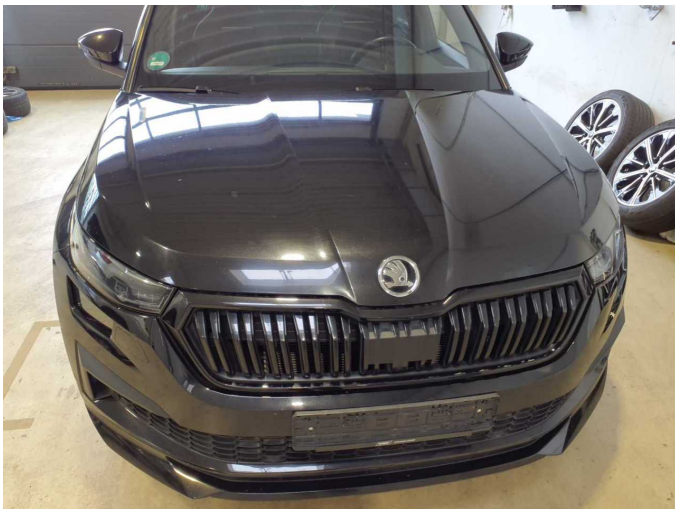
| No. | Component group | Description |
|---|---|---|
| 11 | Rear bumper | Rear bumper (Wellig) - Paint defect - Repair and paint |

Damage 11: Rear bumper: Rear bumper (Wellig) - Paint defect - Repair and paint

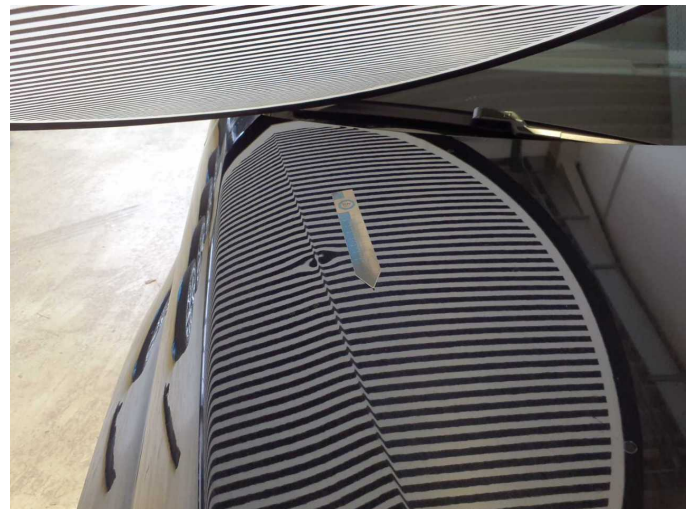
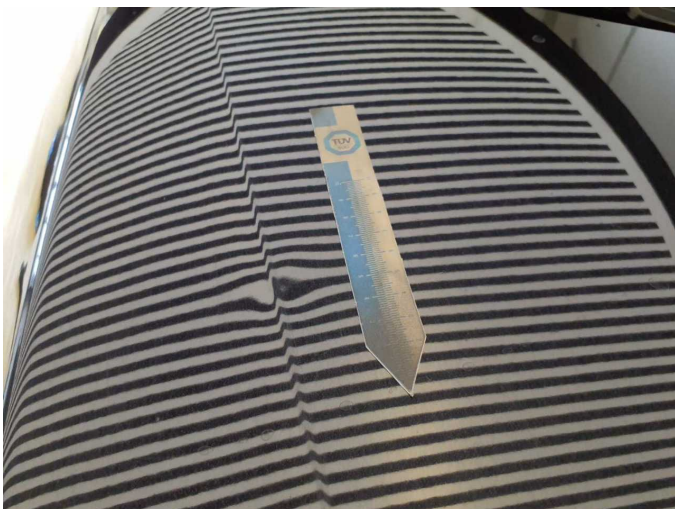
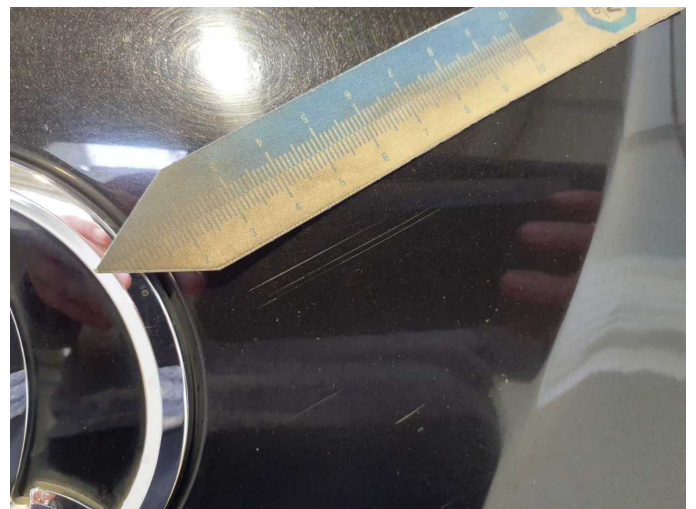
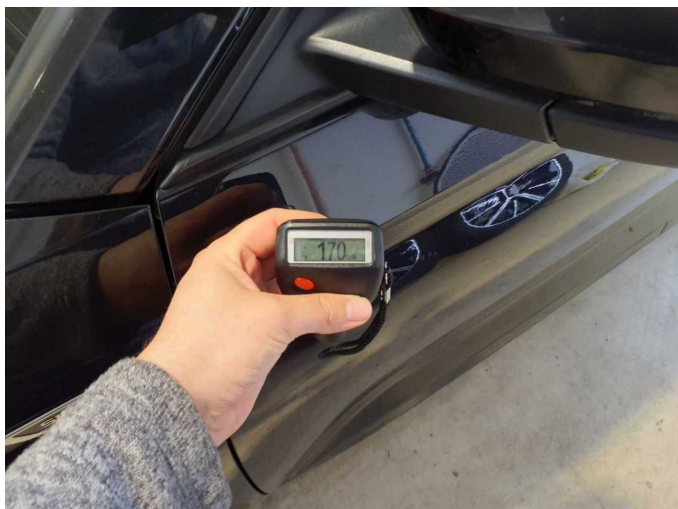
| No. | Component group | Description |
|---|---|---|
| 12 | Bonnet | Bonnet - Dent / paintcoat damage - Repair and paint |

Damage 12: Bonnet: Bonnet - Dent / paintcoat damage - Repair and paint

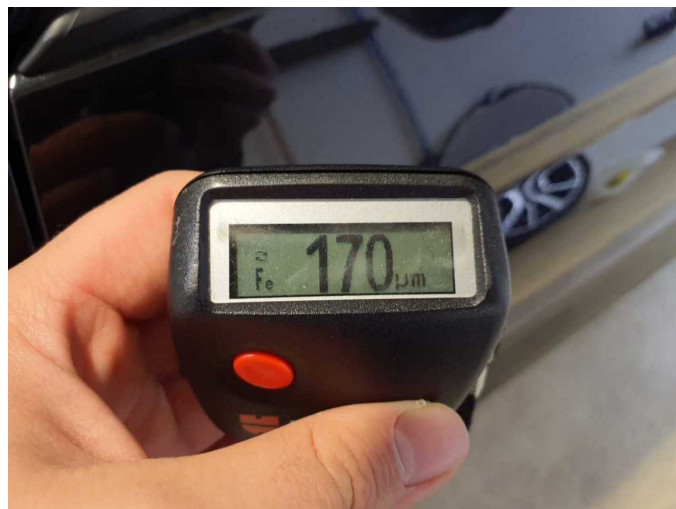
- 1 Door - front left side, Professionally carried out

Door - front left side 170 µm |

Repainting 1: Door - front left side
