Expertise

Protocol number: 46264450
Order No. / Reference: 26509792
Inspection date: 29 Jun 2026

Model: S-Max 2.5 Duratec FHEV VIGNALE

VIN: WF0JXXWPCHNB36111

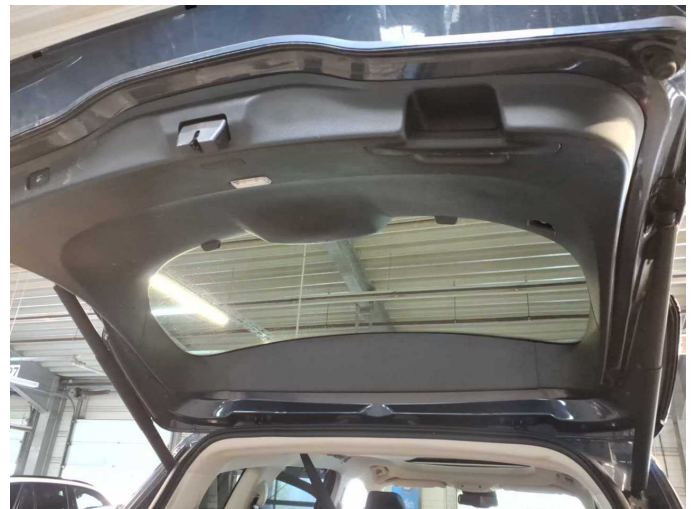
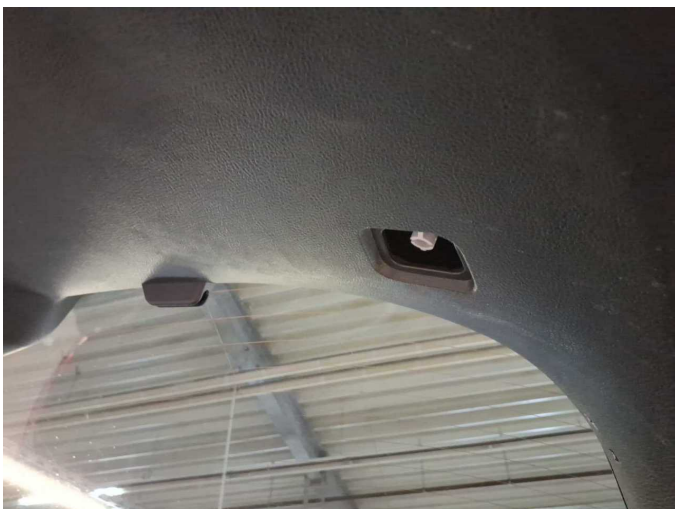
No.	Component group	Description
1	Trim / covers	Boot lid - interior trim (Abdeckkappe fehlt) - Incomplete - Replace
2	Tail light	License plate lamp - right side - Non-operational - Replace
3	Indicator - front	Mirror - left side (Materialabtrag) - Scratched - Replace
4	Side panel - rear left side	Sill - Scratch(es) - Smart repair
5	Door - front right side	Brightware - lower - Scratch(es) - Smart repair
6	Boot lid / rear door	Boot lid - Scratch(es) - Smart repair
7	Door - rear right side	Brightware - lower - Scratch(es) - Smart repair
8	2nd wheel set	1 tyre (Flanke) - Damaged - Replace
9	Wing mirror - right side	Mirror housing (+ Blinker) - Scratched - Replace
10	Rear bumper	Spoiler (Kratzer) - Deformed - Replace
11	Misc.	Inspection / maintenance - Due - Perform
12	2nd wheel set	2 alloy rims - Scratch(es) - Loss in value
13	Front bumper	Spoiler - Scratched - Paint
14	2nd wheel set	1 alloy rim (Materialabtrag) - Scratched - Replace

Damage 1: Trim / covers: Boot lid - interior trim (Abdeckkappe fehlt) - Incomplete - Replace

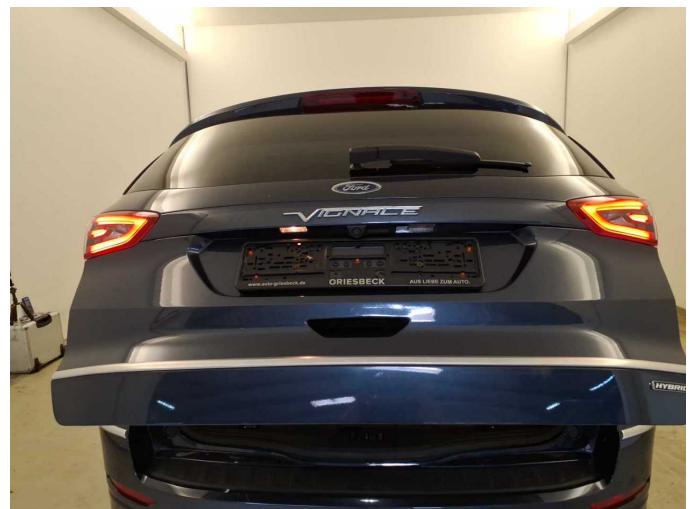
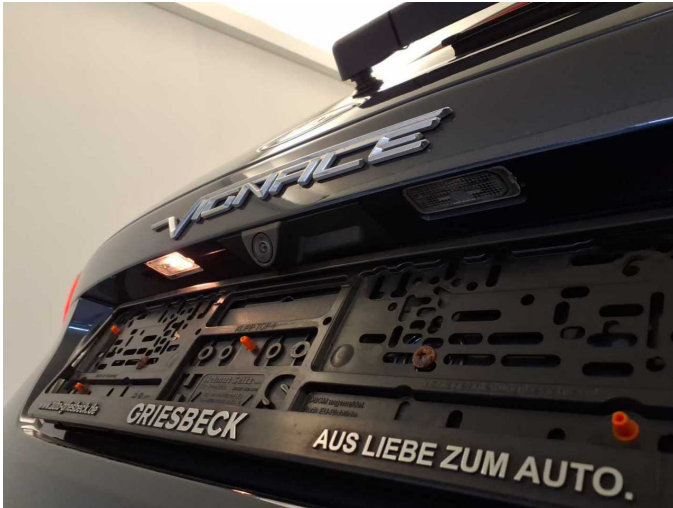
Damage 2: Tail light: License plate lamp - right side - Non-operational - Replace

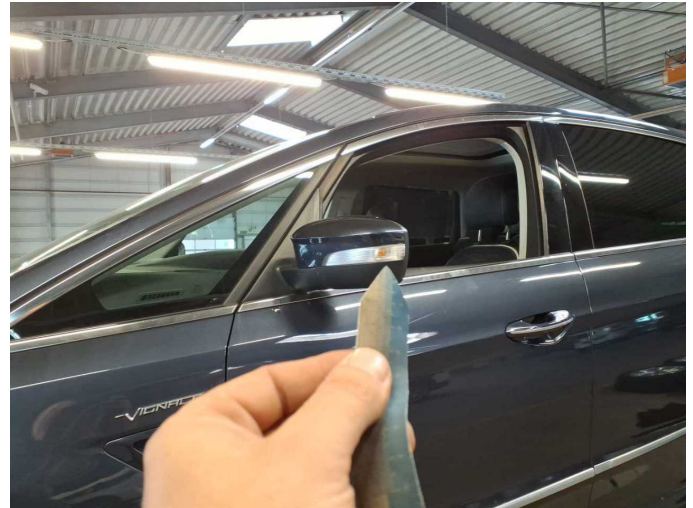
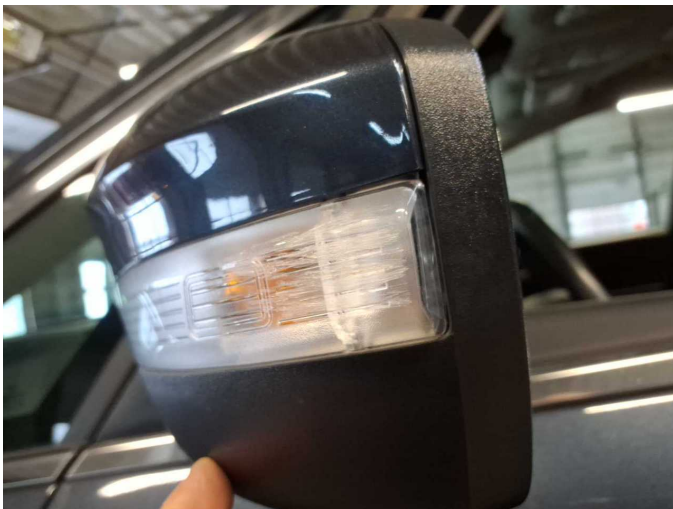
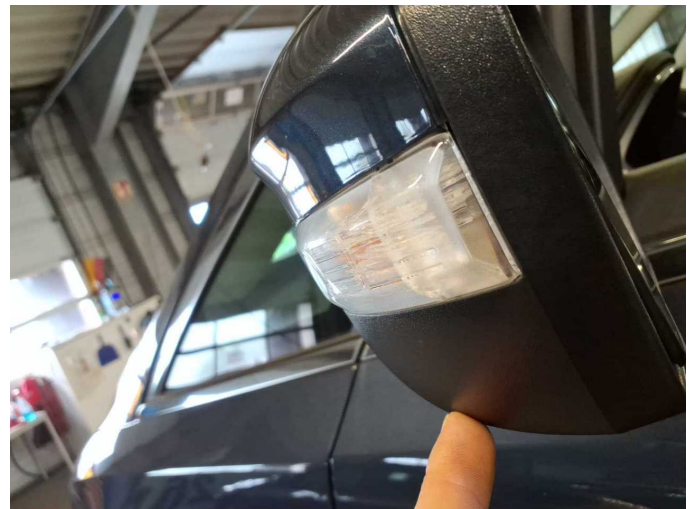
Damage 3: Indicator - front: Mirror - left side (Materialabtrag) - Scratched - Replace

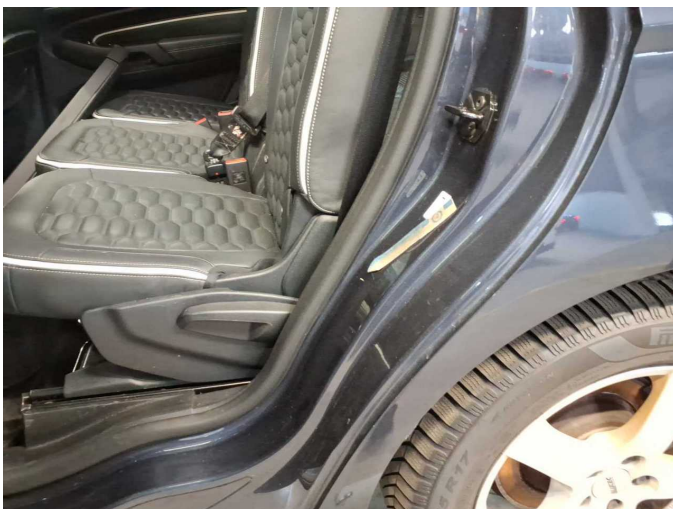
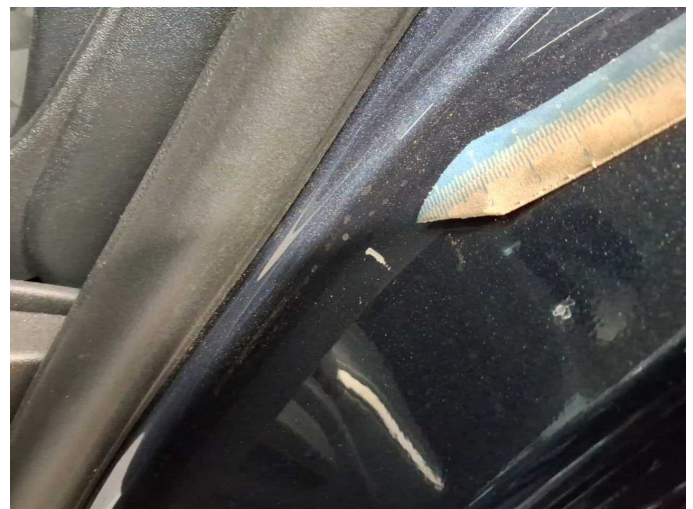
Damage 4: Side panel - rear left side: Sill - Scratch(es) - Smart repair

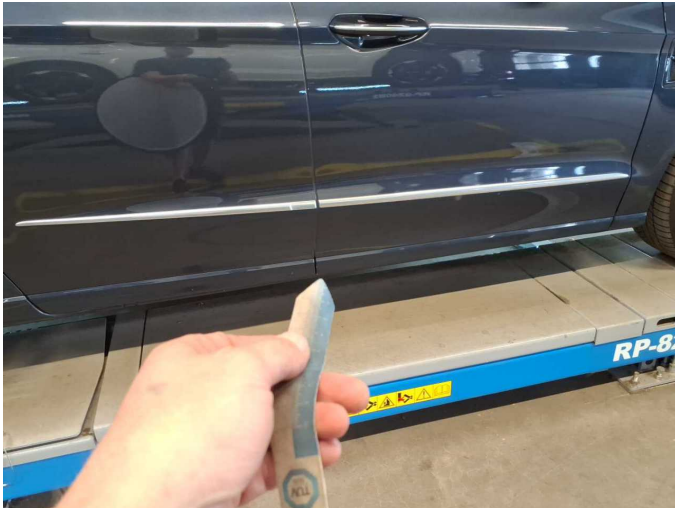
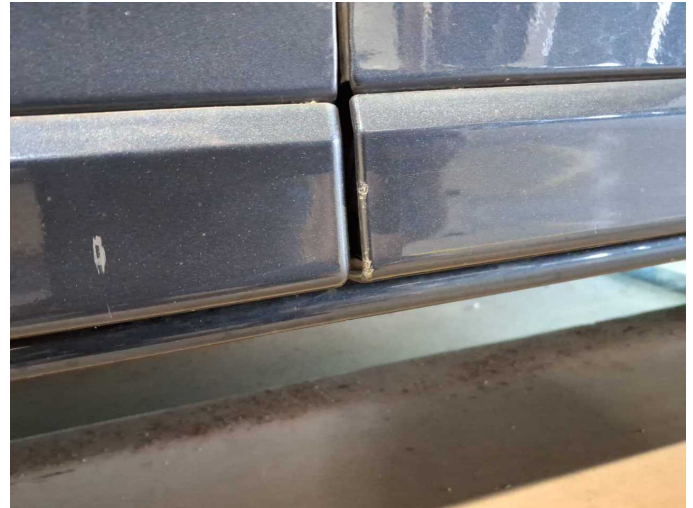
Damage 5: Door - front right side: Brightware - lower - Scratch(es) - Smart repair

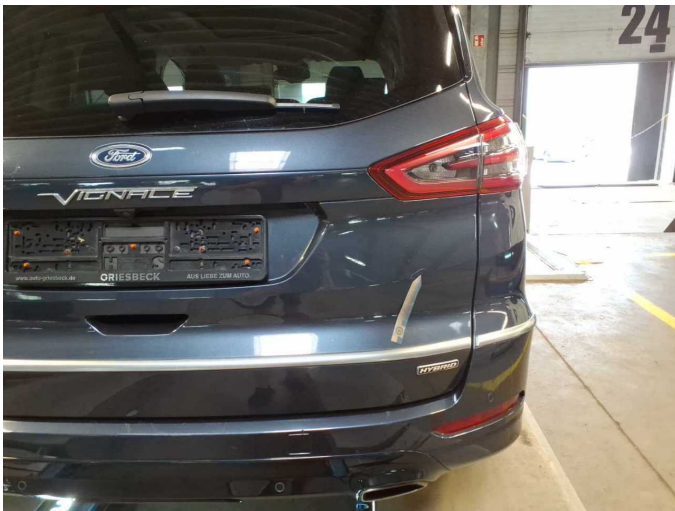
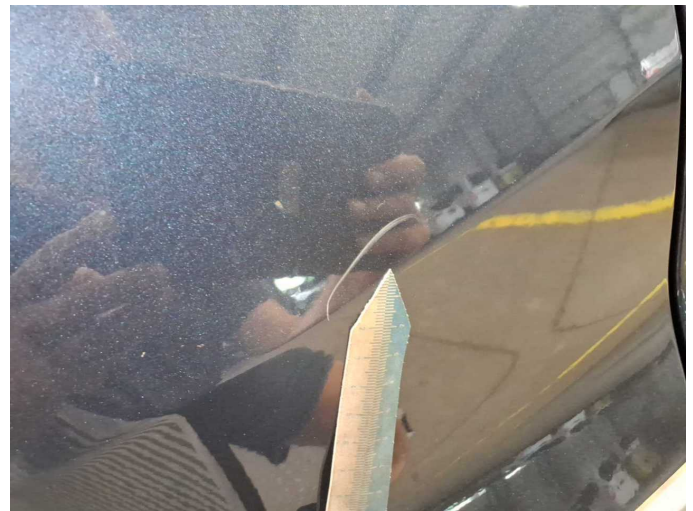
Damage 6: Boot lid / rear door: Boot lid - Scratch(es) - Smart repair

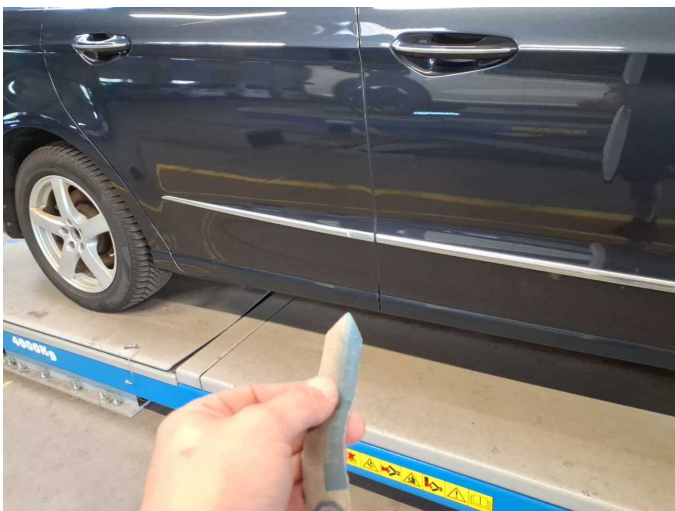
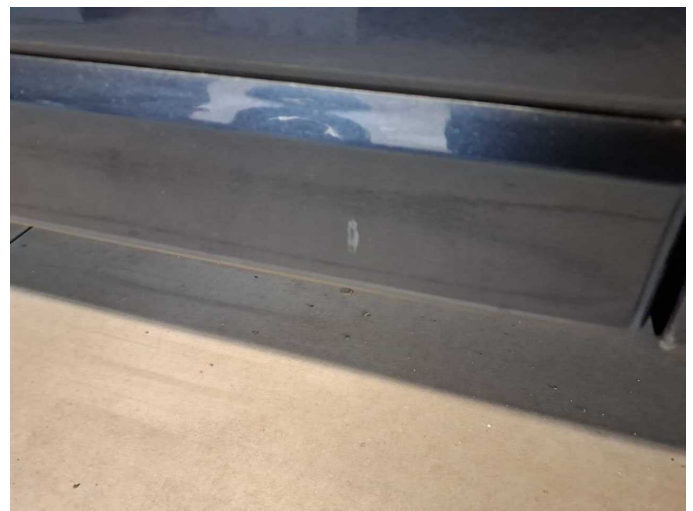
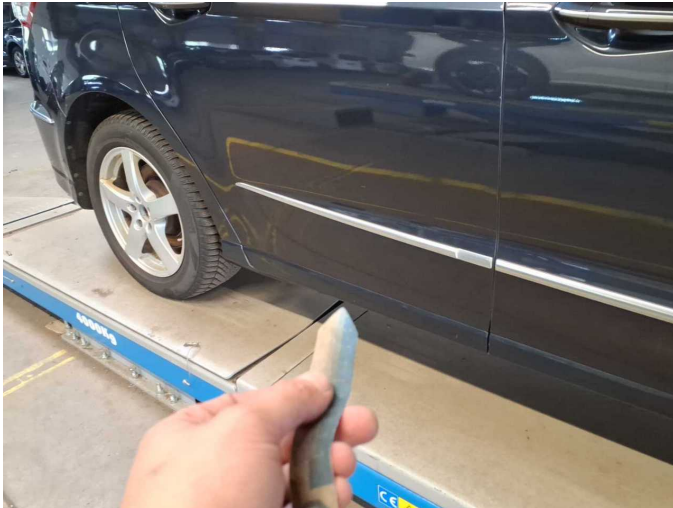
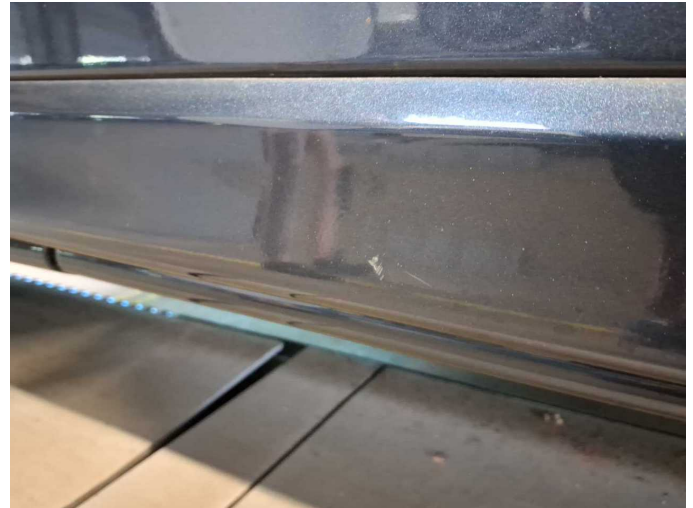
Damage 7: Door - rear right side: Brightware - lower - Scratch(es) - Smart repair

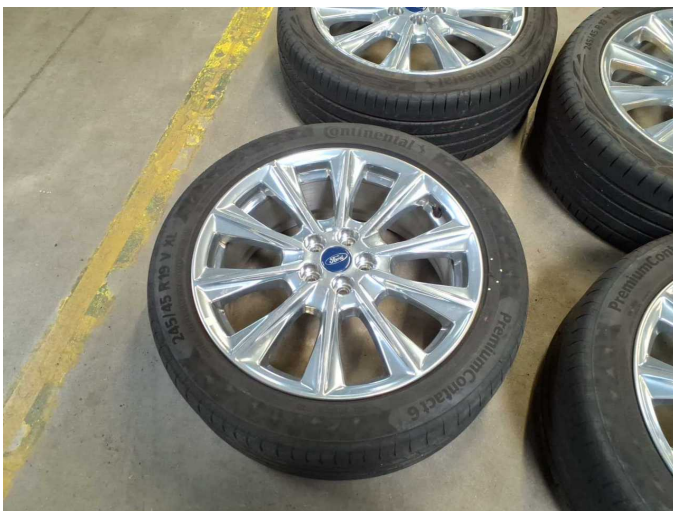
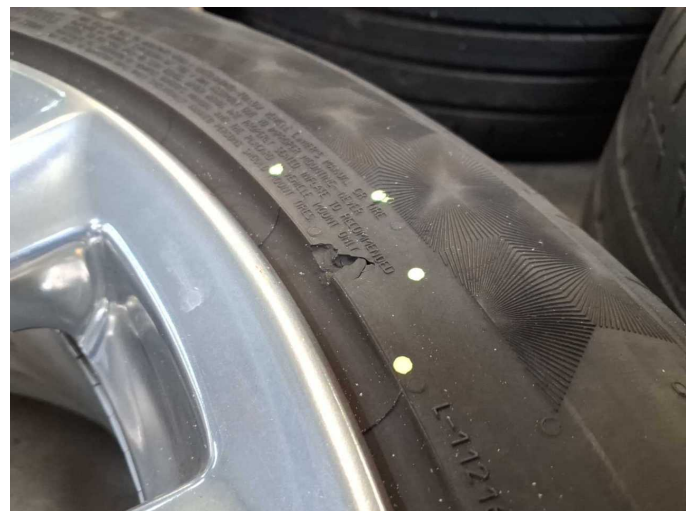
Damage 8: 2nd wheel set: 1 tyre (Flanke) - Damaged - Replace

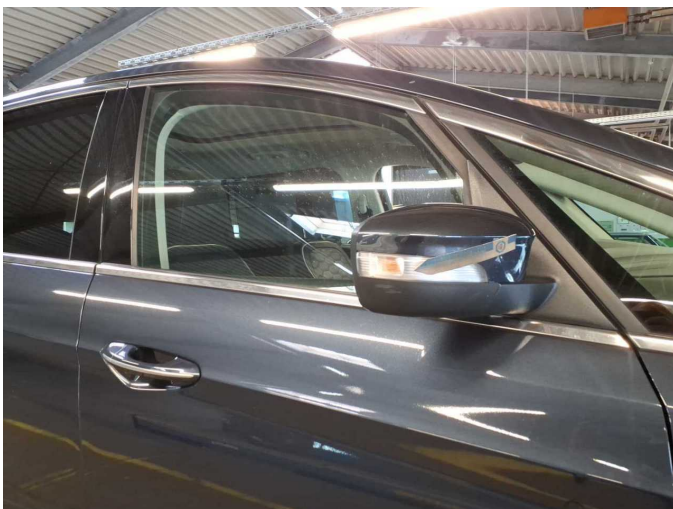
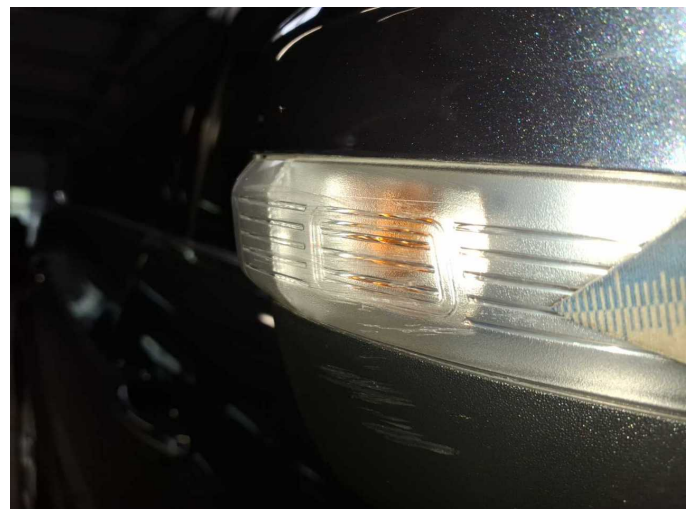
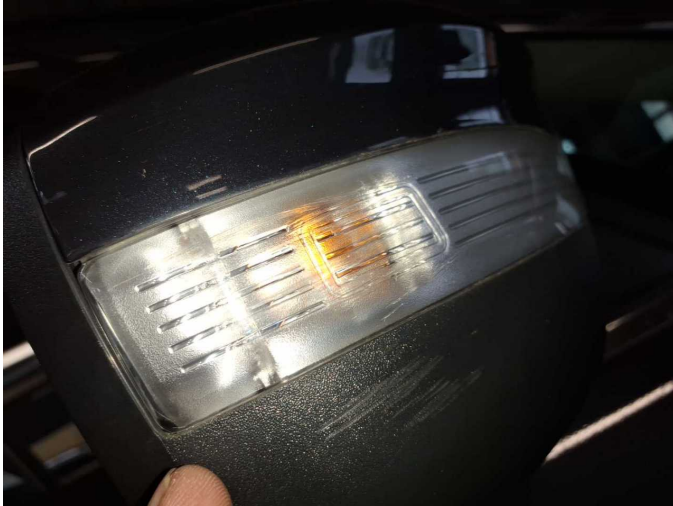
Damage 9: Wing mirror - right side: Mirror housing (+ Blinker) - Scratched - Replace

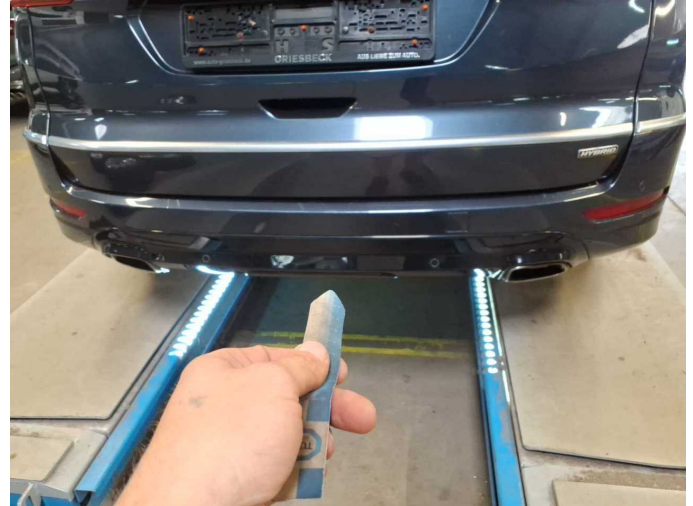
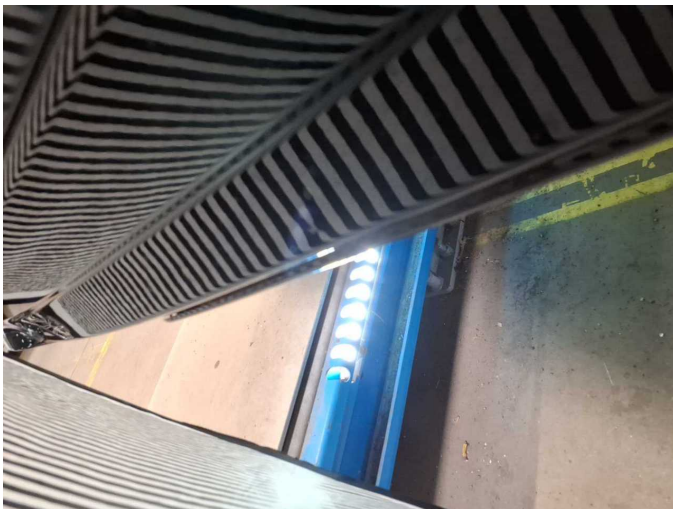
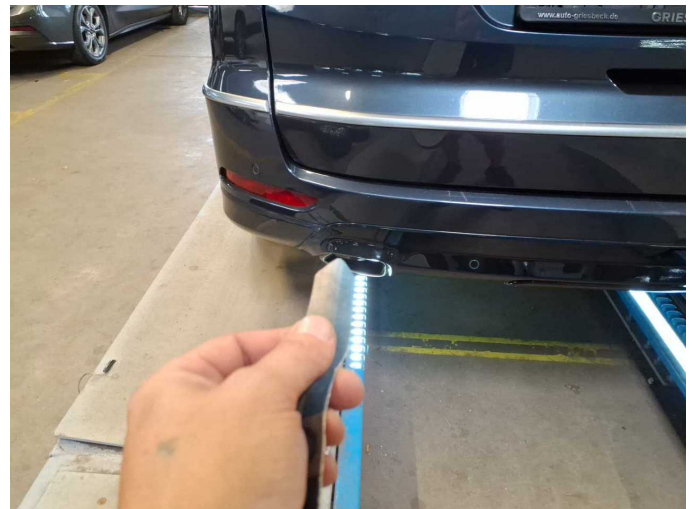
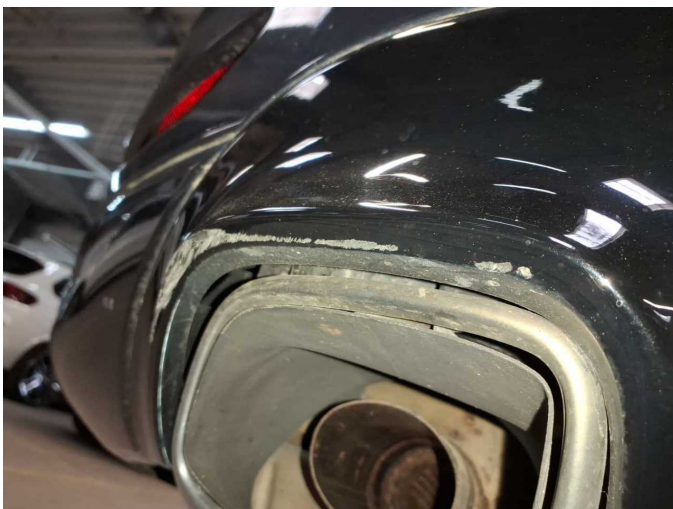
Damage 10: Rear bumper: Spoiler (Kratzer) - Deformed - Replace

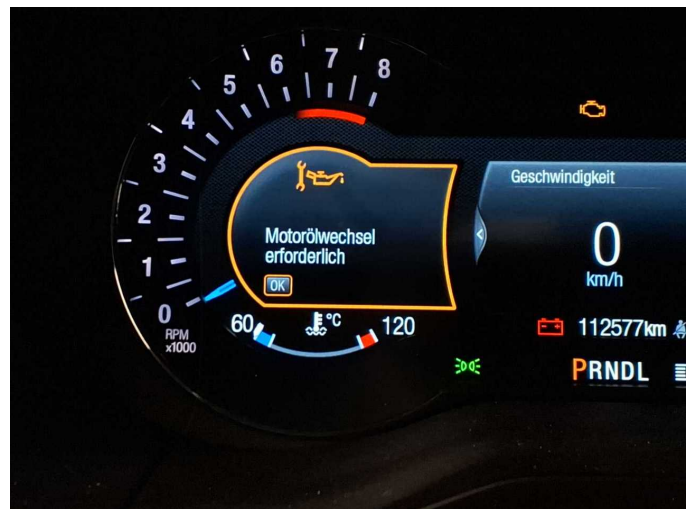
Damage 11: Misc.: Inspection / maintenance - Due - Perform

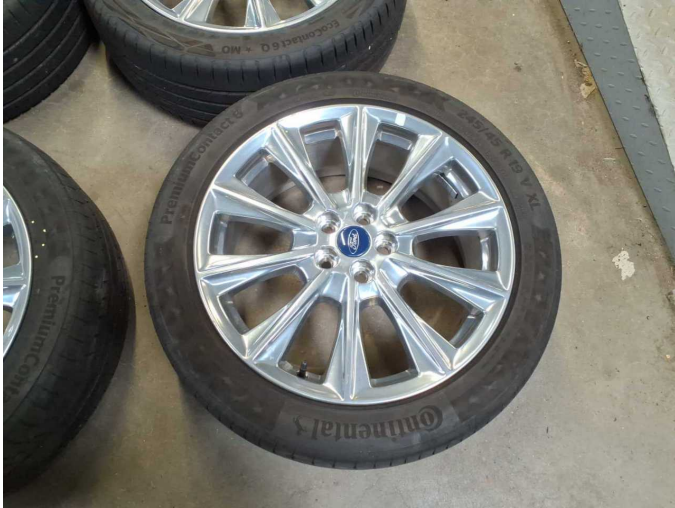
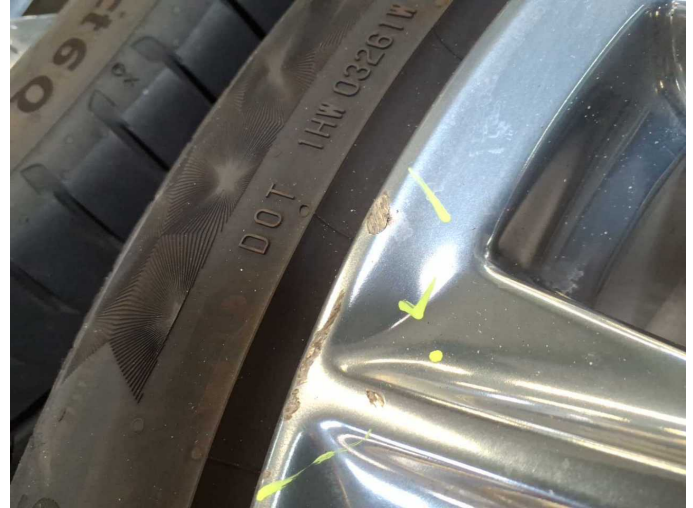
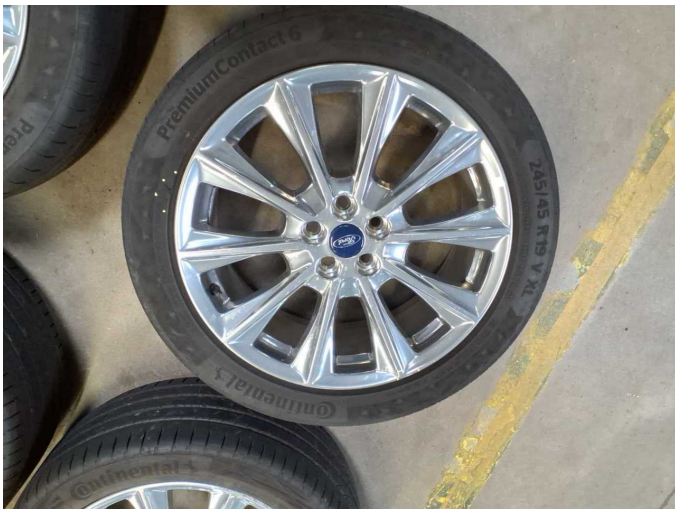
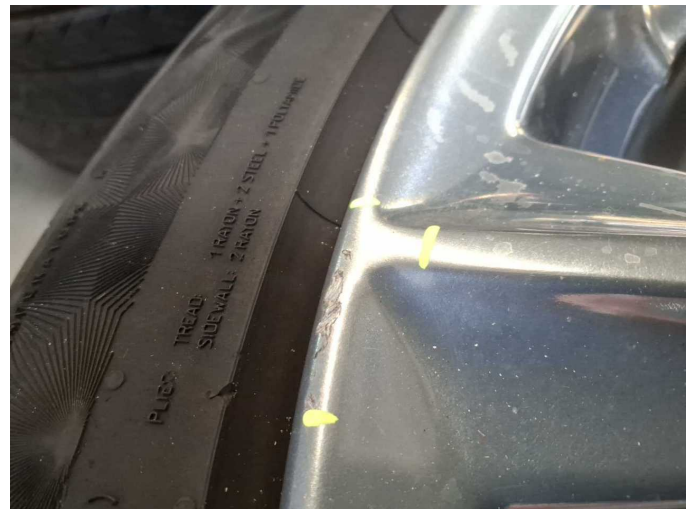
Damage 12: 2nd wheel set: 2 alloy rims - Scratch(es) - Loss in value

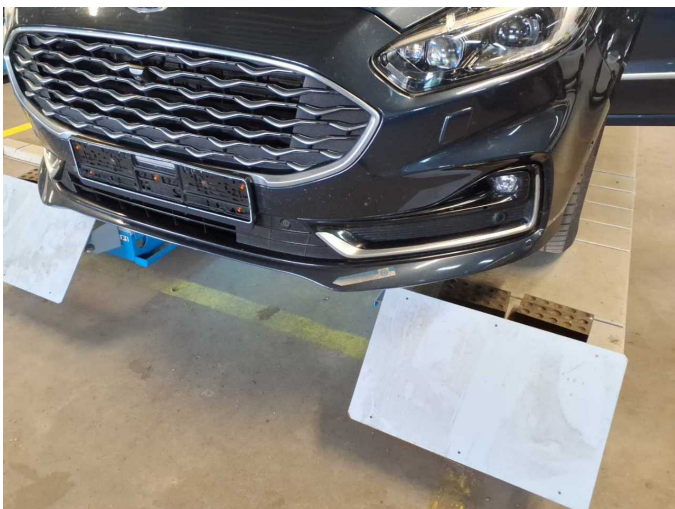
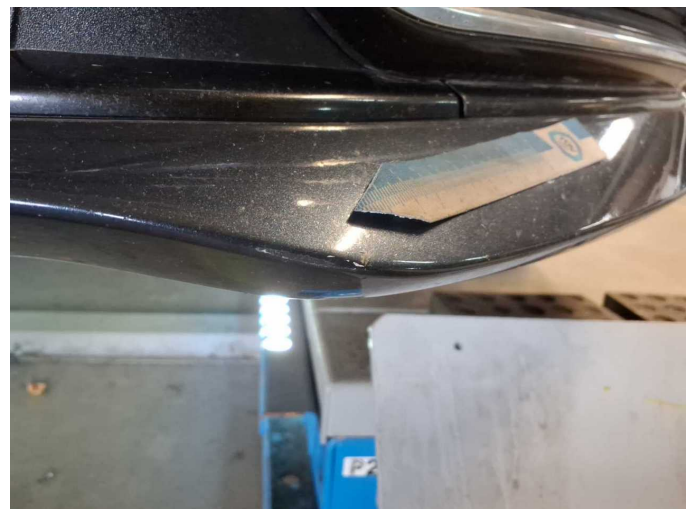
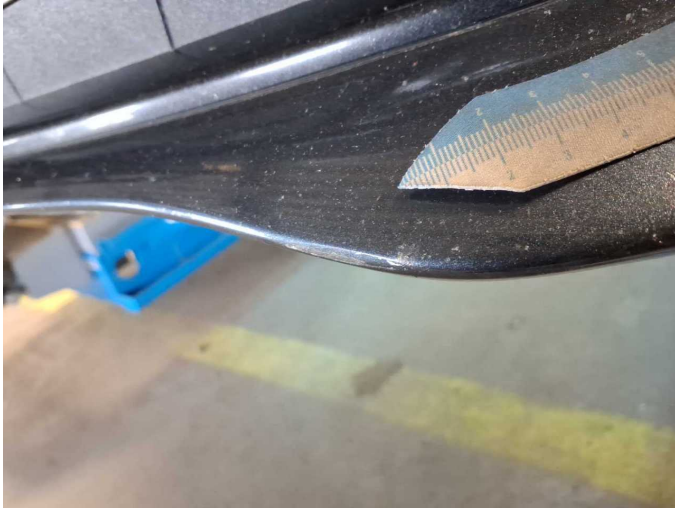
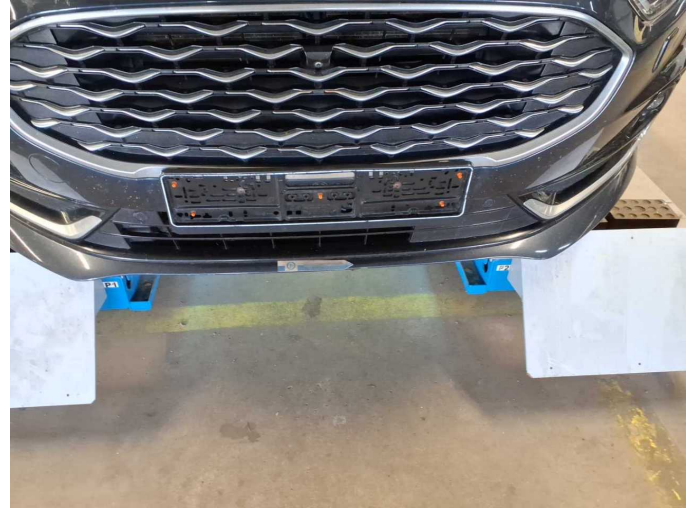
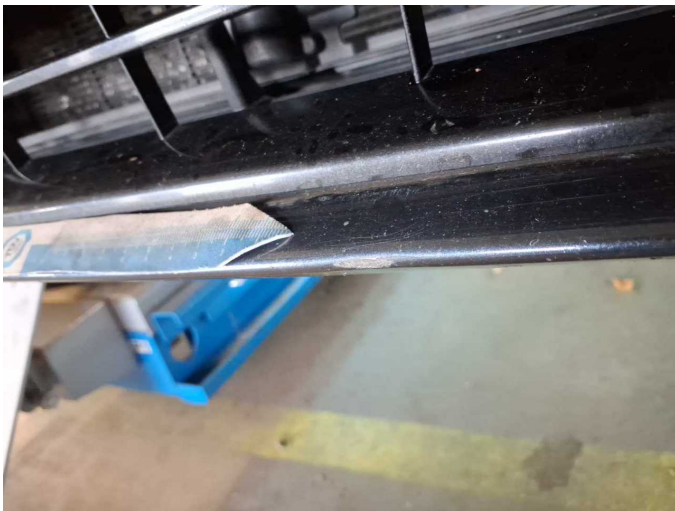
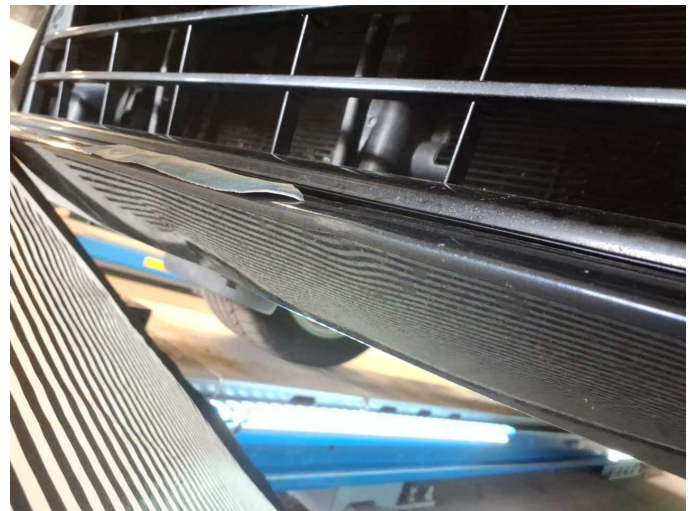
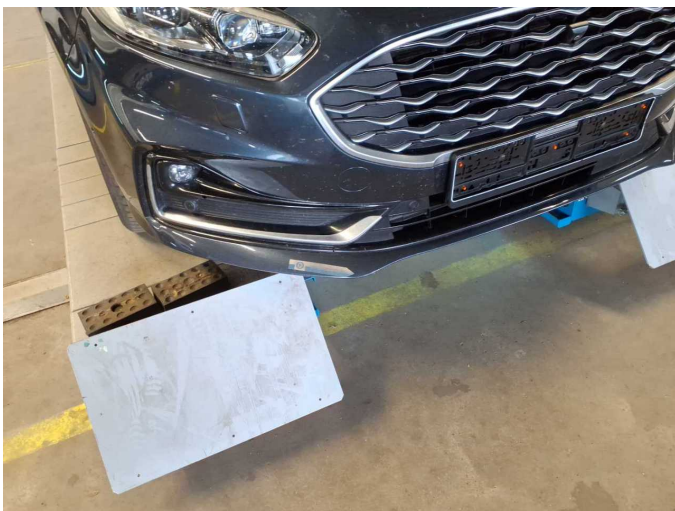
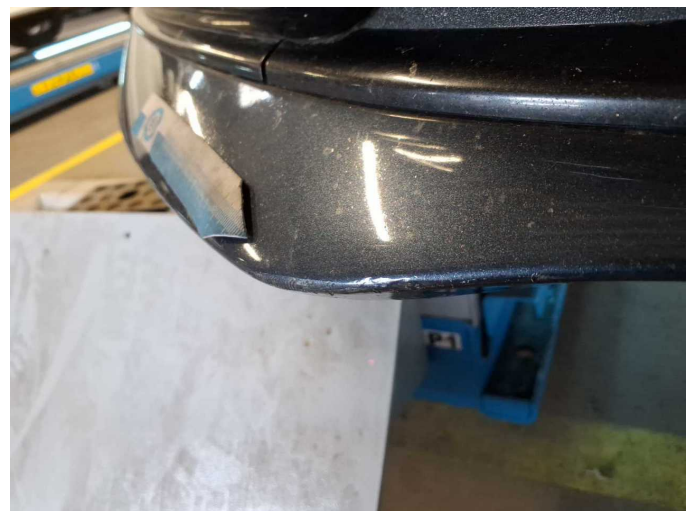
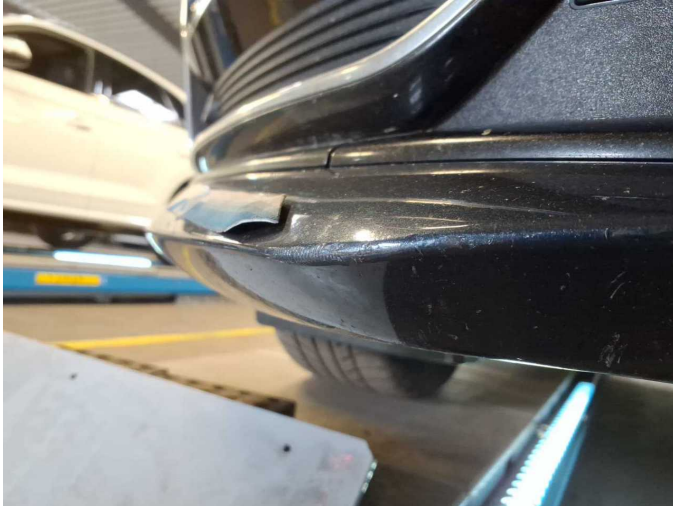
Damage 13: Front bumper: Spoiler - Scratched - Paint

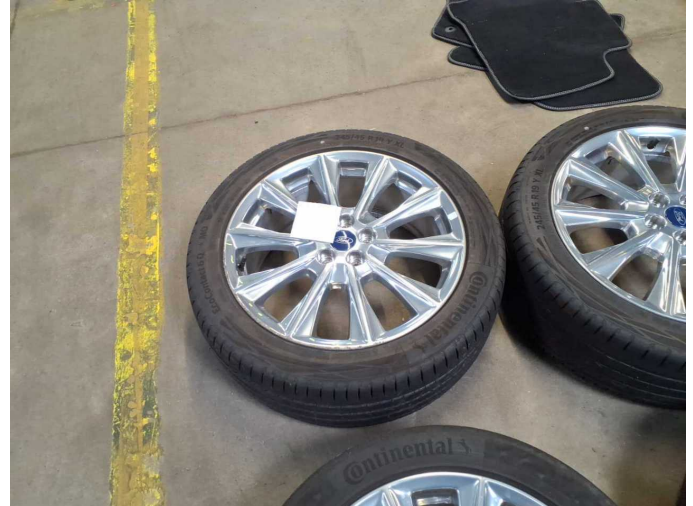
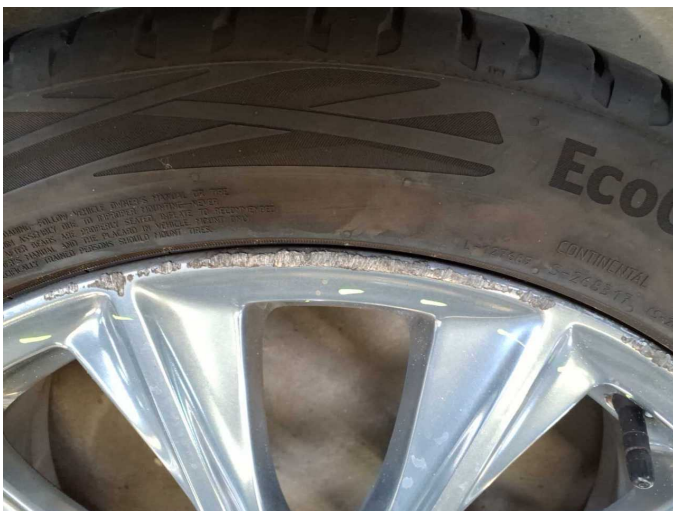
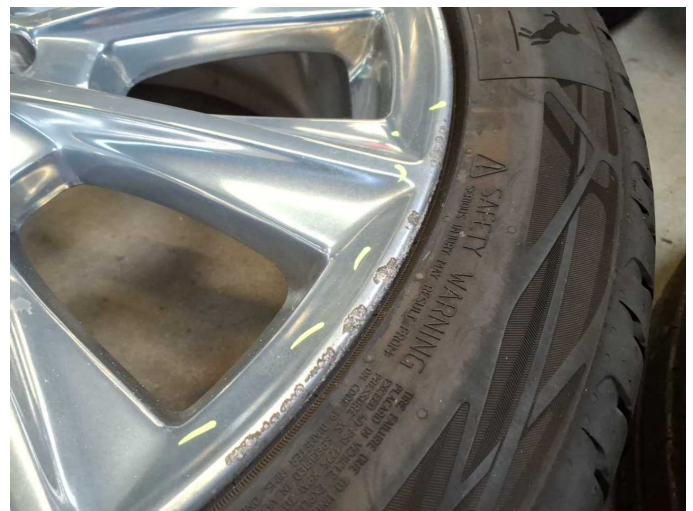
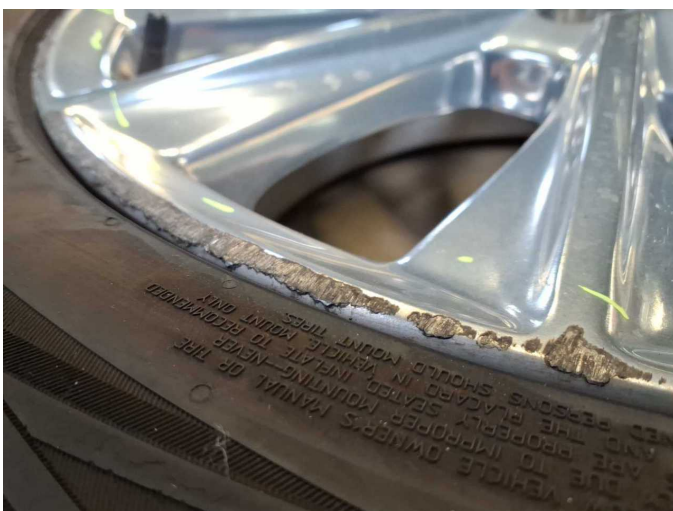
Damage 14: 2nd wheel set: 1 alloy rim (Materialabtrag) - Scratched - Replace

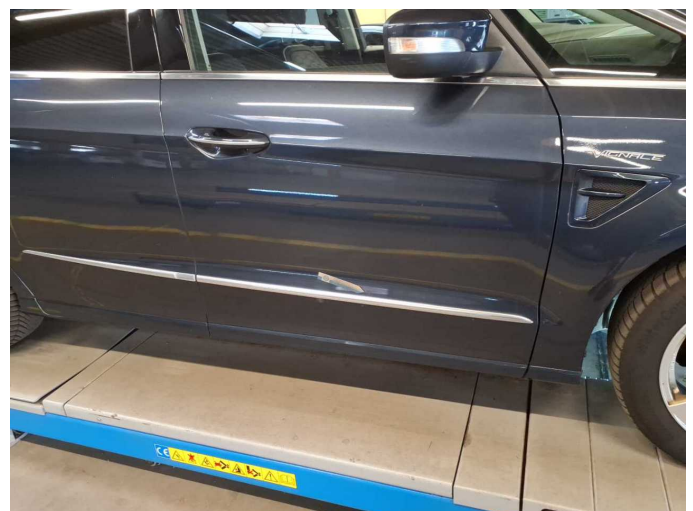
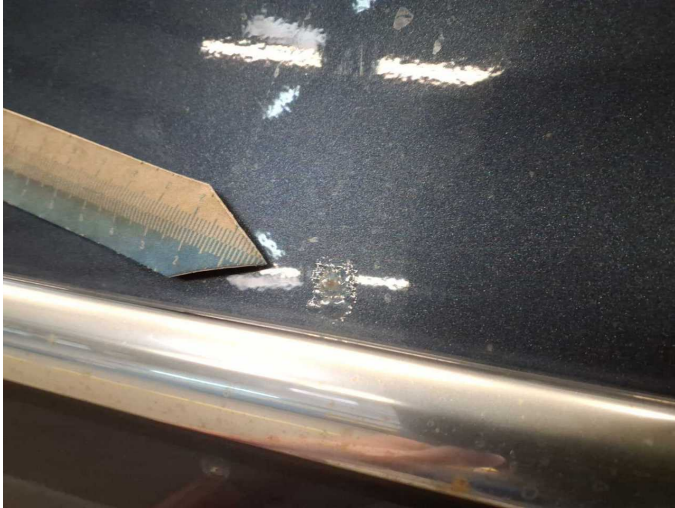
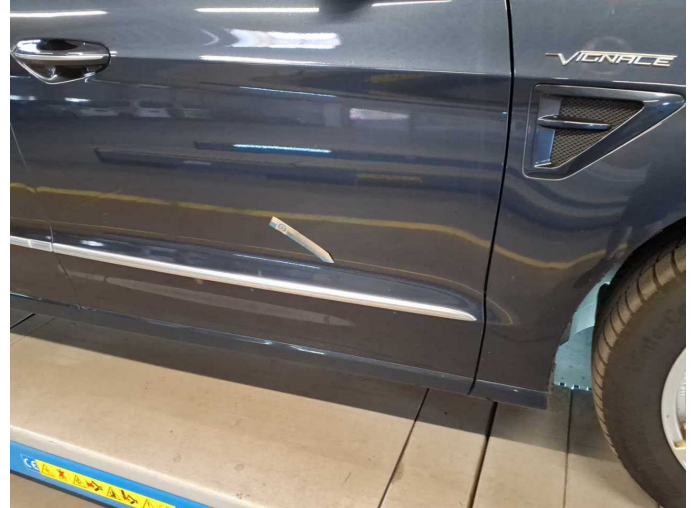
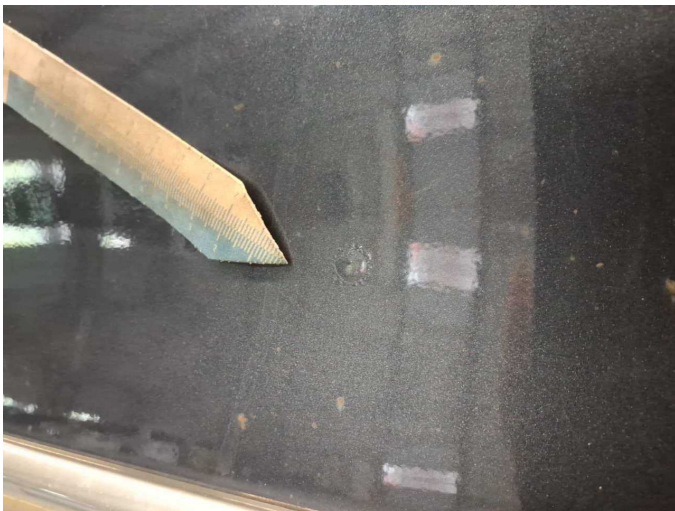
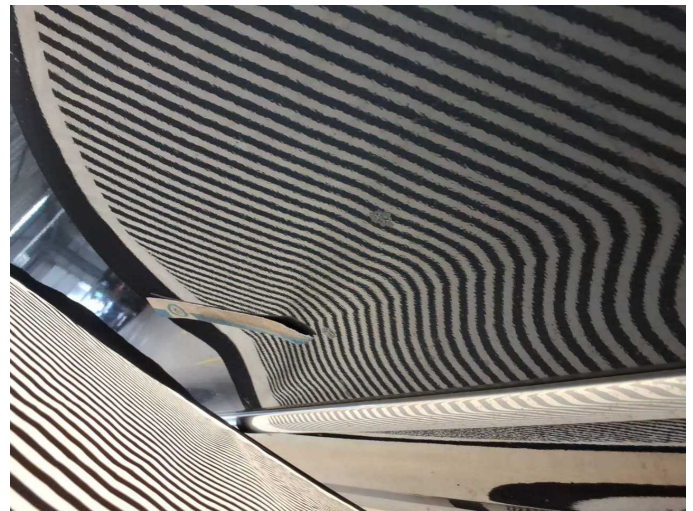
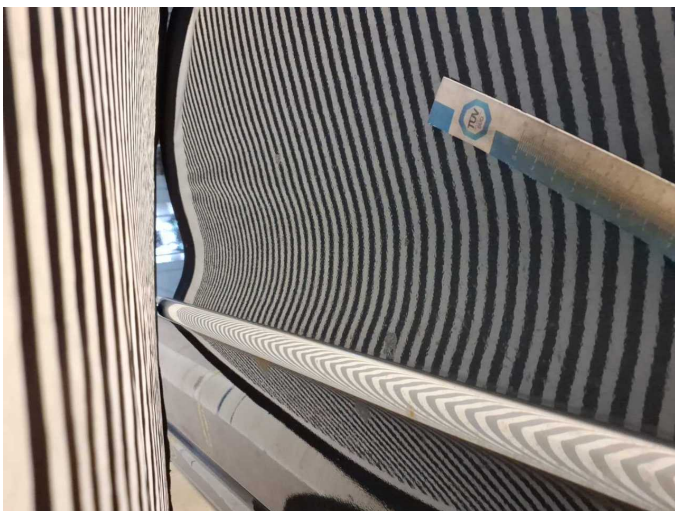
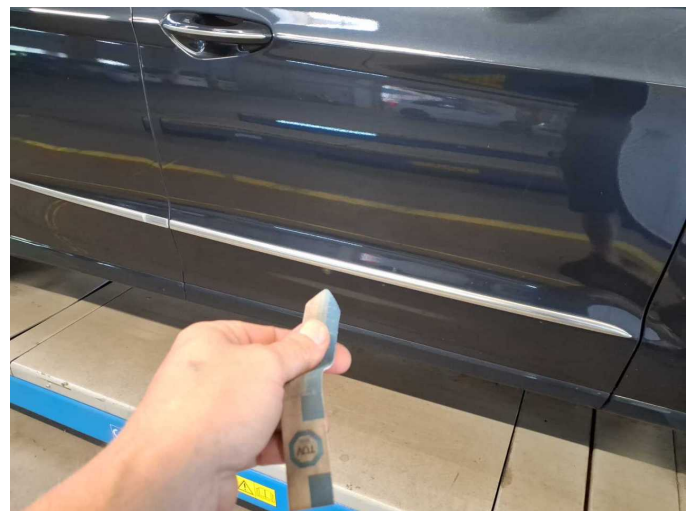
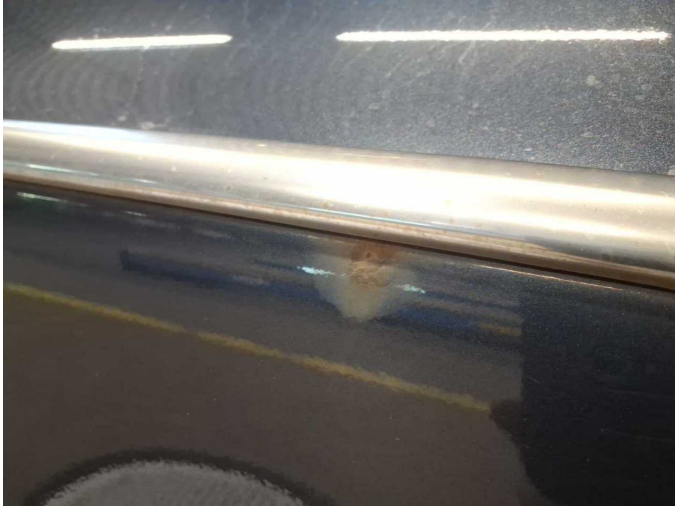
15	Door - front right side	Door - Corrosion - Repair and paint
16	Bonnet	Bonnet (Sandstrahleffekt) - Stone chips - Paint
17	Rear bumper	Rear bumper (Kratzer) - Deformed - Repair and paint

Damage 15: Door - front right side: Door - Corrosion - Repair and paint

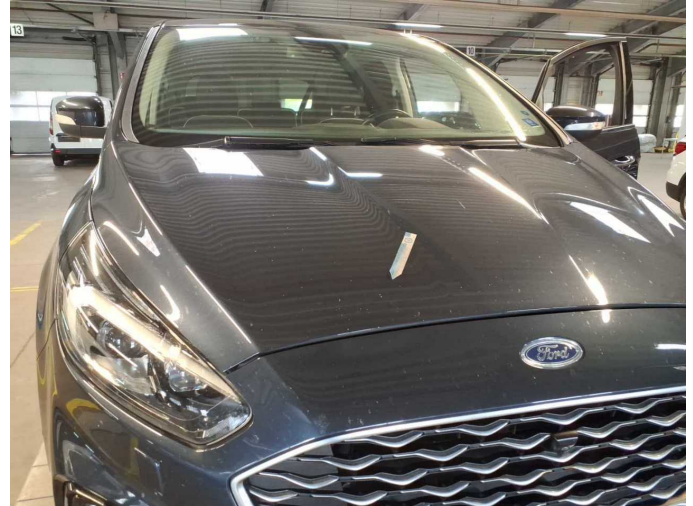
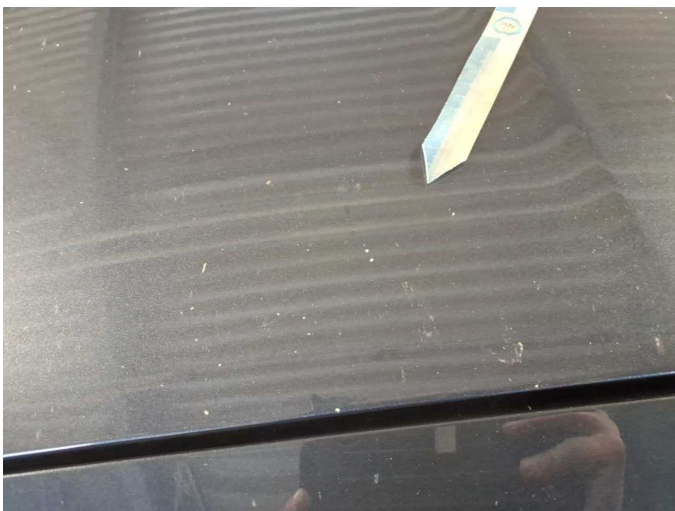
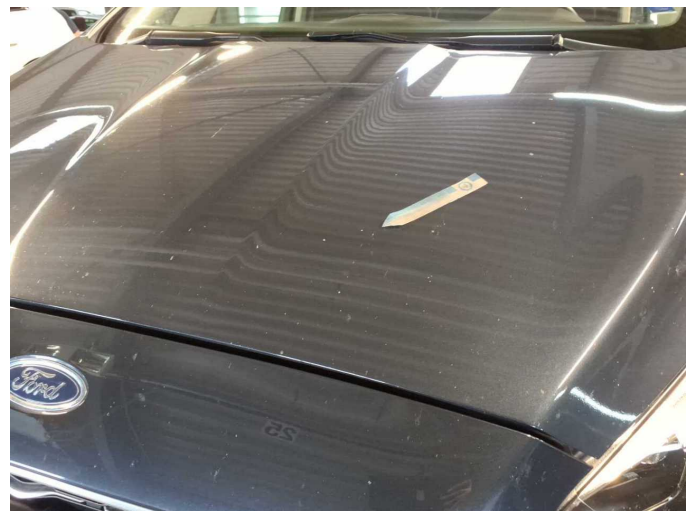
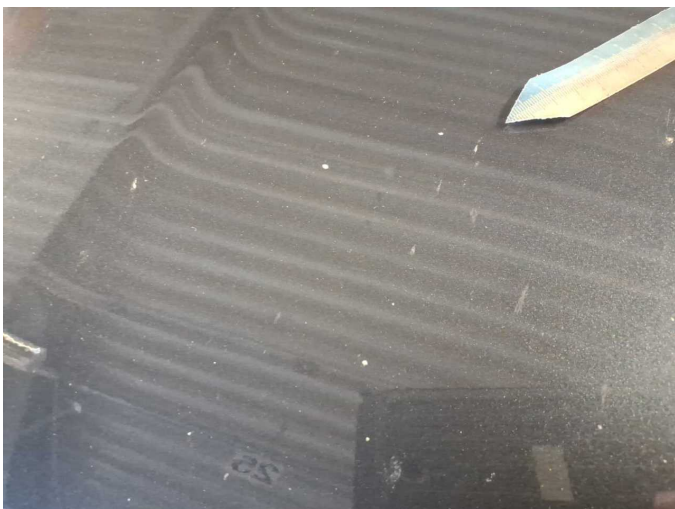
Damage 16: Bonnet: Bonnet (Sandstrahleffekt) - Stone chips - Paint

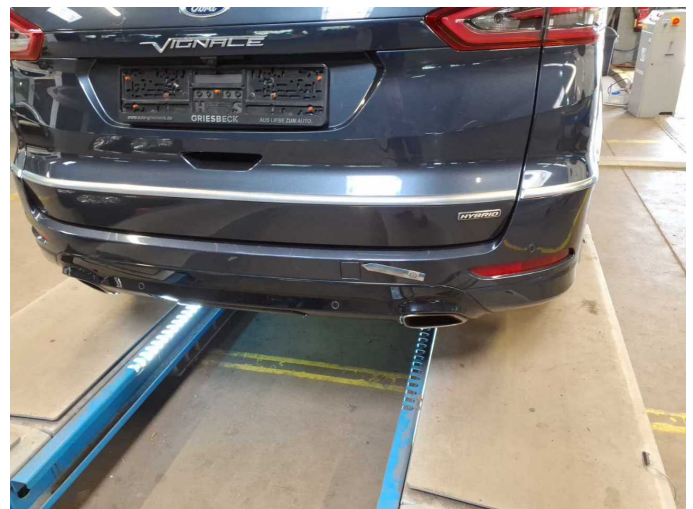
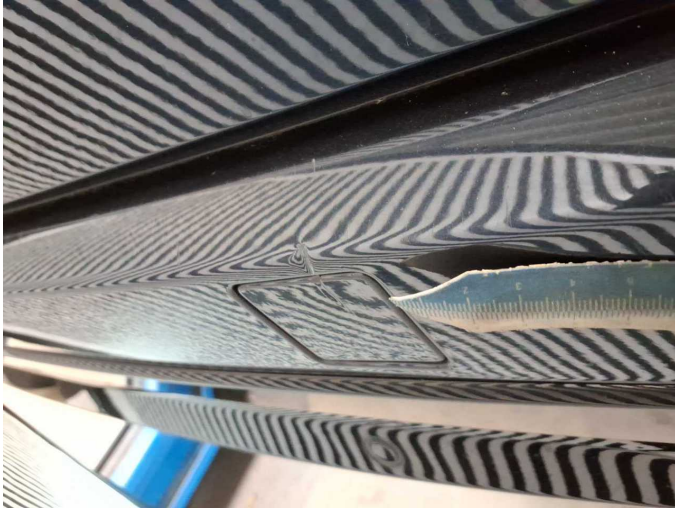
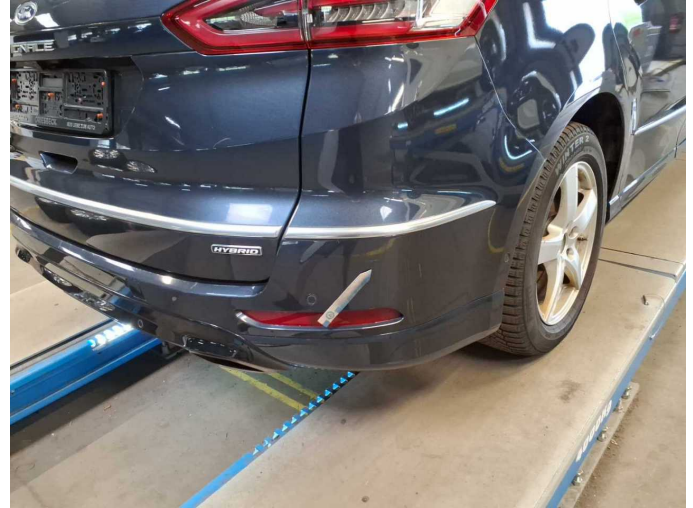
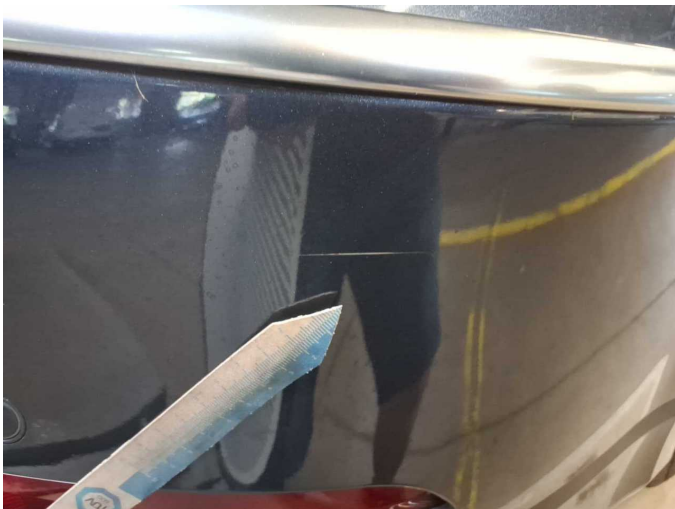
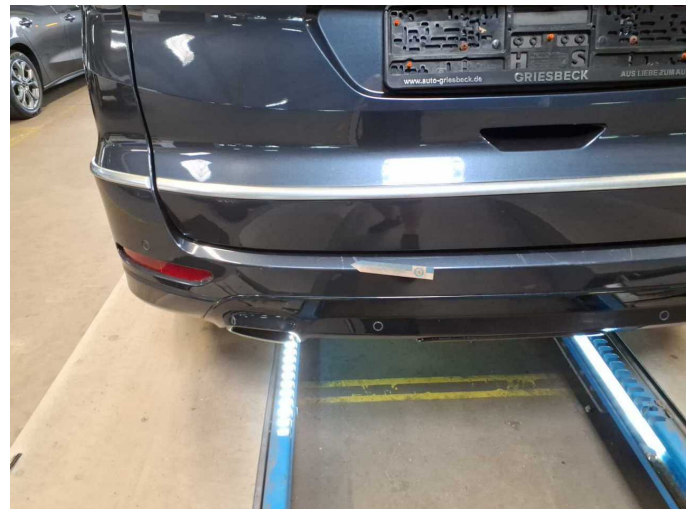
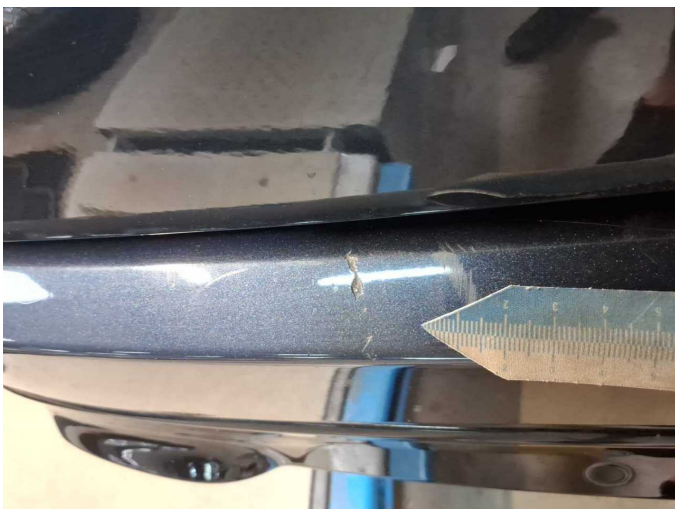
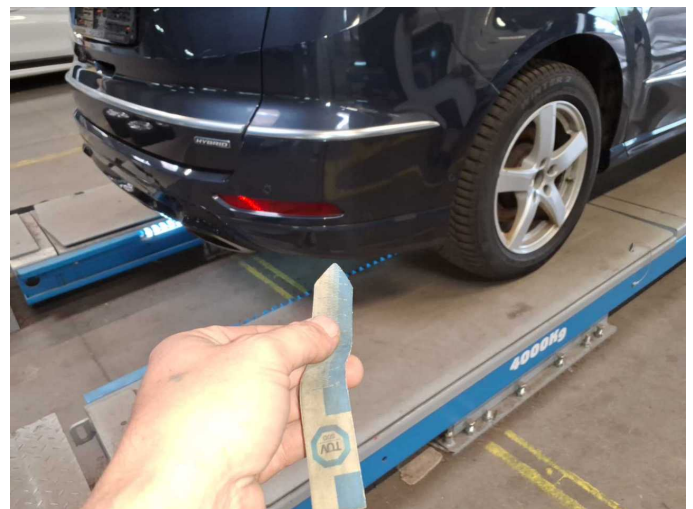
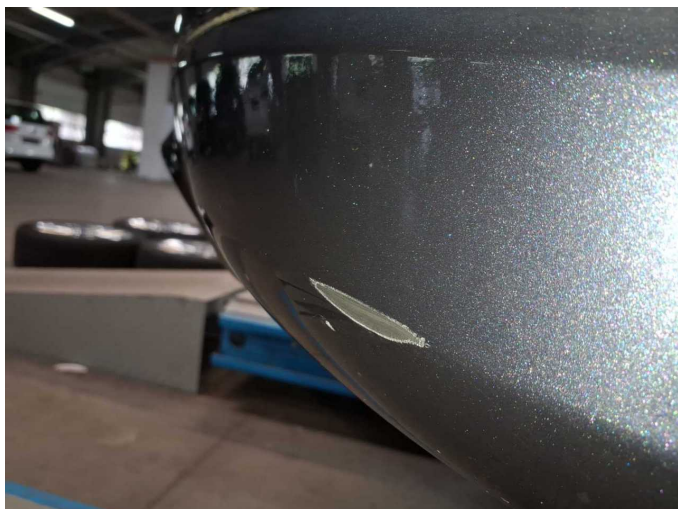
Damage 17: Rear bumper: Rear bumper (Kratzer) - Deformed - Repair and paint
