Expertise

Protocol number: 46054868
Order No. / Reference: 26542677
Inspection date: 19 Jun 2026

Manufacturer: Ford

Model: Transit Connect 230 L2 Trend

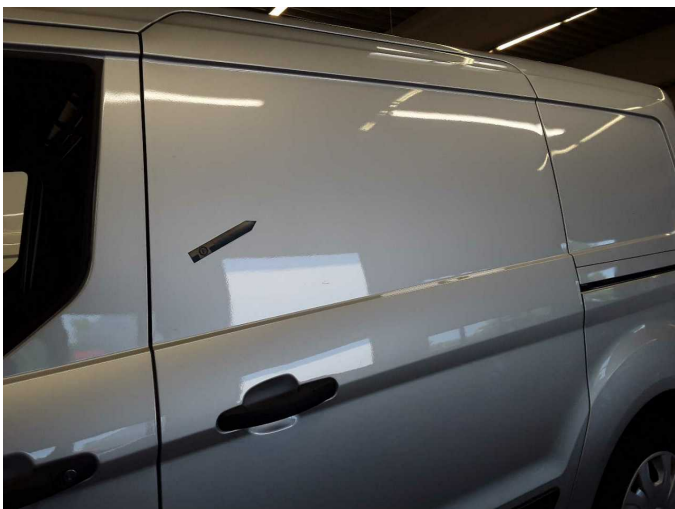
No.	Component group	Description
1	Door - rear left side	Door - dent(s) - Repair and paint
2	Front bumper	Front bumper - Scratch(es) - Smart repair
3	Bonnet	Insulation lining - Damaged - Replace
4	Interior	Cargo area floor - Damaged - Replace

Damage 1: Door - rear left side: Door - dent(s) - Repair and paint

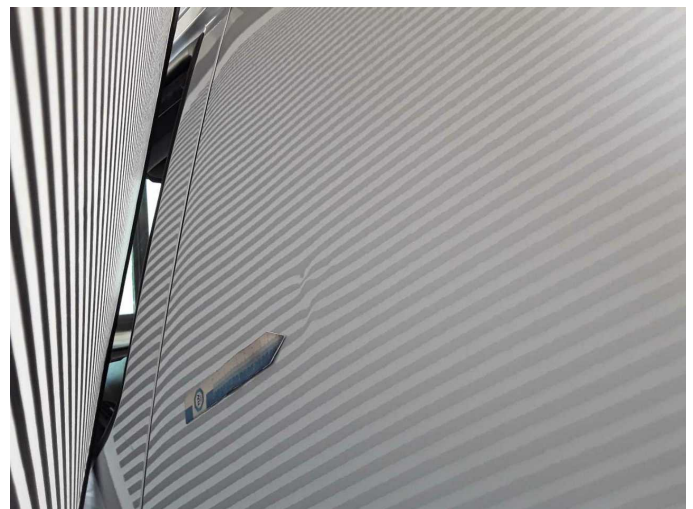
Damage 1: Door - rear left side: Door - dent(s) - Repair and paint

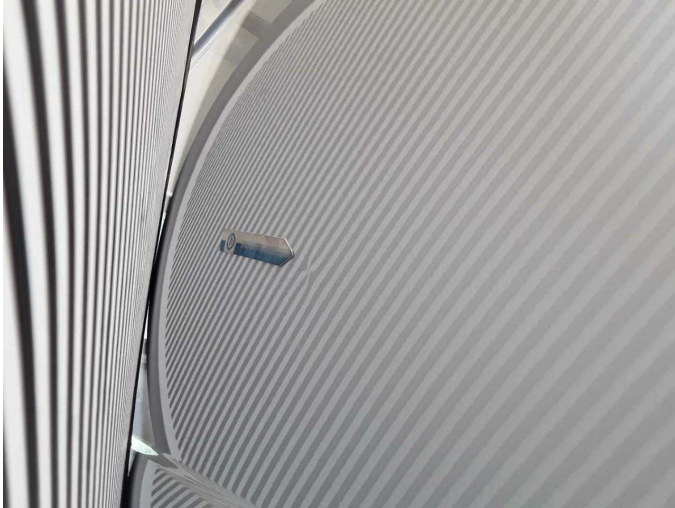
Damage 1: Door - rear left side: Door - dent(s) - Repair and paint

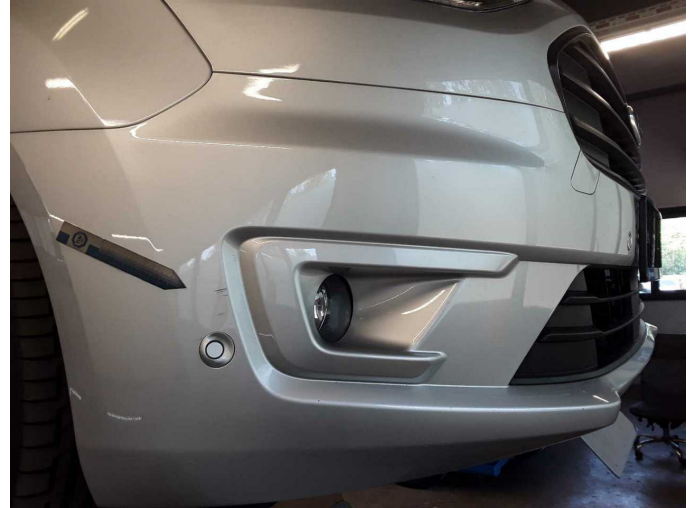
Damage 2: Front bumper: Front bumper - Scratch(es) - Smart repair

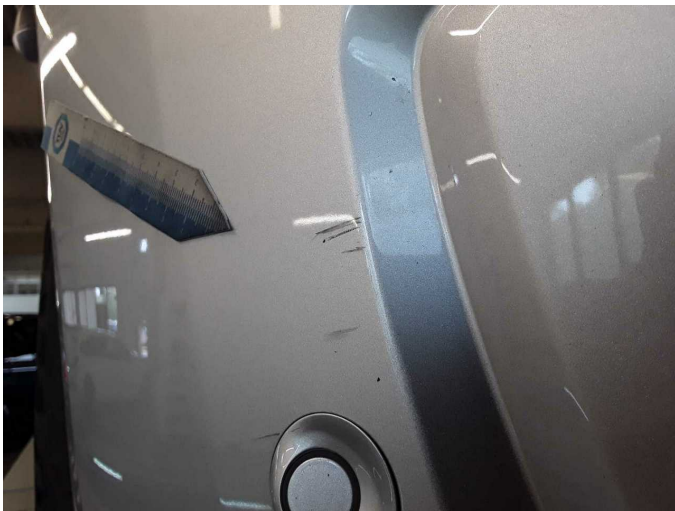
Damage 2: Front bumper: Front bumper - Scratch(es) - Smart repair

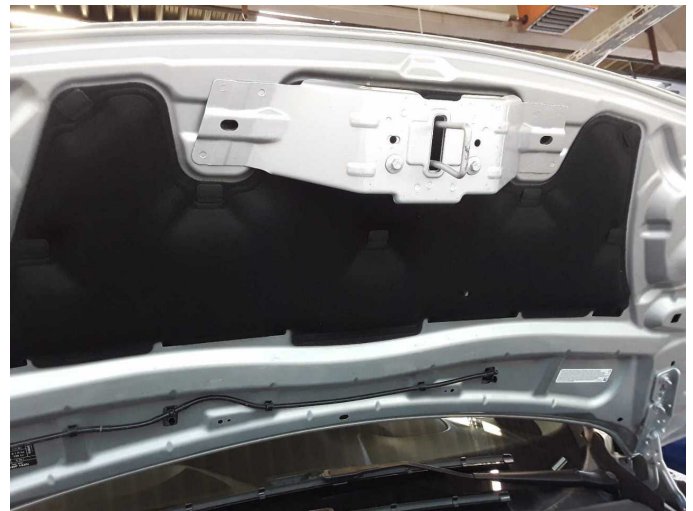
Damage 3: Bonnet: Insulation lining - Damaged - Replace

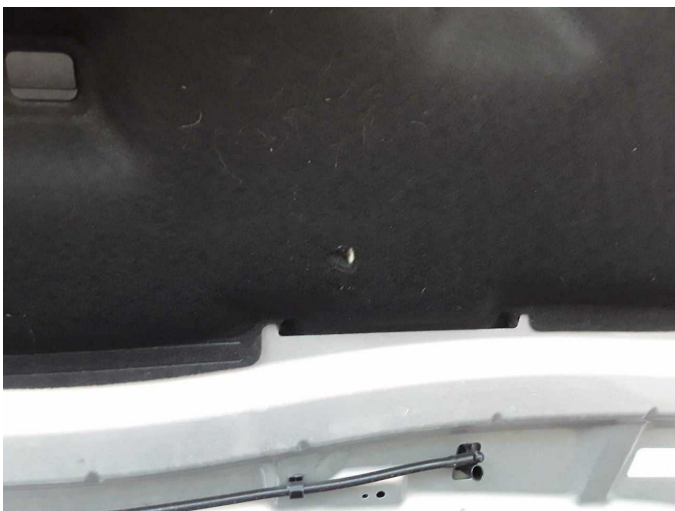
Damage 3: Bonnet: Insulation lining - Damaged - Replace

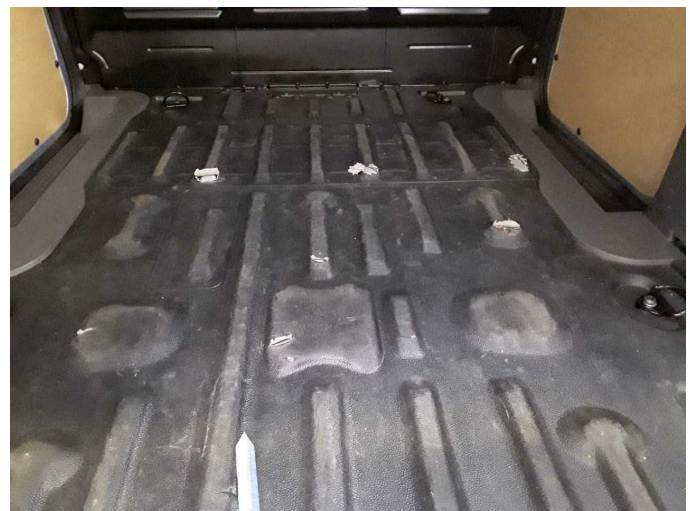
Damage 4: Interior: Cargo area floor - Damaged - Replace

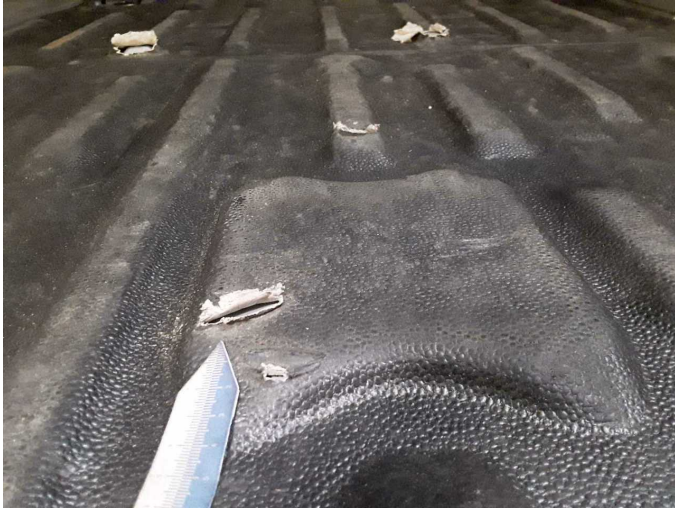
Damage 4: Interior: Cargo area floor - Damaged - Replace

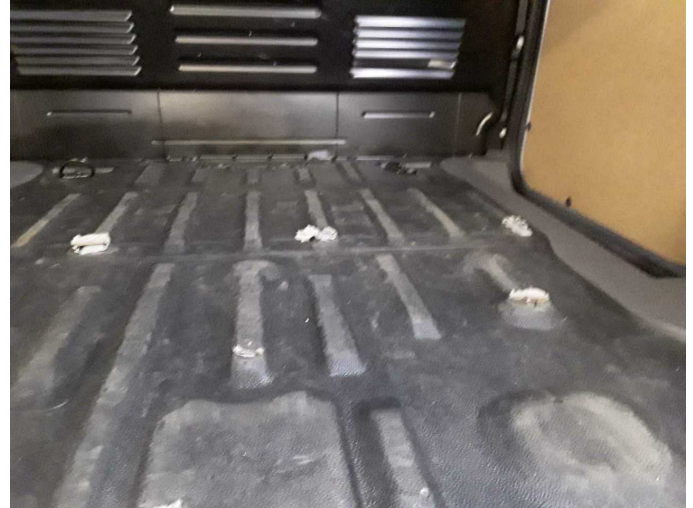
Damage 4: Interior: Cargo area floor - Damaged - Replace

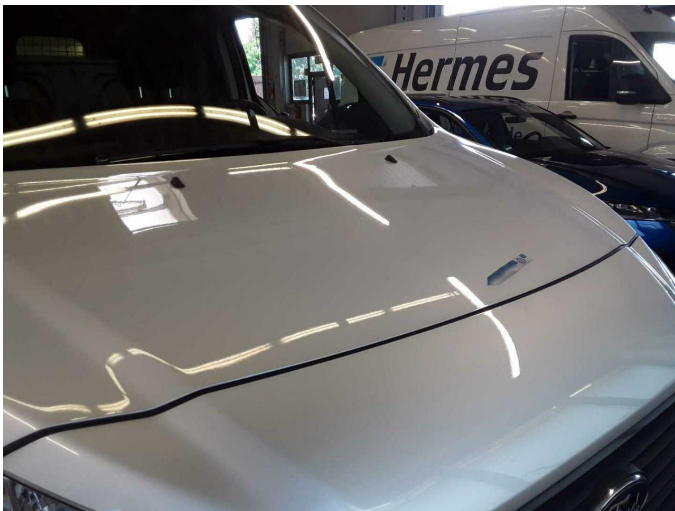
No.	Component group	Description
1	Bonnet	Bonnet - Stone chips - No deduction
2	Vehicle glazing	Windscreen - Stone chips - No deduction
3	Interior	Interior - Scratch(es) - No deduction

Wear and tear 1: Bonnet: Bonnet - Stone chips - No deduction

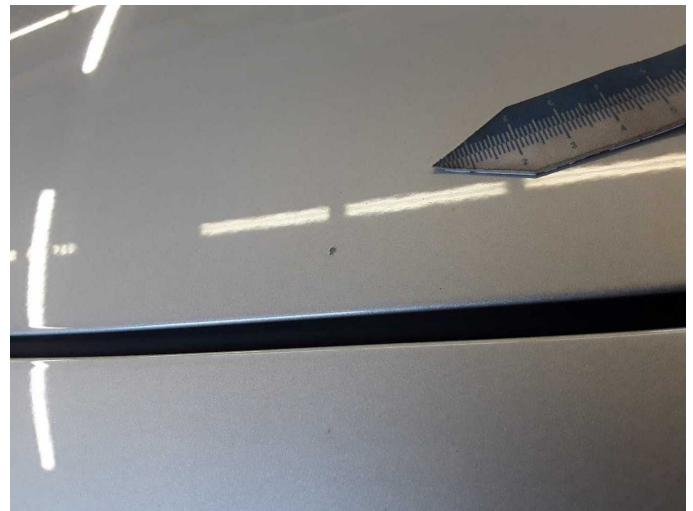
Wear and tear 1: Bonnet: Bonnet - Stone chips - No deduction
