Expertise

Protocol number: 46862319  
Order No. / Reference: 26759313  
Inspection date: 4 Aug 2026

| Manufacturer: Opel | Model: Combo Cargo DoKa 1.5 D L2 EHZ |
| VIN: W0VEDYHT1RJ813206 | |

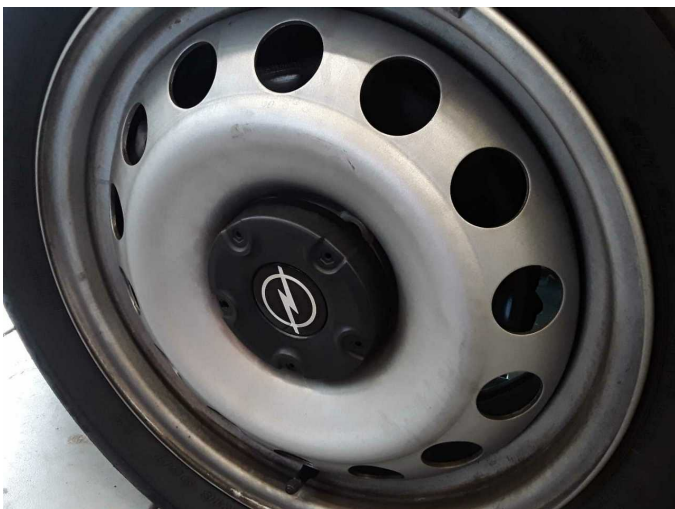
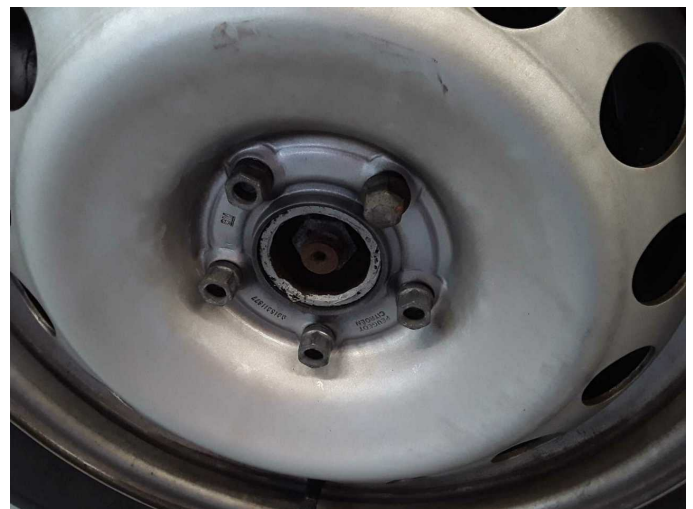
| No. | Component group | Description |
|---|---|---|
| 1 | Wheel / tyres | Wheel rim - front left side (Falsche Schraube) - Differs from the original configuration - Replace |

**Damage 1:** Wheel / tyres: Wheel rim - front left side (Falsche Schraube) - Differs from the original configuration - Replace

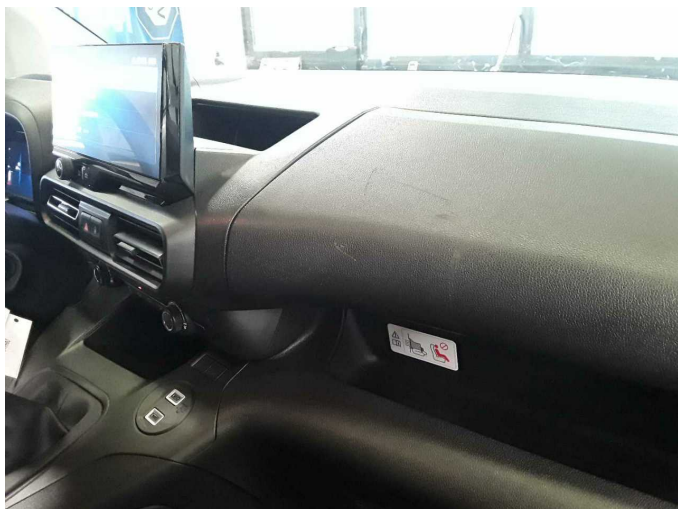
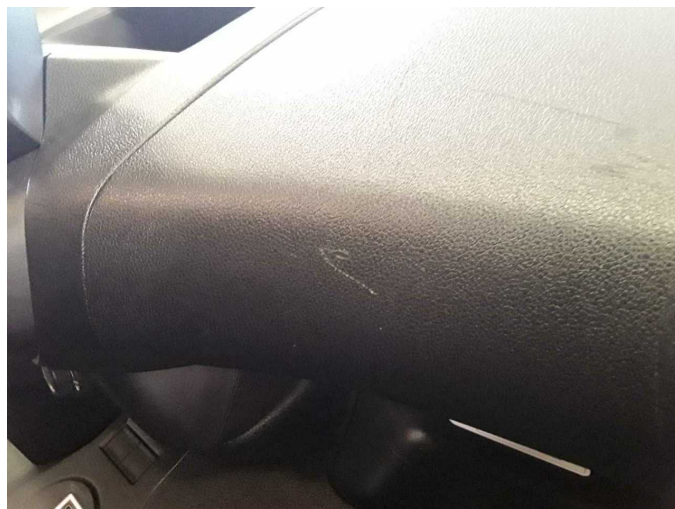
| No. | Component group | Description |
|---|---|---|
| 2 | Instrument panel | Glove box lid - Scratched - Smart repair |

**Damage 2:** Instrument panel: Glove box lid - Scratched - Smart repair

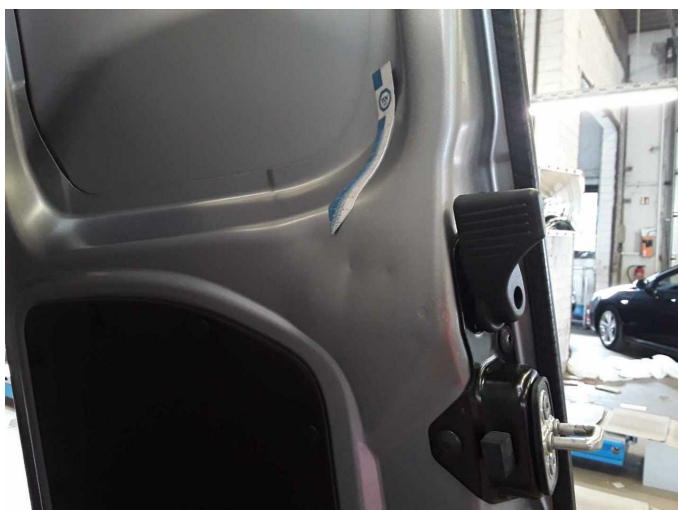
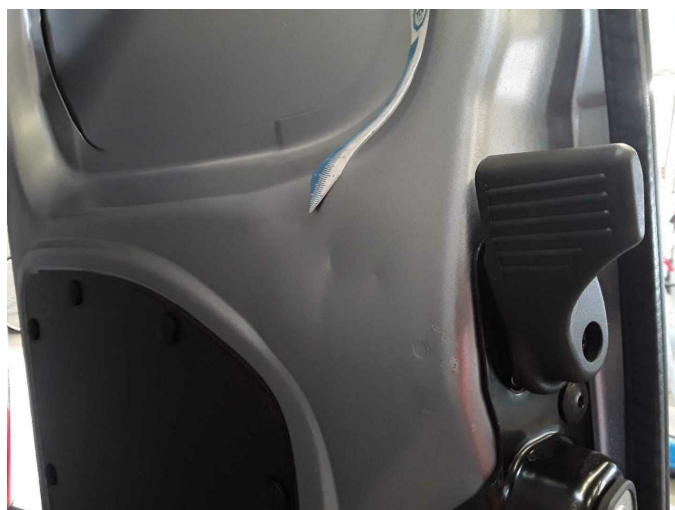
| No. | Component group | Description |
|---|---|---|
| 3 | Boot lid / rear door | Rear door - right side - Dent / paintcoat damage - Smart repair |

**Damage 3:** Boot lid / rear door: Rear door - right side - Dent / paintcoat damage - Smart repair

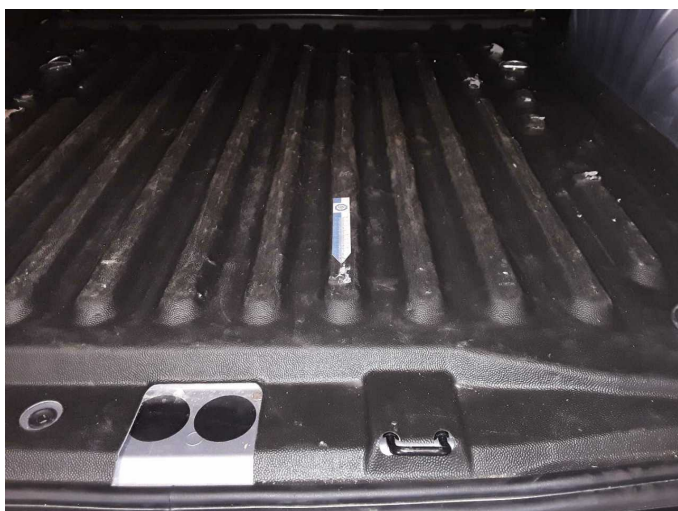
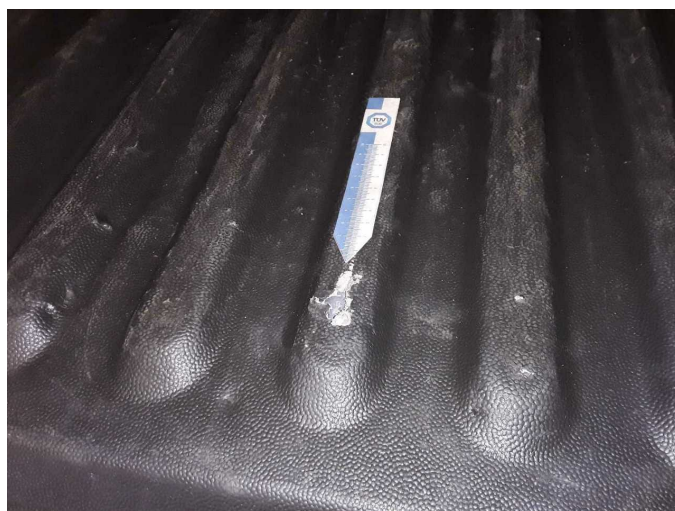
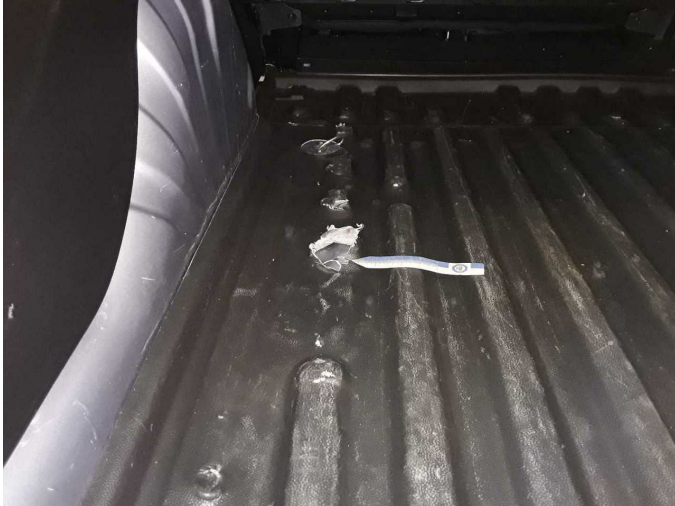
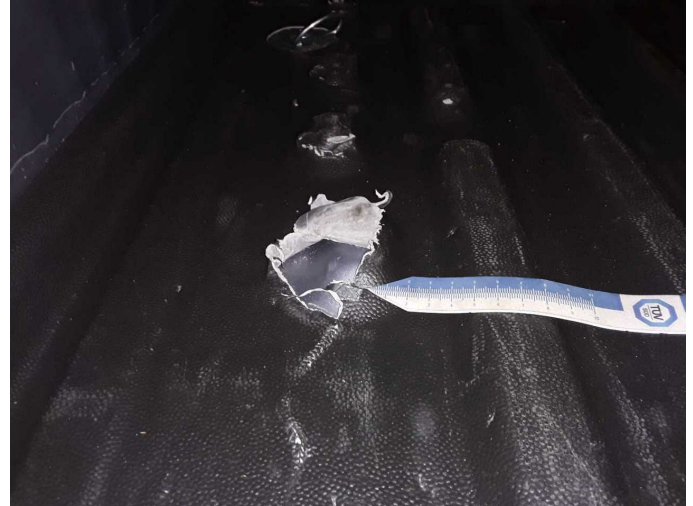
| No. | Component group | Description |
|---|---|---|
| 4 | Interior | Cargo area floor - Broken / torn - Loss in value |

**Damage 4:** Interior: Cargo area floor - Broken / torn - Loss in value

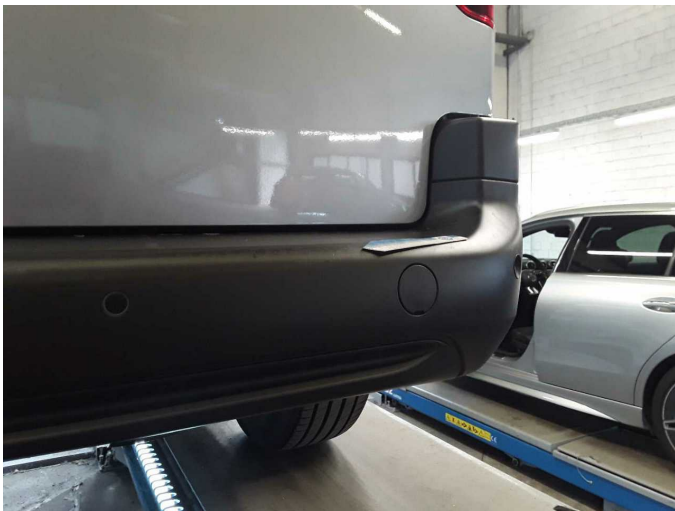
| No. | Component group | Description |
|---|---|---|
| 3 | Rear bumper | Rear bumper - Scratched - No deduction |

**Wear and tear 3:** Rear bumper: Rear bumper - Scratched - No deduction

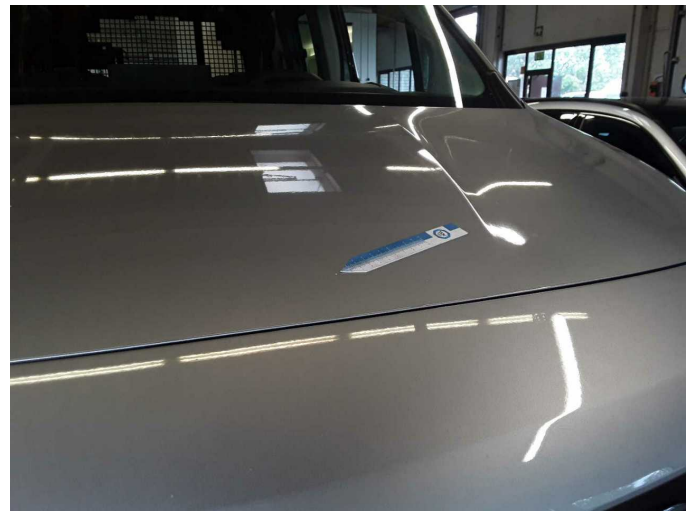
| No. | Component group | Description |
|---|---|---|
| 4 | Bonnet | Bonnet - Stone chips - No deduction |

**Wear and tear 4:** Bonnet: Bonnet - Stone chips - No deduction
