Expertise

Protocol number: 45920655
Order No. / Reference: 26584728
Inspection date: 12 Jun 2026

Manufacturer: Ford

Model: Transit Connect 220 L1 LKW S&S Autm. Trend

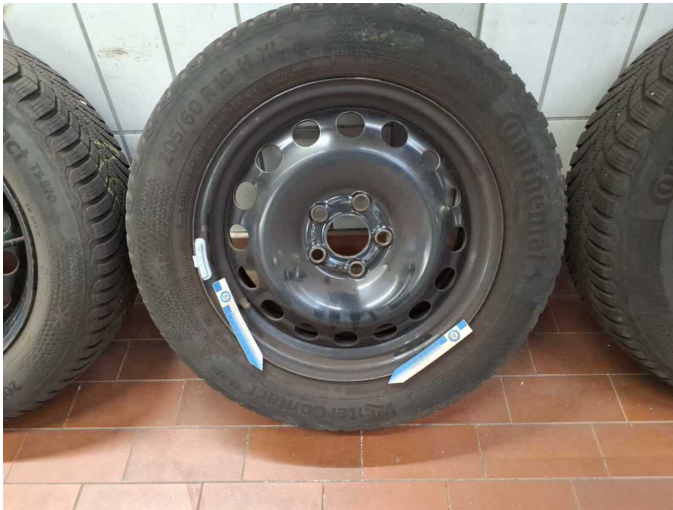
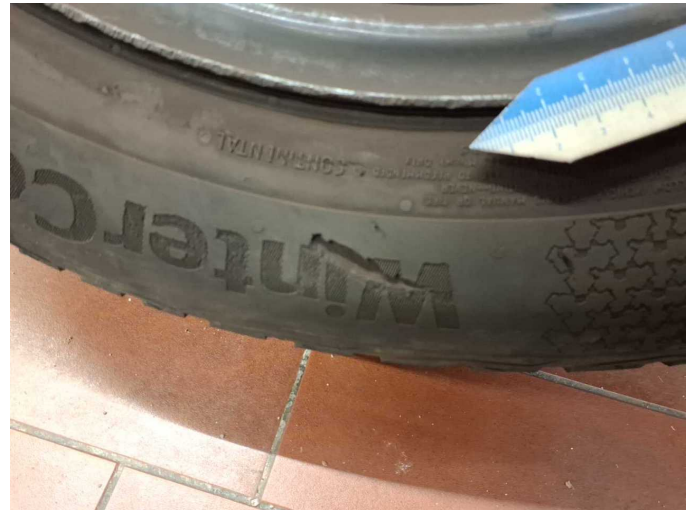
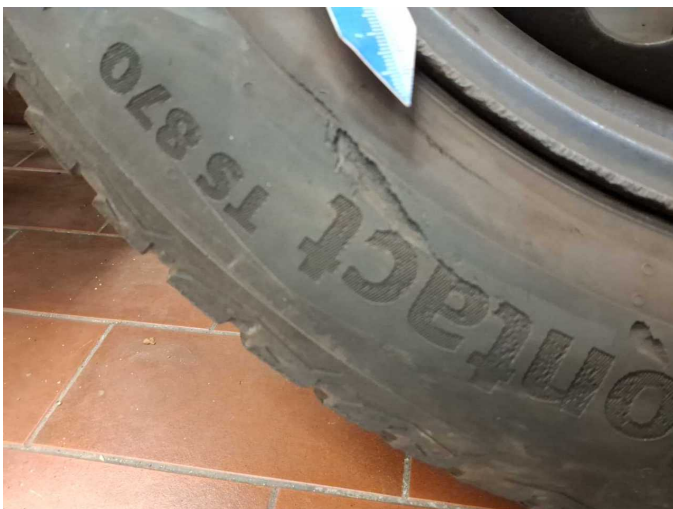
Damage 1: 2nd wheel set: 1 tyre - Porous / cracked - No deduction

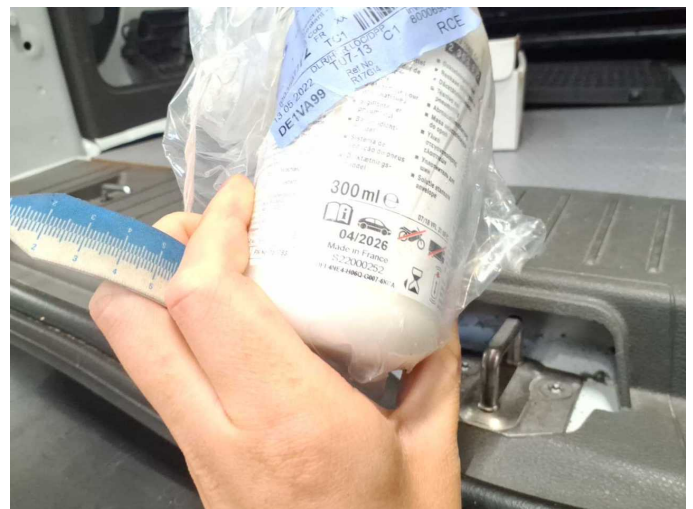
Damage 2: Equipment: Tirefit filler - Due - Replace

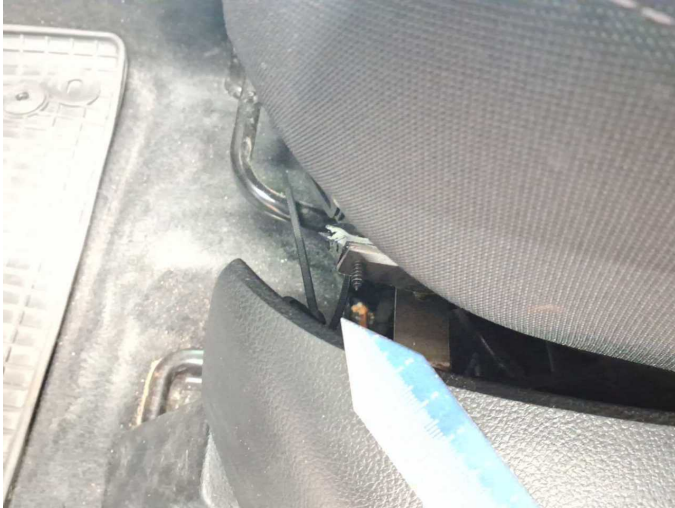
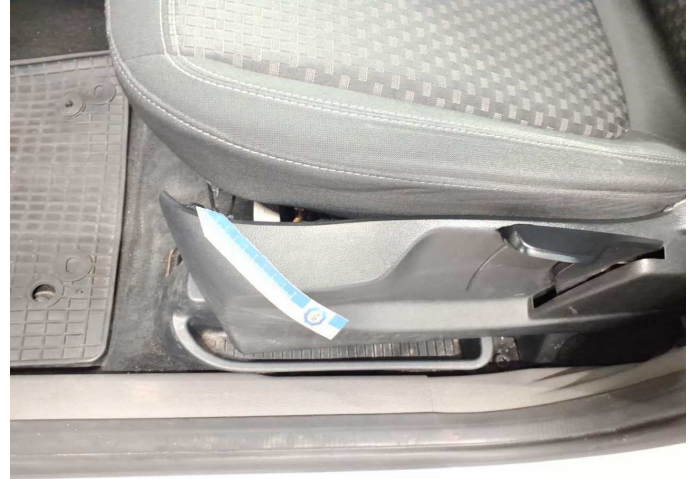
Damage 3: Seat - front: Seat base trim - left side - Broken / torn - Replace

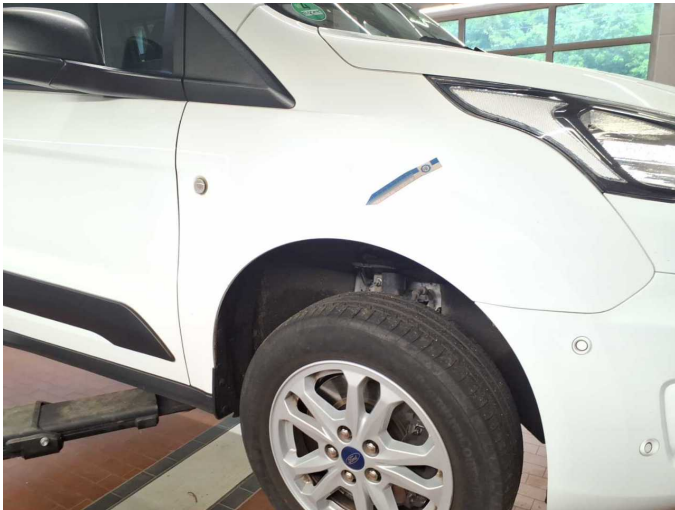
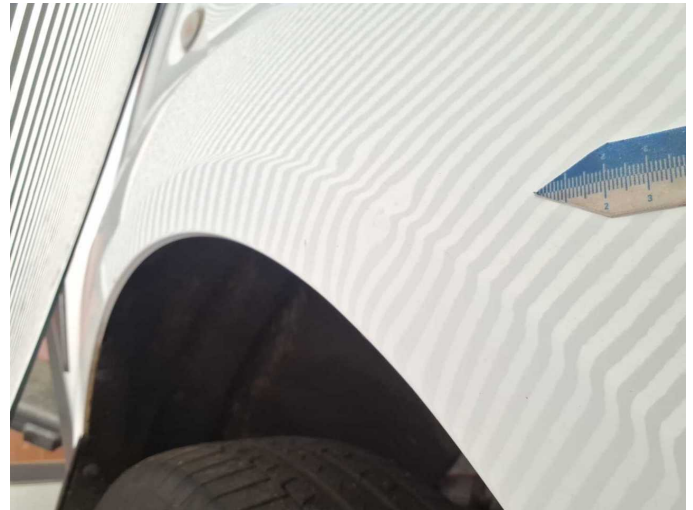
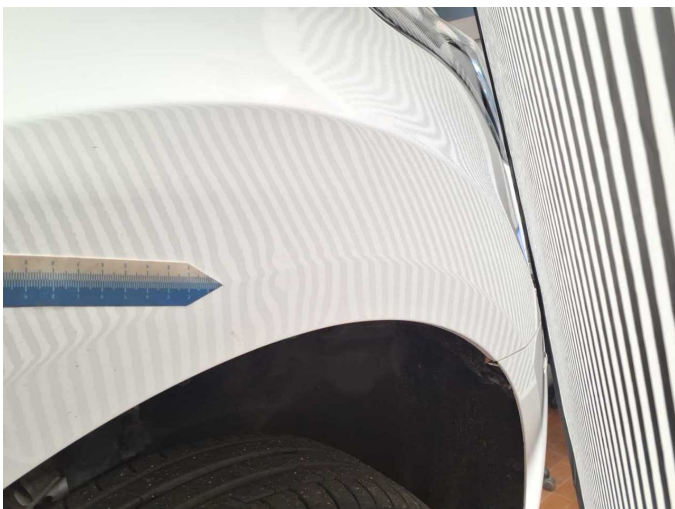
Damage 4: Mudguard - right side: Mudguard - right side - dent(s) - Smooth repair work

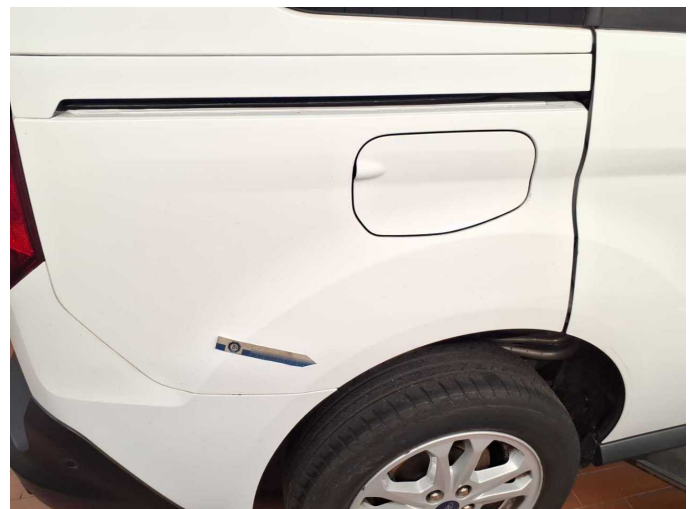
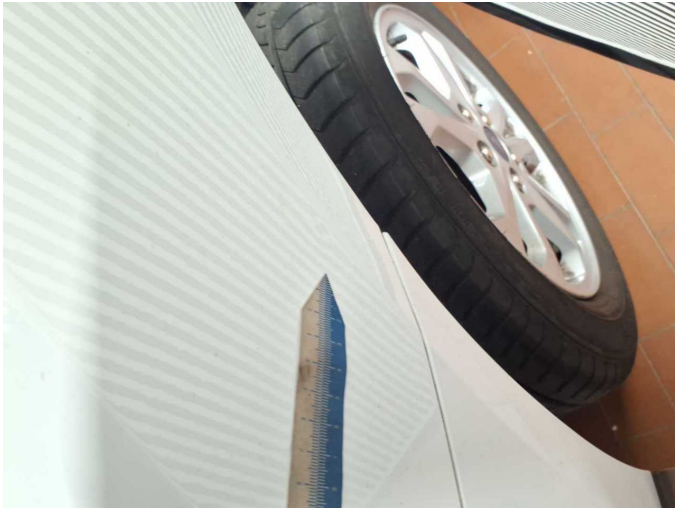
Damage 5: Side panel - rear right side: Side panel - dent(s) - Smooth repair work

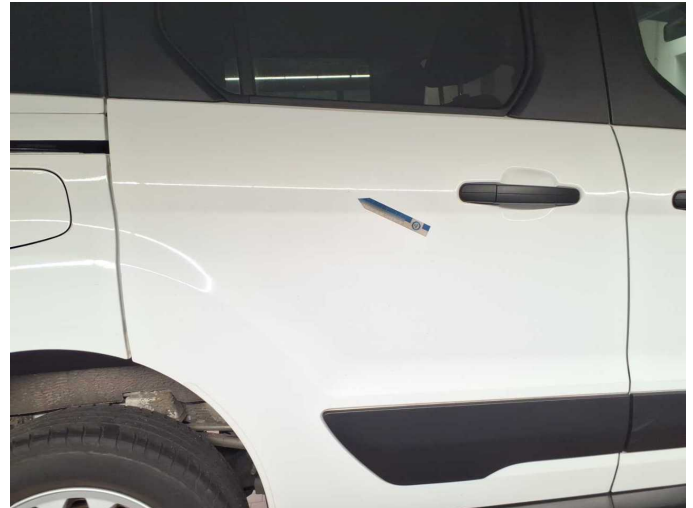
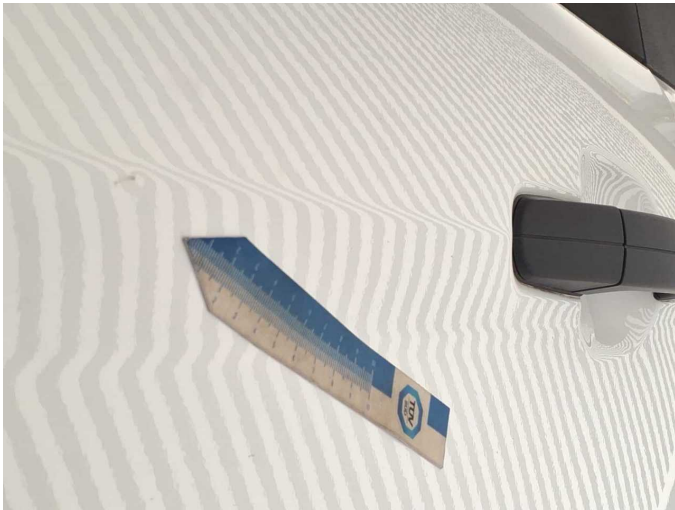
Damage 6: Sliding door, right: Sliding door with glass panel - dent(s) - Smooth repair work

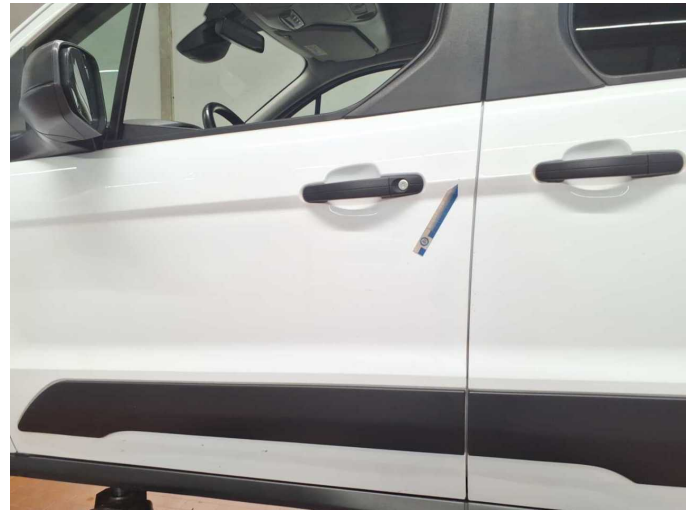
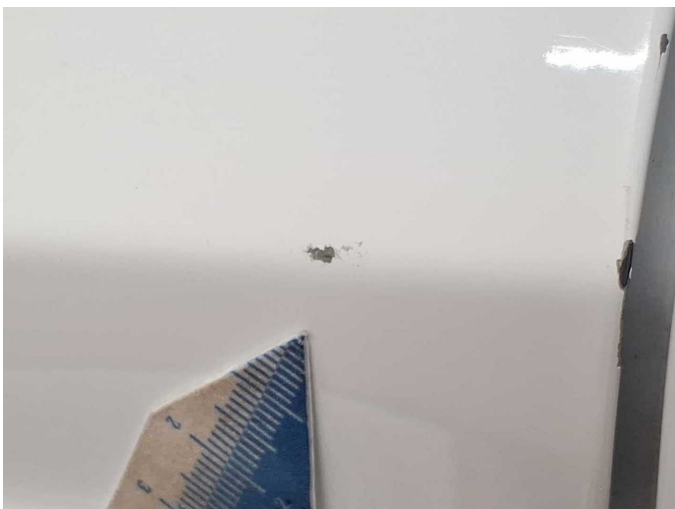
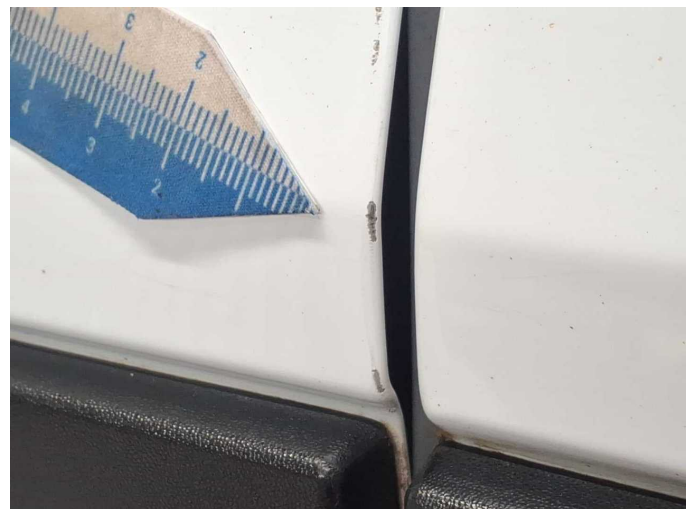
Damage 7: Door - front left side: Door - Scratch(es) - Smart repair

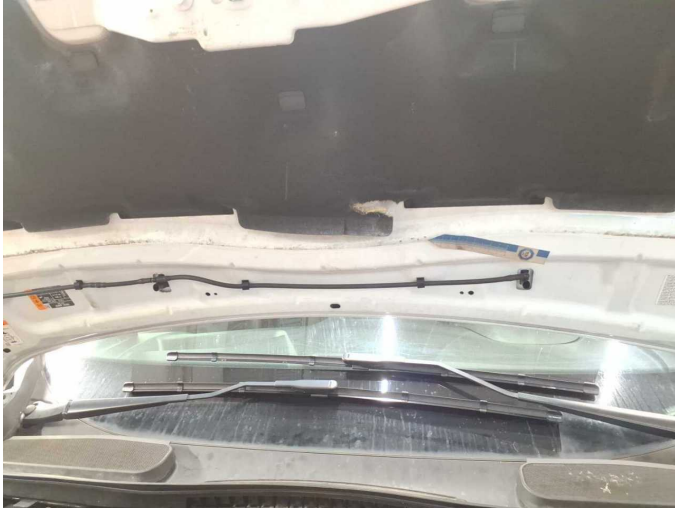
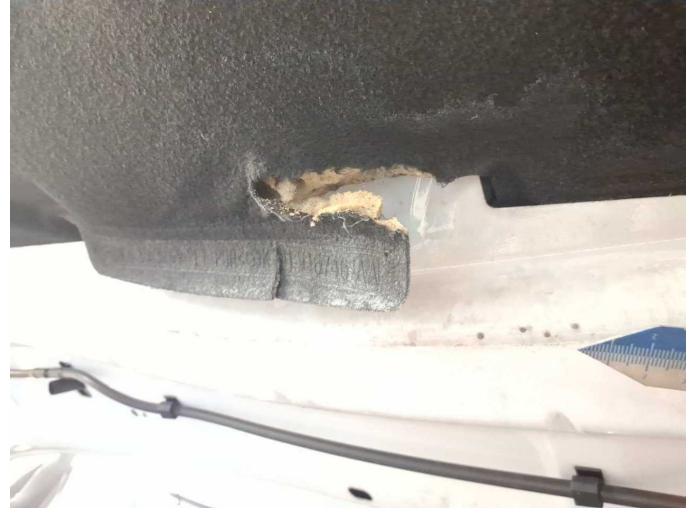
Damage 8: Bonnet: Insulation lining - Broken / torn - Replace

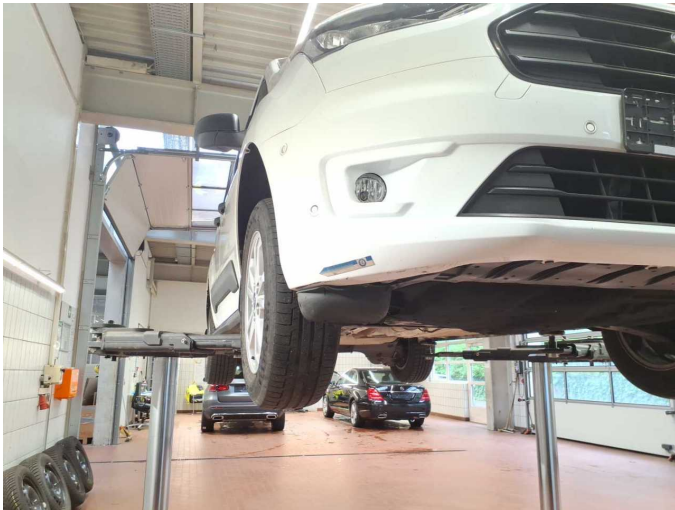
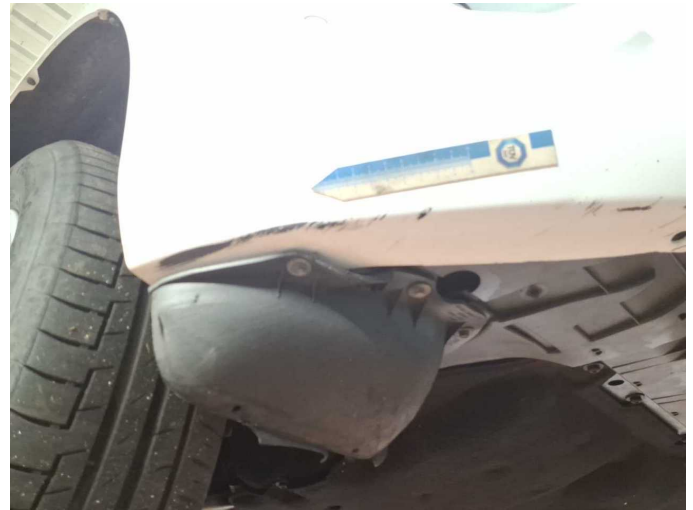
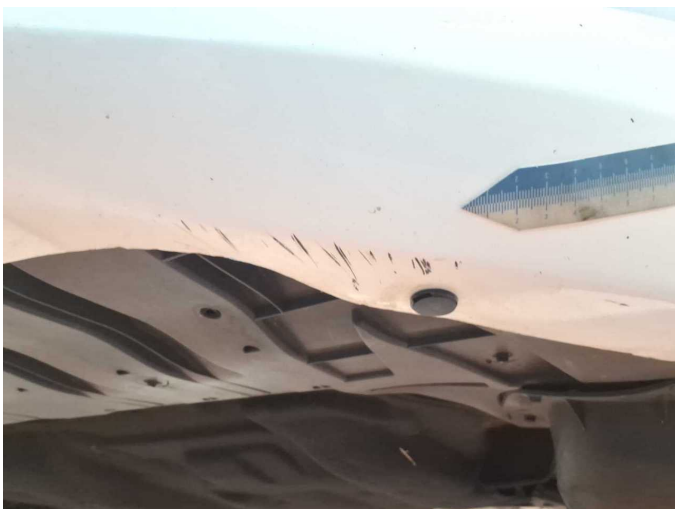
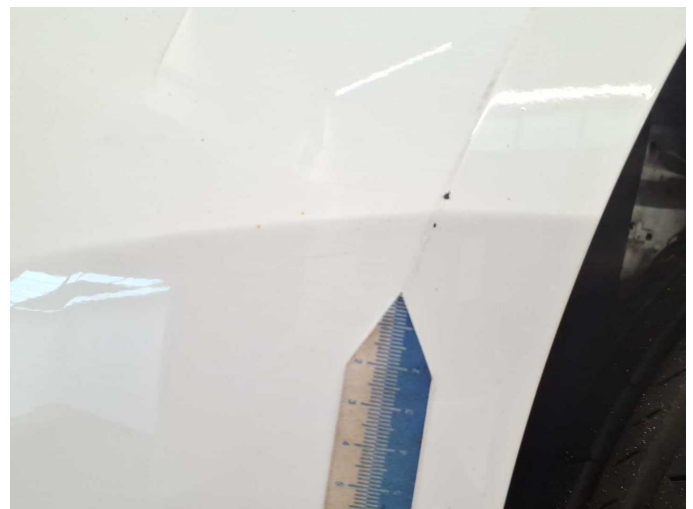
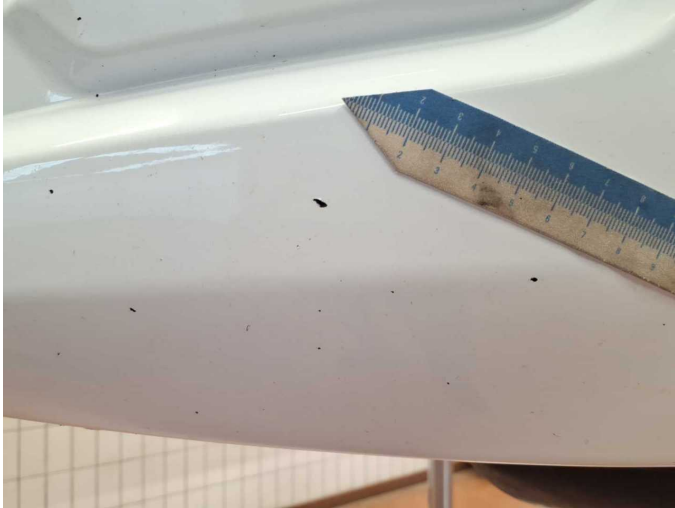
Damage 9: Front bumper: Front bumper - Scratched - Paint

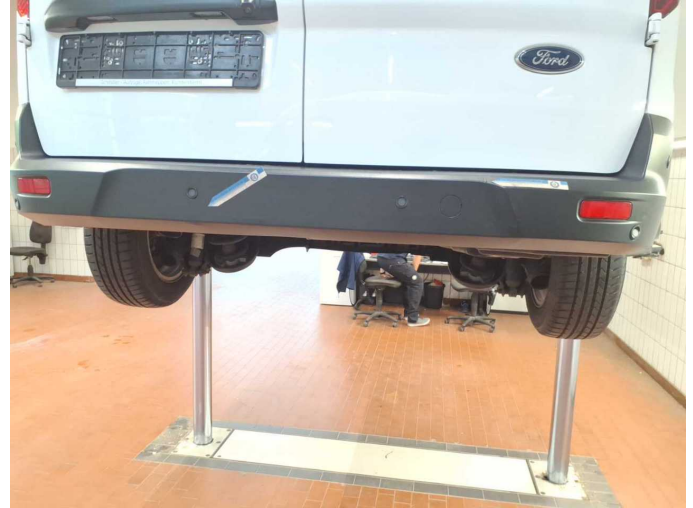
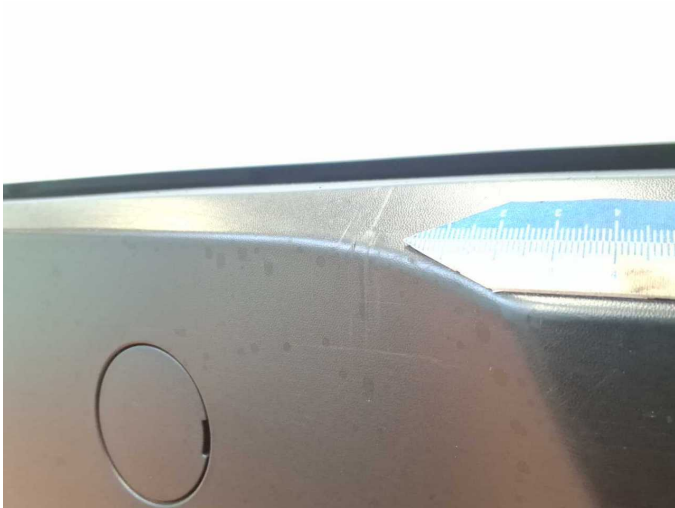
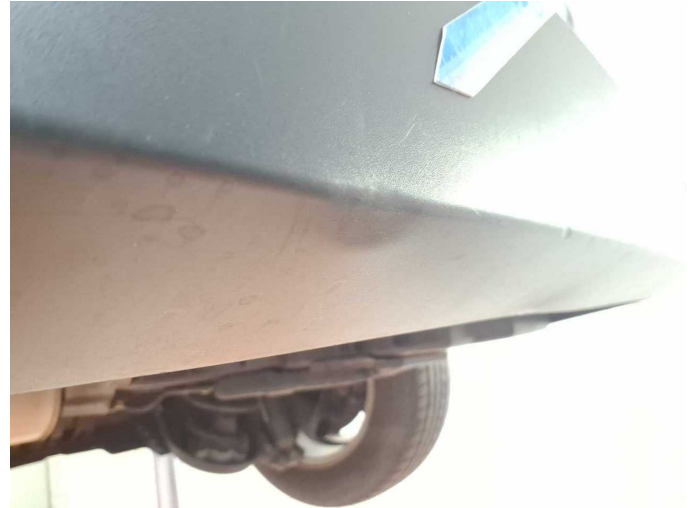
Wear and tear 2: Rear bumper: Rear bumper (unpainted) - Scratched - No deduction

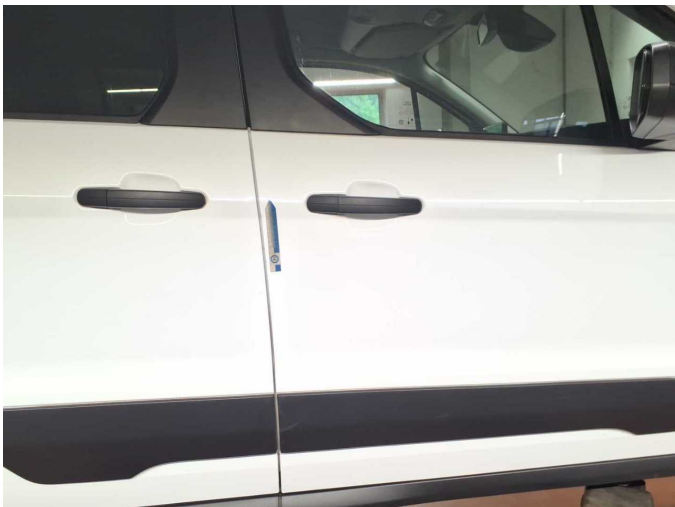
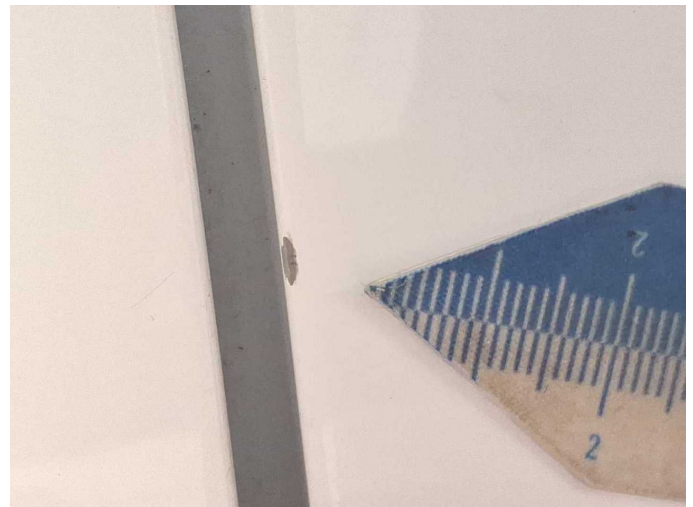
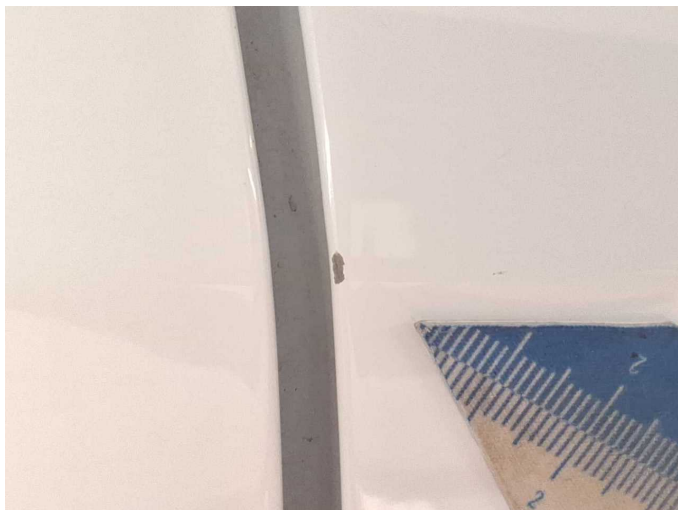
Wear and tear 3: Door - front right side: Door - Scratch(es) - No deduction

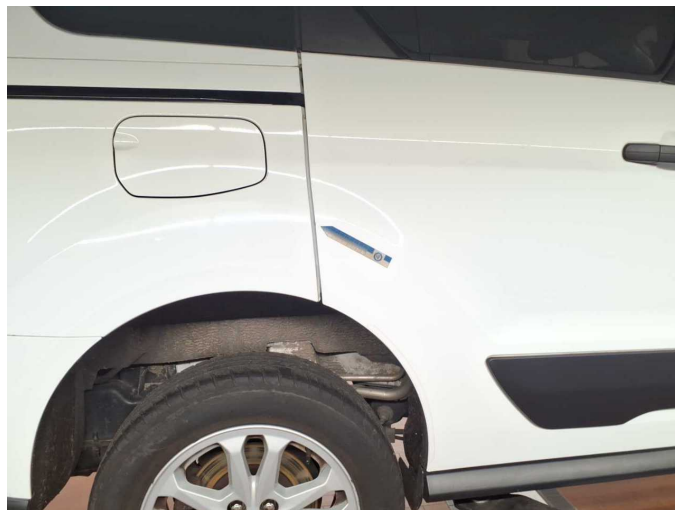
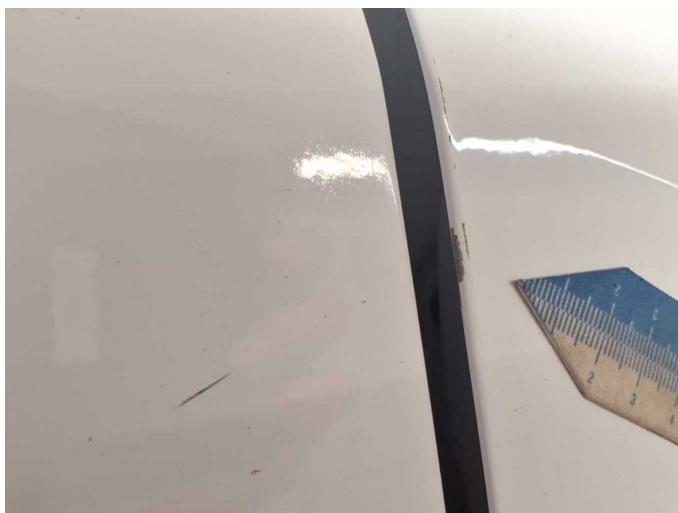
Wear and tear 4: Door - rear right side: Door edge - Scratch(es) - No deduction

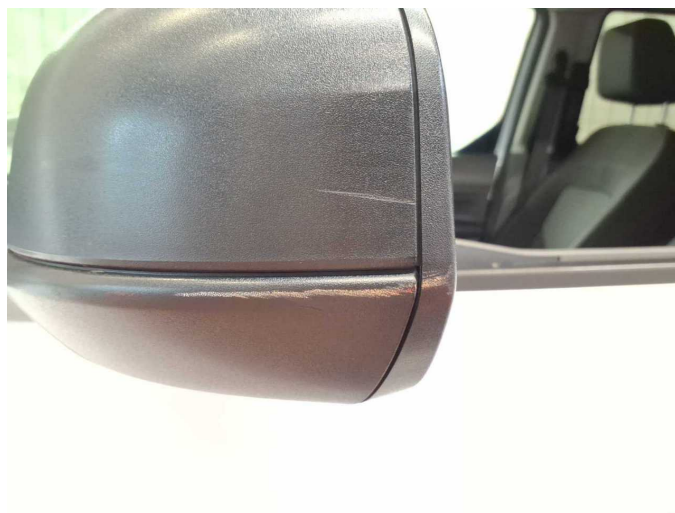
Wear and tear 7: Wing mirror - left side: Mirror housing - Scratch(es) - No deduction
