Expertise

Protocol number: 46171143
Order No. / Reference: 26530177
Inspection date: 24 Jun 2026

Manufacturer: Volkswagen

Model: T7 Multivan 2,0 TDI SCR Kurz Life

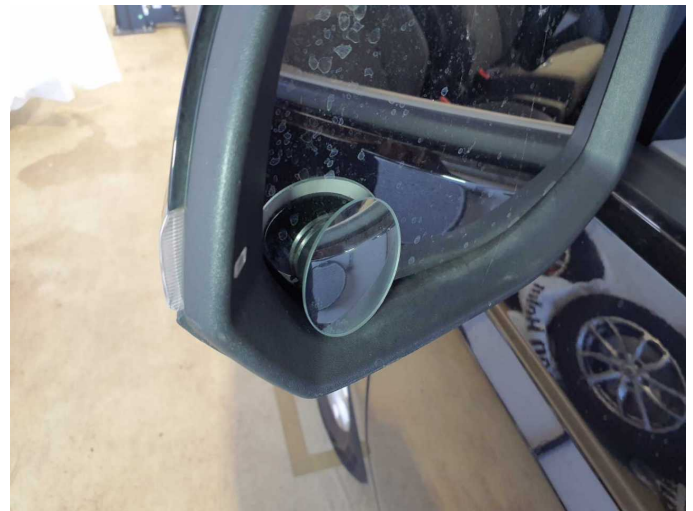
Damage 1: Wing mirror - left side: Mirror glass - Differs from the original configuration - Remove

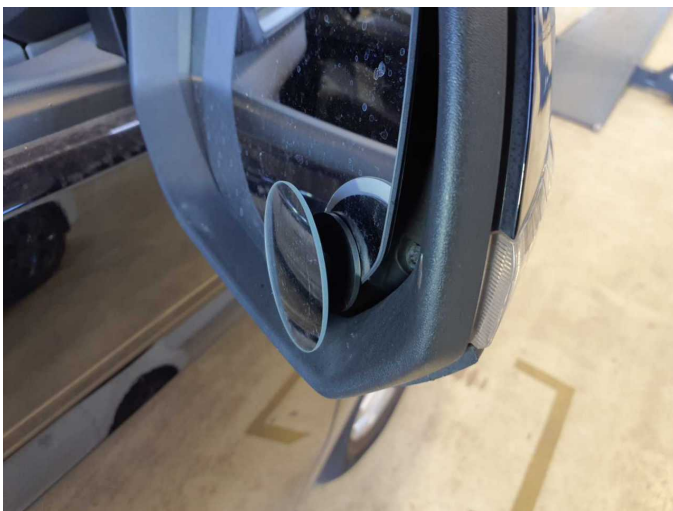
Damage 2: Wing mirror - right side: Mirror glass - Differs from the original configuration - Remove

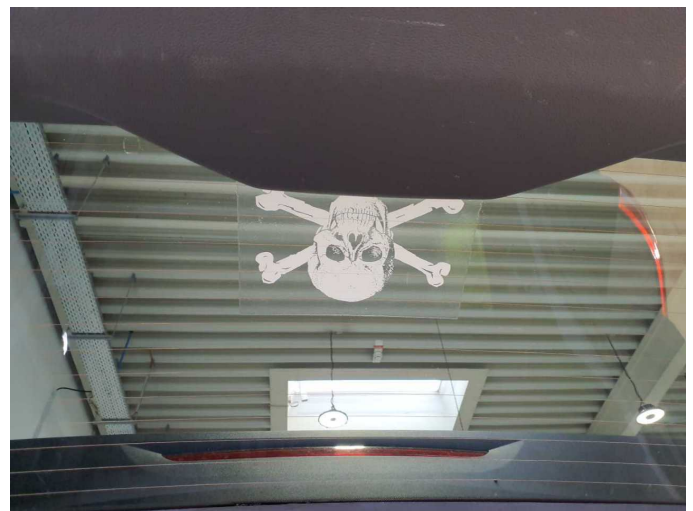
Damage 3: Vehicle glazing: Rear window - Glued / labelled - De-glue / neutralise

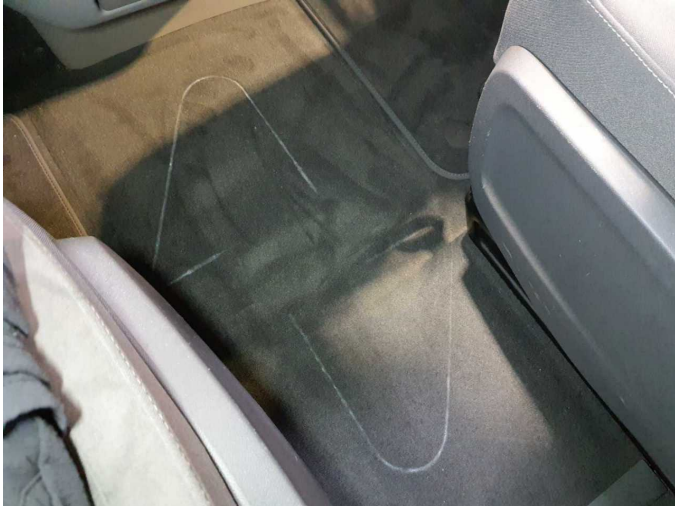
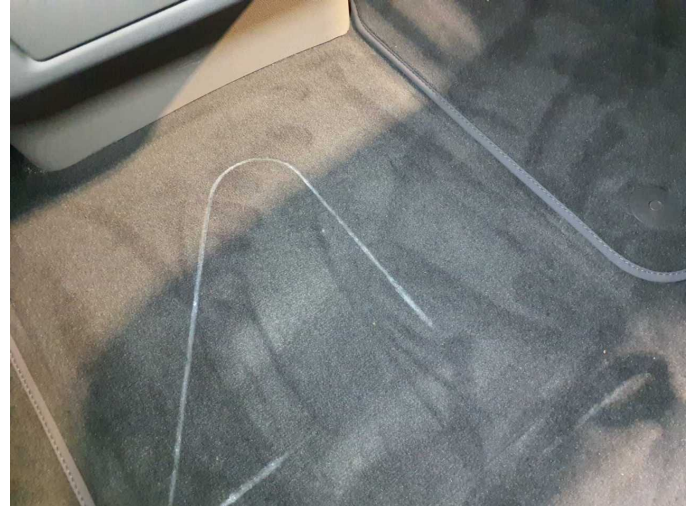
Damage 4: Trim / covers: Carpet - front left side - Scratch(es) - Smart repair

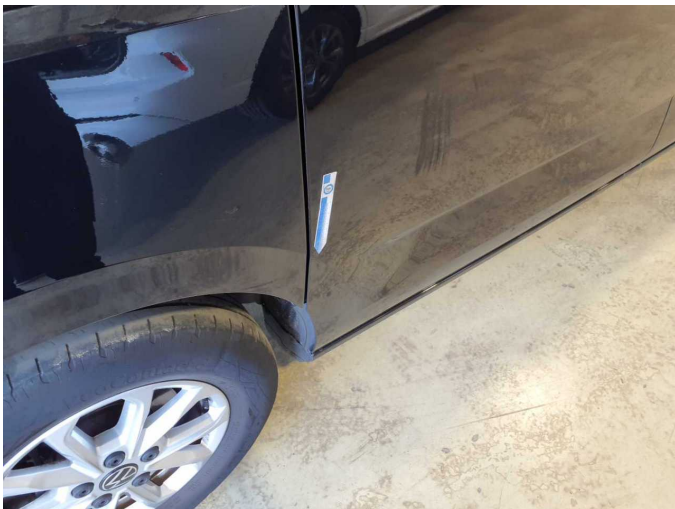
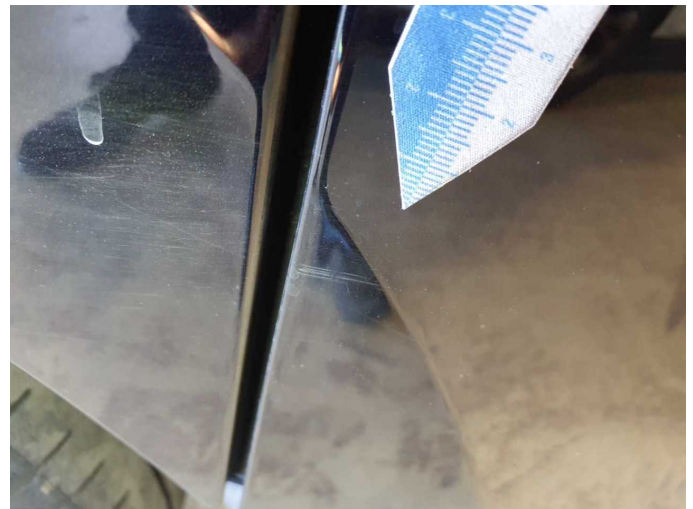
Damage 5: Door - rear right side: Door - Scratch(es) - Smart repair

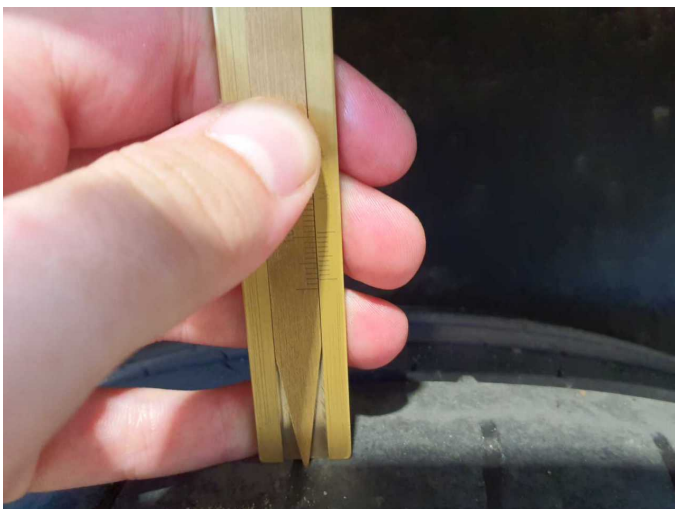
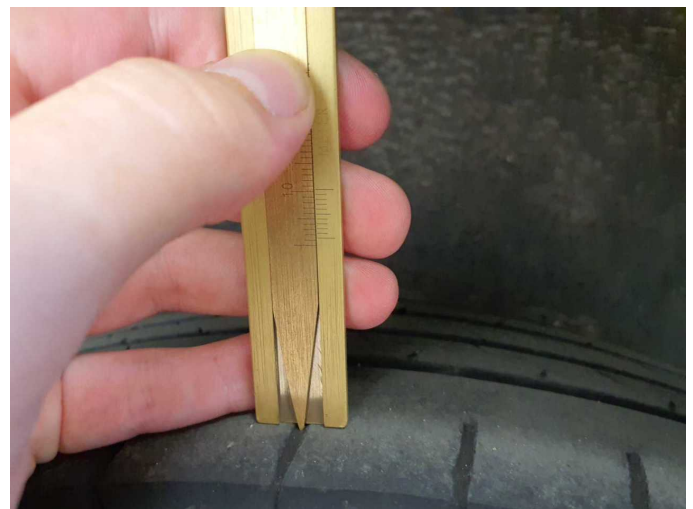
Mounted tyres				
#	Tyre size	Type of tyre	Manufacturer	Tread depth
1)	215/65 R16 102H	Summer tyres on Light alloy	Continental	4mm / 4mm
2)	215/65 R16 102H	Summer tyres on Light alloy	Continental	1mm / 1mm
Additional tyres				
#	Tyre size	Type of tyre	Manufacturer	Tread depth
1)	215/65 R15 102H	Winter tyres on Light alloy	Pirelli	2mm / 2mm
2)	215/65 R15 102H	Winter tyres on Light alloy	Pirelli	4mm / 4mm
Replacement				
Typ	Tyre size	Type of tyre	Manufacturer	Tread depth
	Tirefit	Expiration date 01/2028

Damage 6: Wheel / tyres: Tyre - right - Worn - Replace

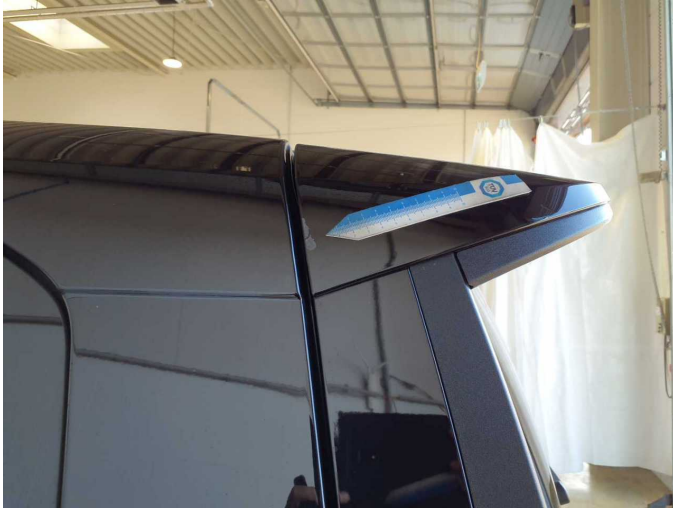
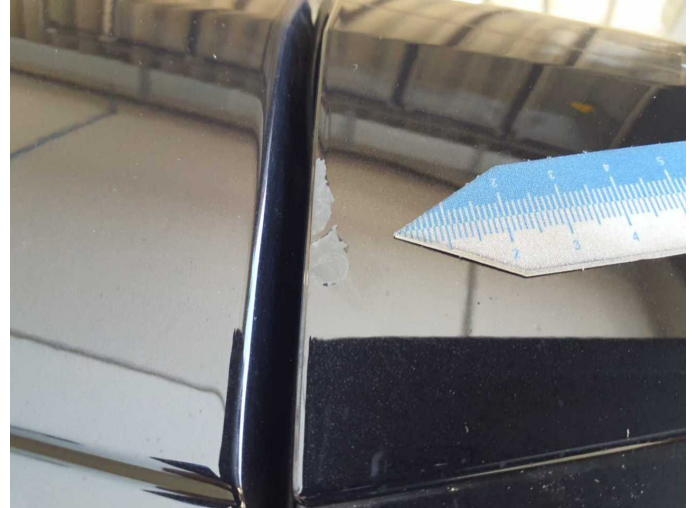
Damage 7: Boot lid / rear door: Rear spoiler - Scratch(es) - Paint

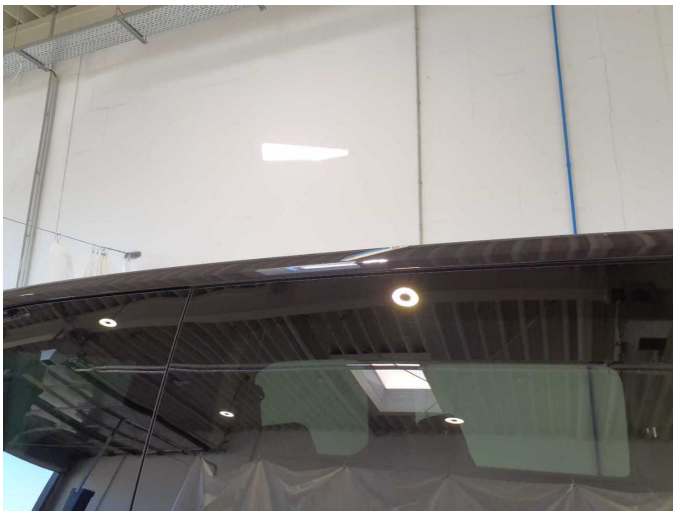
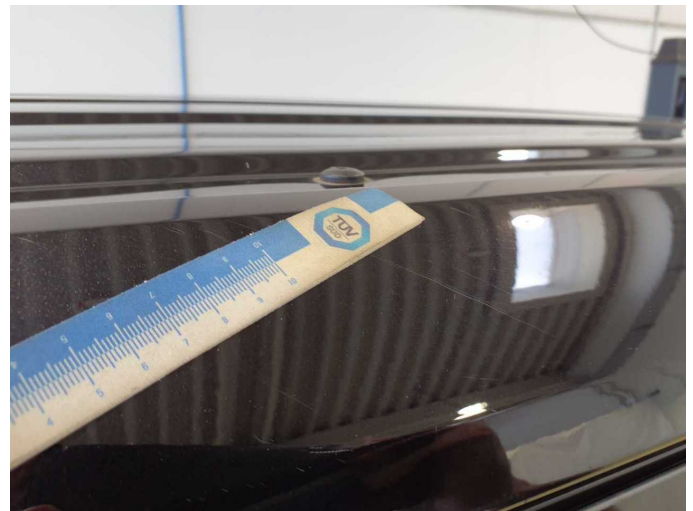
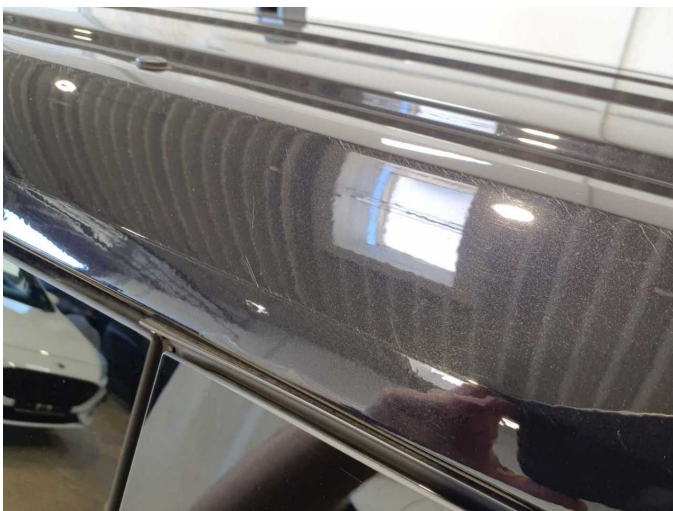
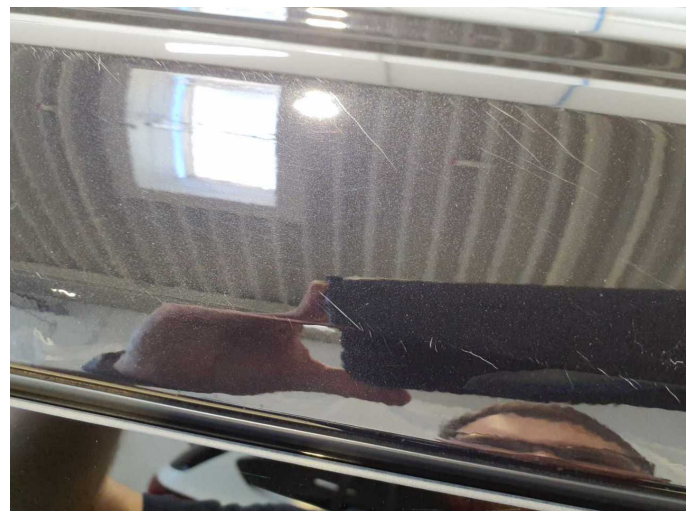
Damage 8: Roof: Roof rail - right side - Scratch(es) - Paint

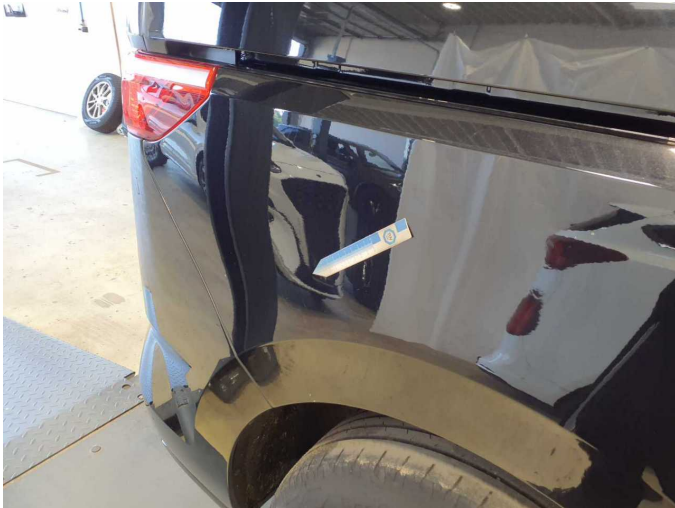
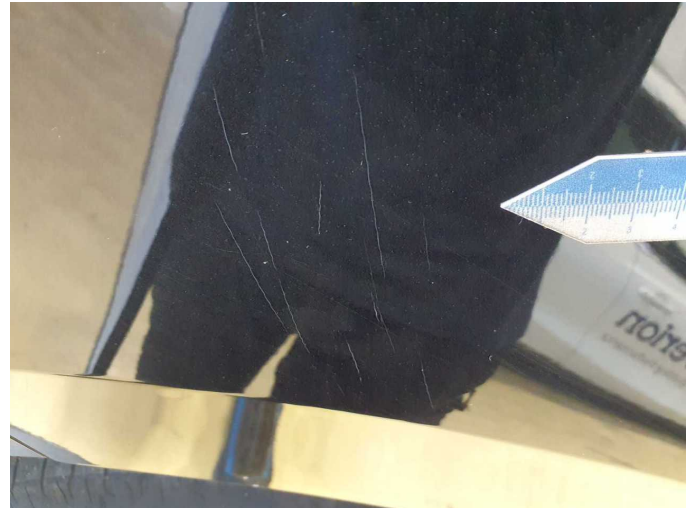
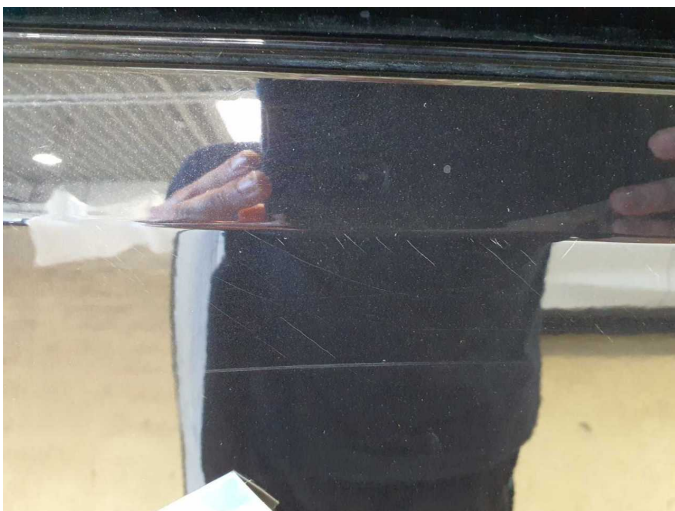
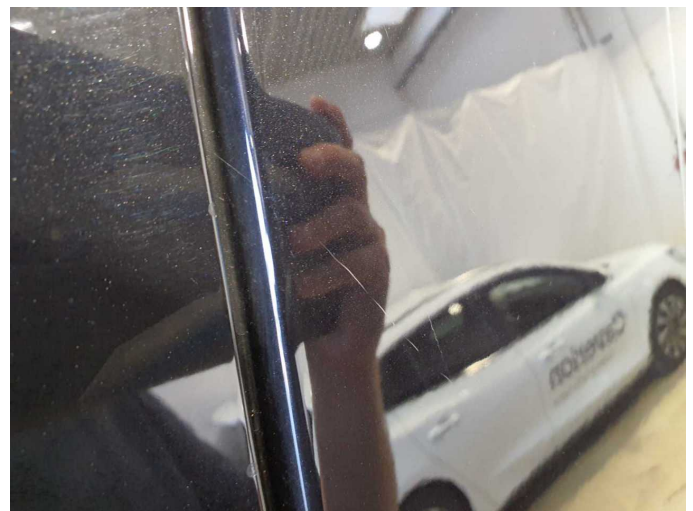
Damage 9: Side panel - rear right side: Side panel - Scratch(es) - Paint

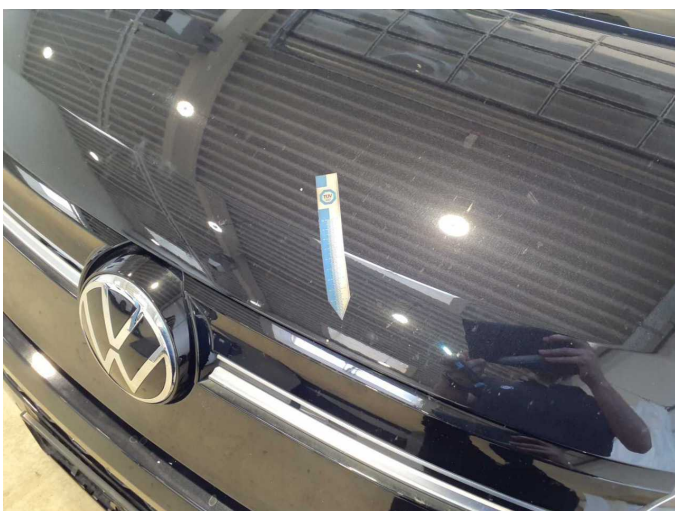
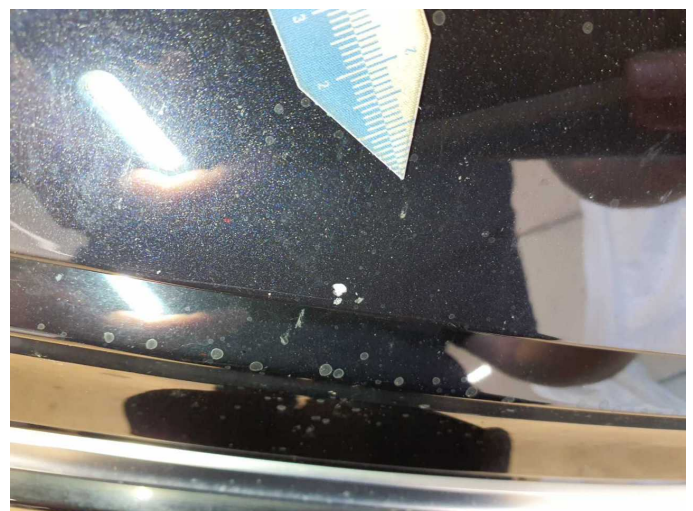
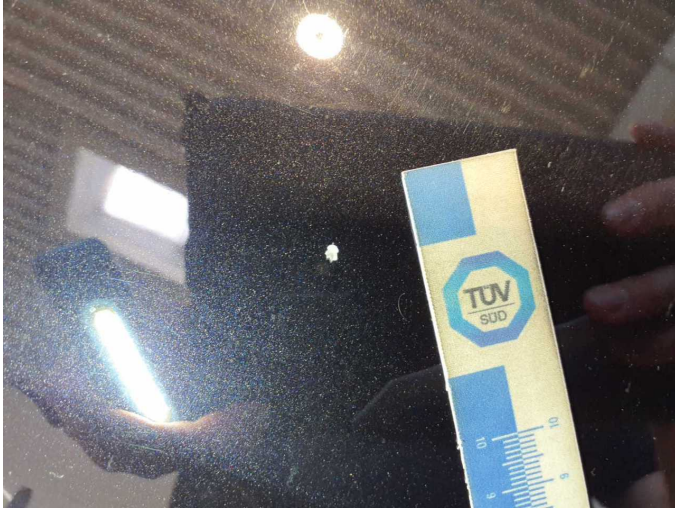
Damage 10: Bonnet: Bonnet - Stone chips - Paint

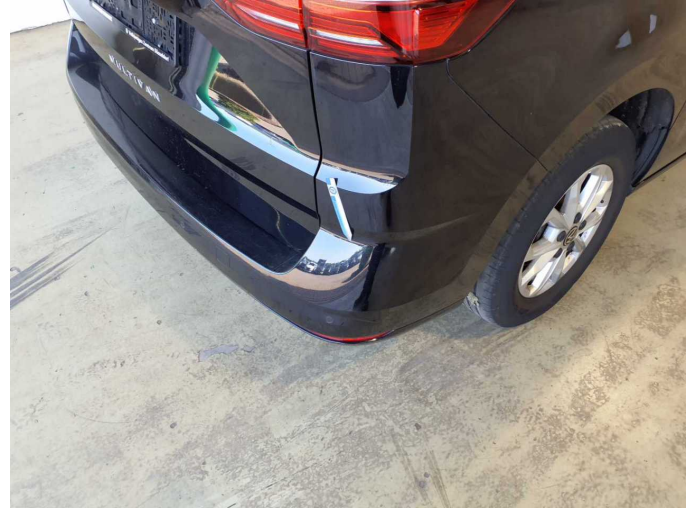
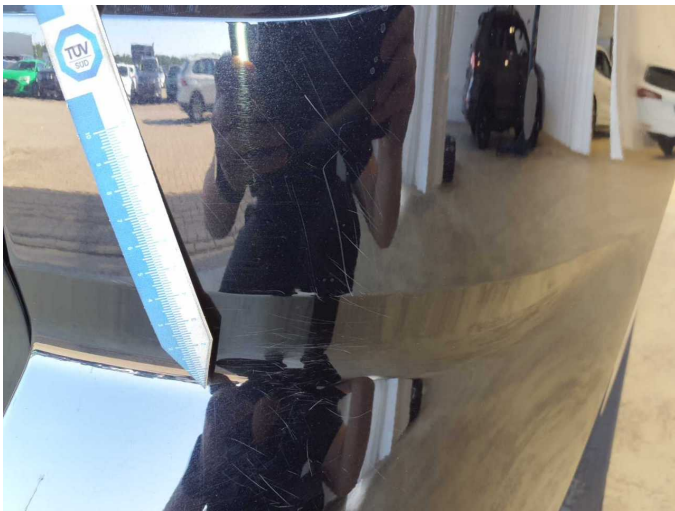
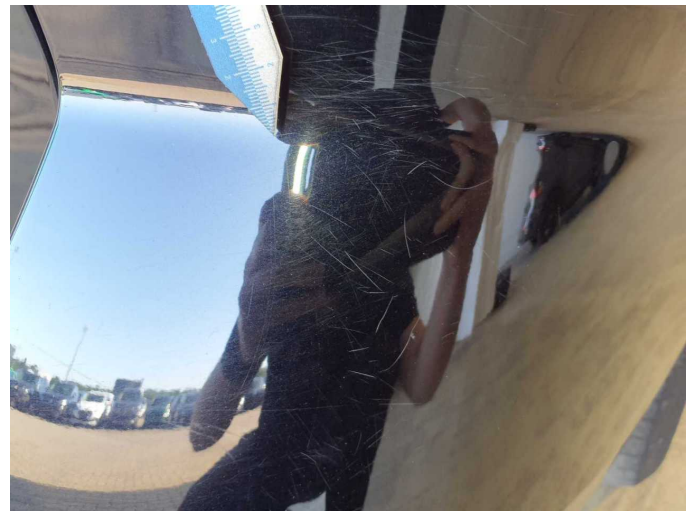
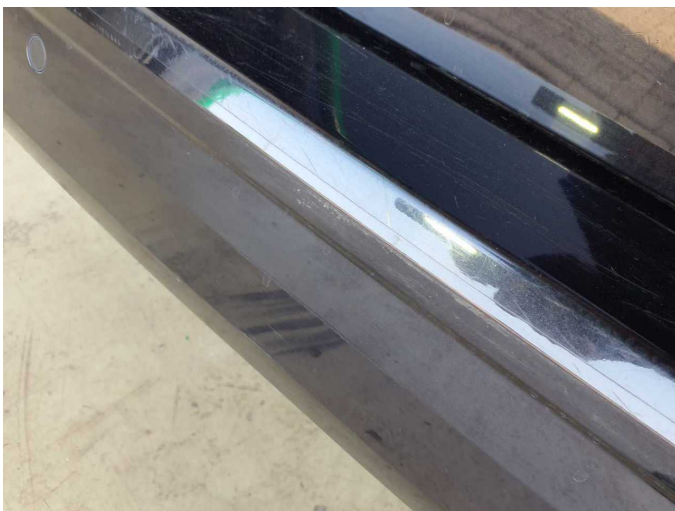
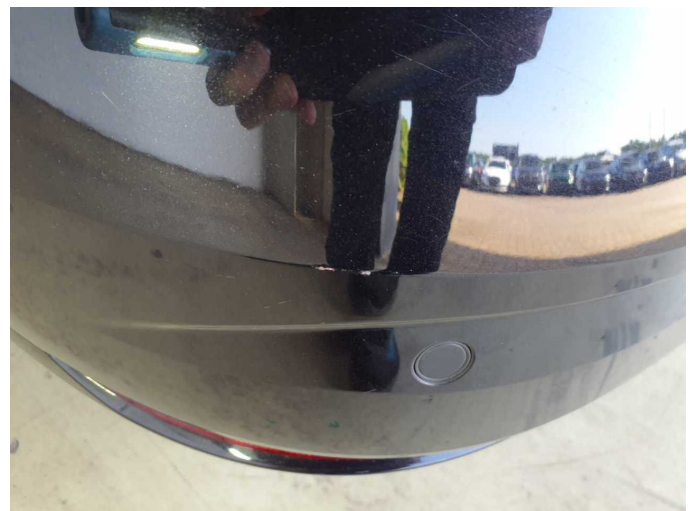
Damage 11: Rear bumper: Rear bumper - Scratch(es) - Paint

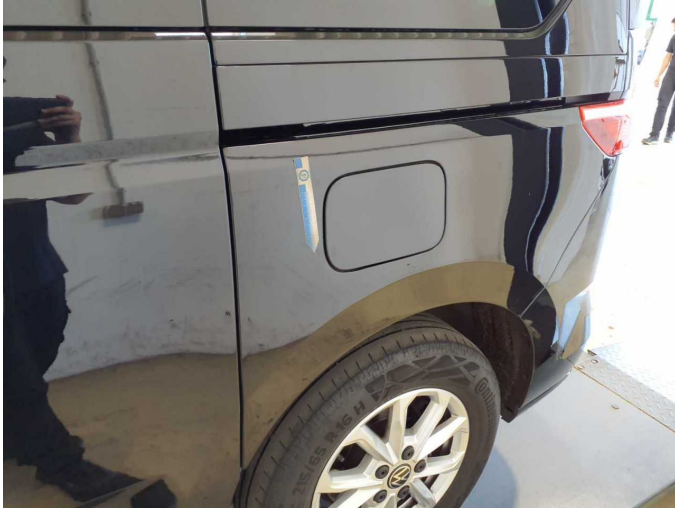
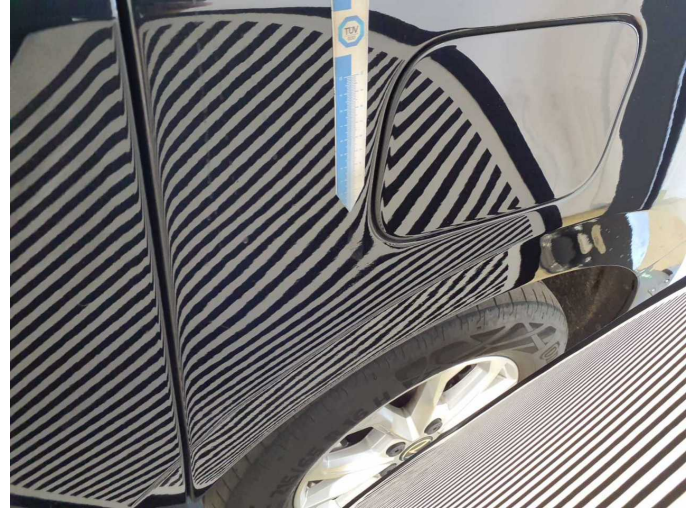
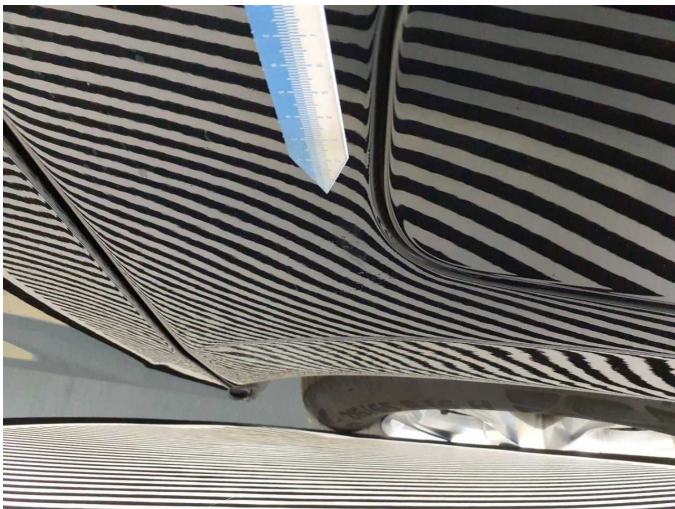
Roof	236 µm	Roof rail - left side	194 µm
Roof rail - right side	221 µm	Side panel - rear left side	771 µm
Door - rear left side	268 µm

Damage 12: Side panel - rear left side: Side panel (Spachtel eingefallen)
- Unprofessionally repaired - Repair and paint

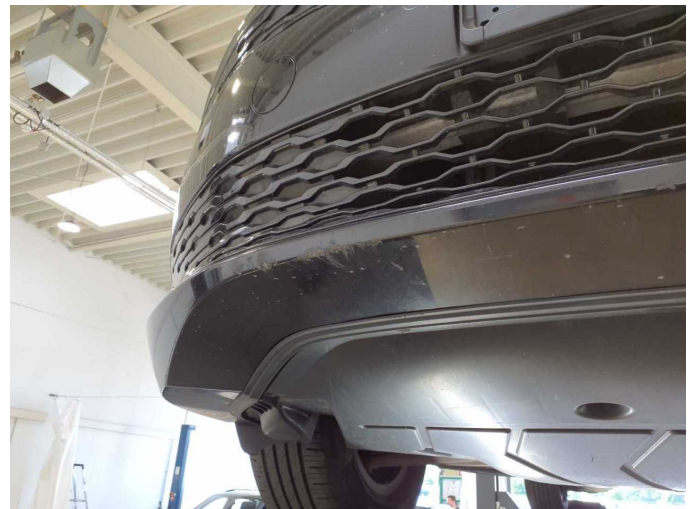
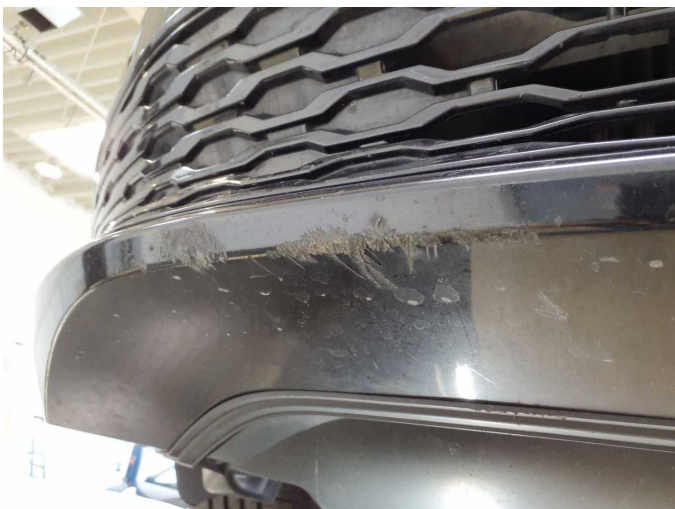
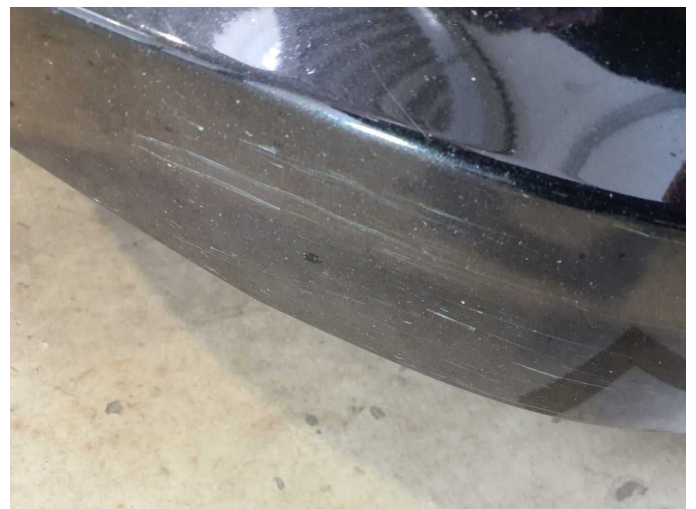
Damage 13: Front bumper: Front bumper - Dent / paintcoat damage -
Repair and paint

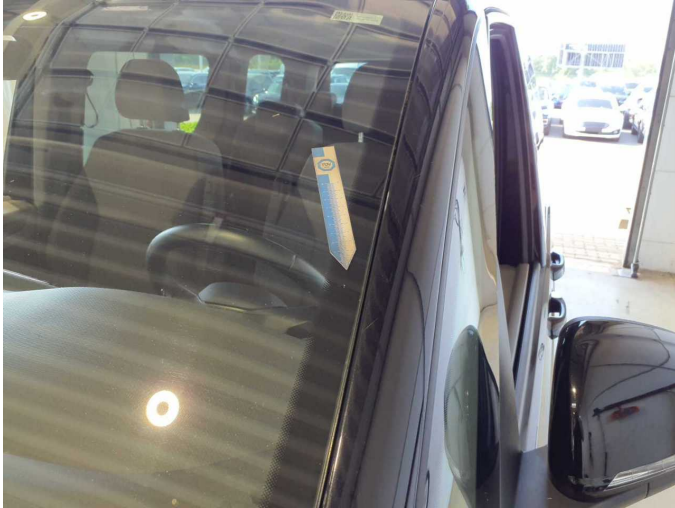
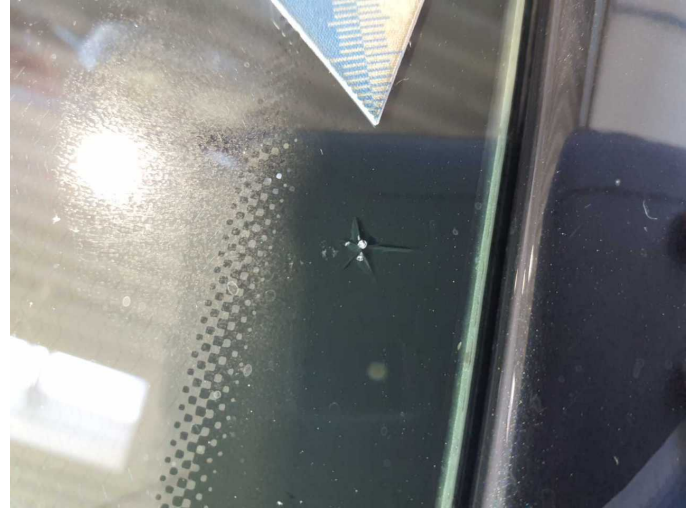
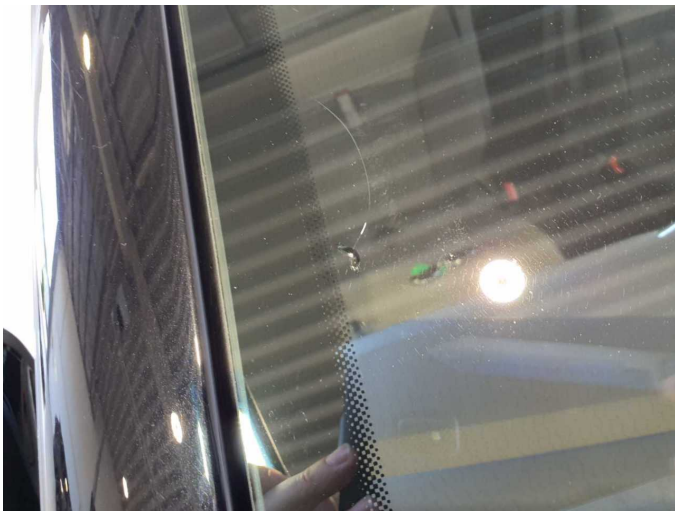
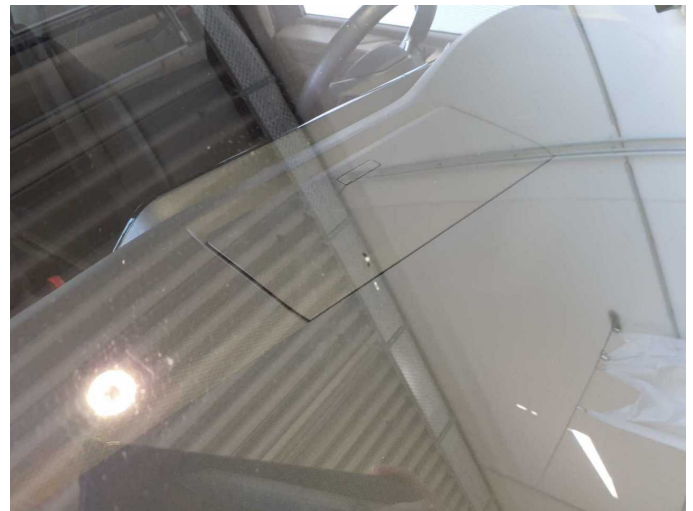
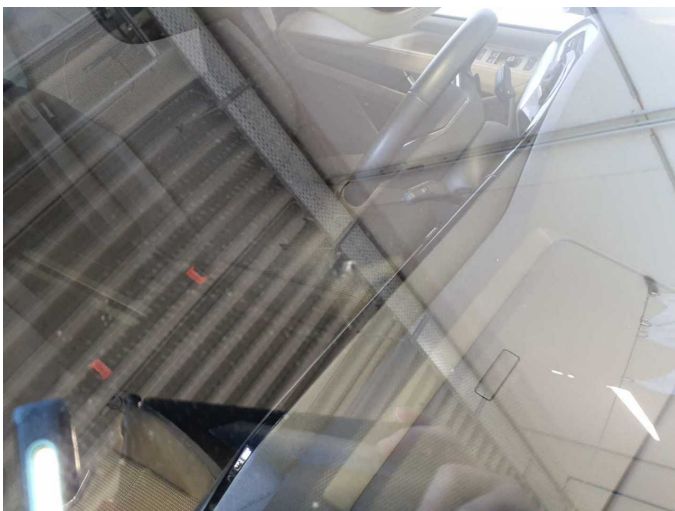
Damage 14: Vehicle glazing: Windscreen - Broken / torn - Replace
