**Report number:** 10284209

**VIN:** WVVZZZ3C2RE033590

- Vehicle Inspection Report -

<b>Vehicle category:</b>	Passenger Car
<b>Vehicle type:</b>	EstateCar
<b>Make:</b>	Volkswagen
<b>Model:</b>	Passat
<b>Manufacturers and type code:</b>	0603 / CIA
<b>Date of first registration:</b>	14.03.2024
<b>Mileage:</b>	90,666 km
<b>Proof of mileage:</b>	ReadOff
<b>Exterior colour:</b>	Mangangrau Metallic
<b>Roof colour:</b>	Mangangrau Metallic
<b>Propulsion:</b>	Front
<b>Fuel:</b>	Petrol
<b>Engine size (cc):</b>	1,500 ccm
<b>Performance:</b>	110 kW (150 PS)
<b>Length:</b>	
<b>Height:</b>	
<b>Width:</b>	
<b>Permitted total weight:</b>	
<b>Wheelbase:</b>	
<b>Number of powered axles:</b>	2
<b>Cylinders:</b>	4
<b>Euronorm:</b>	Euro 6
<b>Number of doors:</b>	4
<b>Number of seats:</b>	5
<b>Gearbox:</b>	Automatic 7-speed
<b>Upholstery type:</b>	Lining fabrics
<b>Interior colour:</b>	Titanschwarz/Titanschwarz/Titanschwarz
<b>Number of keys:</b>	1

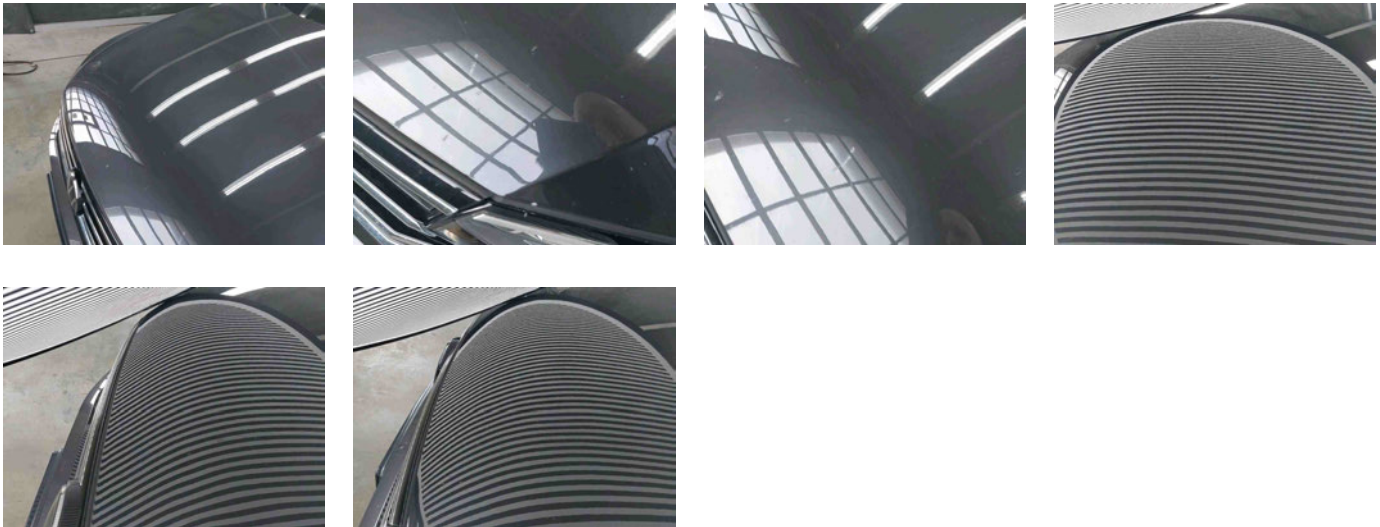
1 - Bonnet - Dent(s) and scratch(es) - Repair and paint (complete)		Repaircosts:	€ 507.50
		Net cost:	€ 319.73
Paint material			€ 147.50
Paint work	30 WU		€ 360.00

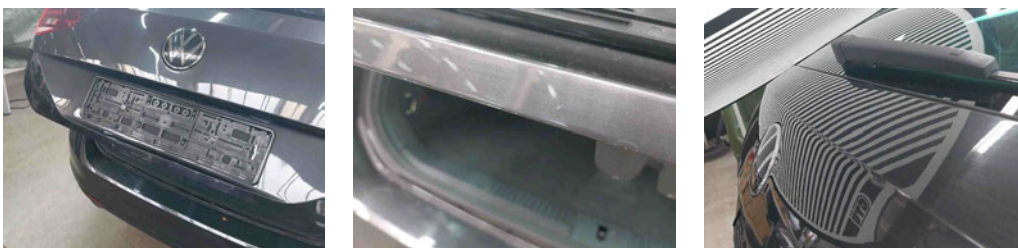
2 - Tailgate / Boot - Dent(s) and scratch(es) - Repair and paint (complete)		Repaircosts:	€ 456.25
		Net cost:	€ 287.44
Paint material			€ 96.25
Paint work	30 WU		€ 360.00

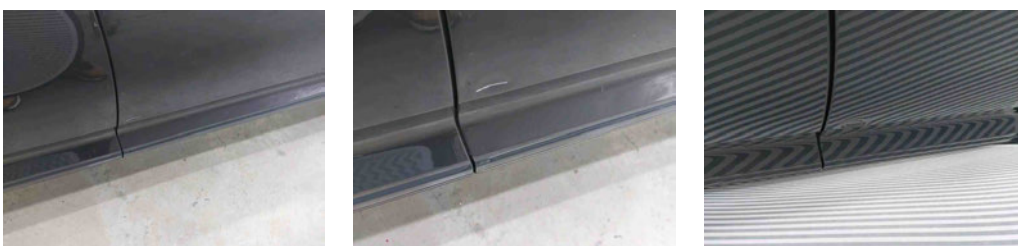
3 - Door FR - Dent(s) and scratch(es) - Repair and paint (complete)		Repaircosts:	€ 387.00
		Net cost:	€ 243.81
Paint material			€ 75.00
Paint work	26 WU		€ 312.00
