## Expertise

Protocol number: 45791101  
Order No. / Reference: 26435664  
Inspection date: 5 Jun 2026

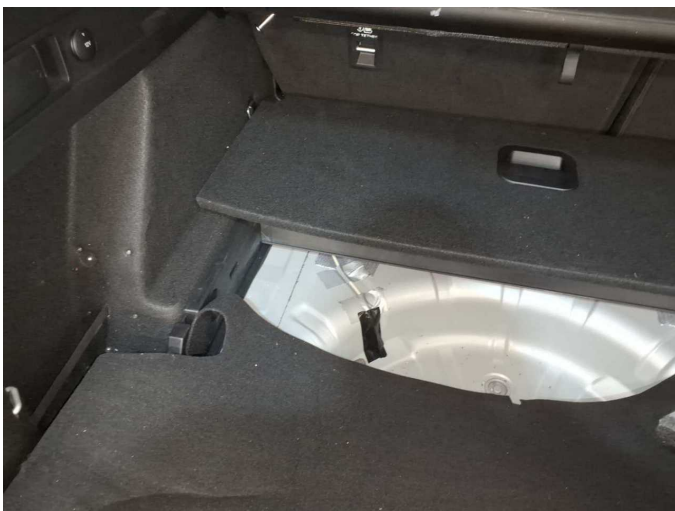
**Damage 3:** Electrical system: Cable strand (Kabelführung von Frontbereich in Laderaum) - Differs from the original configuration - Un-/install

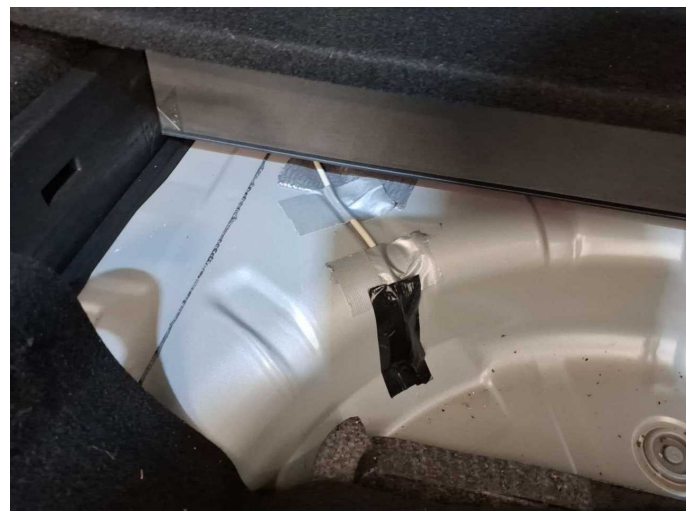
**Damage 3:** Electrical system: Cable strand (Kabelführung von Frontbereich in Laderaum) - Differs from the original configuration - Un-/install

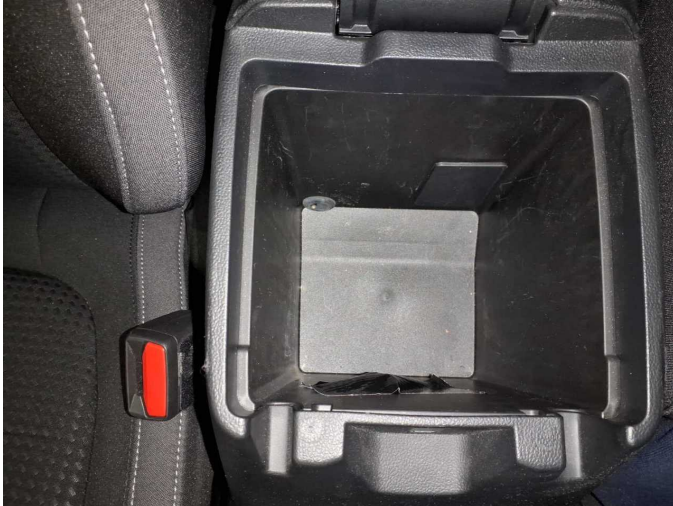
**Damage 4:** Interior: Arm rest, front (Deckel hinten) - Differs from the original configuration - Replace

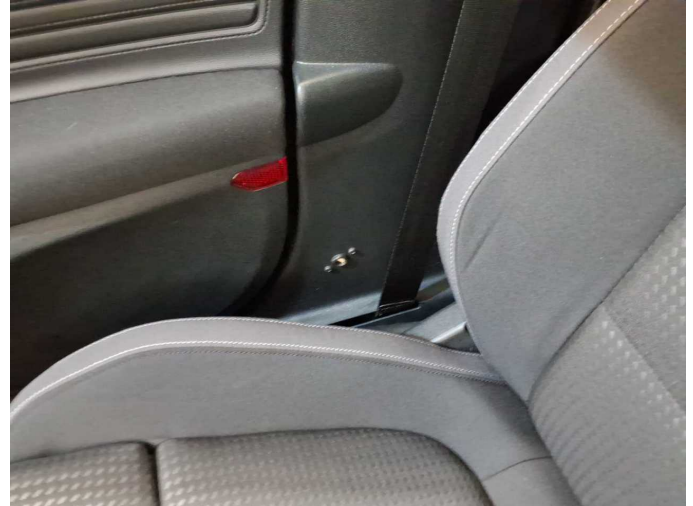
**Damage 5:** Trim / covers: B-pillar - trim - interior, right side (Fehlbohrungen) - Differs from the original configuration - Replace

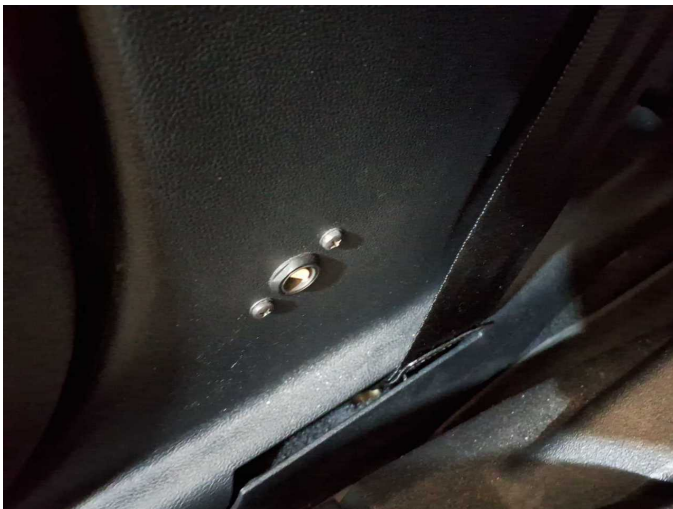
**Damage 5:** Trim / covers: B-pillar - trim - interior, right side (Fehlbohrungen) - Differs from the original configuration - Replace

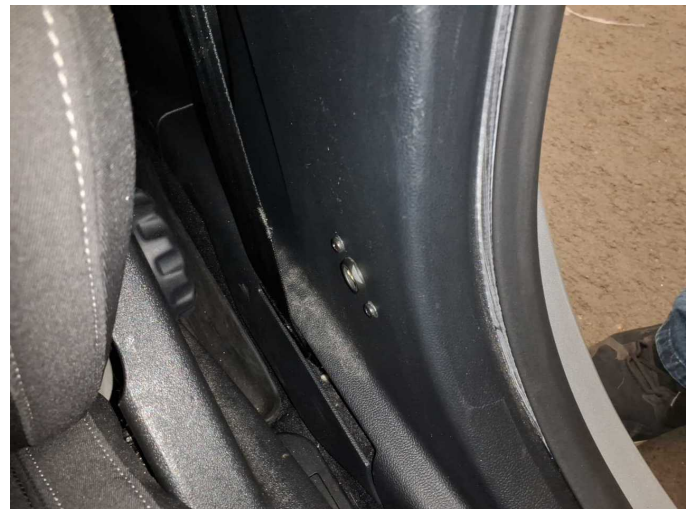
**Damage 6:** Trim / covers: B-pillar - trim - interior, left side (Fehlbohrungen) - Differs from the original configuration - Replace

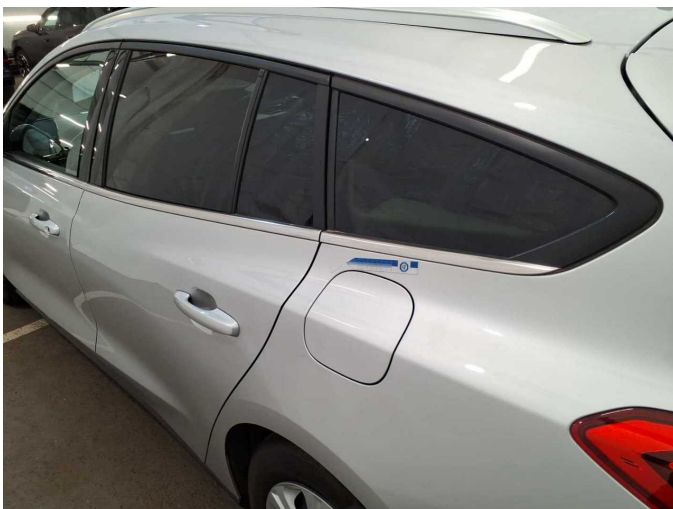
**Damage 7:** Side panel - rear left side: Side panel - Scratched - Smart repair

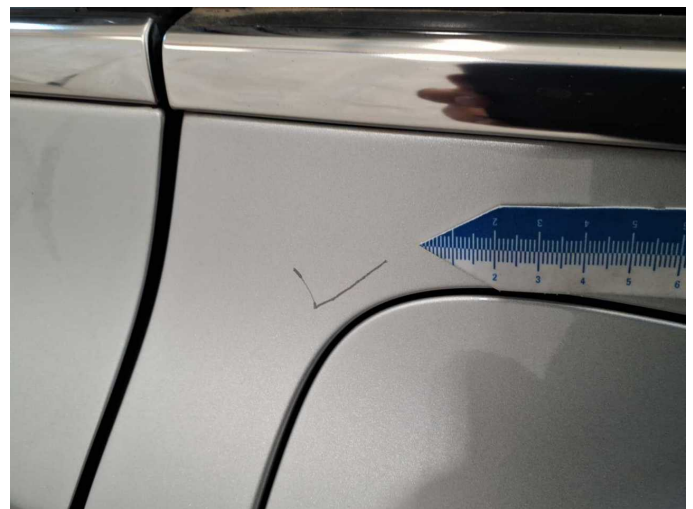
**Damage 7:** Side panel - rear left side: Side panel - Scratched - Smart repair

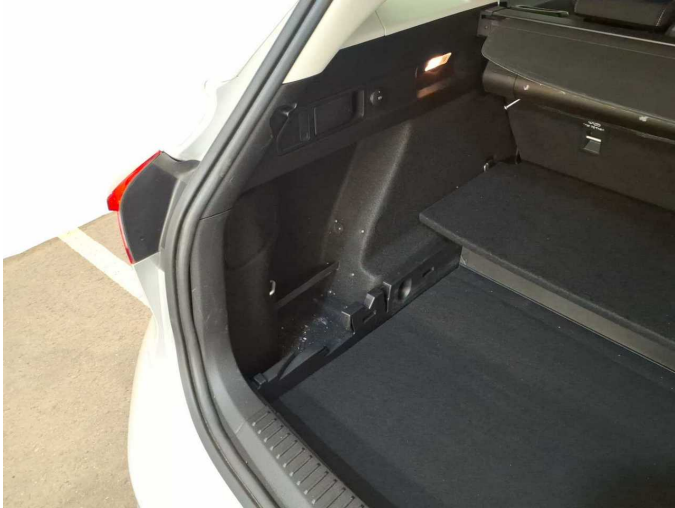
**Damage 8:** Trim / covers: Cargo area - lining -left side (Fehlbohrungen) - Differs from the original configuration - Replace

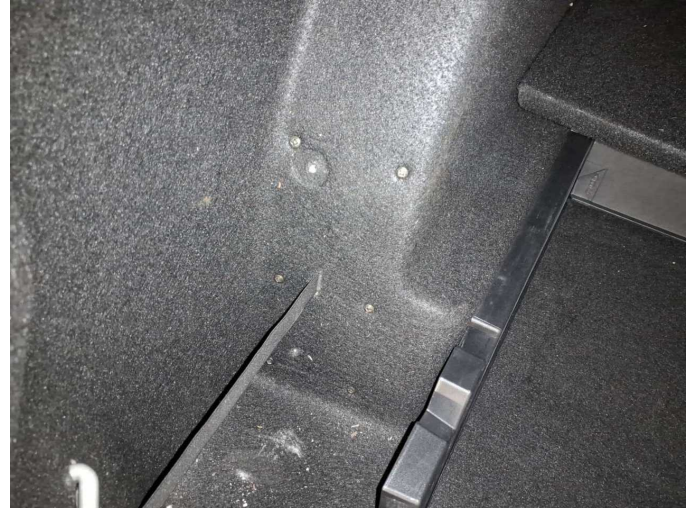
**Damage 8:** Trim / covers: Cargo area - lining -left side (Fehlbohrungen) - Differs from the original configuration - Replace

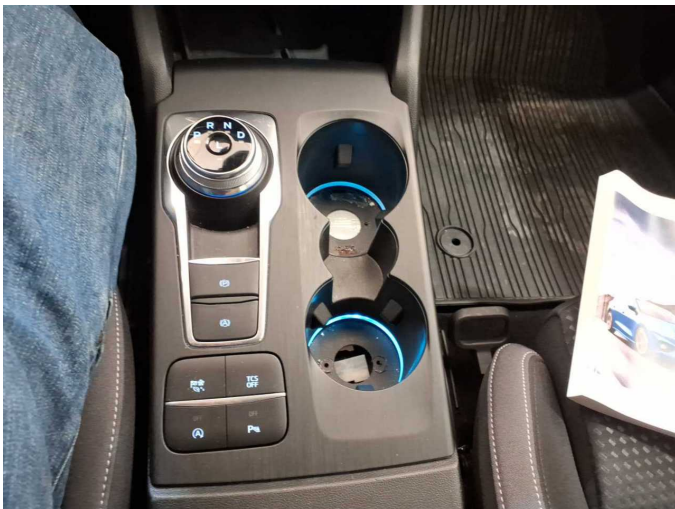
**Damage 9:** Instrument panel: Centre console - front (Getränkehalter, Fehlbohrungen) - Differs from the original configuration - Replace

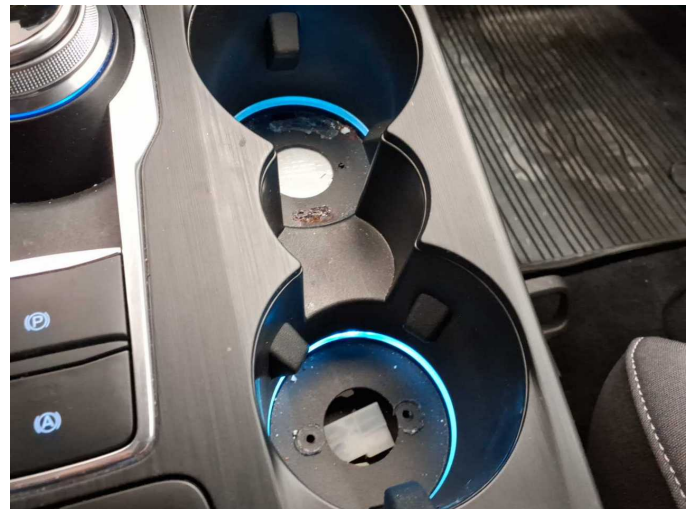
**Damage 9:** Instrument panel: Centre console - front (Getränkehalter, Fehlbohrungen) - Differs from the original configuration - Replace

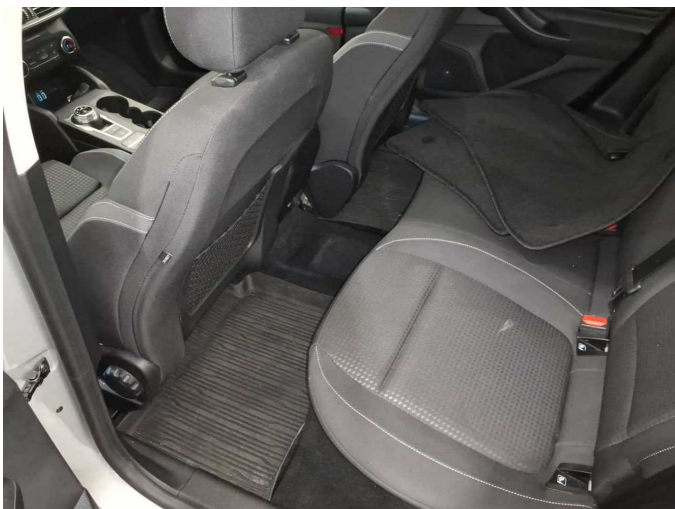
**Damage 10:** Trim / covers: Carpet - Differs from the original configuration - Replace

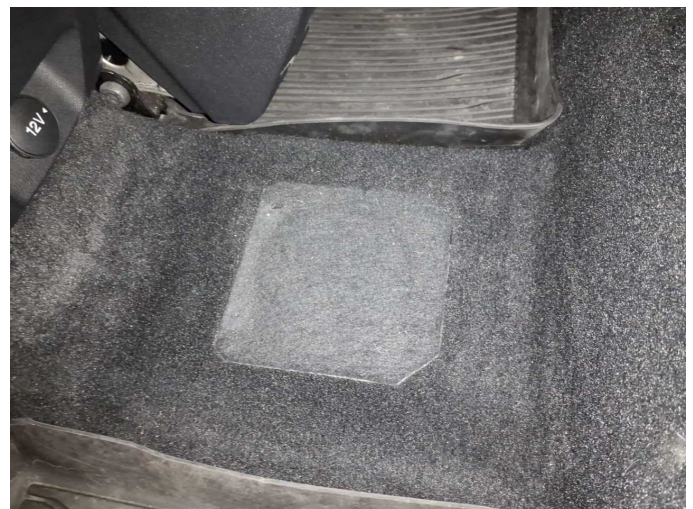
**Damage 10:** Trim / covers: Carpet - Differs from the original configuration - Replace

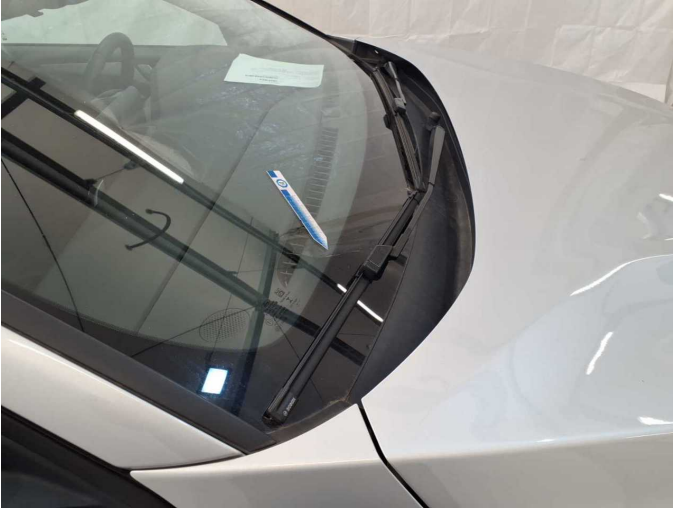
**Wear and tear 6:** Vehicle glazing: Windscreen (Oberflächlich, im Randbereich rechts) - Scratch(es) - No deduction

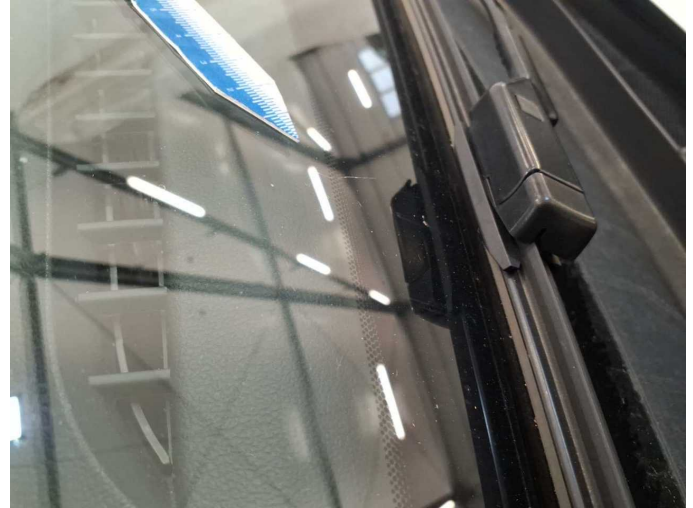
**Wear and tear 6:** Vehicle glazing: Windscreen (Oberflächlich, im Randbereich rechts) - Scratch(es) - No deduction

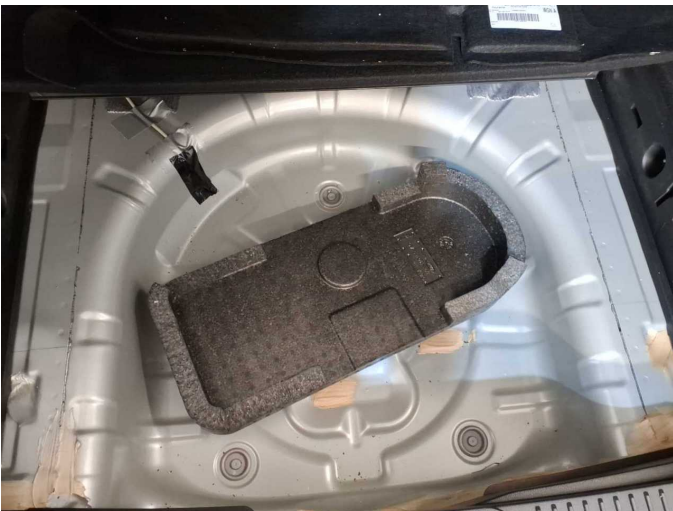
**Missing part 2:** Equipment: Tirefit complete - Missing - Replace
