Expertise

Protocol number: 45297993
Order No. / Reference: 26382338
Inspection date: 5 May 2026

Manufacturer: Peugeot

Model: 308 SW BlueHDi 130 EAT8 Allure Pack

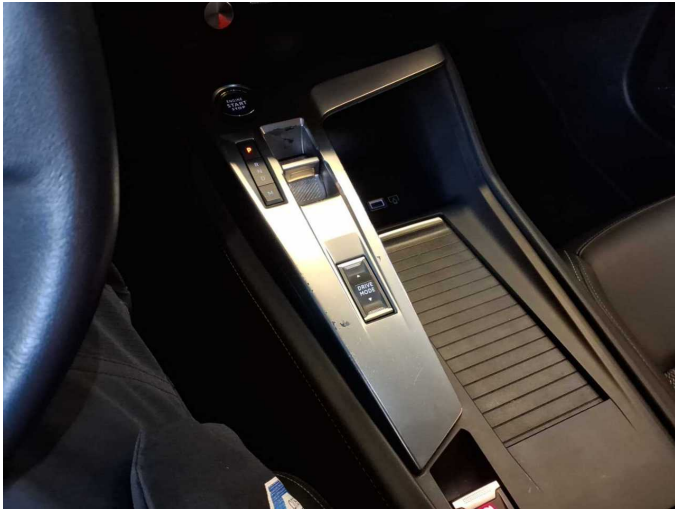
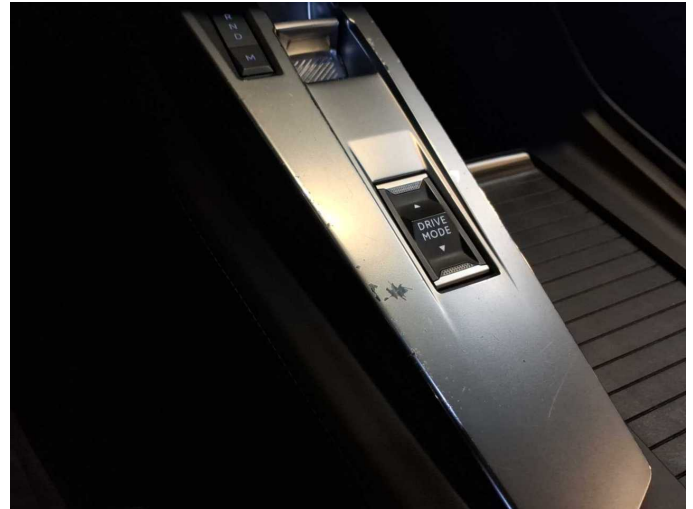
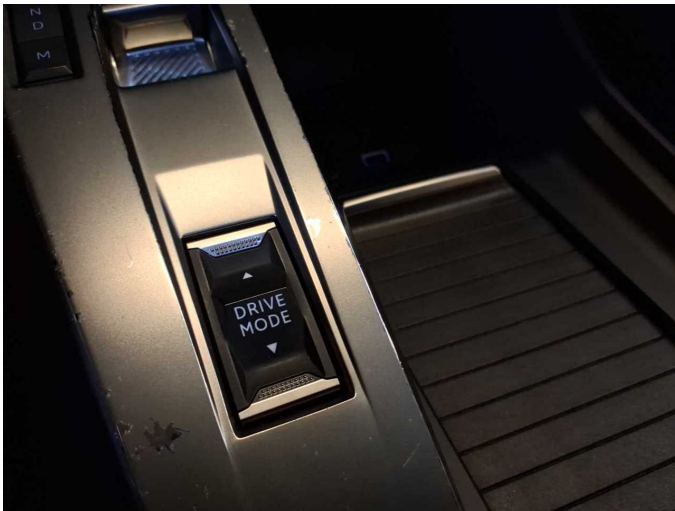
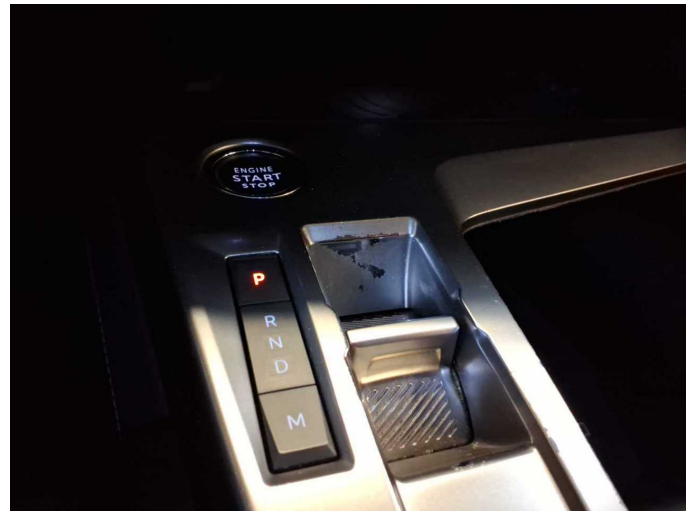
Damage 3: Instrument panel: Centre console - front - Scratched - Loss in value

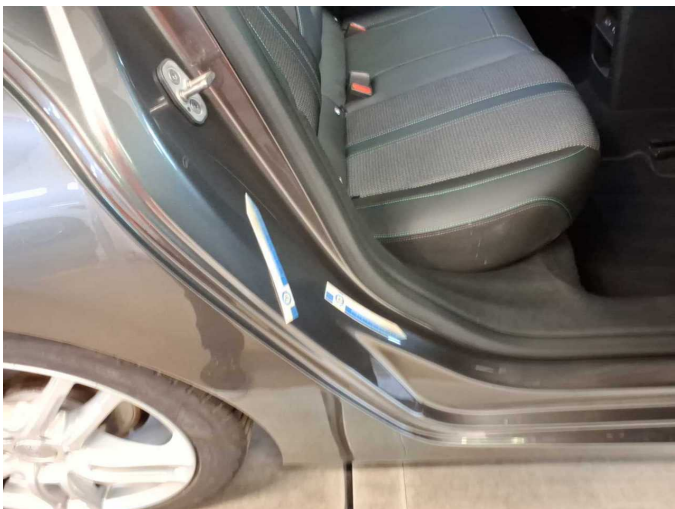
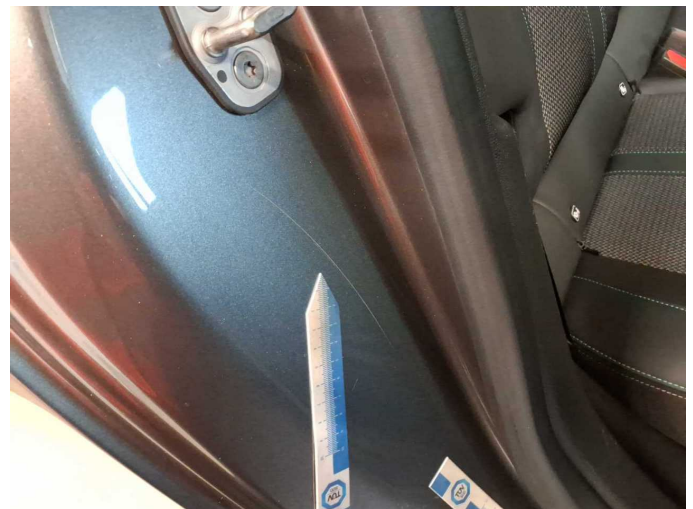
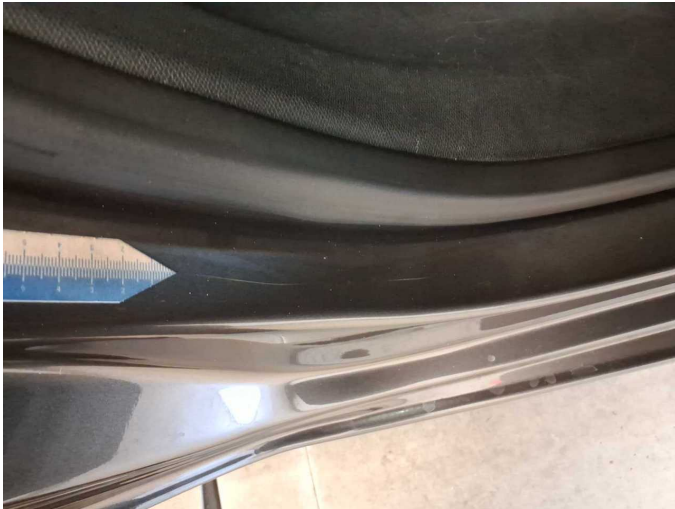
Damage 4: Side panel - rear right side: Sill - Scratch(es) - Smart repair

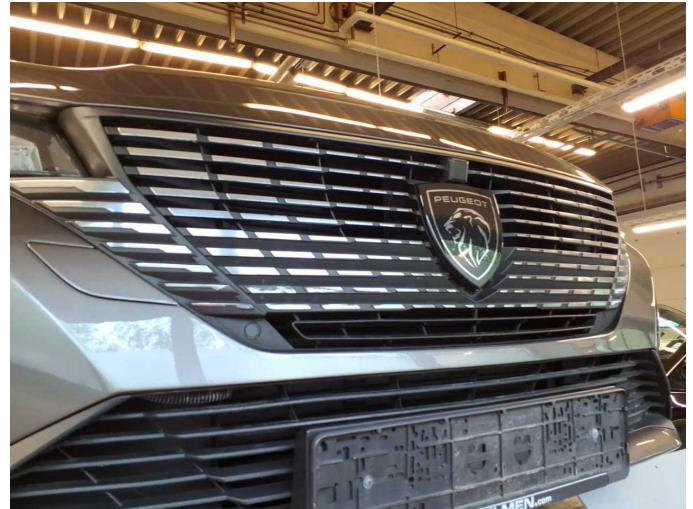
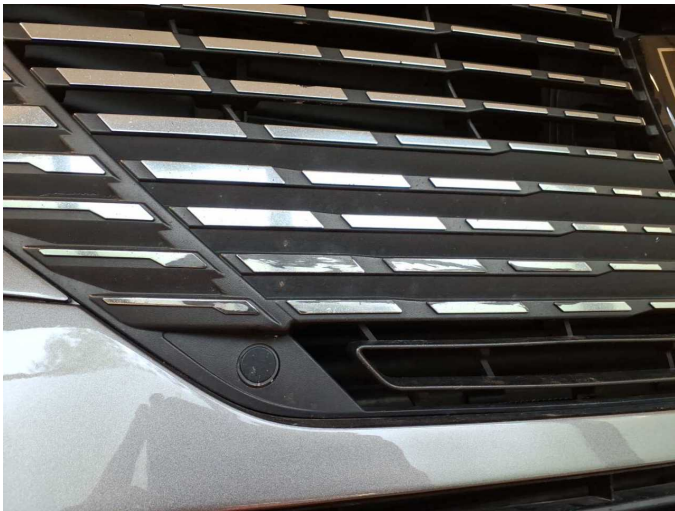
Damage 5: Front bumper: Grille - Scratch(es) - Loss in value

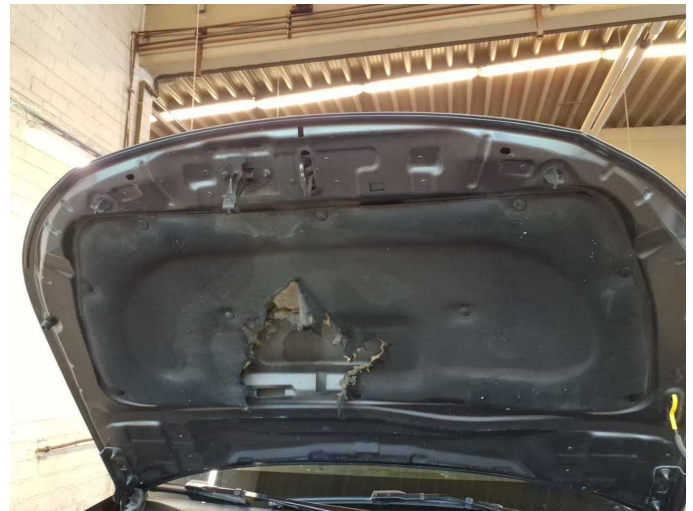
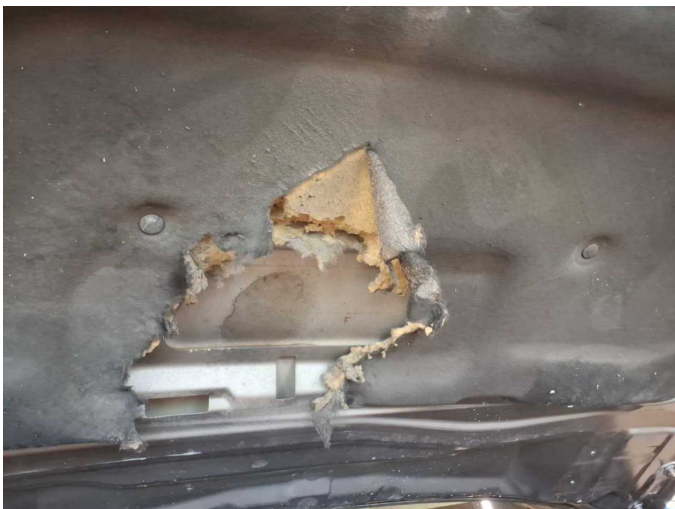
Damage 6: Bonnet: Insulation lining - Damage caused by marten / rodent - Replace

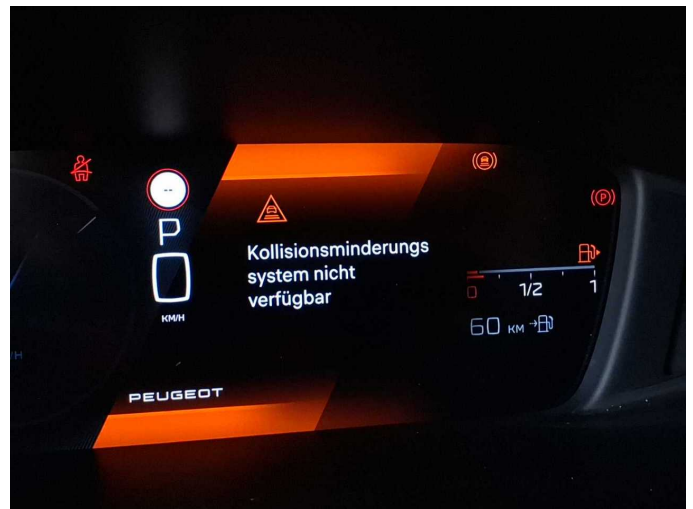
Damage 7: Instrument panel: Indicator light (Kollisionsfehler) - on - Perform diagnosis

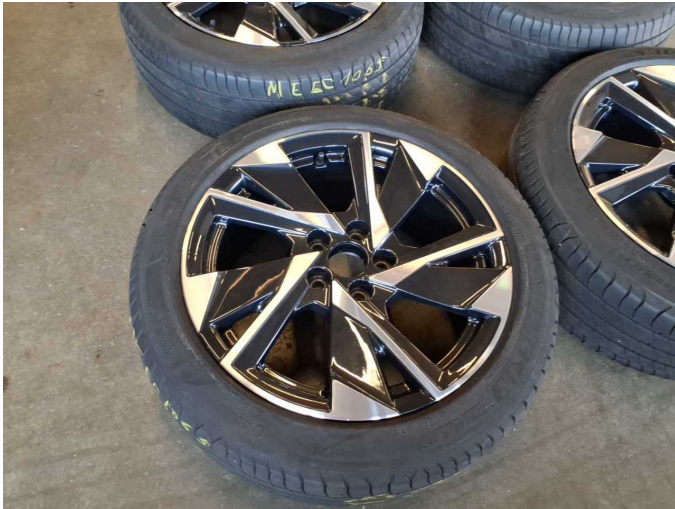
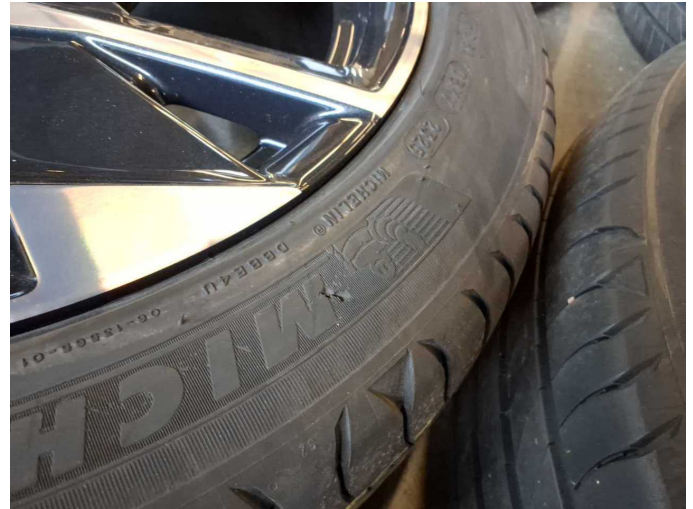
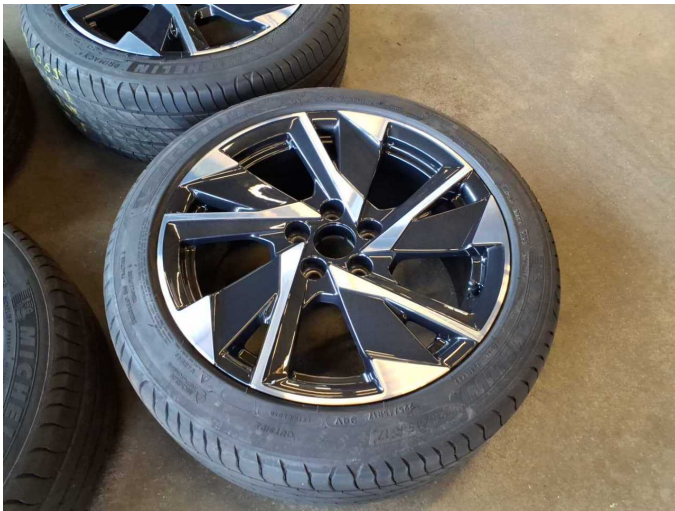
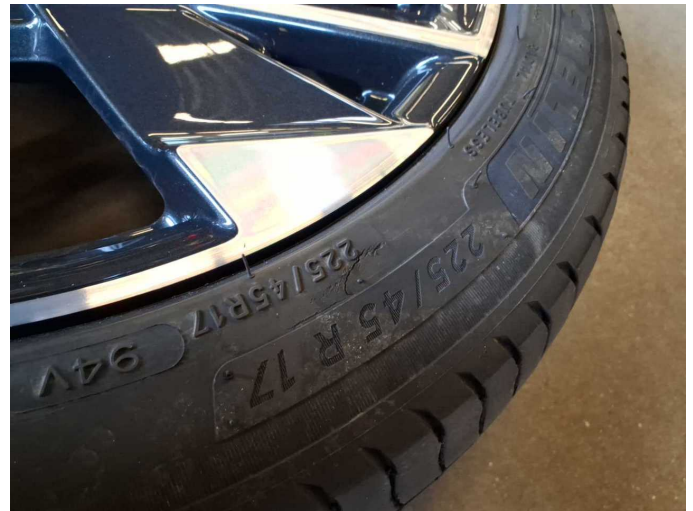
Damage 8: 2nd wheel set: 2 tyres - Damaged - Replace

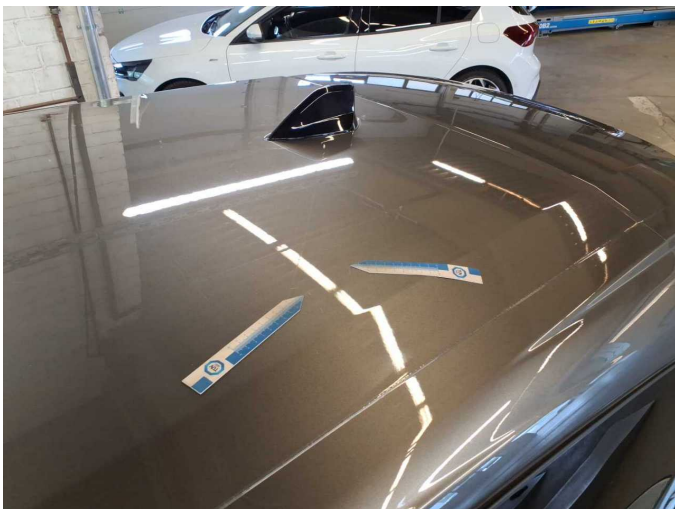
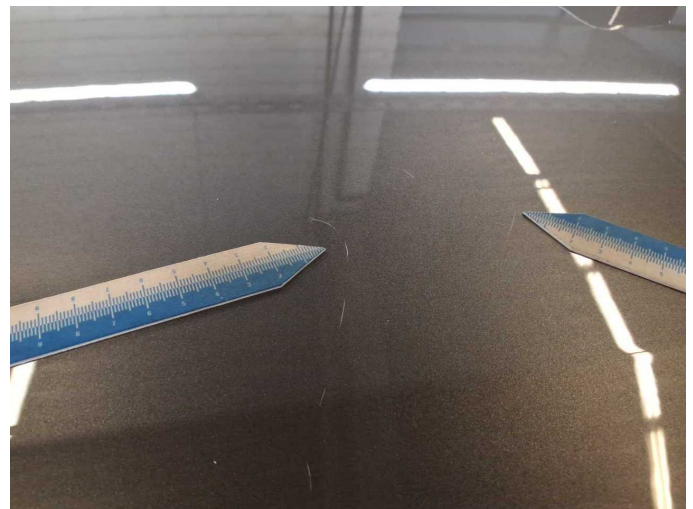
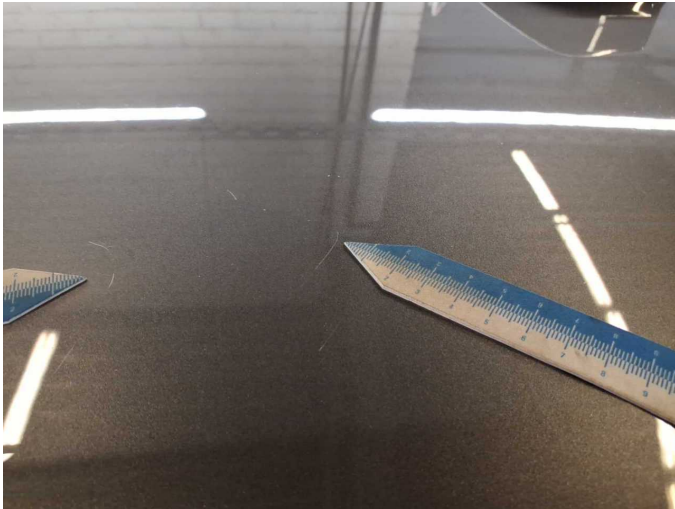
Damage 9: Roof: Roof - Scratch(es) - Paint

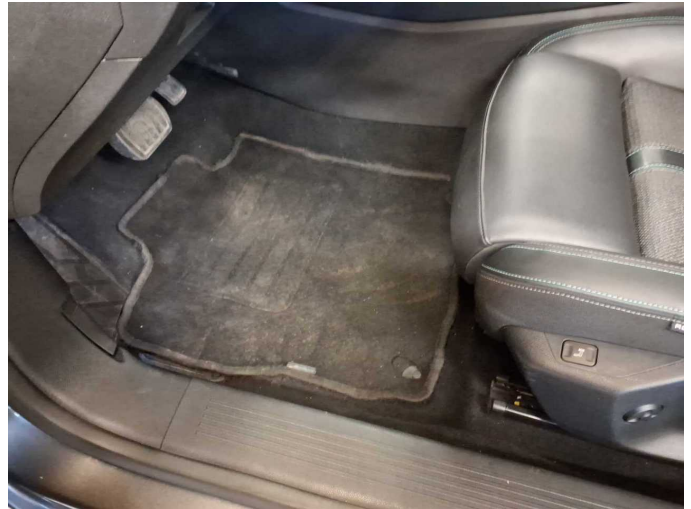
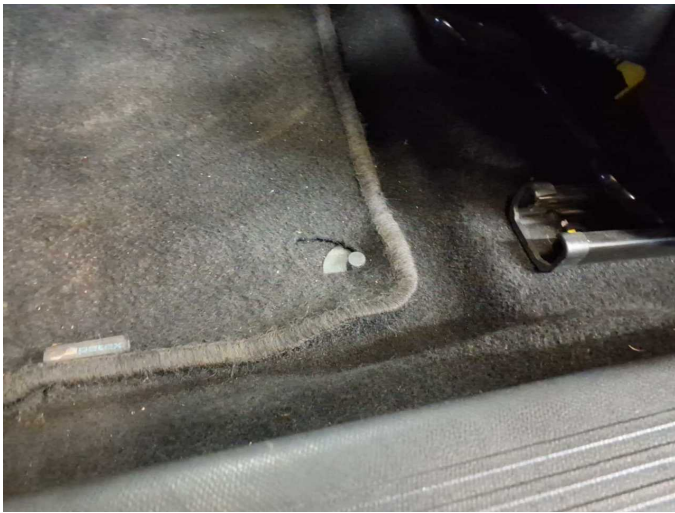
Wear and tear 3: Trim / covers: Floor mats - Broken / torn - No deduction

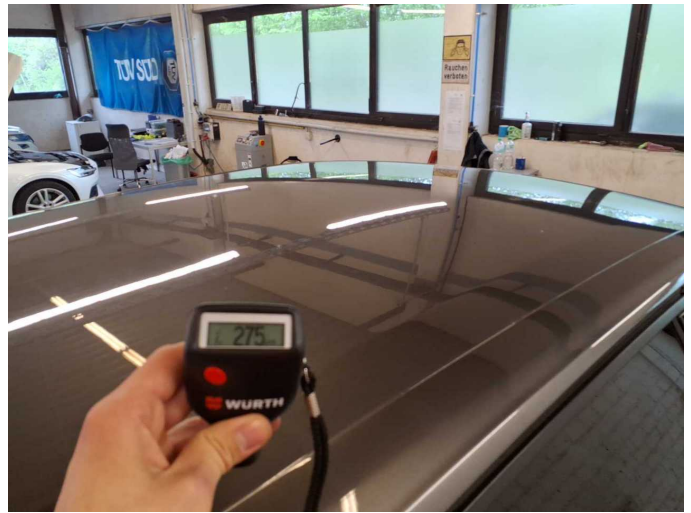
Repainting 1: Roof

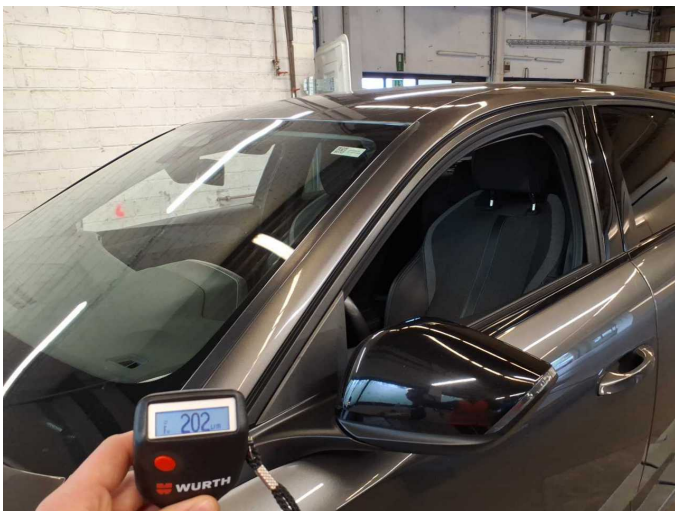
Repainting 2: Roof rail - left side

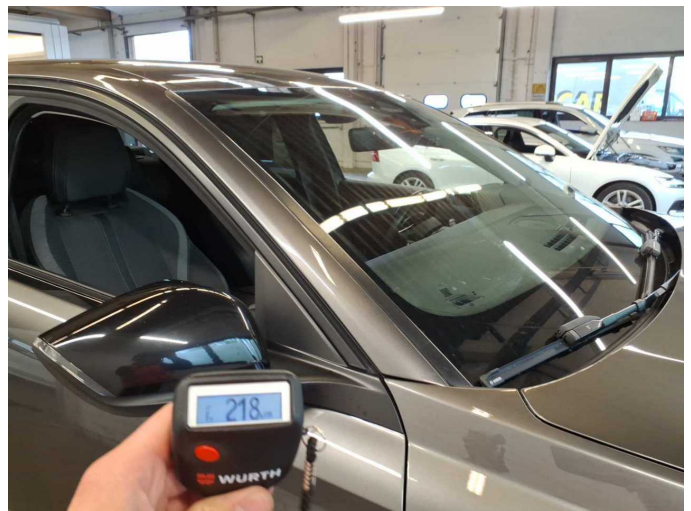
Repainting 3: Roof rail - right side

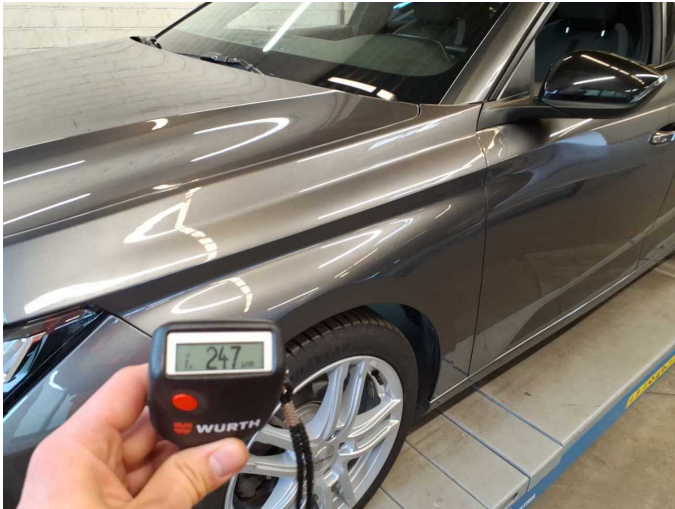
Repainting 4: Mudguard - left side

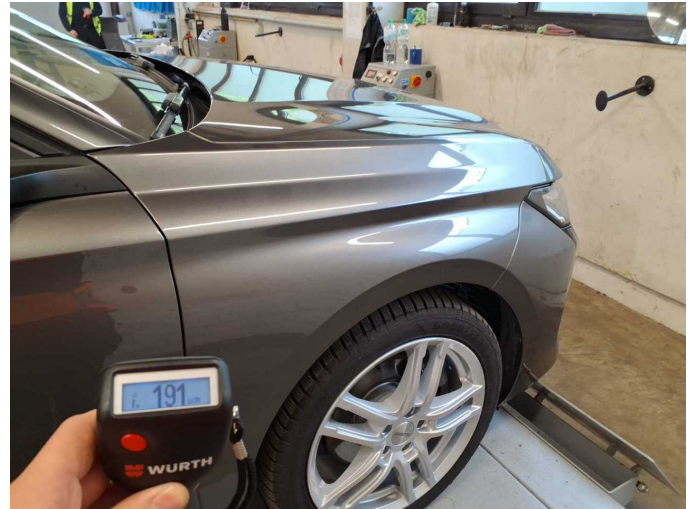
Repainting 5: Mudguard - right side

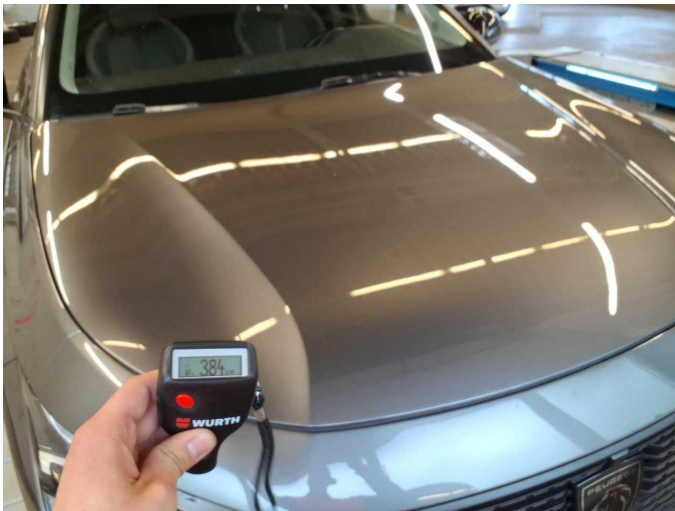
Repainting 6: Bonnet

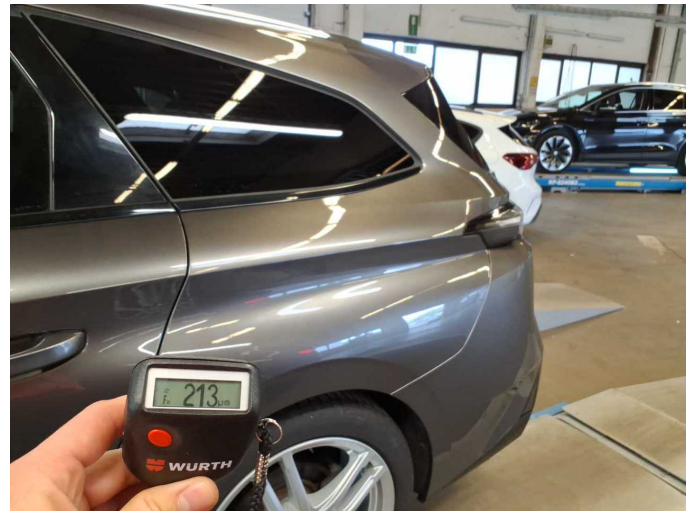
Repainting 7: Side panel - rear left side

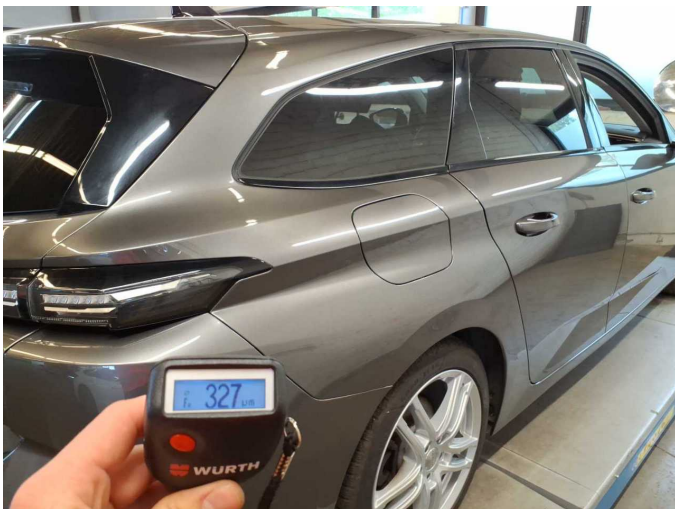
Repainting 8: Side panel - rear right side

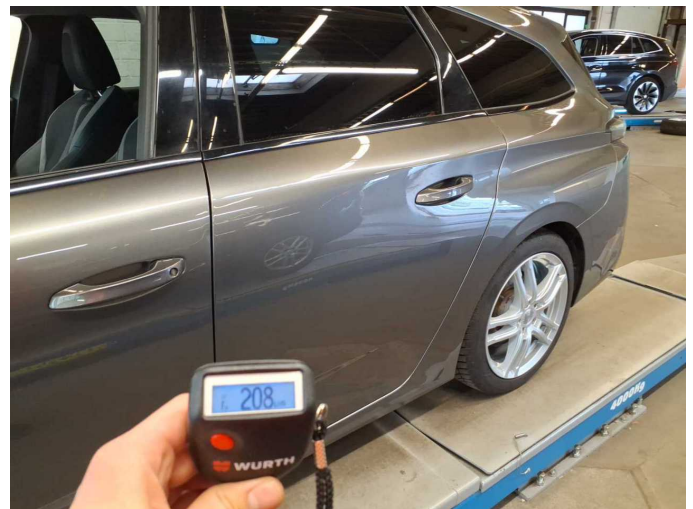
Repainting 9: Door - rear left side

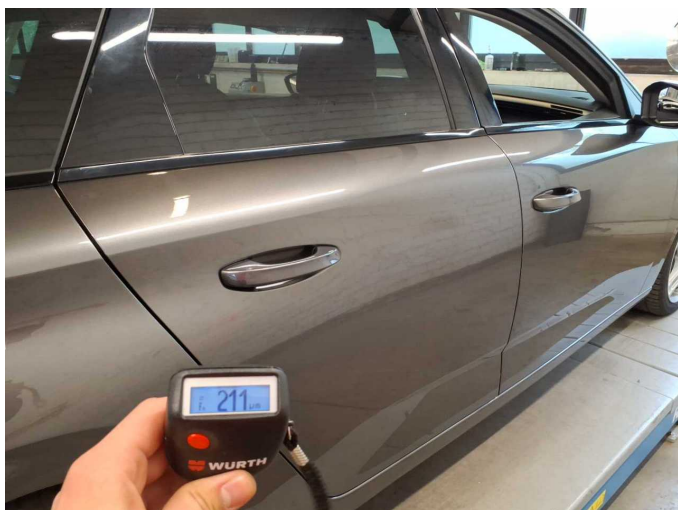
Repainting 10: Door - rear right side

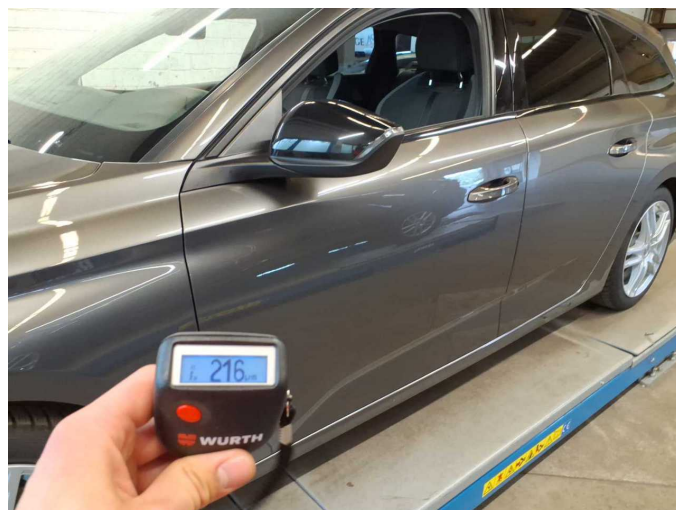
Repainting 11: Door - front left side

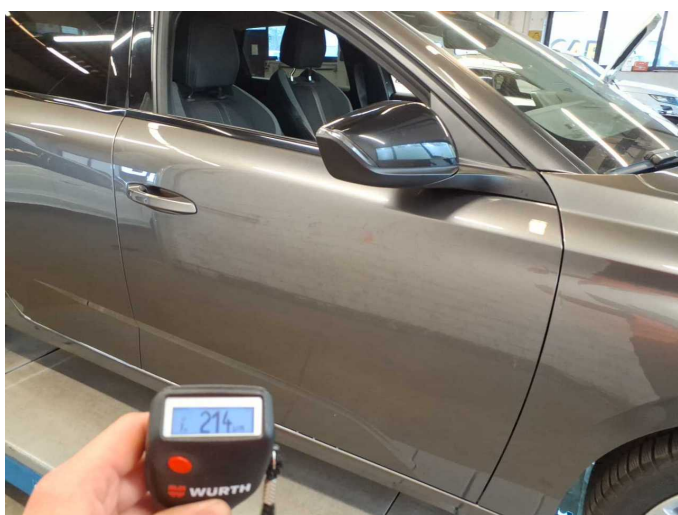
Repainting 12: Door - front right side
