- Vehicle Inspection Report -

Number: 10377218
From: 08.04.2026

Order number: 1002388632
Order completed: 07.04.2026 15:13
Report number: 10377218
VIN: WVVZZZ3CZPE047770

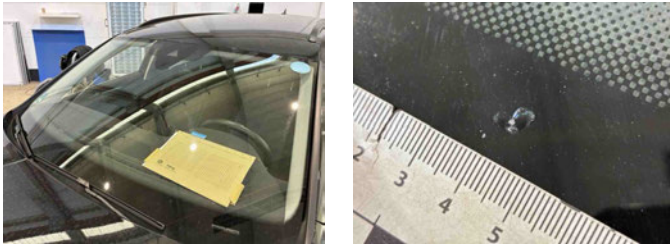
1 - Windscreen - Stone chip(s) - Replace

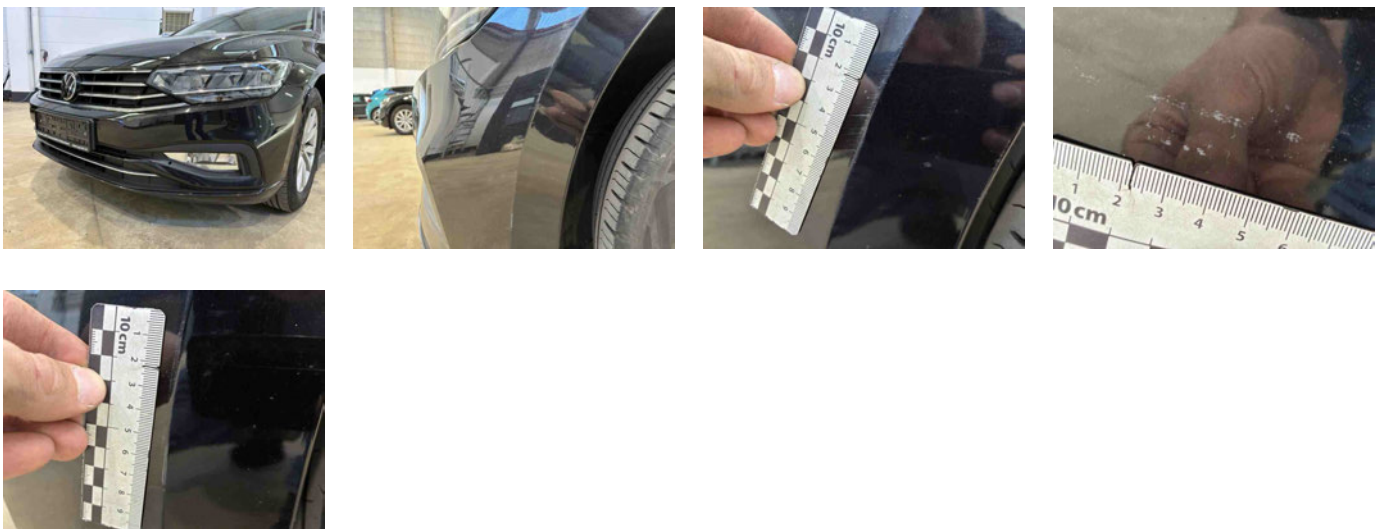
2 - Bumper F - Scratch(es) - Paint

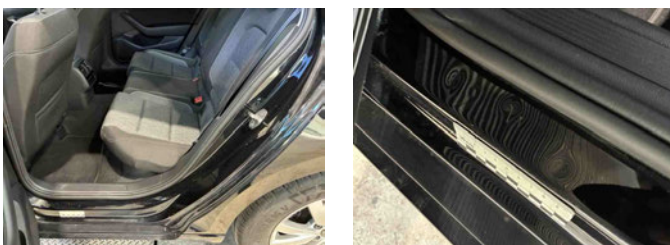
4 - Inner door sill RL - Dent(s) and scratch(es) - Repair and paint (complete)

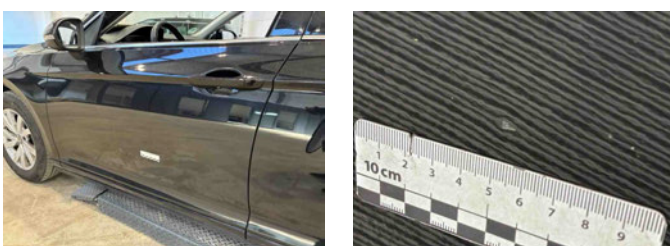
5 - Door FL - Dent(s) and scratch(es) - Spot repair
