Expertise

Protocol number: 45921710
Order No. / Reference: 26465957
Inspection date: 11 Jun 2026

Model: Kodiaq 2.0 TDI 4x4 DSG Ambition

VIN: TMBLJ9NS8N8041316

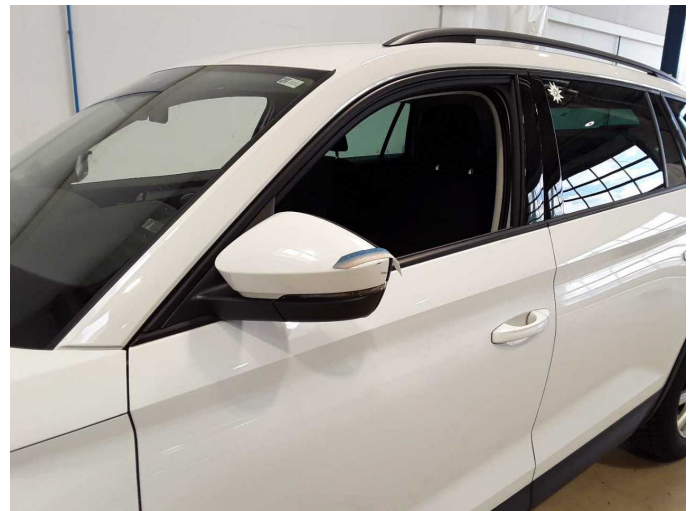
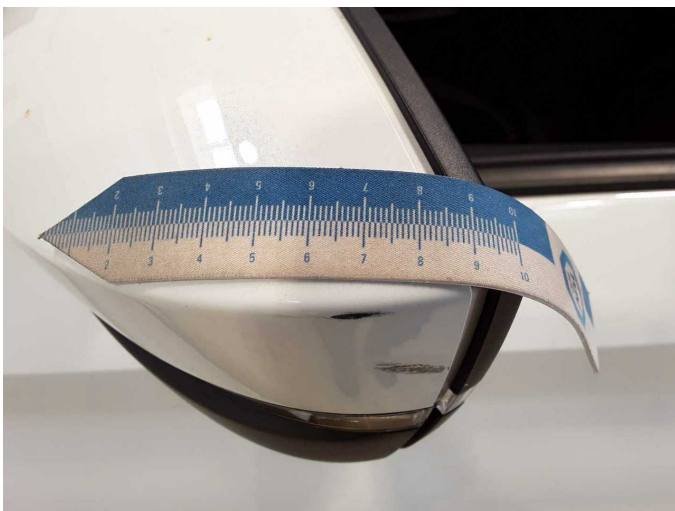
Damage 1: Wing mirror - left side: Cap - Scratch(es) - Smart repair

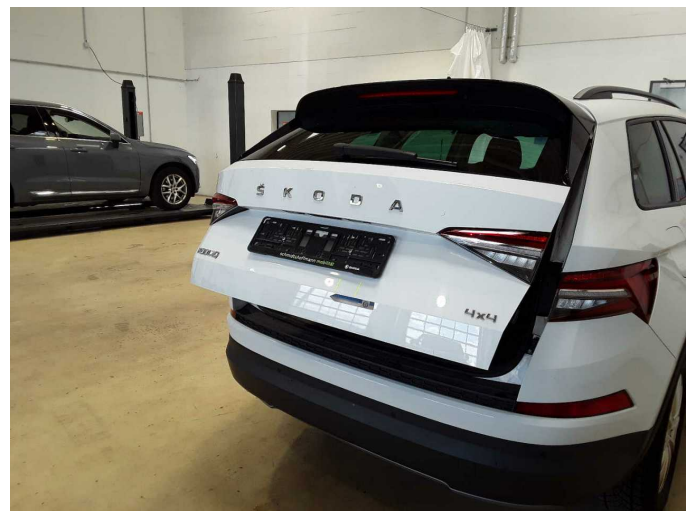
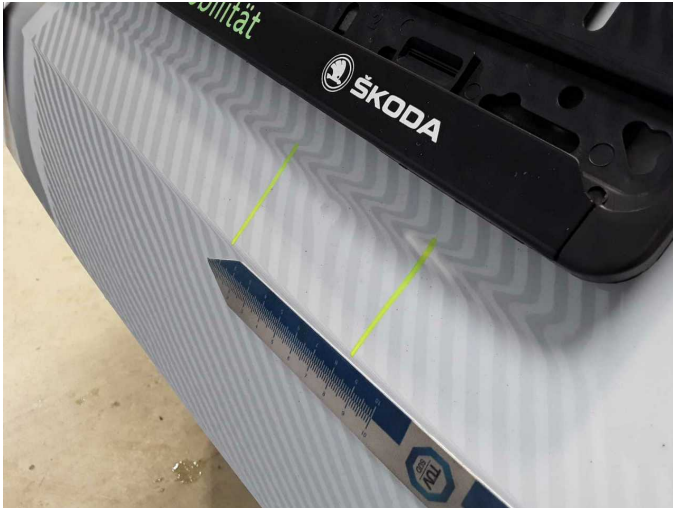
Damage 2: Boot lid / rear door: Boot lid - dent(s) - Smooth repair work

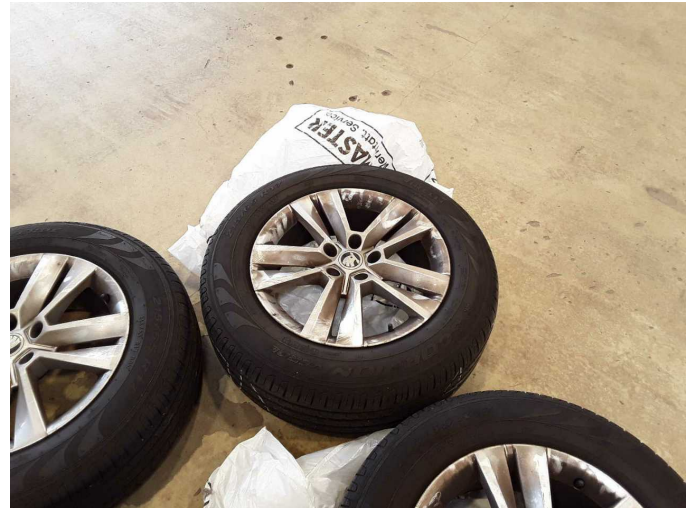
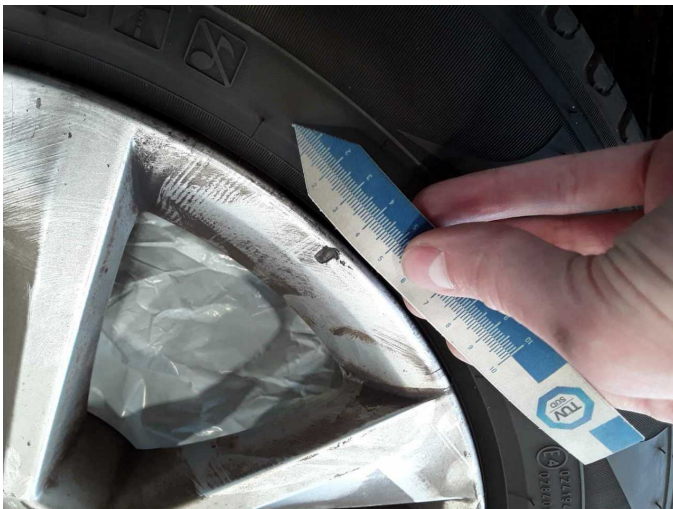
Damage 3: 2nd wheel set: 1 alloy rim - Scratch(es) - Loss in value

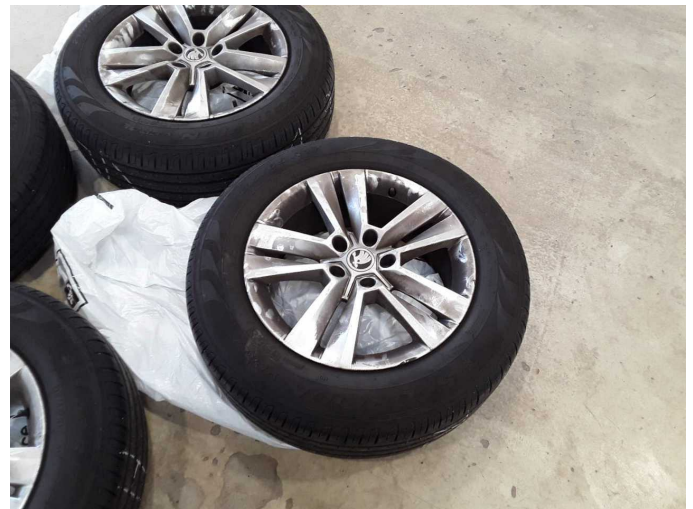
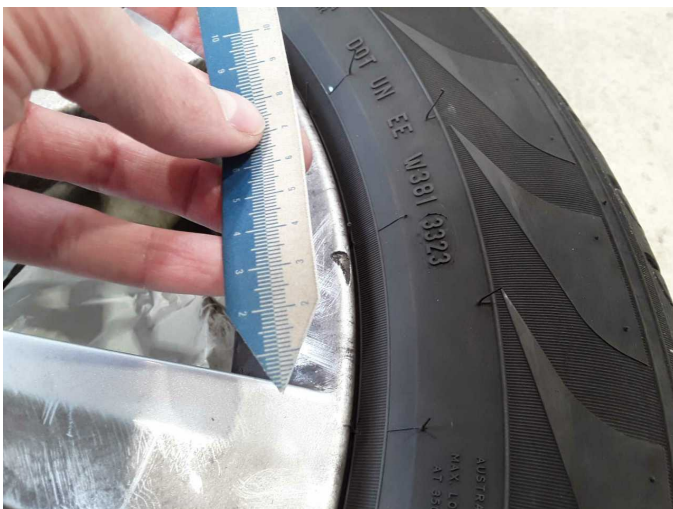
Damage 4: 2nd wheel set: 1 alloy rim - Scratch(es) - Loss in value

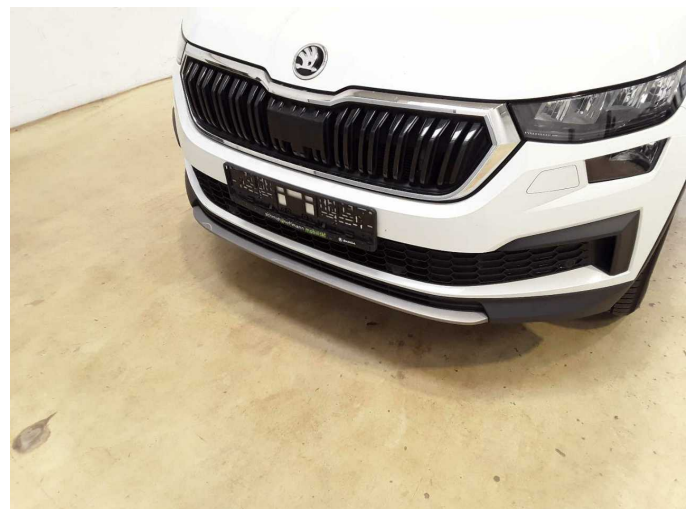
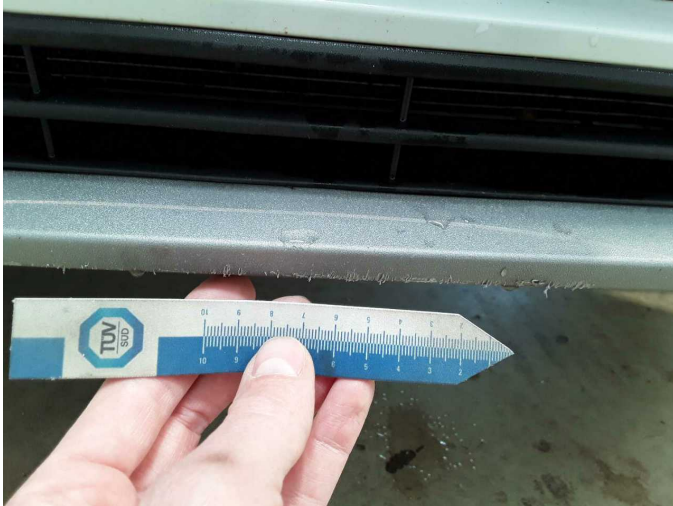
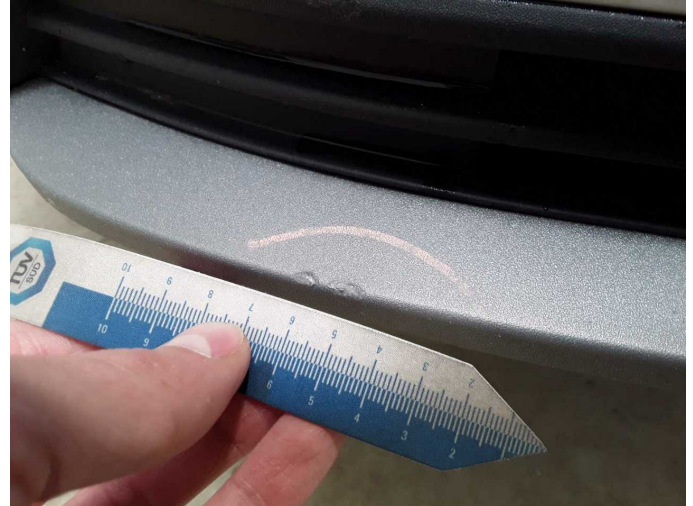
Damage 5: Front bumper: Spoiler - Scratch(es) - Replace

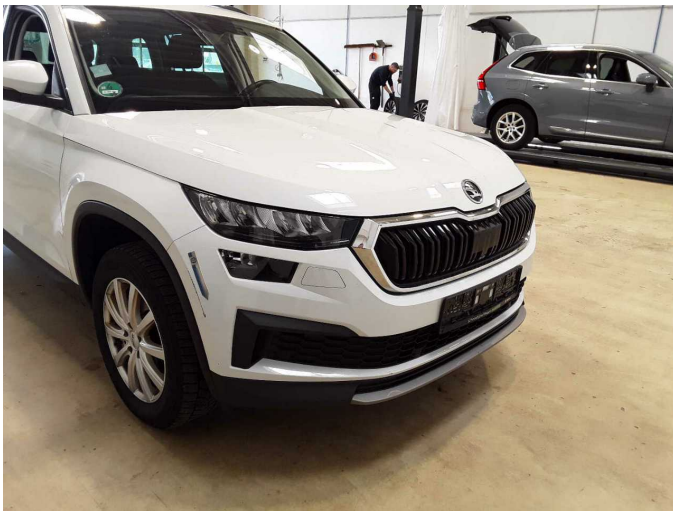
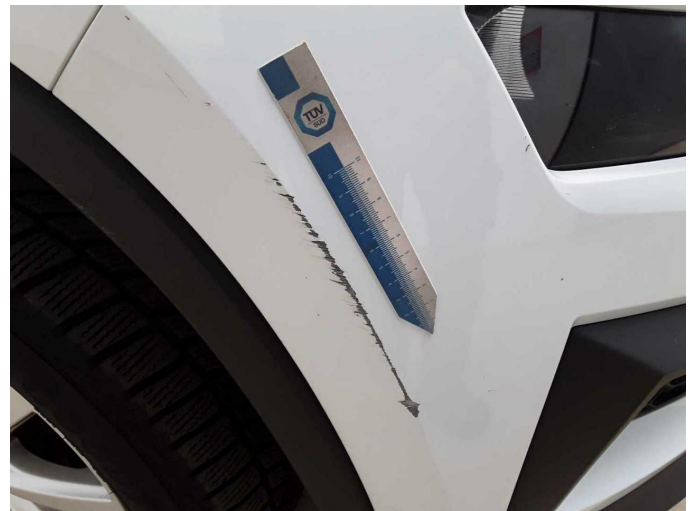
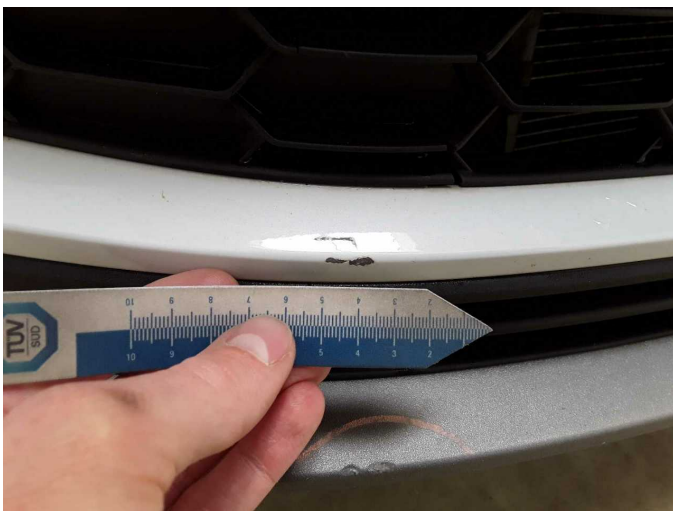
Damage 6: Front bumper: Front bumper - Scratch(es) - Paint
