Expertise

Protocol number: 46616694  
Order No. / Reference: 26718246  
Inspection date: 21 Jul 2026

Manufacturer: Skoda  
VIN: TMBLN9NS8P8039783

Model: Kodiaq 2.0 TDI 4x4 DSG Sportline

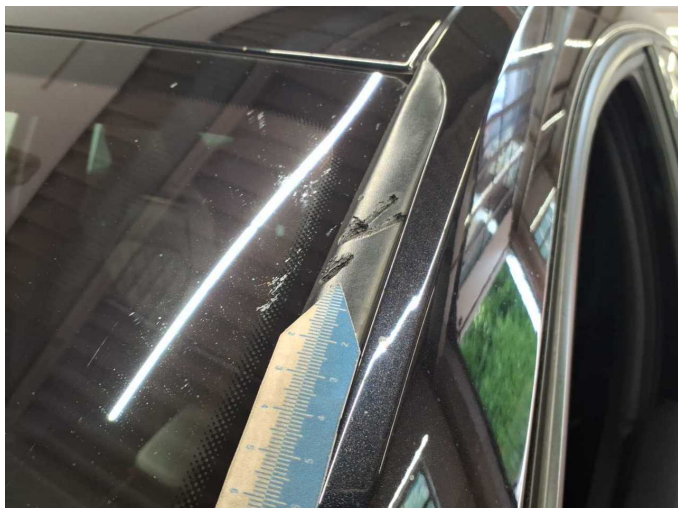
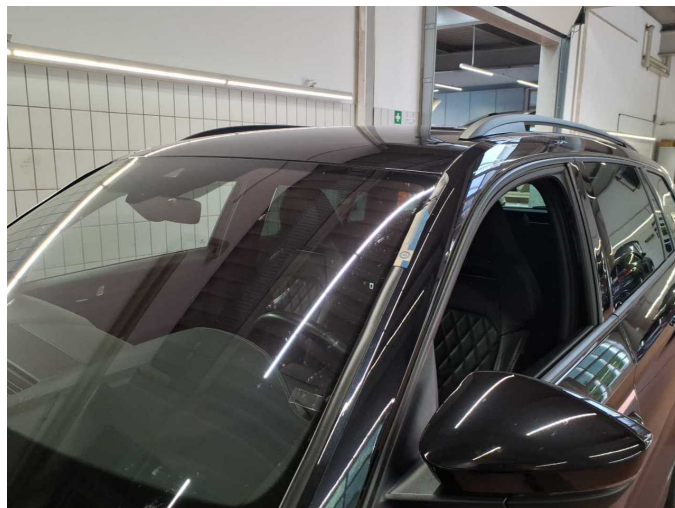
| No. | Component group | Description |
|---|---|---|
| 1 | Roof | Cowl - left side - Scratch(es) - Replace |

**Damage 1:** Roof: Cowl - left side - Scratch(es) - Replace

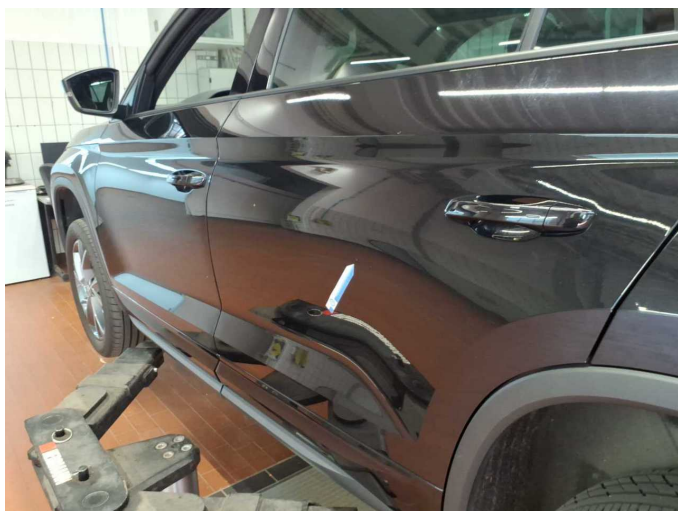
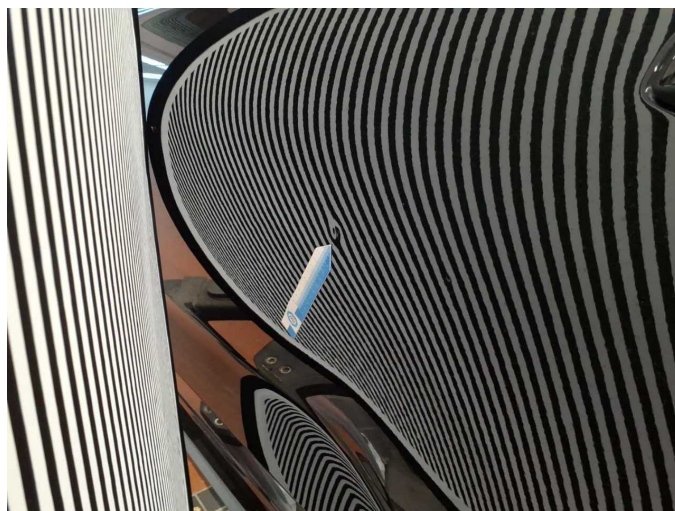
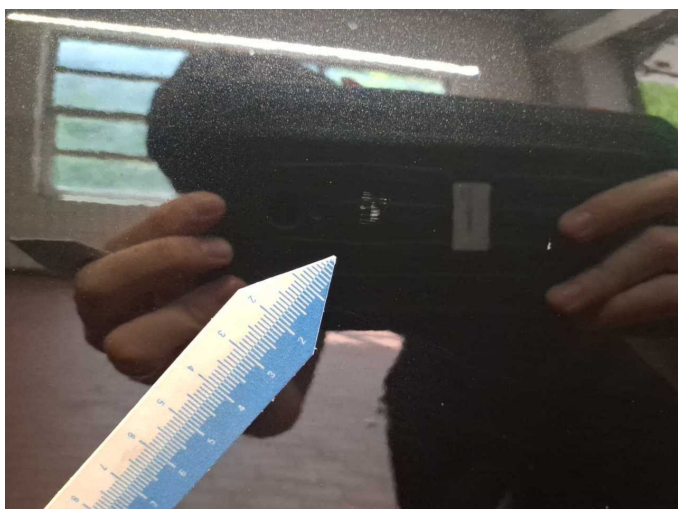
| No. | Component group | Description |
|---|---|---|
| 2 | Door - rear left side | Door - Dent / paintcoat damage - Smart repair |

**Damage 2:** Door - rear left side: Door - Dent / paintcoat damage - Smart repair

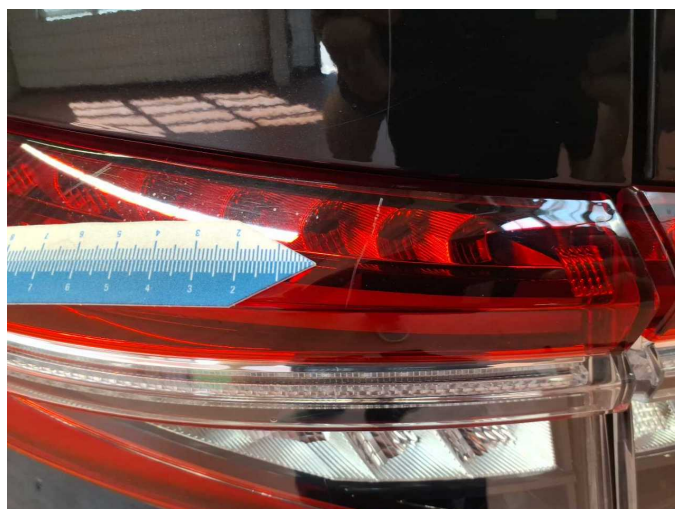
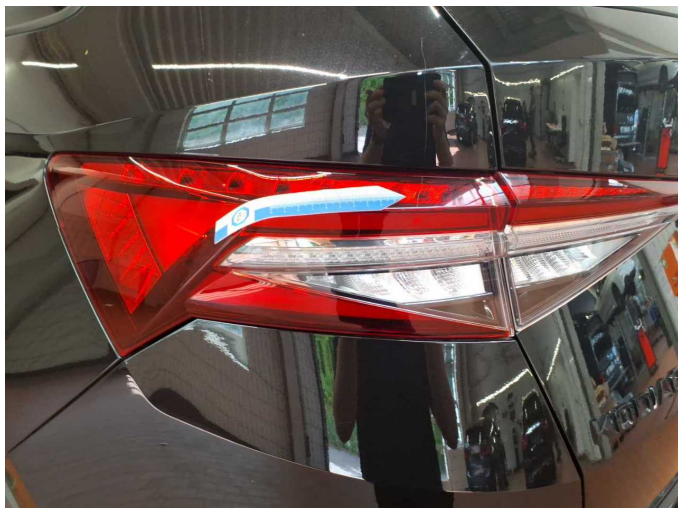
| No. | Component group | Description |
|---|---|---|
| 3 | Tail light | Tail lamp - left side - Scratch(es) - Replace |

**Damage 3:** Tail light: Tail lamp - left side - Scratch(es) - Replace

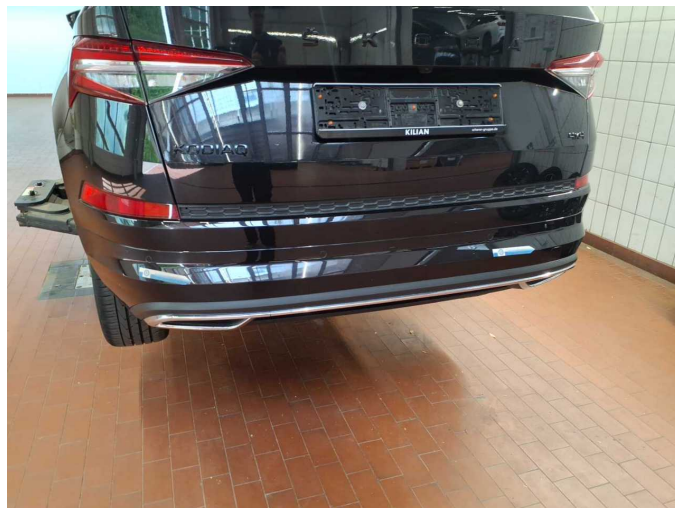
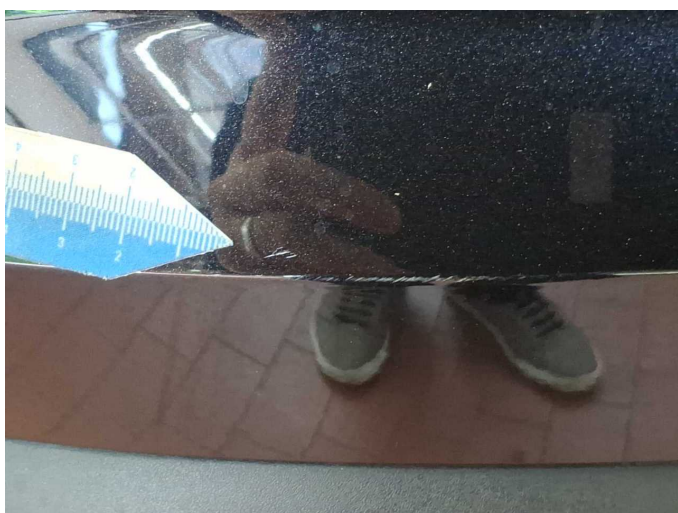
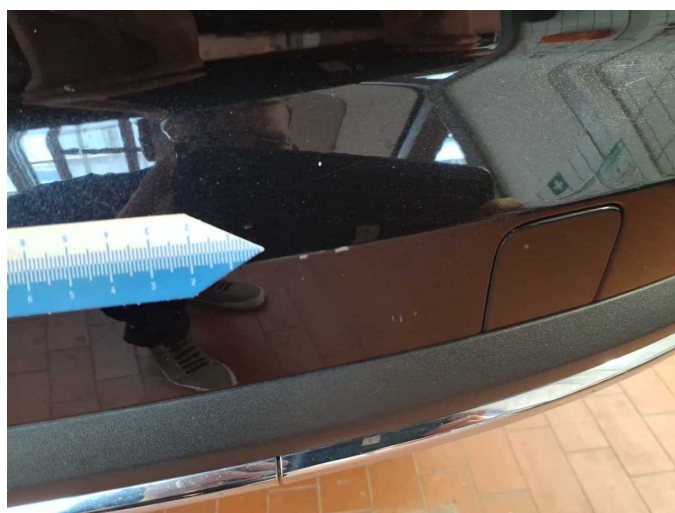
| No. | Component group | Description |
|---|---|---|
| 4 | Rear bumper | Rear bumper - Scratch(es) - Paint |

**Damage 4:** Rear bumper: Rear bumper - Scratch(es) - Paint

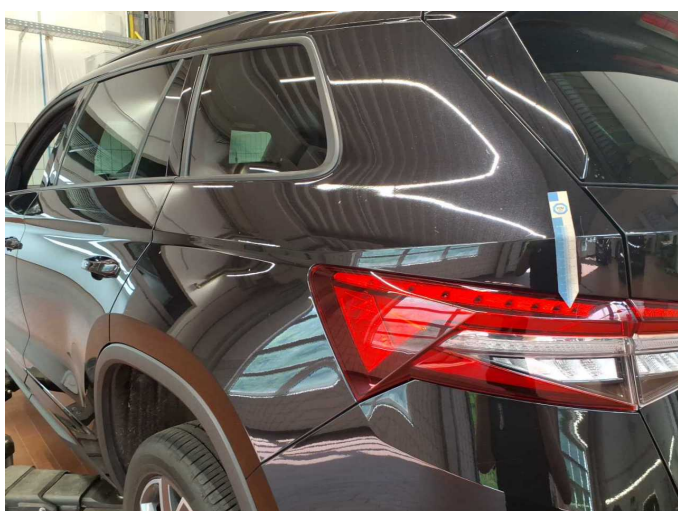
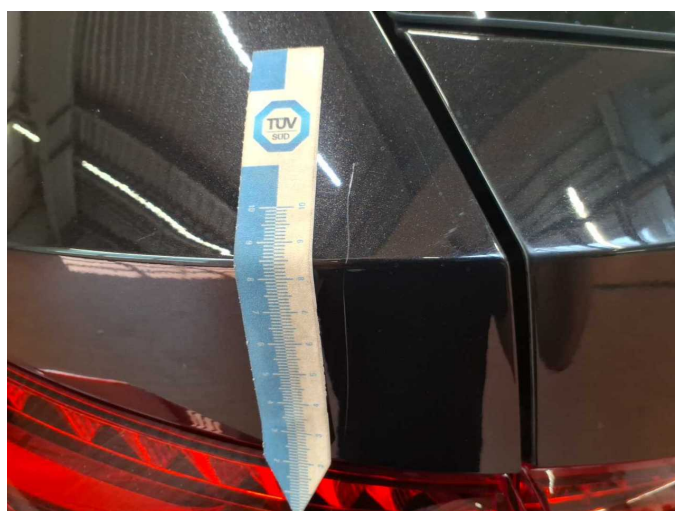
| No. | Component group | Description |
|---|---|---|
| 5 | Side panel - rear left side | Side panel - Scratch(es) - Paint |

**Damage 5:** Side panel - rear left side: Side panel - Scratch(es) - Paint

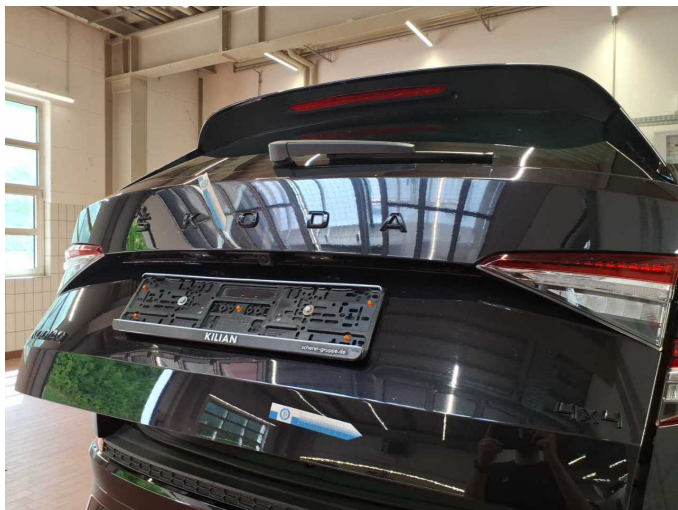
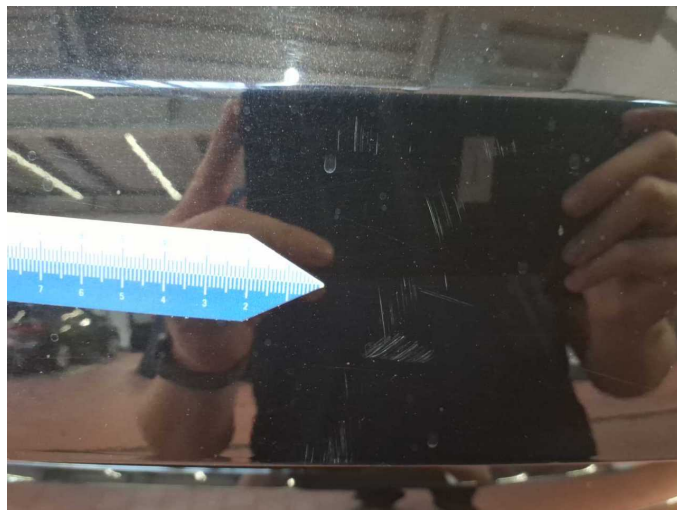
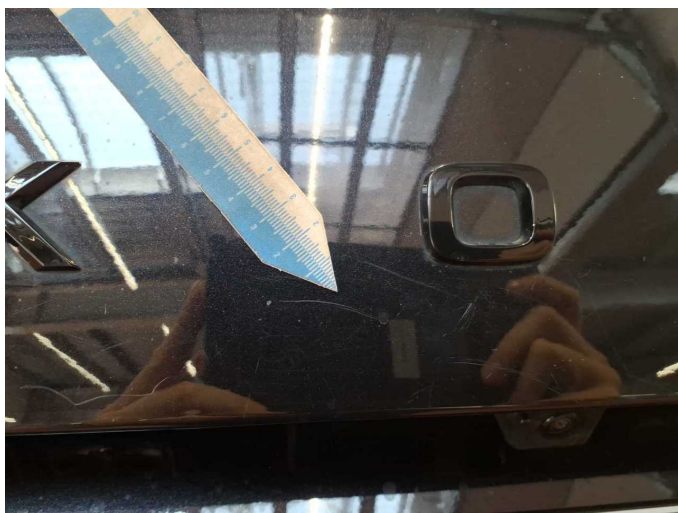
| No. | Component group | Description |
|---|---|---|
| 6 | Boot lid / rear door | Boot lid - Scratch(es) - Paint |

**Damage 6:** Boot lid / rear door: Boot lid - Scratch(es) - Paint

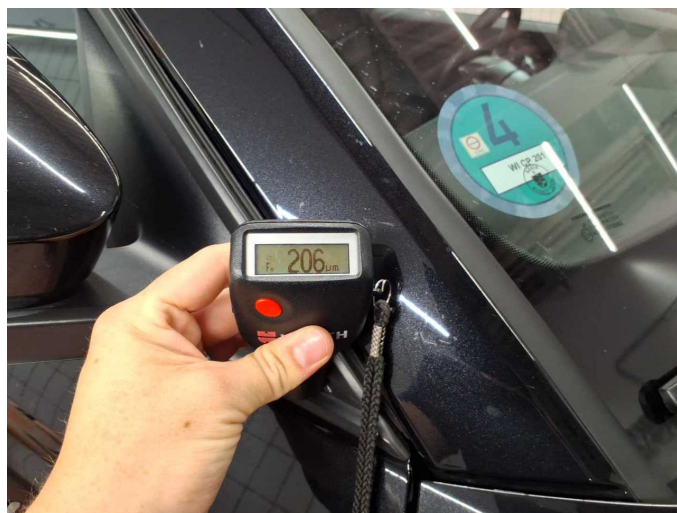
| 1 | Roof rail - right side, Professionally carried out, Invoice of repair done Non-existent |

| Roof rail - right side | 206 µm | Side panel - rear right side | 182 µm |

**Repainting 1:** Roof rail - right side

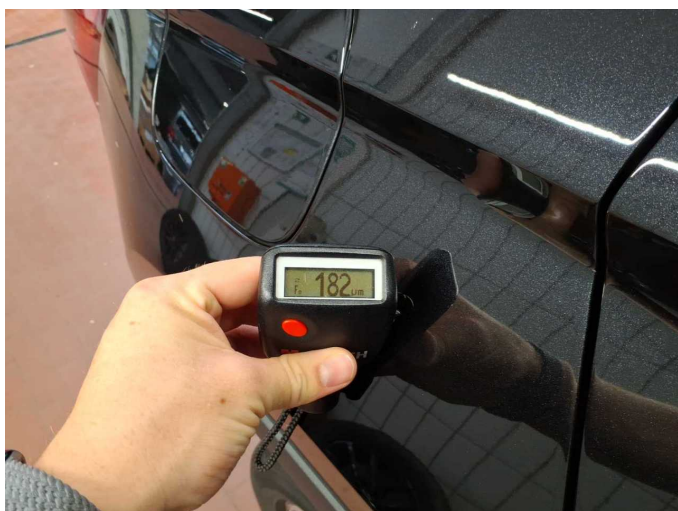
| 2 | Side panel - rear right side, Professionally carried out, Invoice of repair done Non-existent |

**Repainting 2:** Side panel - rear right side

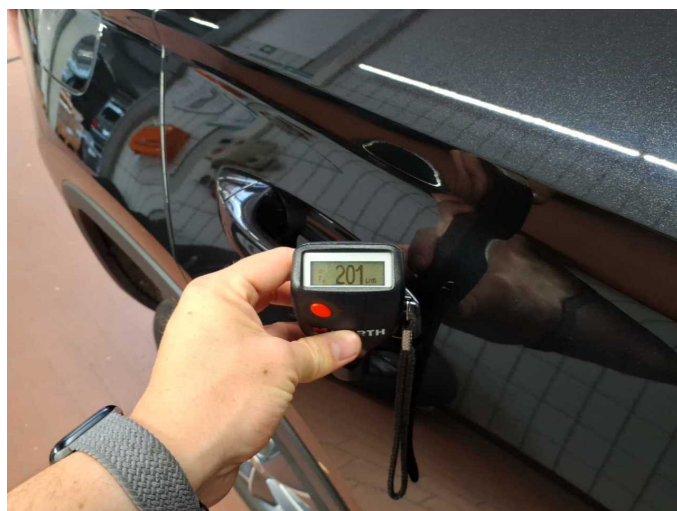
| 3 | Door - rear right side, Professionally carried out, Invoice of repair done Non-existent |

| Door - rear right side | 201 µm | Door - front right side | 194 µm |

**Repainting 3:** Door - rear right side

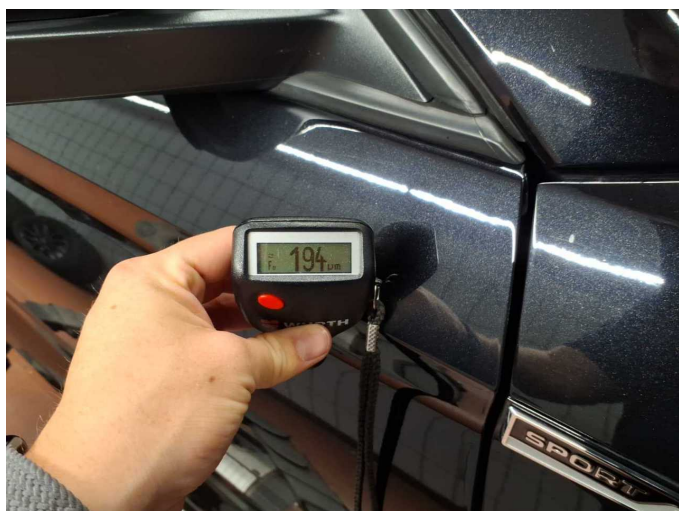
| 4 | Door - front right side, Professionally carried out, Invoice of repair done Non-existent |

**Repainting 4:** Door - front right side
