## Expertise

Protocol number: 45360782  
Order No. / Reference: 26264054  
Inspection date: 6 May 2026

Model: Astra 1.5 D Start/Stop Sports Tourer Automatik Edition

VIN: W0VBD8EV0N8042635

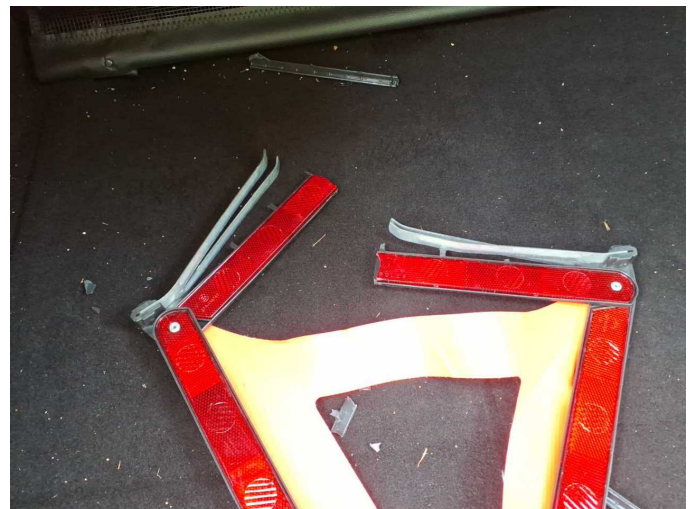
Damage 2: Equipment: Warning triangle - Broken / torn - Replace

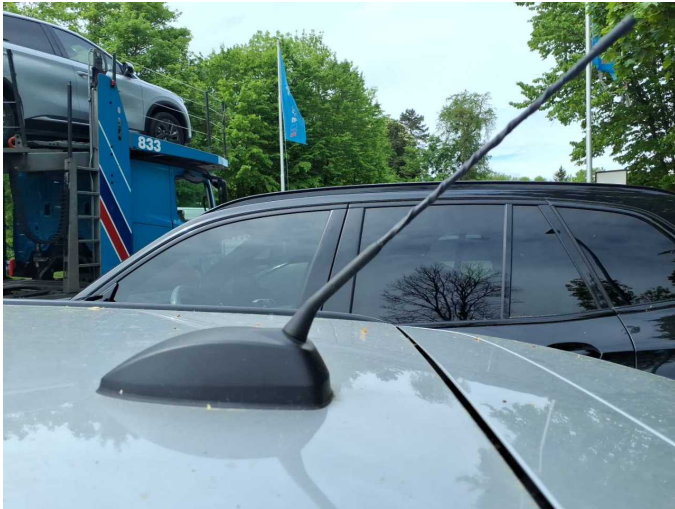
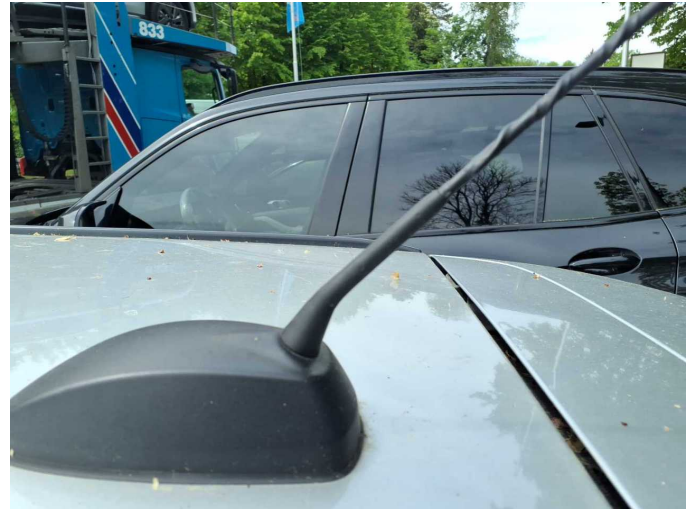
**Damage 4:** Roof: Stub aerial (Knick) - Broken / torn - Replace

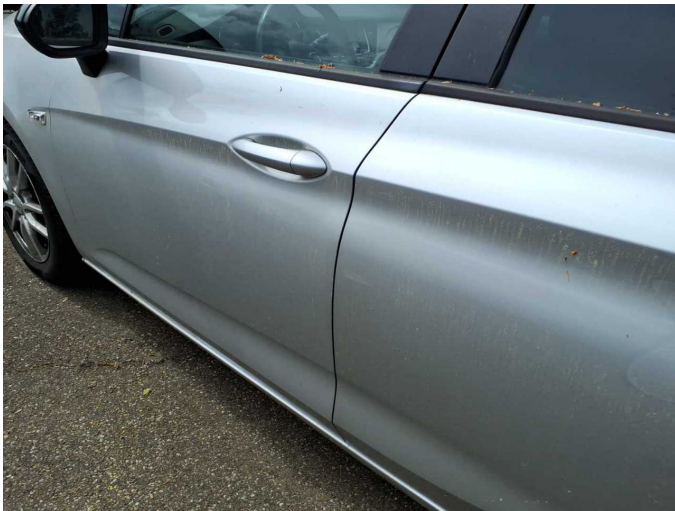
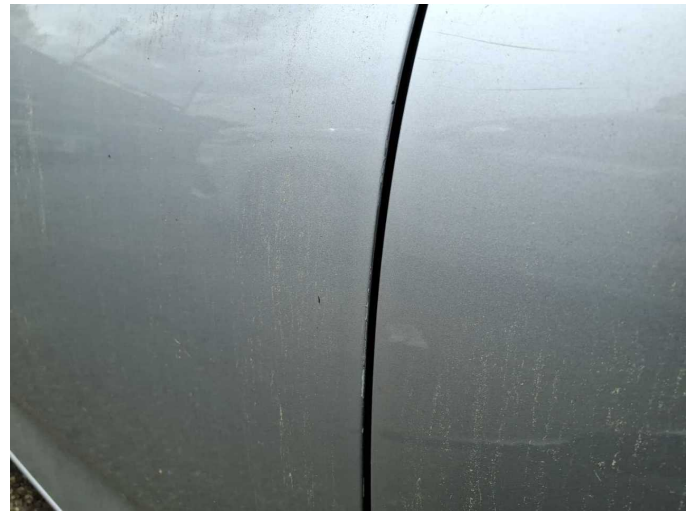
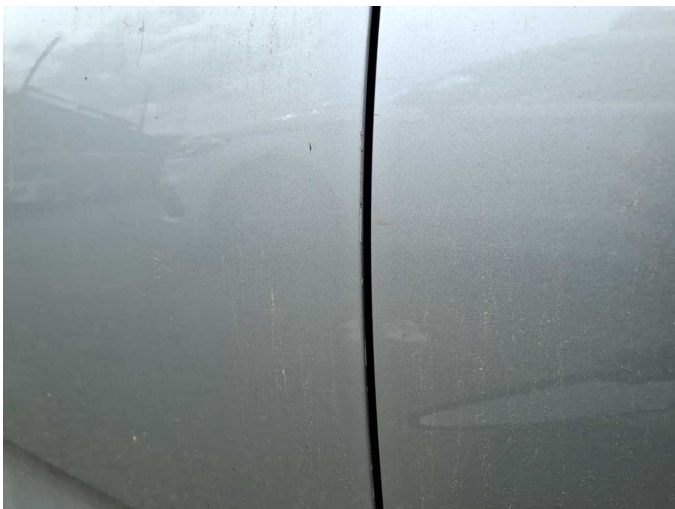
**Damage 5:** Door - front left side: Door edge - Scratch(es) - Smart repair

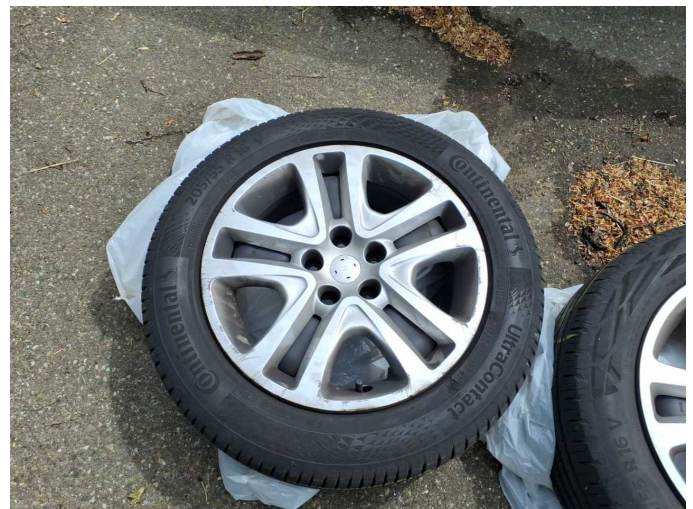
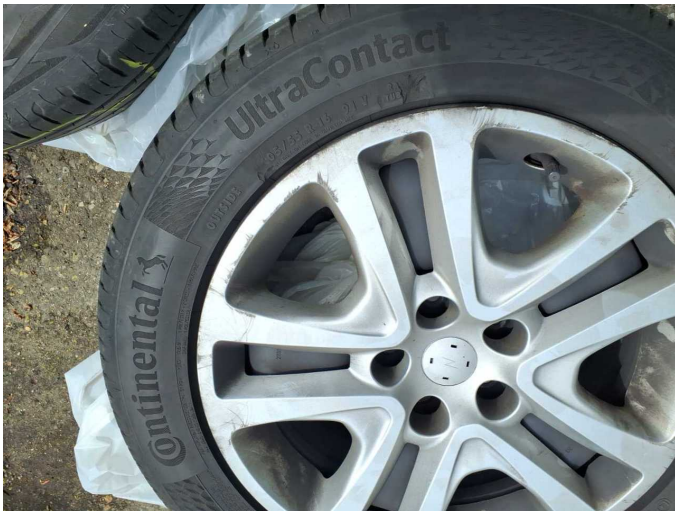
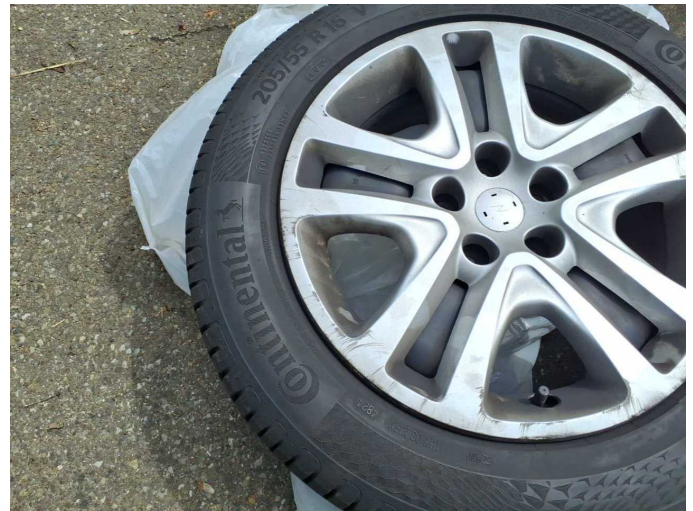
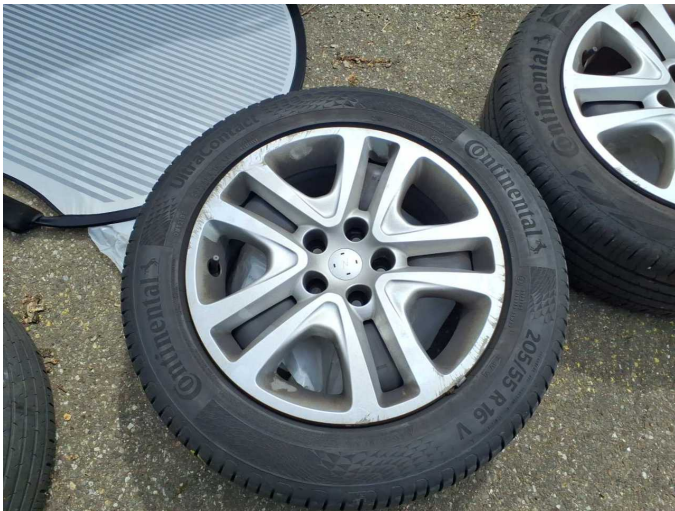
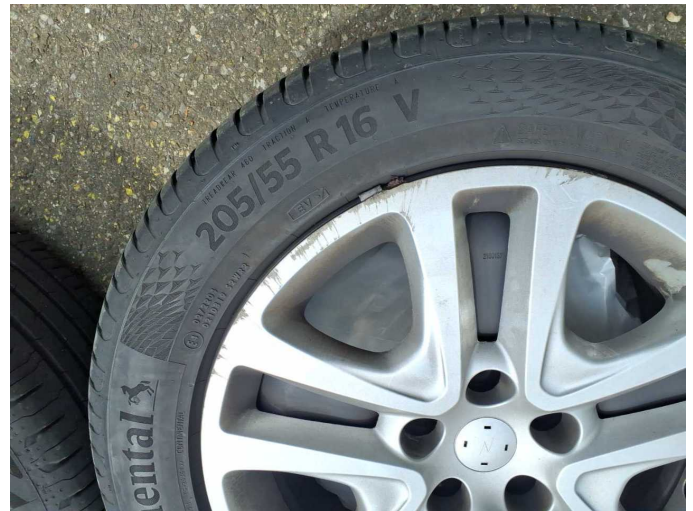
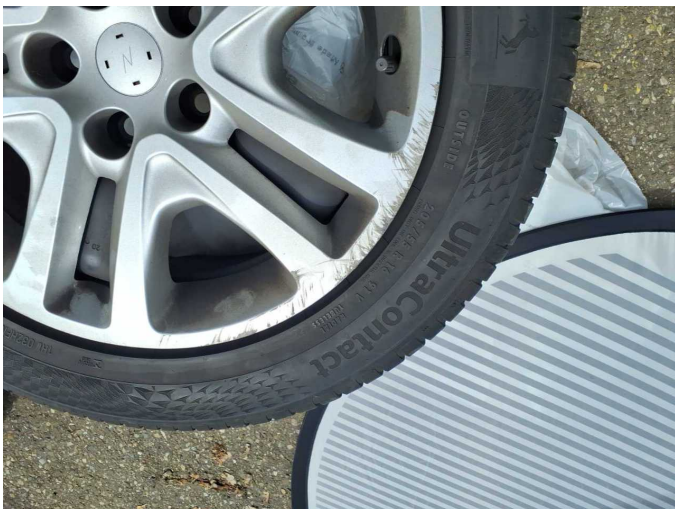
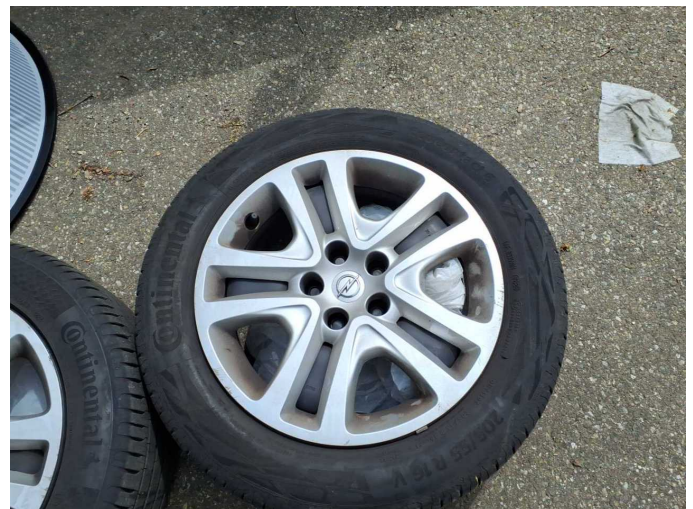
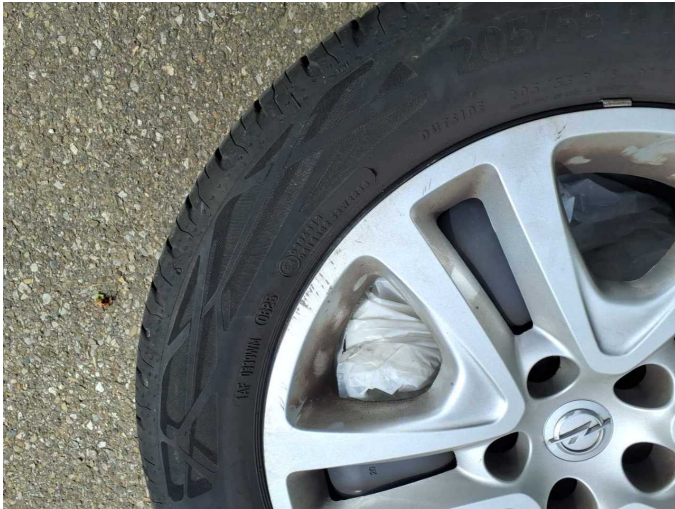
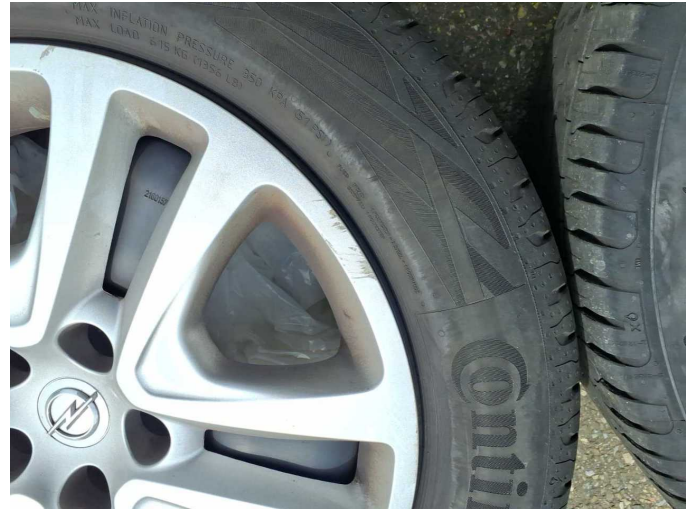
**Damage 6:** 2nd wheel set: 3 wheel covers - Scratch(es) - Replace

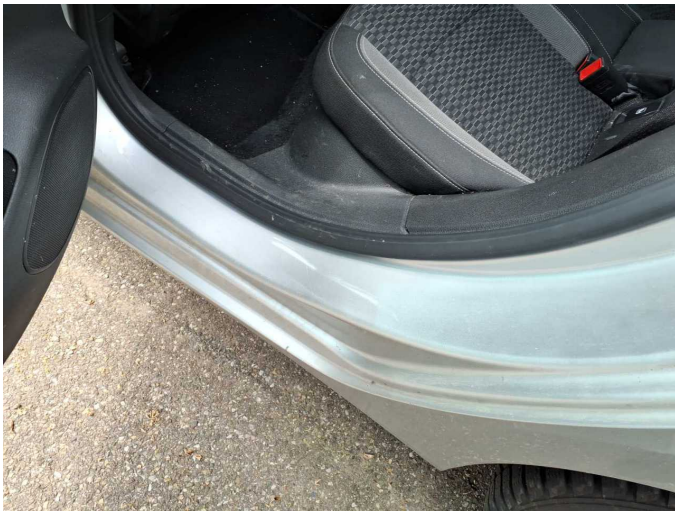
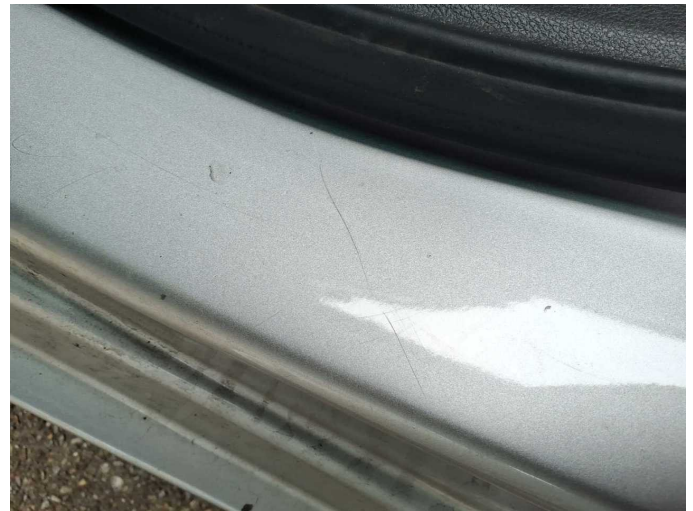
**Damage 7:** Side panel - rear left side: Sill - Scratch(es) - Smart repair

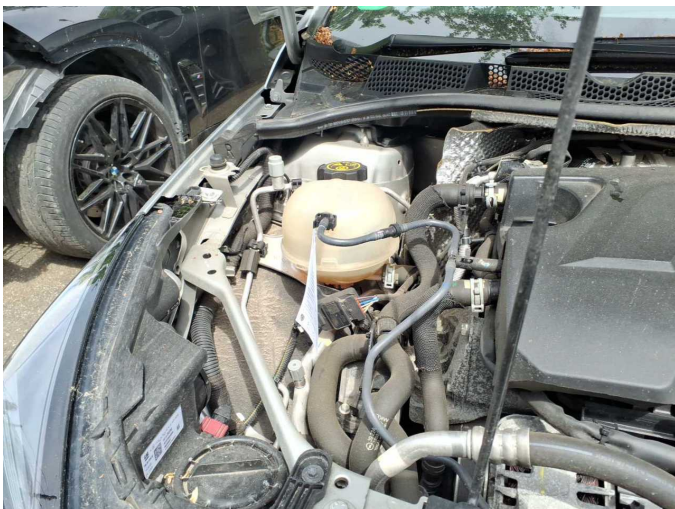
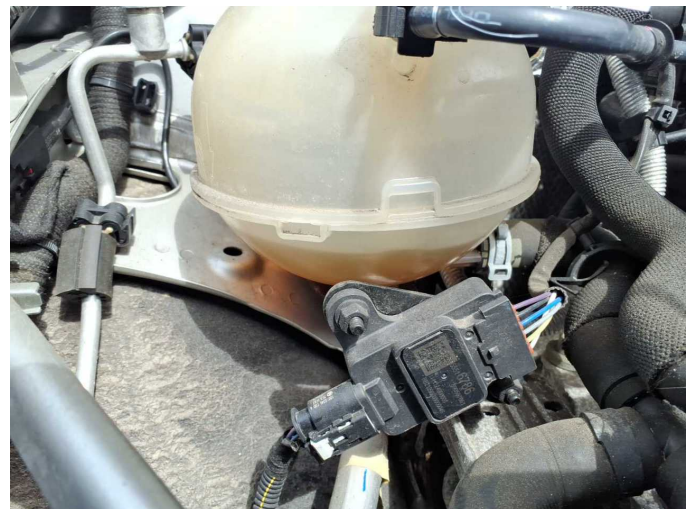
**Damage 8:** Engine cooling: Coolant - Missing - Perform diagnosis

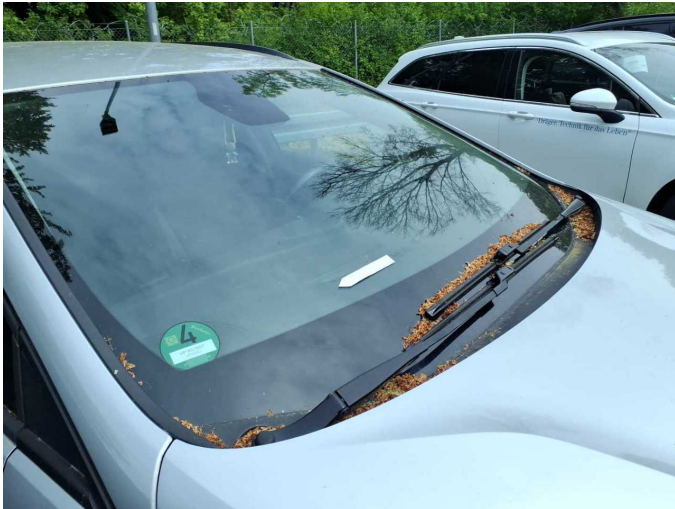
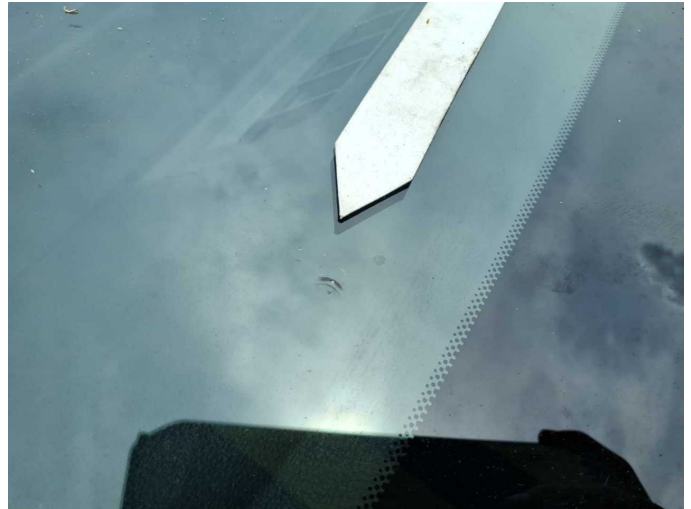
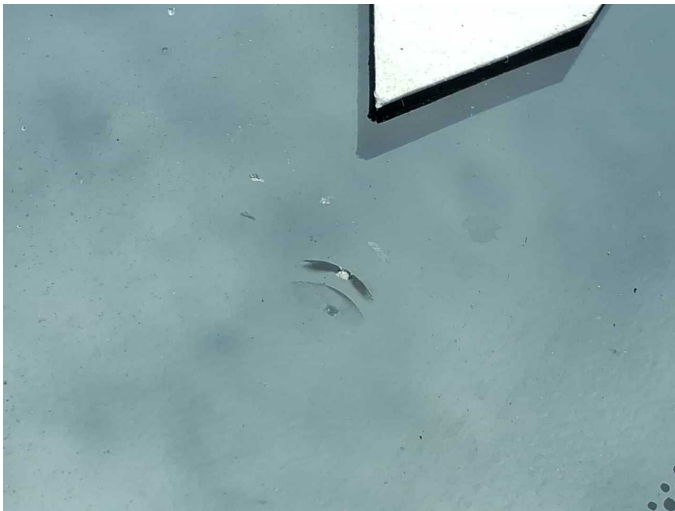
**Damage 9:** Vehicle glazing: Windscreen - Stone chips - Replace

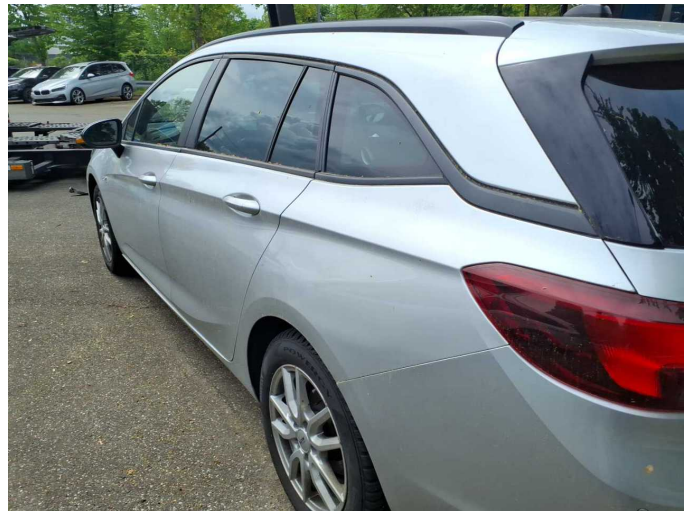
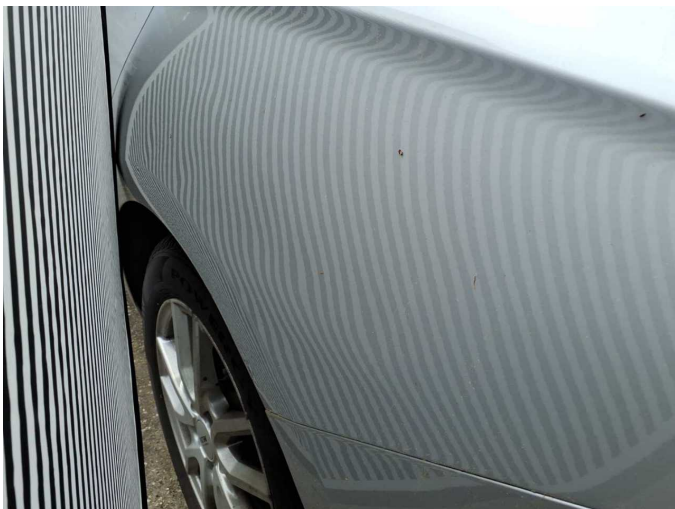
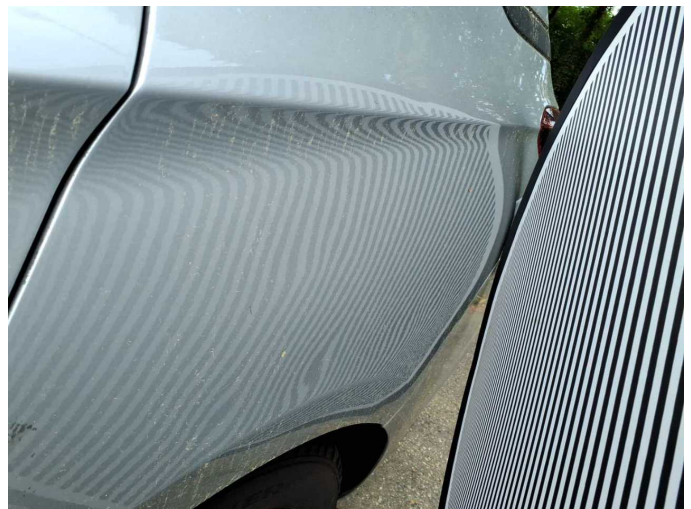
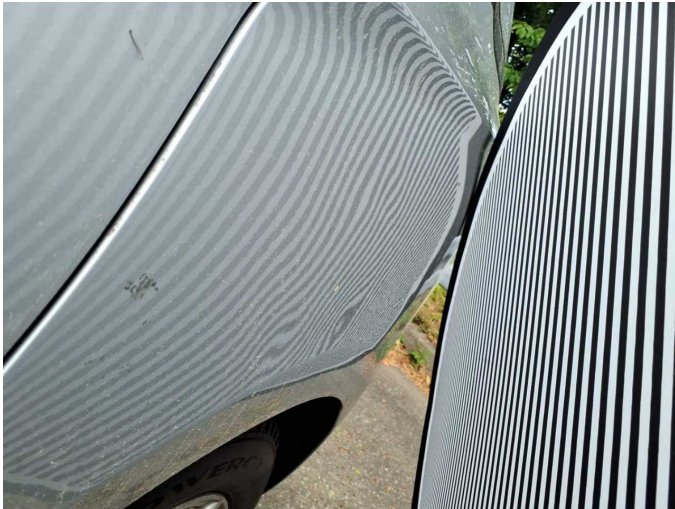
**Damage 10:** Side panel - rear left side: Side panel - dent(s) - Repair and paint

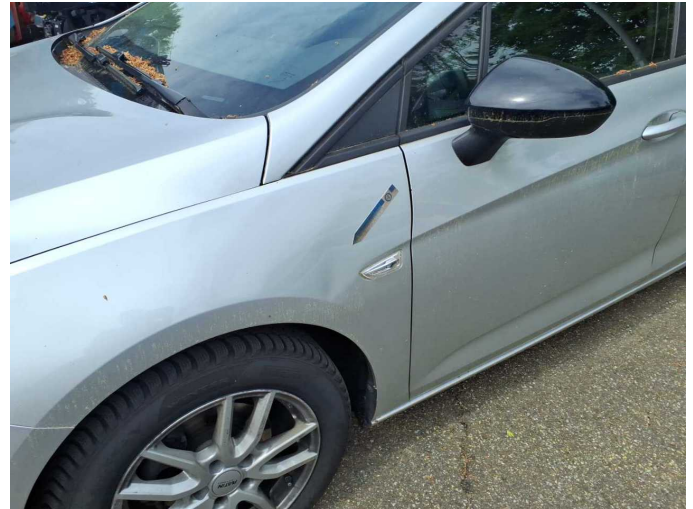
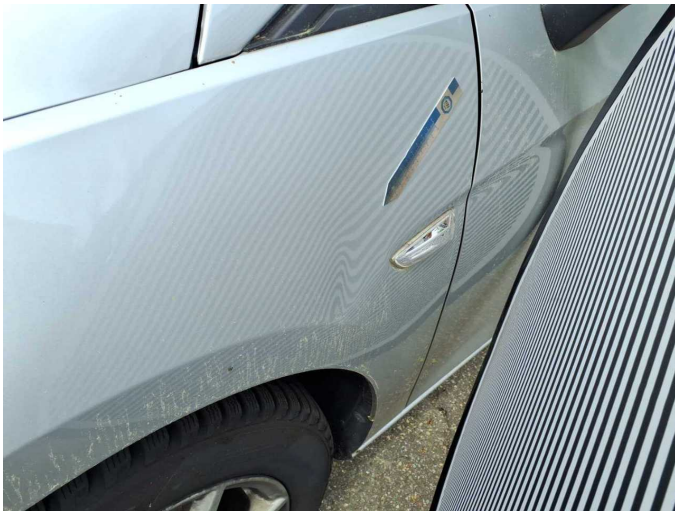
**Damage 11:** Mudguard - left side: Mudguard - left side - Deformed - Replace

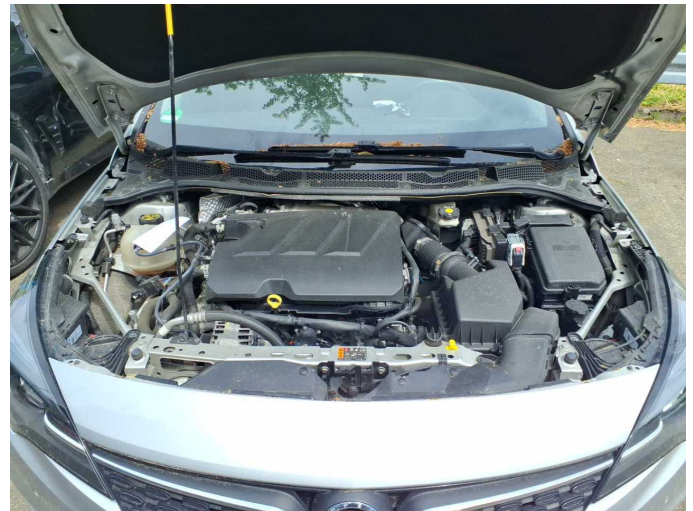
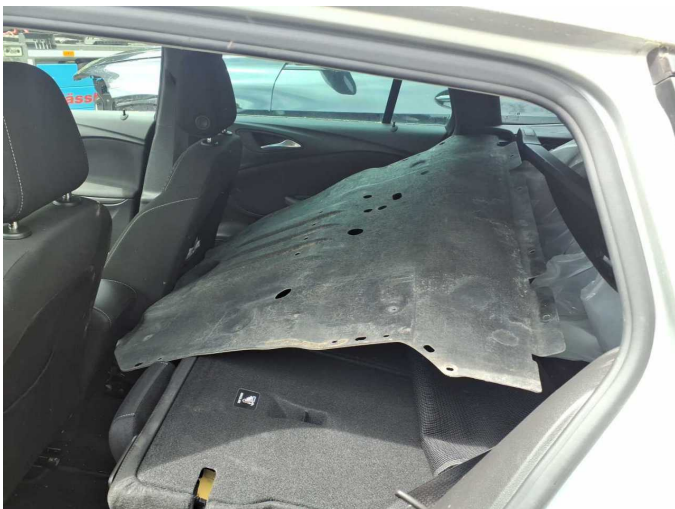
-Ein Motorprobelauf, Getriebefunktionstest sowie Funktionstest der Bordelektronik konnte aufgrund des Motorschaden des Fahrzeuges nicht durchgeführt werden. Zusatzkosten können entstehen.

**Damage 12:** Engine: Engine (Startet nicht.) - Non-operational - repair according to calculation

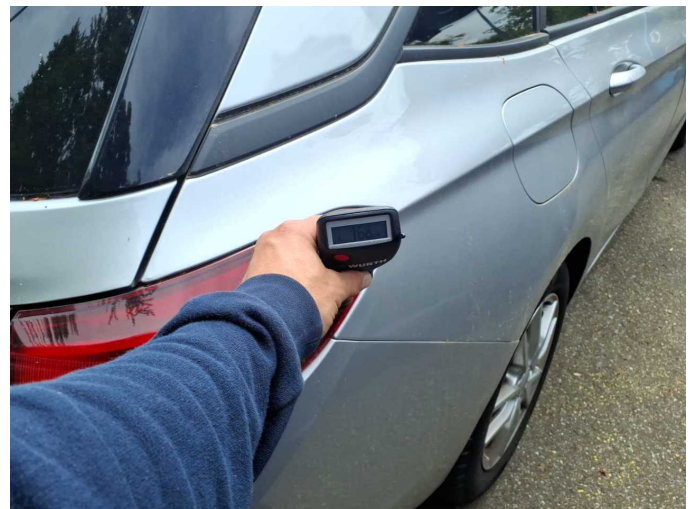
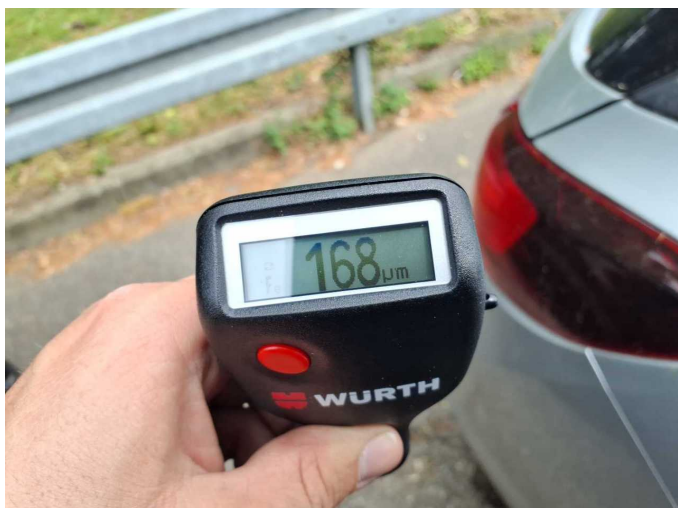
1 Side panel - rear right side, Professionally carried out, Invoice of repair done Non-existent

Side panel - rear right side 168 µm |

**Repainting 1:** Side panel - rear right side
