Expertise

Protocol number: 46056542
Order No. / Reference: 26528408
Inspection date: 17 Jun 2026

Model: Focus 1.5 EcoBlue Start-Stop-System Aut. TITANIUM X

VIN: WF0NXXGCHNPD64332

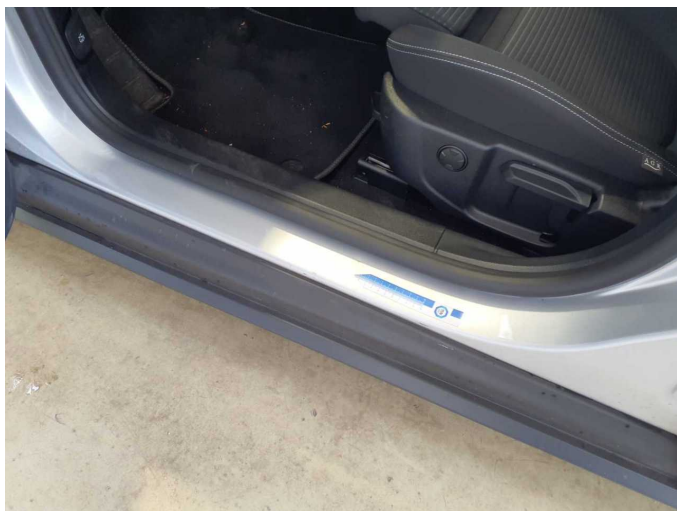
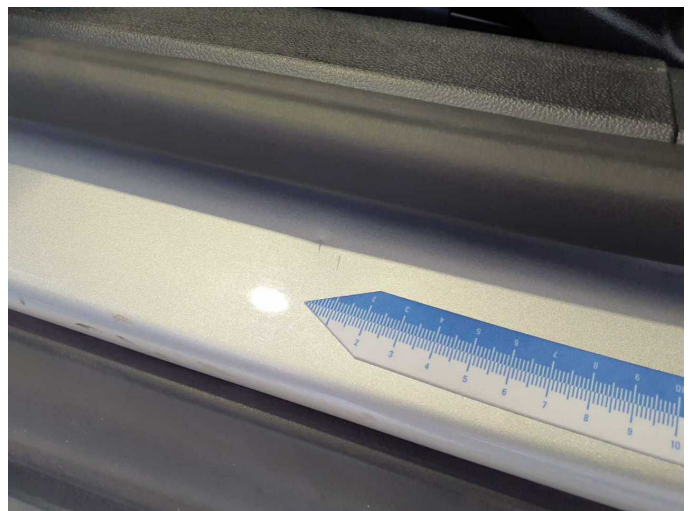
Damage 1: Sill - left side: Sill - Dent / paintcoat damage - Smart repair

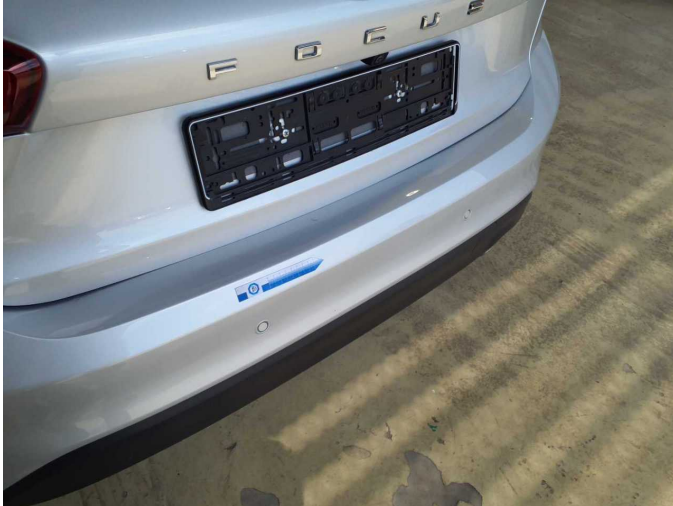
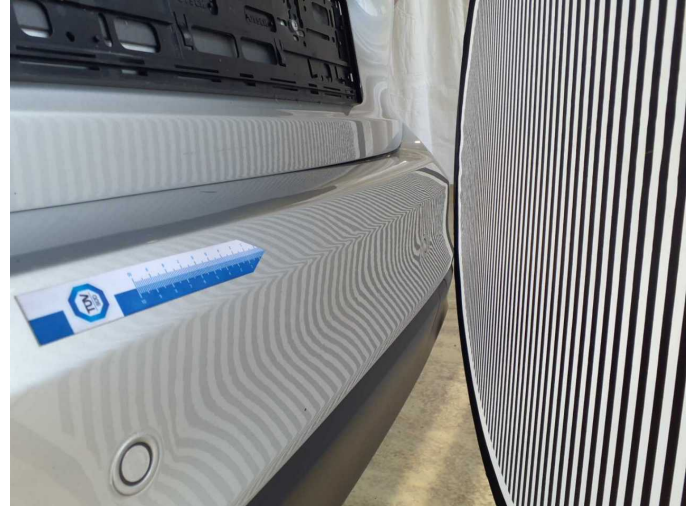
Damage 2: Rear bumper: Rear bumper - dent(s) - Repair and paint

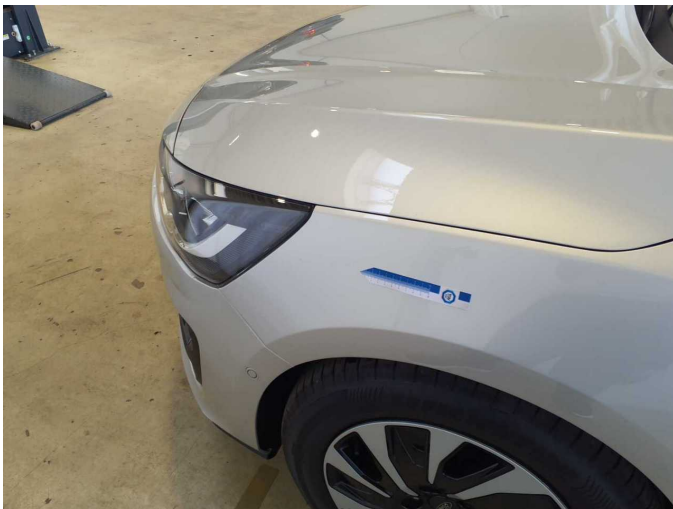
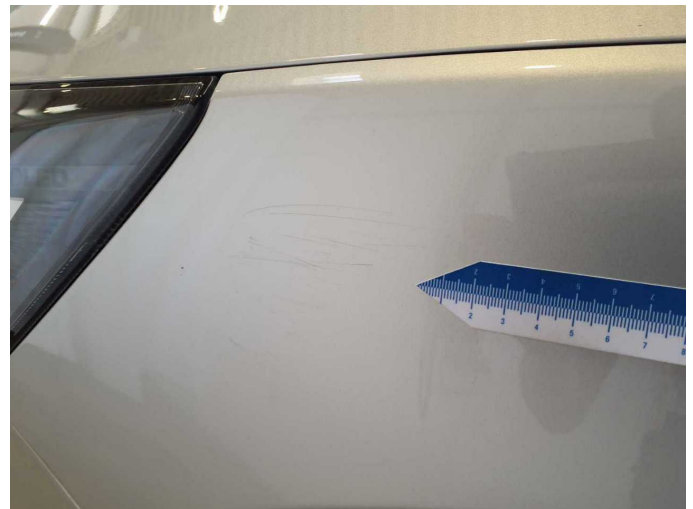
Damage 3: Mudguard - left side: Mudguard - left side - Scratch(es) - Paint

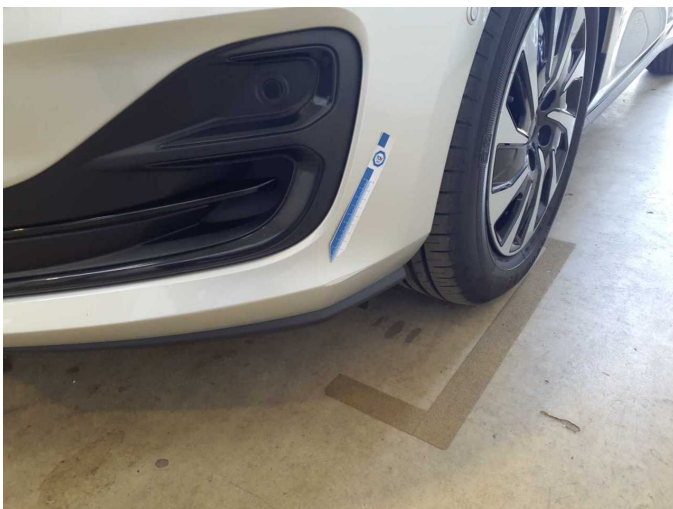
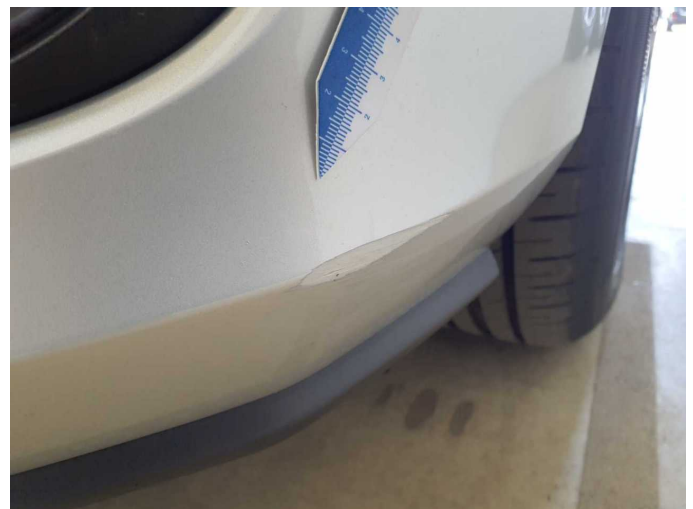
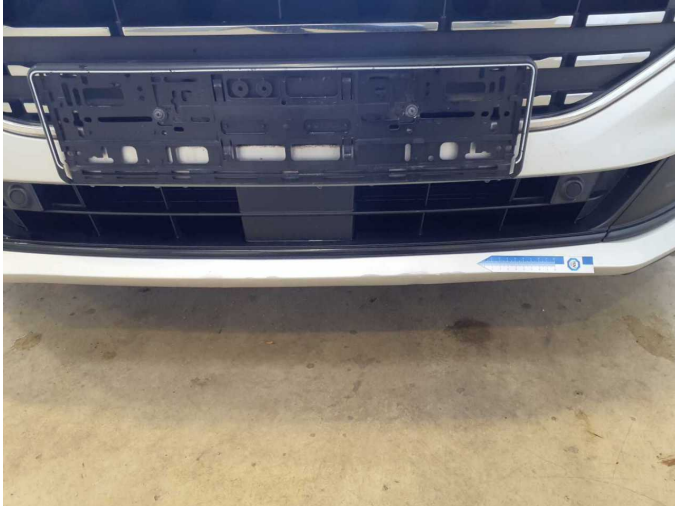
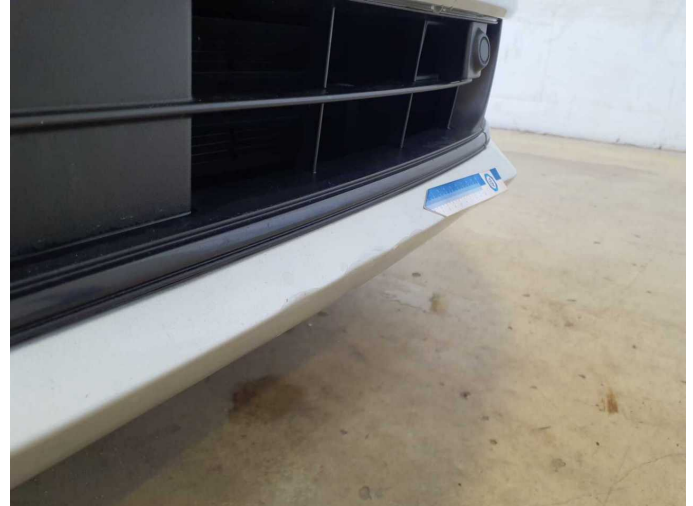
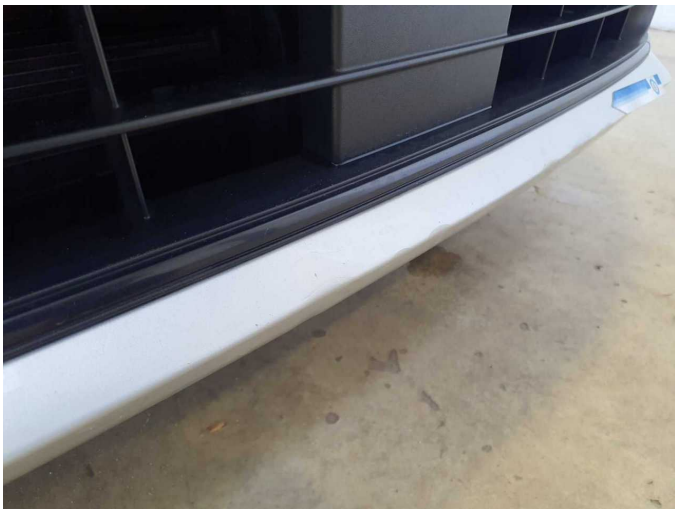
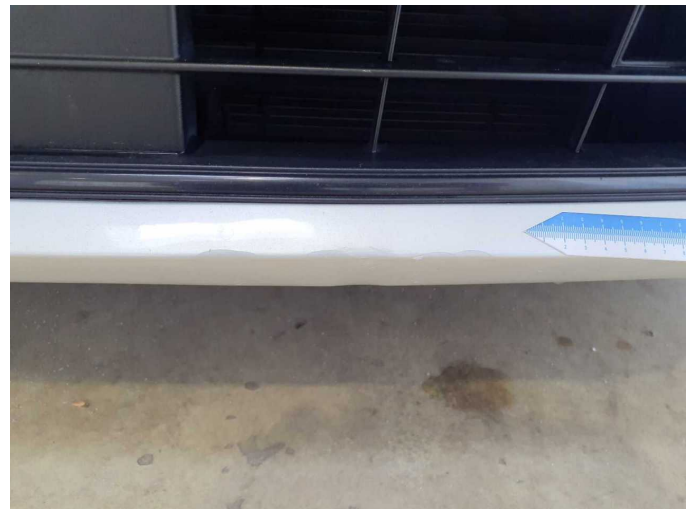
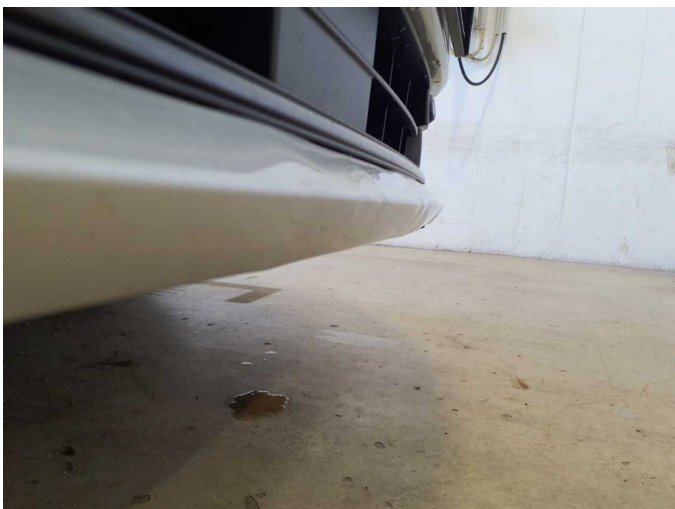
Damage 4: Front bumper: Front bumper - Damaged - Replace

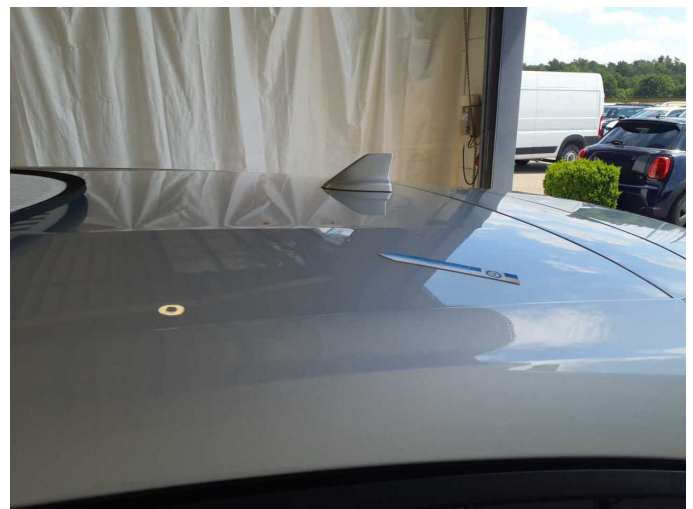
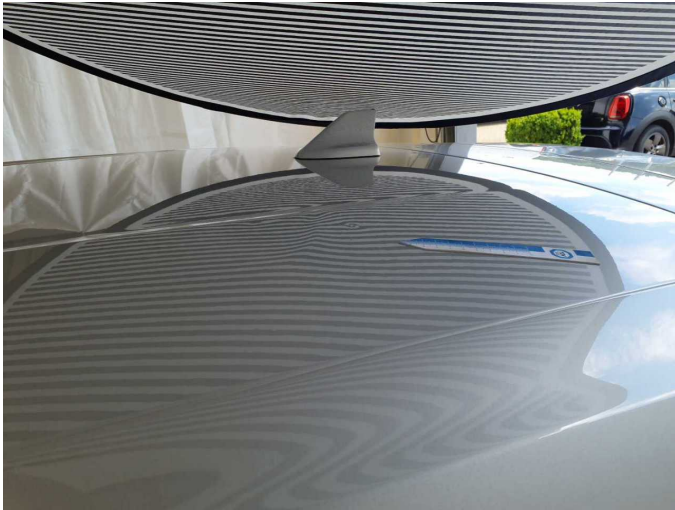
Damage 5: Roof: Roof (Dellen/Wellig) - Deformed - Repair and paint

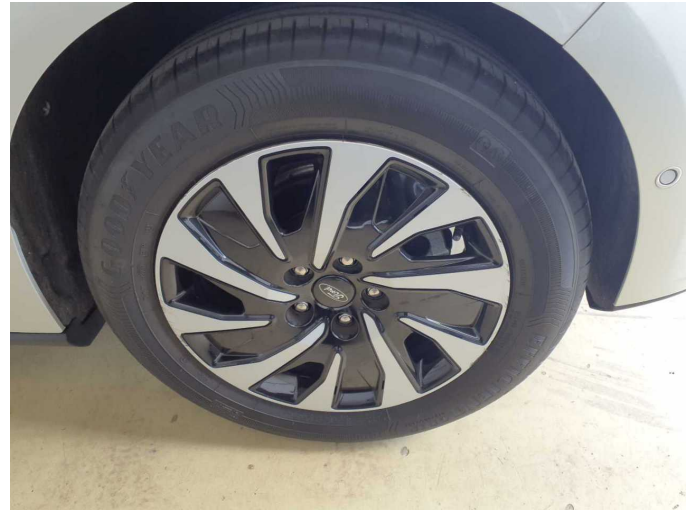
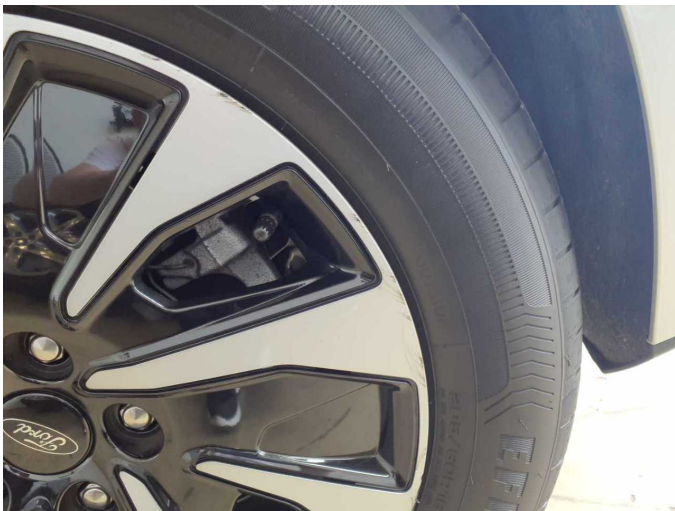
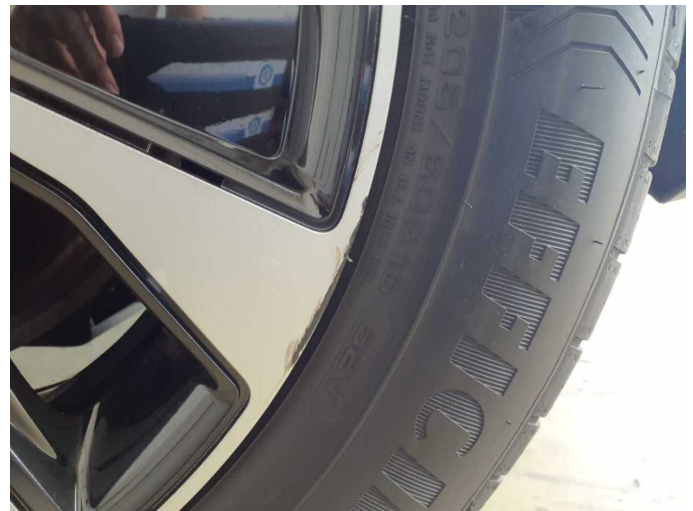
Wear and tear 1: Wheel / tyres: Wheel cover - rear left side - Scratched - No deduction

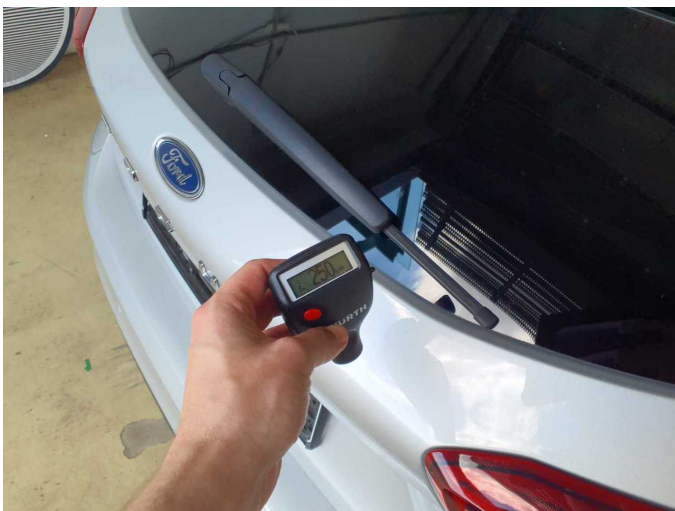
No.	Repainting
1	Boot lid / rear door, Professionally carried out, Invoice of repair done Non-existent

Repainting 1: Boot lid / rear door

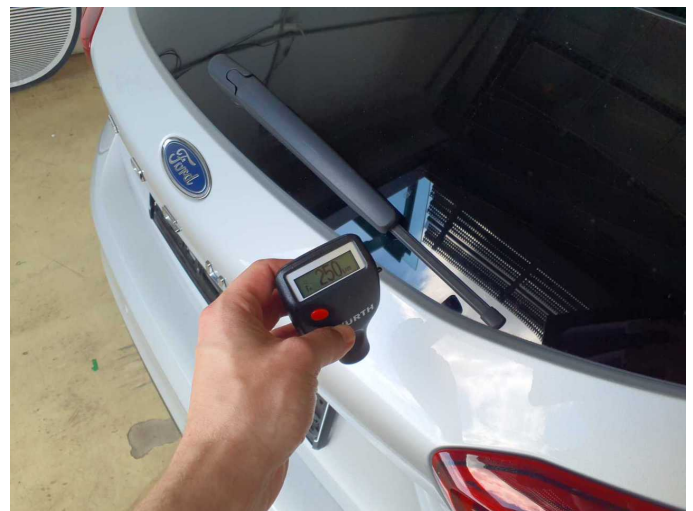
Boot lid / rear door 250 µm |

Boot lid / rear door: 250 µm
