Expertise

Protocol number: 46507870  
Order No. / Reference: 26559489  
Inspection date: 7 Jul 2026

Manufacturer: Volkswagen

Model: Golf Variant 2.0 TDI SCR Life

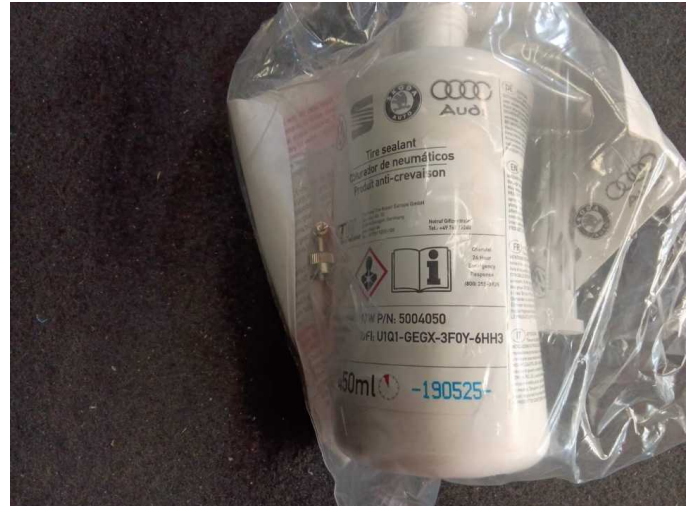
| No. | Component group | Description |
|---|---|---|
| 1 | Equipment | Tirefit filler - Expired - Replace |

**Damage 1:** Equipment: Tirefit filler - Expired - Replace

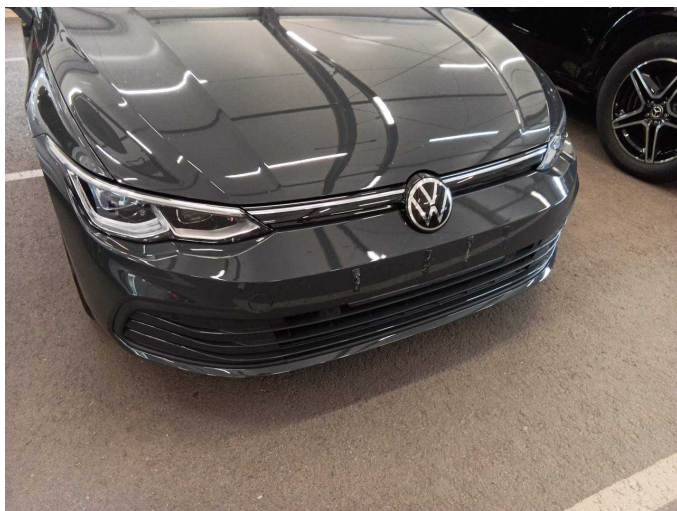
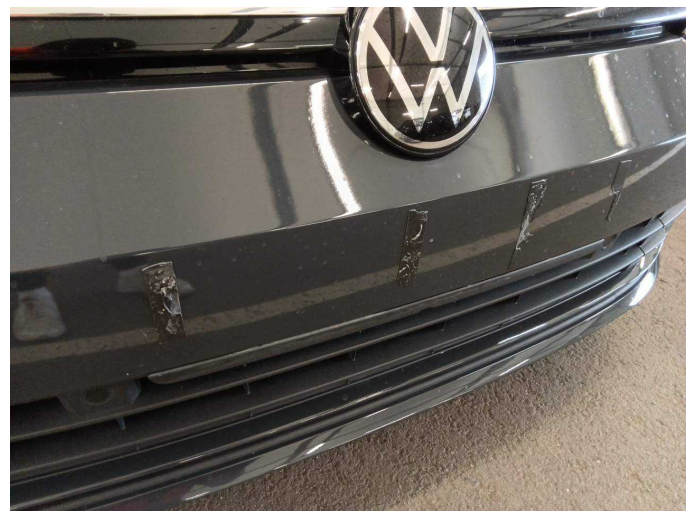
| No. | Component group | Description |
|---|---|---|
| 2 | Front bumper | Front bumper (Kleberreste Kennzeichenhalter) - Glued / labelled - De-glue / neutralise |

**Damage 2:** Front bumper: Front bumper (Kleberreste Kennzeichenhalter)  
- Glued / labelled - De-glue / neutralise

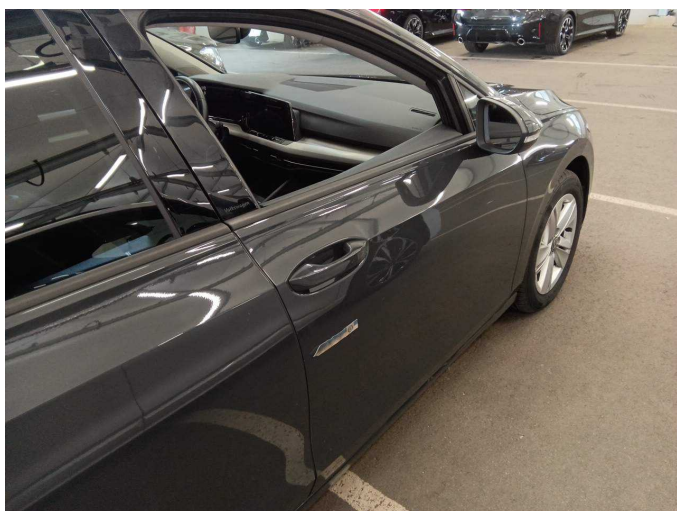
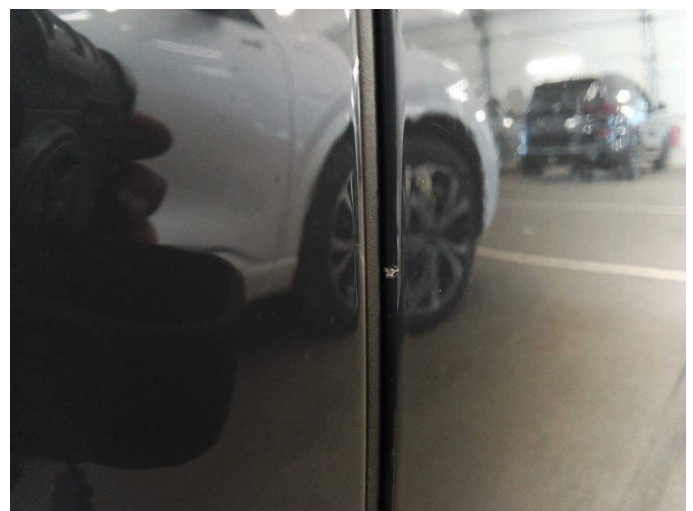
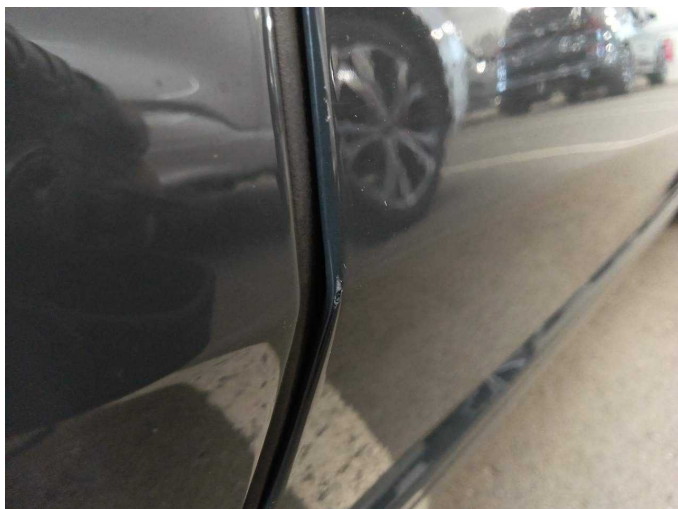
| No. | Component group | Description |
|---|---|---|
| 3 | Door - front right side | Door edge - Scratch(es) - Smart repair |

**Damage 3:** Door - front right side: Door edge - Scratch(es) - Smart repair

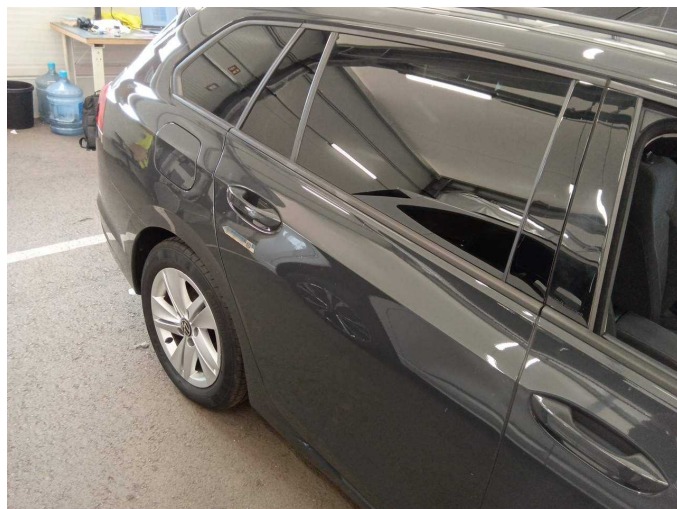
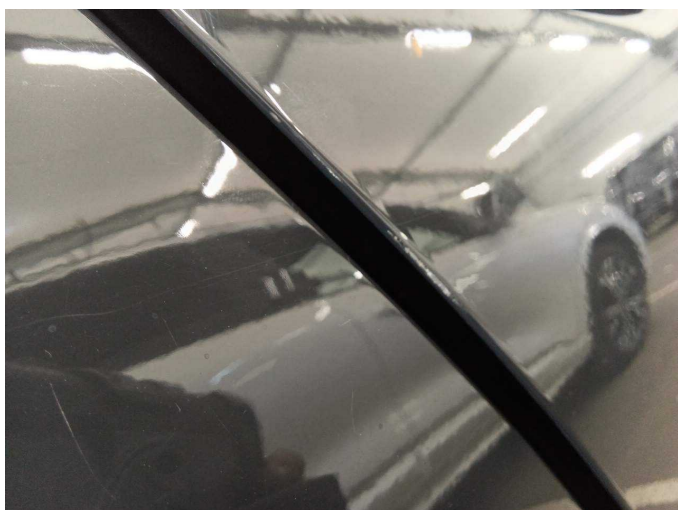
| No. | Component group | Description |
|---|---|---|
| 4 | Door - rear right side | Door edge - Scratch(es) - Smart repair |

**Damage 4:** Door - rear right side: Door edge - Scratch(es) - Smart repair

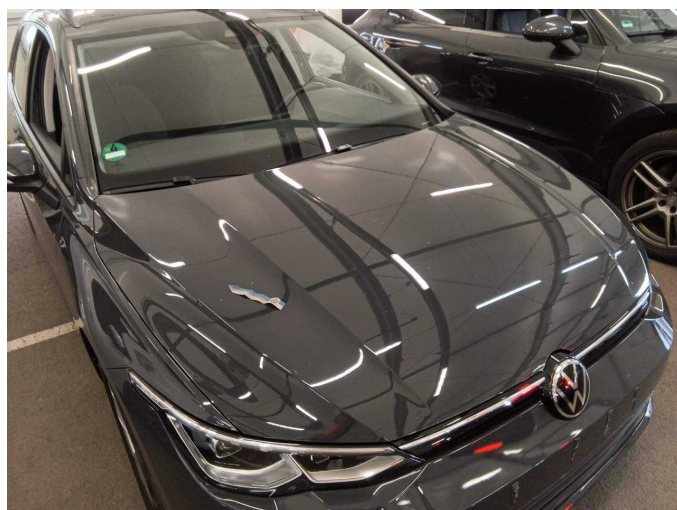
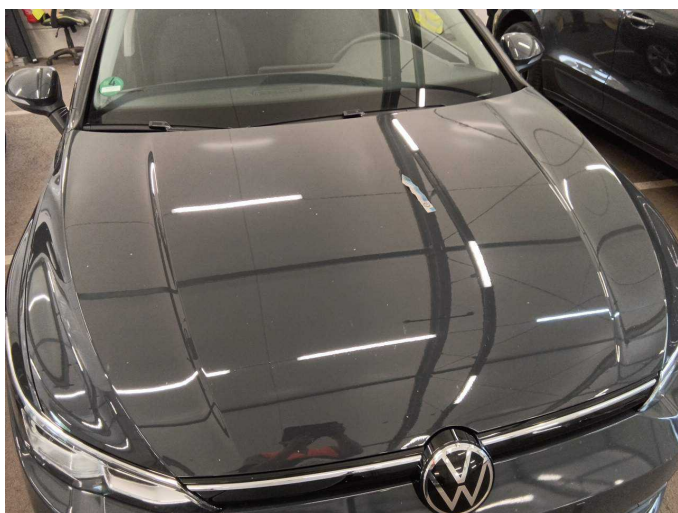
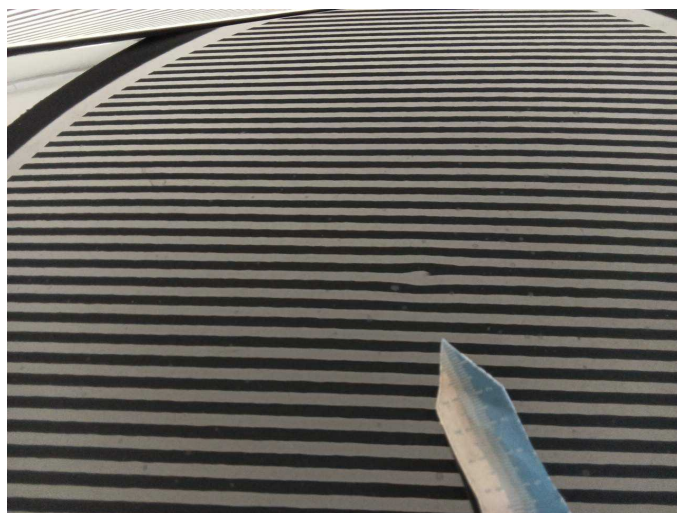
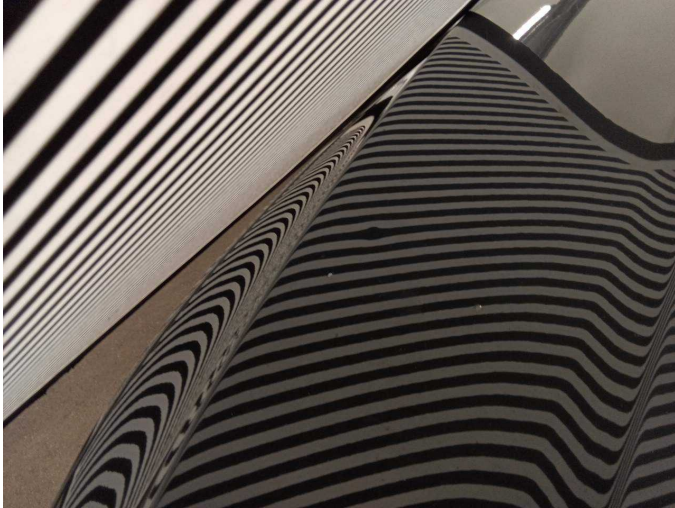
| No. | Component group | Description |
|---|---|---|
| 5 | Bonnet | Bonnet - dent(s) - Smooth repair work |

**Damage 5:** Bonnet: Bonnet - dent(s) - Smooth repair work

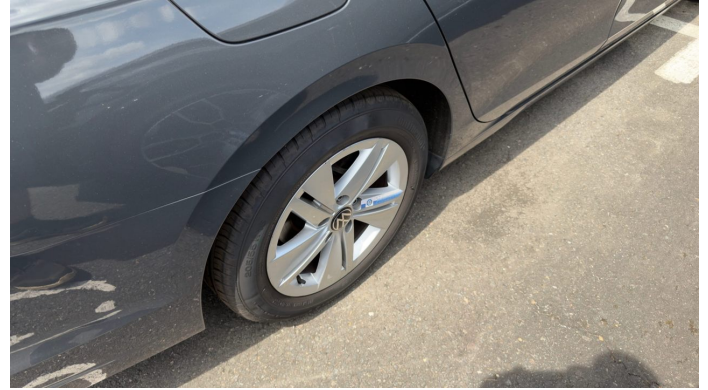
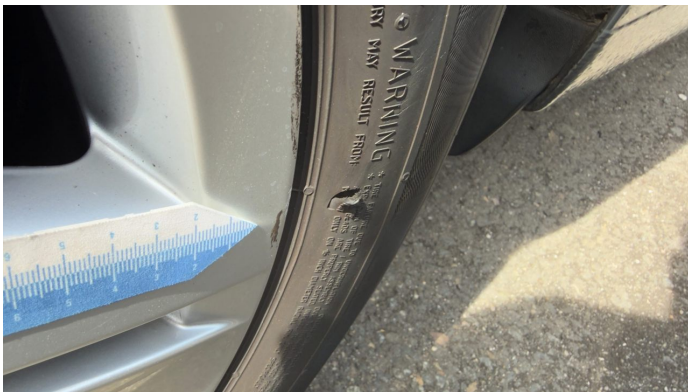
| No. | Component group | Description |
|---|---|---|
| 6 | Wheel / tyres | Tyre - rear right side (Flankenbeschädigung) - Damaged - Replace |

**Damage 6:** Wheel / tyres: Tyre - rear right side (Flankenbeschädigung) - Damaged - Replace

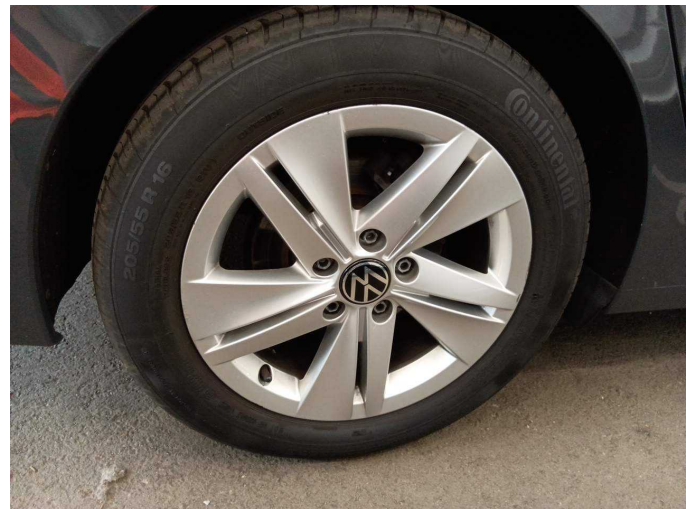
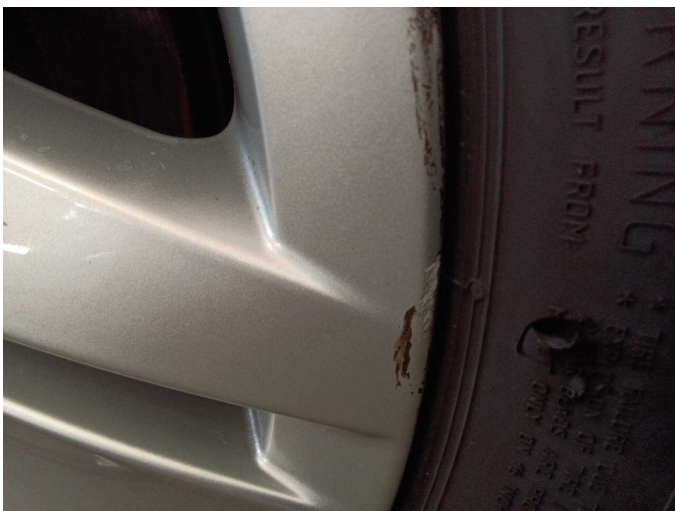
| No. | Component group | Description |
|---|---|---|
| 7 | Wheel / tyres | Alloy rim - rear right side - Scratch(es) - Smart repair |

**Damage 7:** Wheel / tyres: Alloy rim - rear right side - Scratch(es) - Smart repair

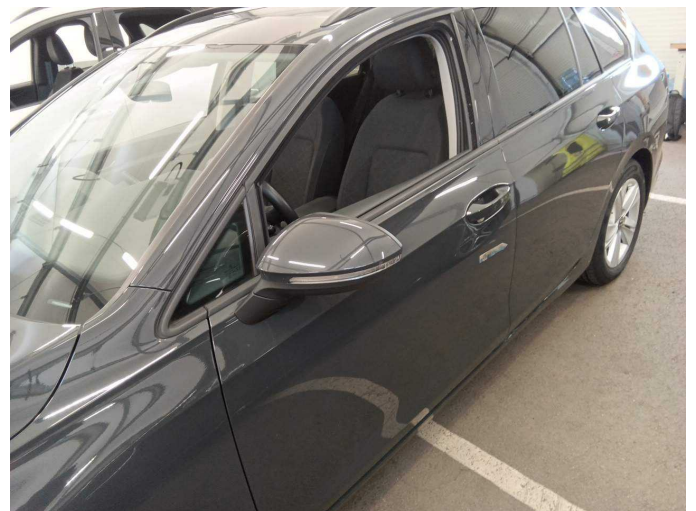
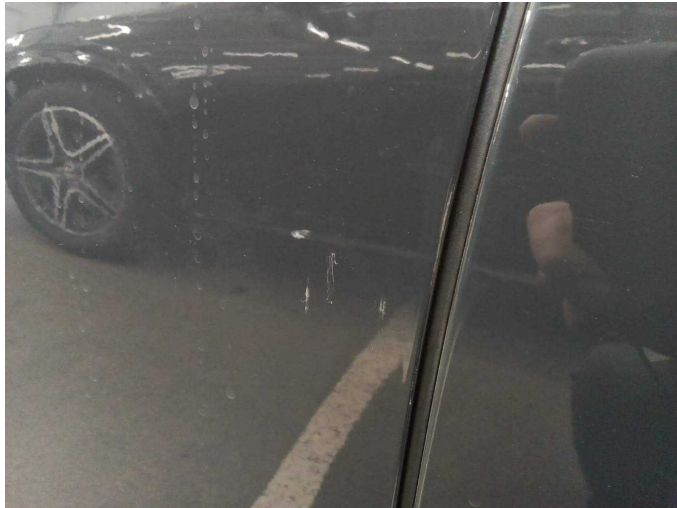
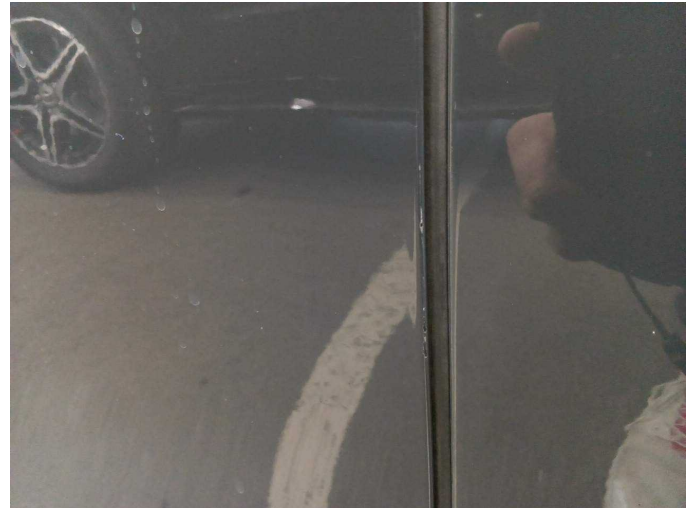
| No. | Component group | Description |
|---|---|---|
| 8 | Door - front left side | Door - Scratch(es) - Smart repair |

**Damage 8:** Door - front left side: Door - Scratch(es) - Smart repair

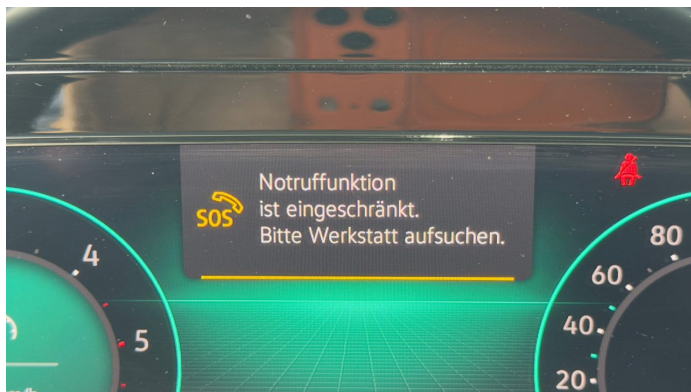
| No. | Component group | Description |
|---|---|---|
| 9 | Electronic systems | Electronic systems (Notrufsystem) - Specify findings - Perform diagnosis |

**Damage 9:** Electronic systems: Electronic systems (Notruffsystem) - Specify findings - Perform diagnosis

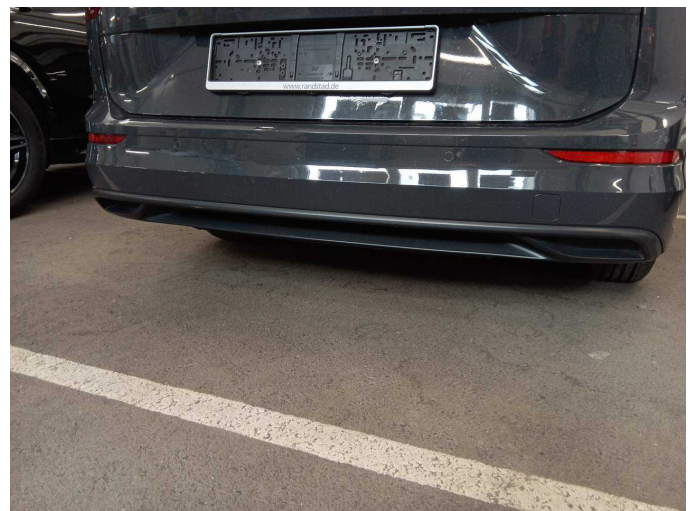
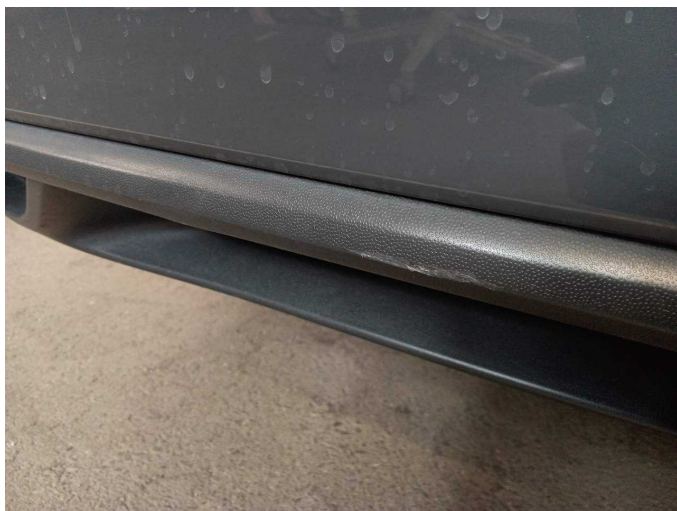
| No. | Component group | Description |
|---|---|---|
| 10 | Rear bumper | Spoiler (Kunststoffbauteil) - Scratch(es) - Replace |

**Damage 10:** Rear bumper: Spoiler (Kunststoffbauteil) - Scratch(es) - Replace

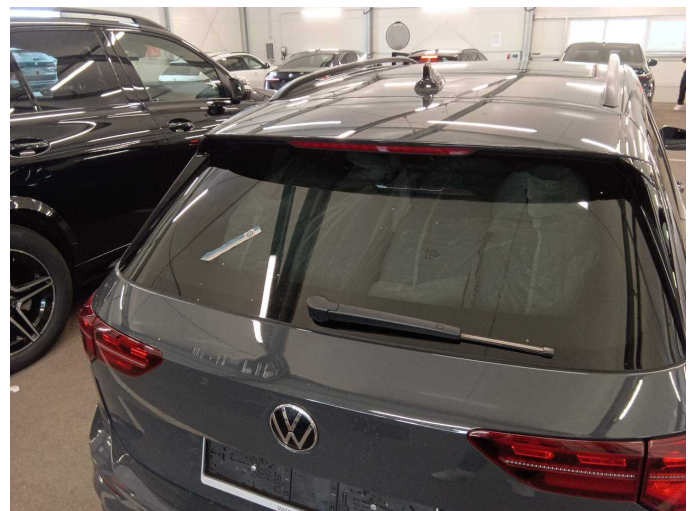
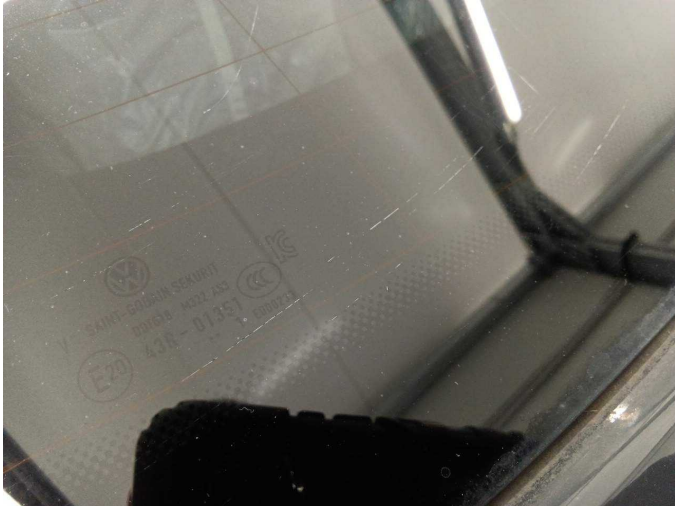
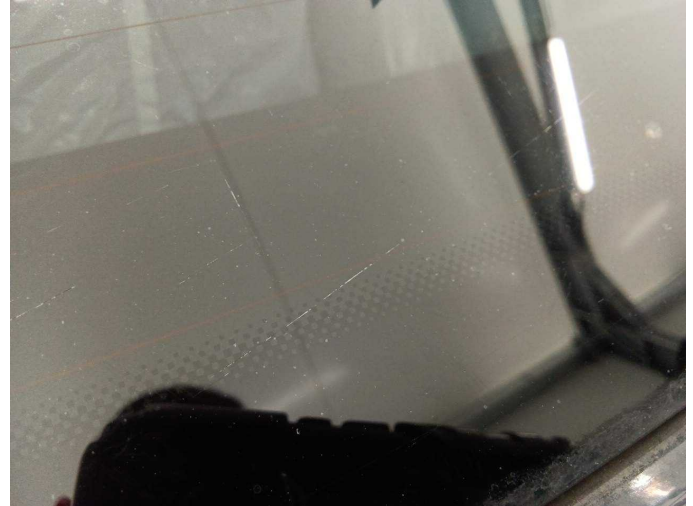
| No. | Component group | Description |
|---|---|---|
| 11 | Vehicle glazing | Rear window (Tiefe Kratzer) - Scratch(es) - Replace |

**Damage 11:** Vehicle glazing: Rear window (Tiefe Kratzer) - Scratch(es) - Replace

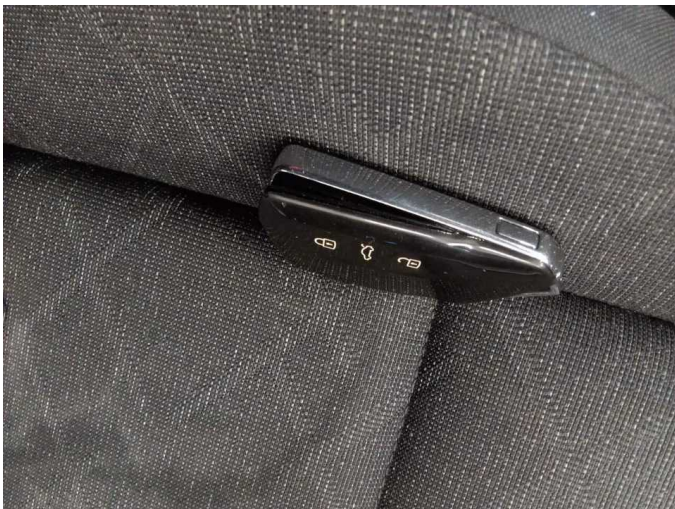
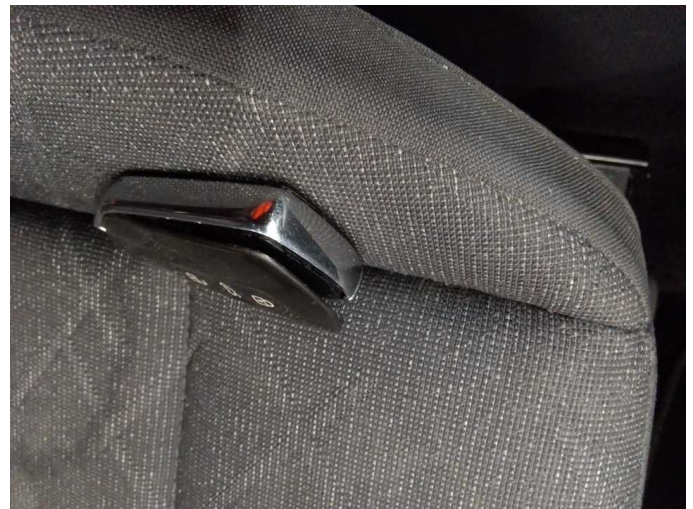
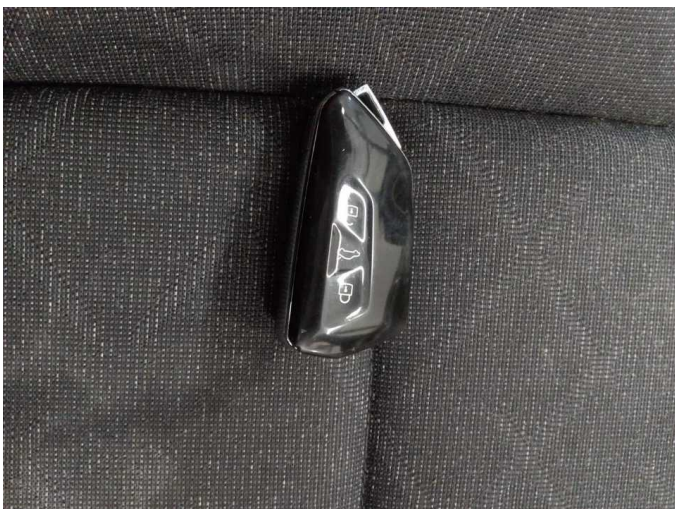
| No. | Component group | Description |
|---|---|---|
| 12 | Equipment | Vehicle key - Damaged - Replace |

**Damage 12:** Equipment: Vehicle key - Damaged - Replace

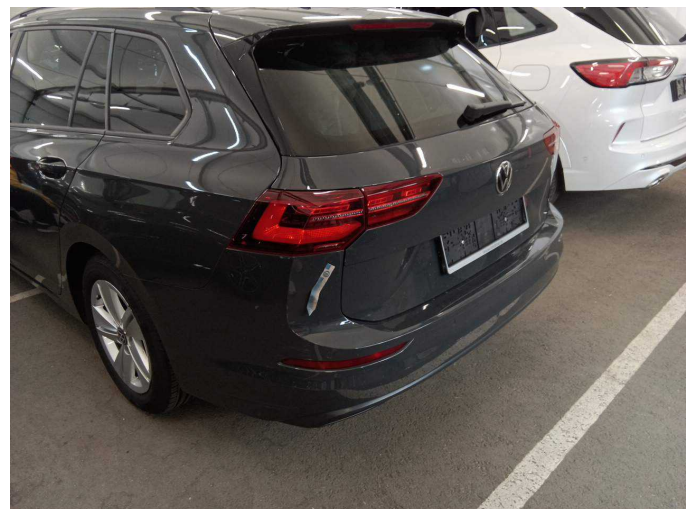
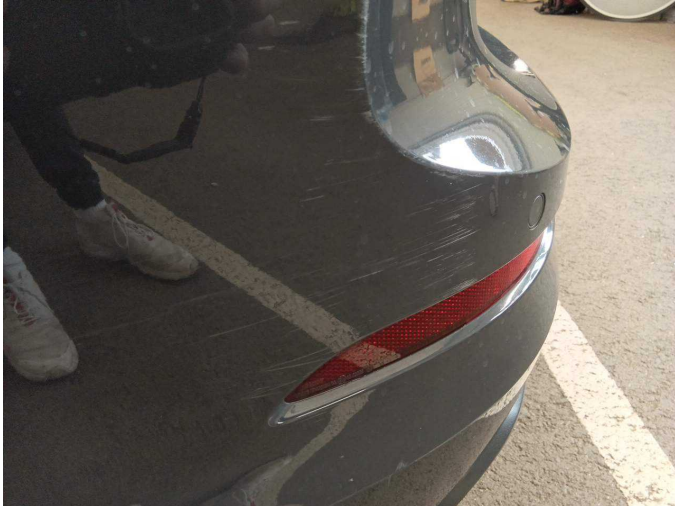
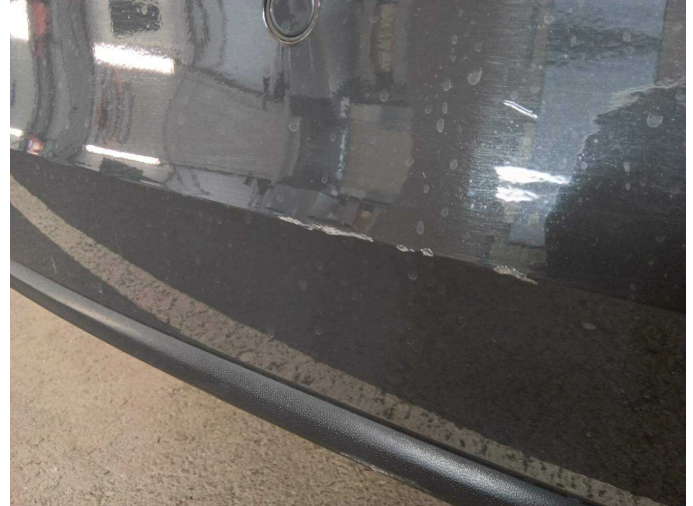
| No. | Component group | Description |
|---|---|---|
| 13 | Rear bumper | Rear bumper - Scratch(es) - Paint |

**Damage 13:** Rear bumper: Rear bumper - Scratch(es) - Paint

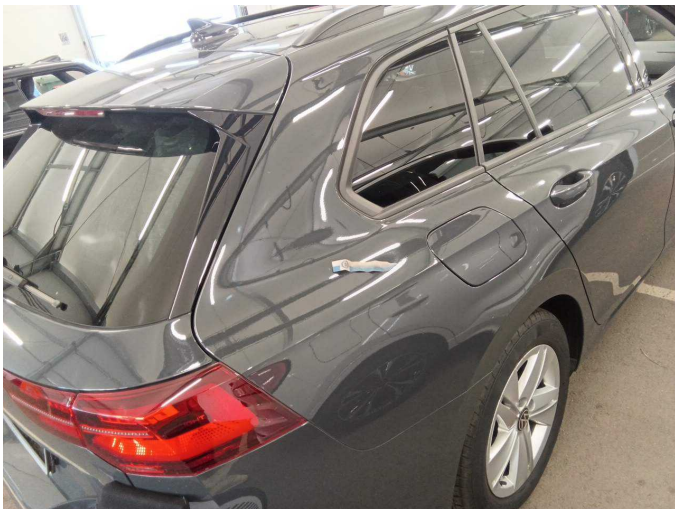
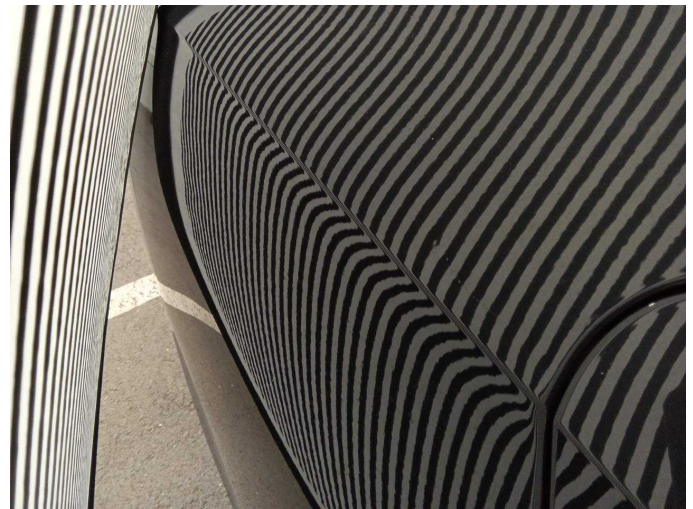
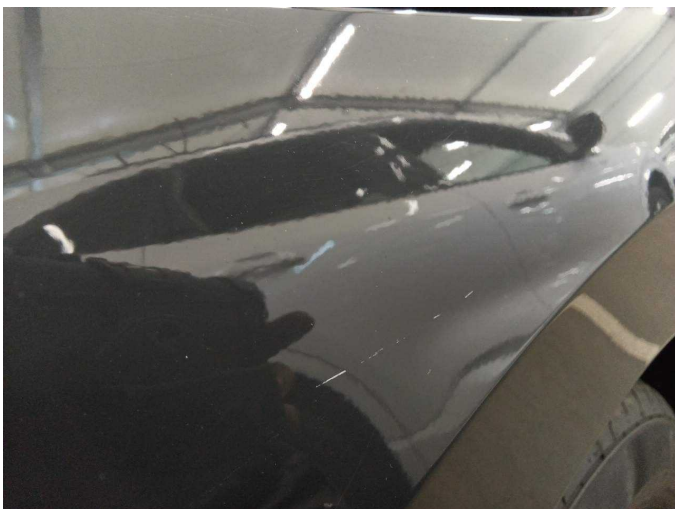
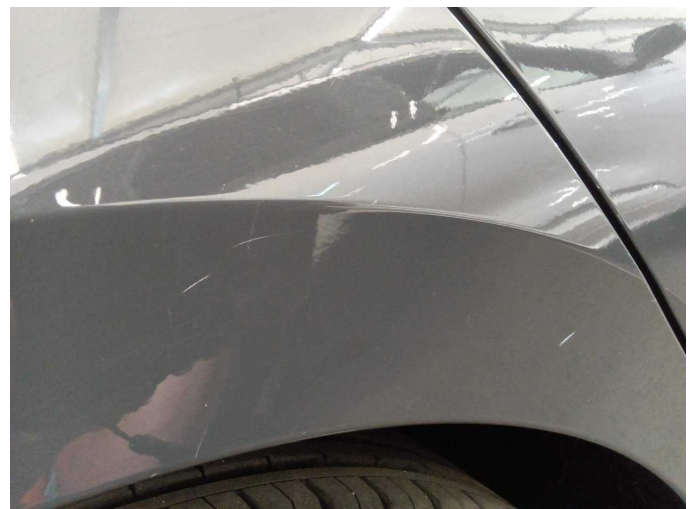
| No. | Component group | Description |
|---|---|---|
| 14 | Side panel - rear right side | Side panel - Dent / paintcoat damage - Paint |

**Damage 14:** Side panel - rear right side: Side panel - Dent / paintcoat damage - Paint

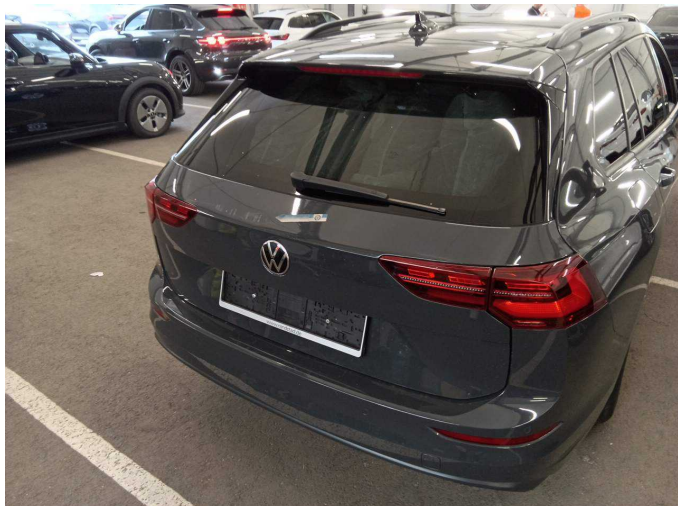
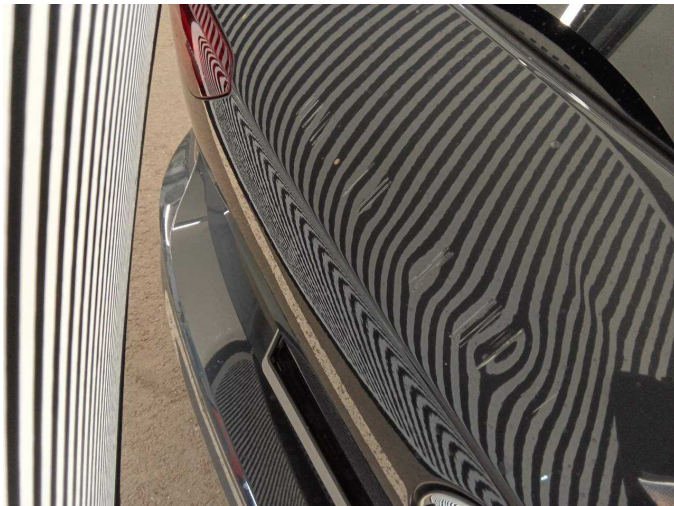
| No. | Component group | Description |
|---|---|---|
| 15 | Boot lid / rear door | Boot lid - Dent / paintcoat damage - Repair and paint |

**Damage 15:** Boot lid / rear door: Boot lid - Dent / paintcoat damage - Repair and paint
