DEKRA Automotive Solutions

VIN	VXKUPMHHD P4262321	Registration date	01/01/1900	Exterior Color	Unknown
Brand	OPEL	Licence Plate		Odometer	43 476 km
Model	CORSA 1.2 55kW S/S

Inspection Details

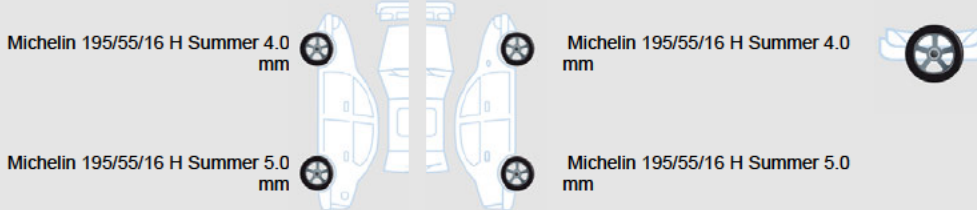
Tyres
