Expertise

Protocol number: 43908413  
Order number / reference: 25858220  
Inspection date: 16 Feb 2026

Manufacturer: Mercedes-Benz

Model: Vito 116 CDI Extralang HA Aut. PRO

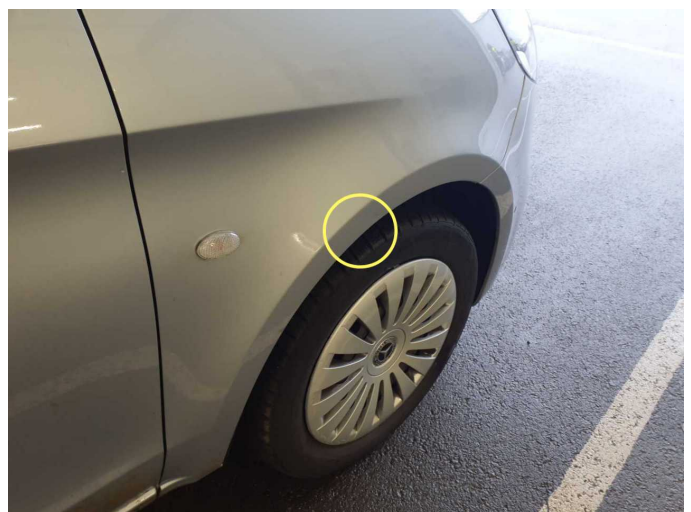
| No. | Component group | Description |
|---|---|---|
| 2 | Mudguard - right side | Mudguard - right side - dent(s) - Smooth repair work |

**Damage 2:** Mudguard - right side: Mudguard - right side - dent(s) - Smooth repair work

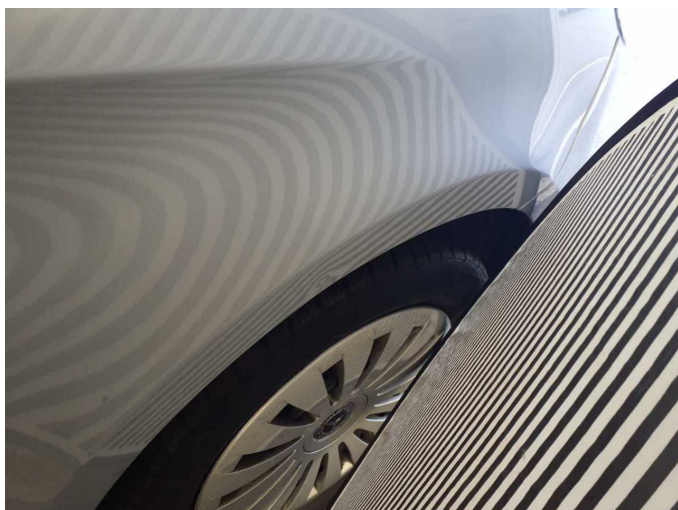
**Damage 2:** Mudguard - right side: Mudguard - right side - dent(s) - Smooth repair work

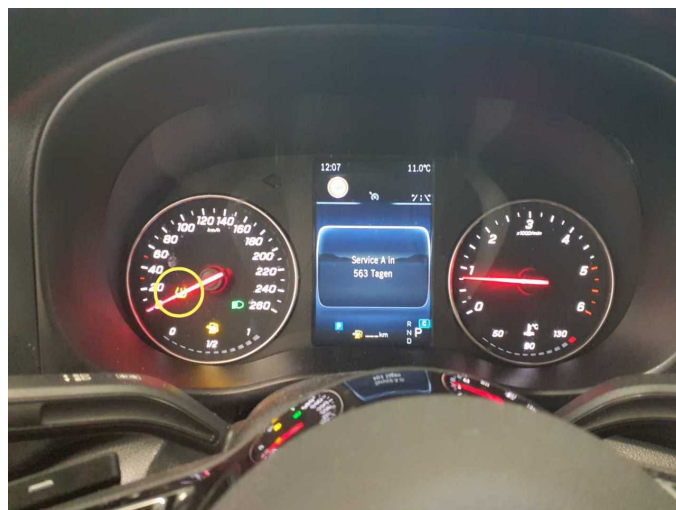
| No. | Component group | Description |
|---|---|---|
| 3 | Instrument panel | Indicator light (Reifendruckkontrollsystem) - on - Perform diagnosis |

**Damage 3:** Instrument panel: Indicator light (Reifendruckkontrollsystem) - on - Perform diagnosis

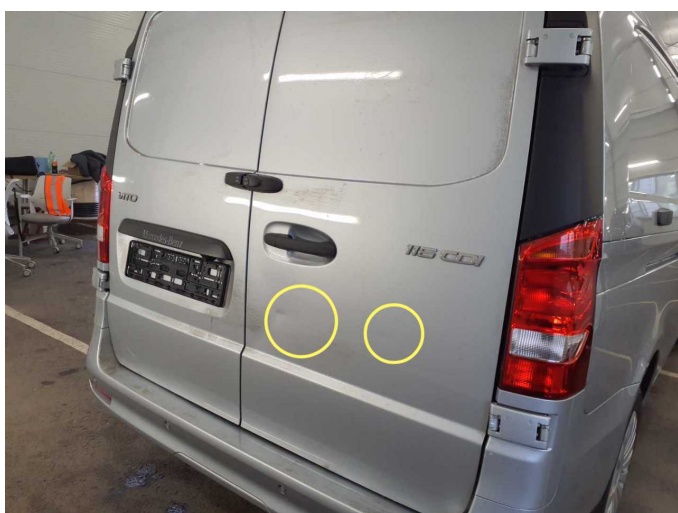
| No. | Component group | Description |
|---|---|---|
| 4 | Boot lid / rear door | Rear door - left side - Dent / paintcoat damage - Repair and paint |

**Damage 4:** Boot lid / rear door: Rear door - left side - Dent / paintcoat damage - Repair and paint

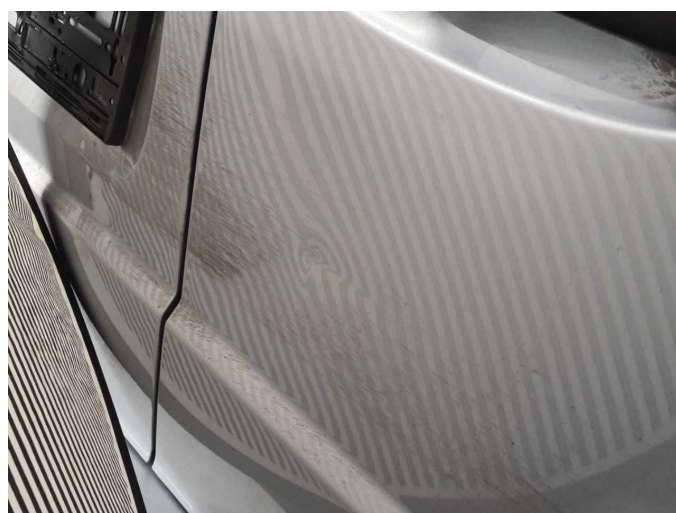
**Damage 4:** Boot lid / rear door: Rear door - left side - Dent / paintcoat damage - Repair and paint

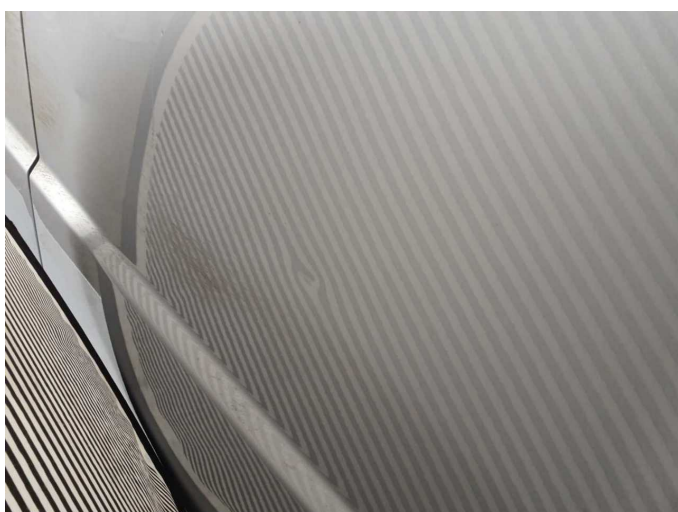
**Damage 4:** Boot lid / rear door: Rear door - left side - Dent / paintcoat damage - Repair and paint

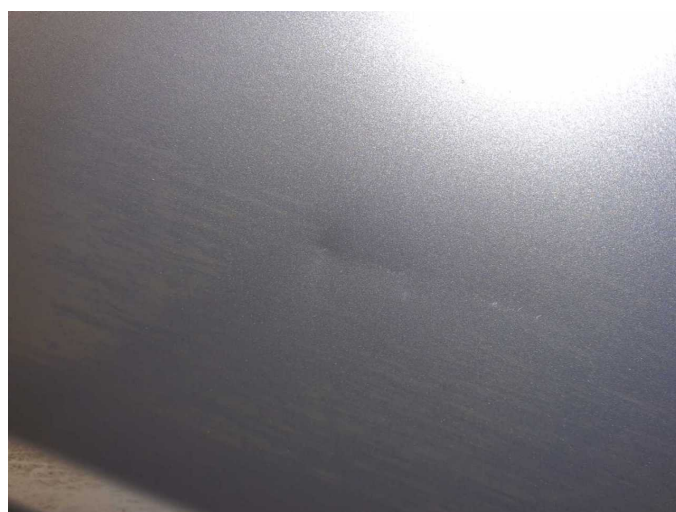
**Damage 4:** Boot lid / rear door: Rear door - left side - Dent / paintcoat damage - Repair and paint

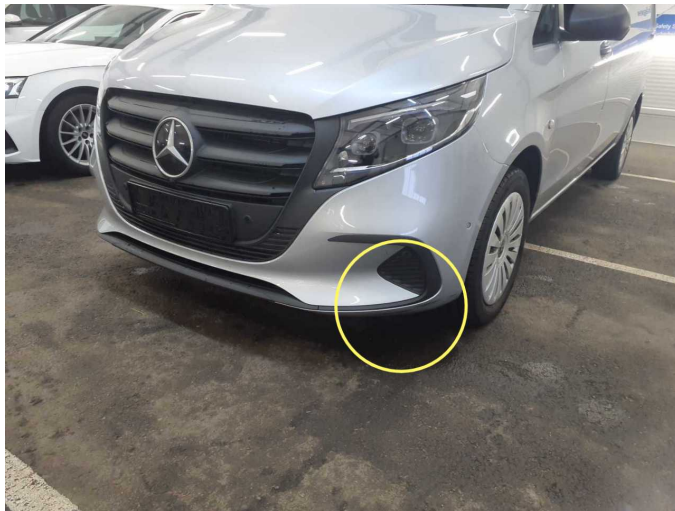
| No. | Component group | Description |
|---|---|---|
| 5 | Front bumper | Front bumper - Scratched - Paint |

**Damage 5:** Front bumper: Front bumper - Scratched - Paint

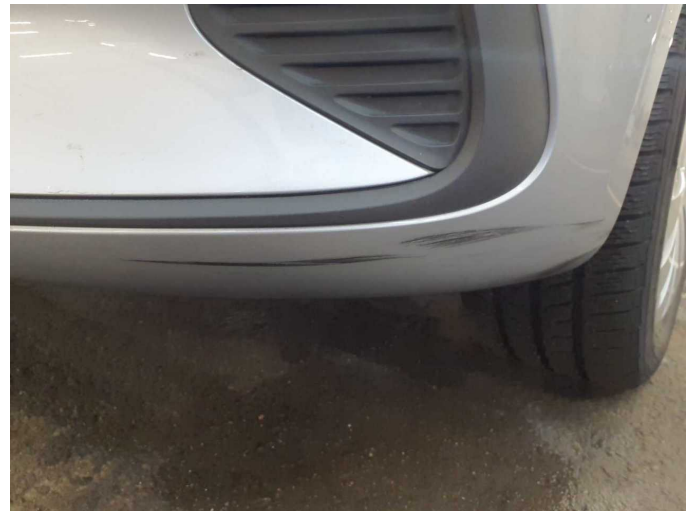
**Damage 5:** Front bumper: Front bumper - Scratched - Paint
