## Expertise

Protocol number: 46164297  
Order No. / Reference: 26469639  
Inspection date: 24 Jun 2026

Manufacturer: Ford

Model: Transit 350 L3H2 Lkw VA Autm. Trend

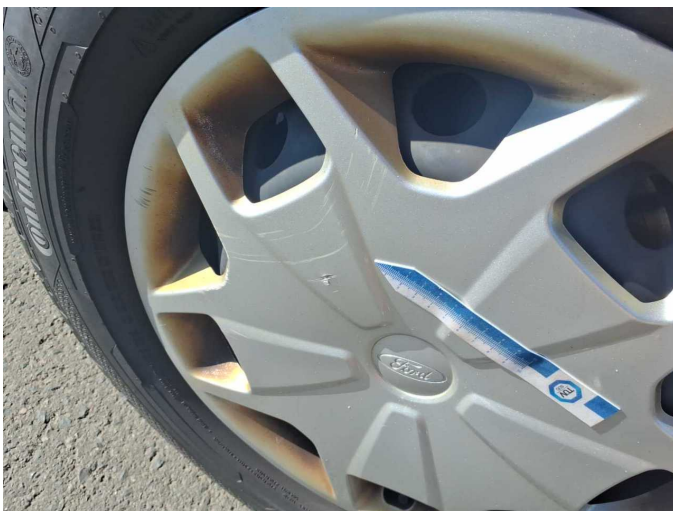
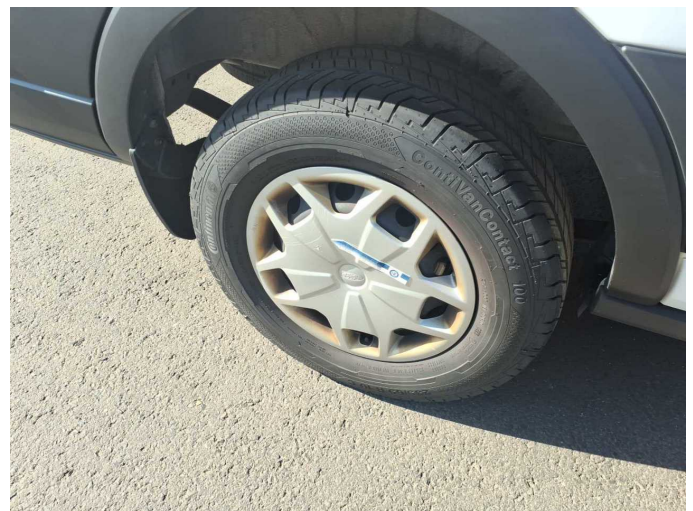
Damage 1: Wheel / tyres: Wheel cover - rear right side - Scratch(es) - Replace

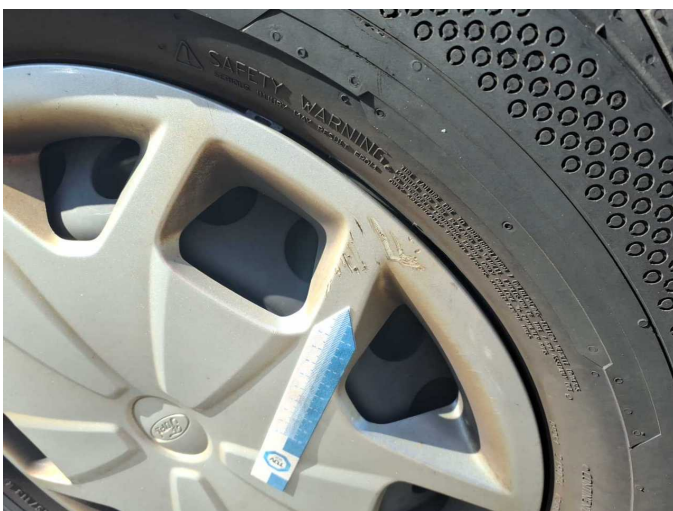
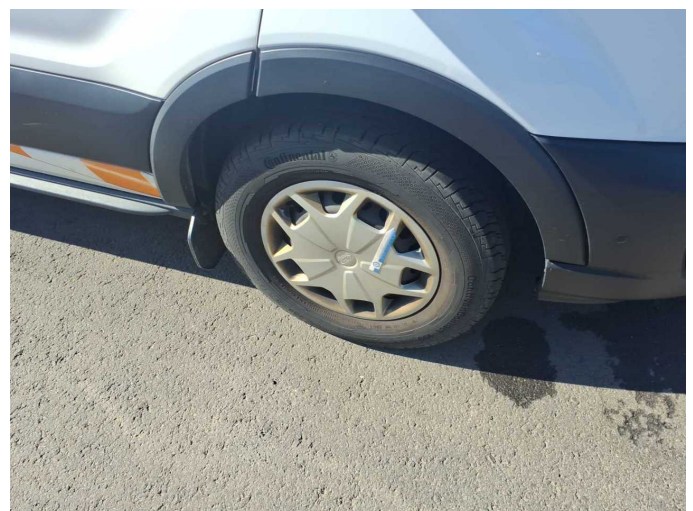
Damage 2: Wheel / tyres: Wheel cover - front right side - Scratch(es) - Replace

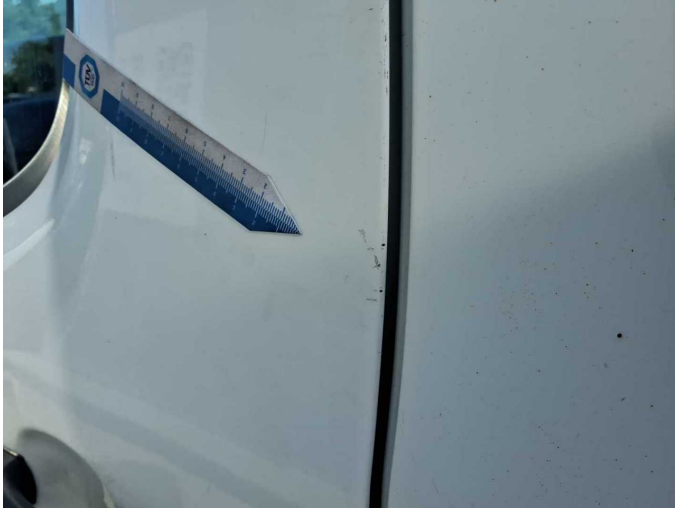
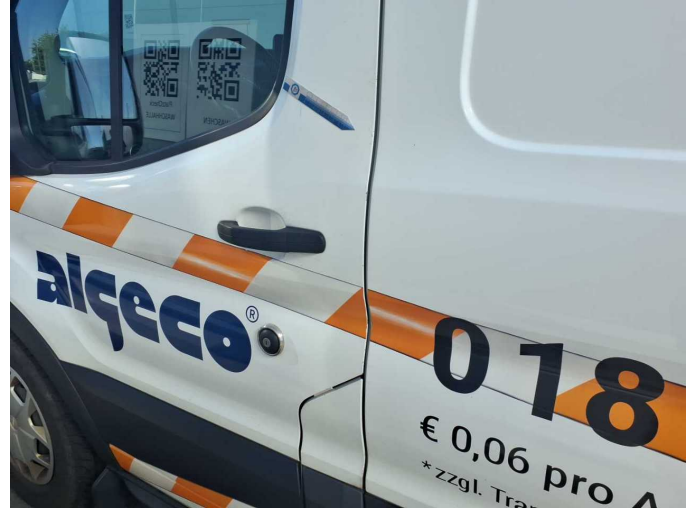
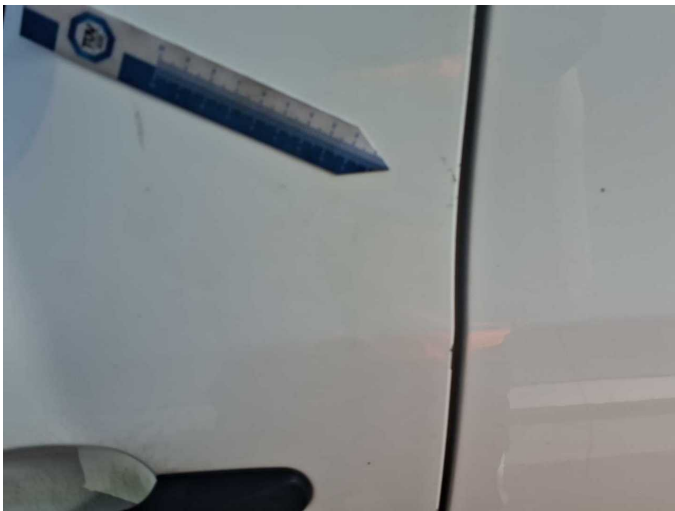
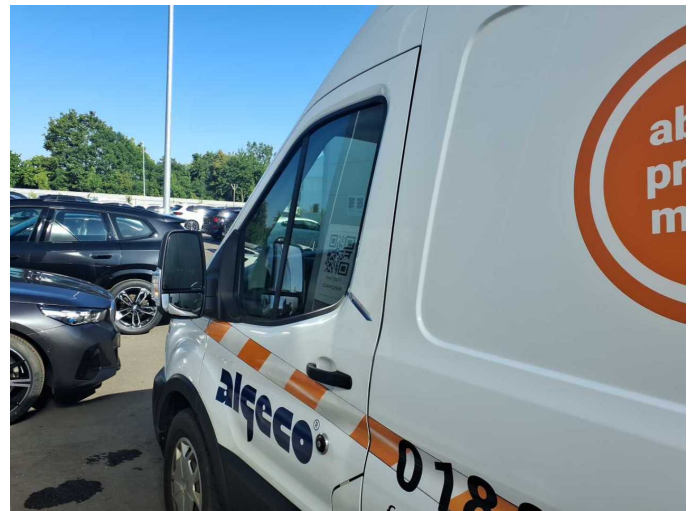
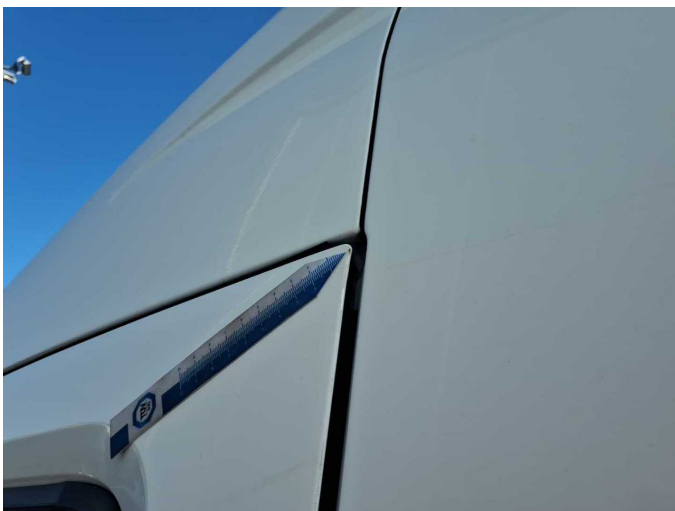
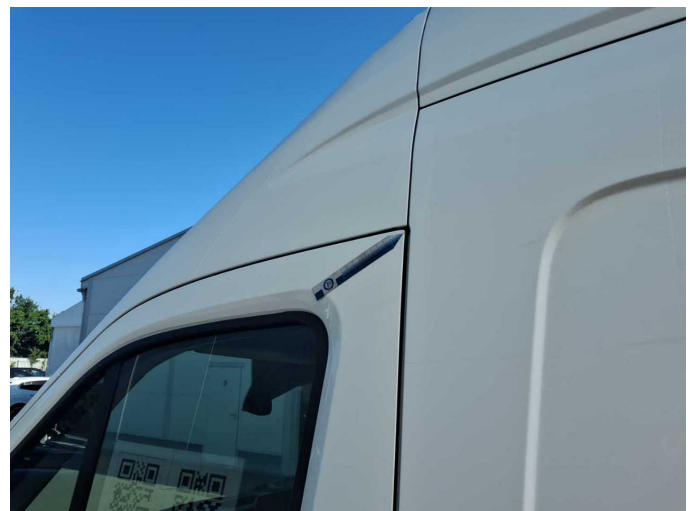
Damage 3: Door - front left side: Door edge - Scratch(es) - Smart repair

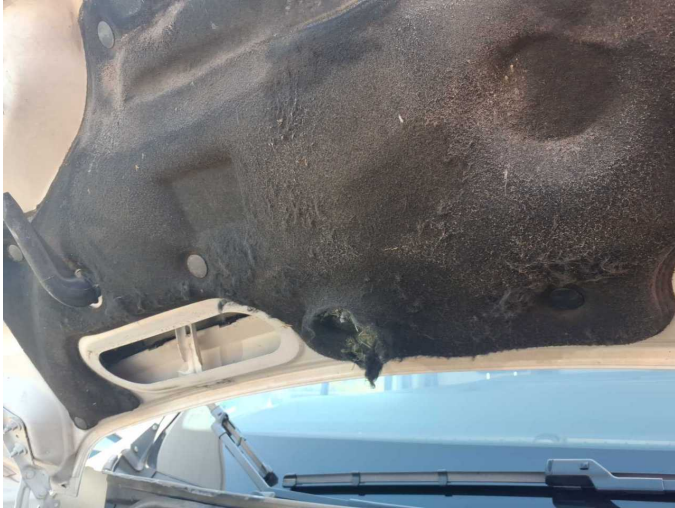
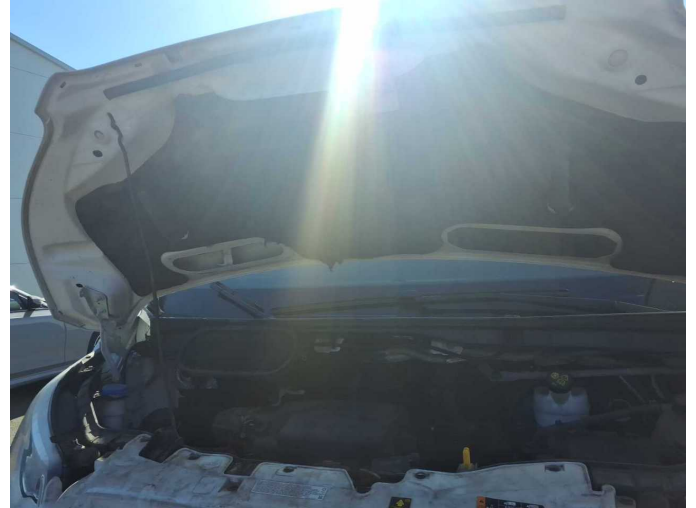
**Damage 4:** Bonnet: Insulation lining - Damage caused by marten / rodent - Replace

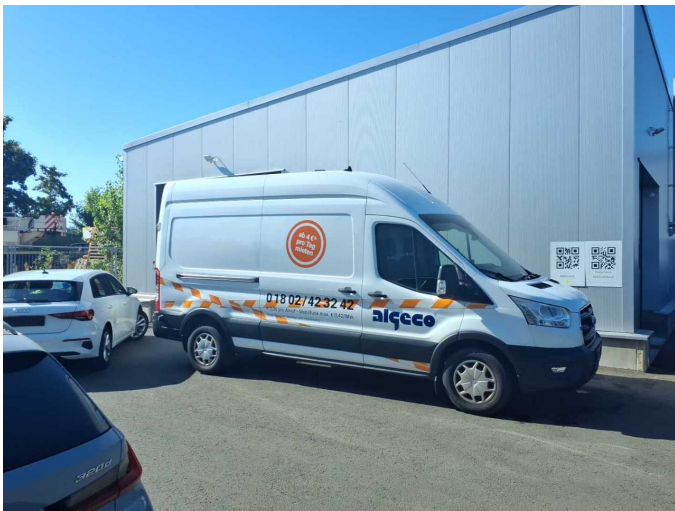
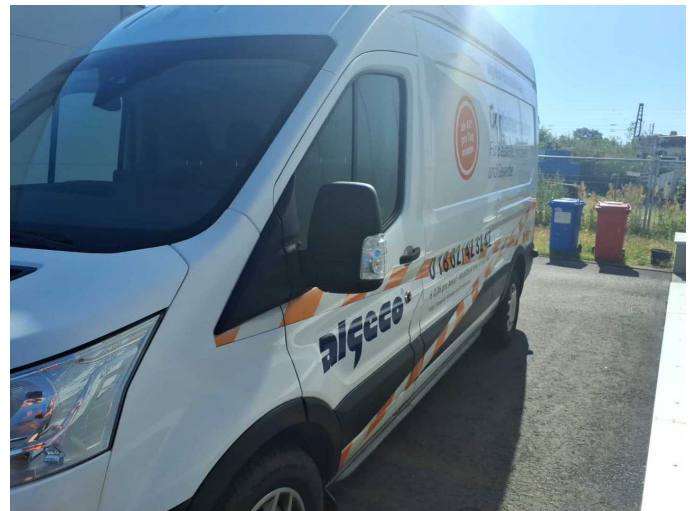
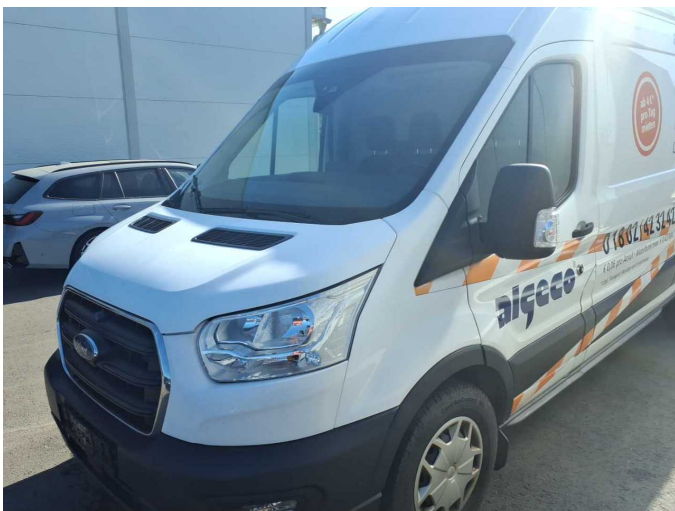
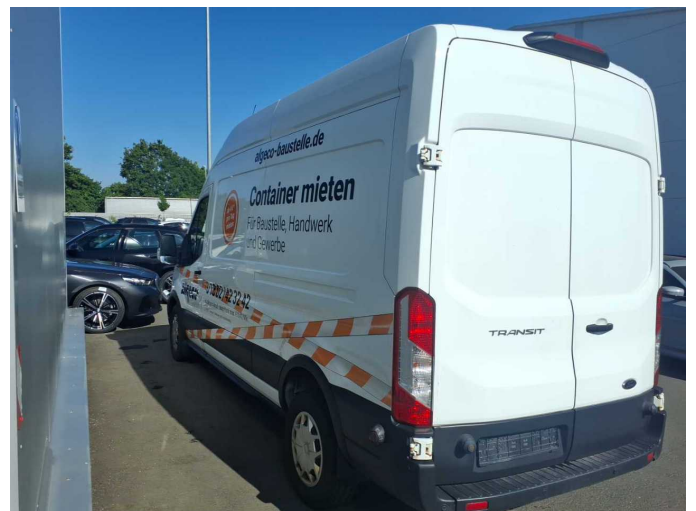
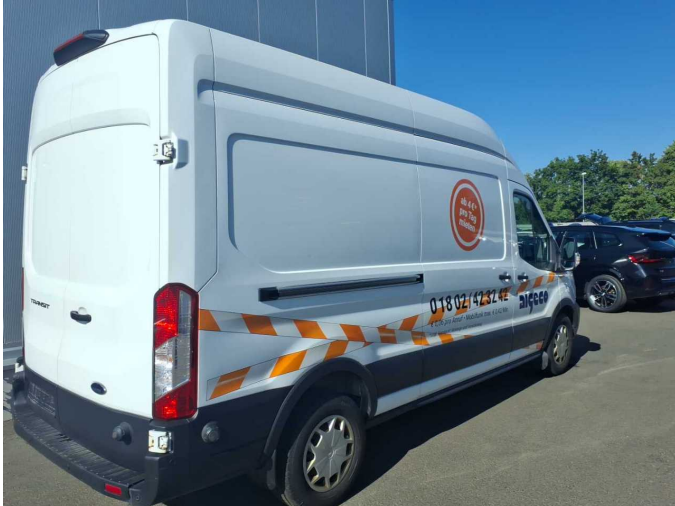
**Damage 5:** Body: Body - Glued / labelled - De-glue / neutralise

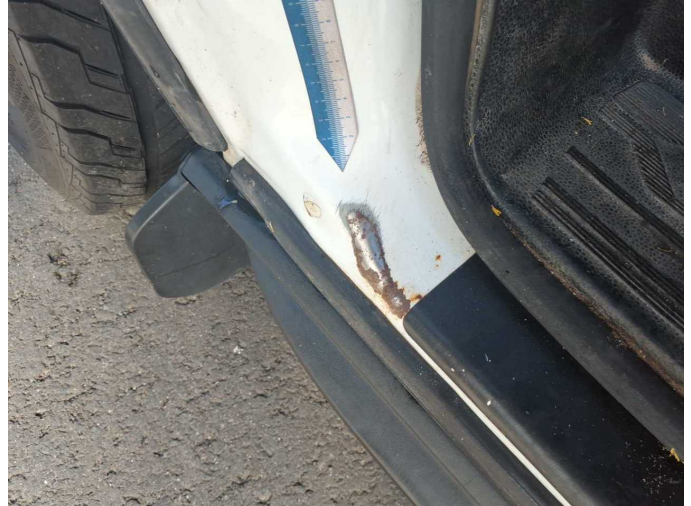
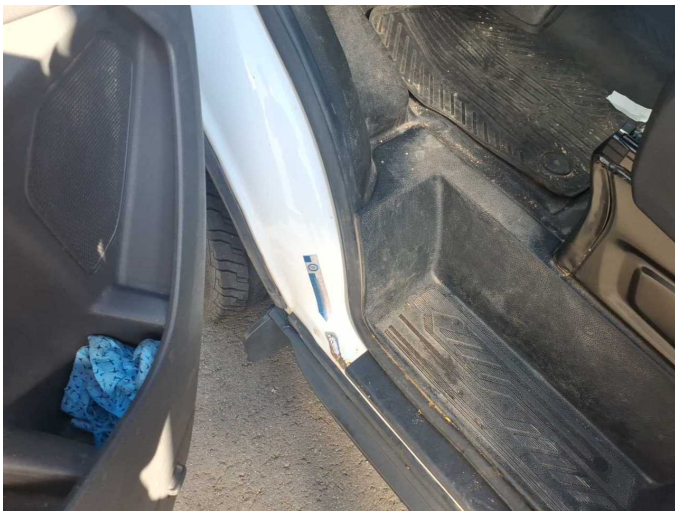
**Damage 6:** Sill - left side: Sill - Corrosion - Repair and paint

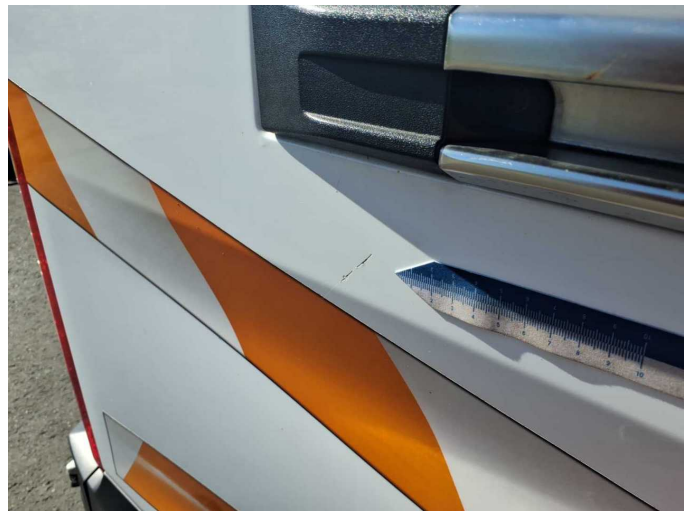
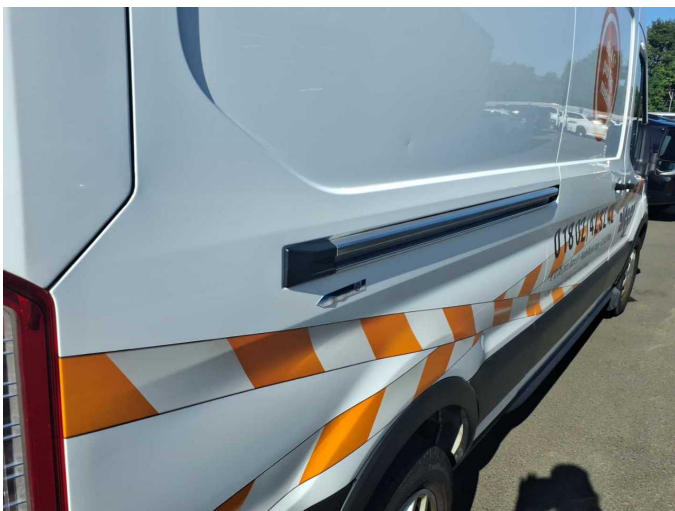
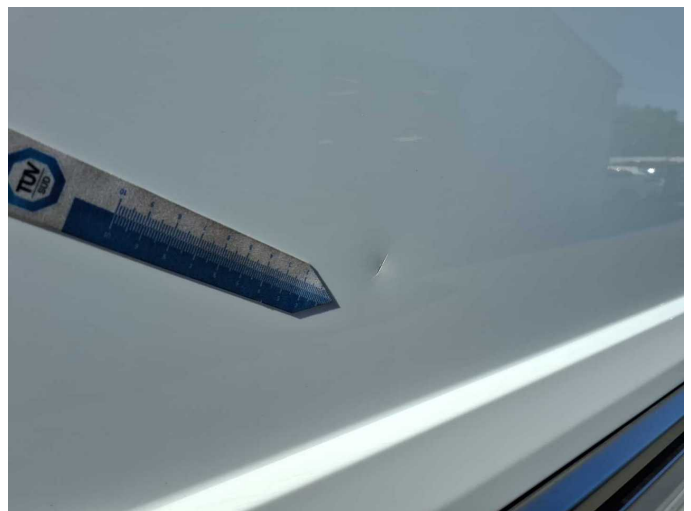
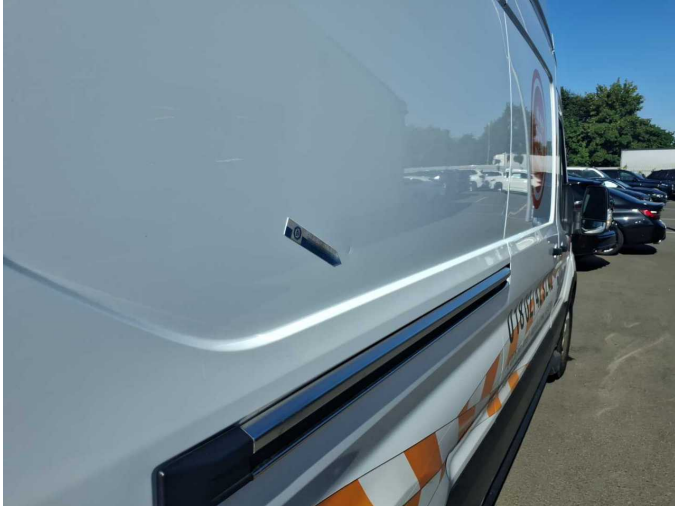
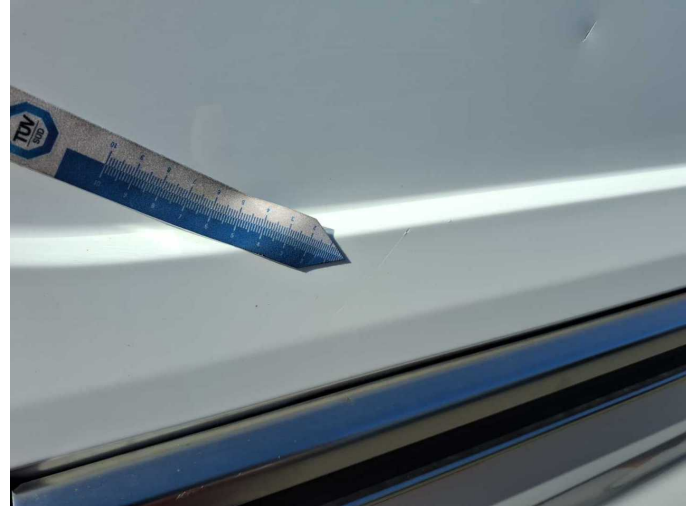
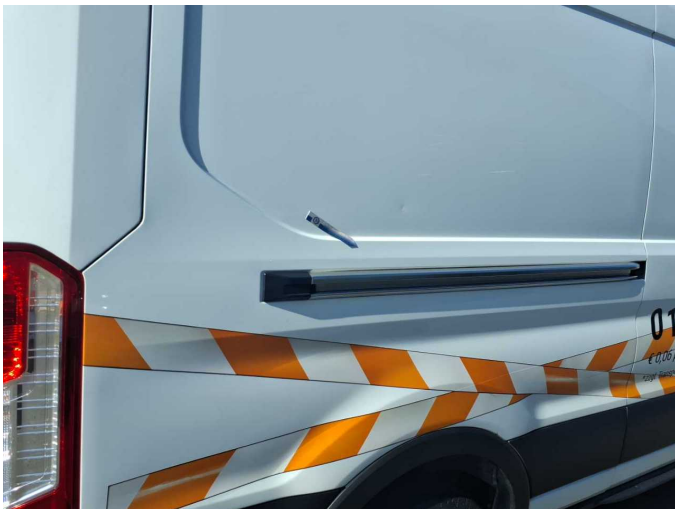
**Damage 7:** Side panel - rear right side: Side panel - Scratched - Paint

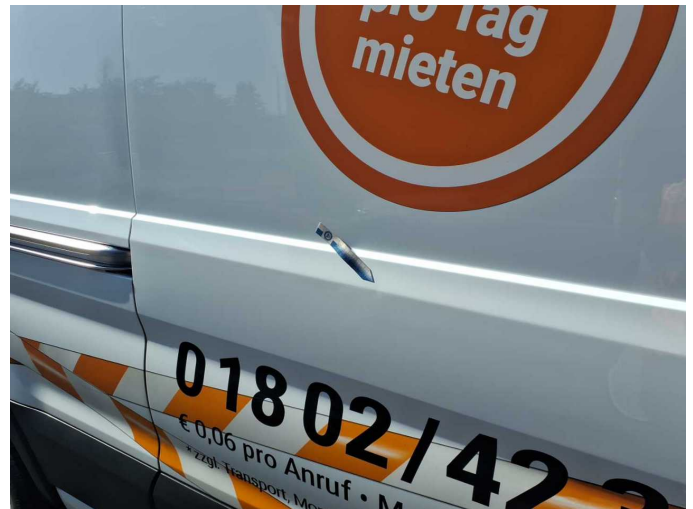
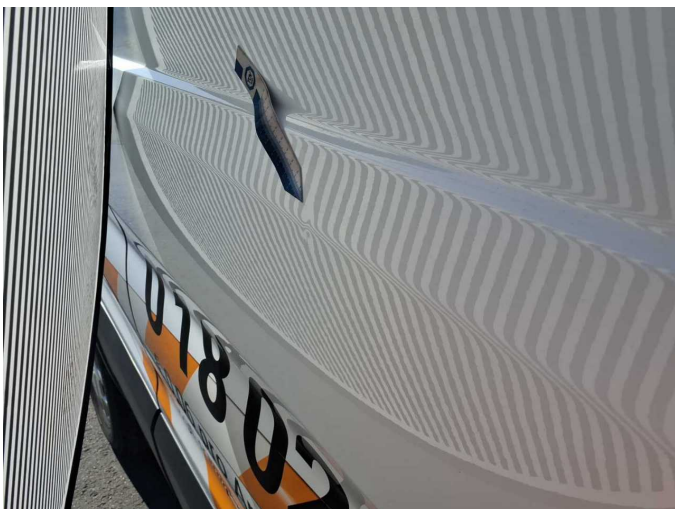
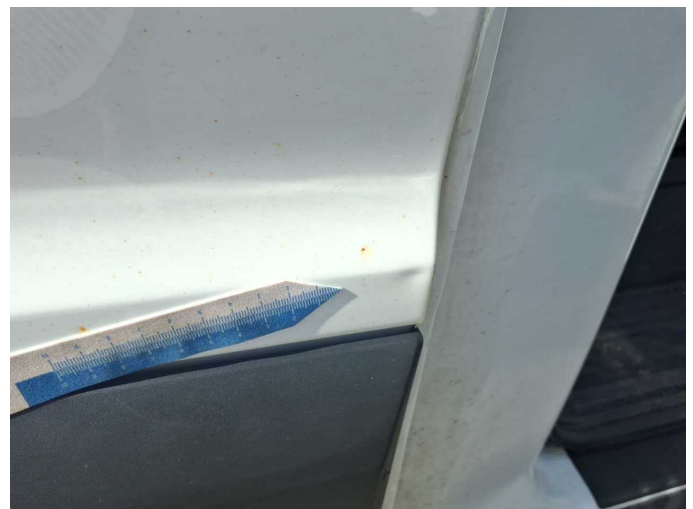
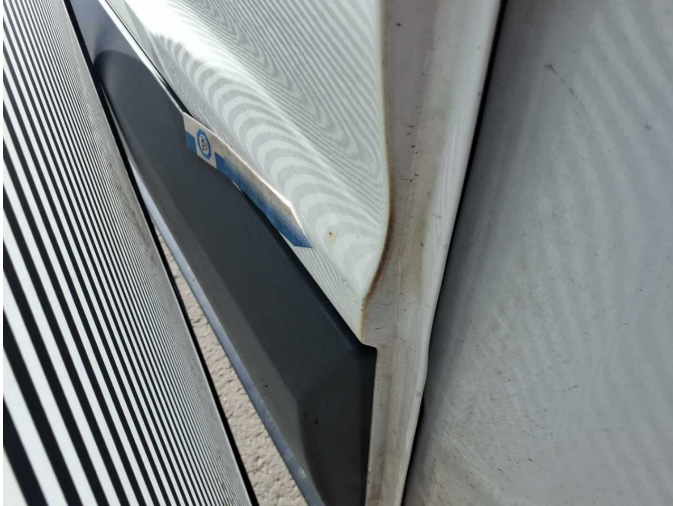
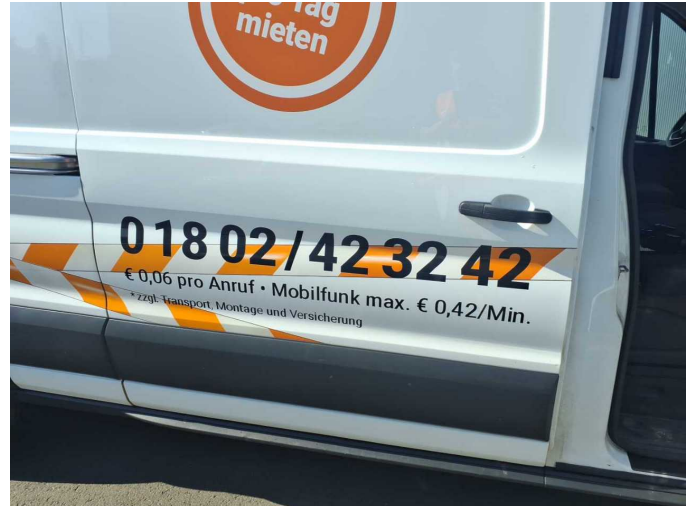
**Damage 8:** Door - rear right side: Door (Steinschlag mit Korrosion) - Dent / paintcoat damage - Repair and paint

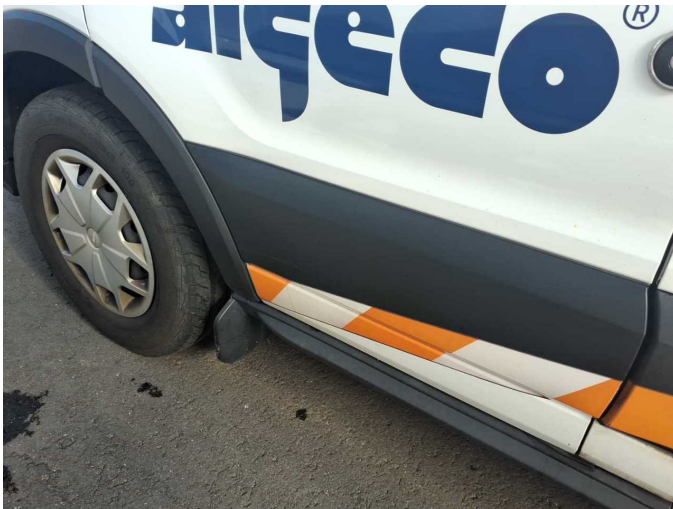
**Wear and tear 1:** Door - front left side: Brightware - lower - Scratch(es) - No deduction

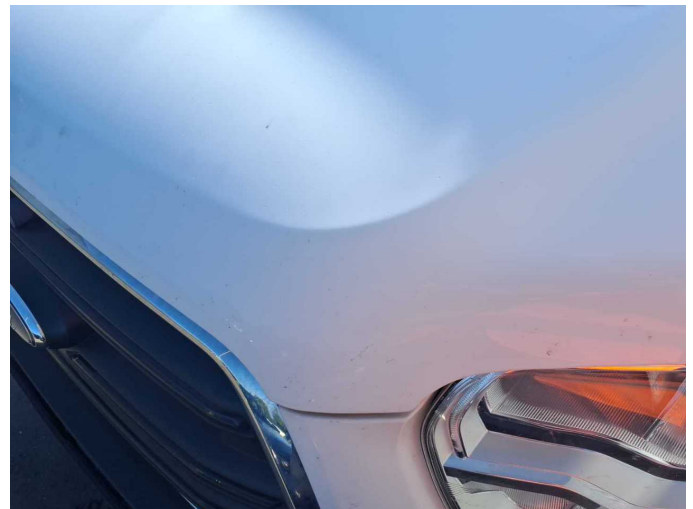
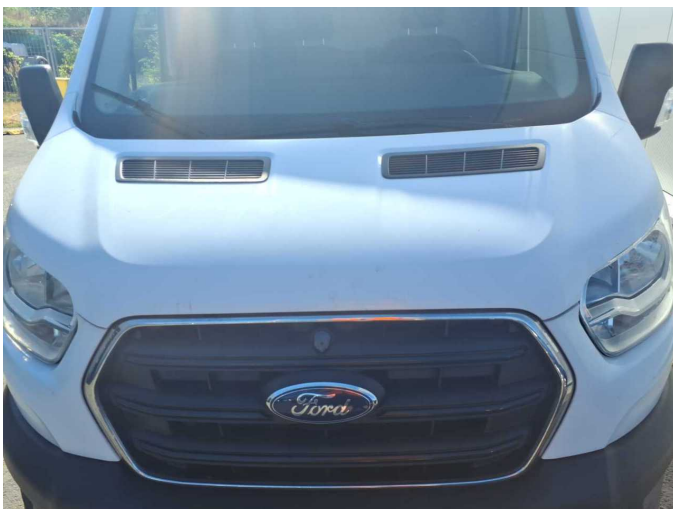
**Wear and tear 2:** Bonnet: Bonnet - Stone chips - No deduction

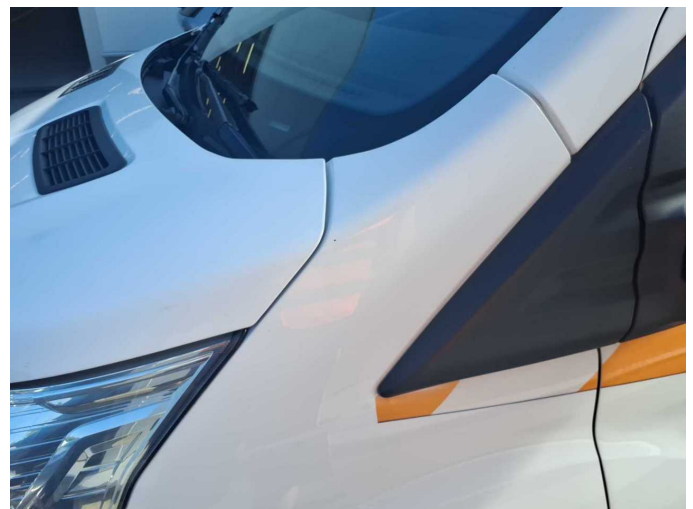
**Wear and tear 3:** Mudguard - left side: Mudguard - left side - Stone chips - No deduction

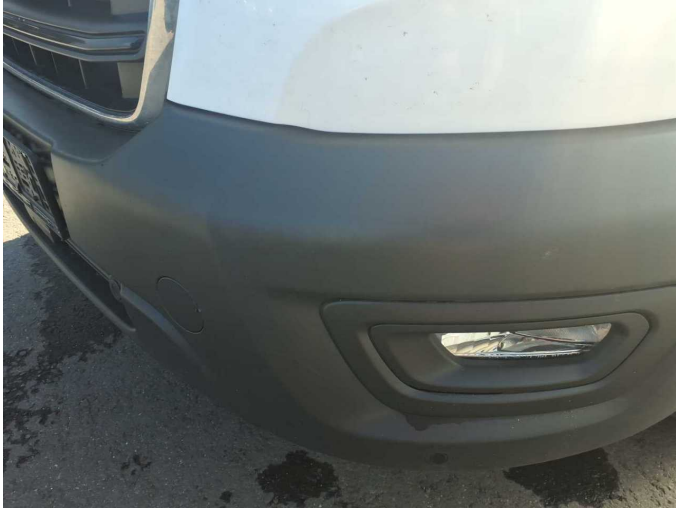
**Wear and tear 4:** Front bumper: Front bumper (unpainted) - Stone chips - No deduction

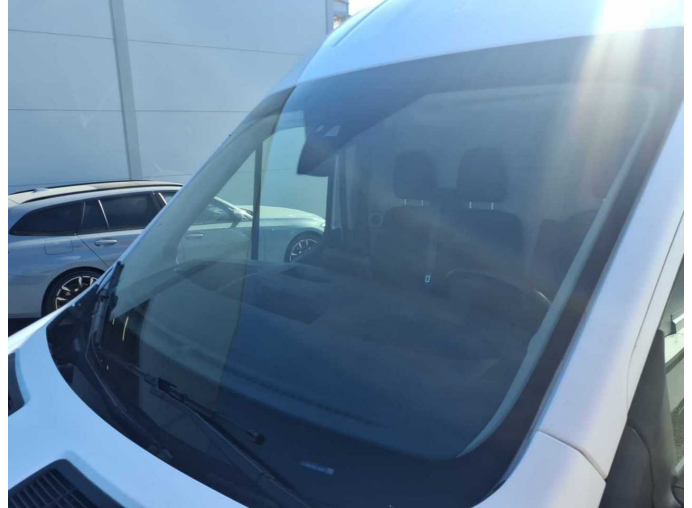
**Wear and tear 5:** Vehicle glazing: Windscreen - Stone chips - No deduction

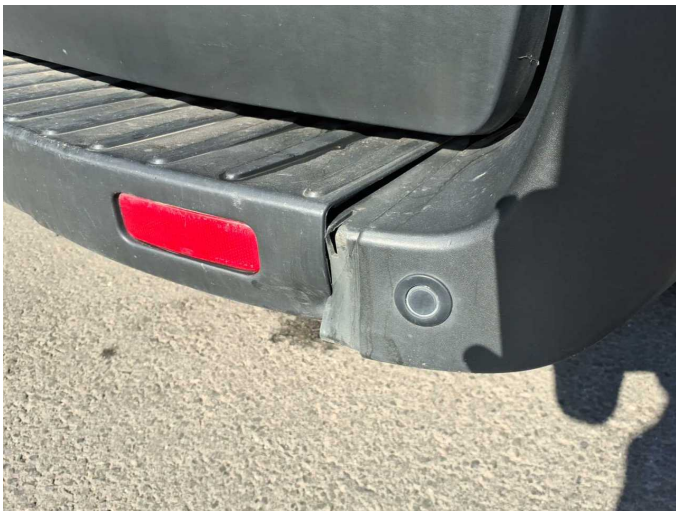
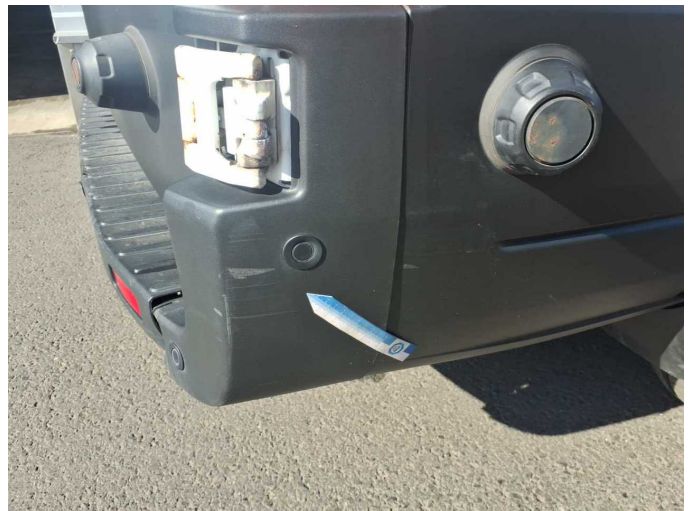
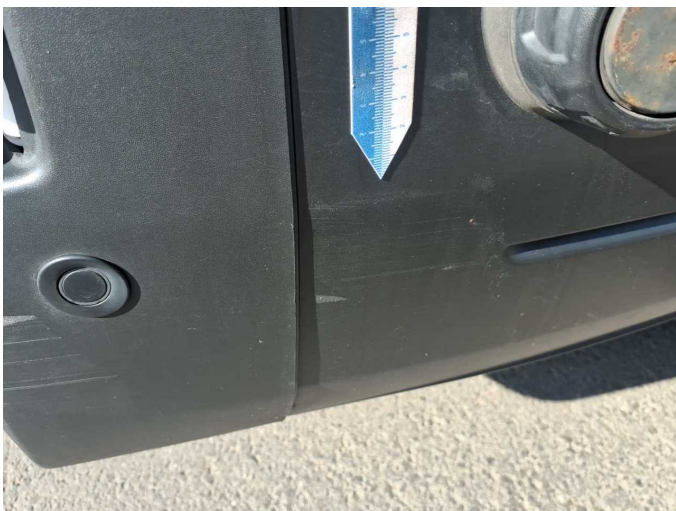
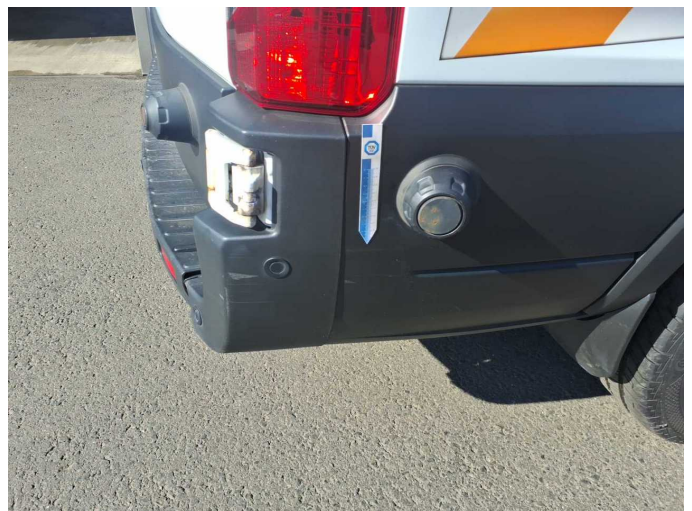
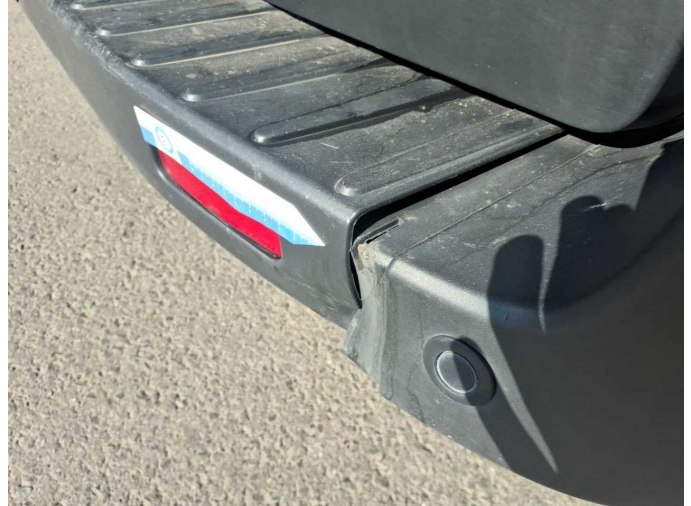
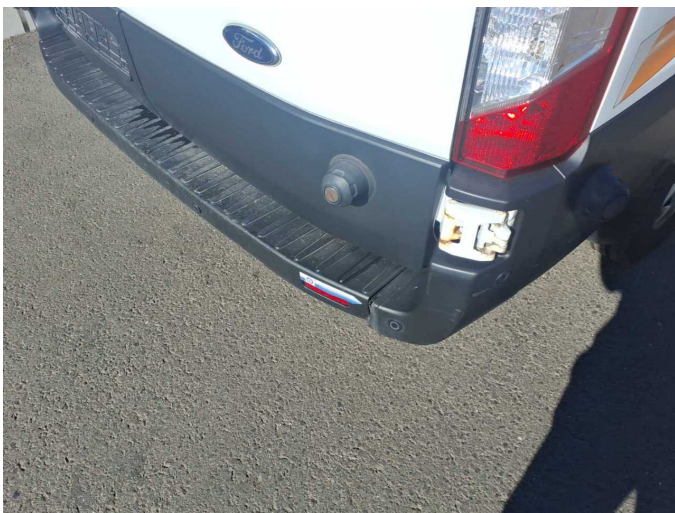
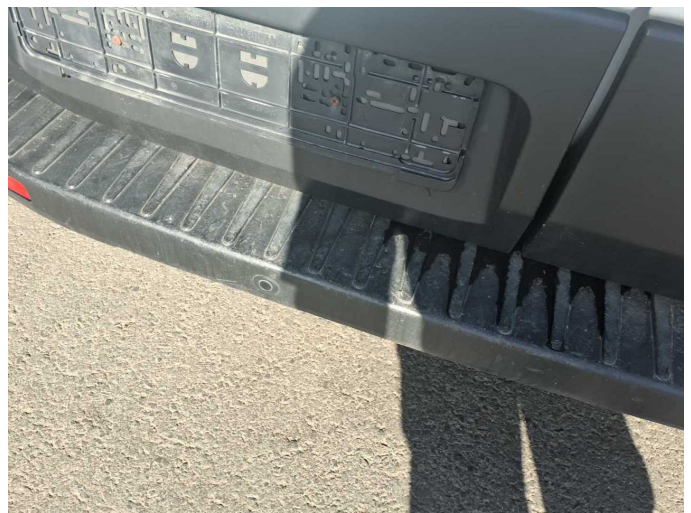
**Accident 1:** Rear, Side right

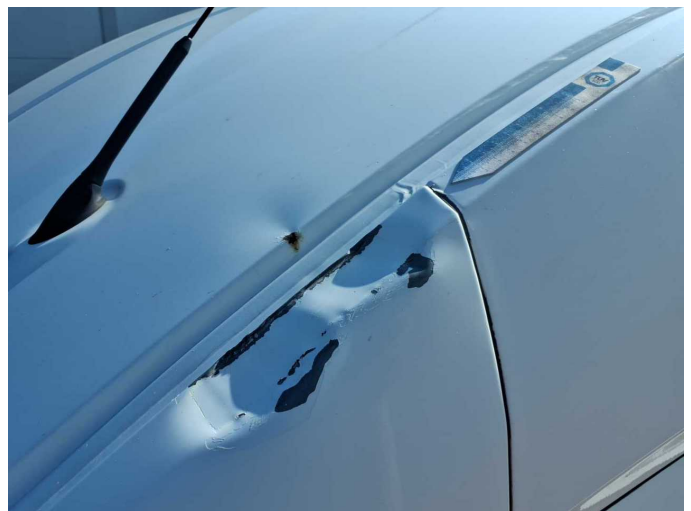
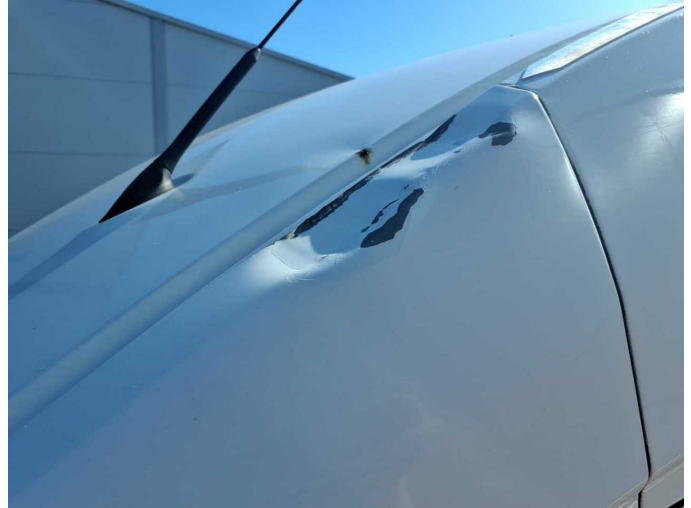
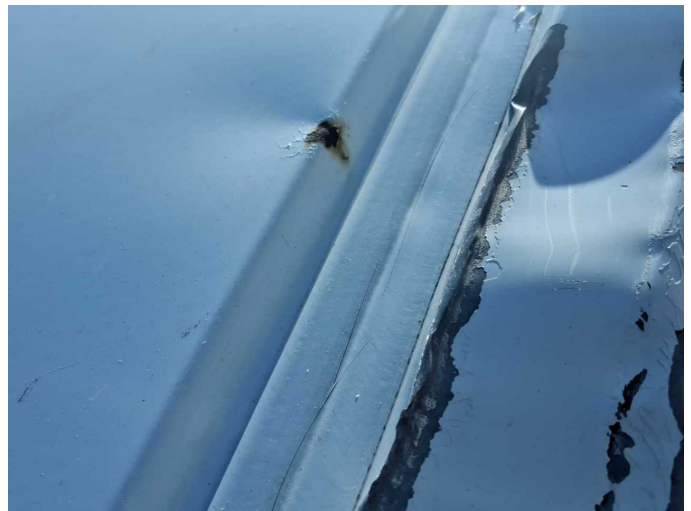
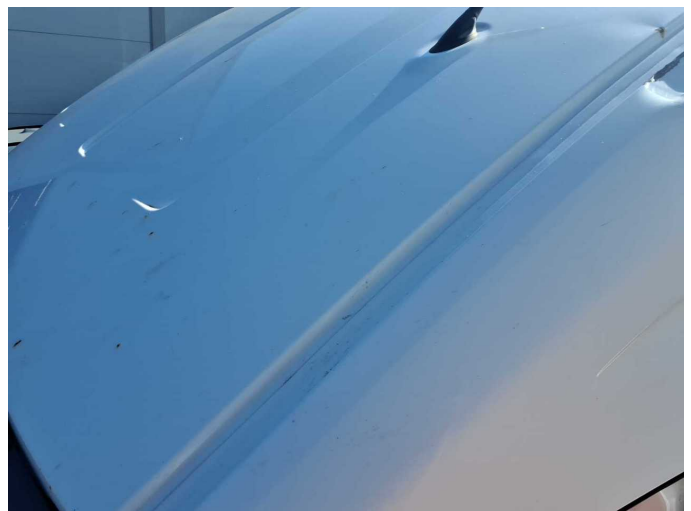
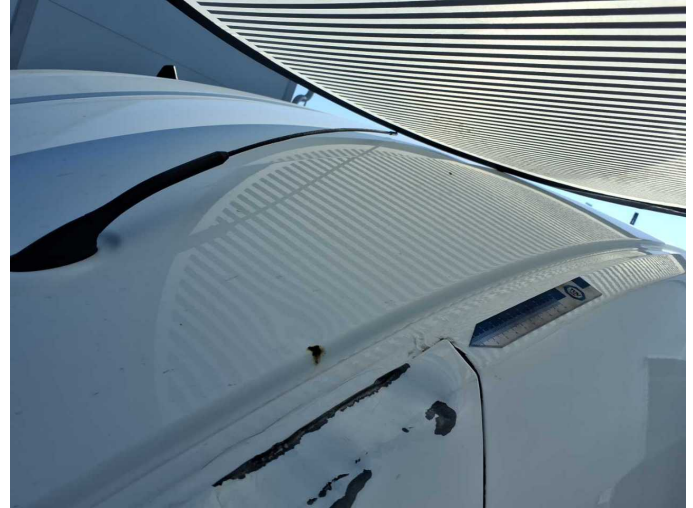
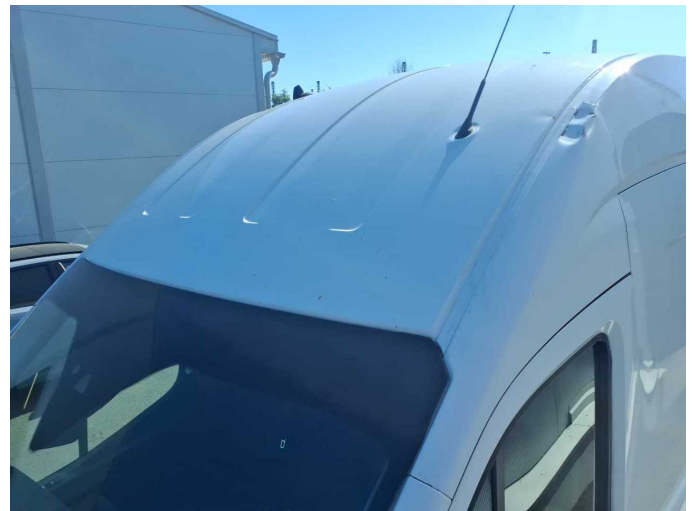
**Accident 2:** Roof, Front

**Accident 2: Roof, Front**

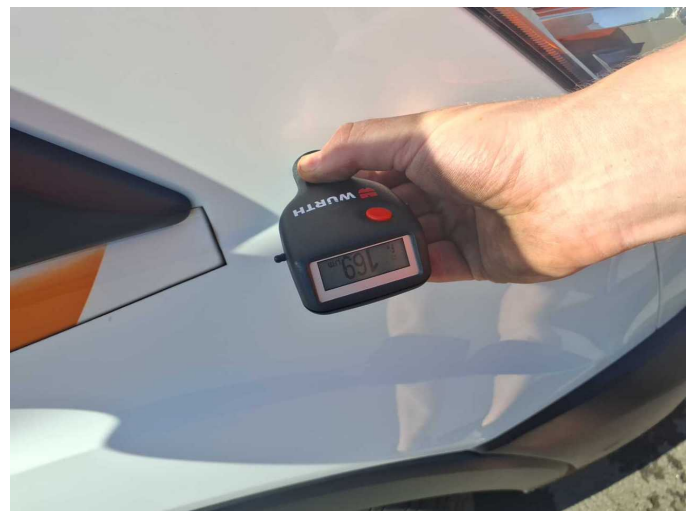
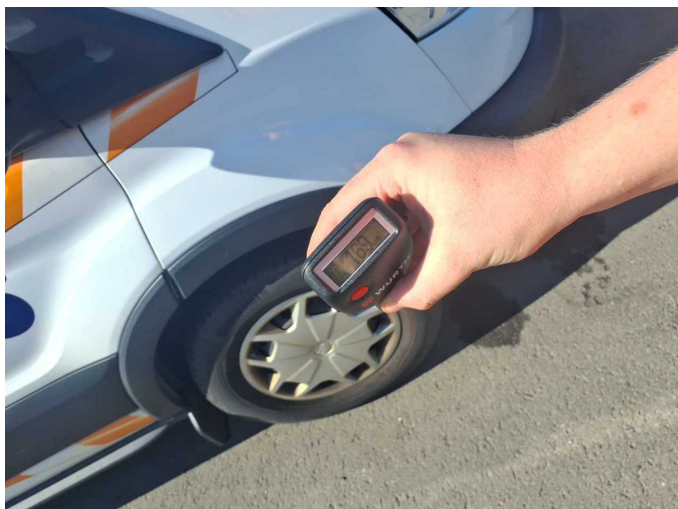
Mudguard - right side	169 µm	Side panel - rear right side	180 µm
-----------------------	--------	------------------------------	--------

**Repainting 1: Mudguard - right side**

**Repainting 1:** Mudguard - right side

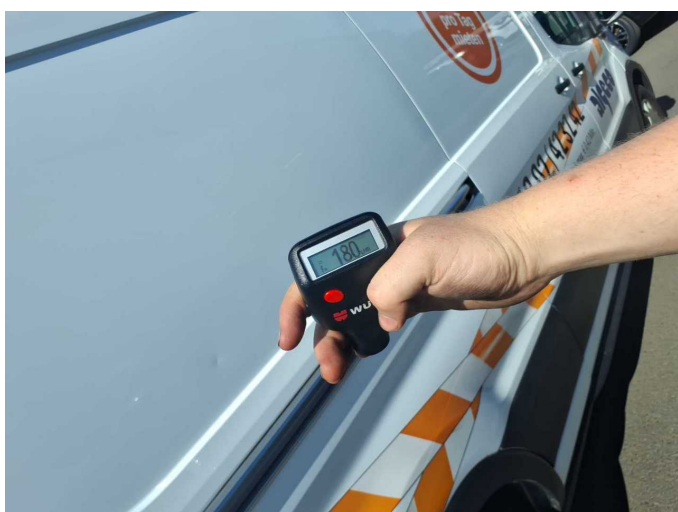
**Repainting 2:** Side panel - rear right side
