## Expertise

Protocol number: 45994475  
Order No. / Reference: 26417276  
Inspection date: 16 Jun 2026

Manufacturer: Volkswagen

Model: Caddy 2.0 TDI BMT (5-Si.) DSG Caddy

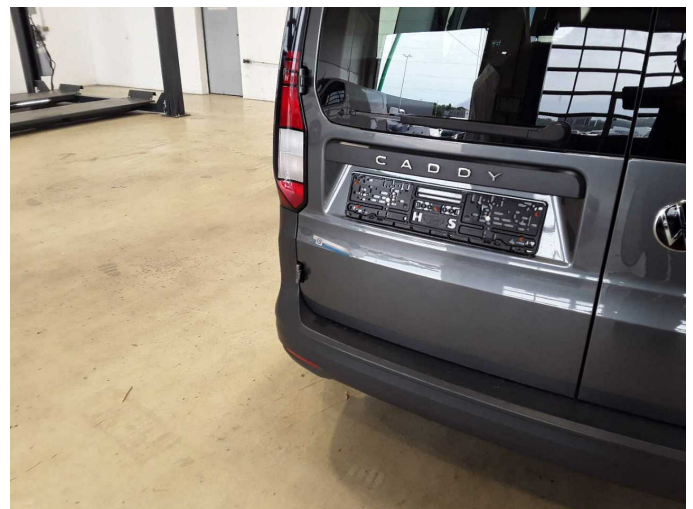
Damage 1: Boot lid / rear door: Rear door - left side - dent(s) - Smart repair

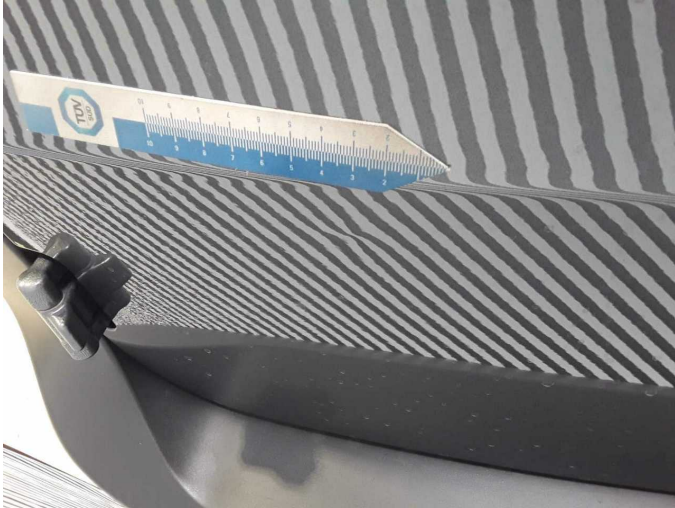
**Damage 1:** Boot lid / rear door: Rear door - left side - dent(s) - Smart repair

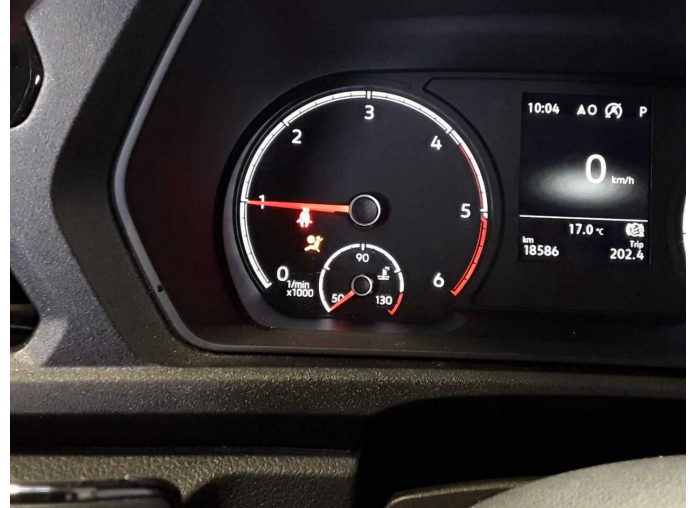
**Damage 2:** Instrument panel: Indicator light (Airbag) - on - Perform diagnosis

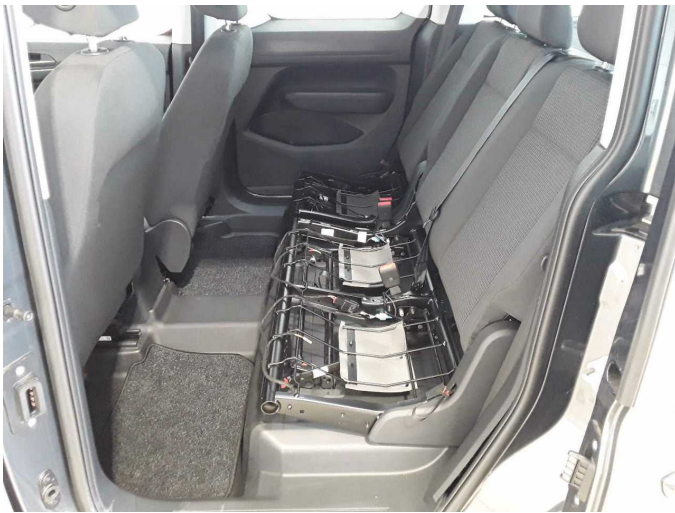
**Damage 3:** Seat - rear: Seat upholstery - 3 seater bench (inkl. Bezug) - Missing - Replace
