Expertise

Protocol number: 45522208
Order No. / Reference: 26382962
Inspection date: 13 May 2026

Manufacturer: Opel

Model: Astra Sports Tourer 1.5 D Automatik Business Edition

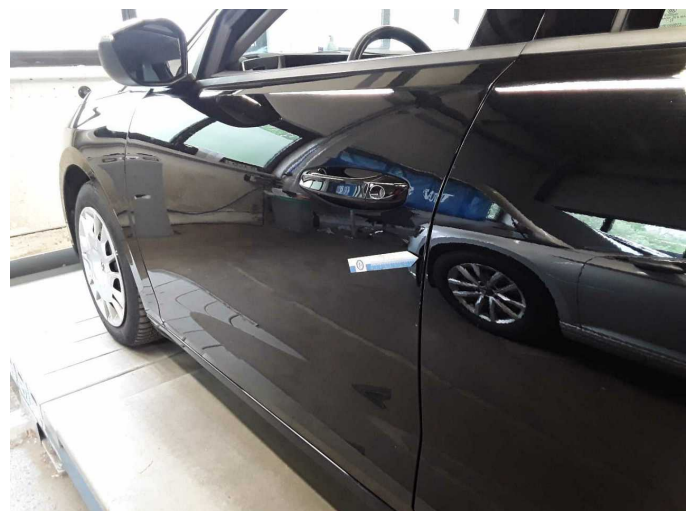
No.	Component group	Description
1	Door - front left side	Door - Scratch(es) - Smart repair
2	Sill - right side	Sill - Scratch(es) - Smart repair
3	Door - rear right side	Door - Scratch(es) - Smart repair
4	Side panel - rear left side	Side panel - Scratch(es) - Paint
5	Rear bumper	Rear bumper - Scratch(es) - Paint
6	Front bumper	Front bumper (Sandstrahleffekt) - Stone chips - Paint

Damage 1: Door - front left side: Door - Scratch(es) - Smart repair

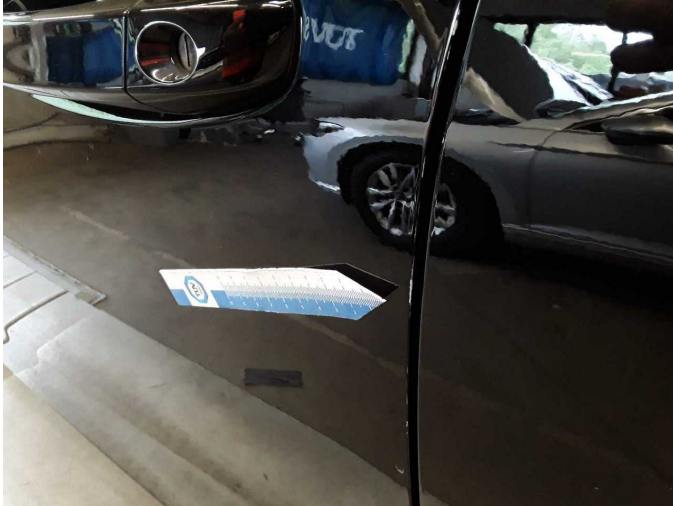
Damage 1: Door - front left side: Door - Scratch(es) - Smart repair

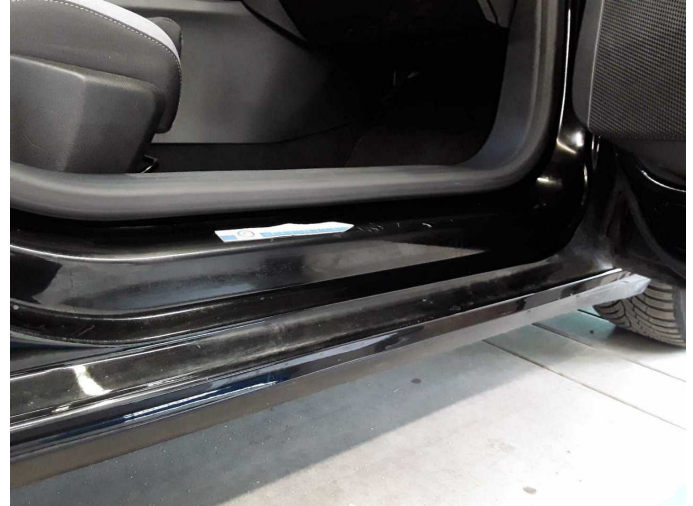
Damage 2: Sill - right side: Sill - Scratch(es) - Smart repair

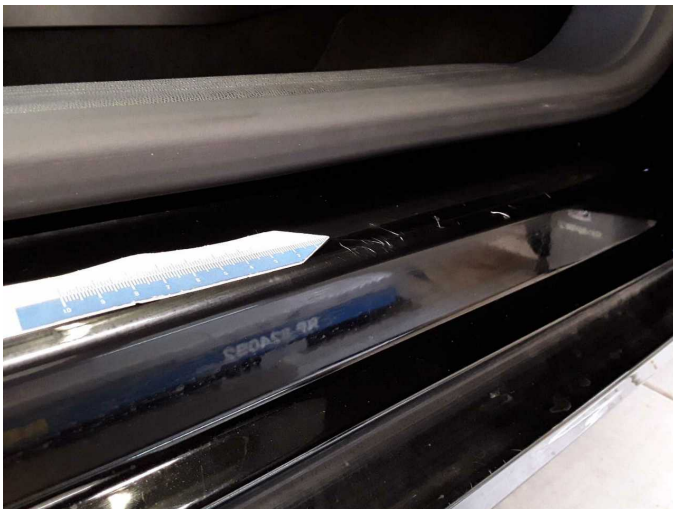
Damage 2: Sill - right side: Sill - Scratch(es) - Smart repair

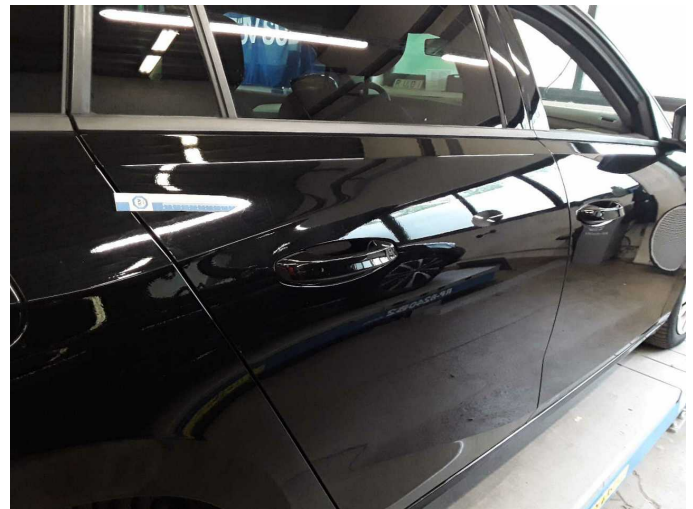
Damage 3: Door - rear right side: Door - Scratch(es) - Smart repair

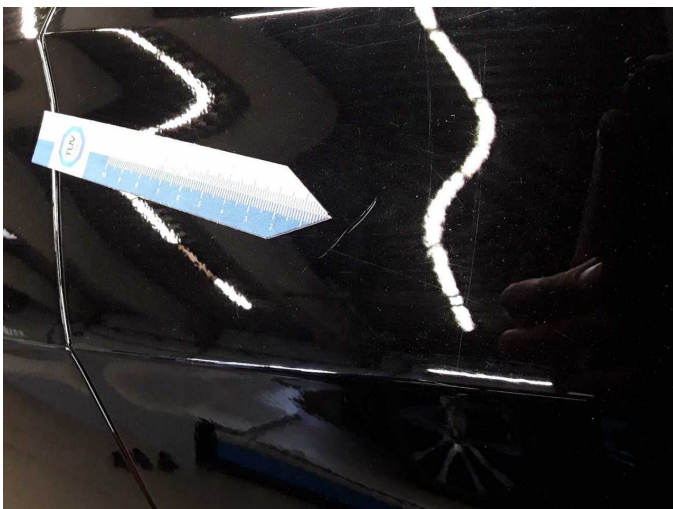
Damage 3: Door - rear right side: Door - Scratch(es) - Smart repair

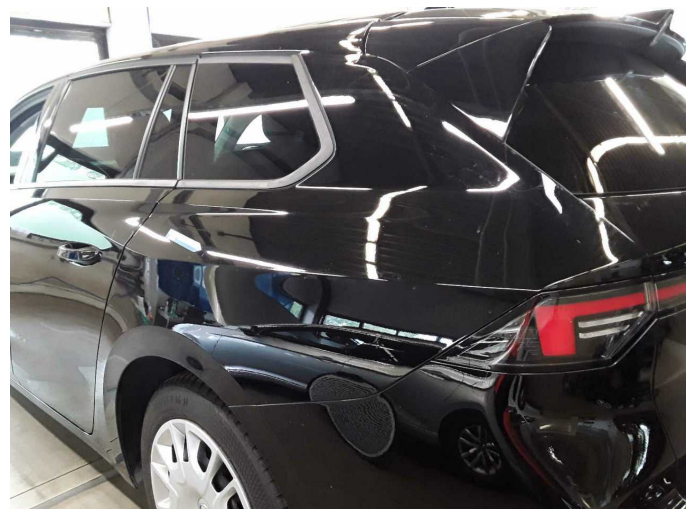
Damage 4: Side panel - rear left side: Side panel - Scratch(es) - Paint

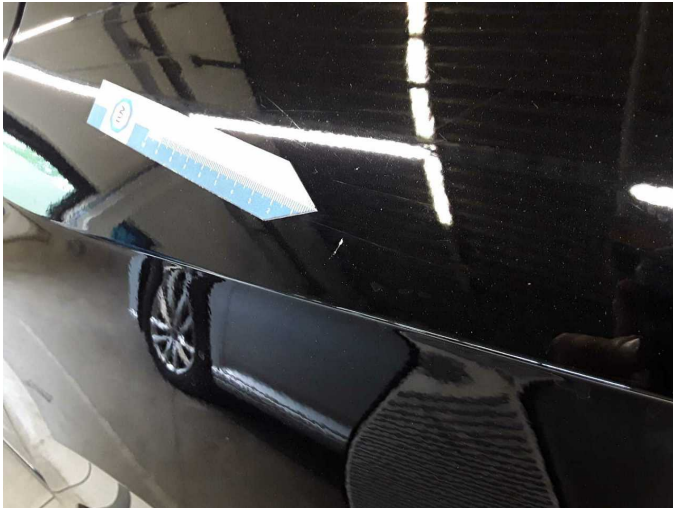
Damage 4: Side panel - rear left side: Side panel - Scratch(es) - Paint

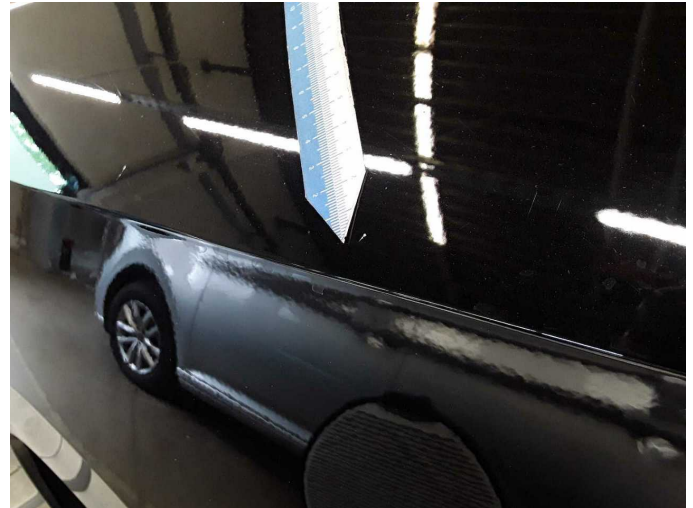
Damage 4: Side panel - rear left side: Side panel - Scratch(es) - Paint

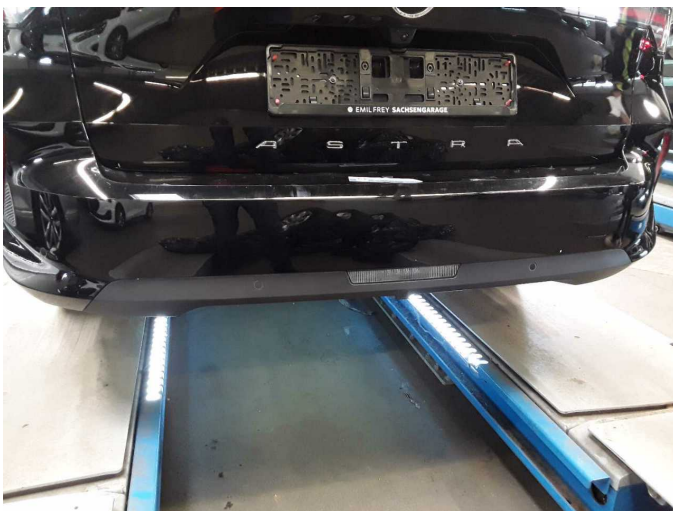
Damage 5: Rear bumper: Rear bumper - Scratch(es) - Paint

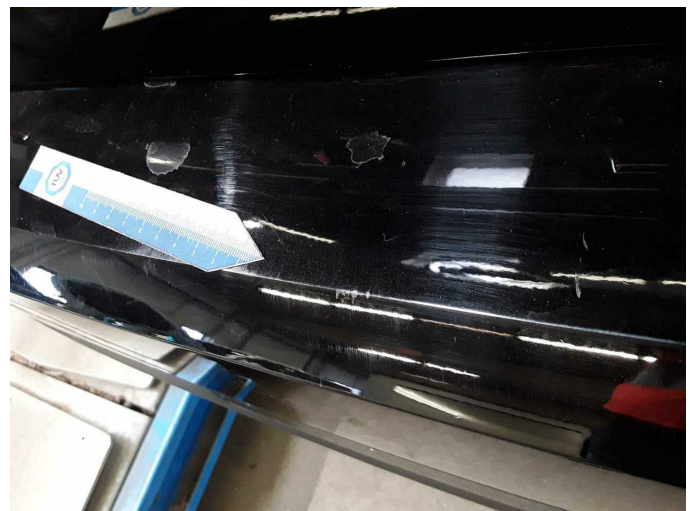
Damage 5: Rear bumper: Rear bumper - Scratch(es) - Paint

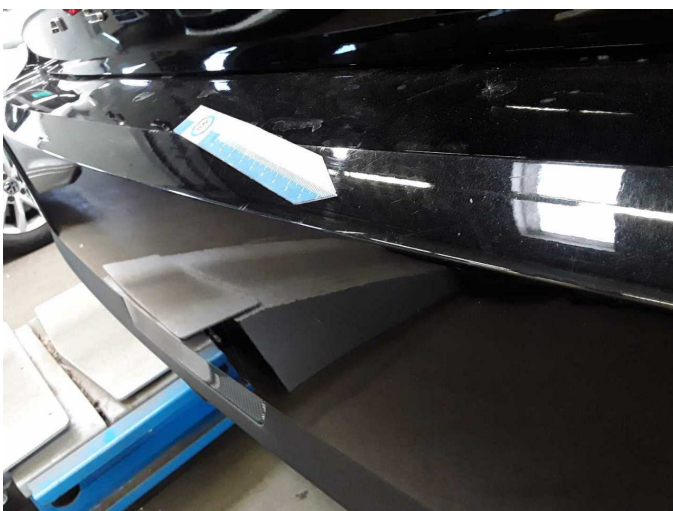
Damage 5: Rear bumper: Rear bumper - Scratch(es) - Paint

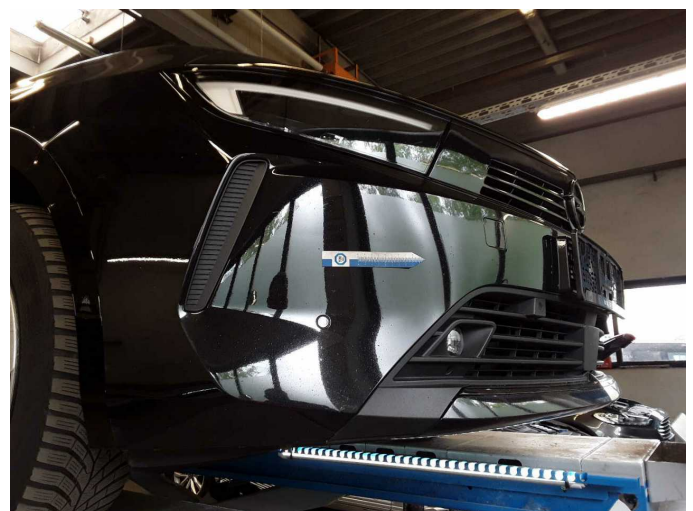
Damage 6: Front bumper: Front bumper (Sandstrahleffekt) - Stone chips - Paint

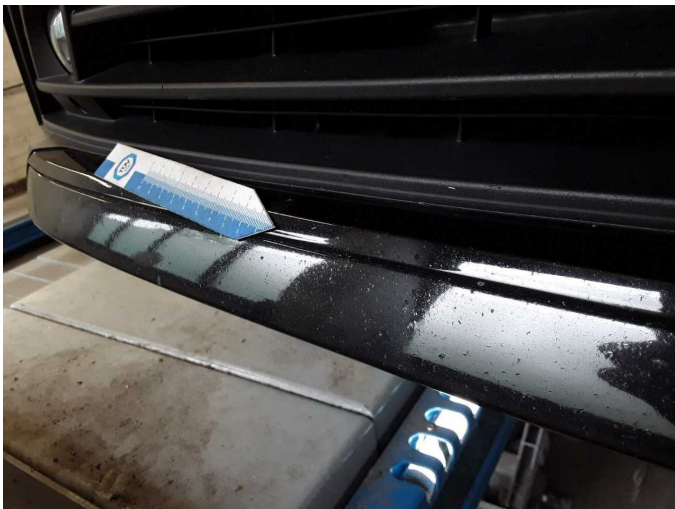
Damage 6: Front bumper: Front bumper (Sandstrahleffekt) - Stone chips - Paint

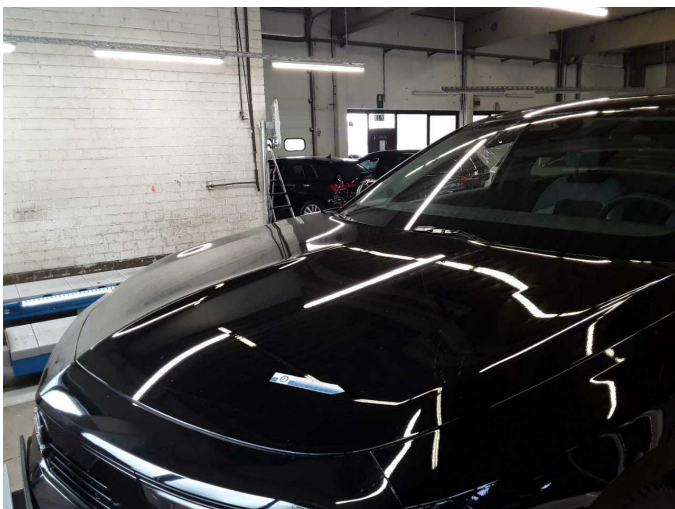
No.	Component group	Description
1	Bonnet	Bonnet - Stone chips - No deduction
2	Vehicle glazing	Windscreen - Stone chips - No deduction
3	Wheel / tyres	Wheel cover - front right side (Kein Teil der Ausstattung) - Scratched - No deduction
4	Wheel / tyres	Tyre - front (Profiltiere <4mm Kein Teil der Ausstattung) - Does not meet the leasing specifications - No deduction

Wear and tear 1: Bonnet: Bonnet - Stone chips - No deduction

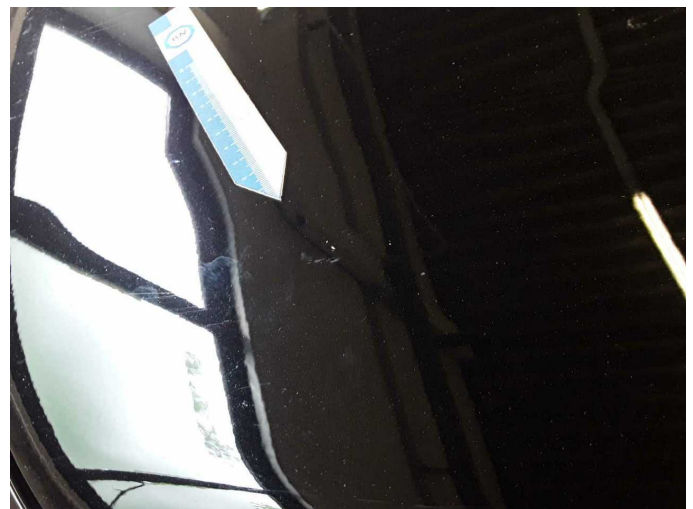
Wear and tear 1: Bonnet: Bonnet - Stone chips - No deduction

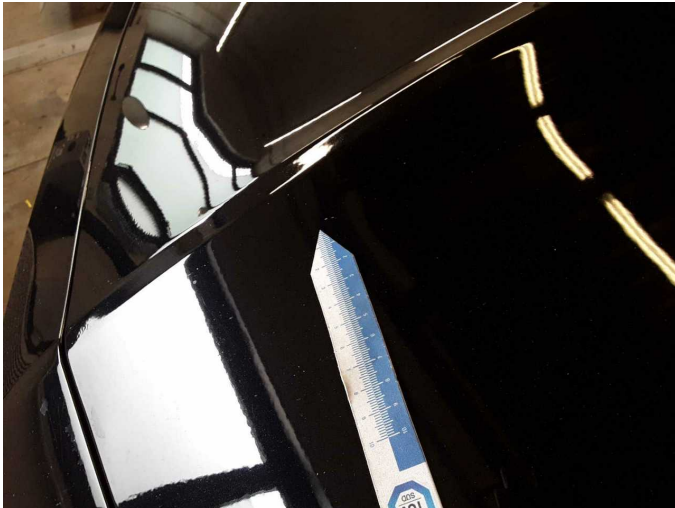
Wear and tear 1: Bonnet: Bonnet - Stone chips - No deduction

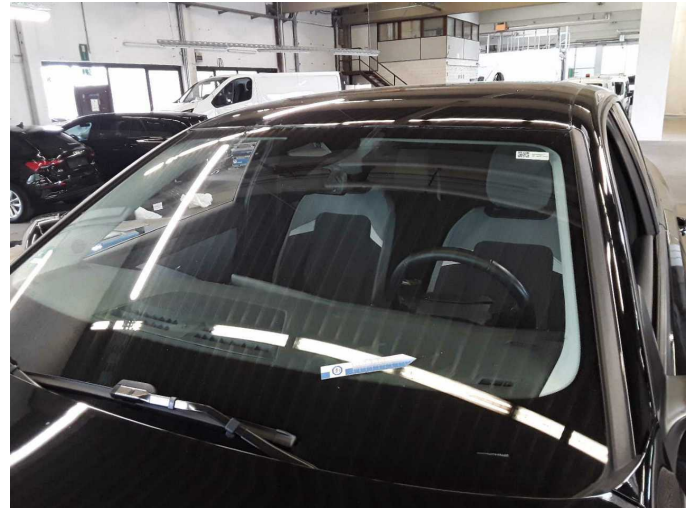
Wear and tear 2: Vehicle glazing: Windscreen - Stone chips - No deduction

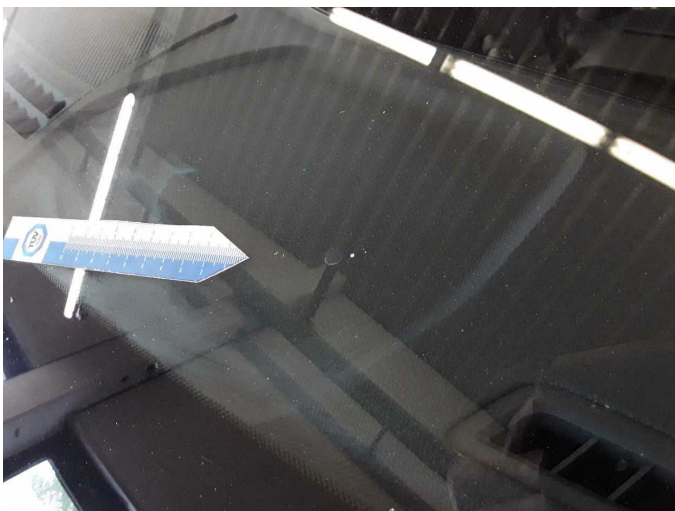
Wear and tear 2: Vehicle glazing: Windscreen - Stone chips - No deduction

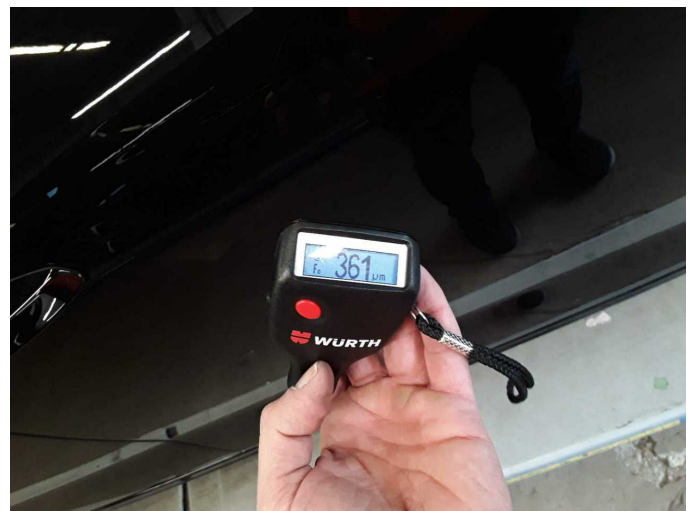
No.	Repainting
1	Roof, Door - front right side, Professionally carried out, Invoice of repair done Non-existent

Roof	318 µm	Door - front right side	361 µm
------	--------	-------------------------	--------

Repainting 1: Roof, Door - front right side

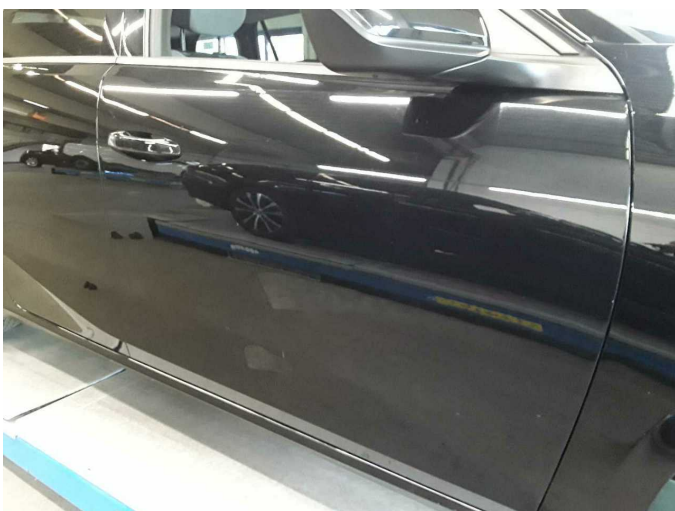
Repainting 1: Roof, Door - front right side

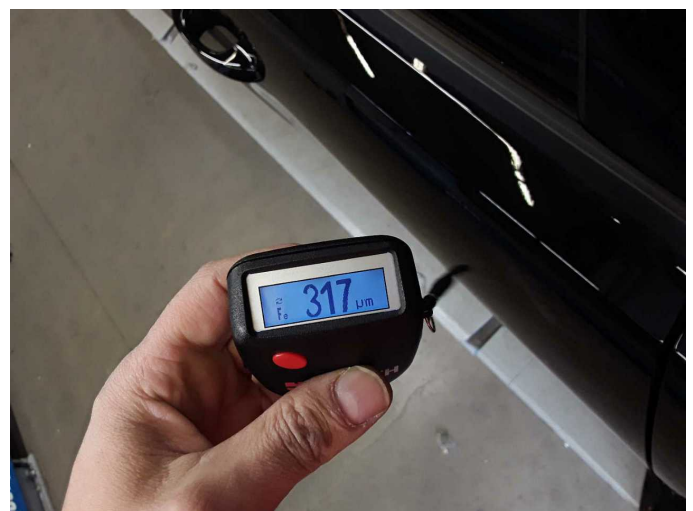
Repainting 1: Roof, Door - front right side

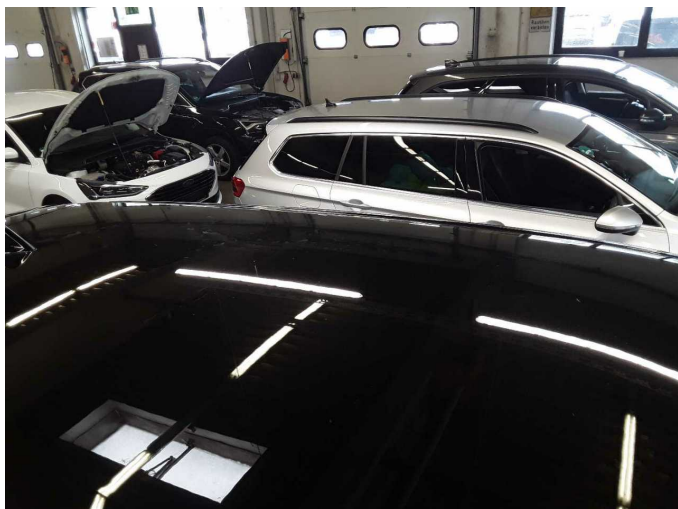
Repainting 1: Roof, Door - front right side
