Expertise

Protocol number: 47165606  
Order No. / Reference: 26803656  
Inspection date: 19 Aug 2026

Manufacturer: Nissan

Model: Leaf 40 kWh N-Connecta

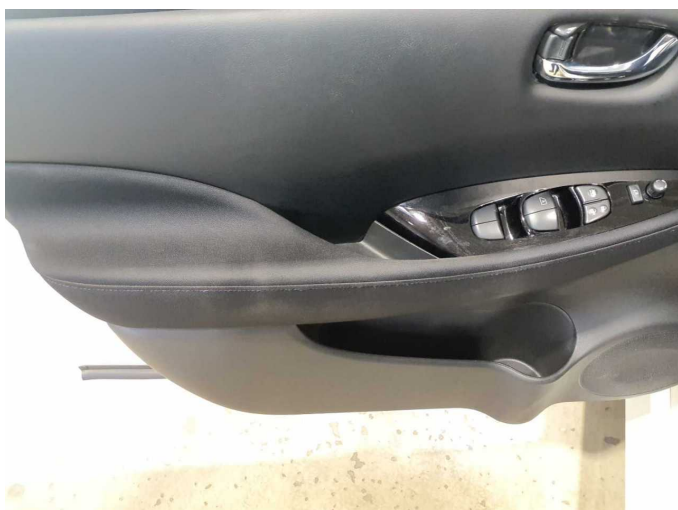
| No. | Component group | Description |
|---|---|---|
| 1 | Trim / covers | Door trim - front left side - Scratch(es) - No deduction |

**Damage 1:** Trim / covers: Door trim - front left side - Scratch(es) - No deduction

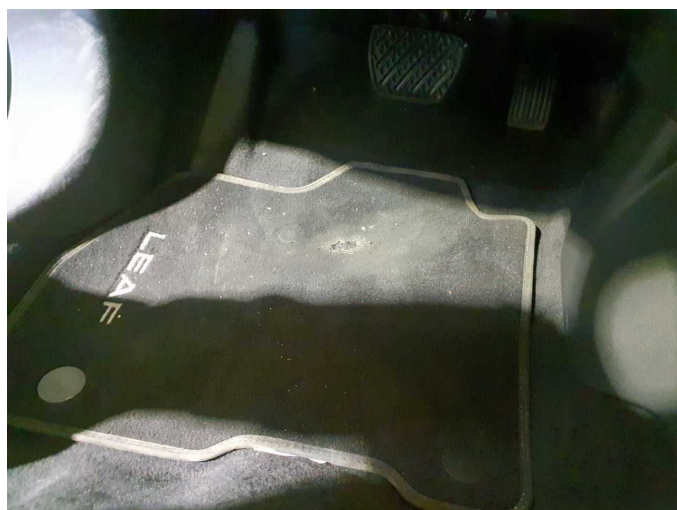
| No. | Component group | Description |
|---|---|---|
| 3 | Trim / covers | Floor mats - Broken / torn - Replace |

**Damage 3:** Trim / covers: Floor mats - Broken / torn - Replace

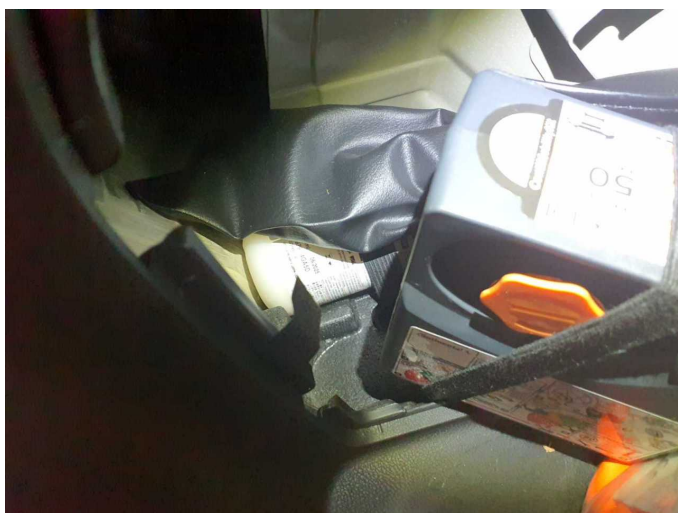
| No. | Component group | Description |
|---|---|---|
| 4 | Equipment | Tirefit filler - Expired - Replace |

**Damage 4:** Equipment: Tirefit filler - Expired - Replace

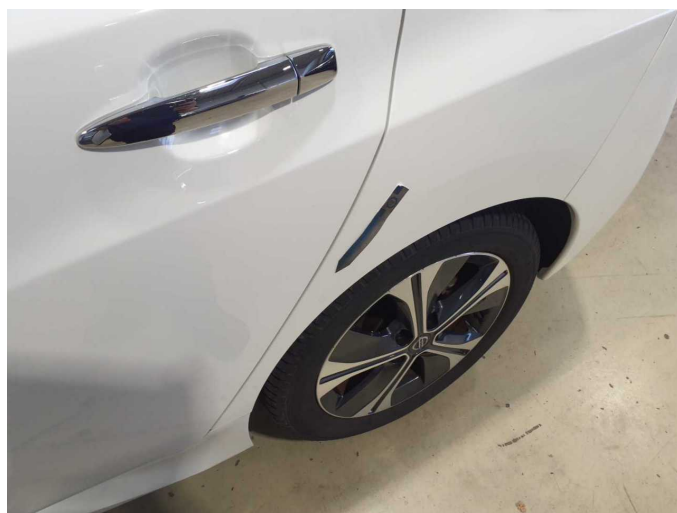
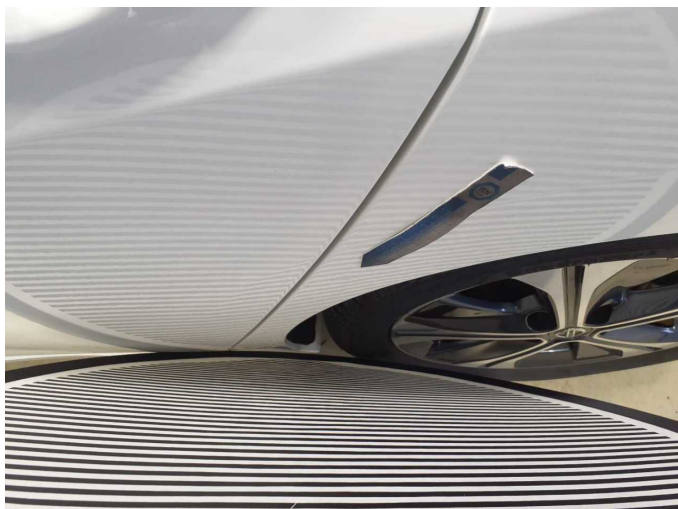
| No. | Component group | Description |
|---|---|---|
| 5 | Side panel - rear left side | Side panel - dent(s) - Smooth repair work |

**Damage 5:** Side panel - rear left side: Side panel - dent(s) - Smooth repair work

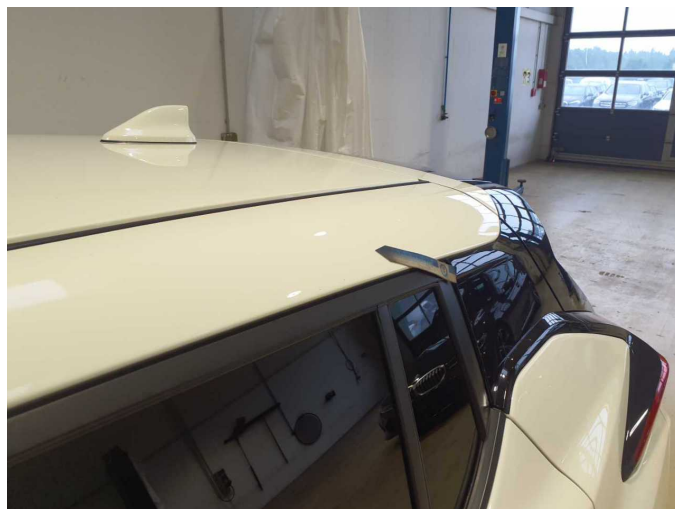
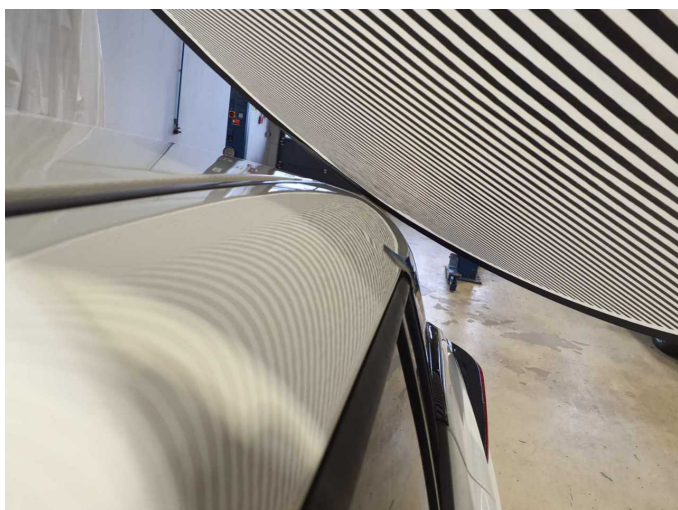
| No. | Component group | Description |
|---|---|---|
| 6 | Roof | Roof rail - left side - dent(s) - Smooth repair work |

**Damage 6:** Roof: Roof rail - left side - dent(s) - Smooth repair work

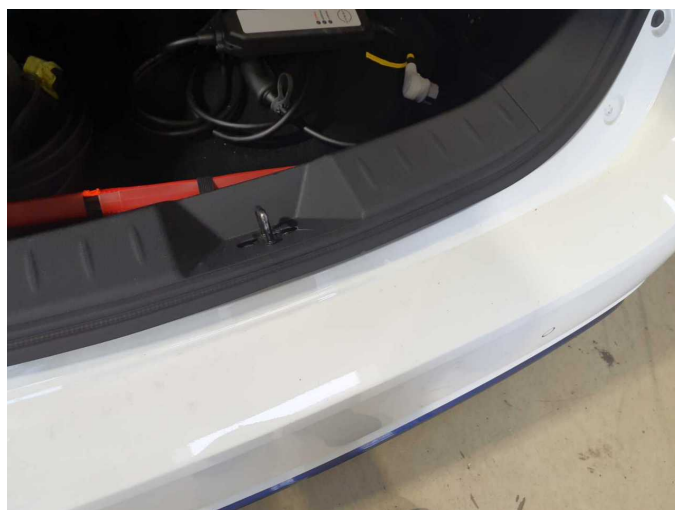
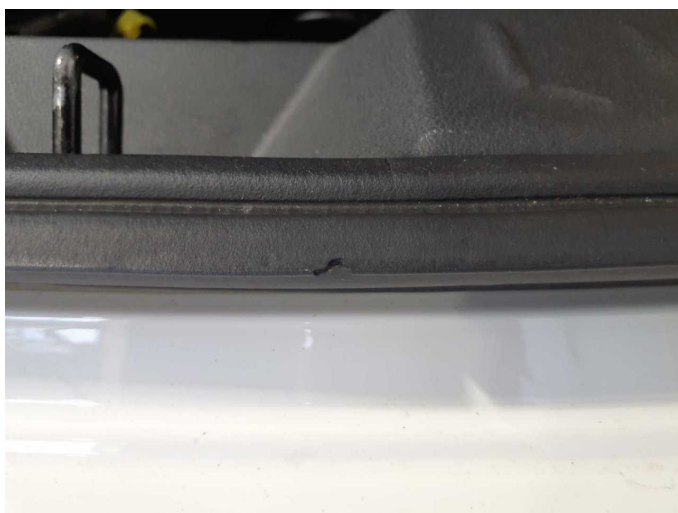
| No. | Component group | Description |
|---|---|---|
| 7 | Boot lid / rear door | Seal - Broken / torn - repair/paint (S1) |

**Damage 7:** Boot lid / rear door: Seal - Broken / torn - repair/paint (S1)

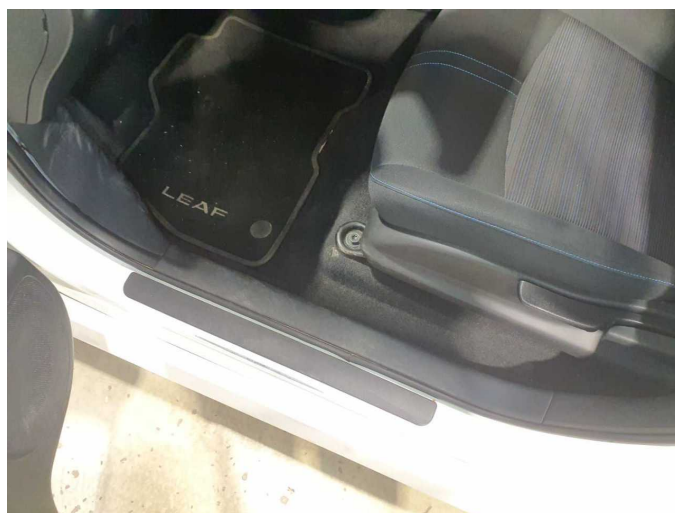
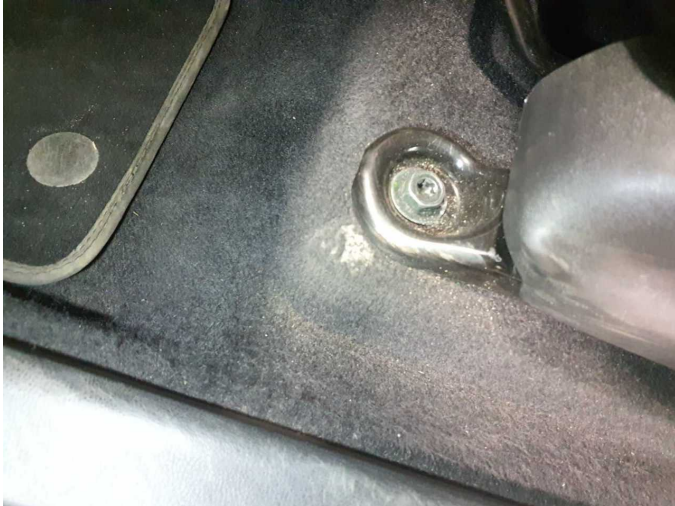
| No. | Component group | Description |
|---|---|---|
| 8 | Trim / covers | Carpet - front left side - Scratch(es) - Smart repair |

**Damage 8:** Trim / covers: Carpet - front left side - Scratch(es) - Smart repair

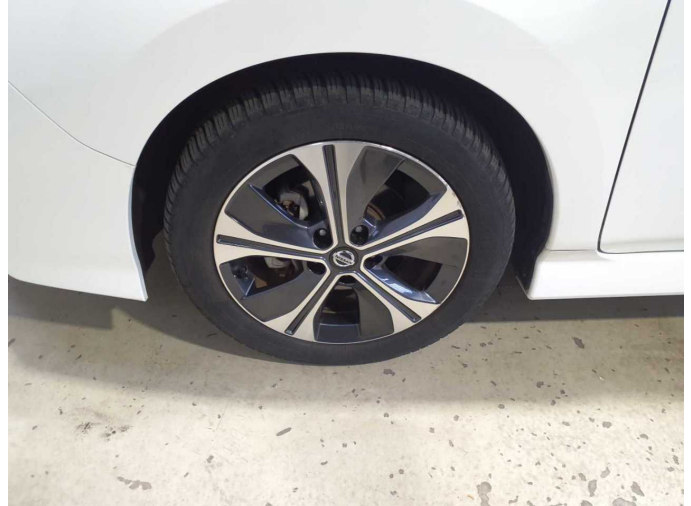
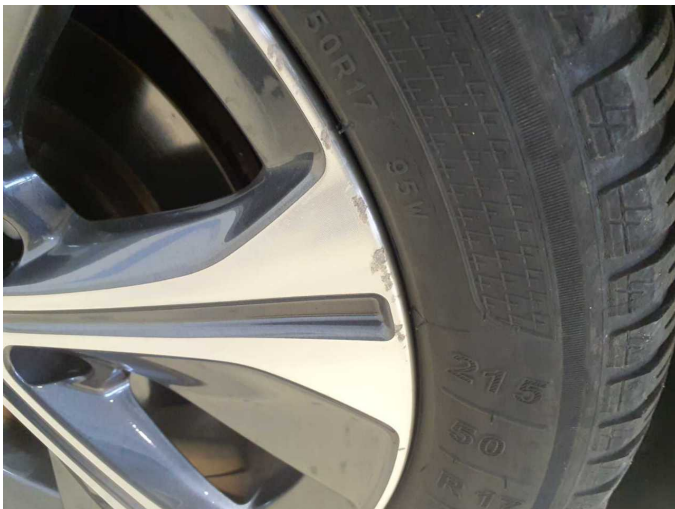
| No. | Component group | Description |
|---|---|---|
| 9 | Wheel / tyres | Alloy rim - front left side - Scratch(es) - Loss in value |

**Damage 9:** Wheel / tyres: Alloy rim - front left side - Scratch(es) - Loss in value

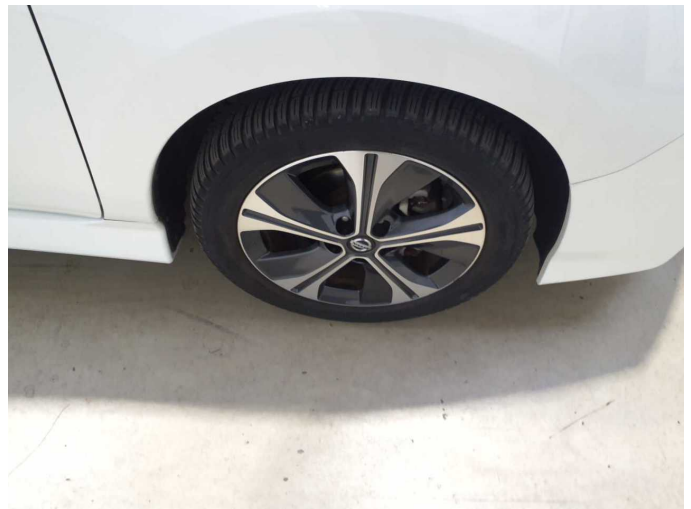
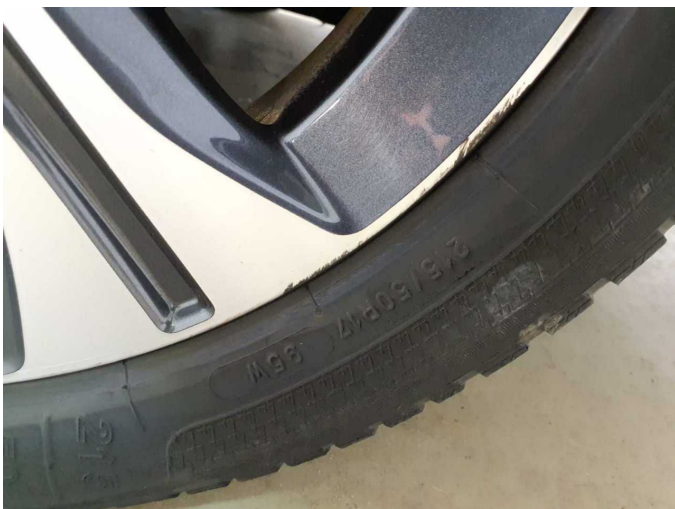
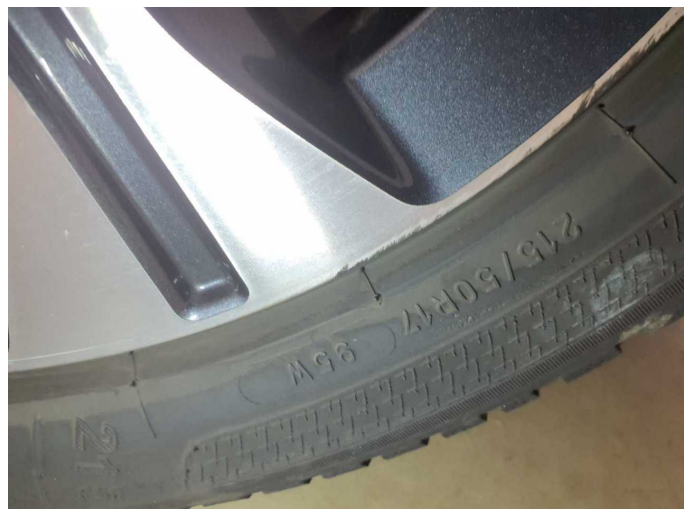
| No. | Component group | Description |
|---|---|---|
| 10 | Wheel / tyres | Alloy rim - front right side - Scratch(es) - Loss in value |

**Damage 10:** Wheel / tyres: Alloy rim - front right side - Scratch(es) - Loss in value

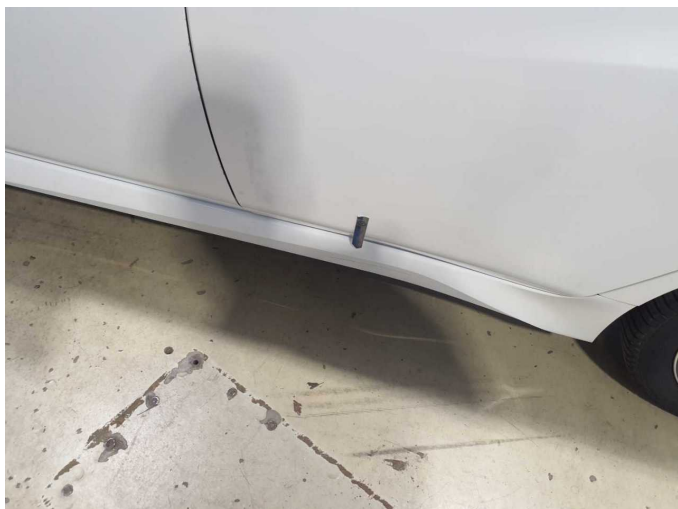
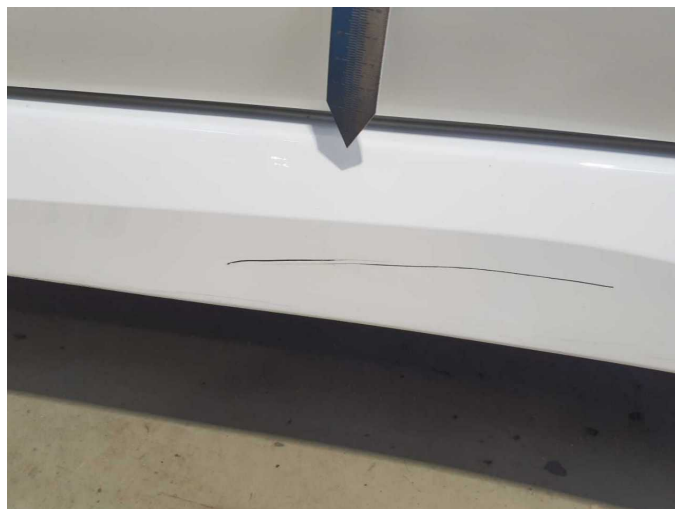
| No. | Component group | Description |
|---|---|---|
| 12 | Sill - left side | Trim - Scratch(es) - Smart repair |

**Damage 12:** Sill - left side: Trim - Scratch(es) - Smart repair

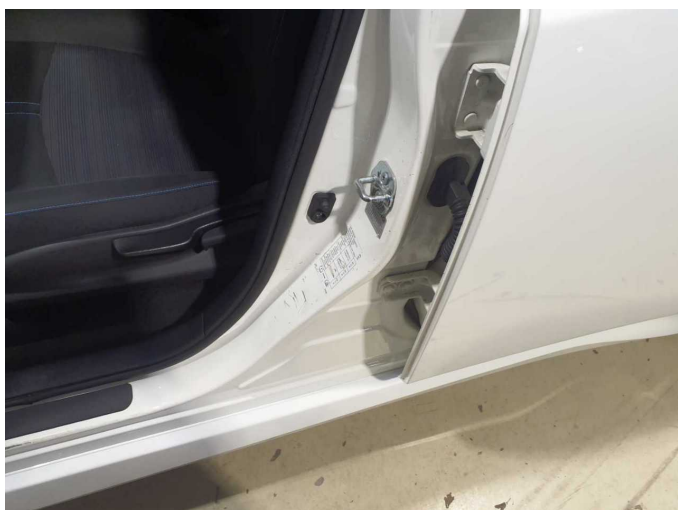
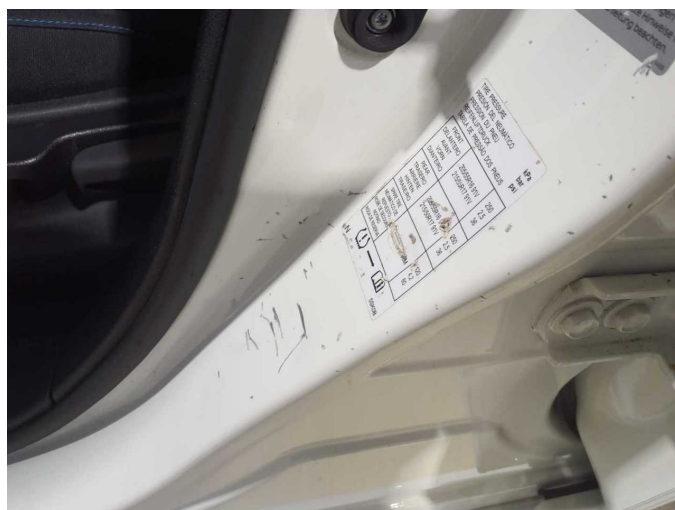
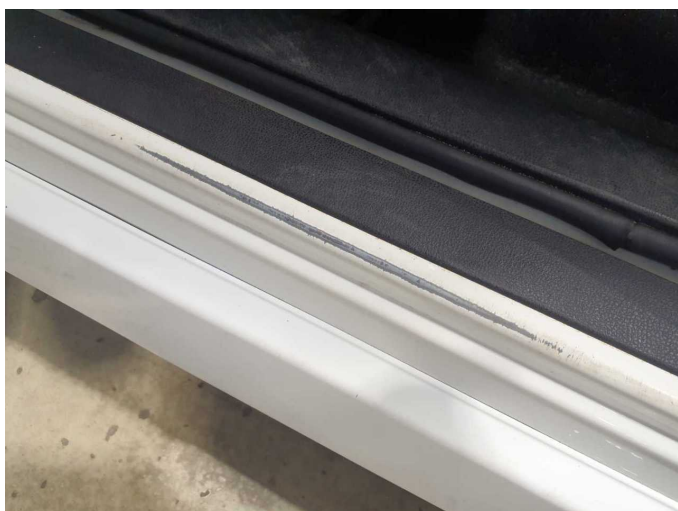
| No. | Component group | Description |
|---|---|---|
| 13 | Sill - left side | Sill - Dent / paintcoat damage - Smart repair |

**Damage 13:** Sill - left side: Sill - Dent / paintcoat damage - Smart repair

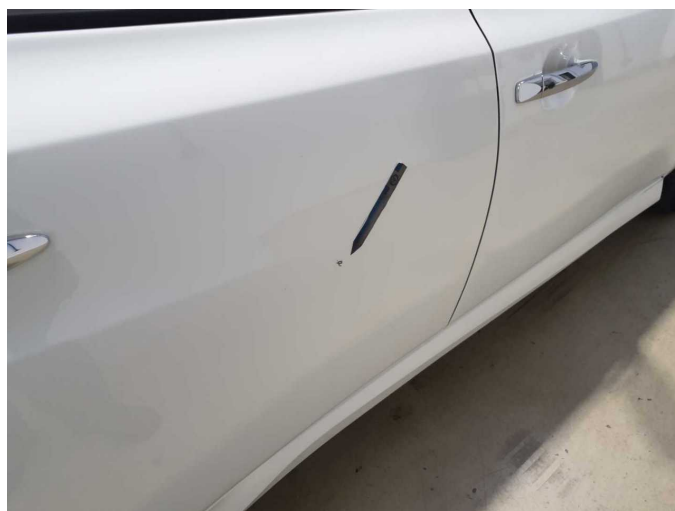
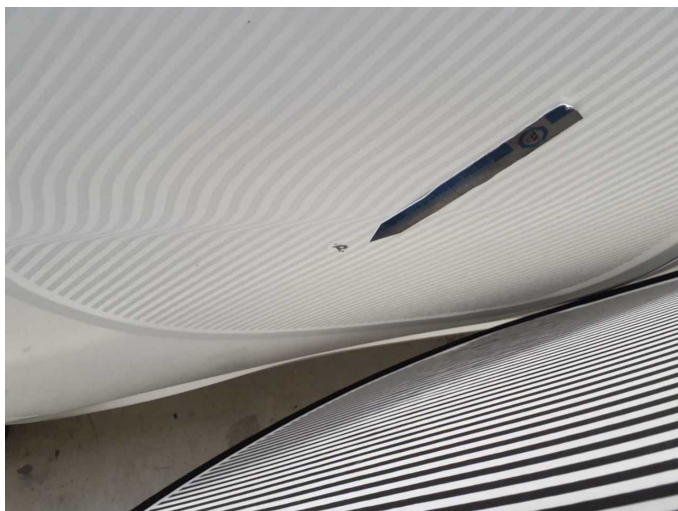
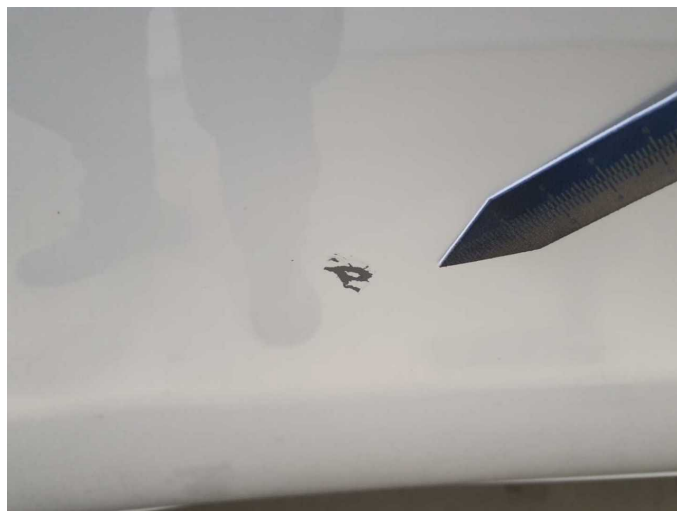
| No. | Component group | Description |
|---|---|---|
| 14 | Door - rear right side | Door - Dent / paintcoat damage - Smart repair |

**Damage 14:** Door - rear right side: Door - Dent / paintcoat damage - Smart repair

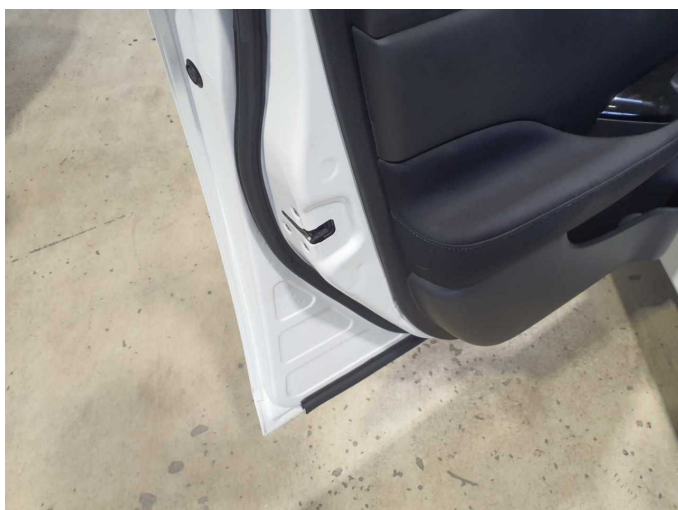
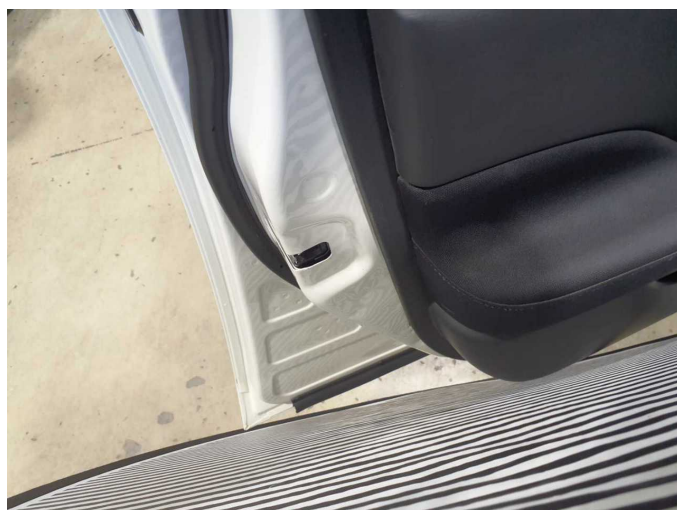
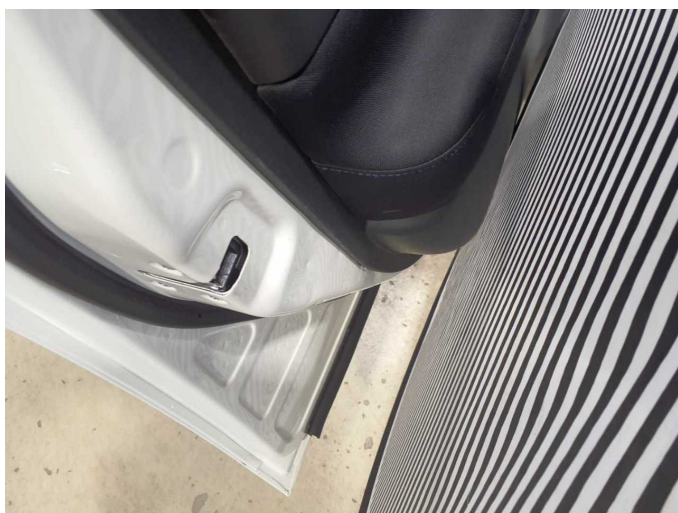
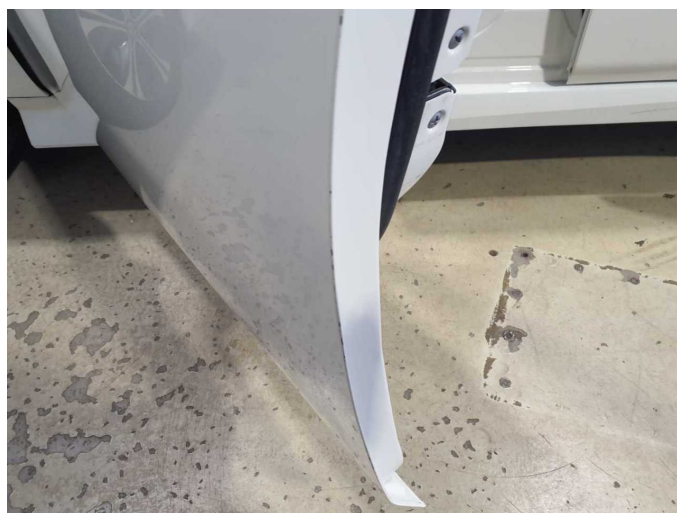
| No. | Component group | Description |
|---|---|---|
| 15 | Door - front left side | Door (innen) - Dent / paintcoat damage - Smart repair |

**Damage 15:** Door - front left side: Door (innen) - Dent / paintcoat damage - Smart repair

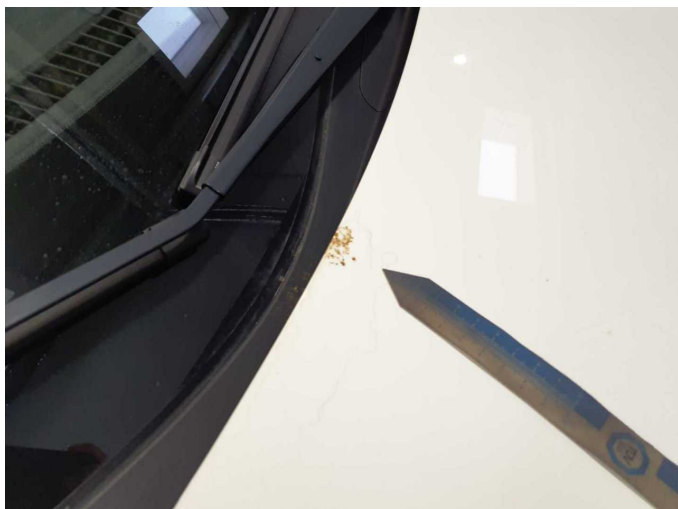
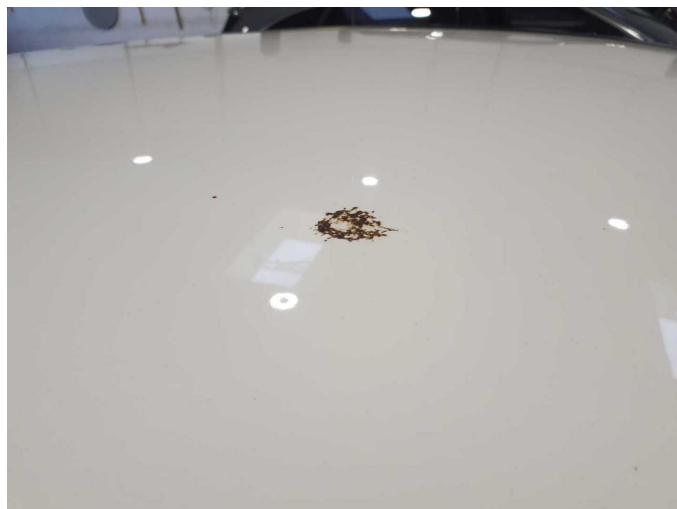
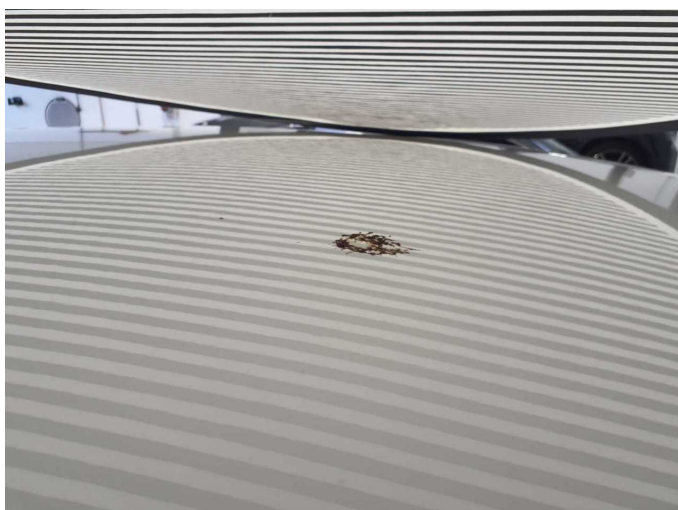
| No. | Component group | Description |
|---|---|---|
| 16 | Body | Body (Anätzung-Mehrkosten möglich) - Paint defect - Conditioning |

Das Fahrzeug weist eine/mehrere Anätzungen auf. Die Schadensumme kann sich somit erhöhen oder erweitern.

**Damage 16:** Body: Body (Anätzung-Mehrkosten möglich) - Paint defect - Conditioning

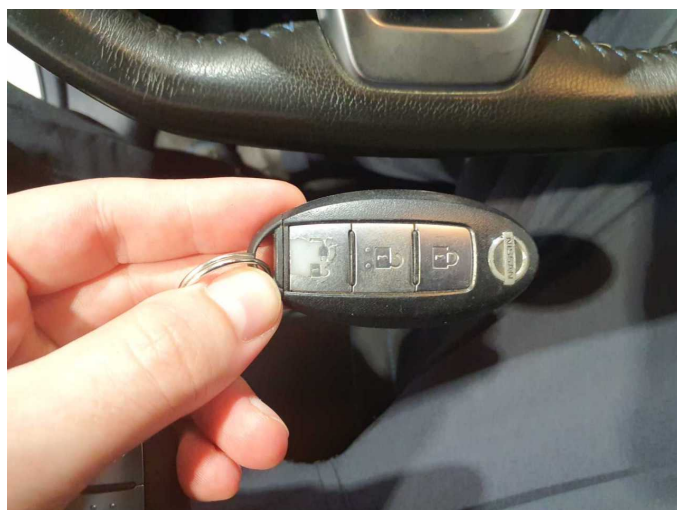
| No. | Component group | Description |
|---|---|---|
| 17 | Equipment | Vehicle key - Scratch(es) - Replace |

**Damage 17:** Equipment: Vehicle key - Scratch(es) - Replace

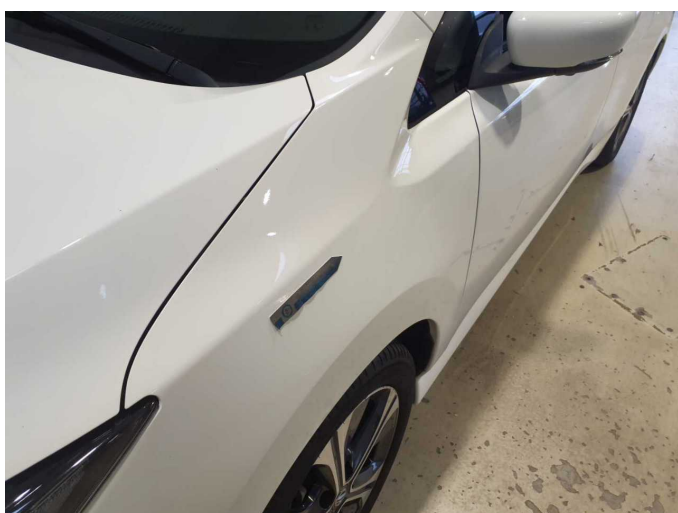
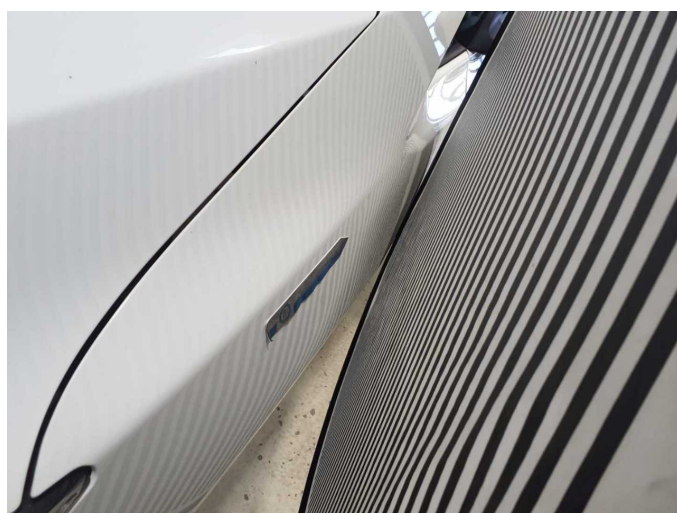
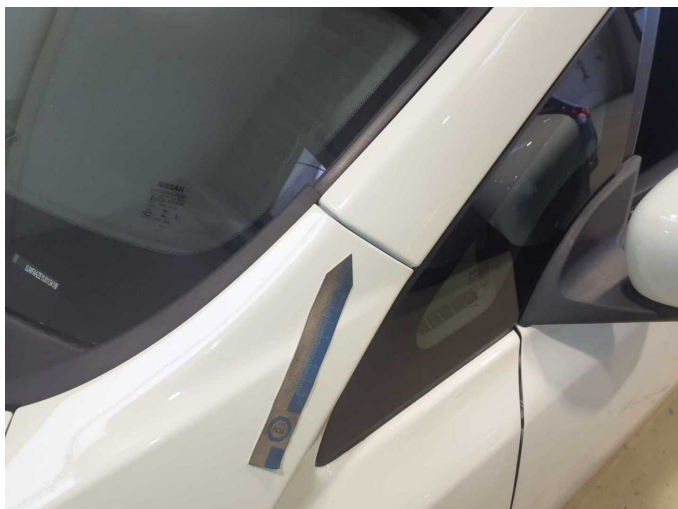
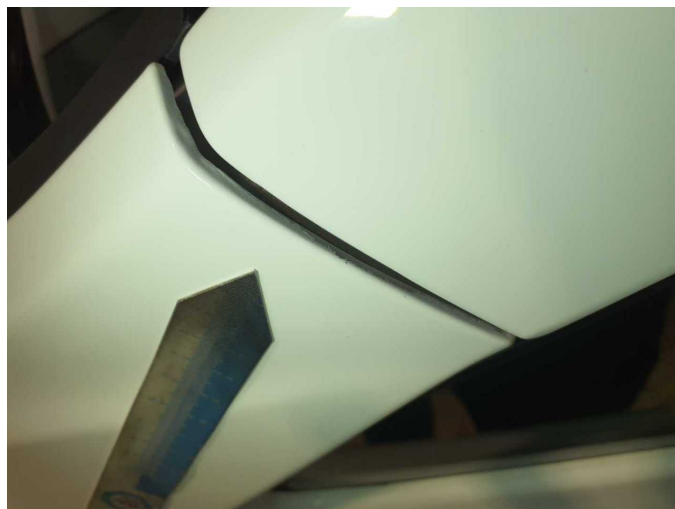
| No. | Component group | Description |
|---|---|---|
| 18 | Mudguard - left side | Mudguard - left side (Lack löst sich) - Paint defect - Repair and paint |

**Damage 18:** Mudguard - left side: Mudguard - left side (Lack löst sich) - Paint defect - Repair and paint

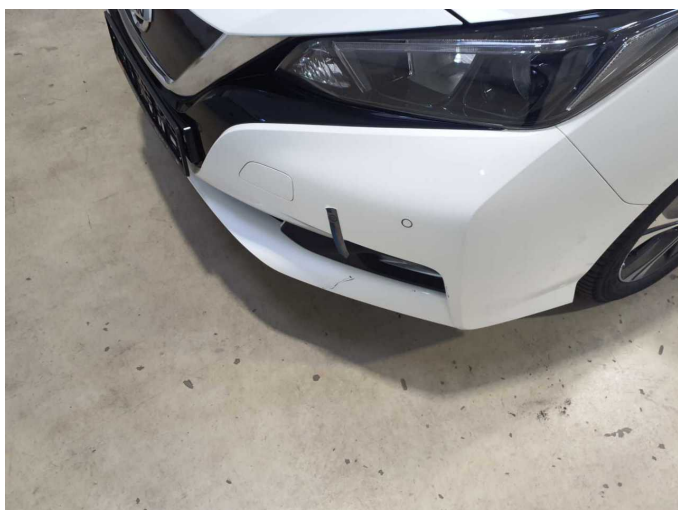
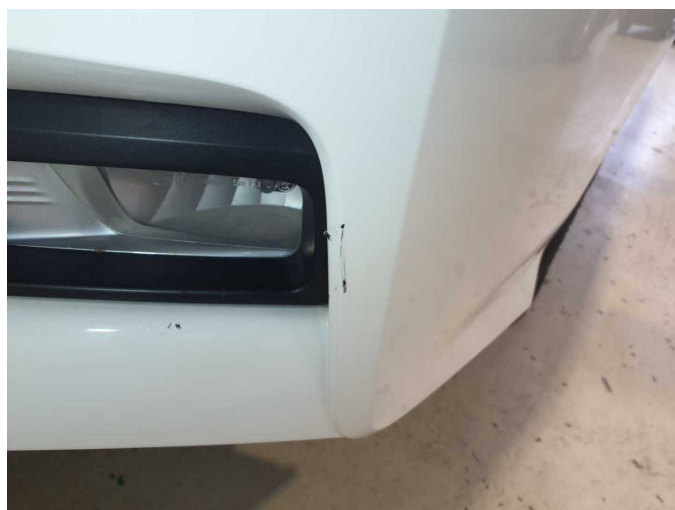
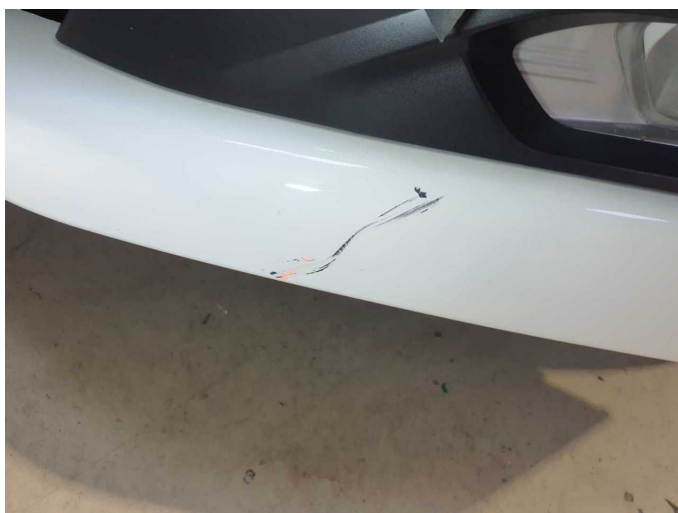
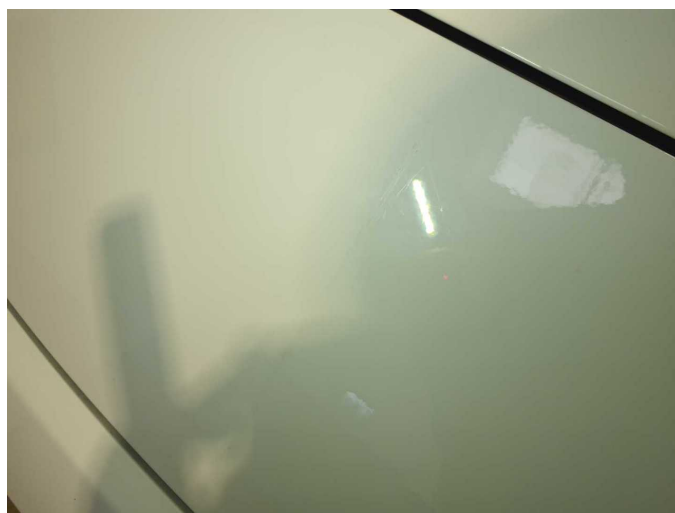
| No. | Component group | Description |
|---|---|---|
| 19 | Front bumper | Front bumper - Scratch(es) - Paint |

**Damage 19:** Front bumper: Front bumper - Scratch(es) - Paint

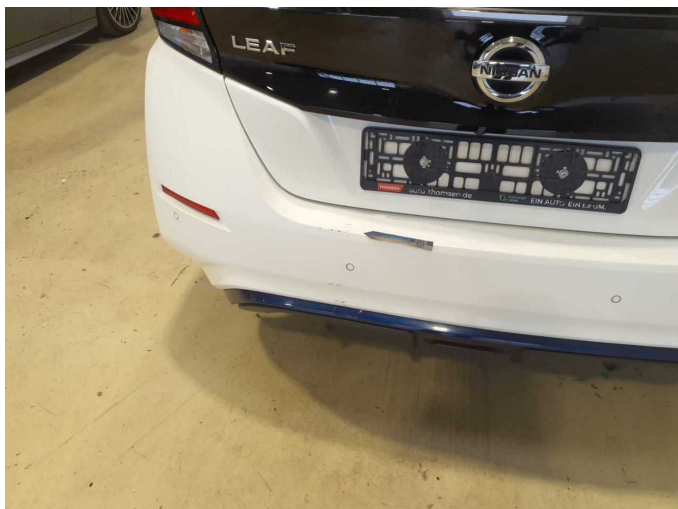
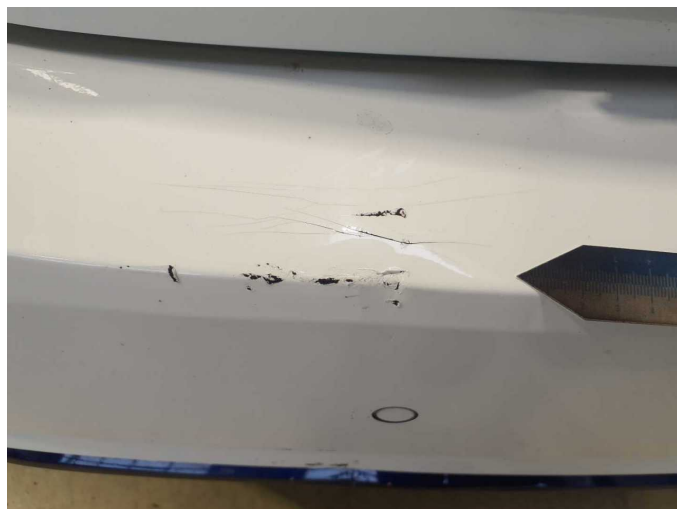
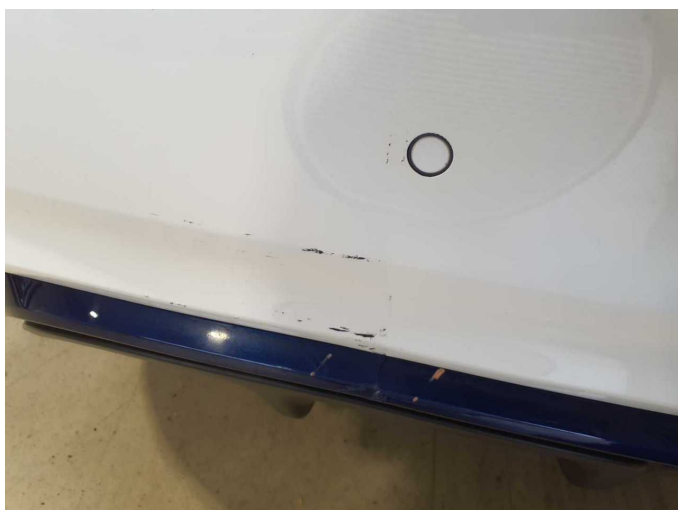
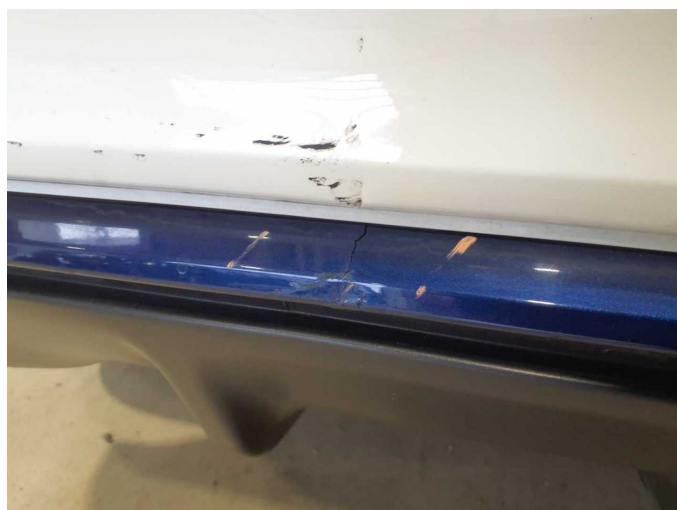
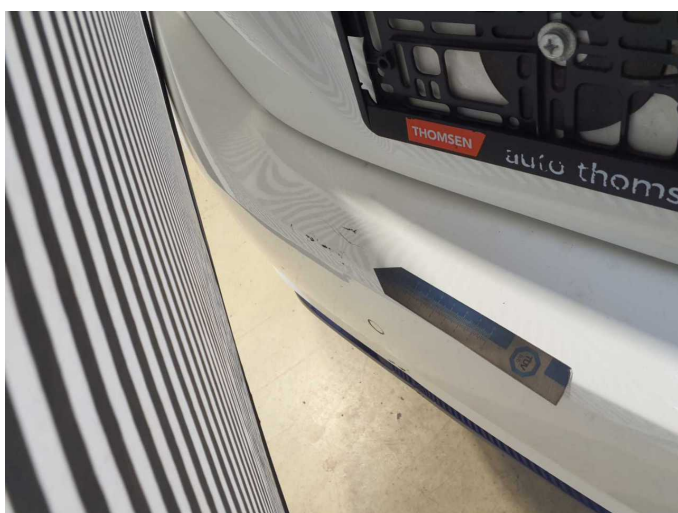
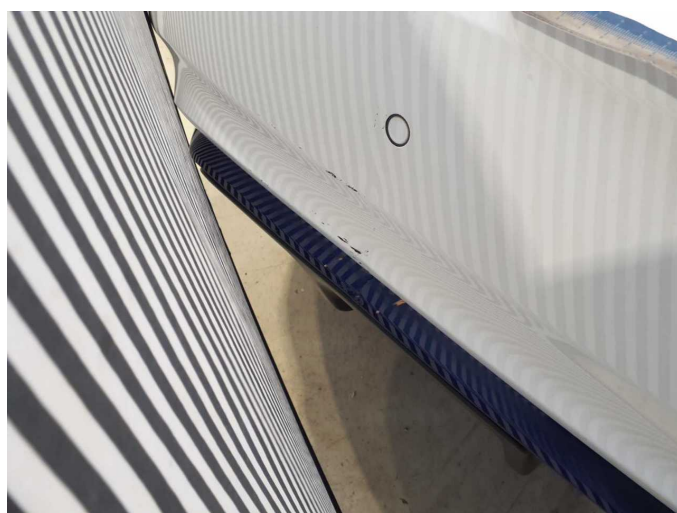
| No. | Component group | Description |
|---|---|---|
| 20 | Rear bumper | Rear bumper (Inklusive anbauteile) - Broken / torn - repair according to calculation |

Die beigefügte Reparaturkostenkalkulation wurde nach bestem Wissen und Gewissen unter eingeschränkten Besichtigungsbedingung im demontagefreien Zustand erstellt. Es können aufgrund verdeckter Beschädigung, Mehrkosten und somit Abweichung der für die Stoßstange ausgewiesenen Reparaturkosten nicht ausgeschlossen werden.

**Damage 20:** Rear bumper: Rear bumper (Inklusive anbauteile) - Broken / torn - repair according to calculation
