Expertise

Protocol number: 46893641  
Order No. / Reference: 26750341  
Inspection date: 5 Aug 2026

Model: T-Roc 1.5 TSI OPF DSG R-Line

VIN: WVGZZA1ZPV739120

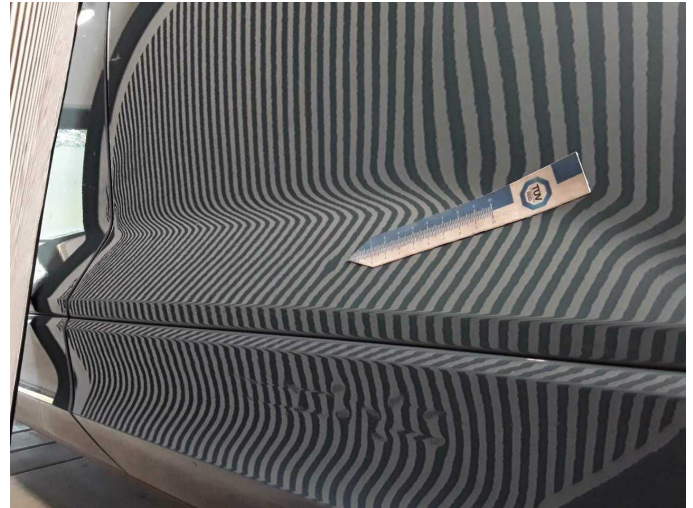
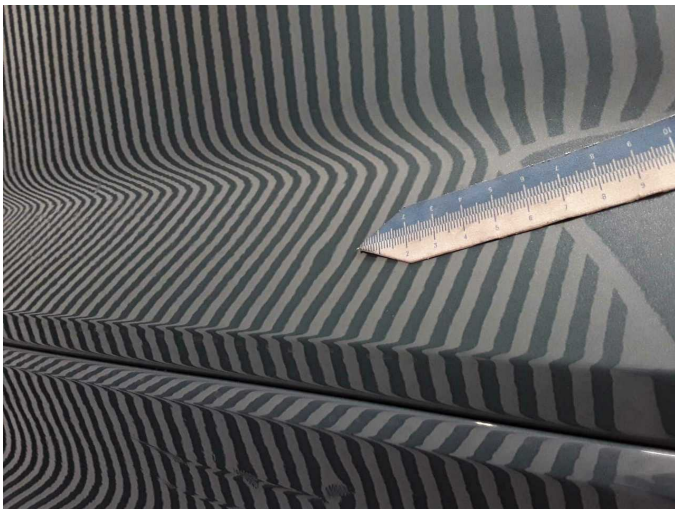
| No. | Component group | Description |
|---|---|---|
| 1 | Door - rear left side | Door - dent(s) - Smooth repair work |

**Damage 1:** Door - rear left side: Door - dent(s) - Smooth repair work

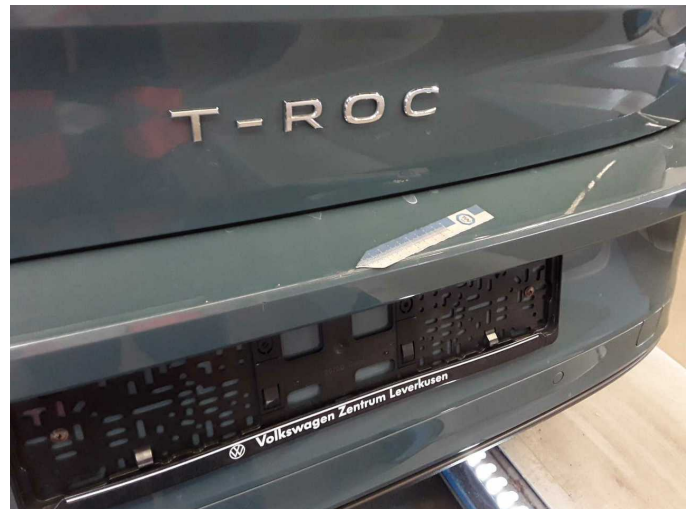
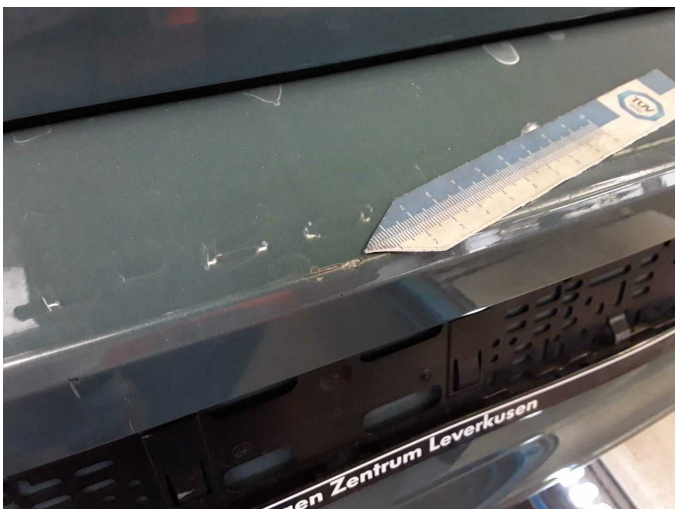
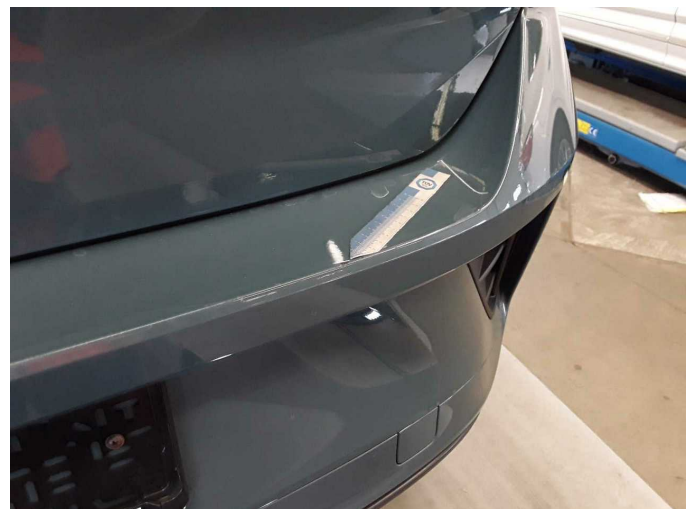
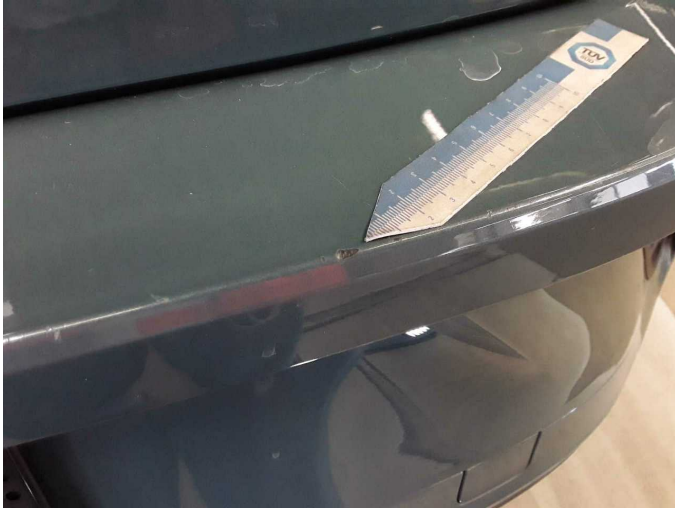
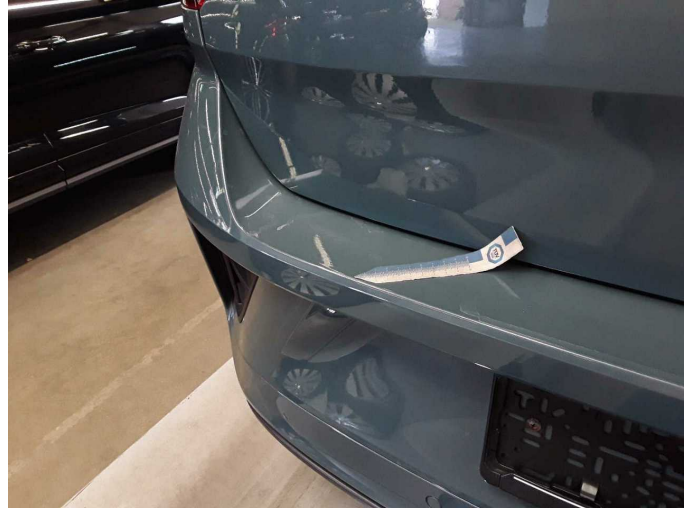
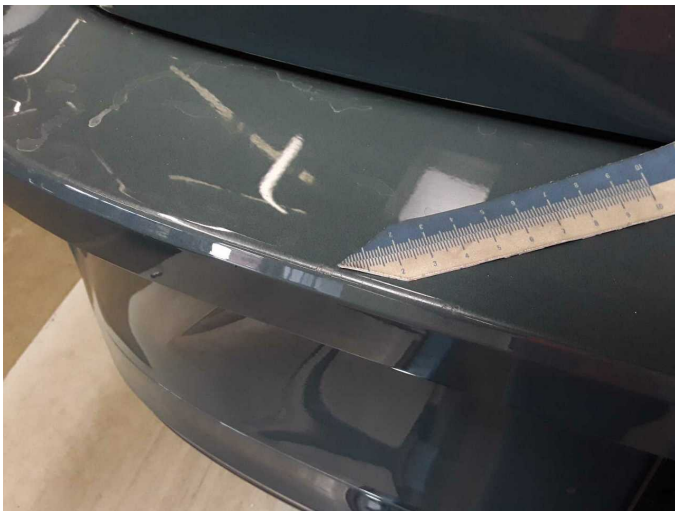
| No. | Component group | Description |
|---|---|---|
| 2 | Rear bumper | Rear bumper - Scratched - Smart repair |

**Damage 2:** Rear bumper: Rear bumper - Scratched - Smart repair

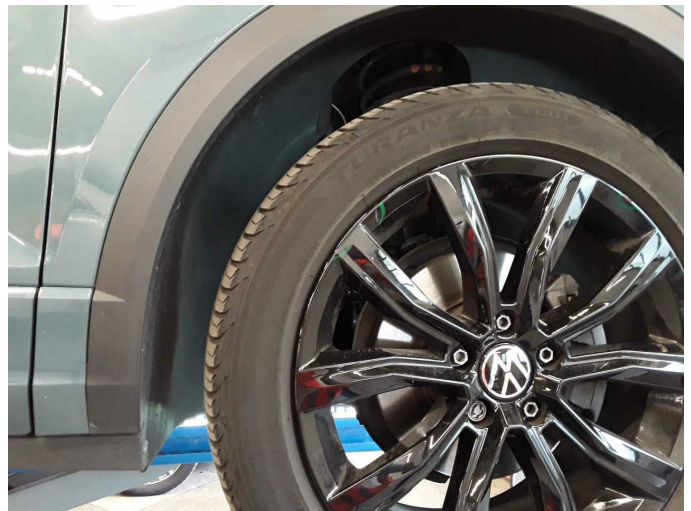
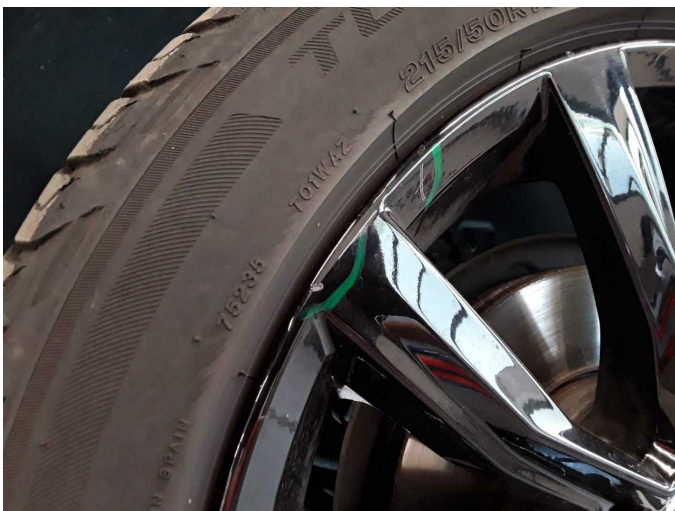
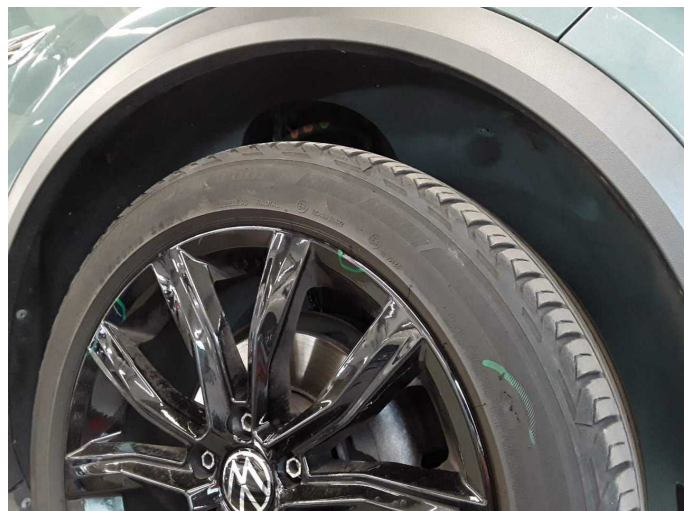
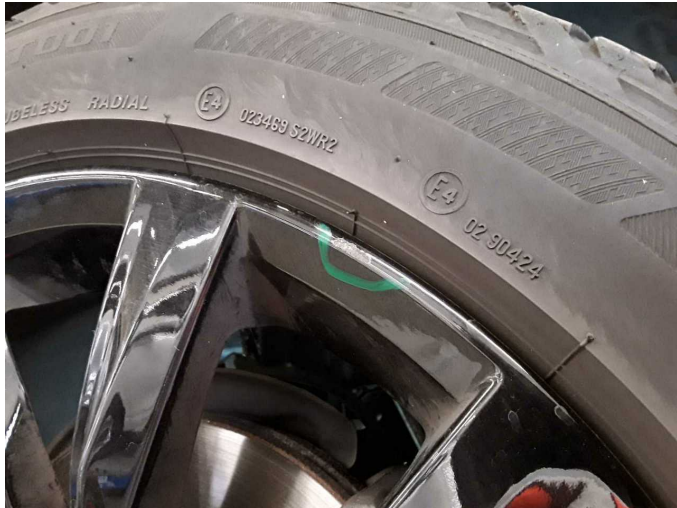
| No. | Component group | Description |
|---|---|---|
| 3 | Wheel / tyres | Alloy rim - front right side - Scratched - Smart repair |

**Damage 3:** Wheel / tyres: Alloy rim - front right side - Scratched - Smart repair

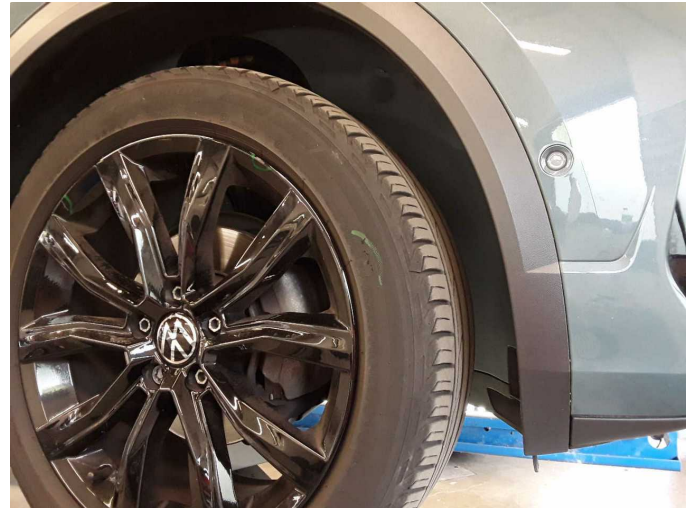
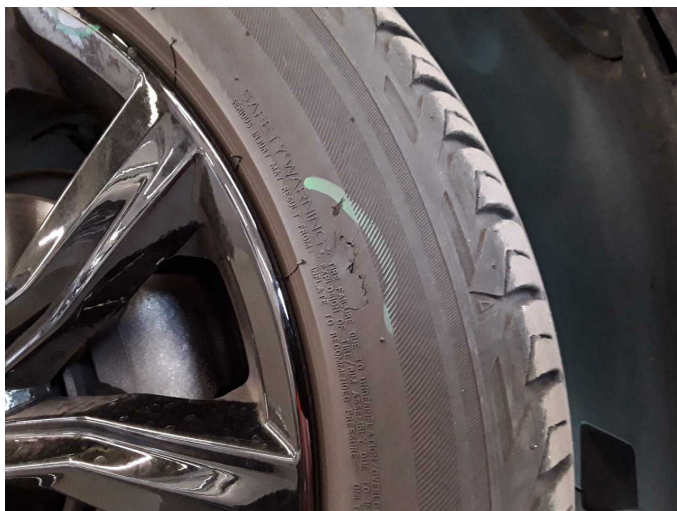
| No. | Component group | Description |
|---|---|---|
| 4 | Wheel / tyres | Tyre - front right side (nicht fahrbereit) - Broken / torn - Replace |

**Damage 4:** Wheel / tyres: Tyre - front right side (nicht fahrbereit) - Broken / torn - Replace

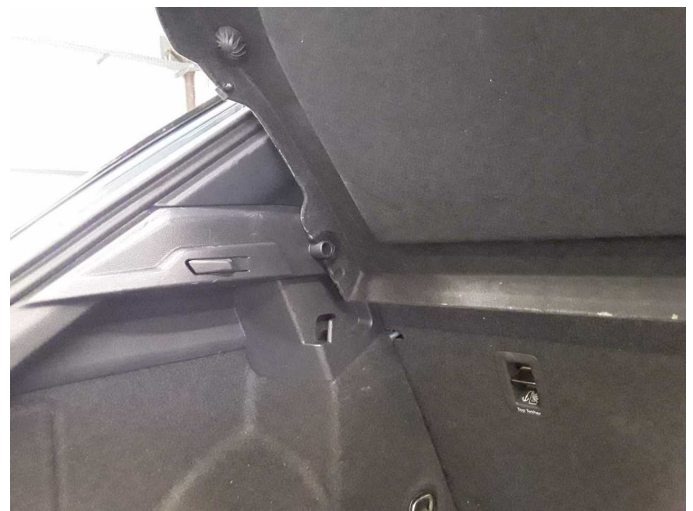
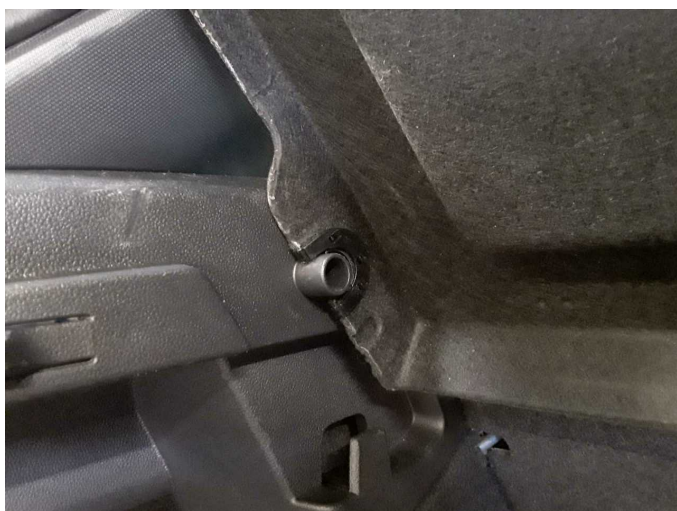
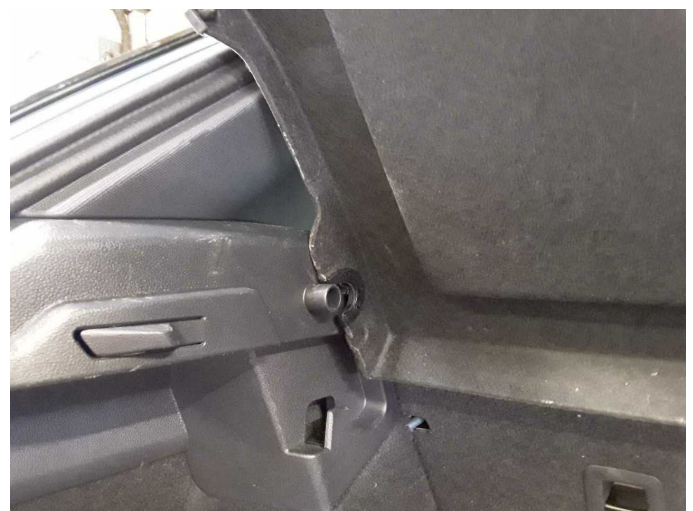
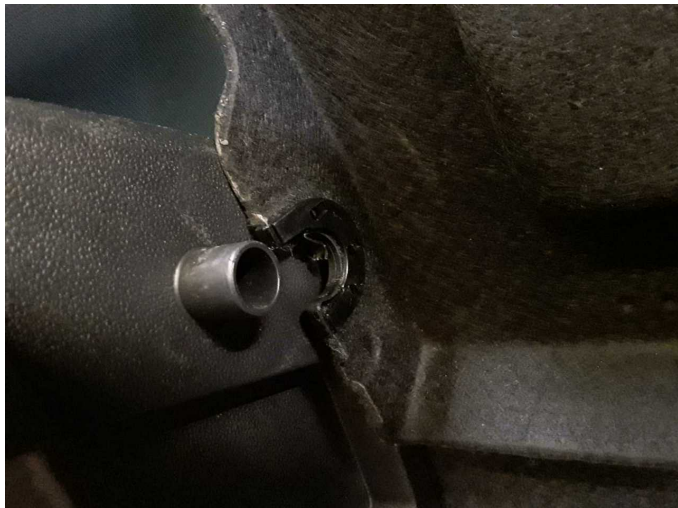
| No. | Component group | Description |
|---|---|---|
| 5 | Interior | Boot cover / roller cover (Halterung defekt) - Defective - Replace |

**Damage 5:** Interior: Boot cover / roller cover (Halterung defekt) - Defective - Replace

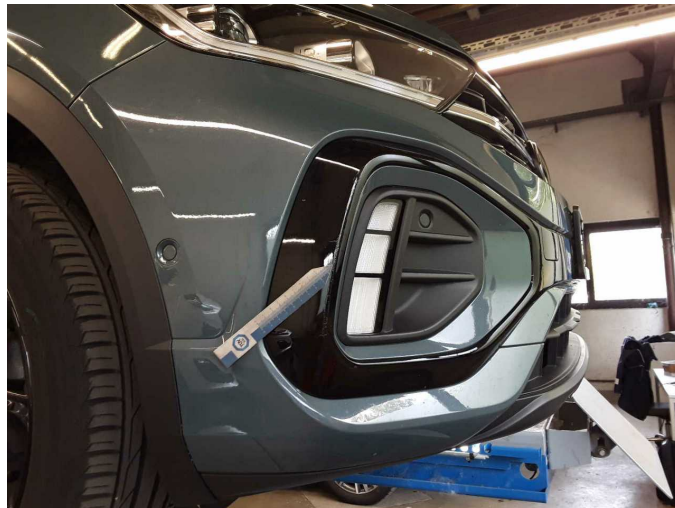
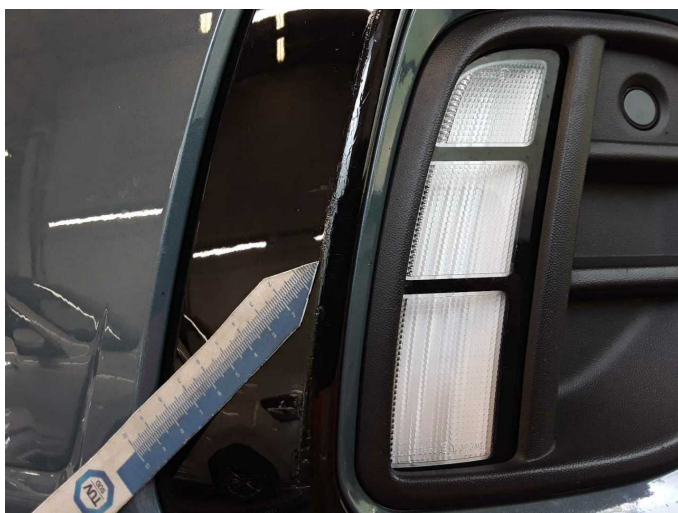
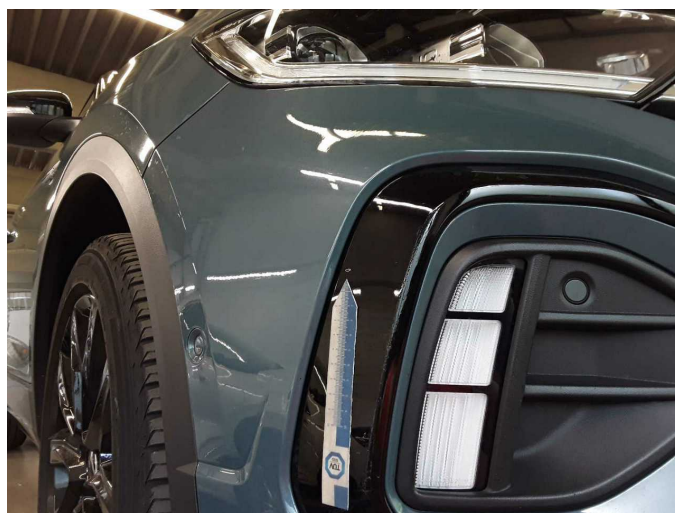
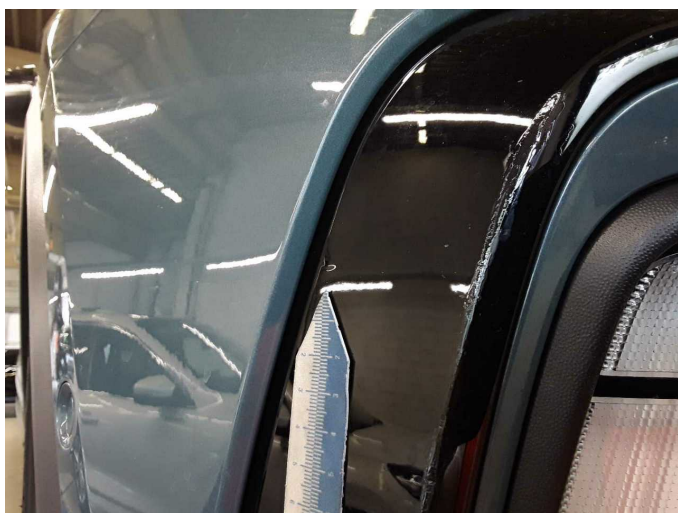
| No. | Component group | Description |
|---|---|---|
| 6 | Front bumper | Bumper - front right side (Blende) - Scratched - Replace |

**Damage 6:** Front bumper: Bumper - front right side (Blende) - Scratched - Replace

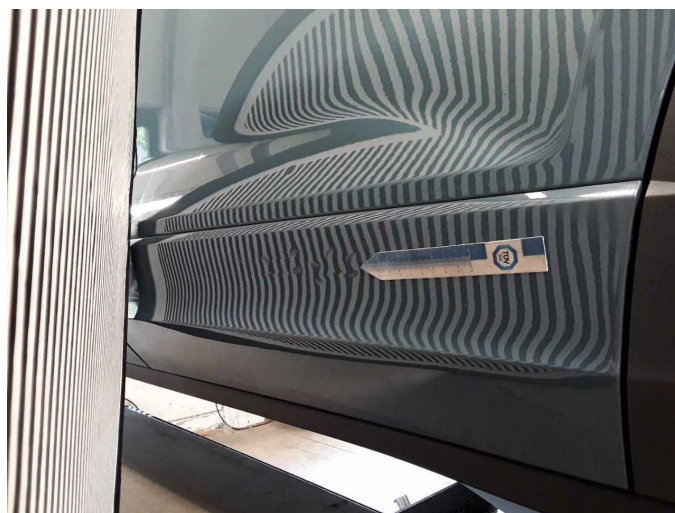
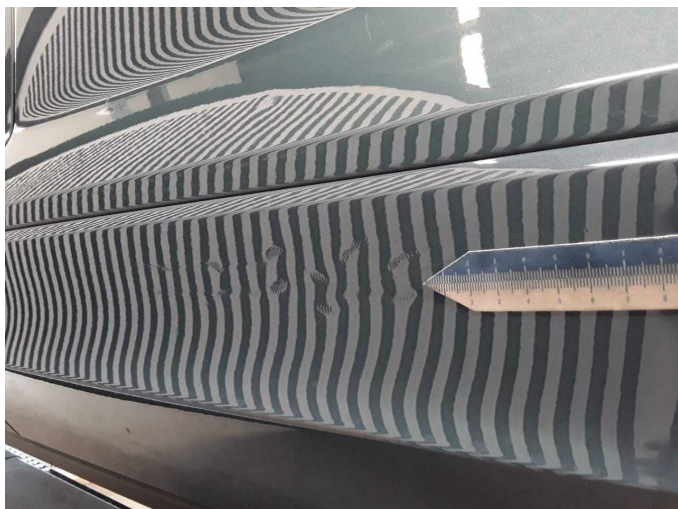
| No. | Component group | Description |
|---|---|---|
| 7 | Trim / covers | Door trim - rear left side - Damaged - Replace |

**Damage 7:** Trim / covers: Door trim - rear left side - Damaged - Replace

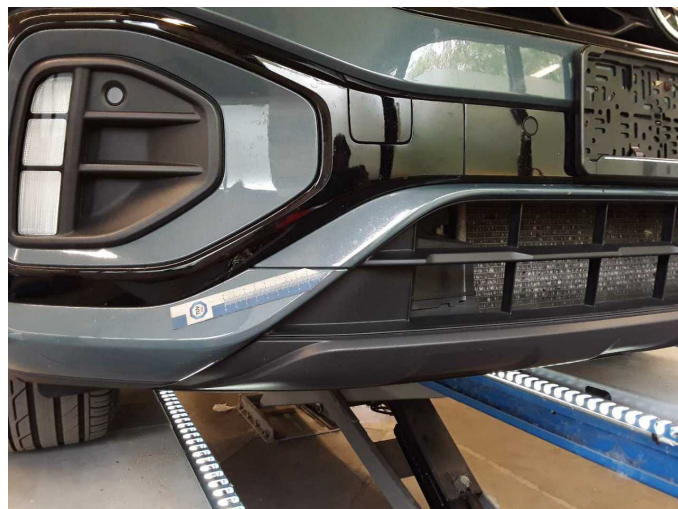
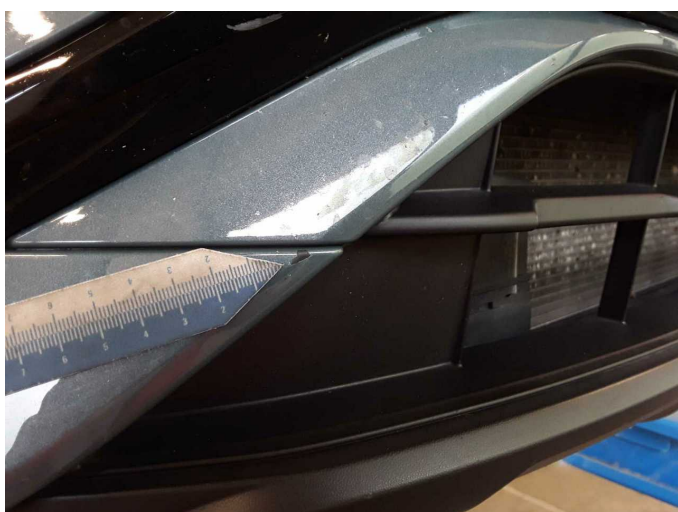
| No. | Component group | Description |
|---|---|---|
| 1 | Front bumper | Front bumper - Stone chips - No deduction |

**Wear and tear 1:** Front bumper: Front bumper - Stone chips - No deduction

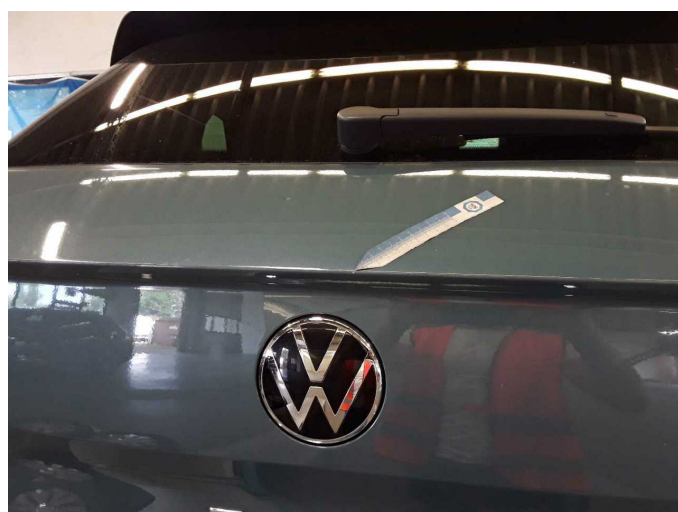
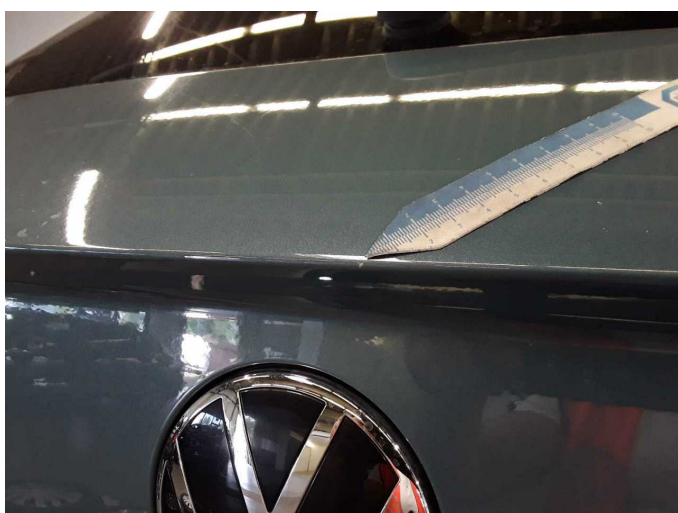
| No. | Component group | Description |
|---|---|---|
| 2 | Boot lid / rear door | Boot lid - Stone chips - No deduction |

**Wear and tear 2:** Boot lid / rear door: Boot lid - Stone chips - No deduction

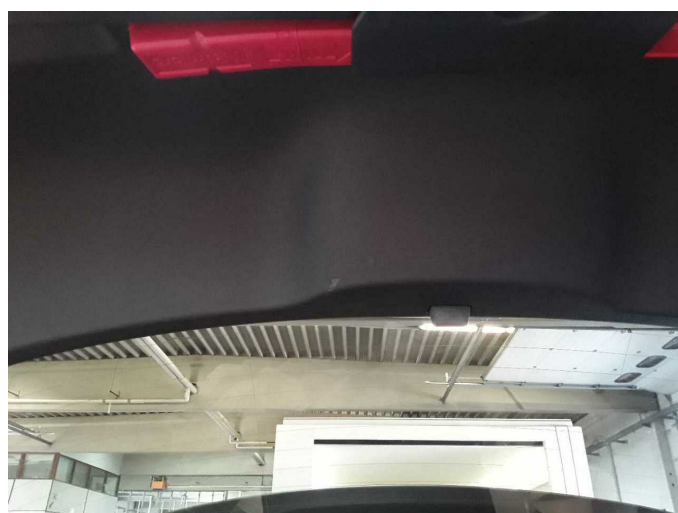
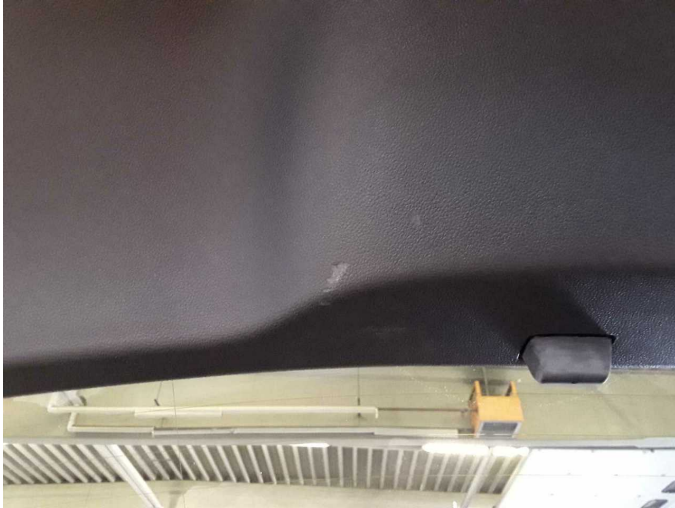
| No. | Component group | Description |
|---|---|---|
| 3 | Boot lid / rear door | Trim - standard - lower - Scratched - No deduction |

**Wear and tear 3:** Boot lid / rear door: Trim - standard - lower - Scratched - No deduction

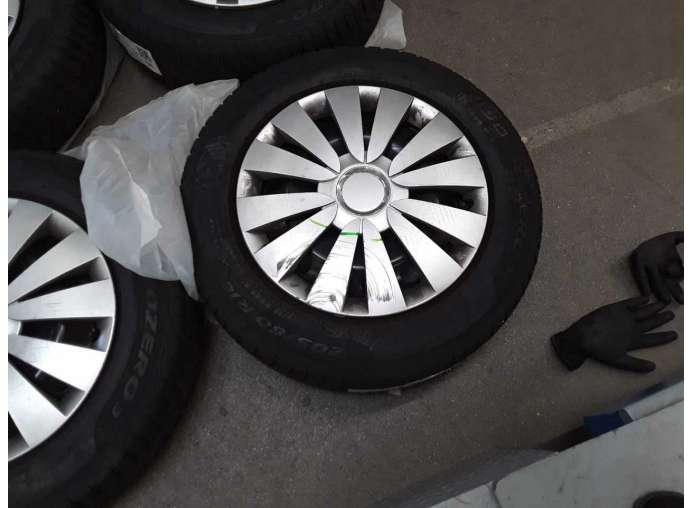
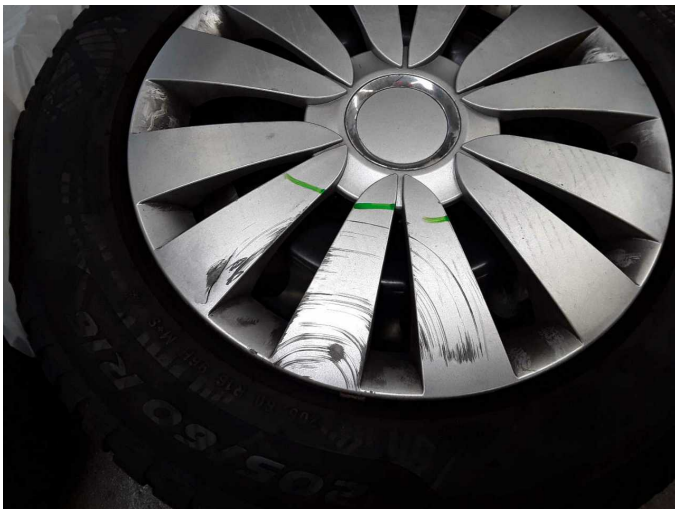
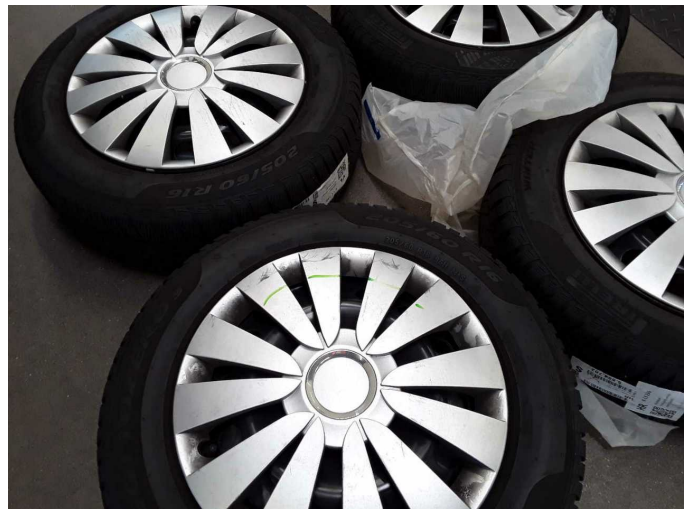
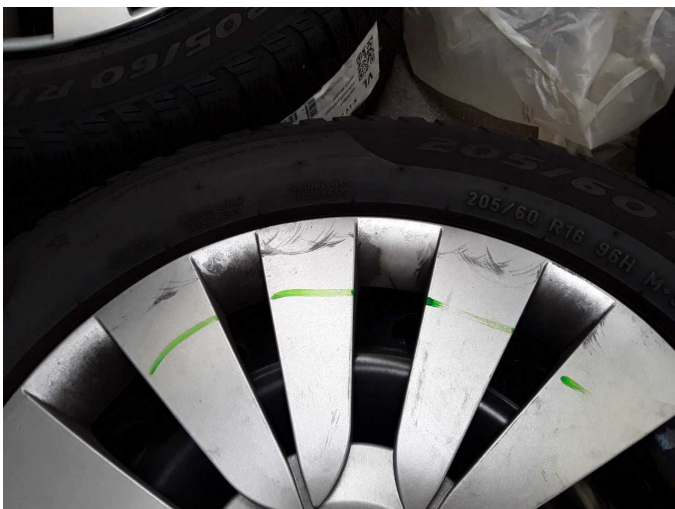
| No. | Component group | Description |
|---|---|---|
| 4 | 2nd wheel set | 2 wheel covers (HL VR) - Scratched - No deduction |

**Wear and tear 4:** 2nd wheel set: 2 wheel covers (HL VR) - Scratched - No deduction

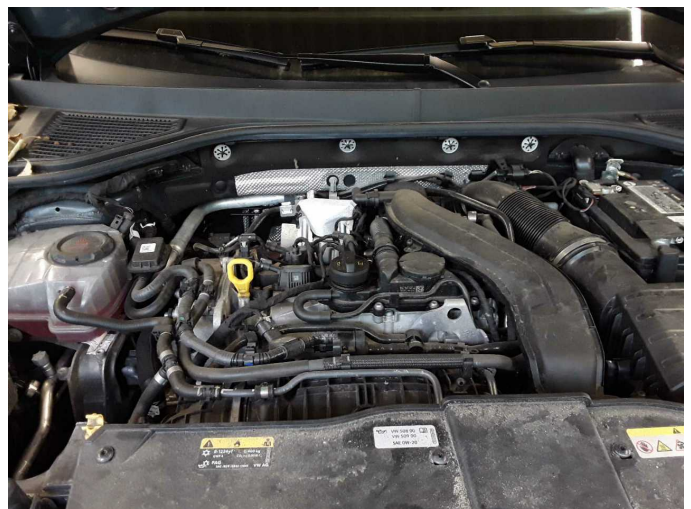
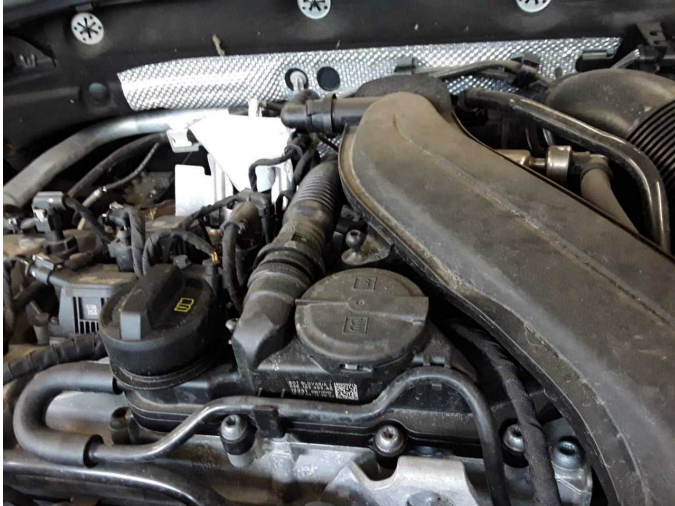
Engine - Engine cover

**Missing part 1:** Engine: Engine cover - Missing - Replace

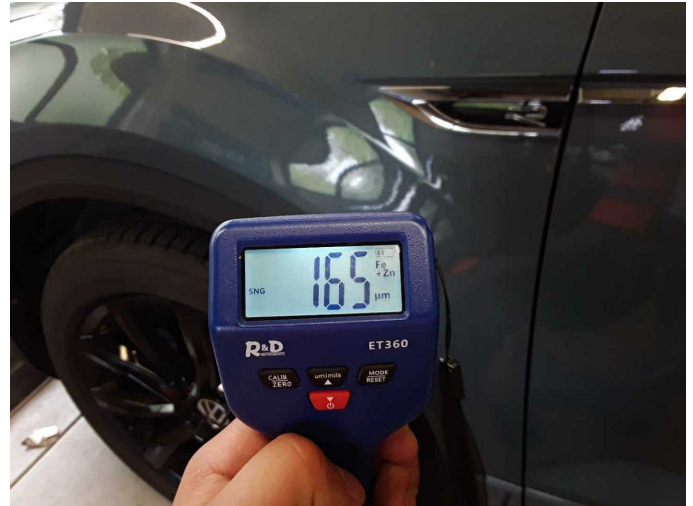
1 Mudguard - left side, Bonnet, Door - front left side, Professionally carried out, Invoice of repair done Non-existent

**Mudguard - left side:** 165 µm

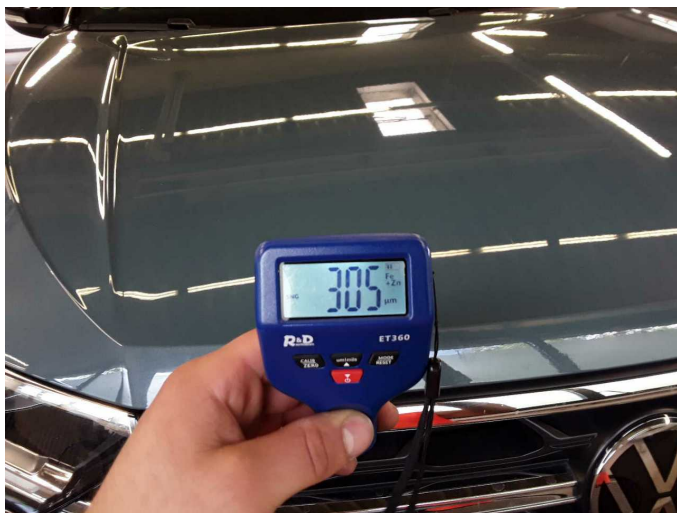
**Bonnet:** 305 µm

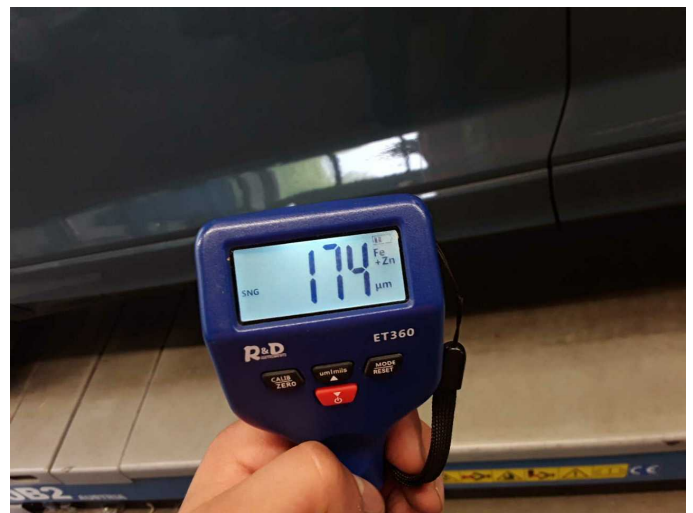
**Door - front left side:** 174 µm
