Expertise

Protocol number: 46222926  
Order No. / Reference: 26598375  
Inspection date: 26 Jun 2026

Manufacturer: Opel

Model: Astra Sports Tourer 1.5 D Automatik Ultimate

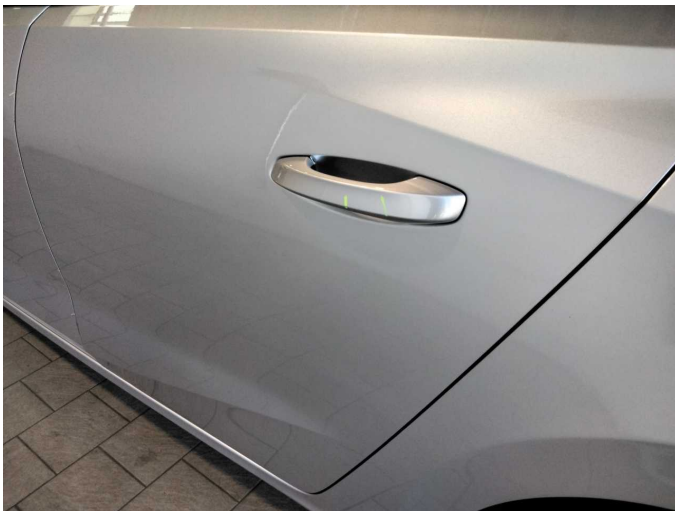
| No. | Component group | Description |
|---|---|---|
| 1 | Door - rear left side | Door handle - outside - Scratch(es) - Smart repair |

**Damage 1:** Door - rear left side: Door handle - outside - Scratch(es) - Smart repair

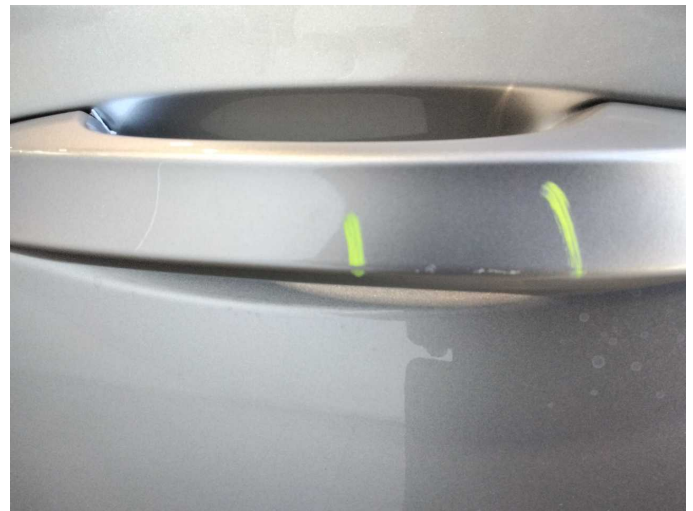
**Damage 1:** Door - rear left side: Door handle - outside - Scratch(es) - Smart repair

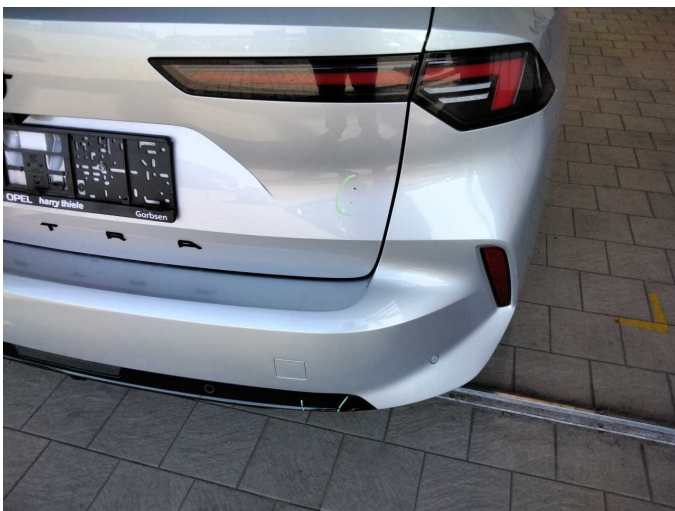
| No. | Component group | Description |
|---|---|---|
| 2 | Boot lid / rear door | Boot lid - Scratch(es) - Smart repair |

**Damage 2:** Boot lid / rear door: Boot lid - Scratch(es) - Smart repair

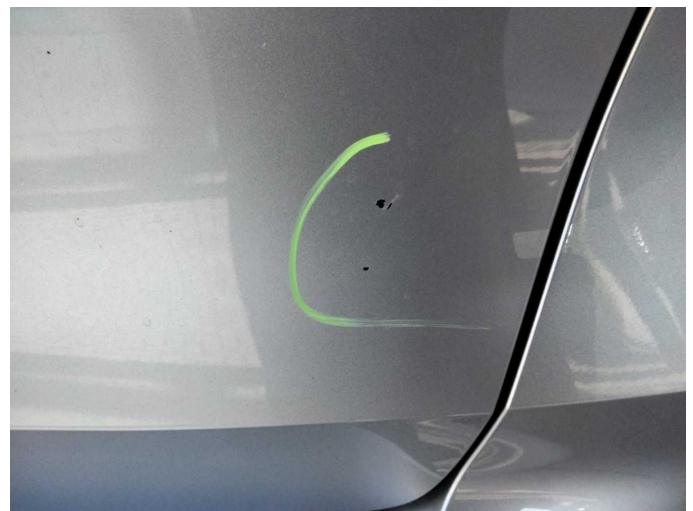
**Damage 2:** Boot lid / rear door: Boot lid - Scratch(es) - Smart repair

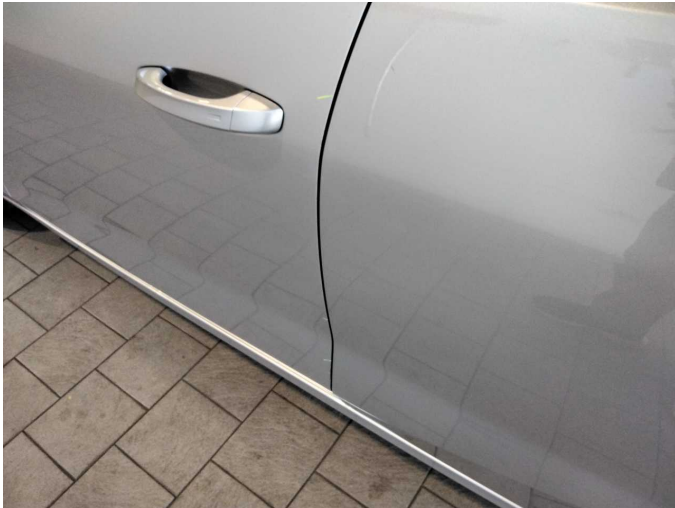
| No. | Component group | Description |
|---|---|---|
| 3 | Door - front left side | Door edge - Scratch(es) - Smart repair |

**Damage 3:** Door - front left side: Door edge - Scratch(es) - Smart repair

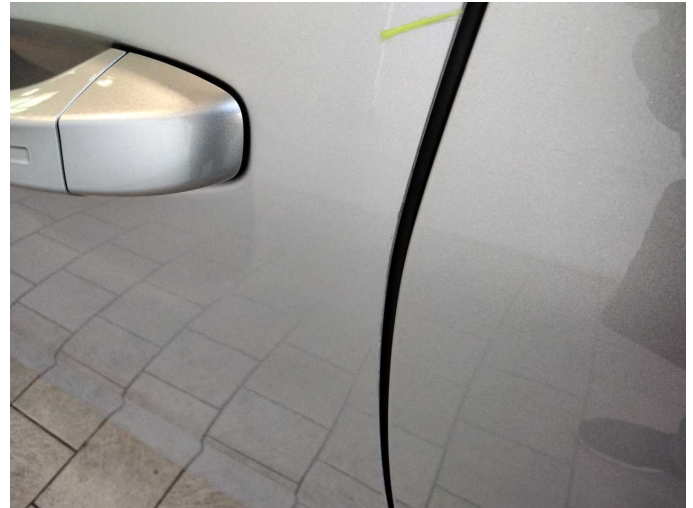
**Damage 3:** Door - front left side: Door edge - Scratch(es) - Smart repair

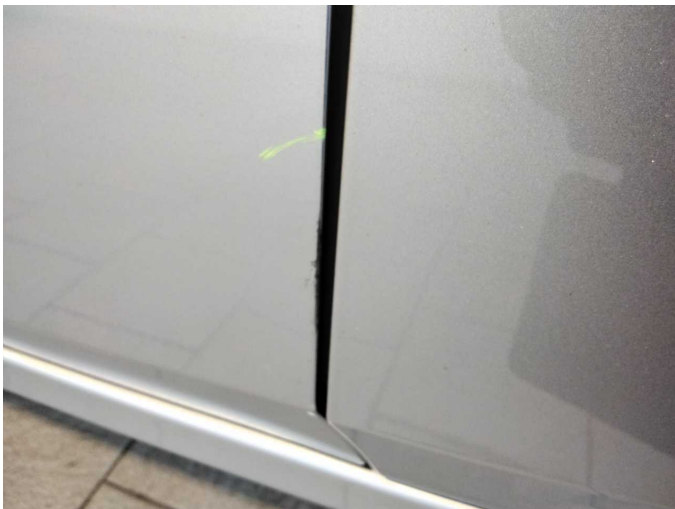
**Damage 3:** Door - front left side: Door edge - Scratch(es) - Smart repair

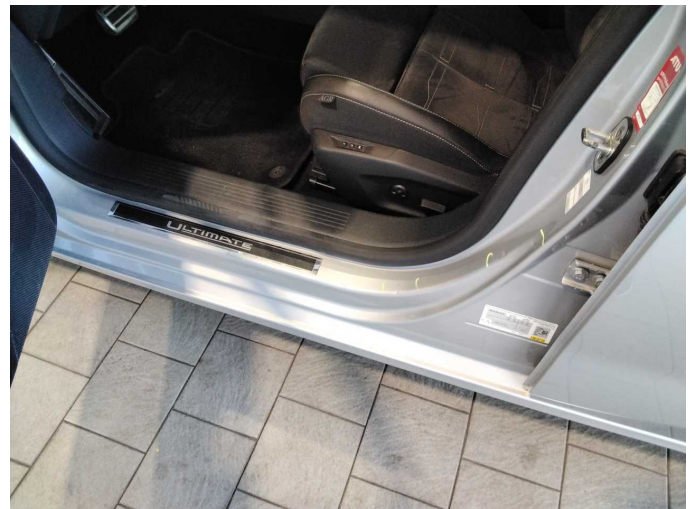
| No. | Component group | Description |
|---|---|---|
| 4 | Sill - left side | Sill - Dent / paintcoat damage - Smart repair |

**Damage 4:** Sill - left side: Sill - Dent / paintcoat damage - Smart repair

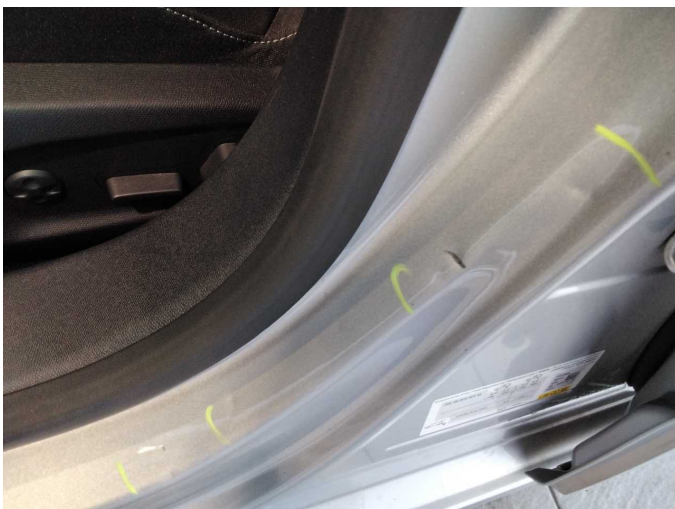
**Damage 4:** Sill - left side: Sill - Dent / paintcoat damage - Smart repair

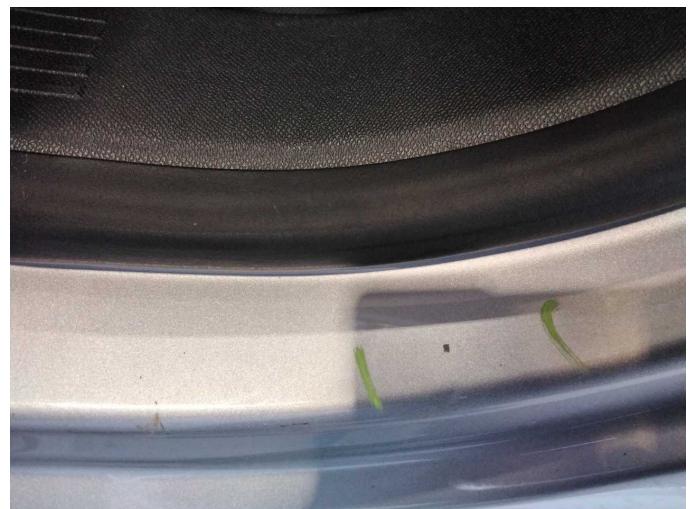
**Damage 4:** Sill - left side: Sill - Dent / paintcoat damage - Smart repair

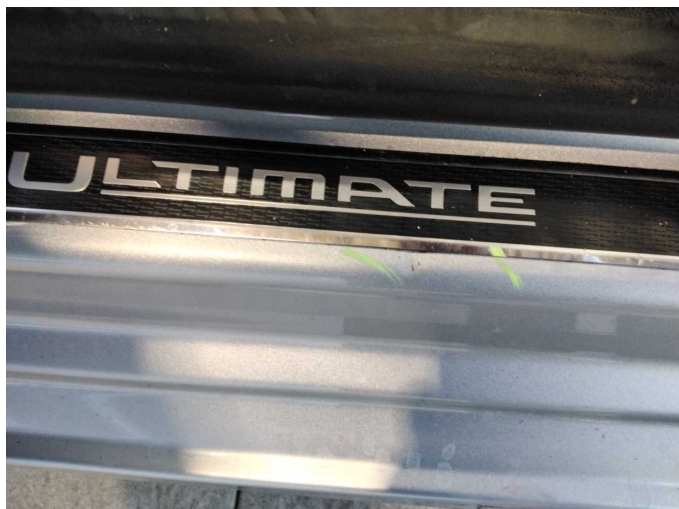
**Damage 4:** Sill - left side: Sill - Dent / paintcoat damage - Smart repair

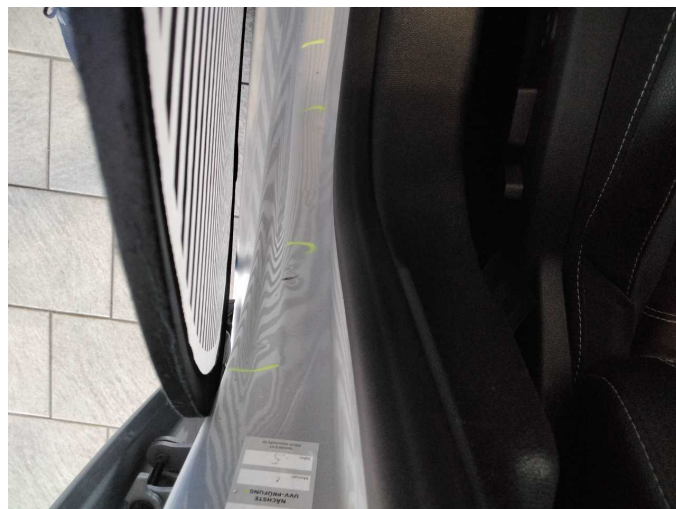
**Damage 4:** Sill - left side: Sill - Dent / paintcoat damage - Smart repair

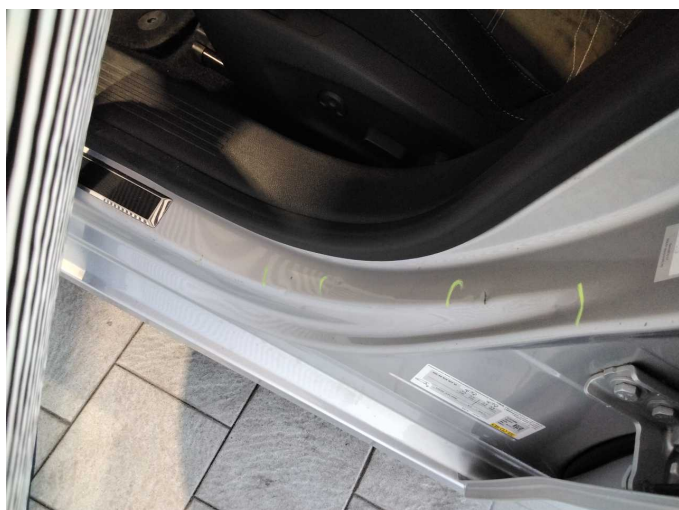
**Damage 4:** Sill - left side: Sill - Dent / paintcoat damage - Smart repair

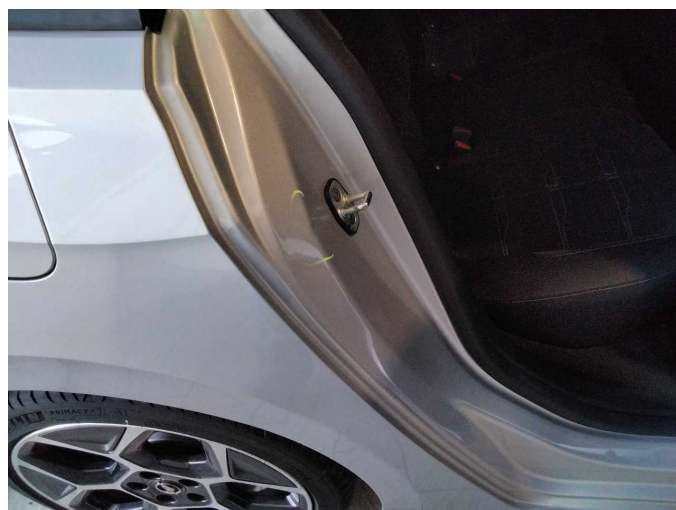
| No. | Component group | Description |
|---|---|---|
| 5 | Body | C-pillar - right side - dent(s) - Smart repair |

**Damage 5:** Body: C-pillar - right side - dent(s) - Smart repair

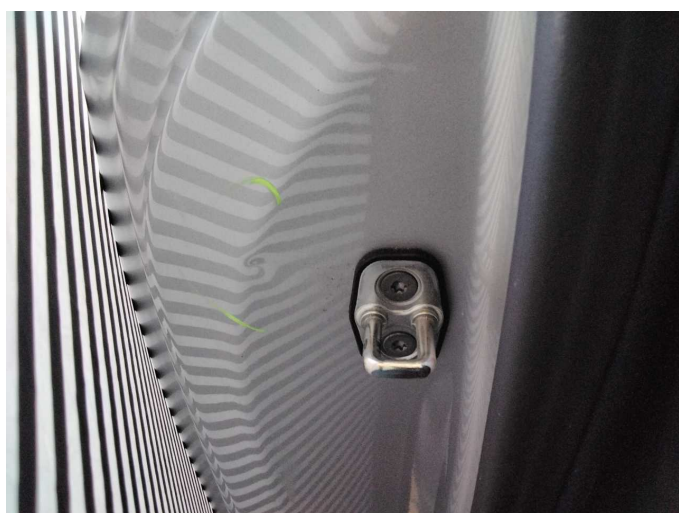
**Damage 5:** Body: C-pillar - right side - dent(s) - Smart repair

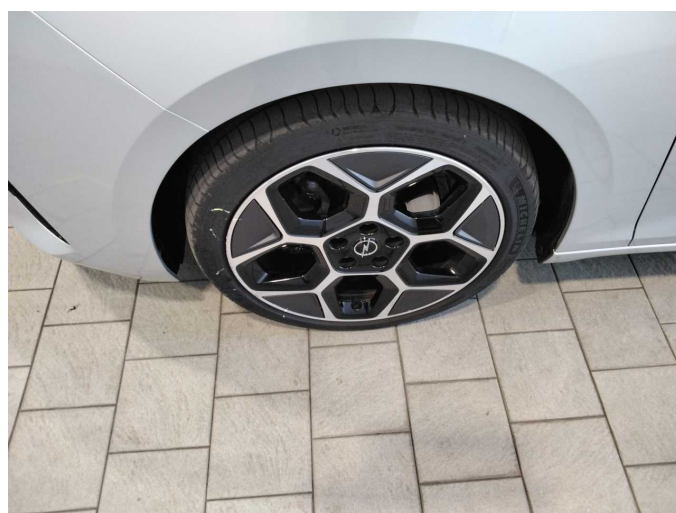
| No. | Component group | Description |
|---|---|---|
| 6 | Wheel / tyres | Tyre - front left side (nicht fahrbereit) - Damaged - Replace |

**Damage 6:** Wheel / tyres: Tyre - front left side (nicht fahrbereit) - Damaged - Replace

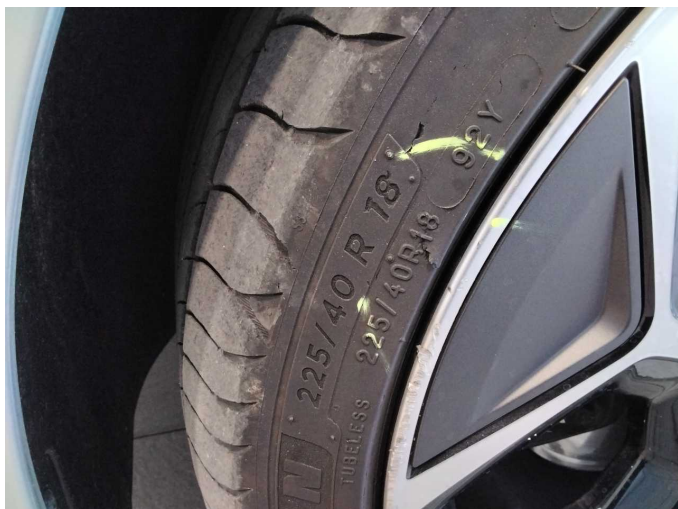
**Damage 6:** Wheel / tyres: Tyre - front left side (nicht fahrbereit) - Damaged - Replace

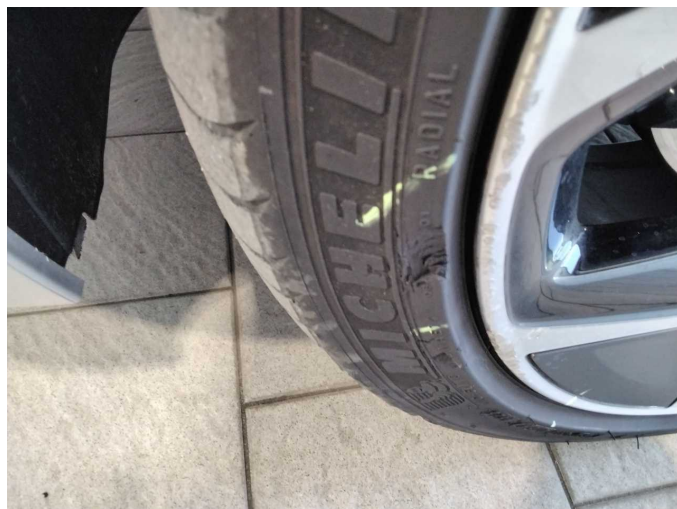
**Damage 6:** Wheel / tyres: Tyre - front left side (nicht fahrbereit) - Damaged - Replace

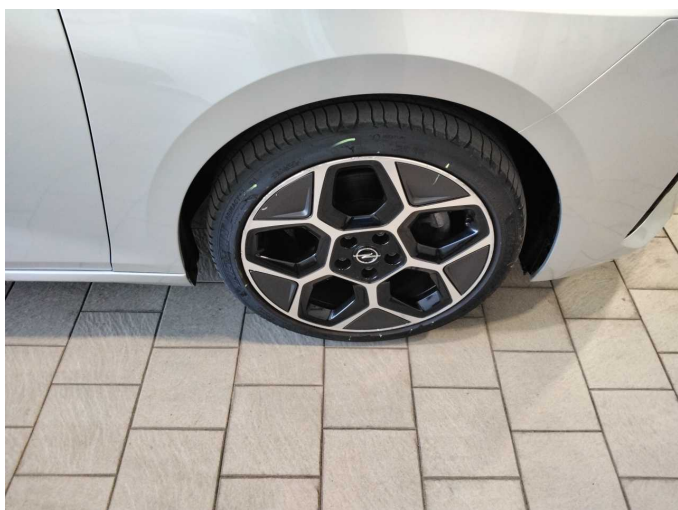
| No. | Component group | Description |
|---|---|---|
| 7 | Wheel / tyres | Tyre - front right side (nicht fahrbereit) - Damaged - Replace |

**Damage 7:** Wheel / tyres: Tyre - front right side (nicht fahrbereit) - Damaged - Replace

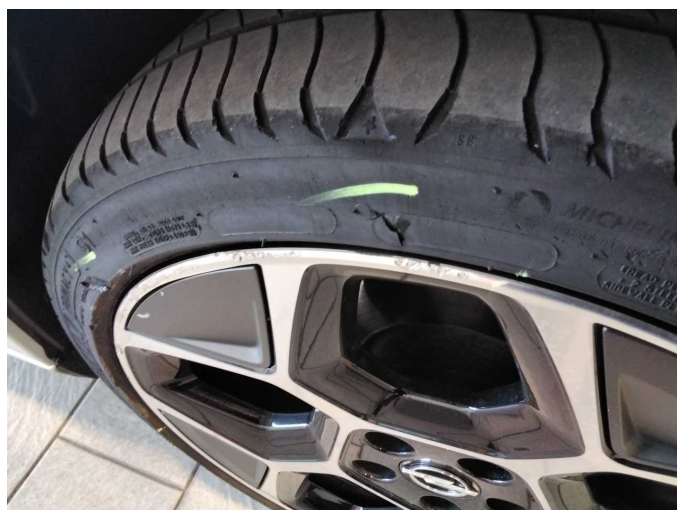
**Damage 7:** Wheel / tyres: Tyre - front right side (nicht fahrbereit) - Damaged - Replace

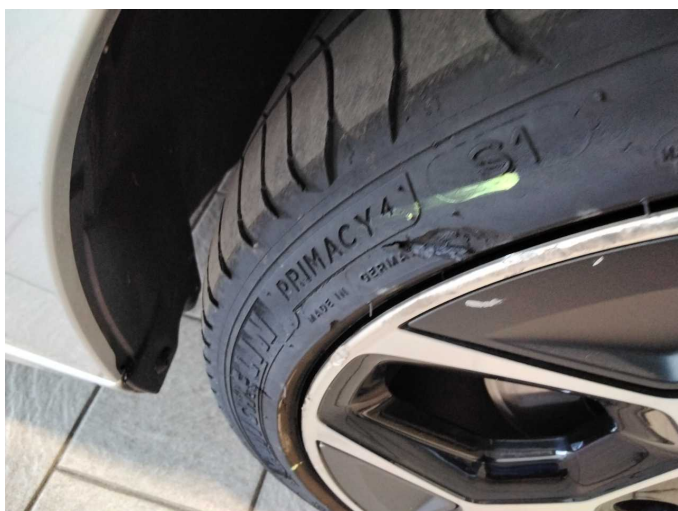
**Damage 7:** Wheel / tyres: Tyre - front right side (nicht fahrbereit) - Damaged - Replace

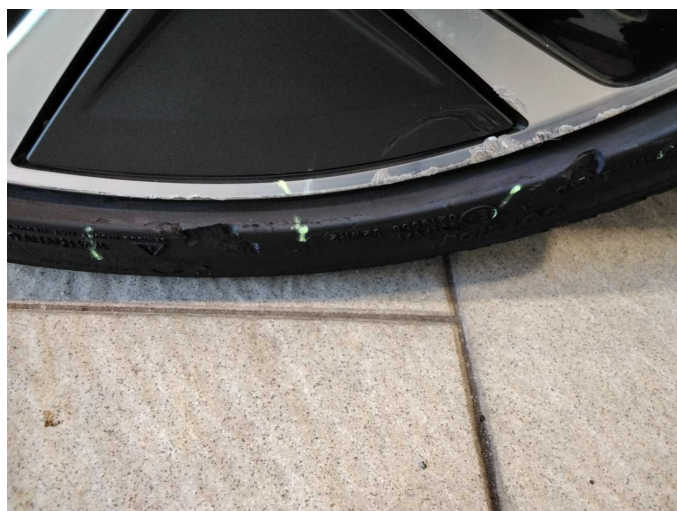
**Damage 7:** Wheel / tyres: Tyre - front right side (nicht fahrbereit) - Damaged - Replace

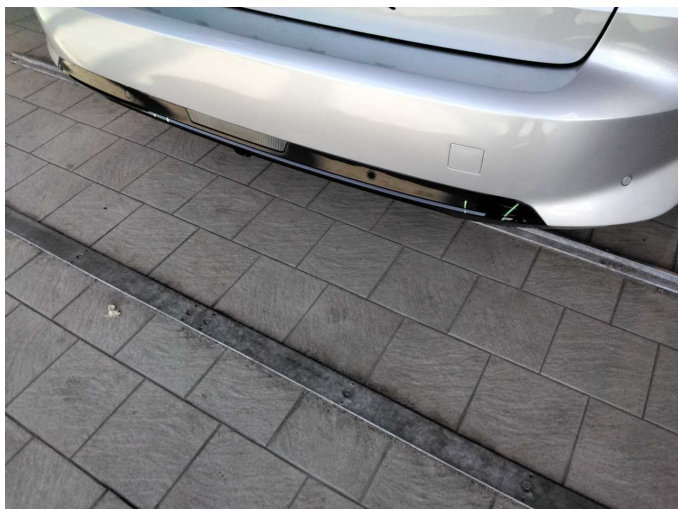
| No. | Component group | Description |
|---|---|---|
| 8 | Rear bumper | Spoiler - Scratch(es) - Smart repair |

**Damage 8:** Rear bumper: Spoiler - Scratch(es) - Smart repair

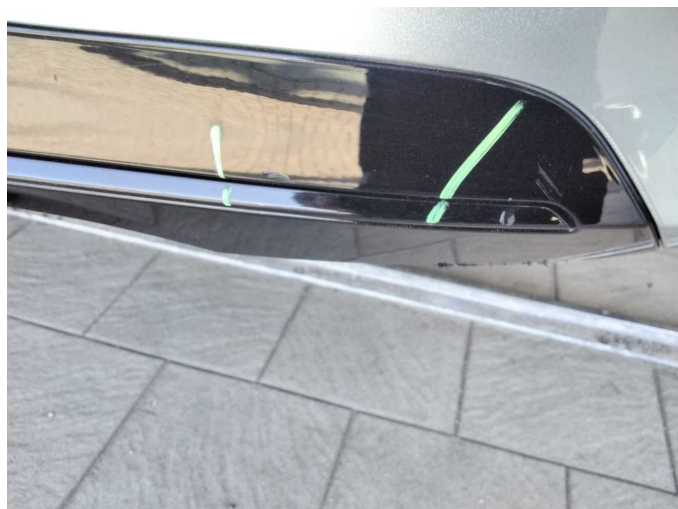
**Damage 8:** Rear bumper: Spoiler - Scratch(es) - Smart repair

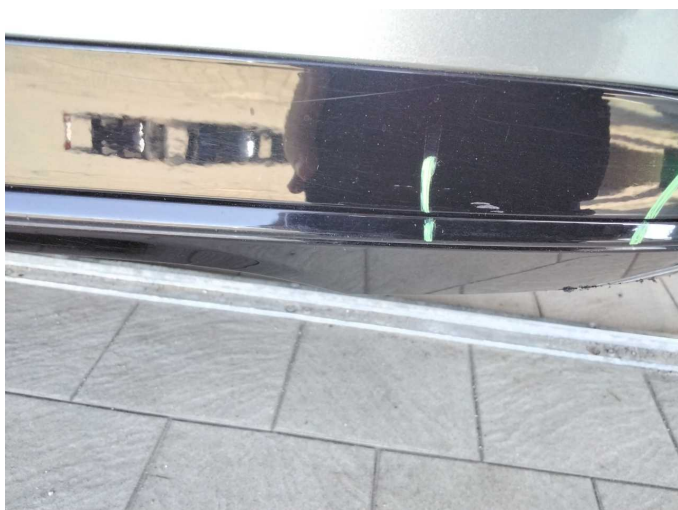
**Damage 8:** Rear bumper: Spoiler - Scratch(es) - Smart repair

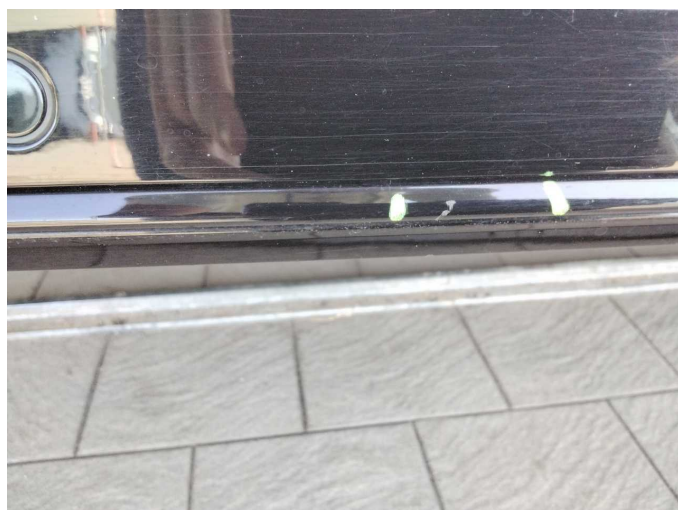
**Damage 8:** Rear bumper: Spoiler - Scratch(es) - Smart repair

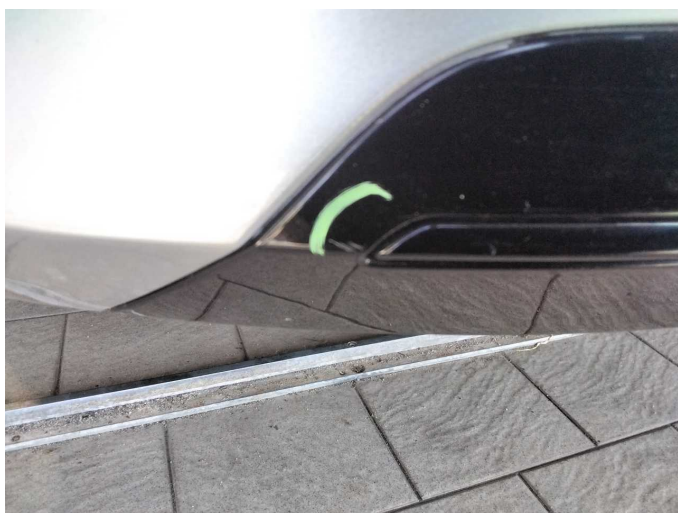
**Damage 8:** Rear bumper: Spoiler - Scratch(es) - Smart repair

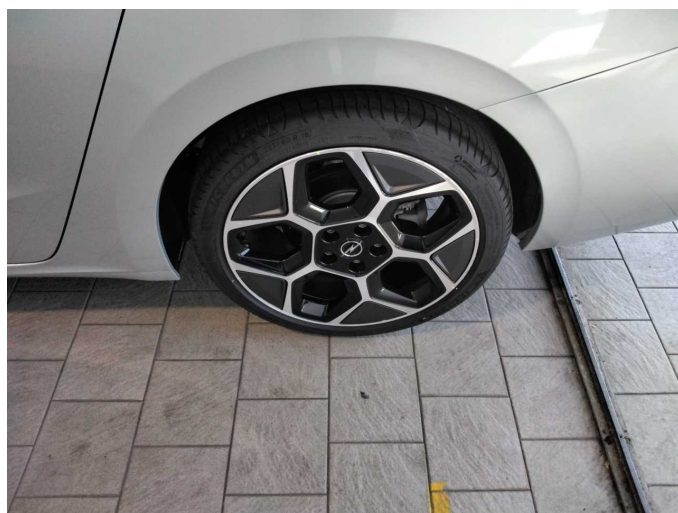
| No. | Component group | Description |
|---|---|---|
| 9 | Wheel / tyres | Alloy rim - rear left side - Scratch(es) - Loss in value |

**Damage 9:** Wheel / tyres: Alloy rim - rear left side - Scratch(es) - Loss in value

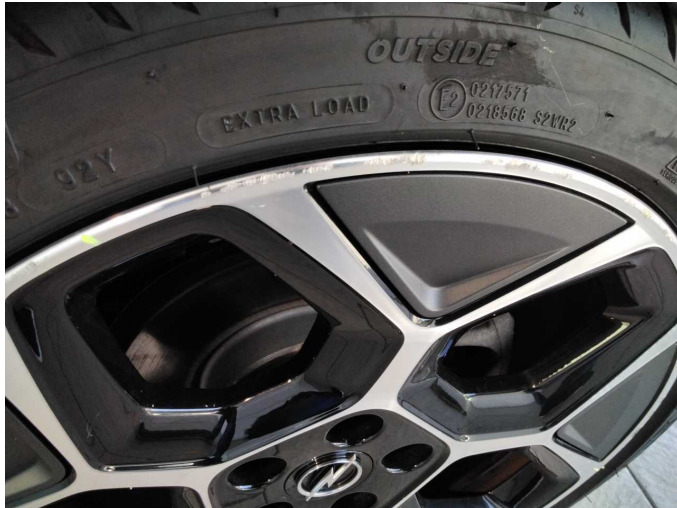
**Damage 9:** Wheel / tyres: Alloy rim - rear left side - Scratch(es) - Loss in value

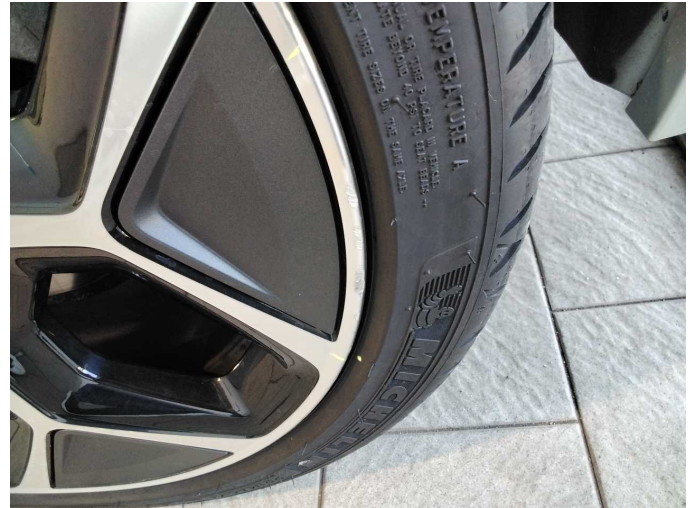
**Damage 9:** Wheel / tyres: Alloy rim - rear left side - Scratch(es) - Loss in value

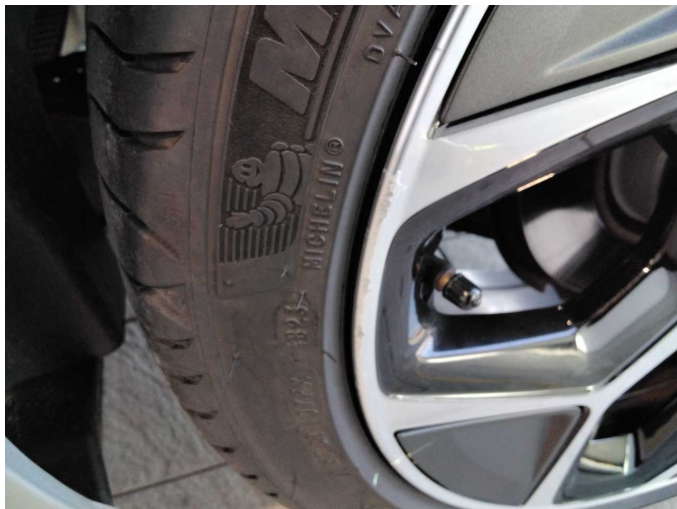
**Damage 9:** Wheel / tyres: Alloy rim - rear left side - Scratch(es) - Loss in value

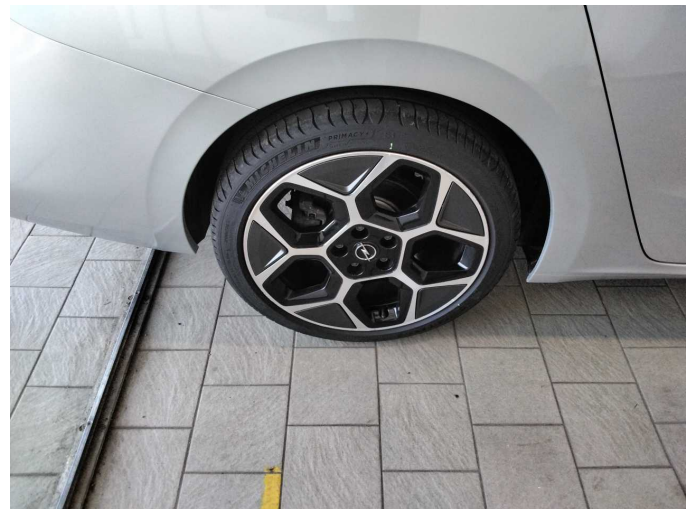
| No. | Component group | Description |
|---|---|---|
| 10 | Wheel / tyres | Alloy rim - rear right side - Scratch(es) - Loss in value |

**Damage 10:** Wheel / tyres: Alloy rim - rear right side - Scratch(es) - Loss in value

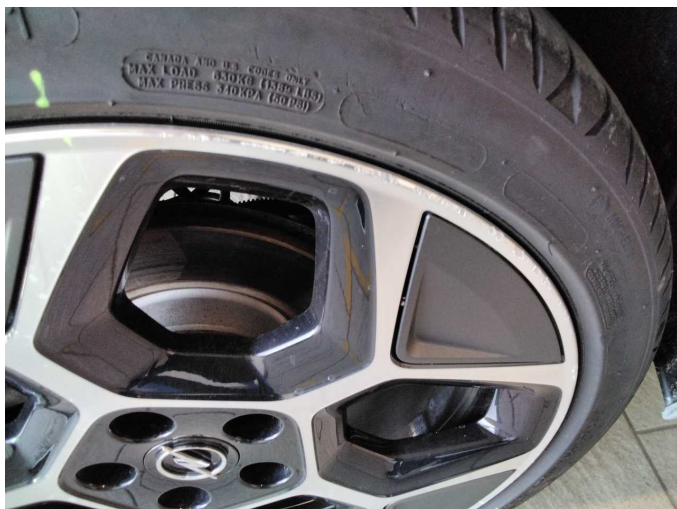
**Damage 10:** Wheel / tyres: Alloy rim - rear right side - Scratch(es) - Loss in value

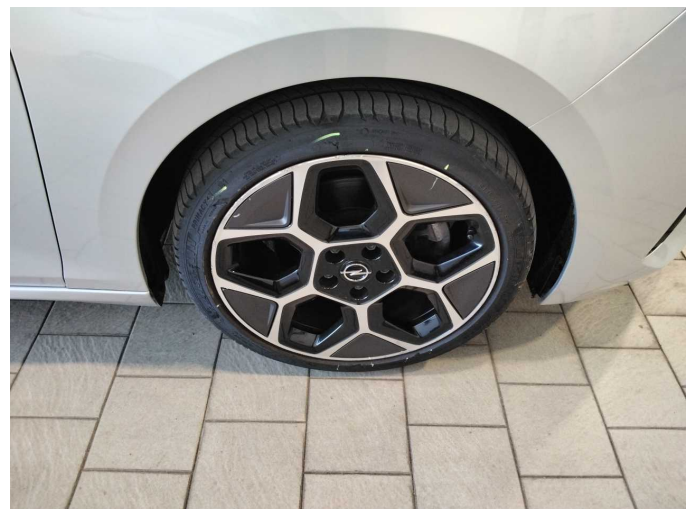
| No. | Component group | Description |
|---|---|---|
| 11 | Wheel / tyres | Alloy rim - front right side - Scratch(es) - Replace |

**Damage 11:** Wheel / tyres: Alloy rim - front right side - Scratch(es) - Replace

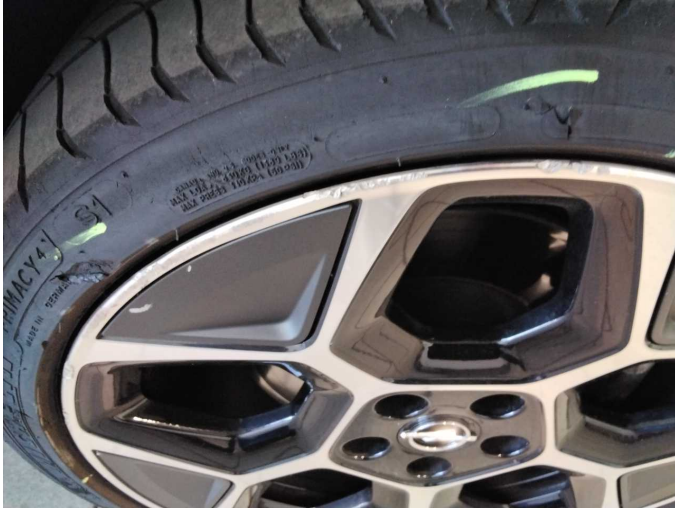
**Damage 11:** Wheel / tyres: Alloy rim - front right side - Scratch(es) - Replace

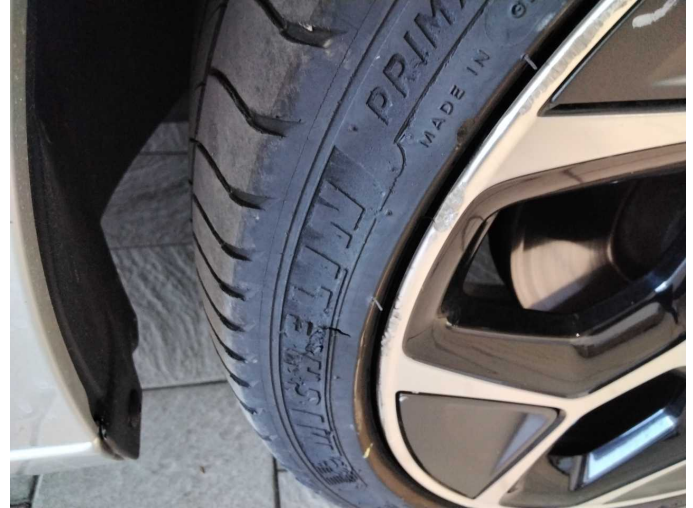
**Damage 11:** Wheel / tyres: Alloy rim - front right side - Scratch(es) - Replace

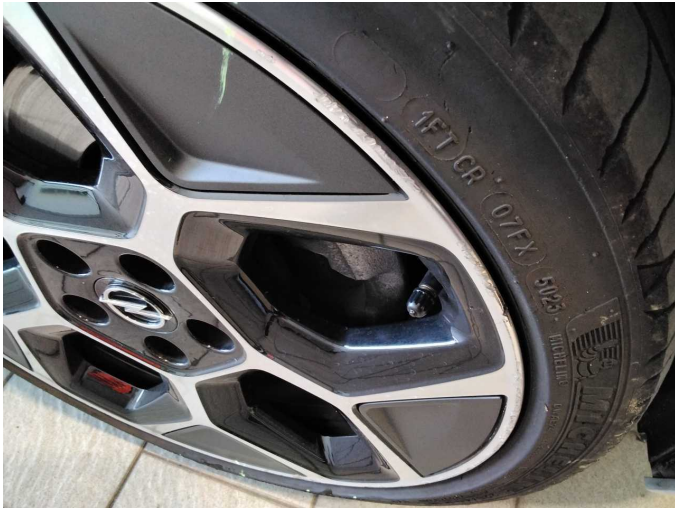
**Damage 11:** Wheel / tyres: Alloy rim - front right side - Scratch(es) - Replace

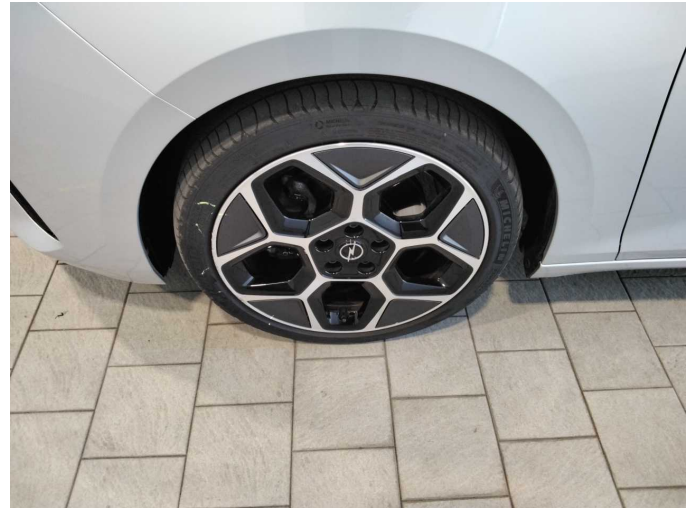
| No. | Component group | Description |
|---|---|---|
| 12 | Wheel / tyres | Alloy rim - front left side - Scratch(es) - Replace |

**Damage 12:** Wheel / tyres: Alloy rim - front left side - Scratch(es) - Replace

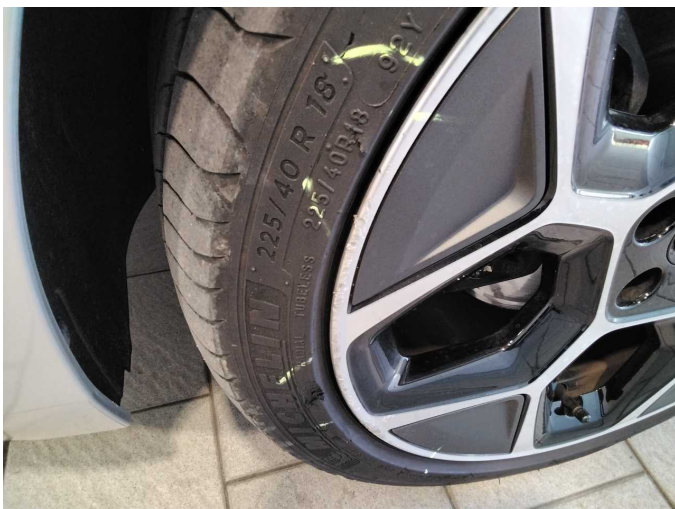
**Damage 12:** Wheel / tyres: Alloy rim - front left side - Scratch(es) - Replace

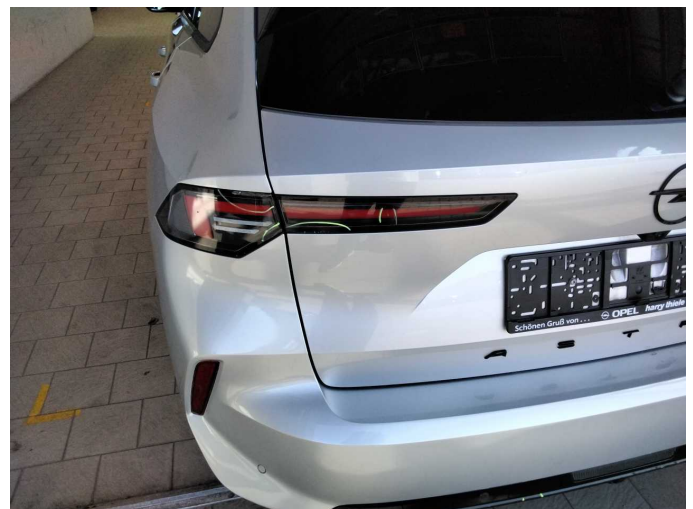
| No. | Component group | Description |
|---|---|---|
| 13 | Tail light | Tail lamp - left side (2 x) - Damaged - Replace |

**Damage 13:** Tail light: Tail lamp - left side (2 x) - Damaged - Replace

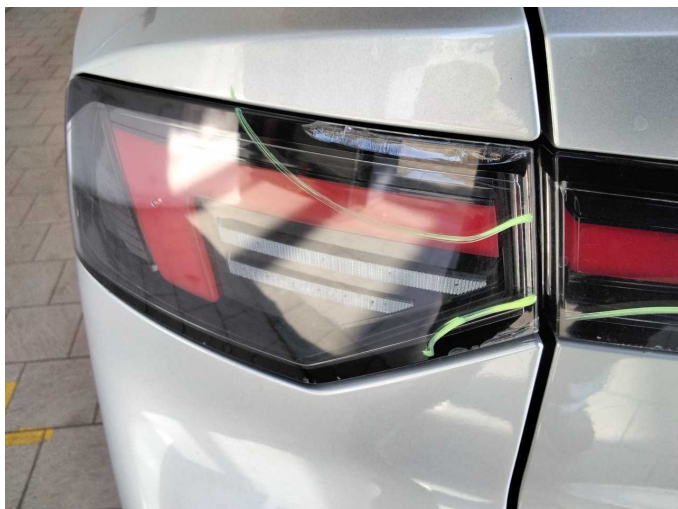
**Damage 13:** Tail light: Tail lamp - left side (2 x) - Damaged - Replace

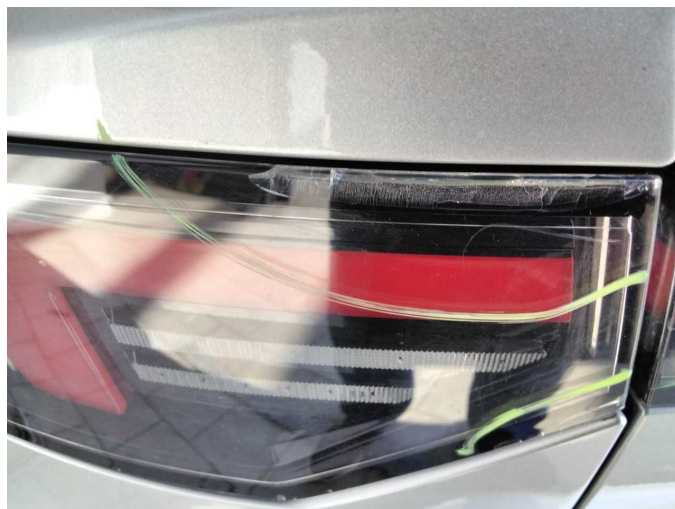
**Damage 13:** Tail light: Tail lamp - left side (2 x) - Damaged - Replace

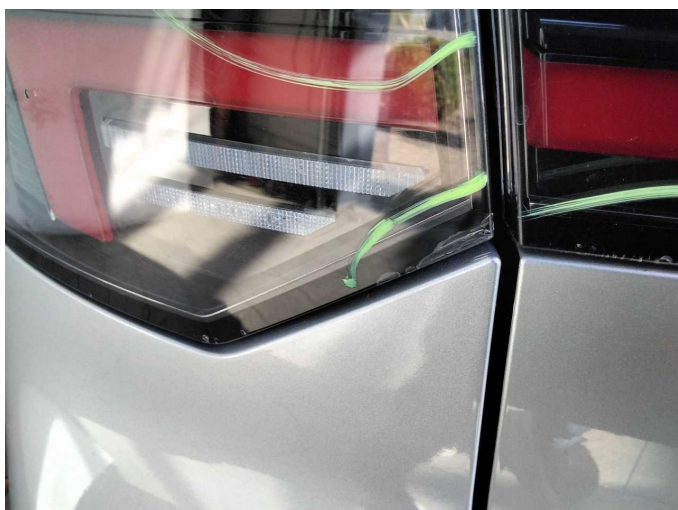
**Damage 13:** Tail light: Tail lamp - left side (2 x) - Damaged - Replace

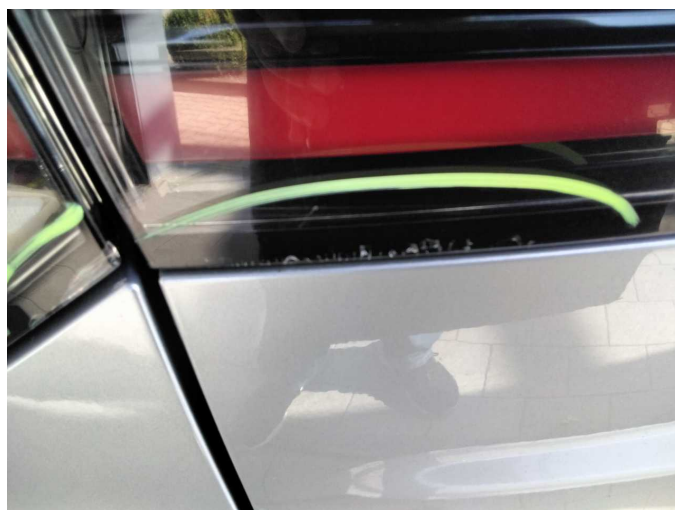
**Damage 13:** Tail light: Tail lamp - left side (2 x) - Damaged - Replace

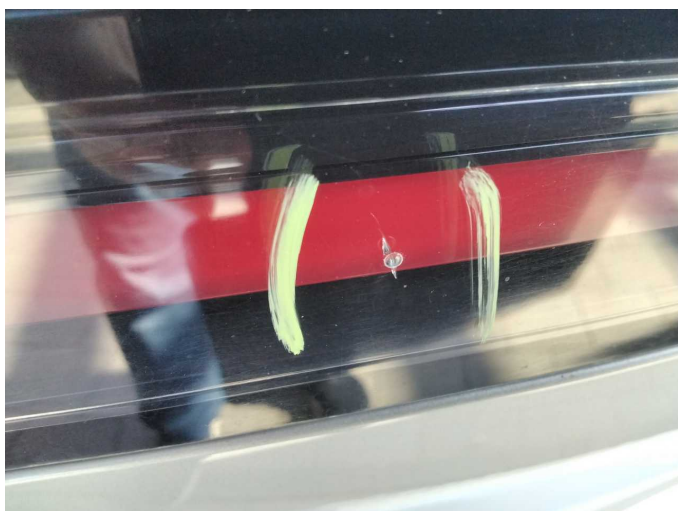
**Damage 13:** Tail light: Tail lamp - left side (2 x) - Damaged - Replace

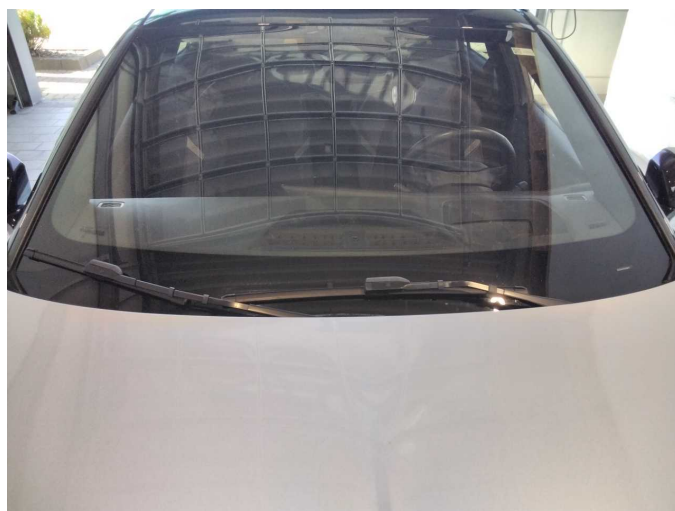
| No. | Component group | Description |
|---|---|---|
| 1 | Vehicle glazing | Windscreen - Stone chips - No deduction |

**Wear and tear 1:** Vehicle glazing: Windscreen - Stone chips - No deduction
