Expertise

Protocol number: 46192480
Order No. / Reference: 26530395
Inspection date: 26 Jun 2026

Manufacturer: Ford

Model: Transit Connect 230 L2 Trend Kasten

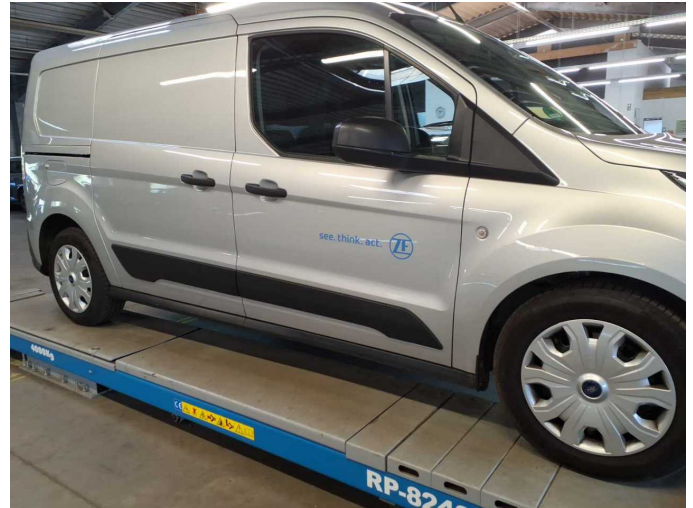
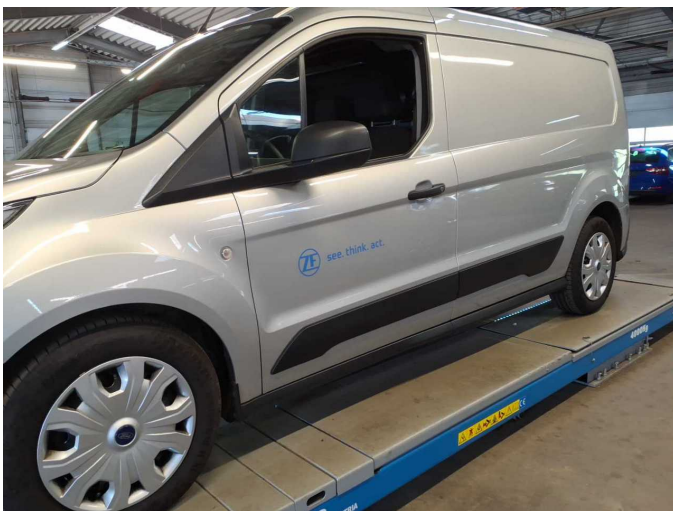
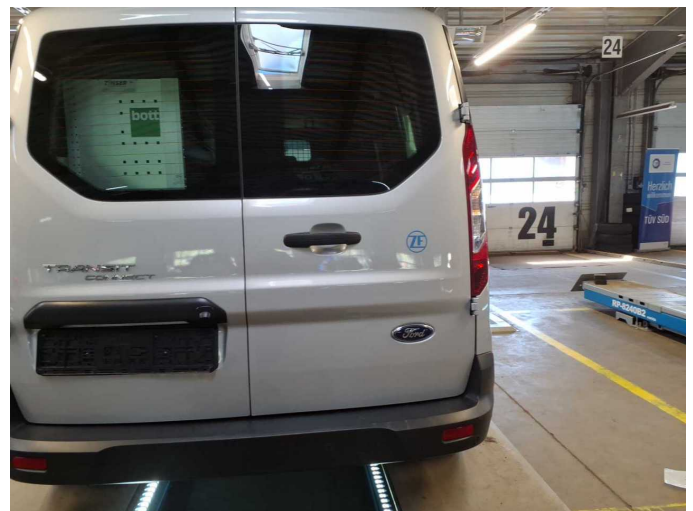
No.	Component group	Description
1	Body	Body - Glued / labelled - De-glue / neutralise
2	Sliding door, right	Trim plywood - lower - Broken / torn - Replace
3	Front bumper	Front bumper - Scratched - Paint

Damage 1: Body: Body - Glued / labelled - De-glue / neutralise

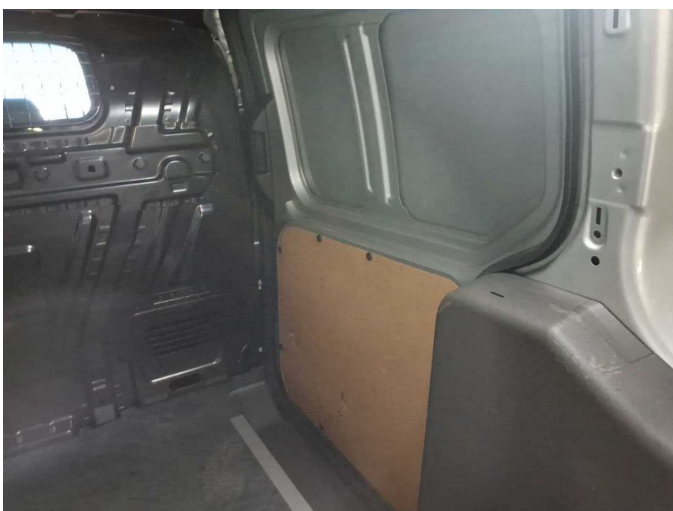
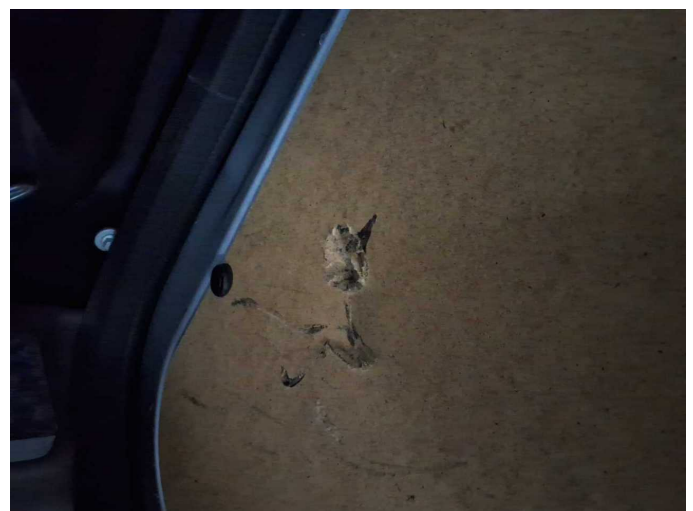
Damage 2: Sliding door, right: Trim plywood - lower - Broken / torn - Replace

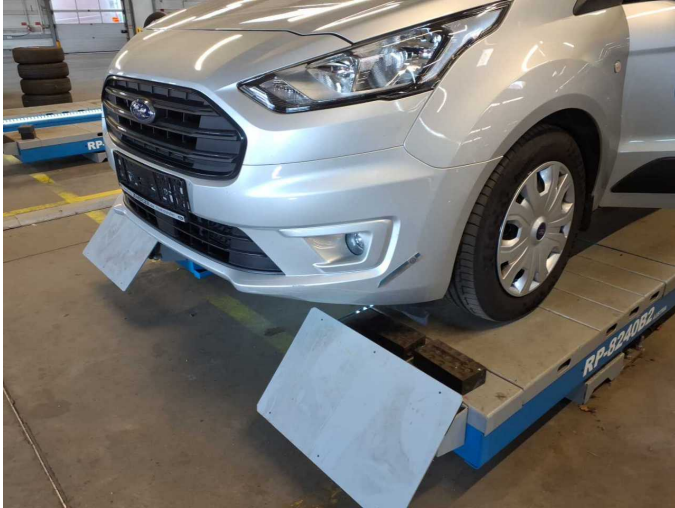
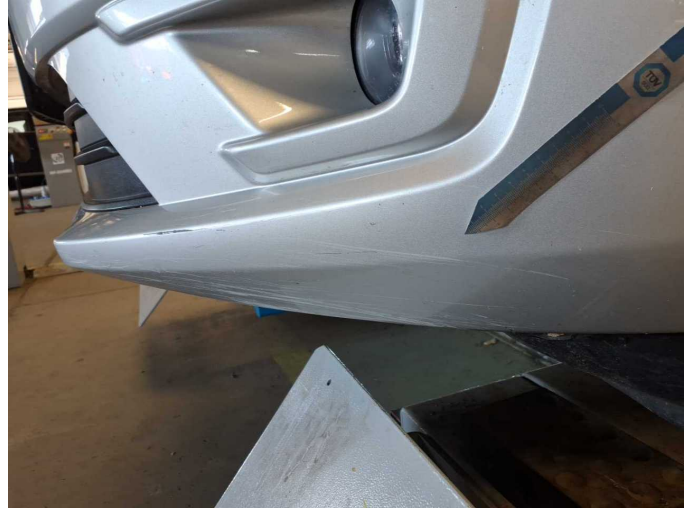
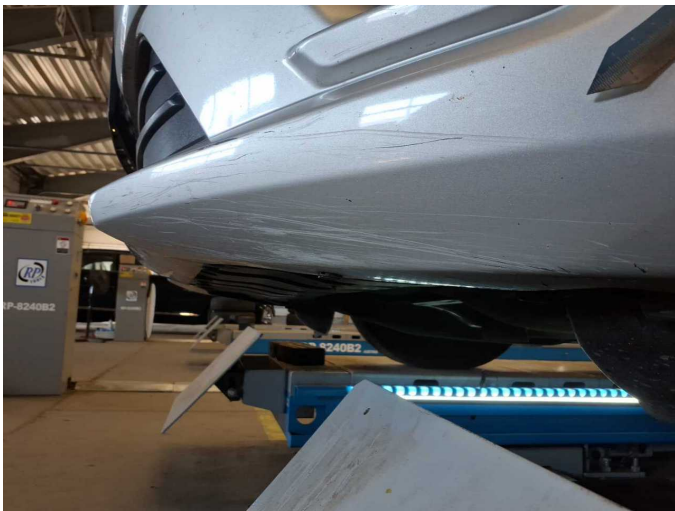
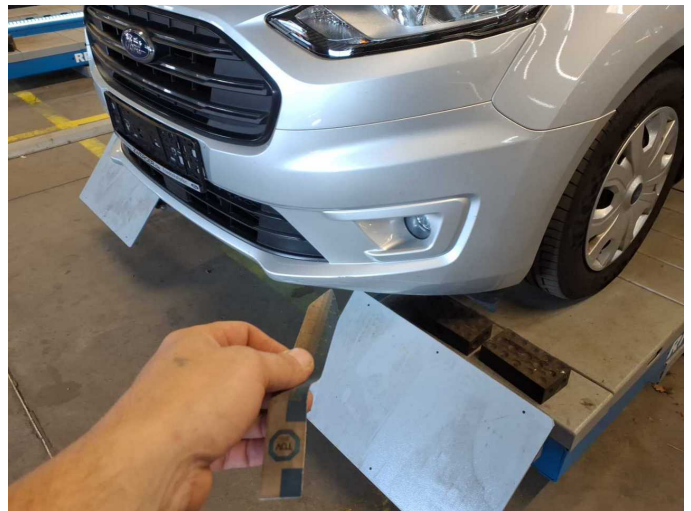
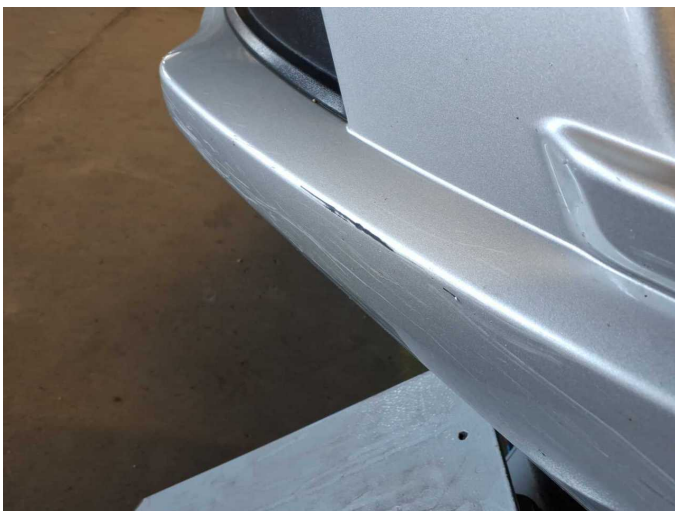
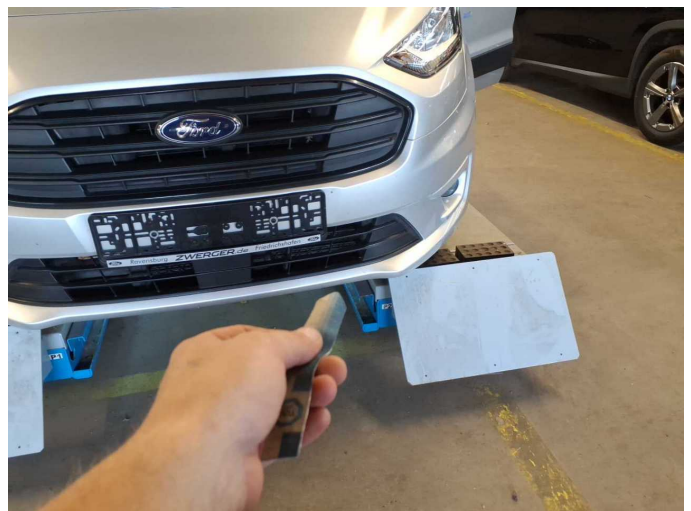
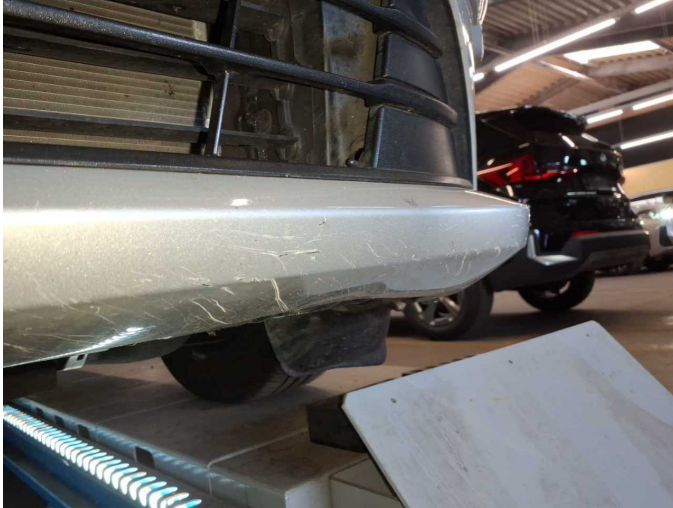
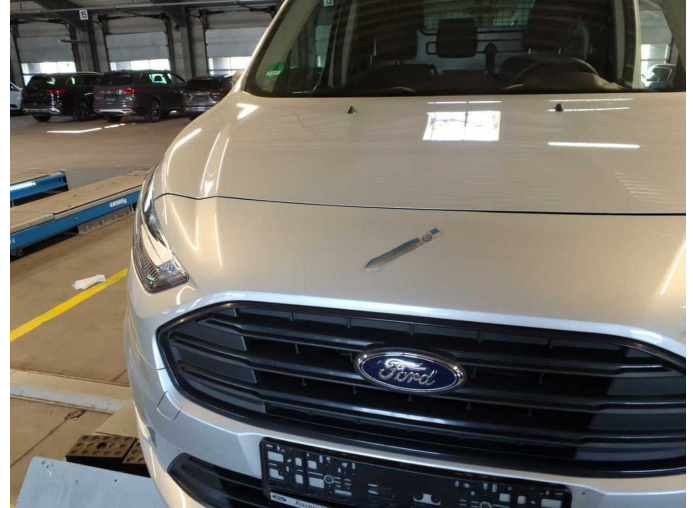
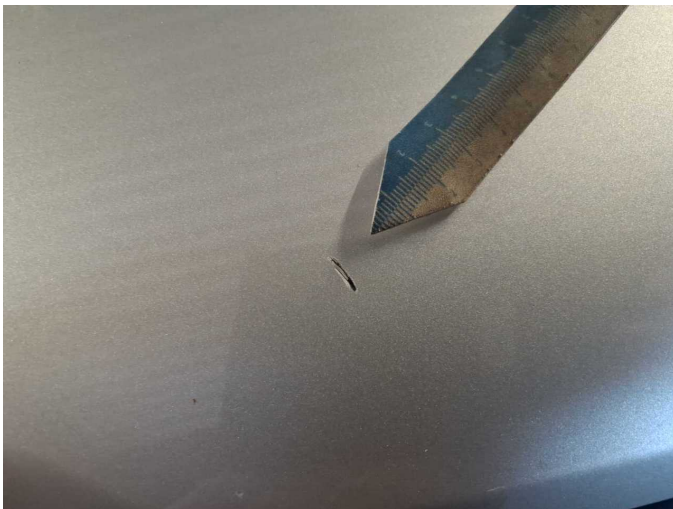
Damage 3: Front bumper: Front bumper - Scratched - Paint

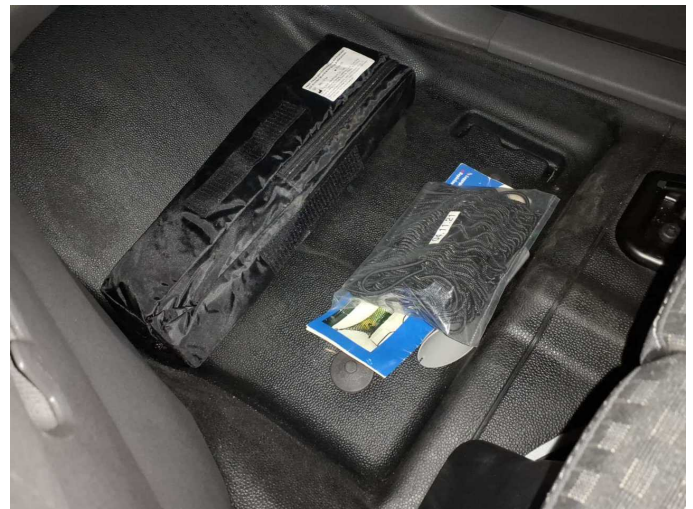
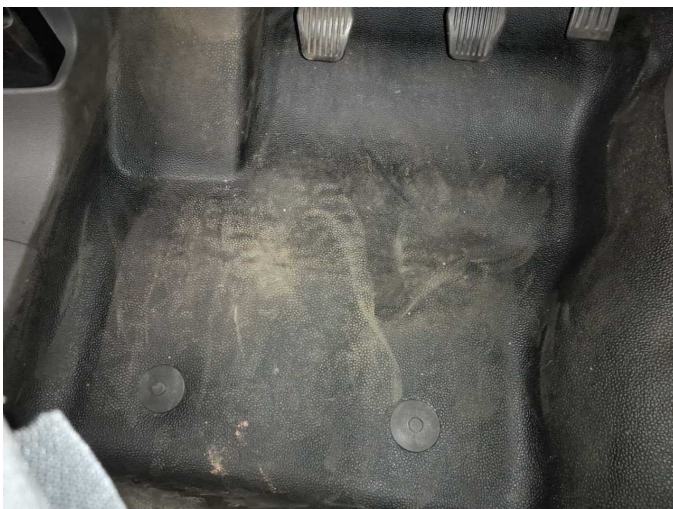
Missing part 1: Trim / covers: Floor mats (Beide) - Missing - Replace

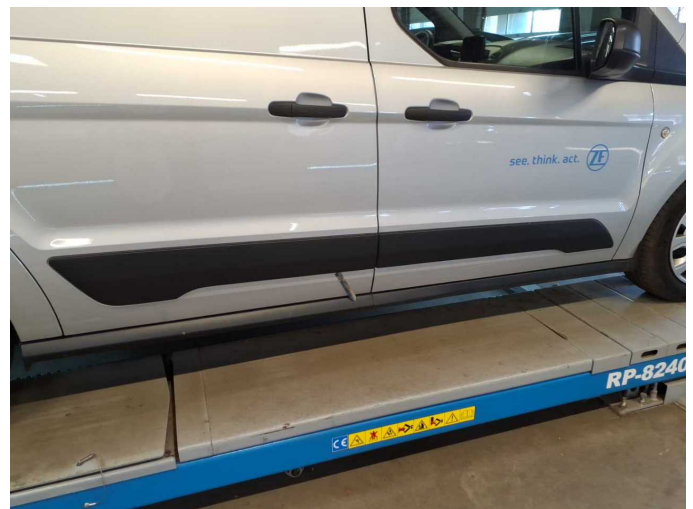
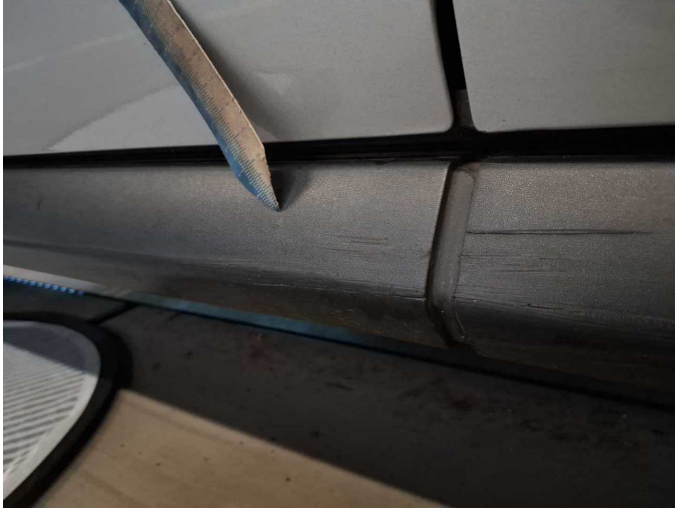
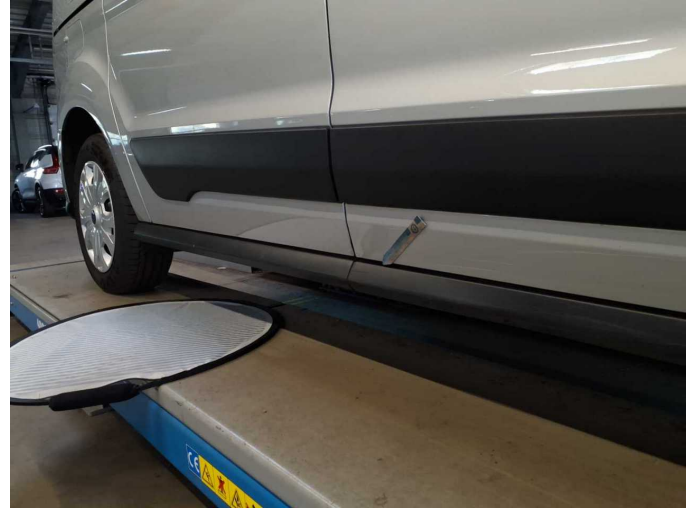
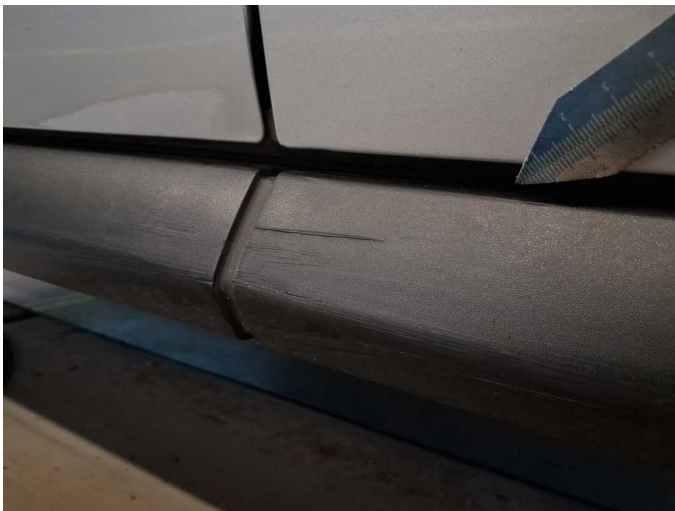
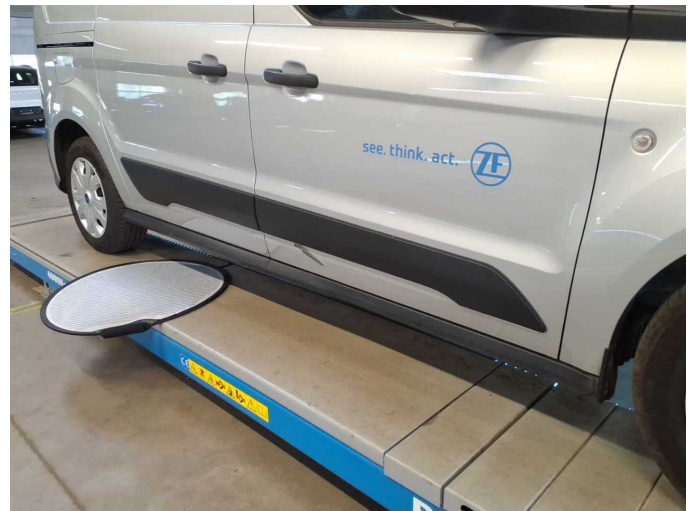
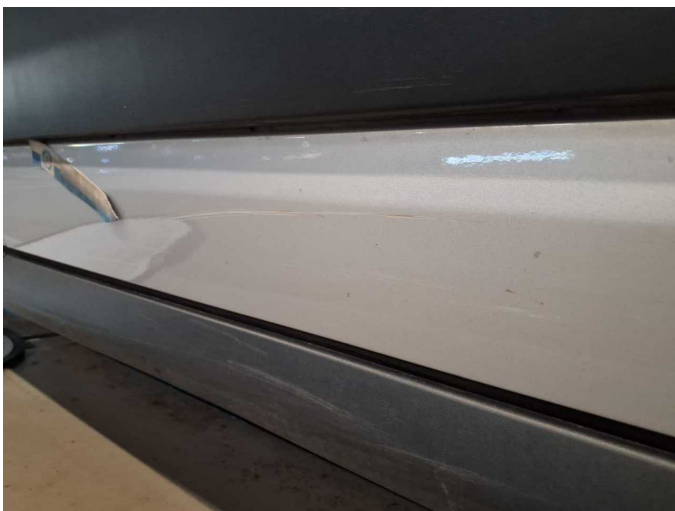
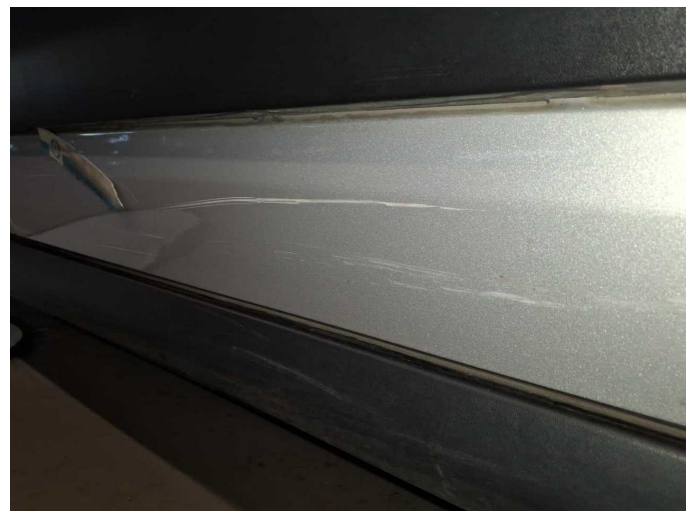
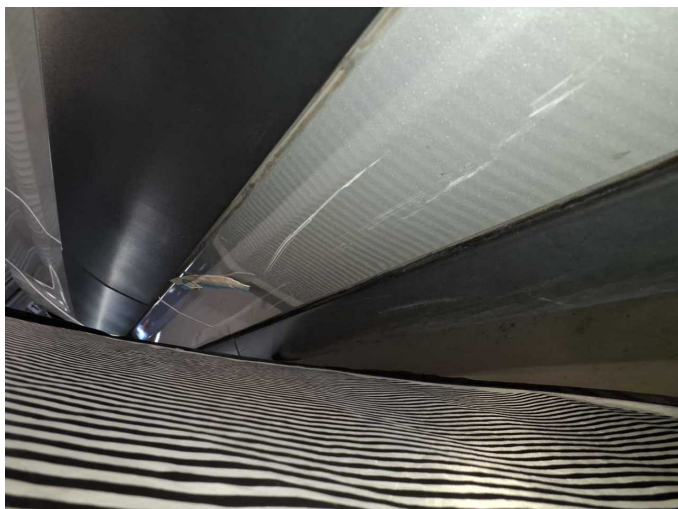
Accident 1: Side right
