Expertise

Protocol number: 46447845  
Order No. / Reference: 26028744  
Inspection date: 8 Jul 2026

Manufacturer: Mercedes-Benz

Model: Vito 116 CDI Lang HA Aut. PRO Kasten

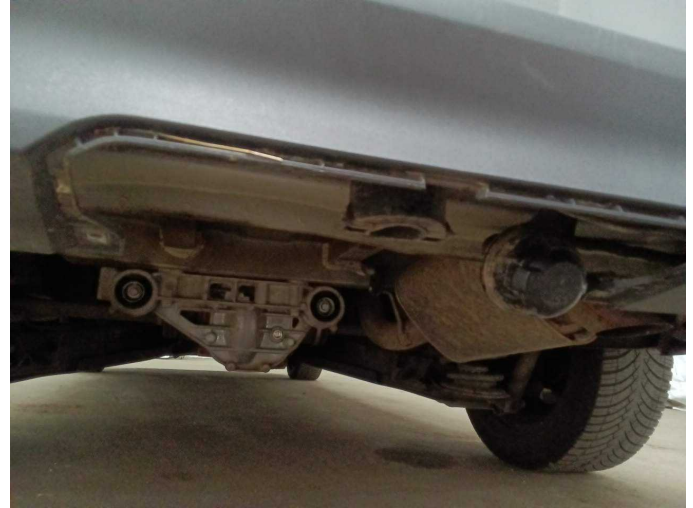
| No. | Component group | Description |
|---|---|---|
| 1 | Trim / covers | Trim / covers - Missing - Replace |

**Damage 1:** Trim / covers: Trim / covers - Missing - Replace

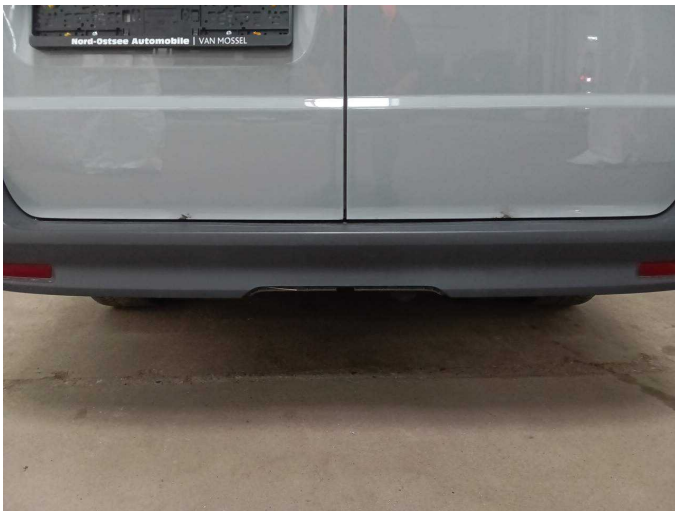
**Damage 1:** Trim / covers: Trim / covers - Missing - Replace

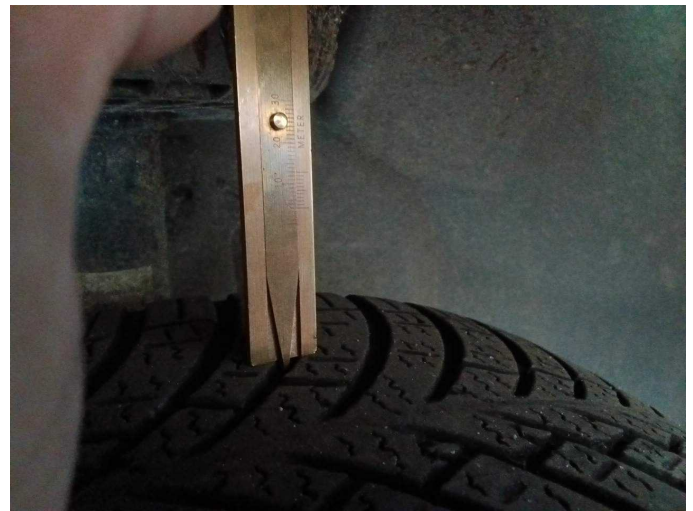
| # | Tyre size | Type of tyre | Manufacturer | Tread depth |
|---|---|---|---|---|
| 1) | 225/55 R17 107H | All-season tyres on Steel rim with wheel cover | Goodyear | 3mm / 3mm |
| 2) | 225/55 R17 107H | All-season tyres on Steel rim with wheel cover | Goodyear | 4mm / 4mm |

| No. | Component group | Description |
|---|---|---|
| 2 | Wheel / tyres | Tyres - complete set - Worn - Replace |

**Damage 2:** Wheel / tyres: Tyres - complete set - Worn - Replace

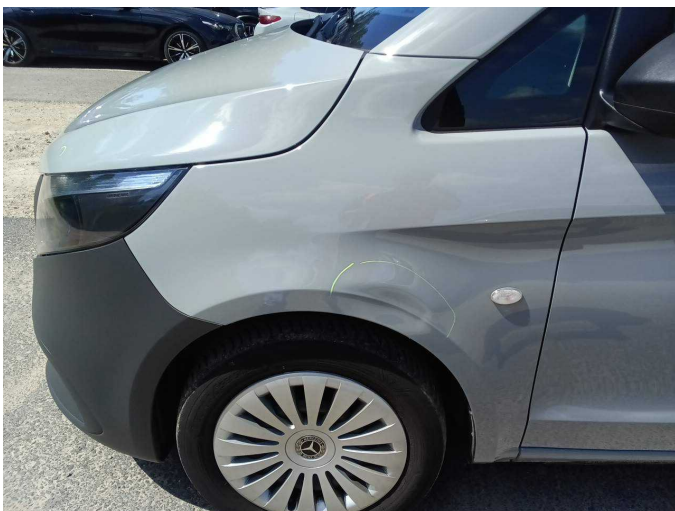
| No. | Component group | Description |
|---|---|---|
| 3 | Mudguard - left side | Mudguard - left side - Dent / paintcoat damage - Repair and paint |

**Damage 3:** Mudguard - left side: Mudguard - left side - Dent / paintcoat damage - Repair and paint

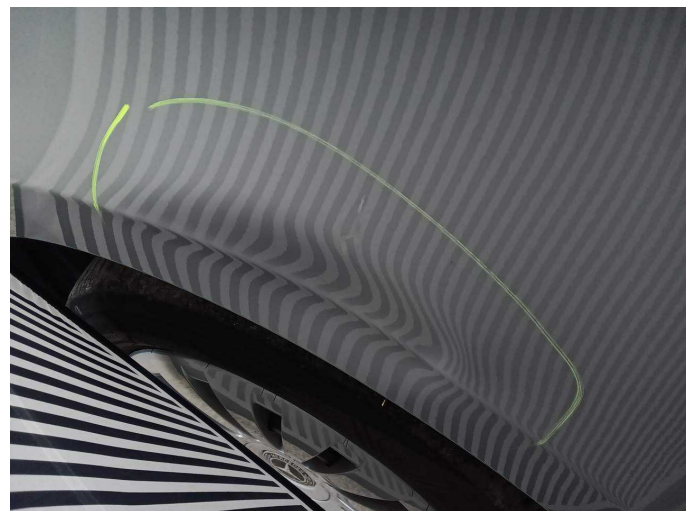
**Damage 3:** Mudguard - left side: Mudguard - left side - Dent / paintcoat damage - Repair and paint

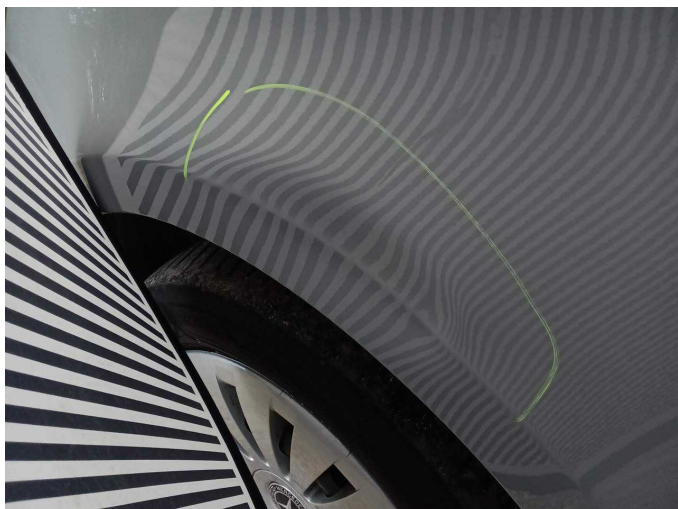
**Damage 3:** Mudguard - left side: Mudguard - left side - Dent / paintcoat damage - Repair and paint

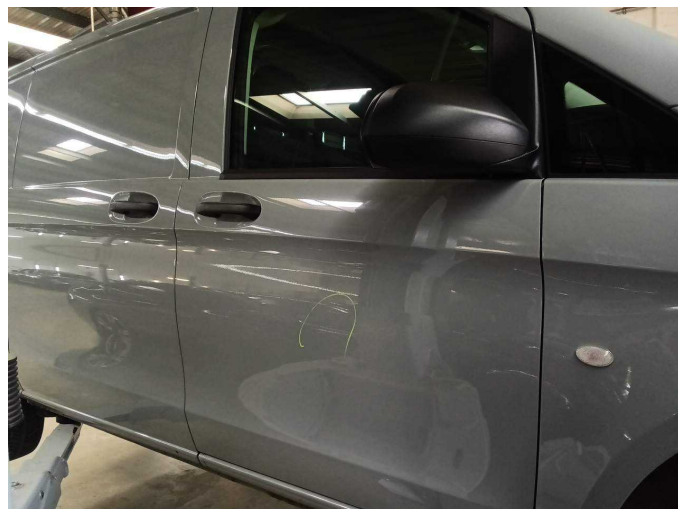
| No. | Component group | Description |
|---|---|---|
| 4 | Door - front right side | Door - Scratch(es) - Paint |

**Damage 4:** Door - front right side: Door - Scratch(es) - Paint

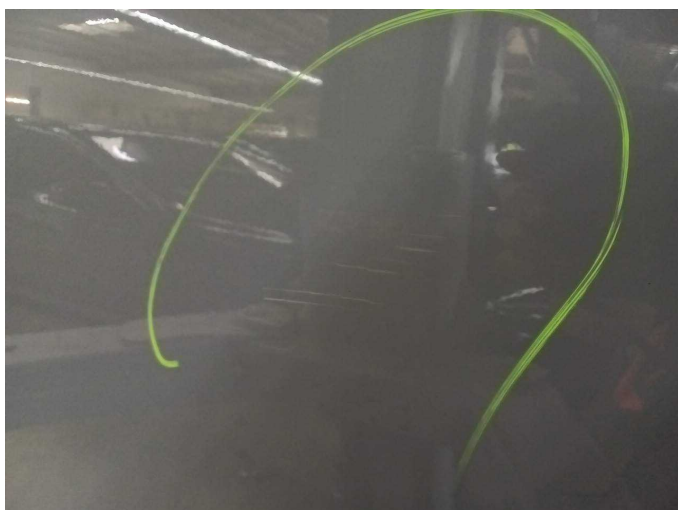
**Damage 4:** Door - front right side: Door - Scratch(es) - Paint

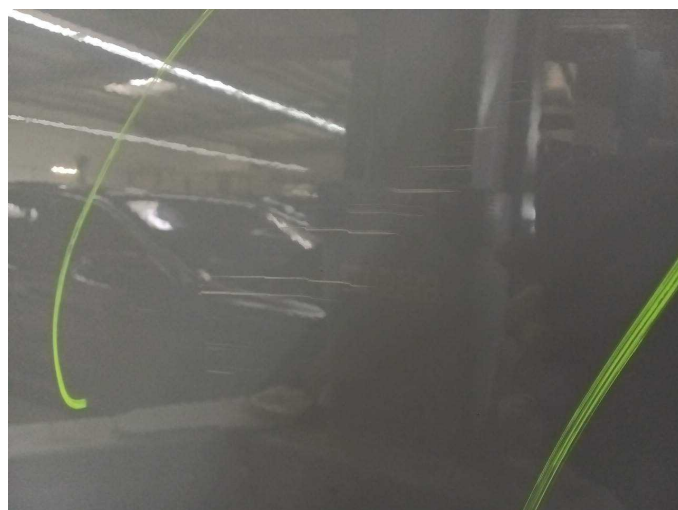
**Damage 4:** Door - front right side: Door - Scratch(es) - Paint

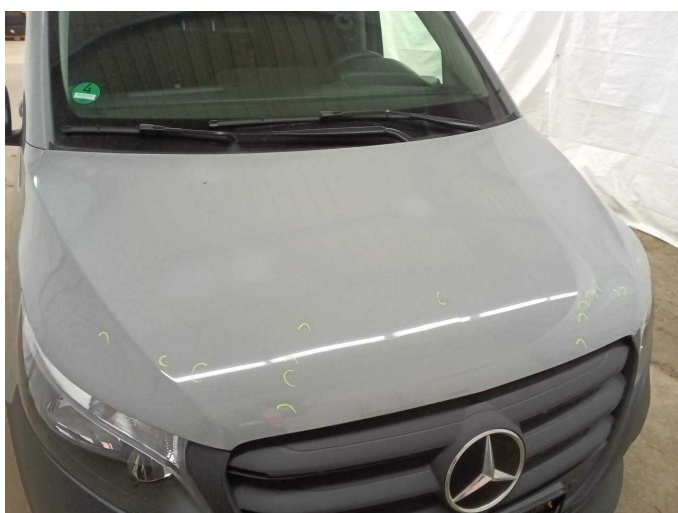
| No. | Component group | Description |
|---|---|---|
| 5 | Bonnet | Bonnet - Stone chips - Paint |

**Damage 5:** Bonnet: Bonnet - Stone chips - Paint

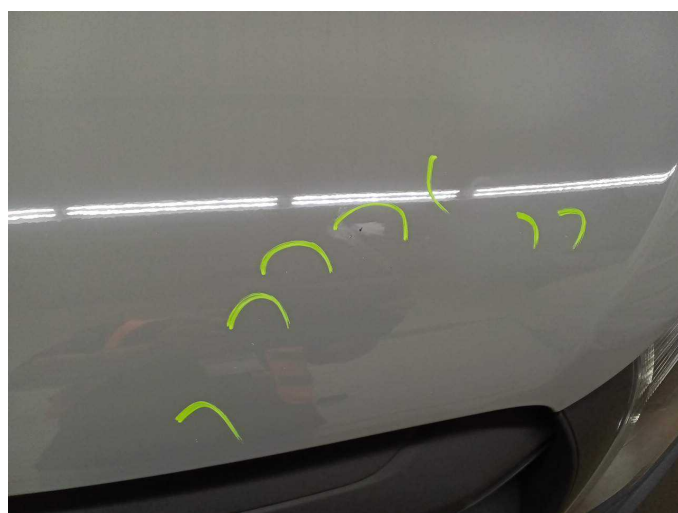
**Damage 5:** Bonnet: Bonnet - Stone chips - Paint

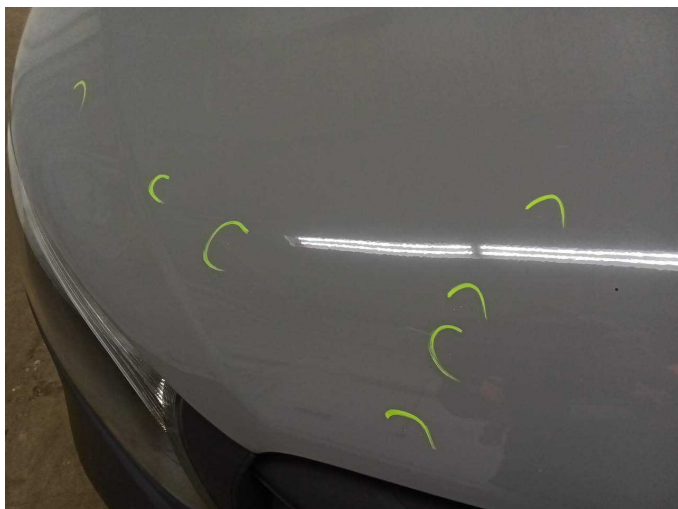
**Damage 5:** Bonnet: Bonnet - Stone chips - Paint
