Expertise

Protocol number: 46502663  
Order No. / Reference: 26621369  
Inspection date: 14 Jul 2026

Model: Vito 110 CDI Kompakt HA BASE Kasten

VIN: W1V44760114123316

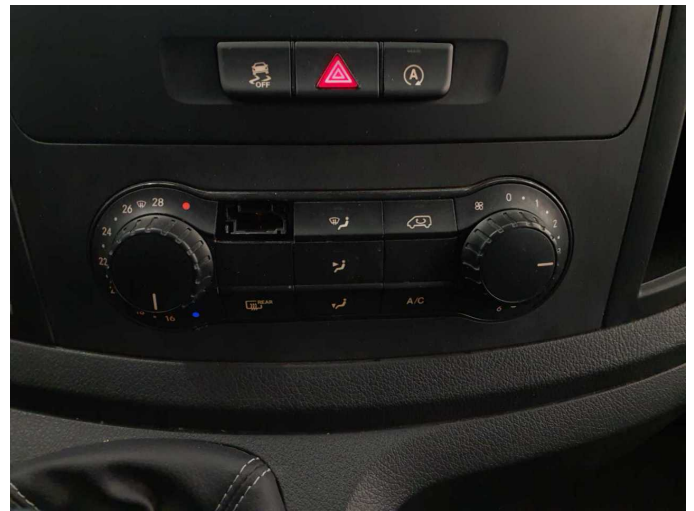
| No. | Component group | Description |
|---|---|---|
| 1 | Air-conditioning system | Air-conditioning system (Knopf) - Missing - Replace |

**Damage 1:** Air-conditioning system: Air-conditioning system (Knopf) - Missing - Replace

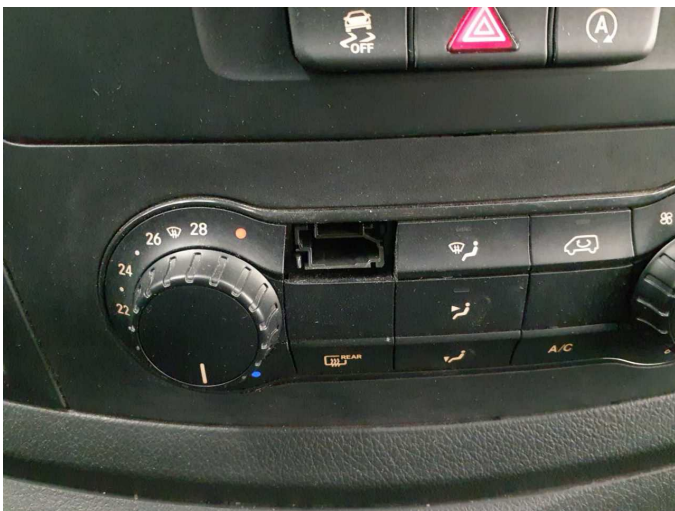
**Damage 1:** Air-conditioning system: Air-conditioning system (Knopf) - Missing - Replace

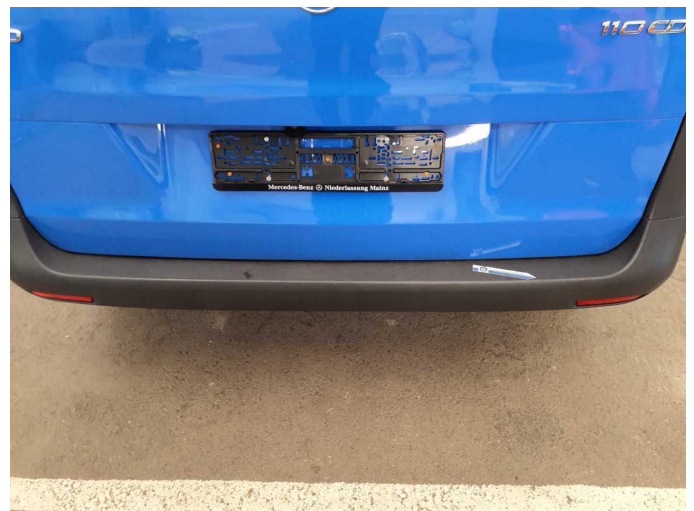
| No. | Component group | Description |
|---|---|---|
| 2 | Rear bumper | Rear bumper - Scratch(es) - Loss in value |

**Damage 2:** Rear bumper: Rear bumper - Scratch(es) - Loss in value

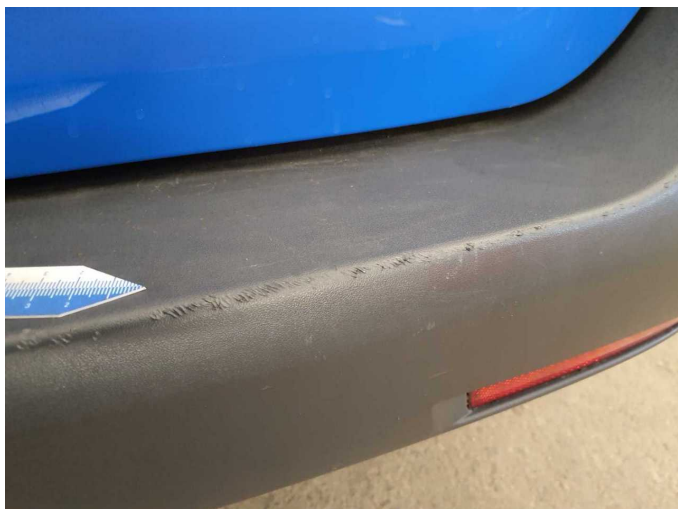
**Damage 2:** Rear bumper: Rear bumper - Scratch(es) - Loss in value

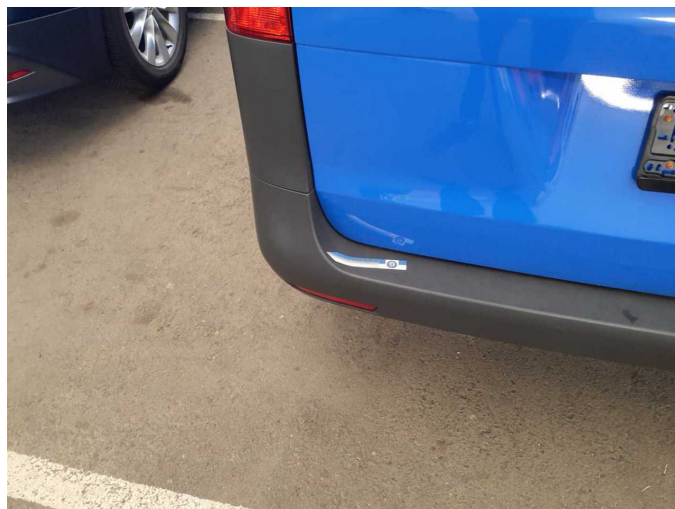
**Damage 2:** Rear bumper: Rear bumper - Scratch(es) - Loss in value

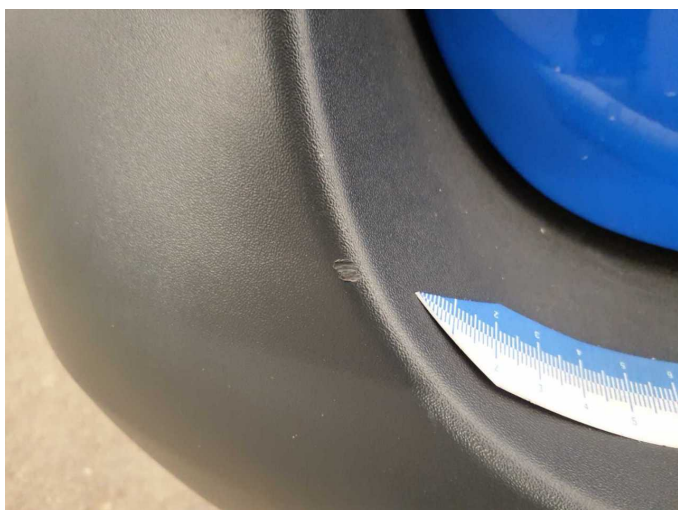
**Damage 2:** Rear bumper: Rear bumper - Scratch(es) - Loss in value

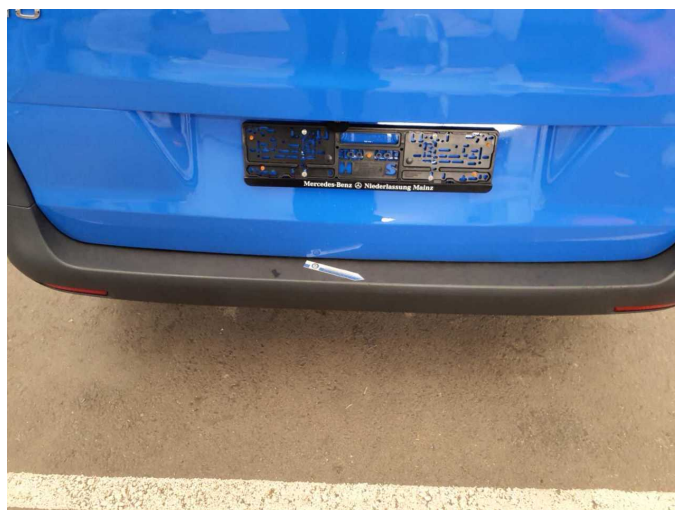
**Damage 2:** Rear bumper: Rear bumper - Scratch(es) - Loss in value

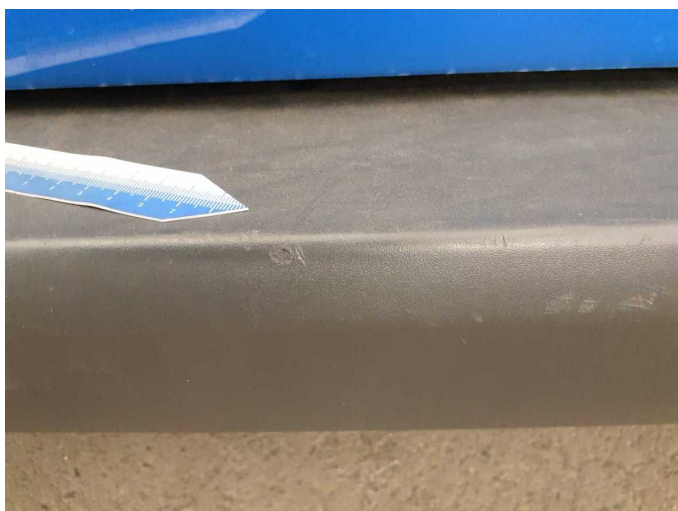
**Damage 2:** Rear bumper: Rear bumper - Scratch(es) - Loss in value

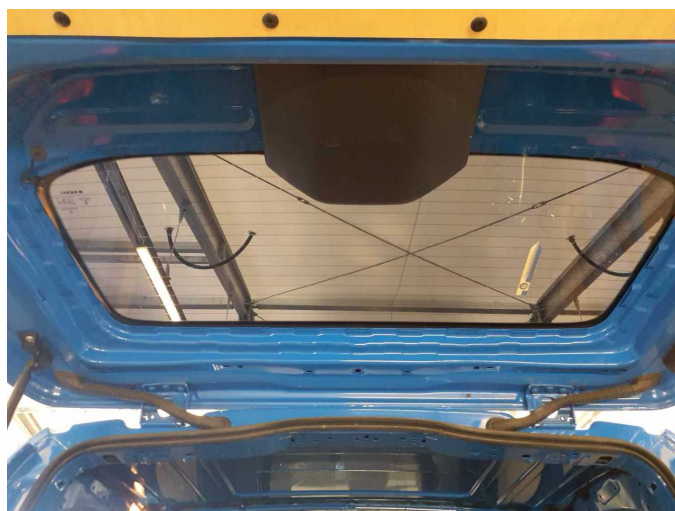
| No. | Component group | Description |
|---|---|---|
| 3 | Vehicle glazing | Rear window (Folie) - Scratch(es) - Loss in value |

**Damage 3:** Vehicle glazing: Rear window (Folie) - Scratch(es) - Loss in value

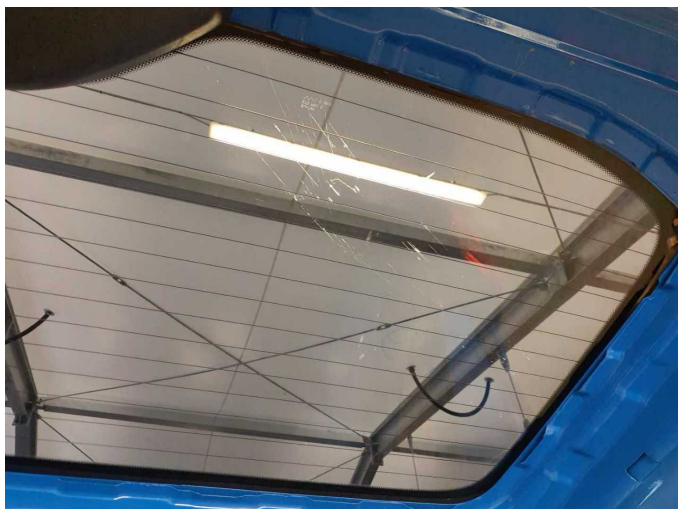
**Damage 3:** Vehicle glazing: Rear window (Folie) - Scratch(es) - Loss in value

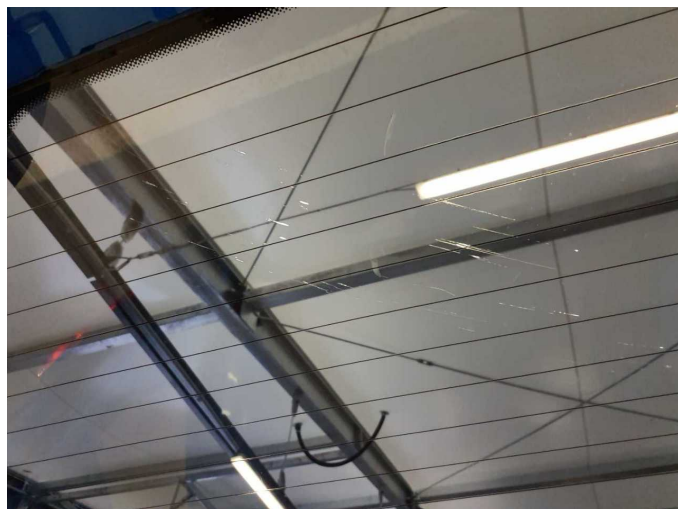
**Damage 3:** Vehicle glazing: Rear window (Folie) - Scratch(es) - Loss in value

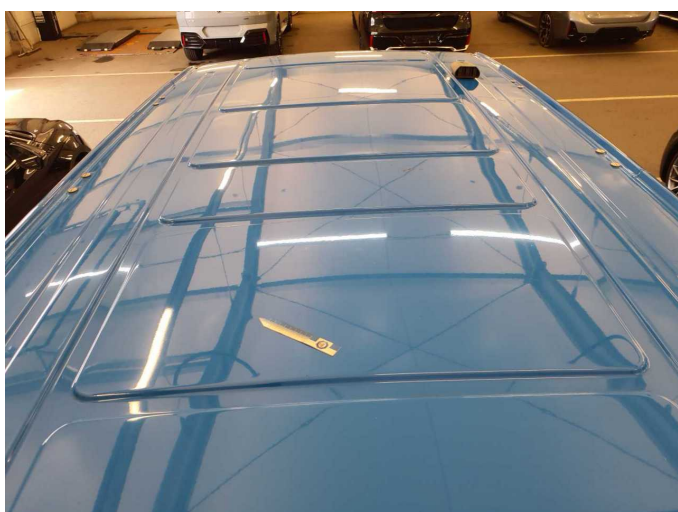
| No. | Component group | Description |
|---|---|---|
| 4 | Roof | Roof - dent(s) - Smart repair |

**Damage 4:** Roof: Roof - dent(s) - Smart repair

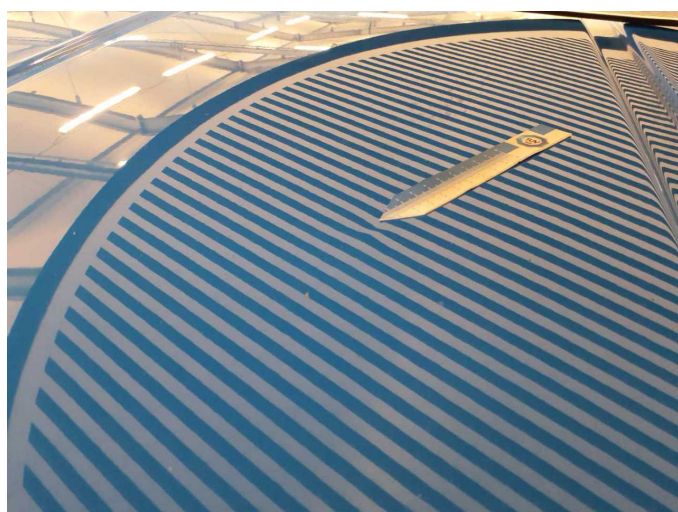
**Damage 4:** Roof: Roof - dent(s) - Smart repair

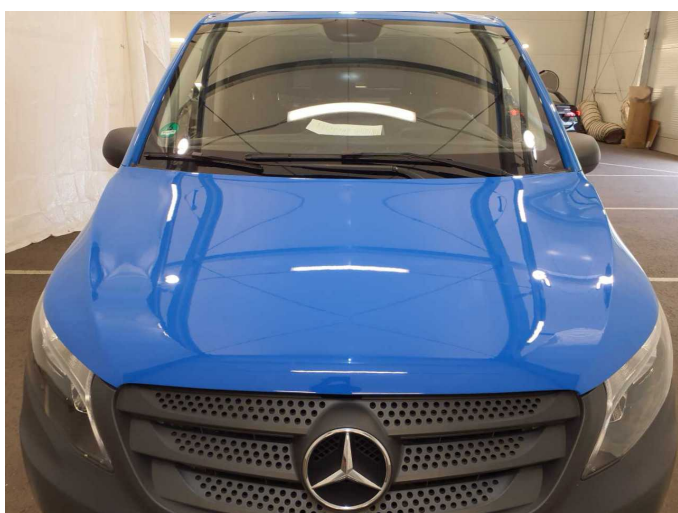
| No. | Component group | Description |
|---|---|---|
| 5 | Bonnet | Bonnet (Farbunterschied) - Paint defect - Paint |

**Damage 5:** Bonnet: Bonnet (Farbunterschied) - Paint defect - Paint

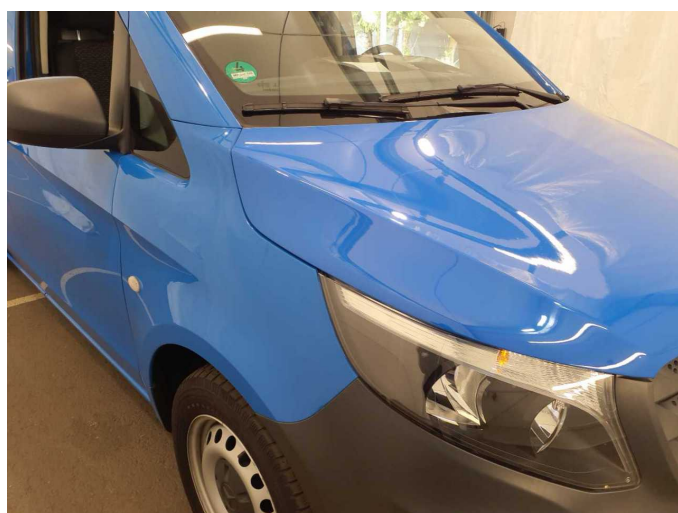
**Damage 5:** Bonnet: Bonnet (Farbunterschied) - Paint defect - Paint

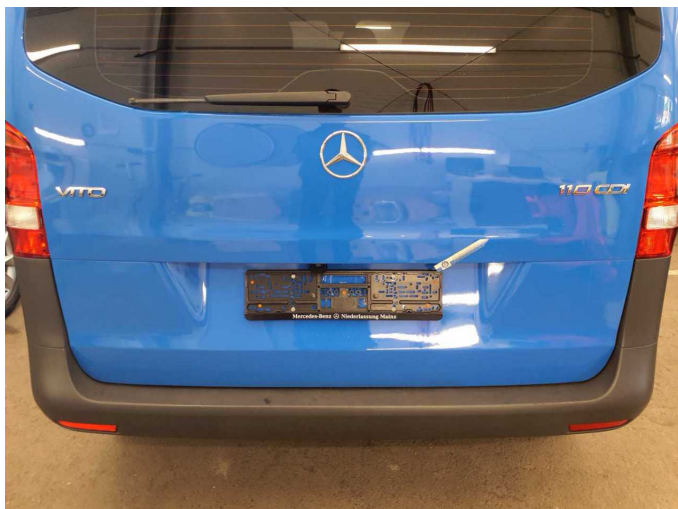
| No. | Component group | Description |
|---|---|---|
| 6 | Boot lid / rear door | Boot lid (Orangenhaut) - Paint defect - Paint |

**Damage 6:** Boot lid / rear door: Boot lid (Orangenhaut) - Paint defect - Paint

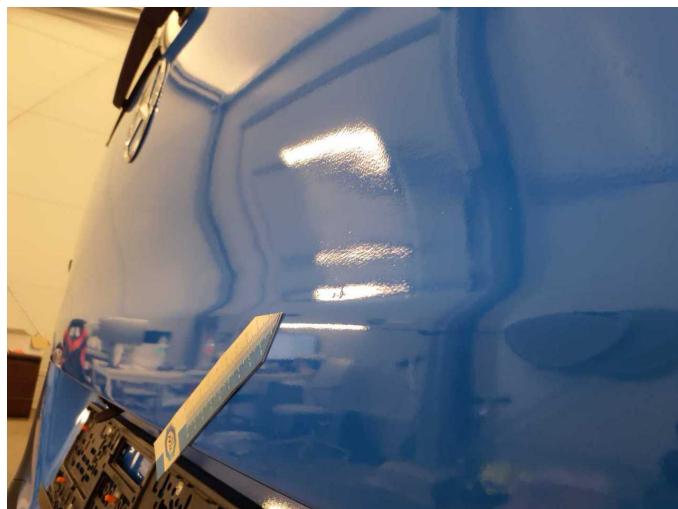
**Damage 6:** Boot lid / rear door: Boot lid (Orangenhaut) - Paint defect - Paint

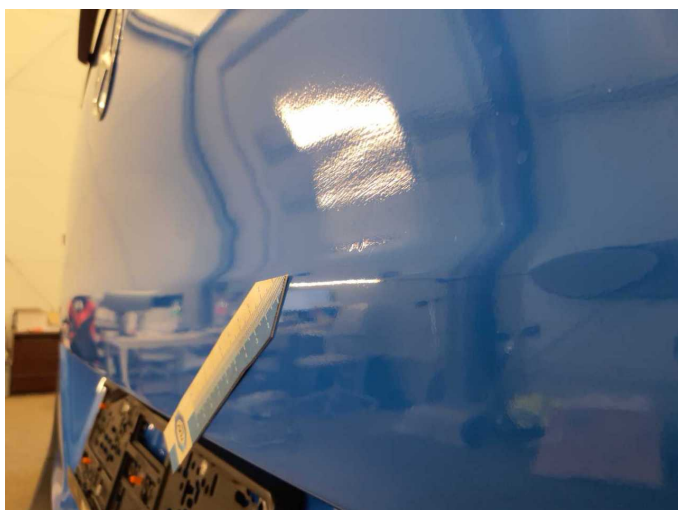
**Damage 6:** Boot lid / rear door: Boot lid (Orangenhaut) - Paint defect - Paint

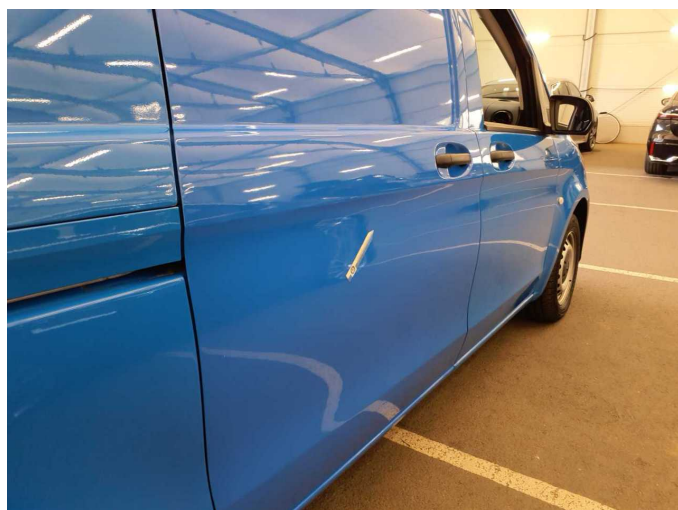
| No. | Component group | Description |
|---|---|---|
| 7 | Sliding door, right | Sliding door (Orangenhaut + Farbunterschied) - Paint defect - Paint |

**Damage 7:** Sliding door, right: Sliding door (Orangenhaut + Farbunterschied) - Paint defect - Paint

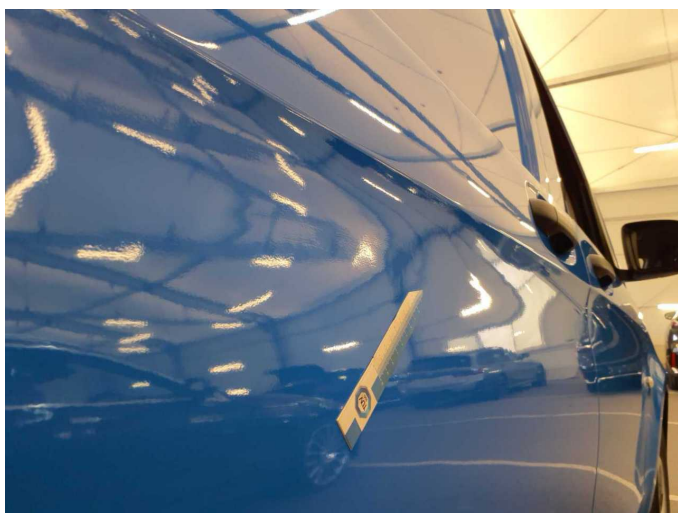
**Damage 7:** Sliding door, right: Sliding door (Orangenhaut + Farbunterschied) - Paint defect - Paint

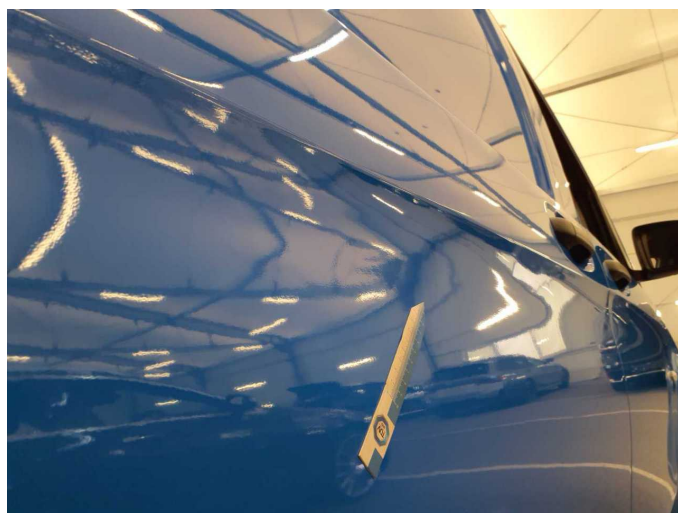
**Damage 7:** Sliding door, right: Sliding door (Orangenhaut + Farbunterschied) - Paint defect - Paint

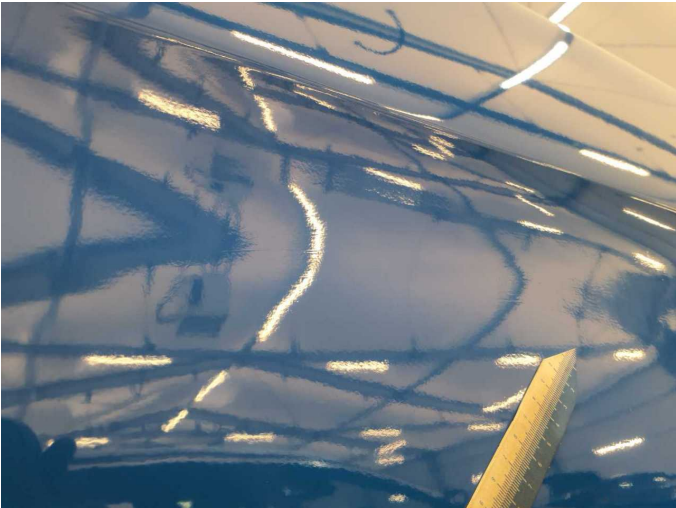
Damage 7: Sliding door, right: Sliding door (Orangenhaut + Farbunterschied) - Paint defect - Paint

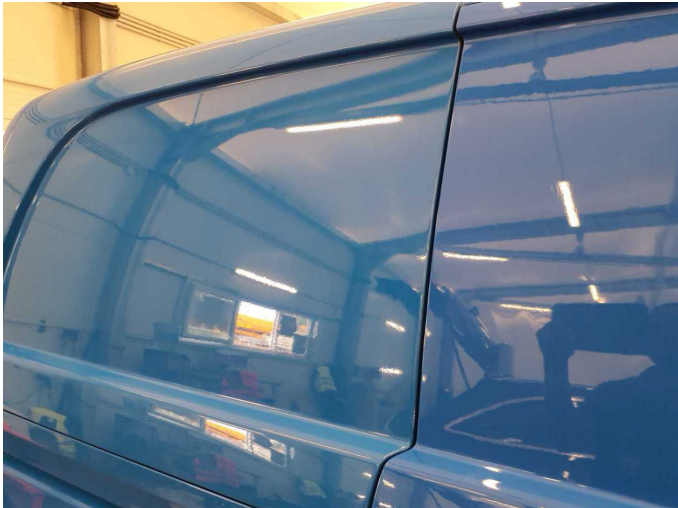
Damage 7: Sliding door, right: Sliding door (Orangenhaut + Farbunterschied) - Paint defect - Paint

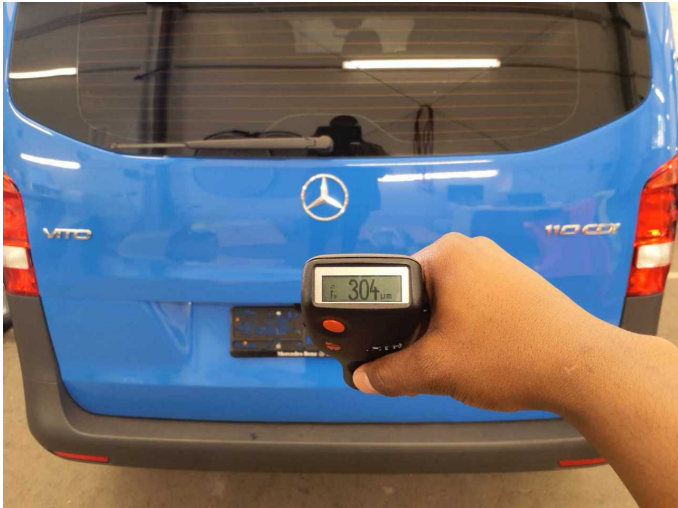
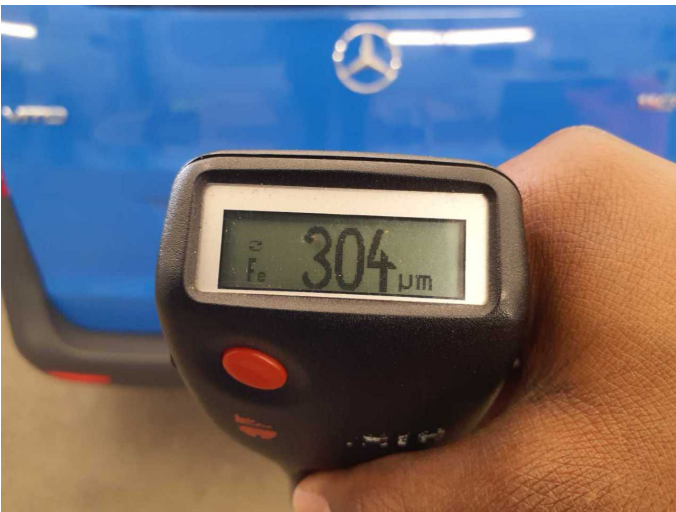
Repainting 1: Boot lid / rear door

- 1 Boot lid / rear door, Unprofessionally carried out, Invoice of repair done Non-existent
- 2 Bonnet, Unprofessionally carried out, Invoice of repair done Non-existent
- 3 Door - rear right side, Unprofessionally carried out, Invoice of repair done Non-existent

| Boot lid / rear door | 304 µm | Bonnet | 230 µm |

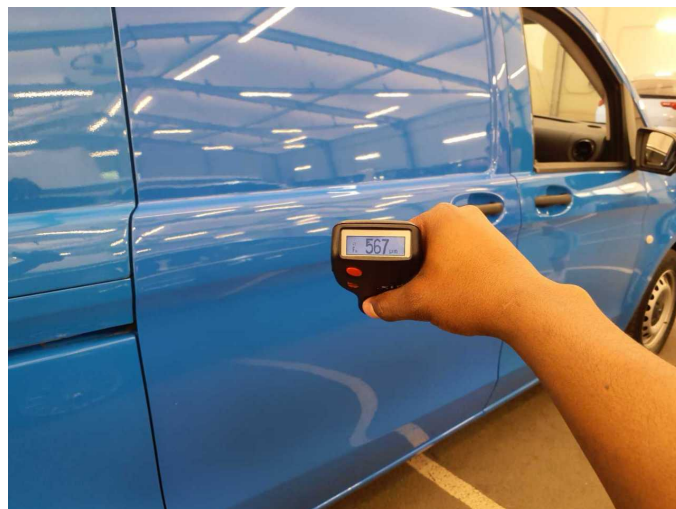
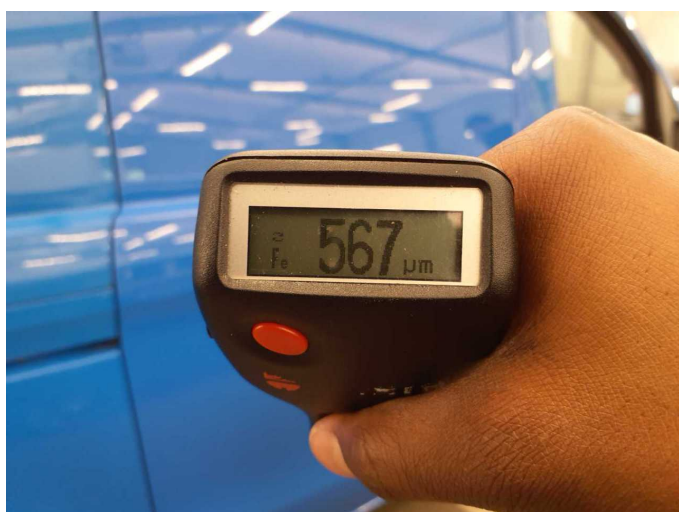
**Repainting 3:** Door - rear right side

| Door - rear right side | 567 µm | | |
