Expertise

Protocol number: 46146189
Order No. / Reference: 26521554
Inspection date: 24 Jun 2026

Manufacturer: Peugeot

Model: 3008 BlueHDi 130 Stop & Start Active Business-Paket

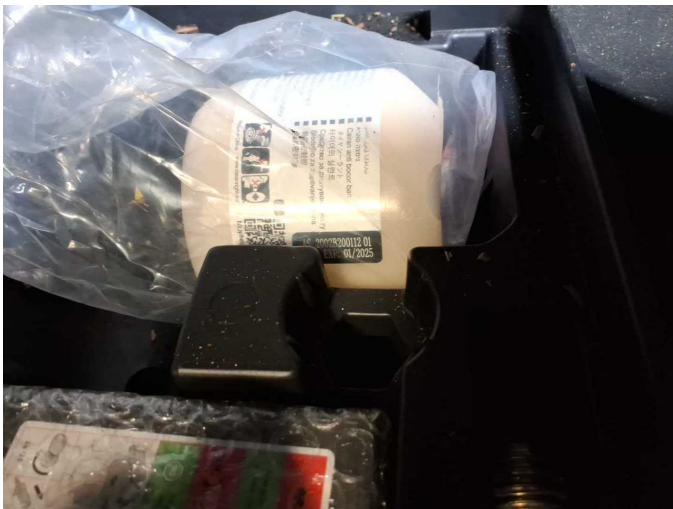
Damage 1: Equipment: Tirefit filler - Expired - Replace

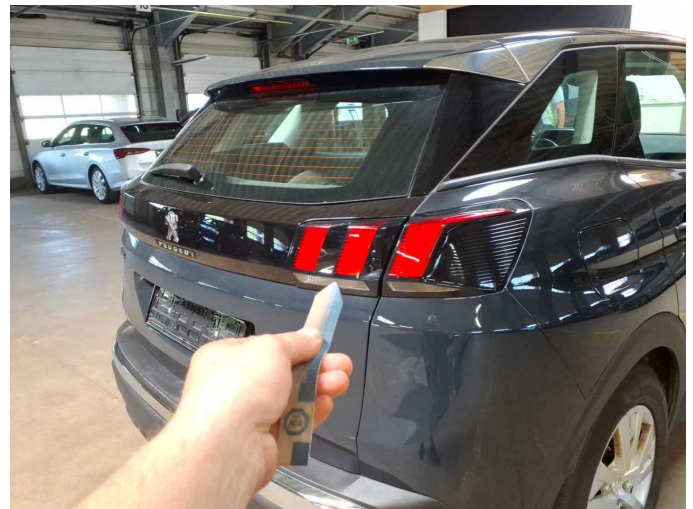
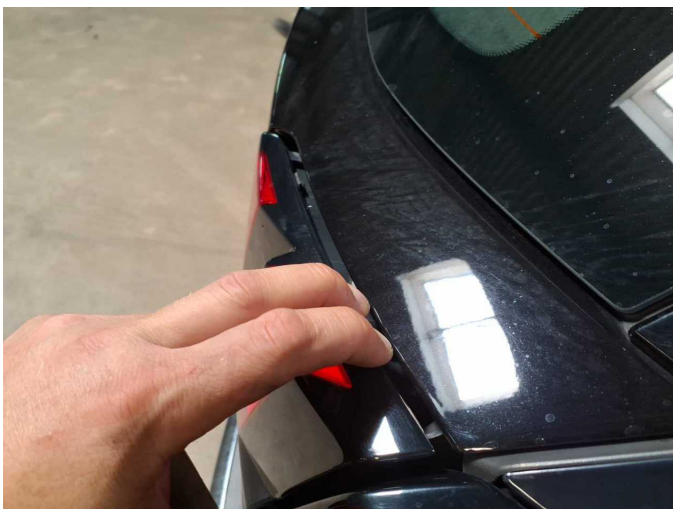
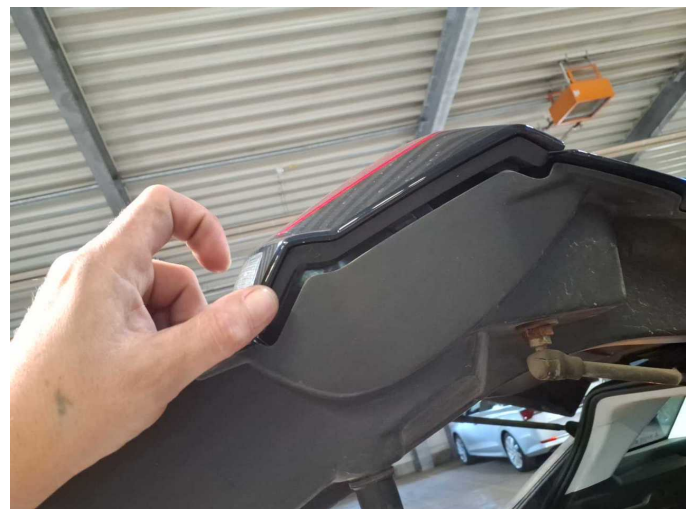
Damage 2: Tail light: Tail lamp - right side (Heckklappe, evtl. erneuern) - Loose - Un- / install

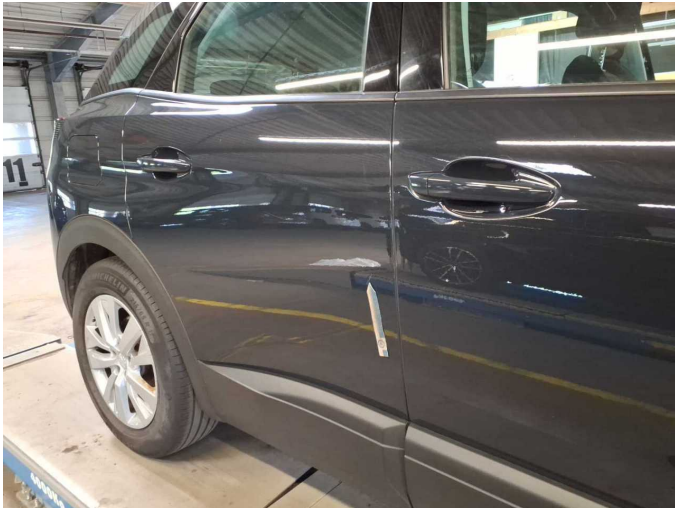
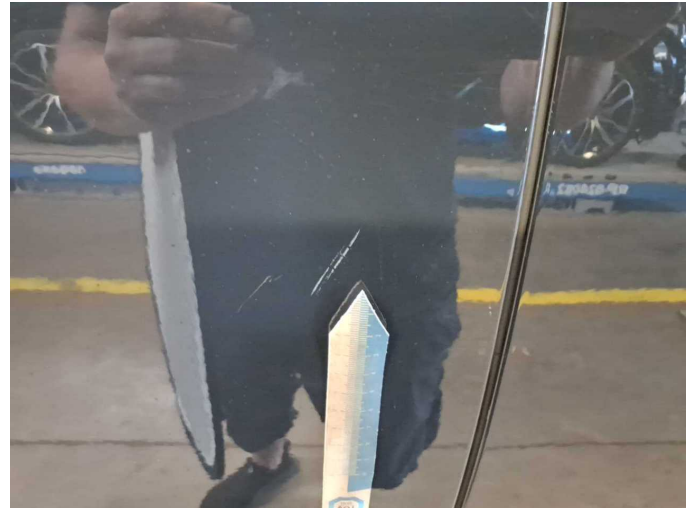
Damage 3: Door - rear right side: Door - Scratch(es) - Smart repair

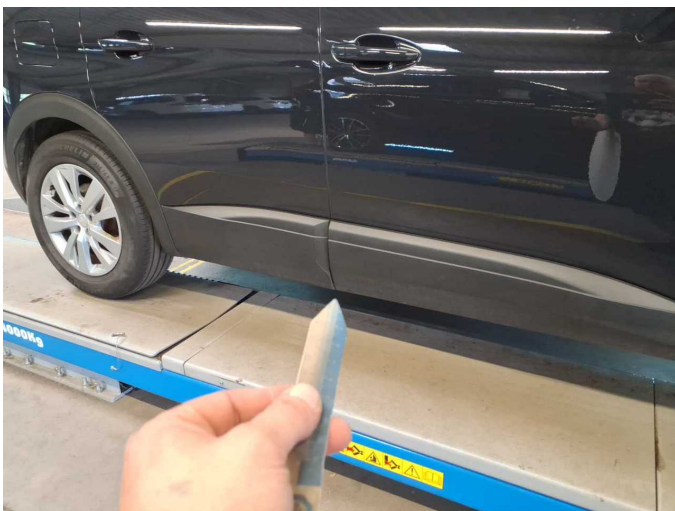
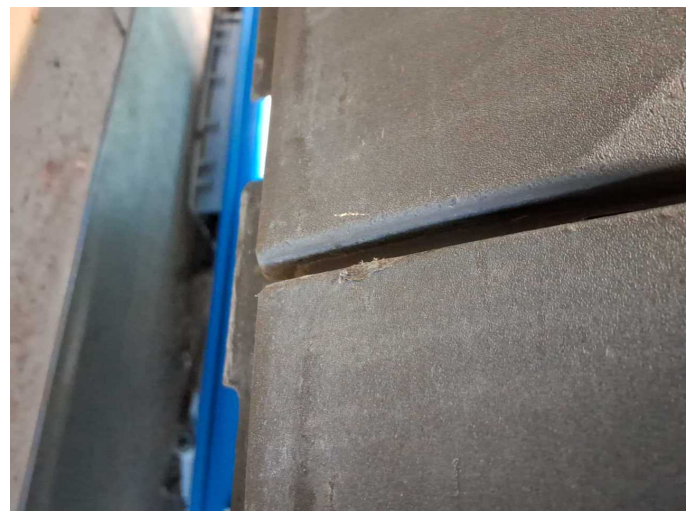
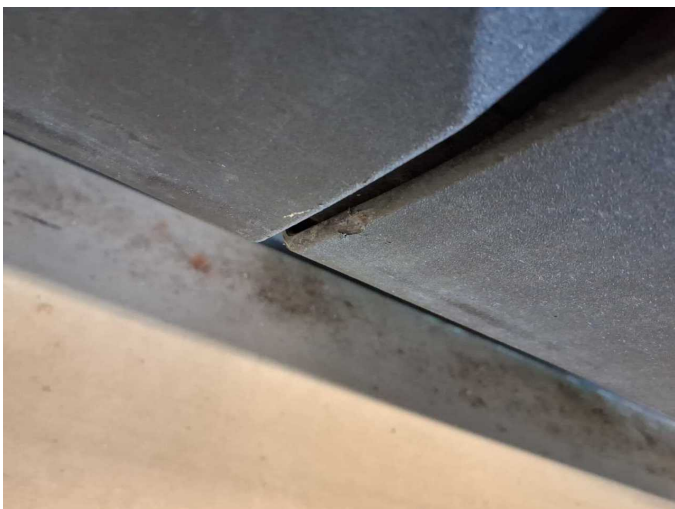
Damage 4: Door - front right side: Brightware - lower - Scratch(es) - Smart repair

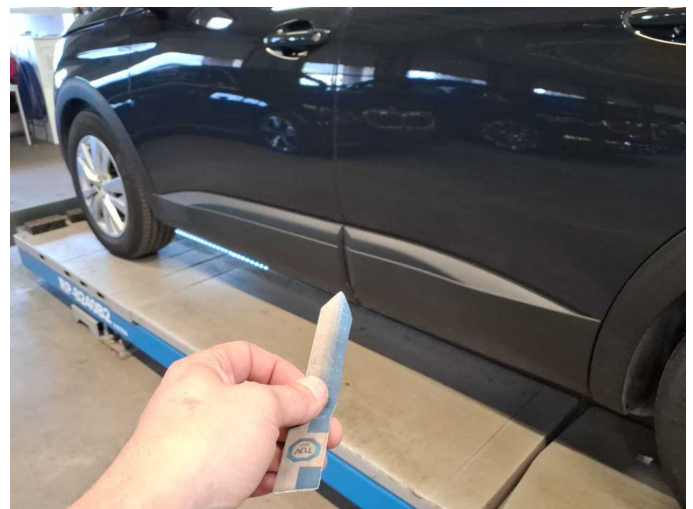
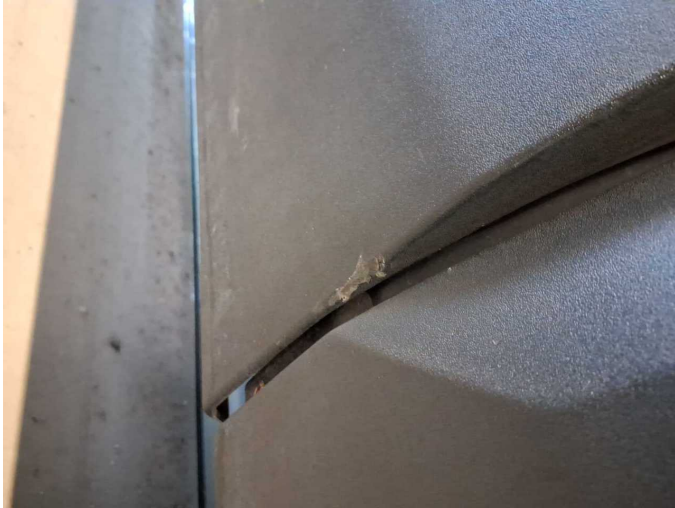
Damage 5: Door - front left side: Brightware - lower - Scratch(es) - Smart repair

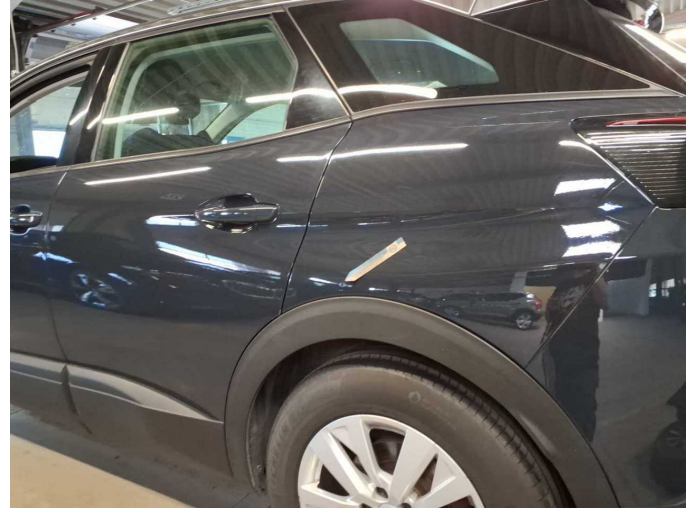
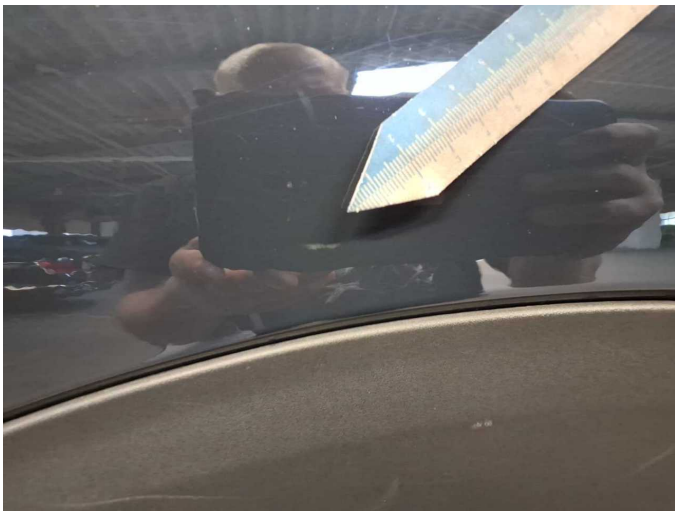
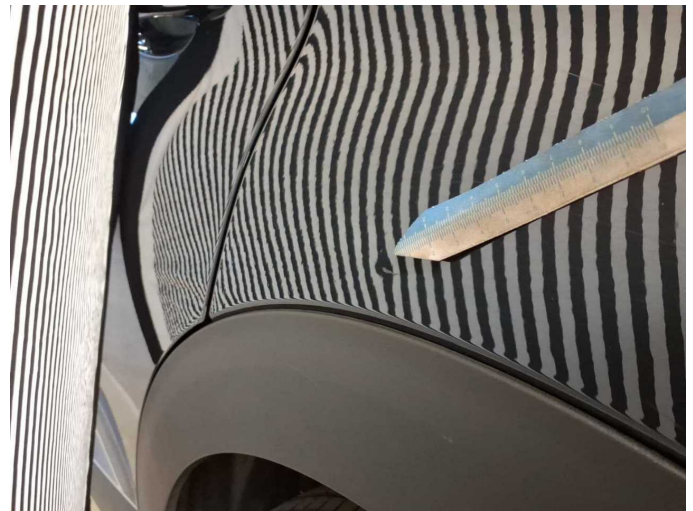
Damage 6: Side panel - rear left side: Side panel - Dent / paintcoat damage - Smart repair

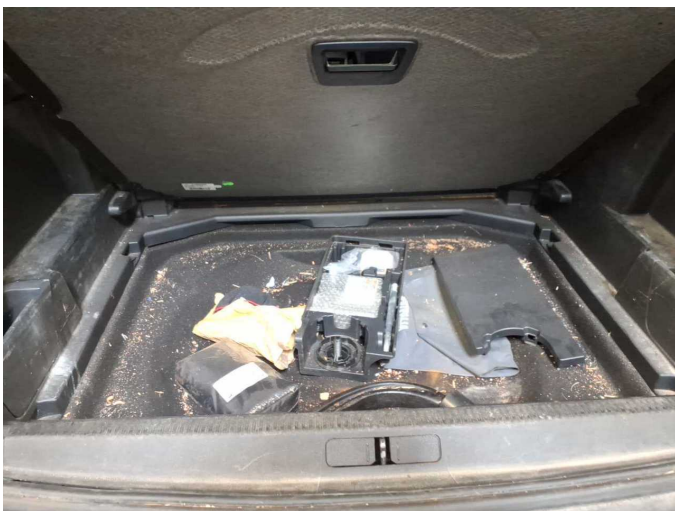
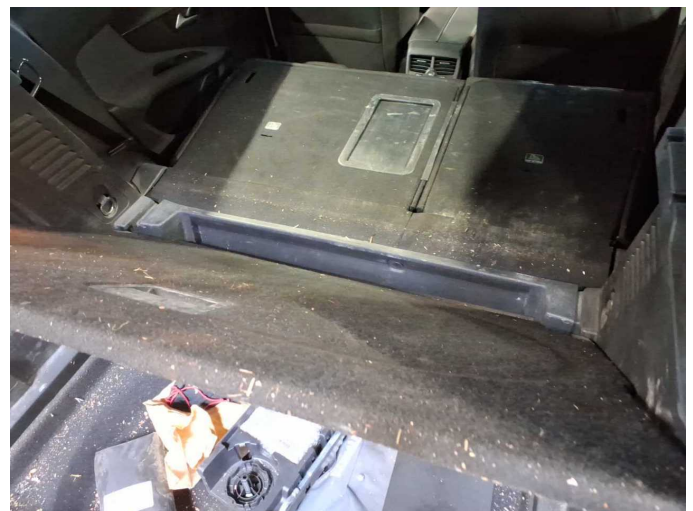
Damage 7: Interior: Interior - Soiled - Clean

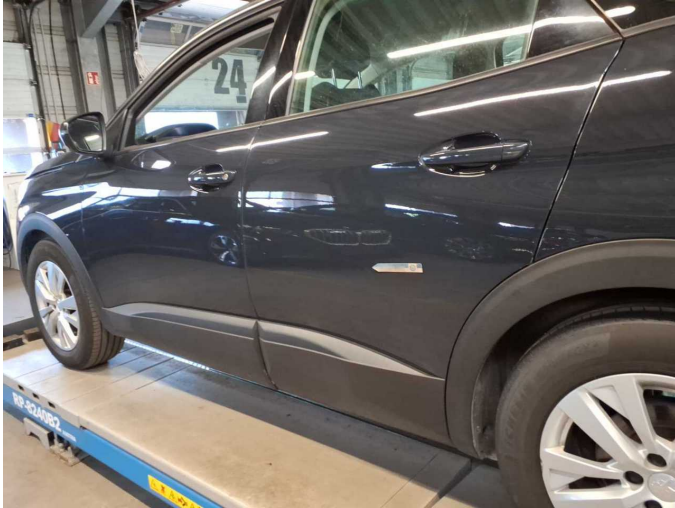
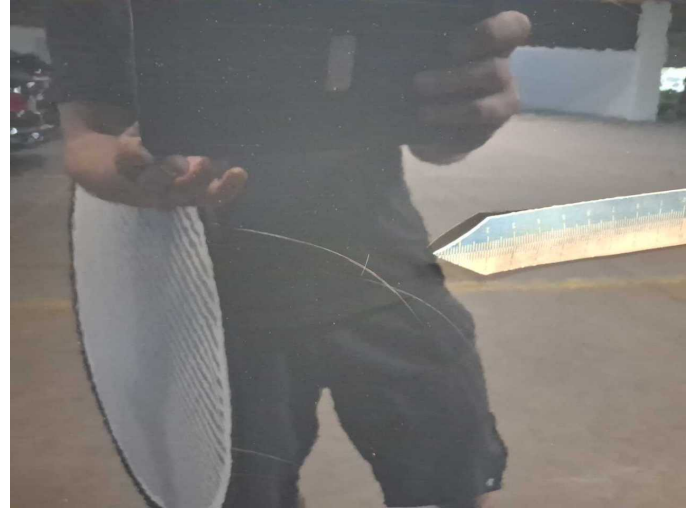
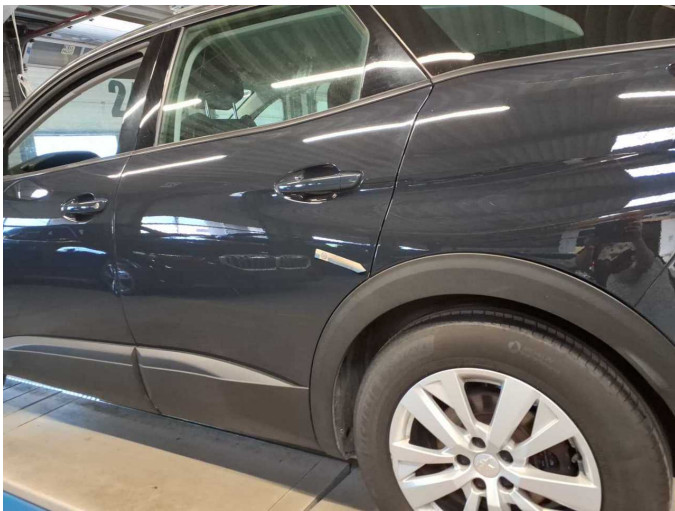
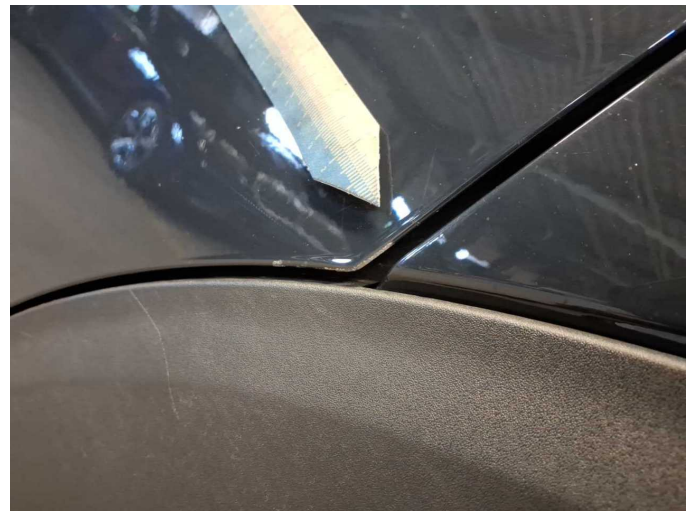
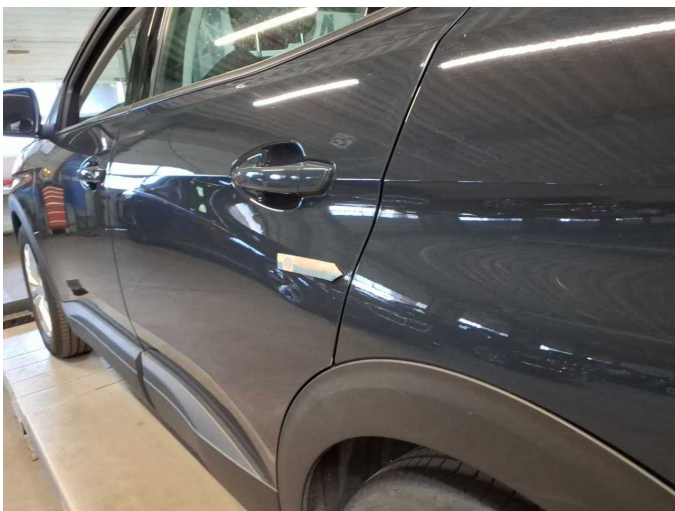
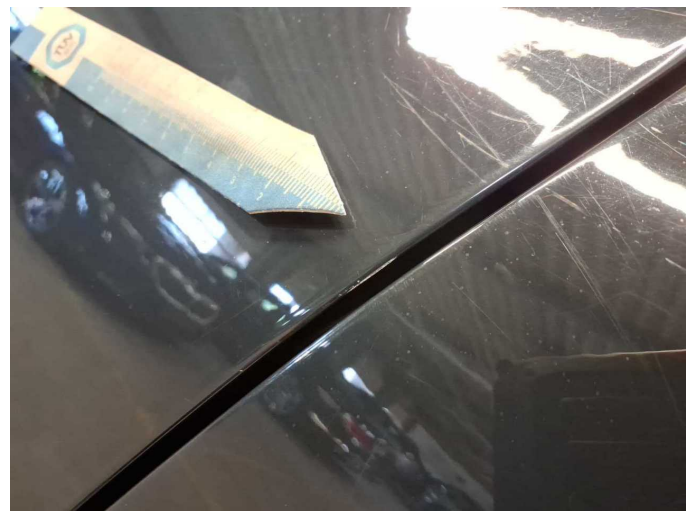
Damage 8: Door - rear left side: Door - Scratch(es) - Paint

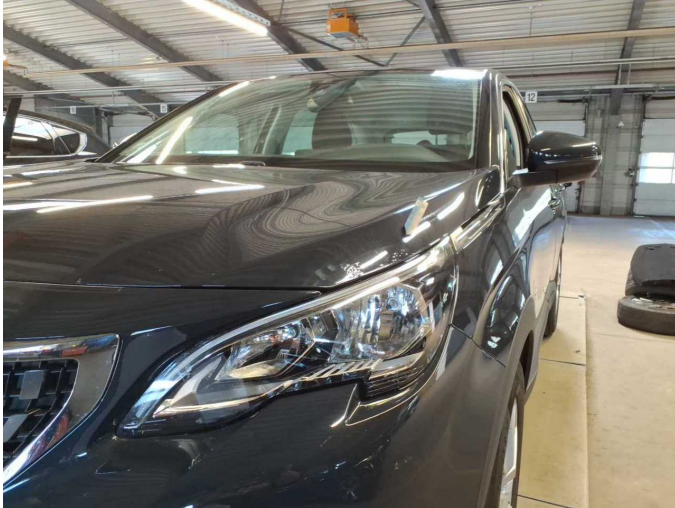
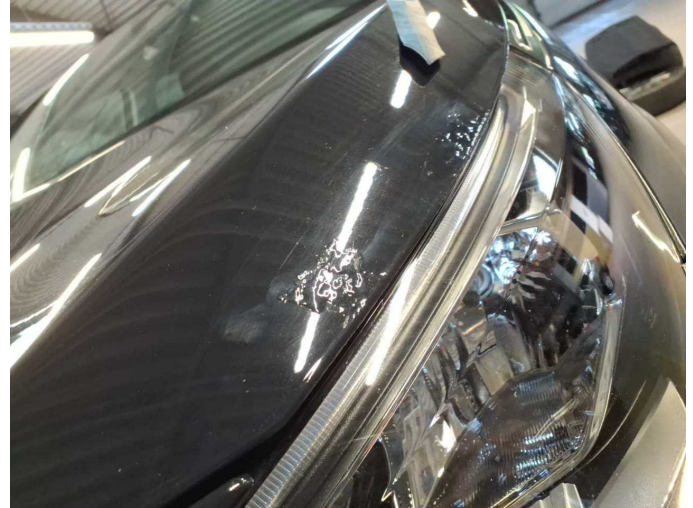
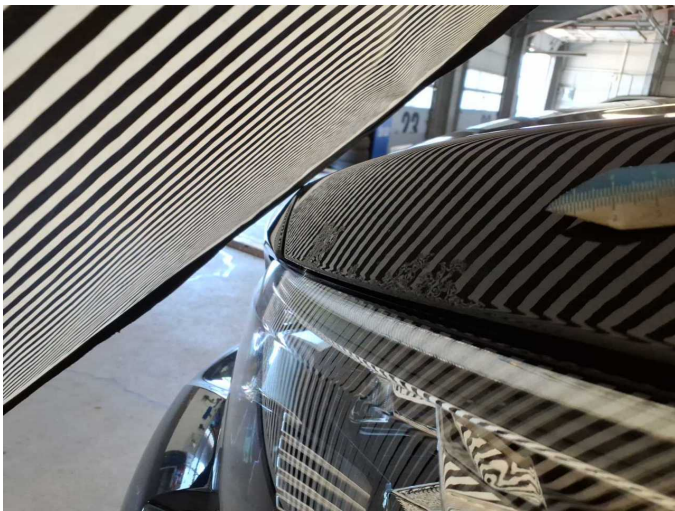
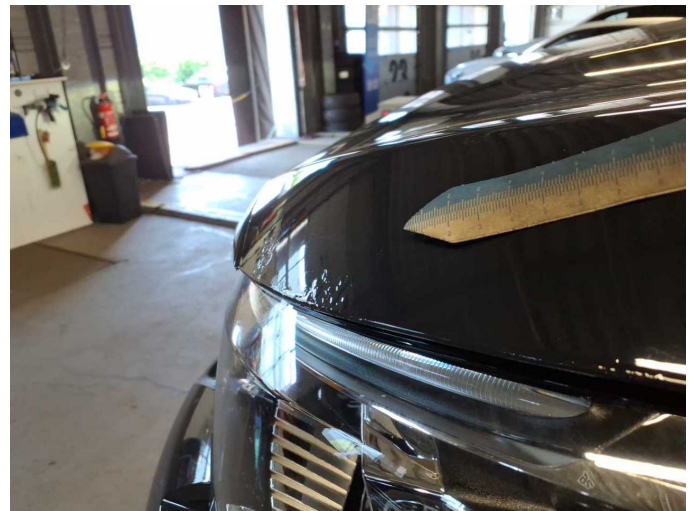
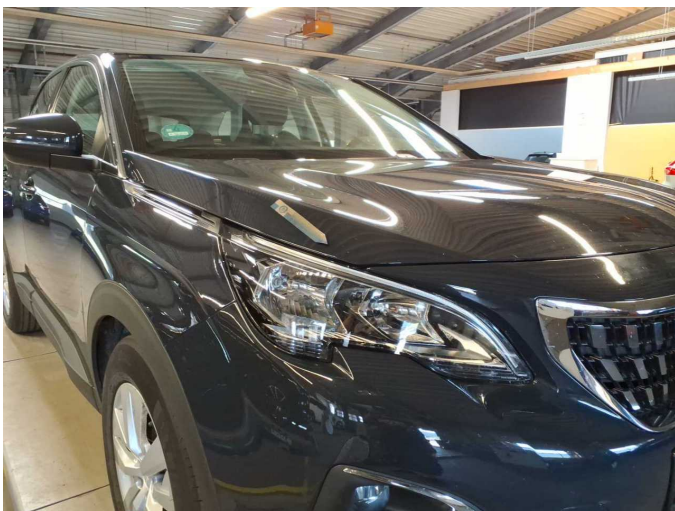
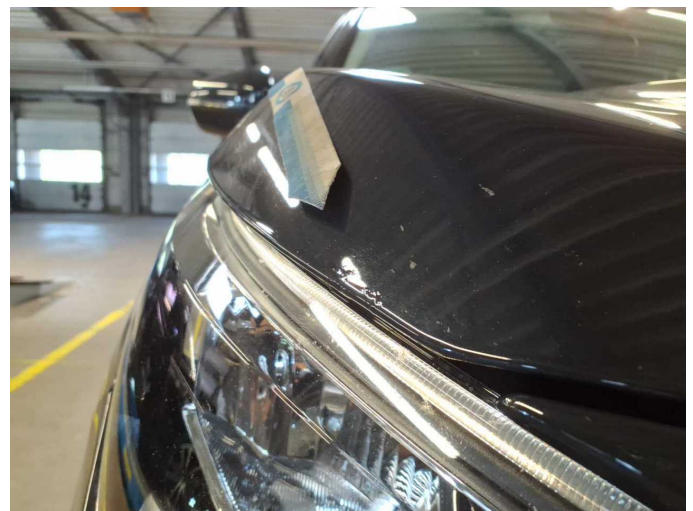
Damage 9: Bonnet: Bonnet - Corrosion - Repair and paint

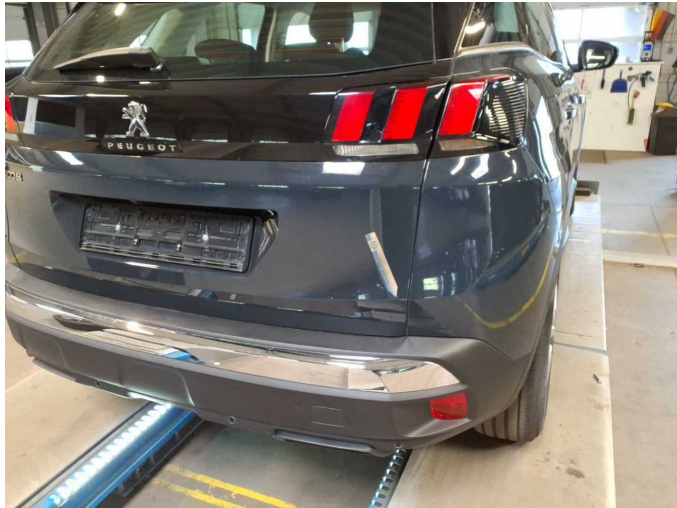
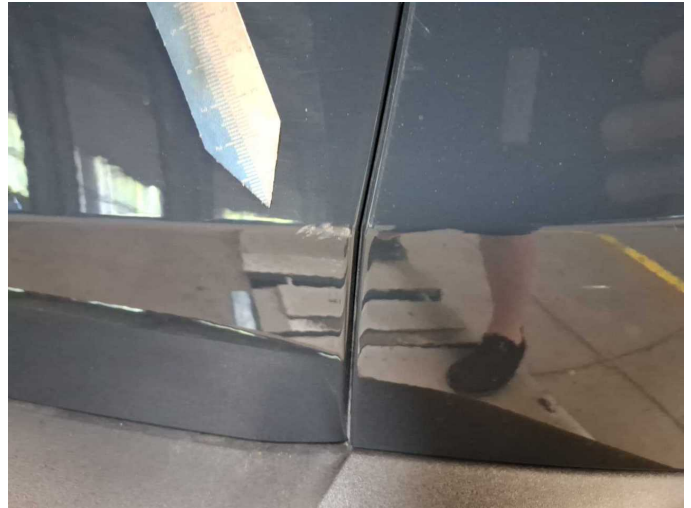
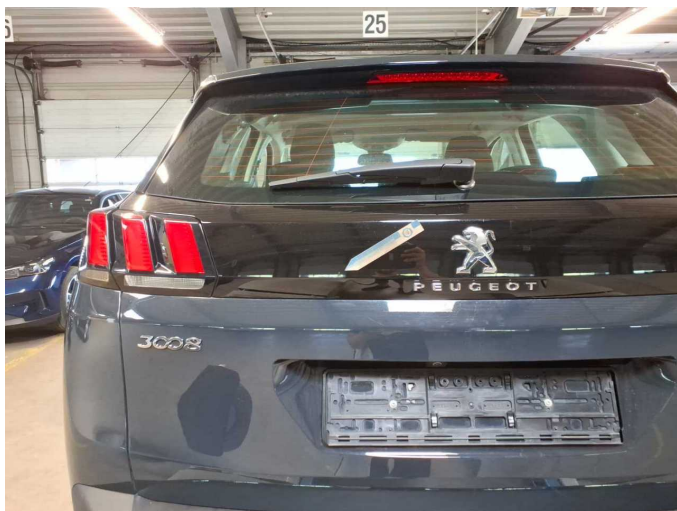
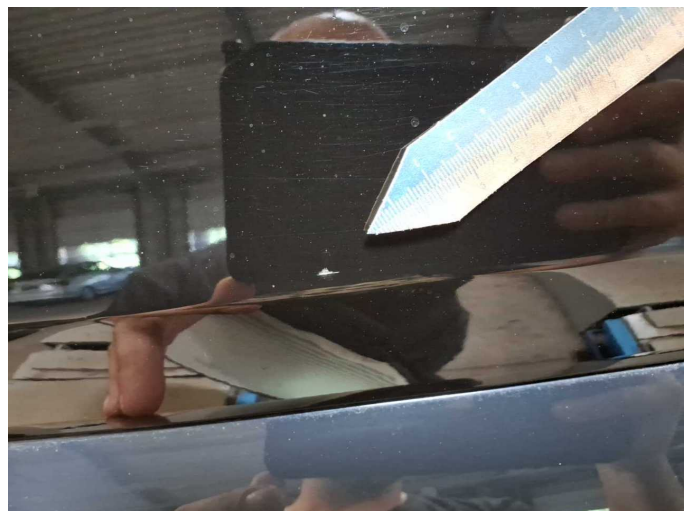
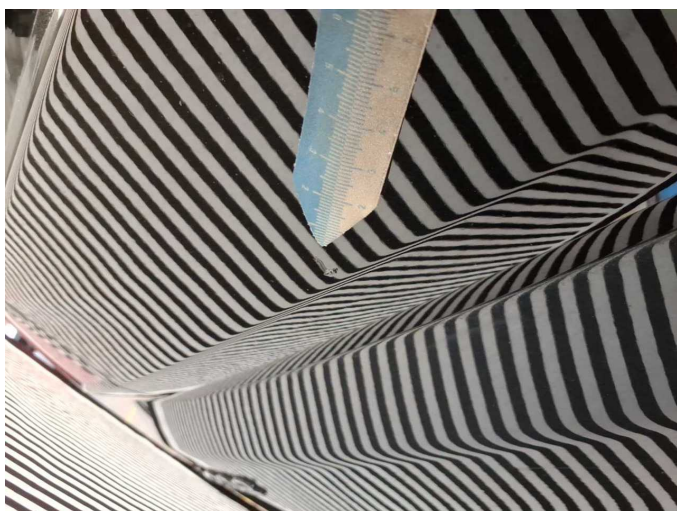
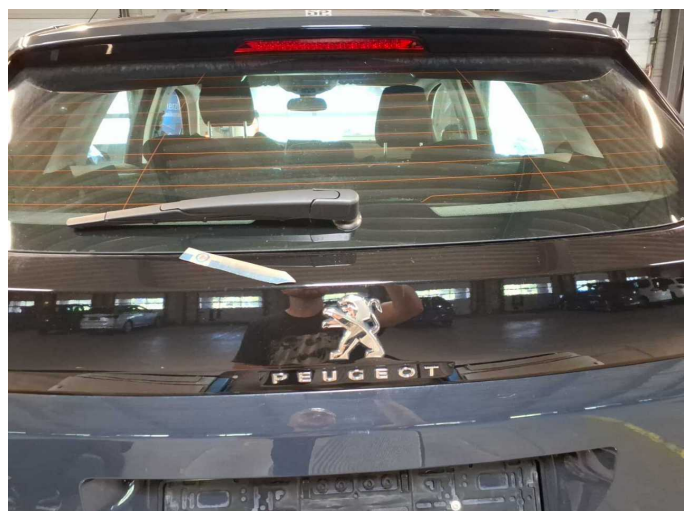
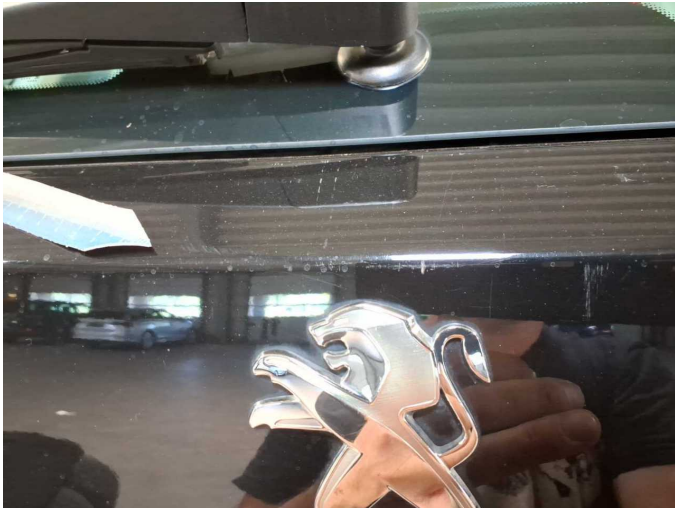
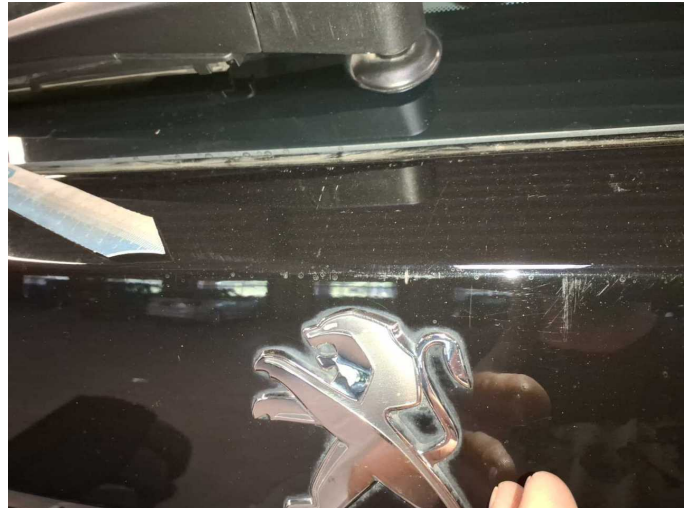
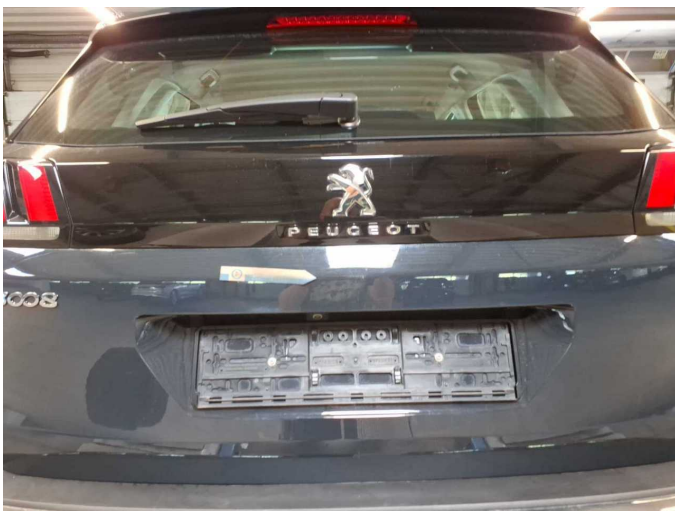
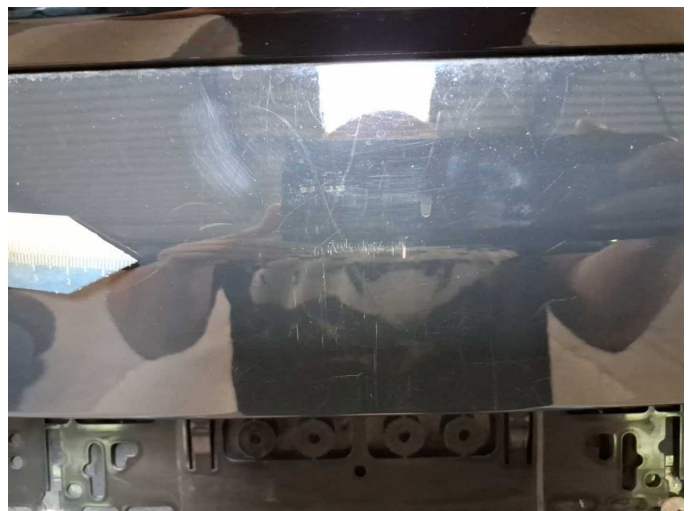
Damage 10: Boot lid / rear door: Boot lid - Scratched - Repair and paint
