Expertise

Protocol number: 46470156  
Order No. / Reference: 26196230  
Inspection date: 9 Jul 2026

Manufacturer: Mercedes-Benz

Model: Vito 116 CDI Lang HA Aut. PRO

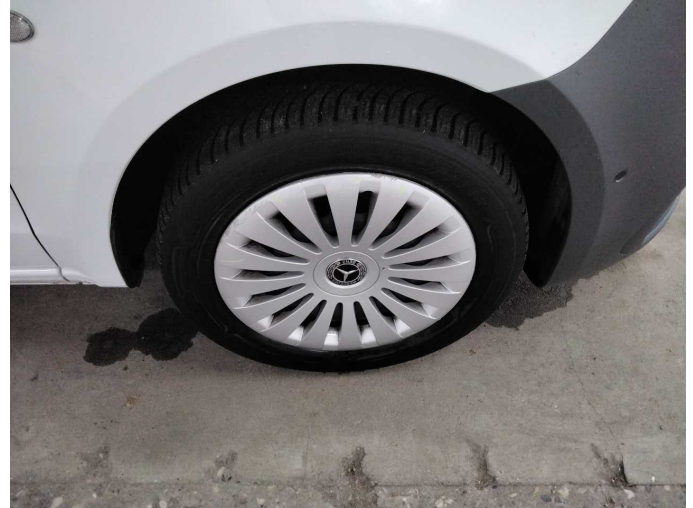
| No. | Component group | Description |
|---|---|---|
| 1 | Wheel / tyres | Wheel cover - front right side - Scratch(es) - Replace |

**Damage 1:** Wheel / tyres: Wheel cover - front right side - Scratch(es) - Replace

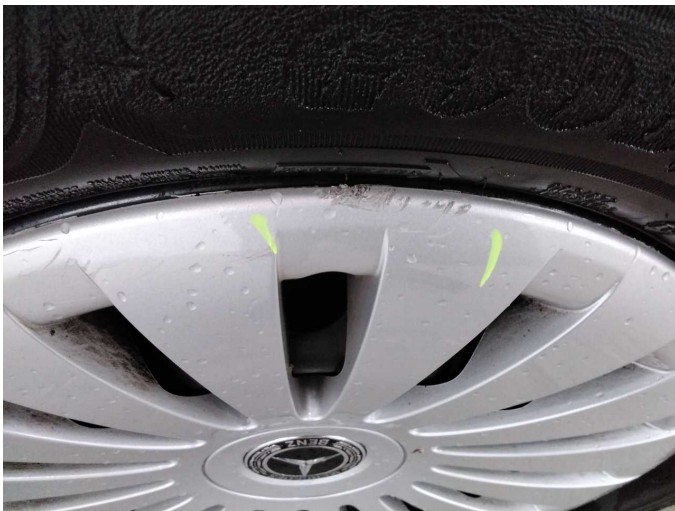
**Damage 1:** Wheel / tyres: Wheel cover - front right side - Scratch(es) - Replace

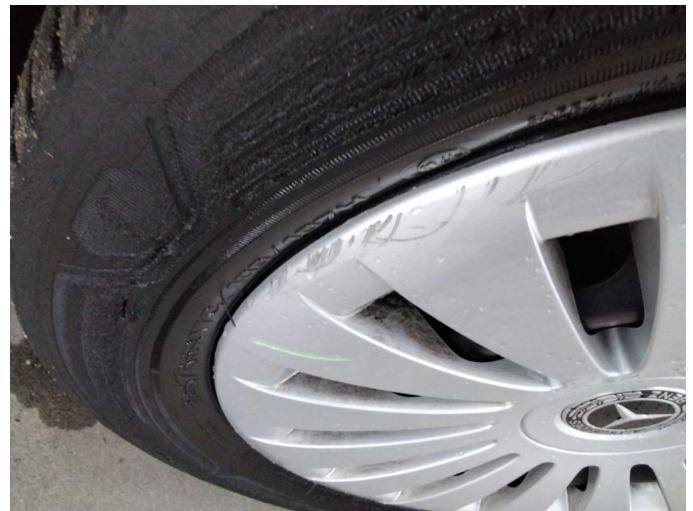
**Damage 1:** Wheel / tyres: Wheel cover - front right side - Scratch(es) - Replace

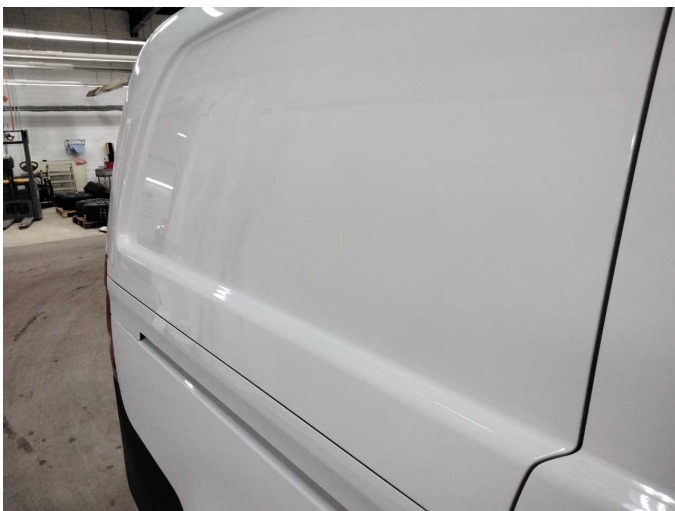
| No. | Component group | Description |
|---|---|---|
| 2 | Side panel - rear right side | Side panel - dent(s) - Smooth repair work |

**Damage 2:** Side panel - rear right side: Side panel - dent(s) - Smooth repair work

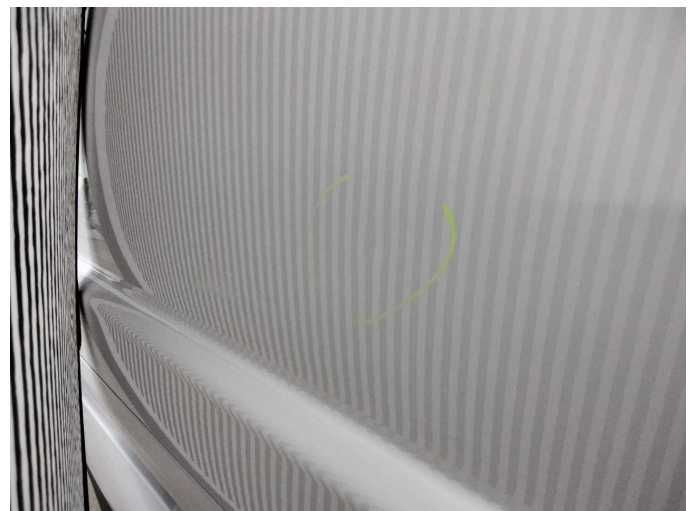
**Damage 2:** Side panel - rear right side: Side panel - dent(s) - Smooth repair work

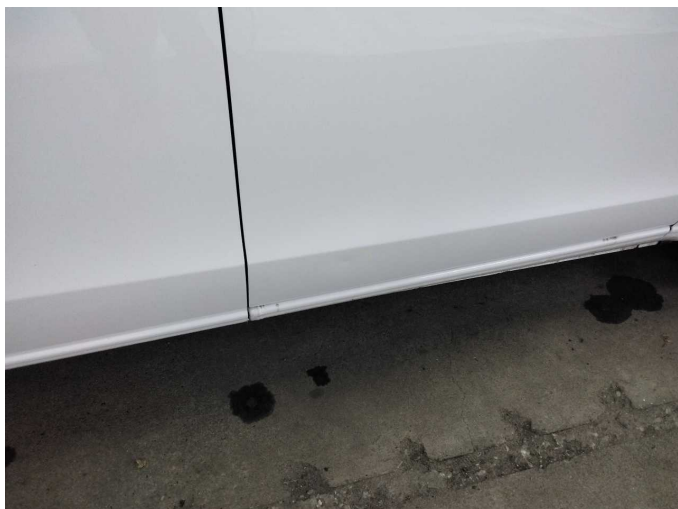
| No. | Component group | Description |
|---|---|---|
| 3 | Door - front right side | Door - Dent / paintcoat damage - Smart repair |

**Damage 3:** Door - front right side: Door - Dent / paintcoat damage - Smart repair

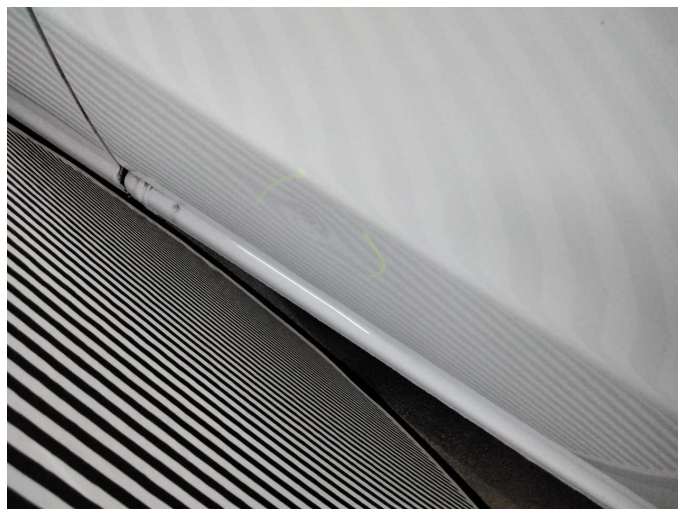
**Damage 3:** Door - front right side: Door - Dent / paintcoat damage - Smart repair

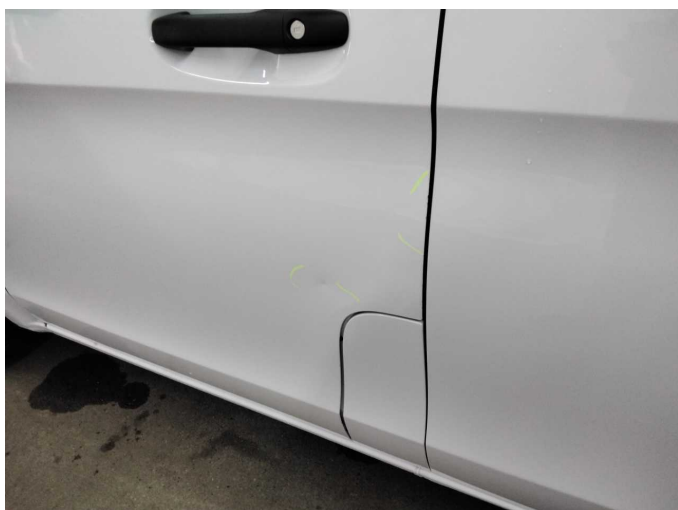
| No. | Component group | Description |
|---|---|---|
| 4 | Door - front left side | Door - Dent / paintcoat damage - Repair and paint |

**Damage 4:** Door - front left side: Door - Dent / paintcoat damage - Repair and paint

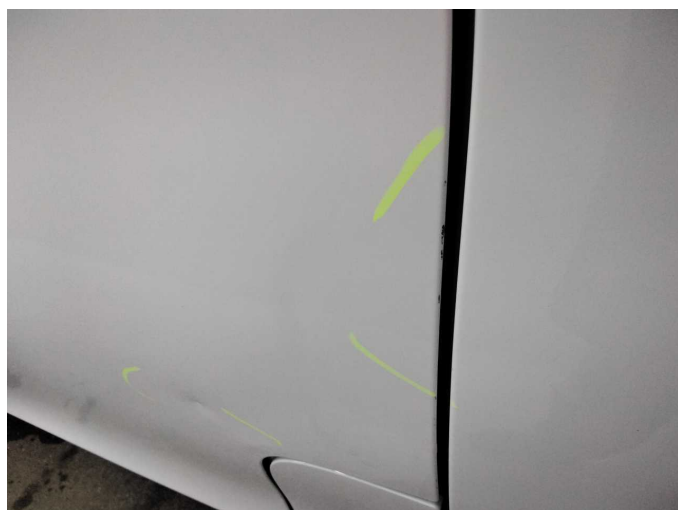
**Damage 4:** Door - front left side: Door - Dent / paintcoat damage - Repair and paint

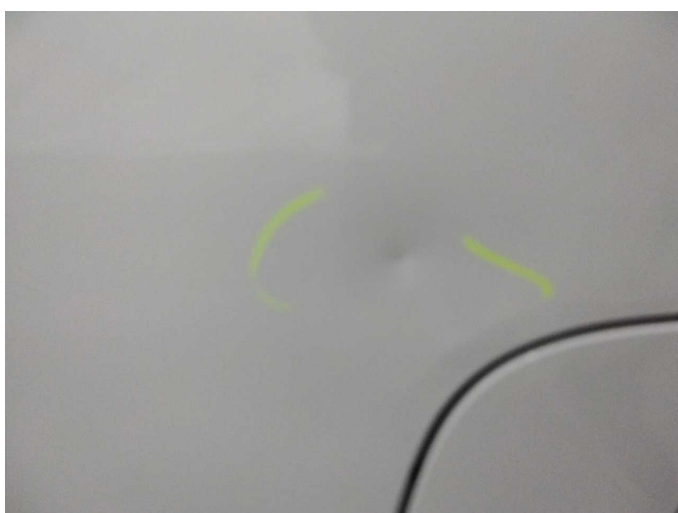
**Damage 4:** Door - front left side: Door - Dent / paintcoat damage - Repair and paint

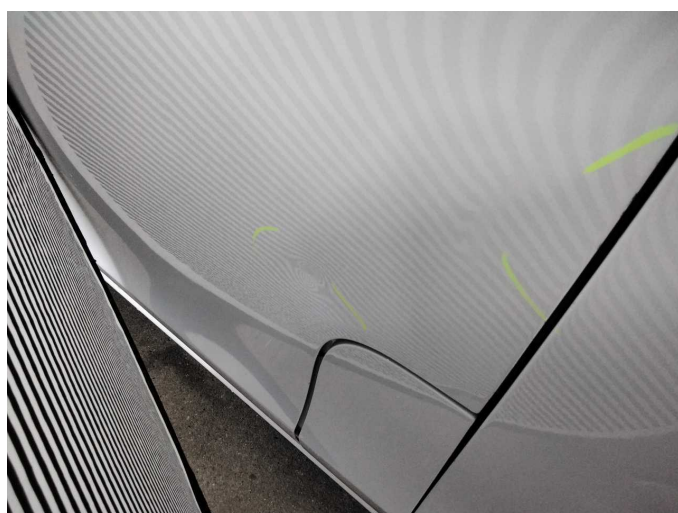
**Damage 4:** Door - front left side: Door - Dent / paintcoat damage - Repair and paint

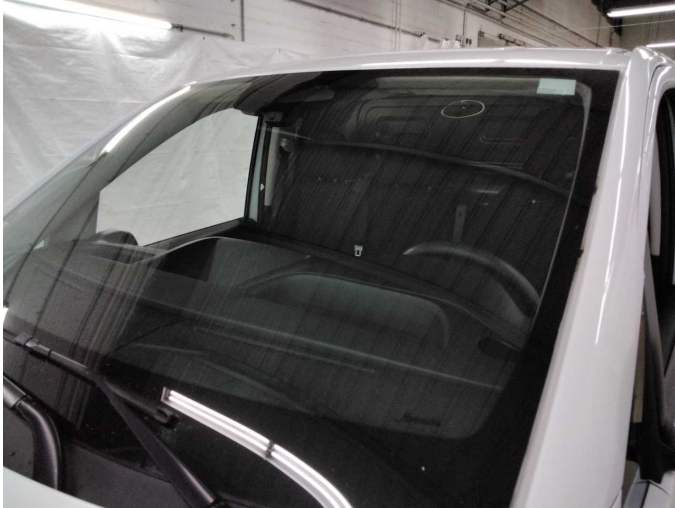
| No. | Component group | Description |
|---|---|---|
| 5 | Vehicle glazing | Windscreen - Stone chips - repair according to calculation |

**Damage 5:** Vehicle glazing: Windscreen - Stone chips - repair according to calculation

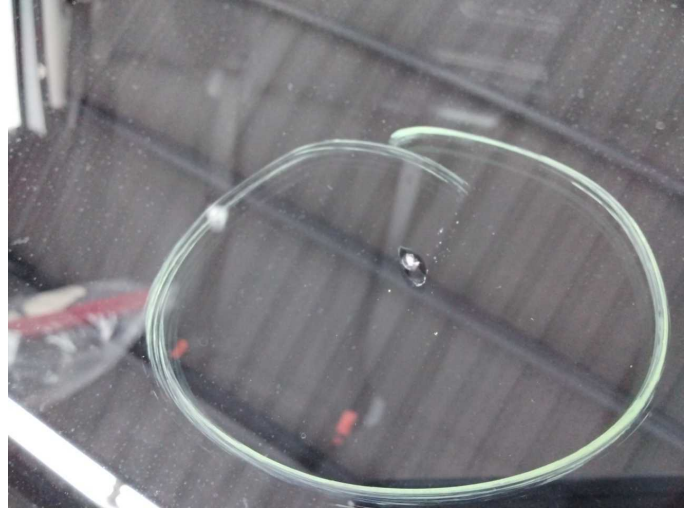
**Damage 5:** Vehicle glazing: Windscreen - Stone chips - repair according to calculation

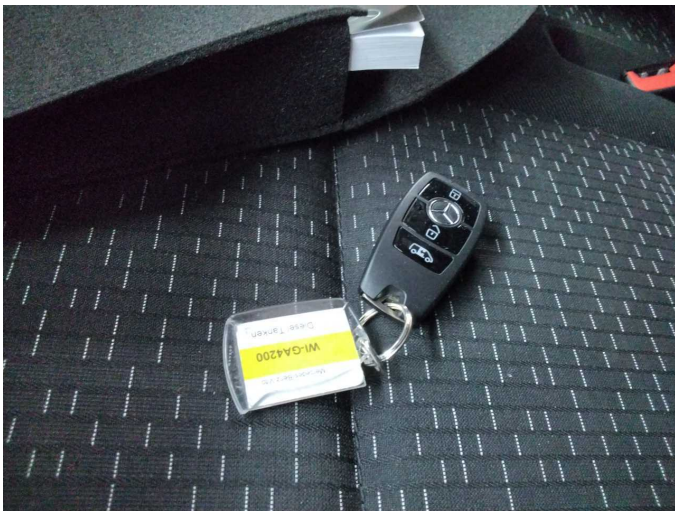
Equipment - Vehicle key

**Missing part 1:** Equipment: Vehicle key - Missing - Replace
