Expertise

Protocol number: 46267854
Order No. / Reference: 26503843
Inspection date: 1 Jul 2026

Manufacturer: Volkswagen

Model: Golf Variant 2.0 TDI SCR DSG Style

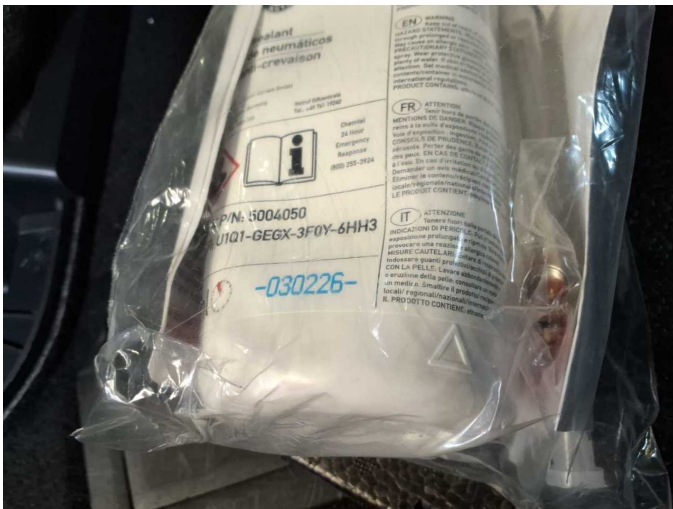
Damage 1: Equipment: Tirefit filler - Expired - Replace

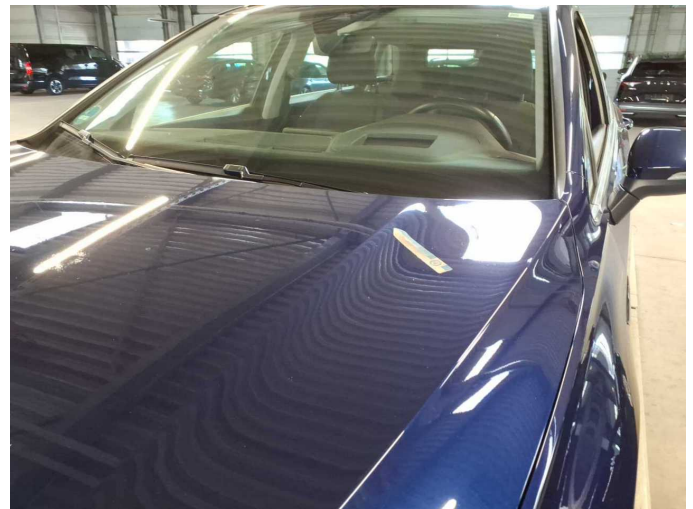
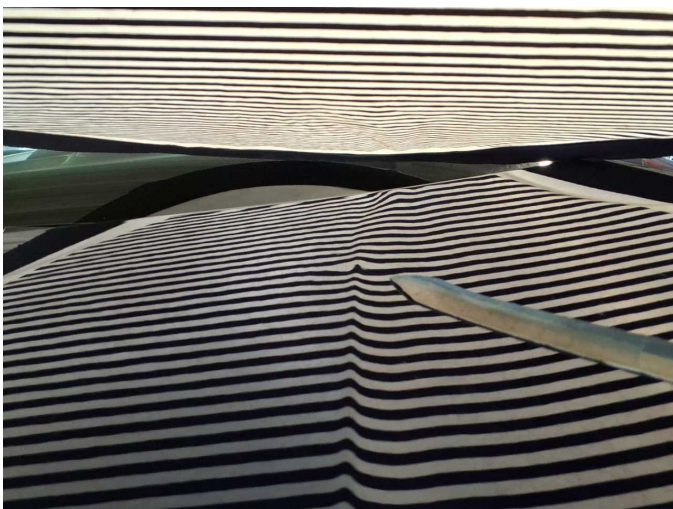
Damage 2: Bonnet: Bonnet - dent(s) - Smooth repair work

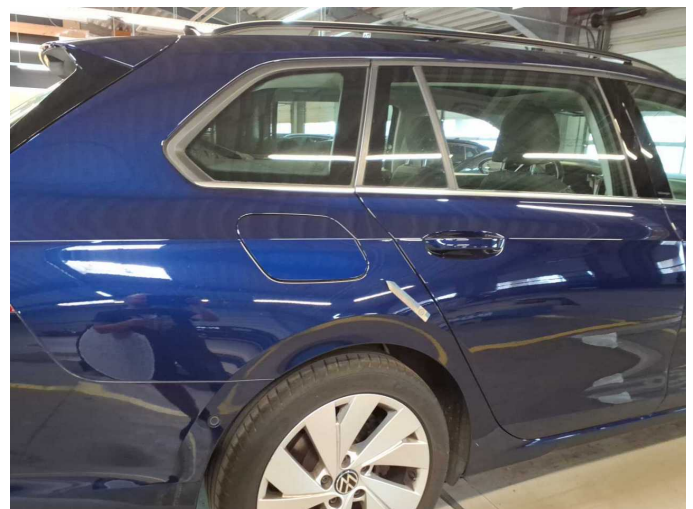
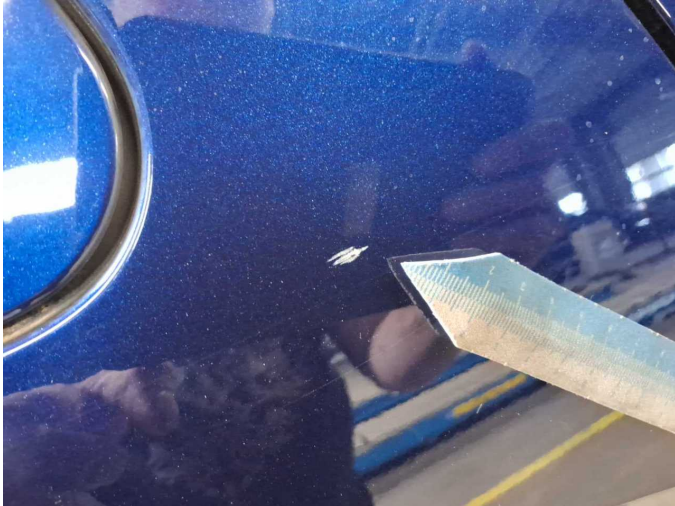
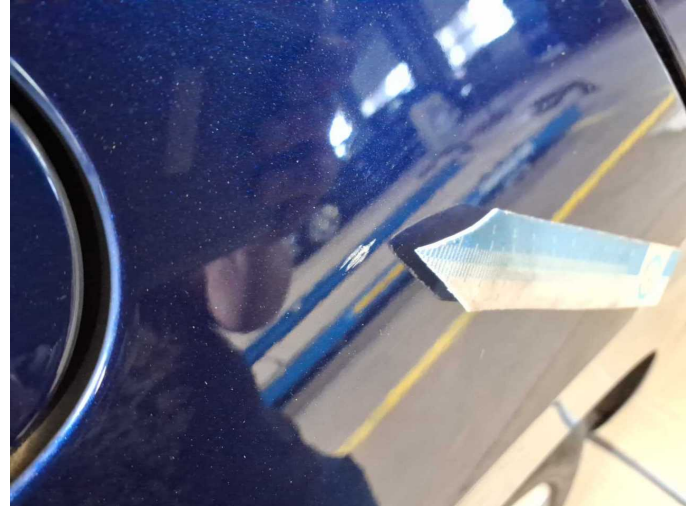
Damage 3: Side panel - rear right side: Side panel - Scratch(es) - Smart repair

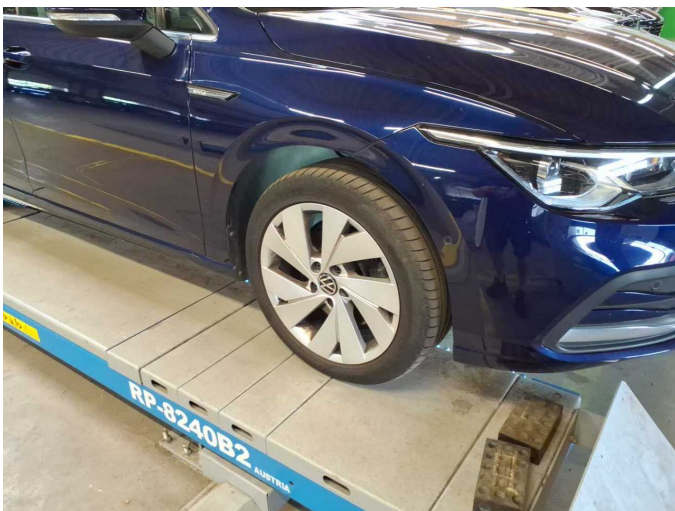
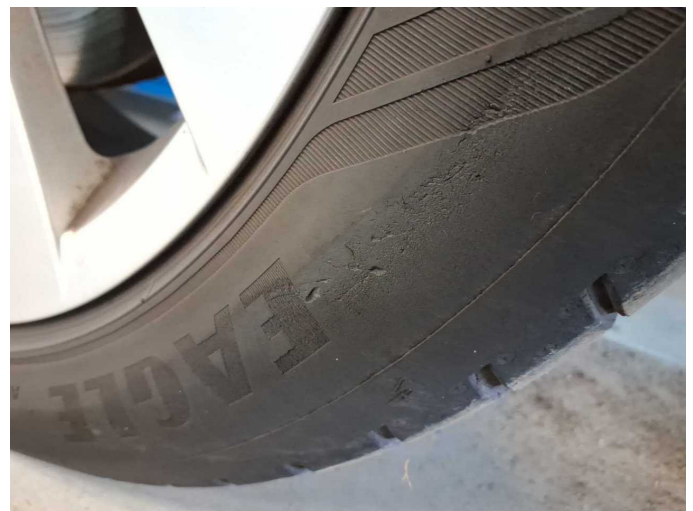
Damage 4: Wheel / tyres: Tyre - front right side (Flanke) - Damaged - Replace

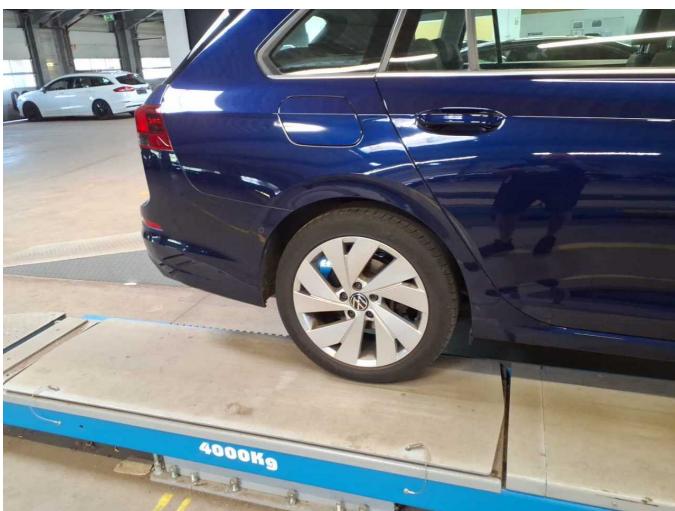
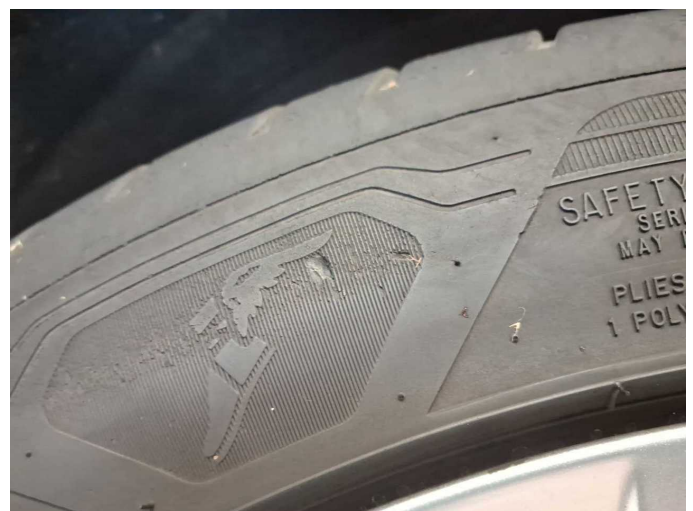
Damage 5: Wheel / tyres: Tyre - rear right side (Flanke) - Damaged - Replace

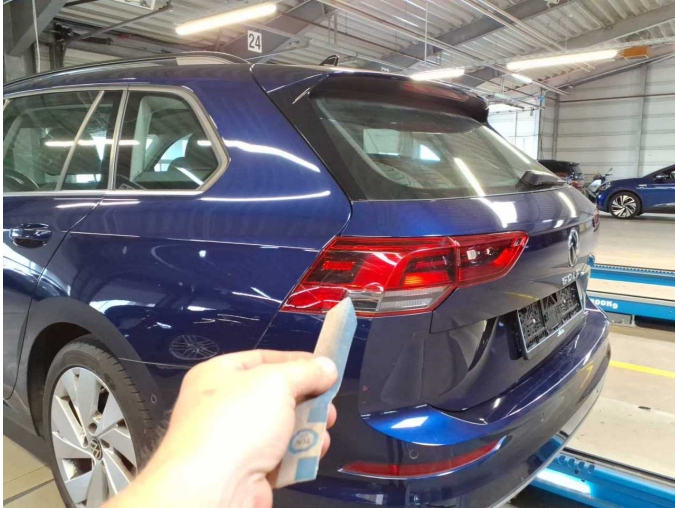
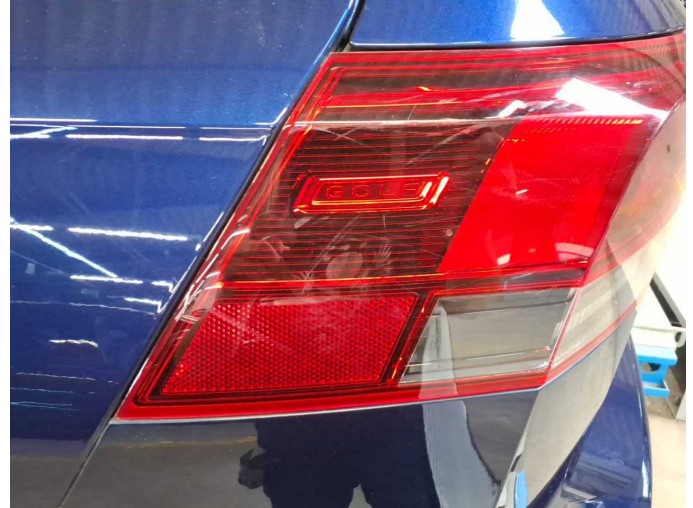
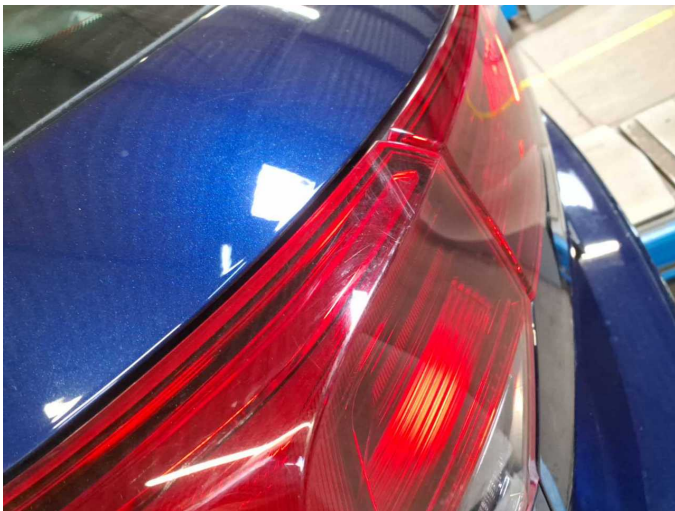
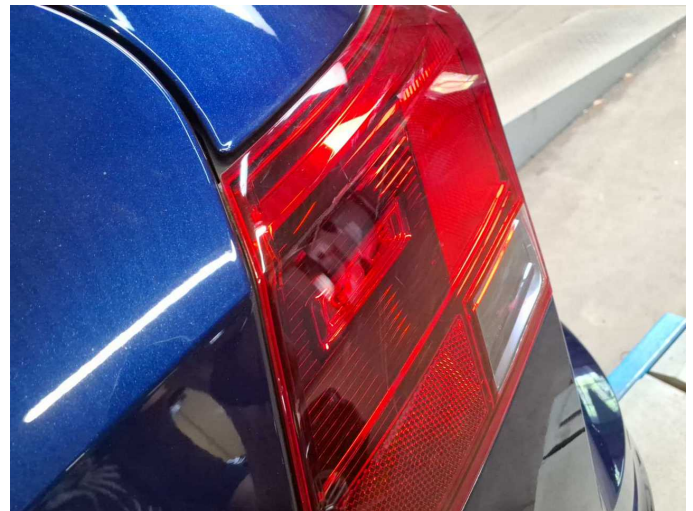
Damage 6: Tail light: Tail lamp - left side - Scratched - Replace

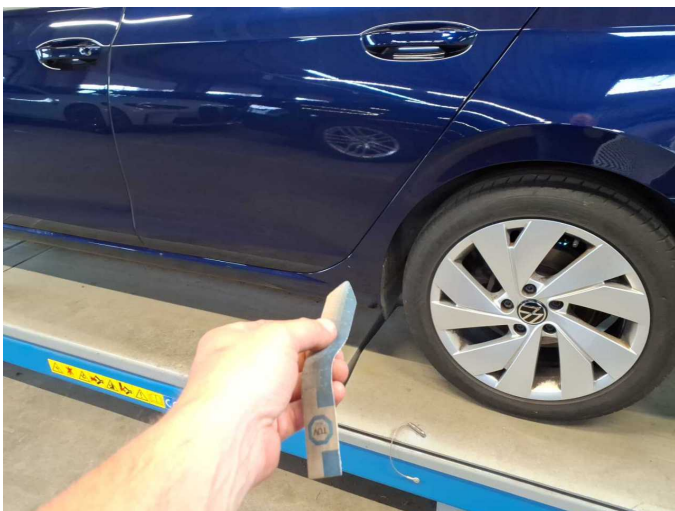
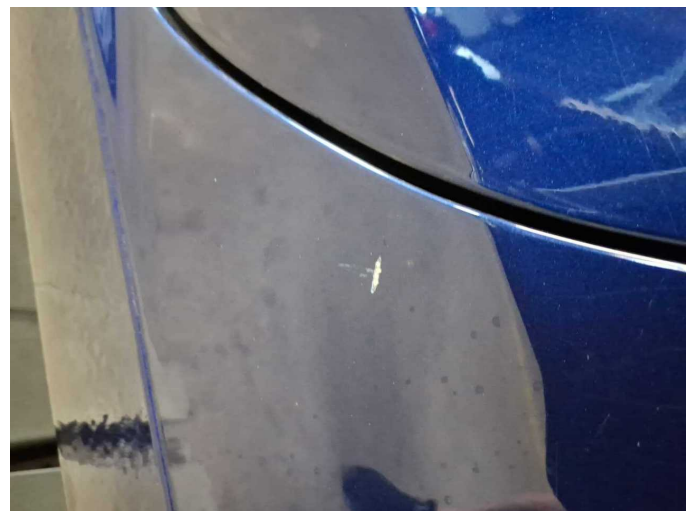
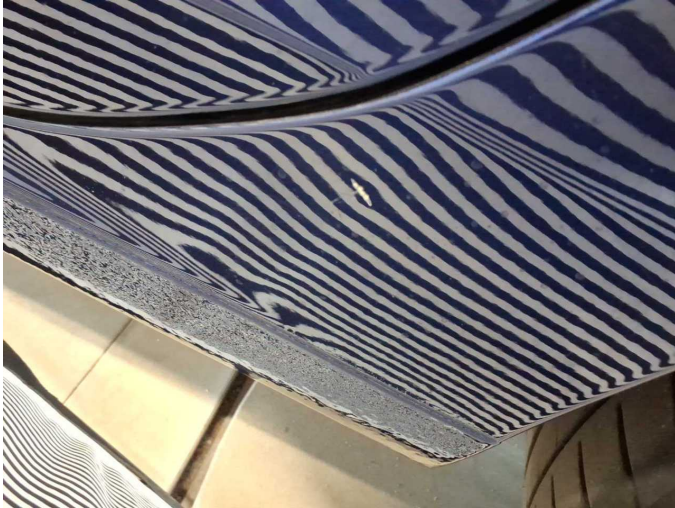
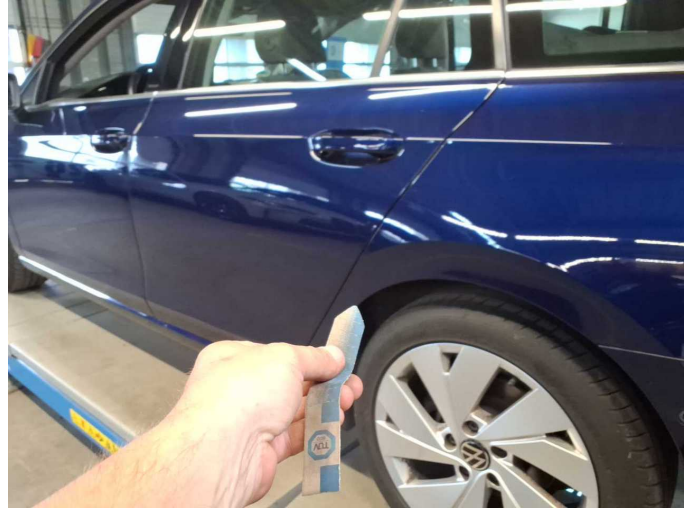
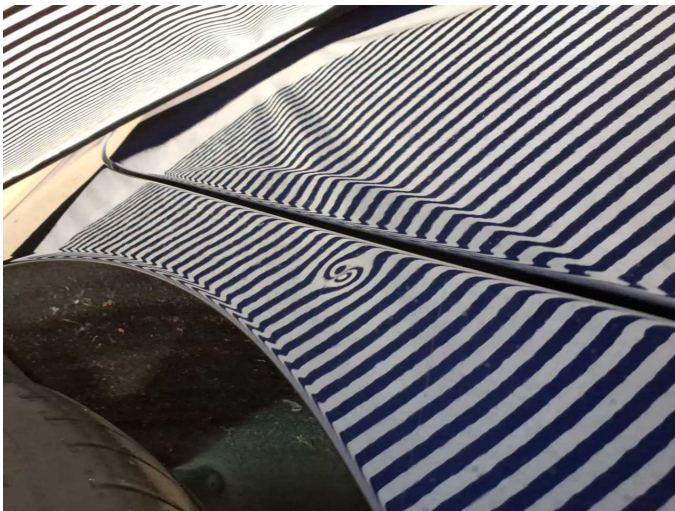
Damage 7: Side panel - rear left side: Side panel - Dent / paintcoat damage - Repair and paint

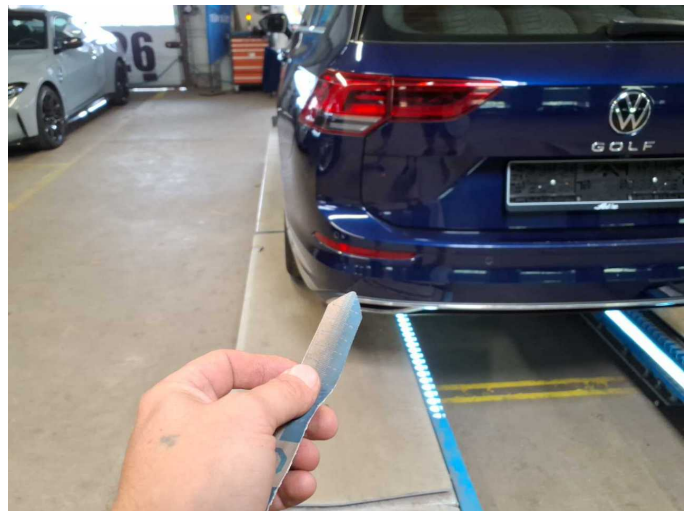
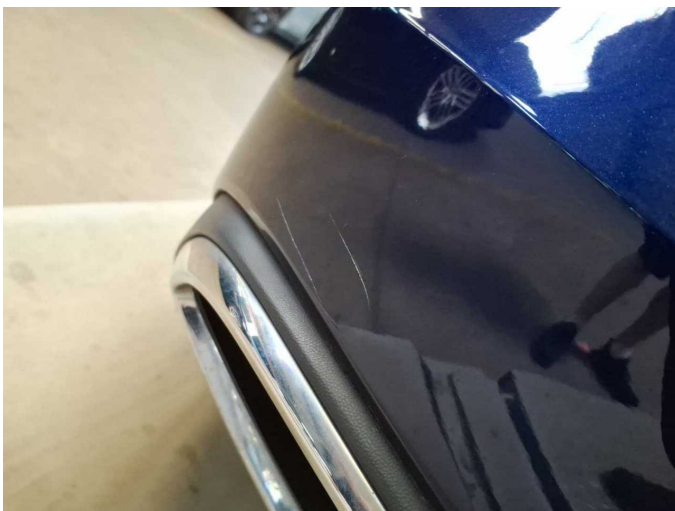
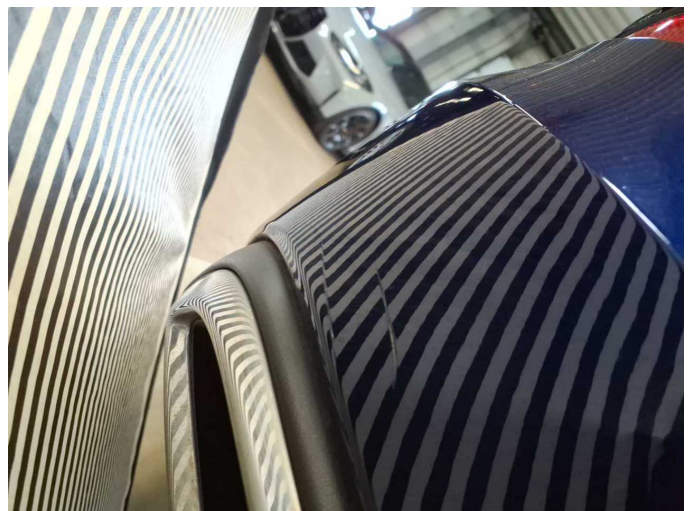
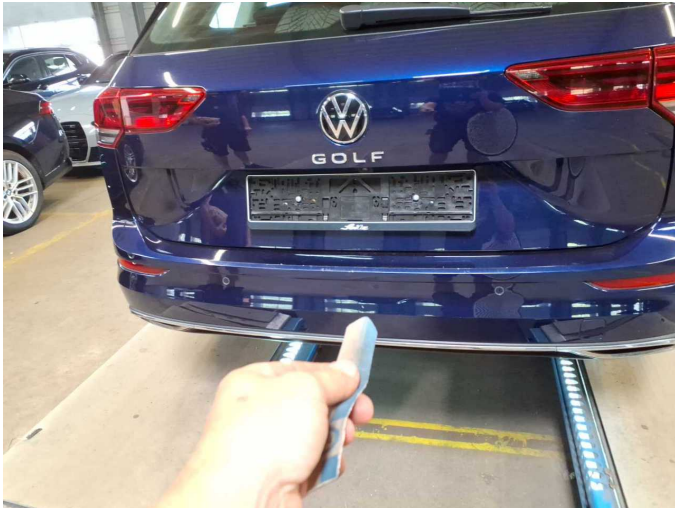
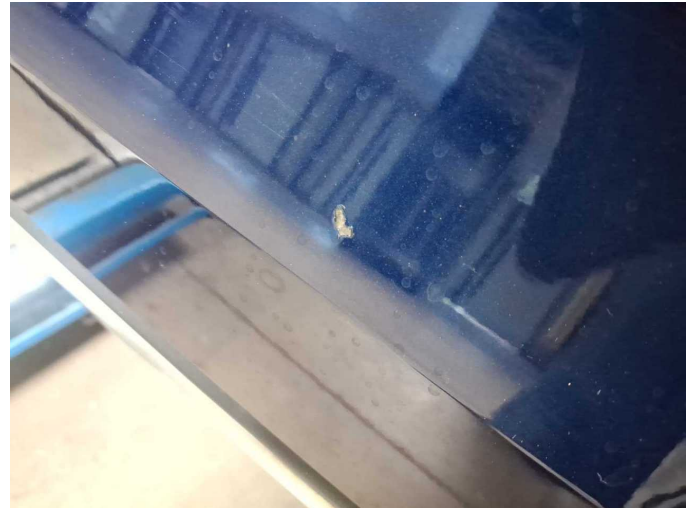
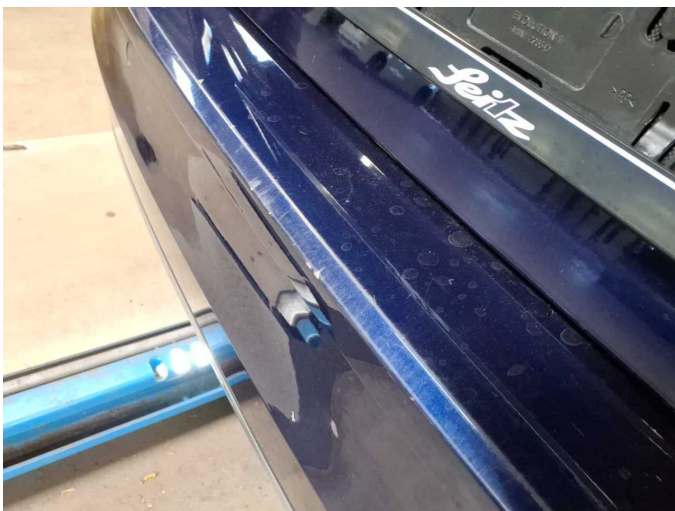
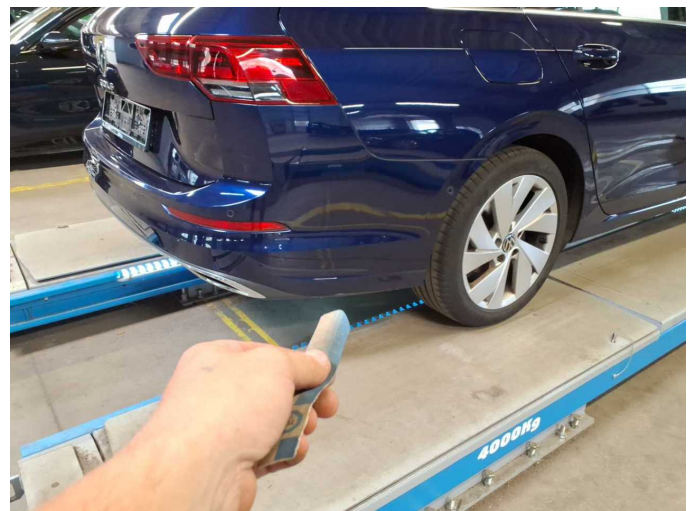
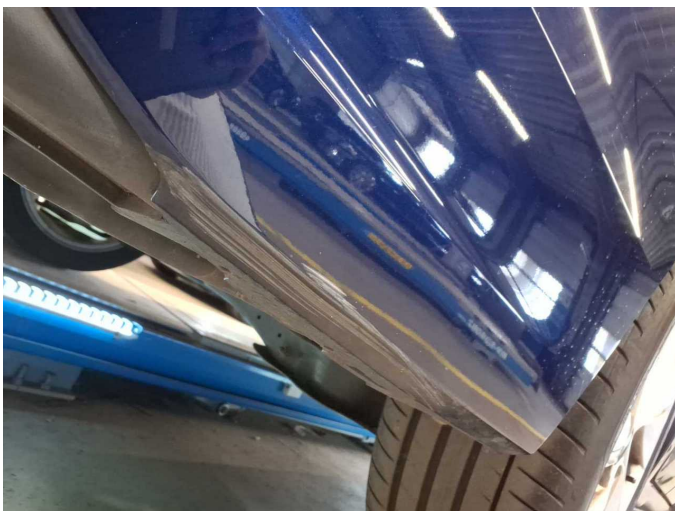
Damage 8: Rear bumper: Rear bumper - Scratched - Repair and paint

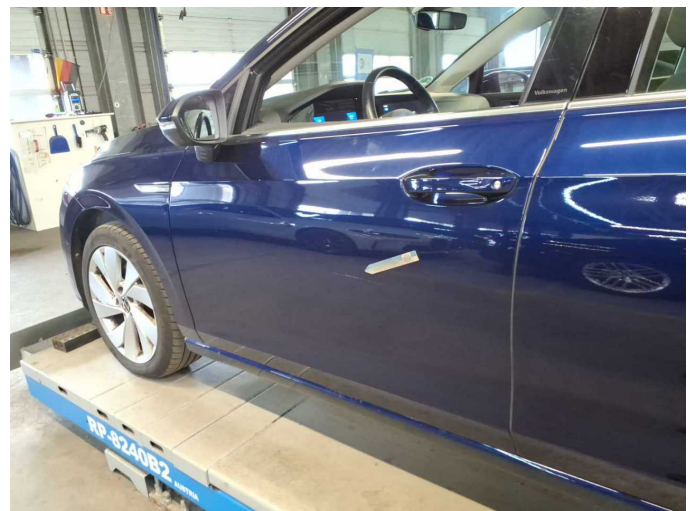
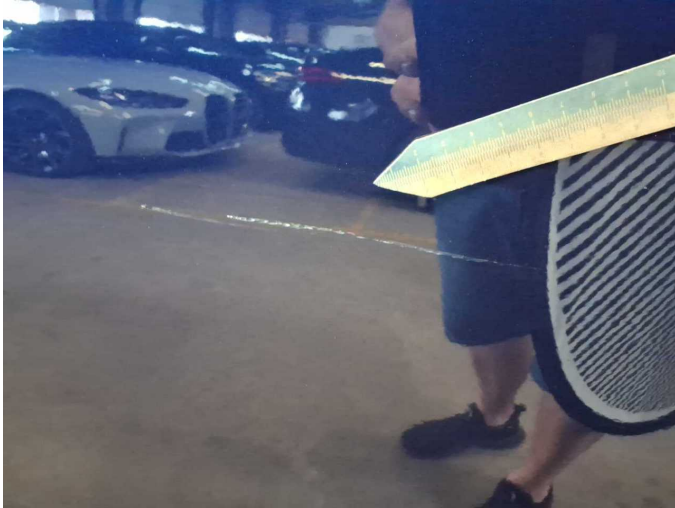
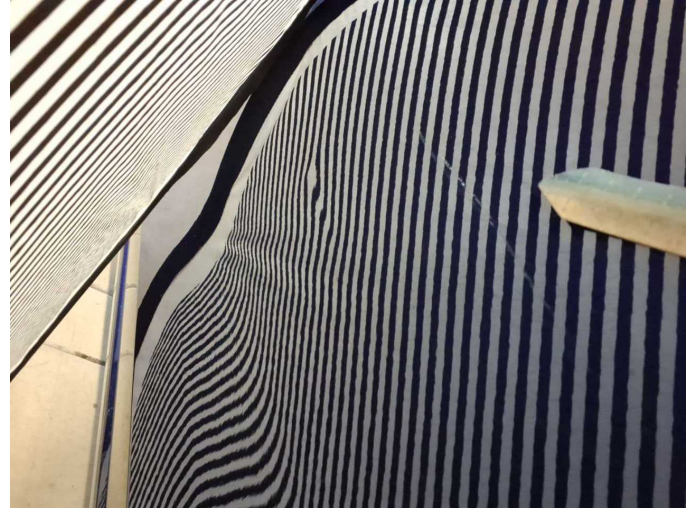
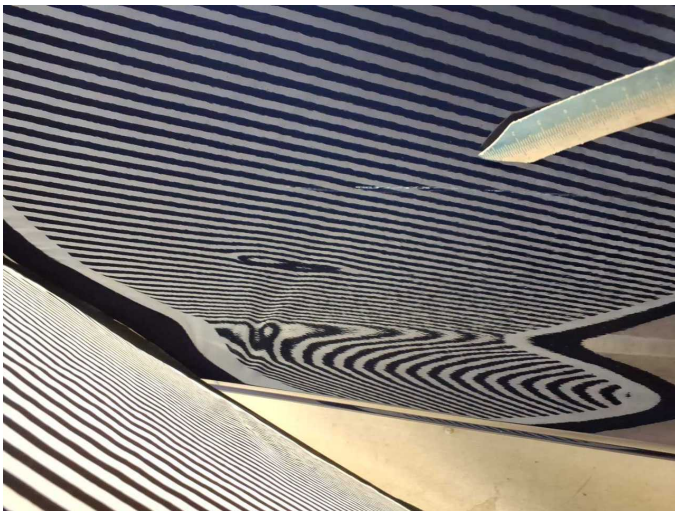
Damage 9: Door - front left side: Door - Dent / paintcoat damage - Repair and paint
