Expertise

Protocol number: 46589179  
Order No. / Reference: 26678705  
Inspection date: 20 Jul 2026

Manufacturer: Volkswagen

Model: Transporter T6.1 DSG Kurz

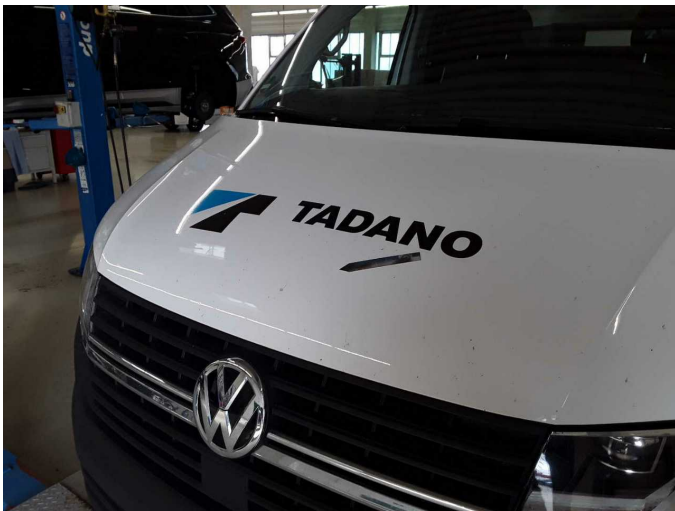
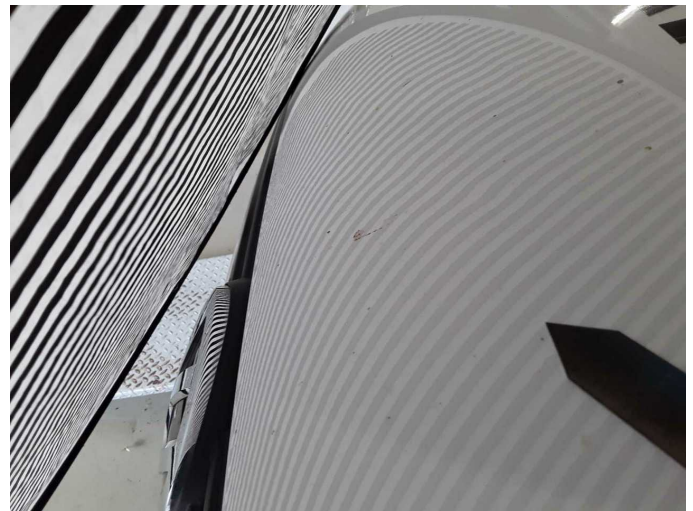
| No. | Component group | Description |
|---|---|---|
| 2 | Bonnet | Bonnet - dent(s) - Smart repair |

Damage 2: Bonnet: Bonnet - dent(s) - Smart repair

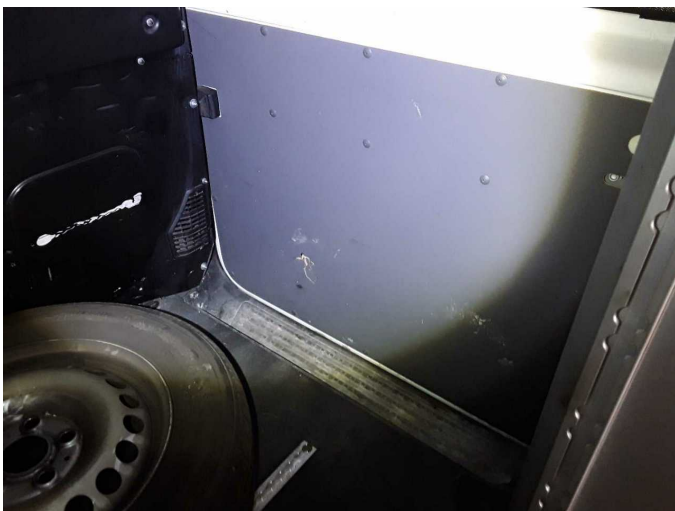
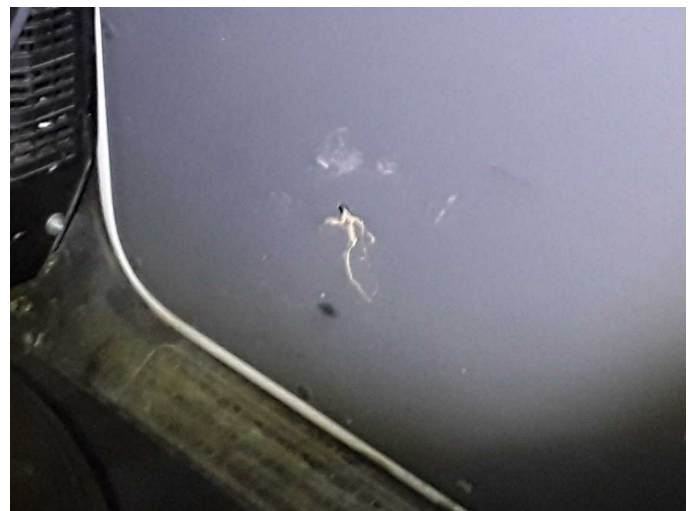
| No. | Component group | Description |
|---|---|---|
| 3 | Sliding door, right | Trim - Broken / torn - Replace |

Damage 3: Sliding door, right: Trim - Broken / torn - Replace

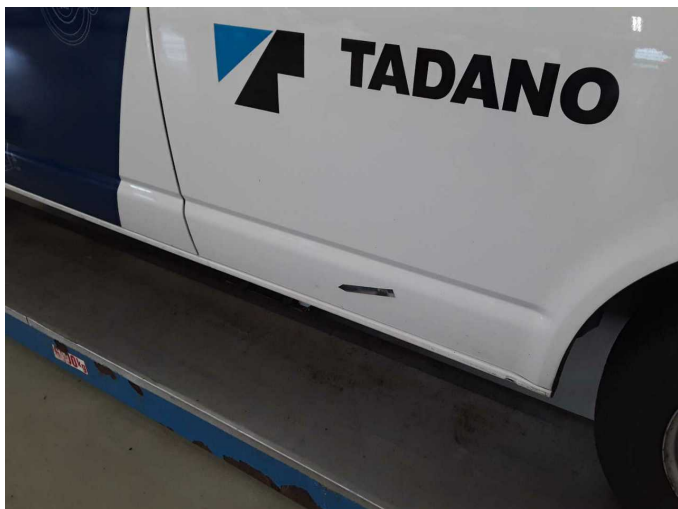
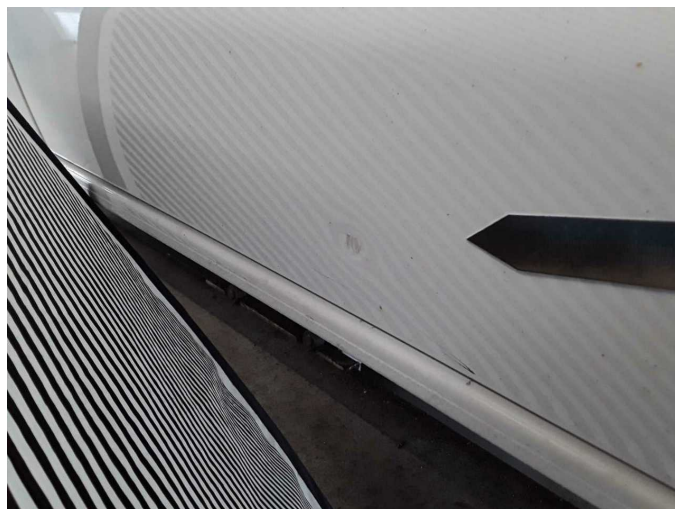
| No. | Component group | Description |
|---|---|---|
| 4 | Door - front right side | Door - Dent / paintcoat damage - Smart repair |

**Damage 4:** Door - front right side: Door - Dent / paintcoat damage - Smart repair

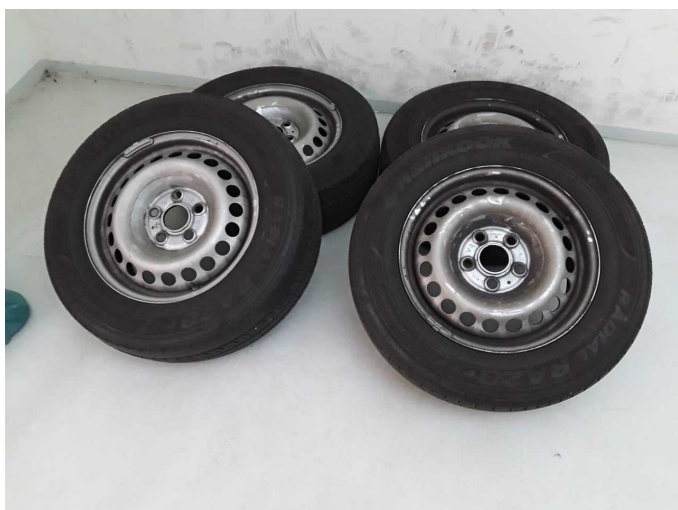
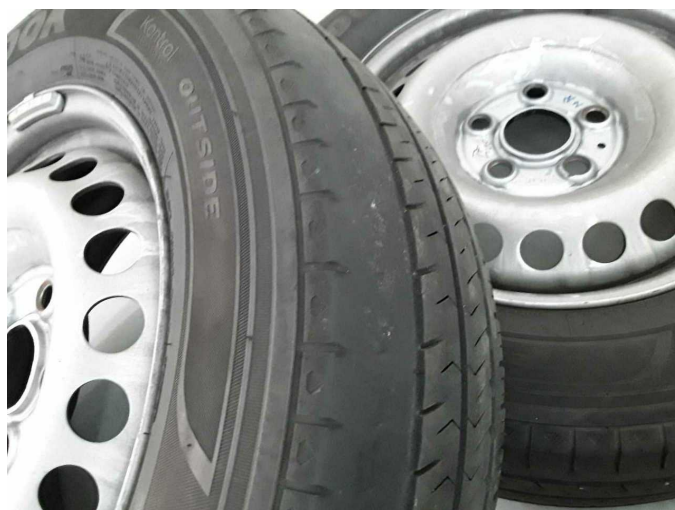
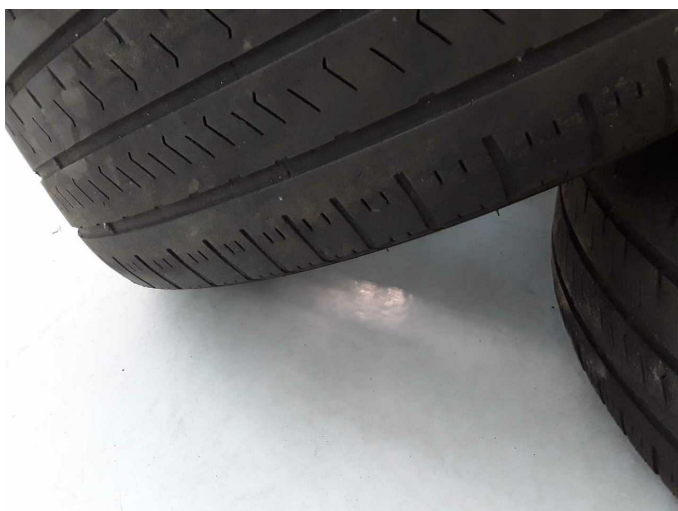
| # | Tyre size | Type of tyre | Manufacturer | Tread depth |
|---|---|---|---|---|
| 2) | 215/65 R16 106T | Summer tyres on Steel | Hankook | 0mm / 0mm |

| No. | Component group | Description |
|---|---|---|
| 6 | 2nd wheel set | 2 tyres - Worn - Replace |

**Damage 6:** 2nd wheel set: 2 tyres - Worn - Replace

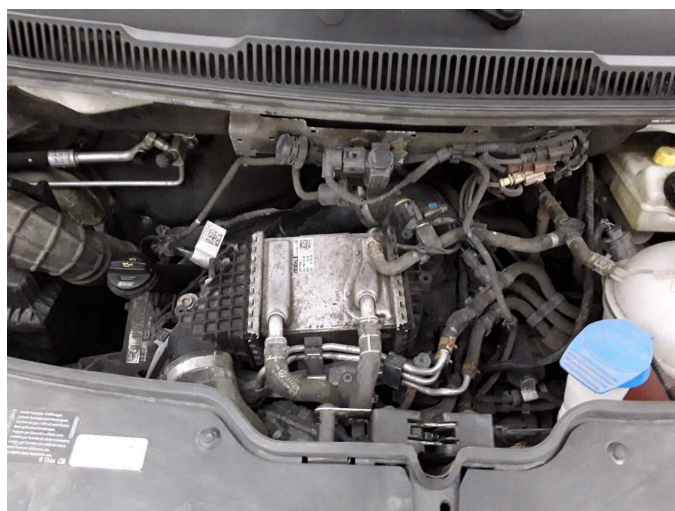
| No. | Component group | Description |
|---|---|---|
| 7 | Engine | Engine (Zusatzkosten können entstehen) - Noise - Perform diagnosis |

**Damage 7:** Engine: Engine (Zusatzkosten können entstehen) - Noise - Perform diagnosis

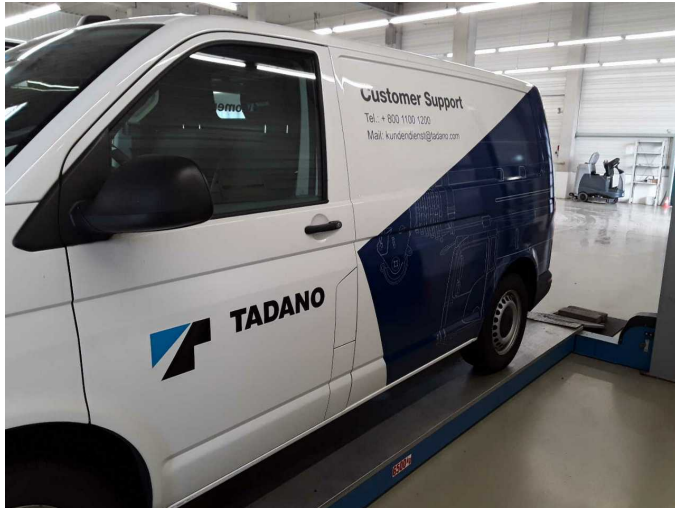
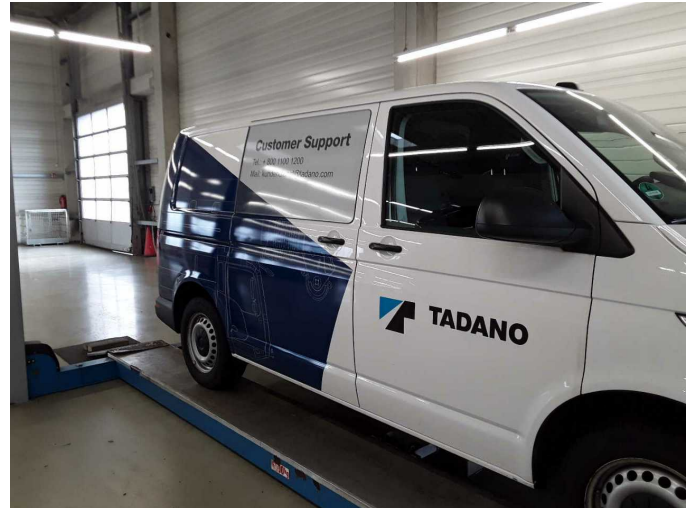
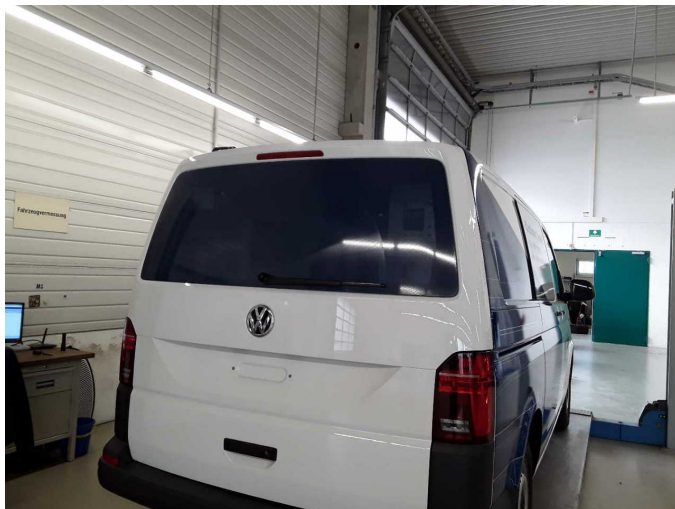
| No. | Component group | Description |
|---|---|---|
| 8 | Body | Body (Zusatzkosten können entstehen) - Glued / labelled - De-glue / neutralise |

**Damage 8:** Body: Body (Zusatzkosten können entstehen) - Glued / labelled - De-glue / neutralise

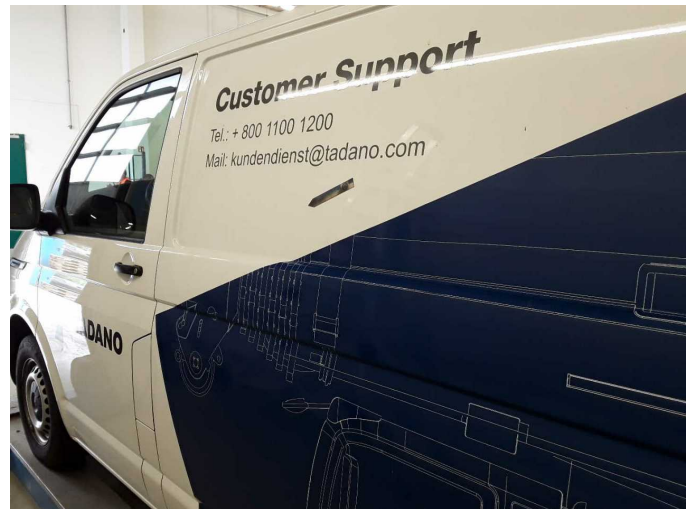
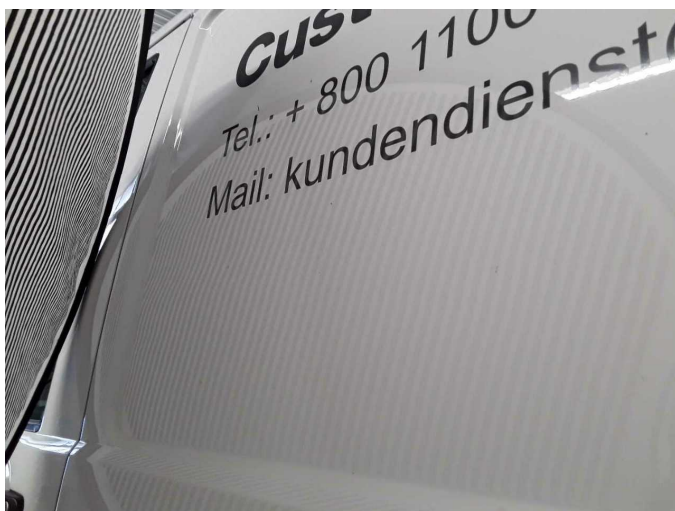
| No. | Component group | Description |
|---|---|---|
| 4 | Side panel - rear left side | Side panel - dent(s) - No deduction |

**Wear and tear 4:** Side panel - rear left side: Side panel - dent(s) - No deduction

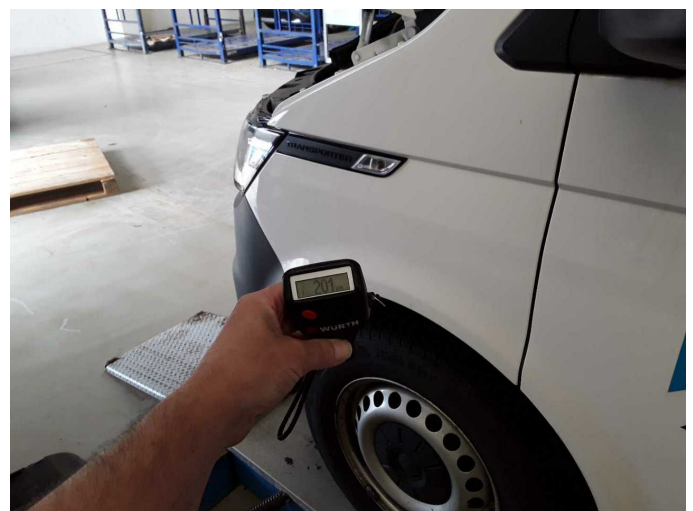
- 1 Mudguard - left side, Professionally carried out

**Mudguard - left side:** 201  $\mu$ m
