Expertise

Protocol number: 46131936
Order No. / Reference: 26469619
Inspection date: 24 Jun 2026

Manufacturer: Ford

Model: Transit 350 L3H2 Lkw HA Trend

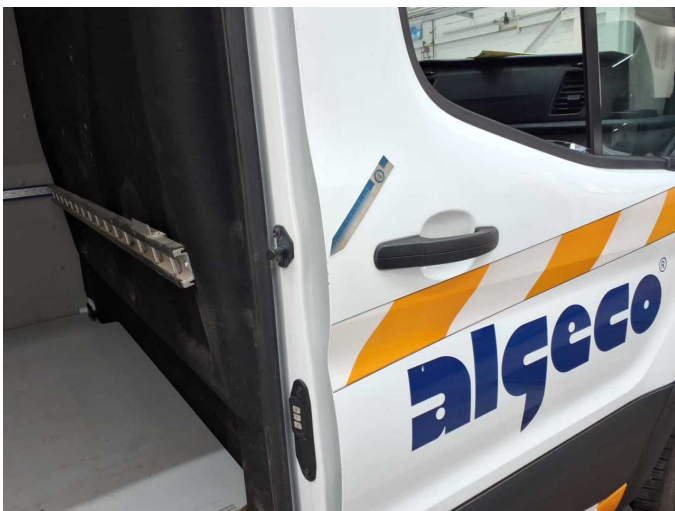
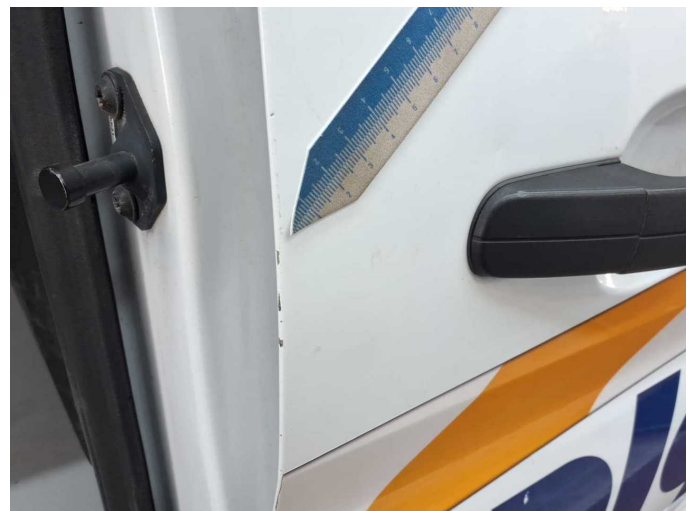
Damage 1: Door - front right side: Door - Scratch(es) - Smart repair

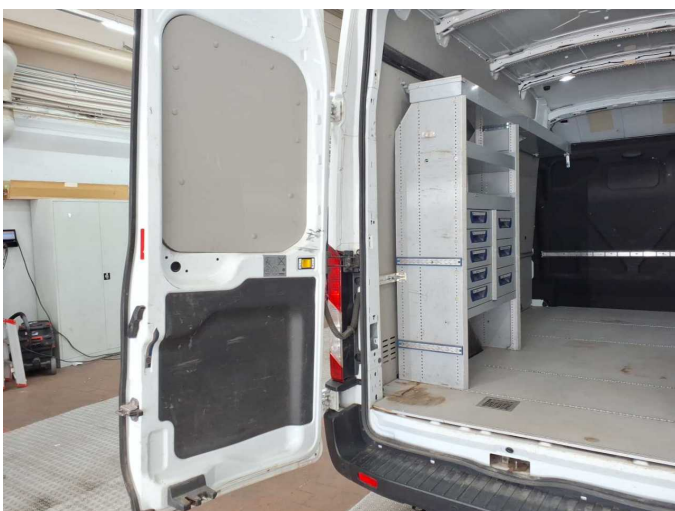
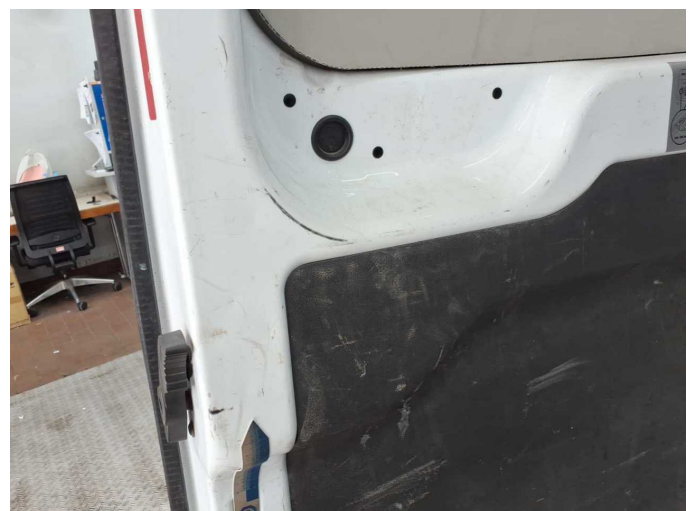
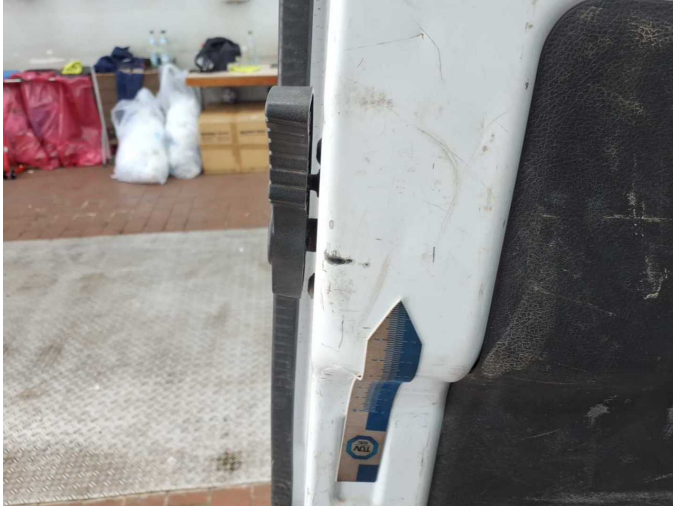
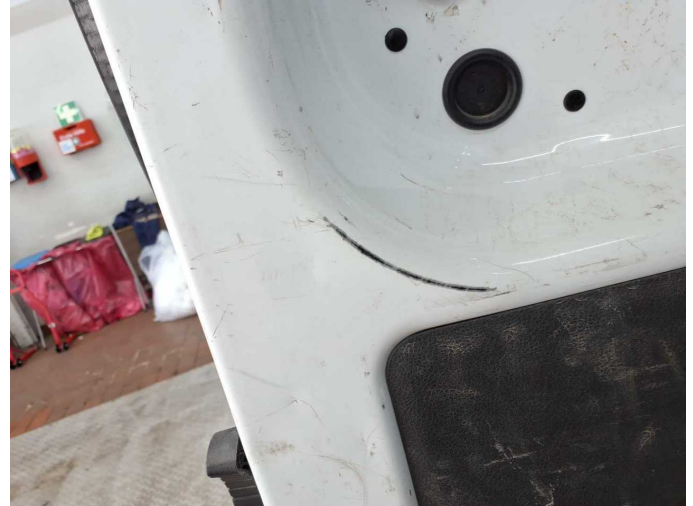
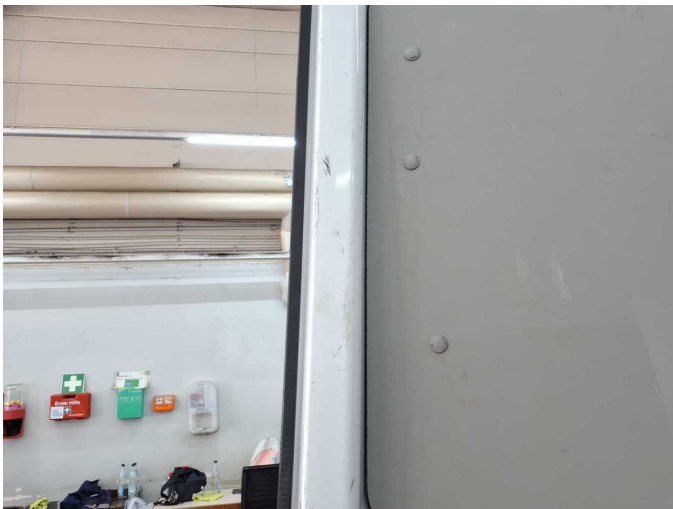
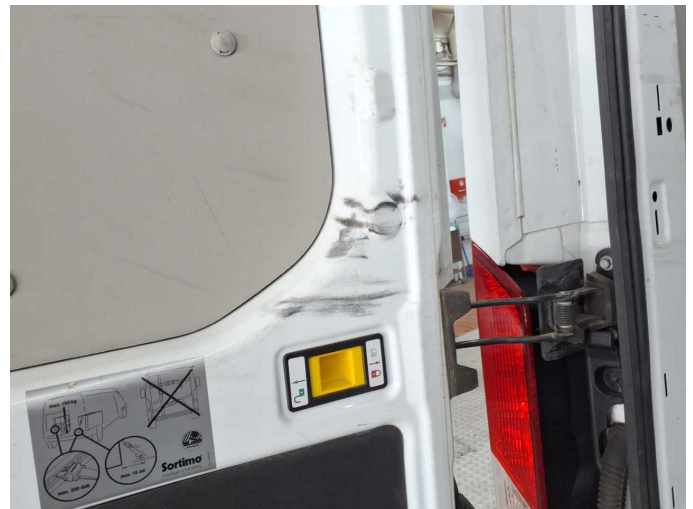
Damage 2: Boot lid / rear door: Rear door - left side (innen) - Scratch(es)
- Loss in value

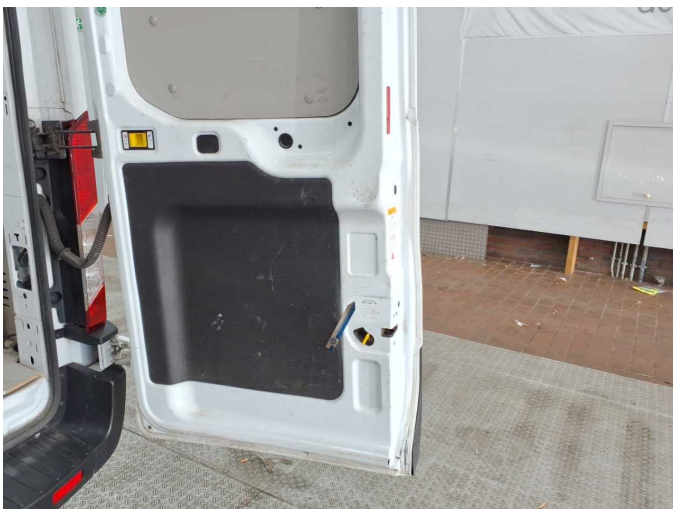
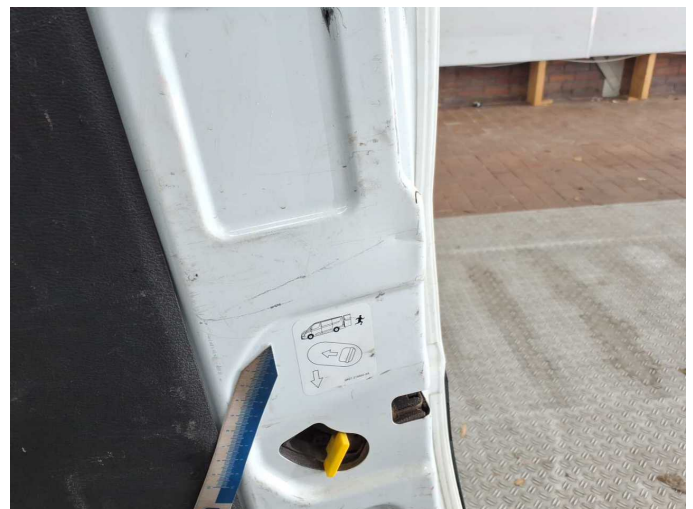
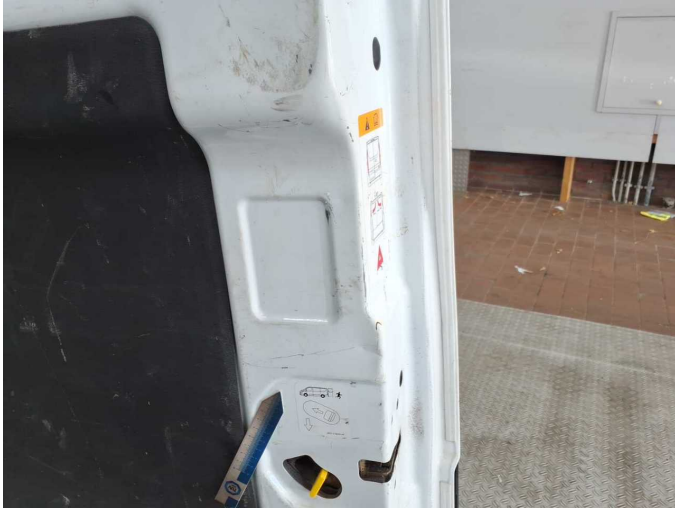
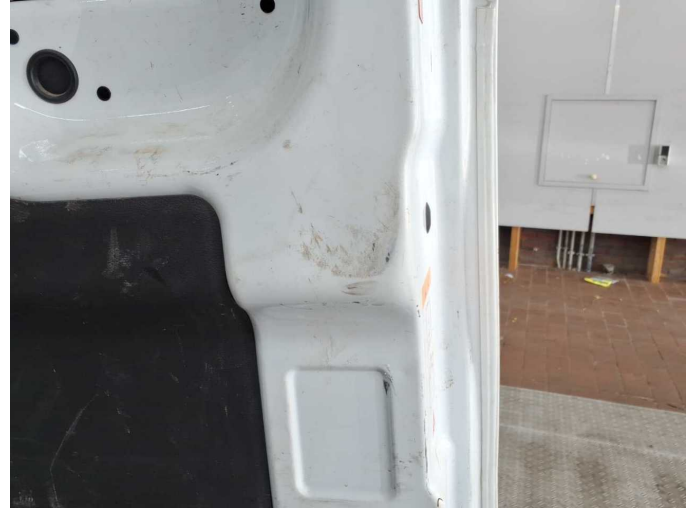
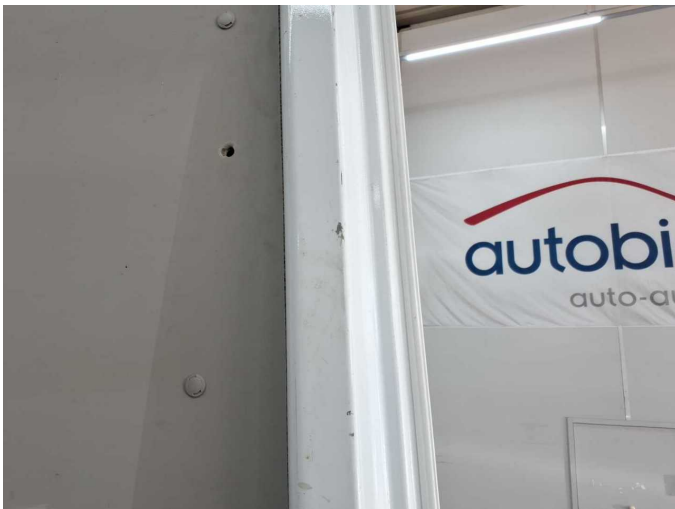
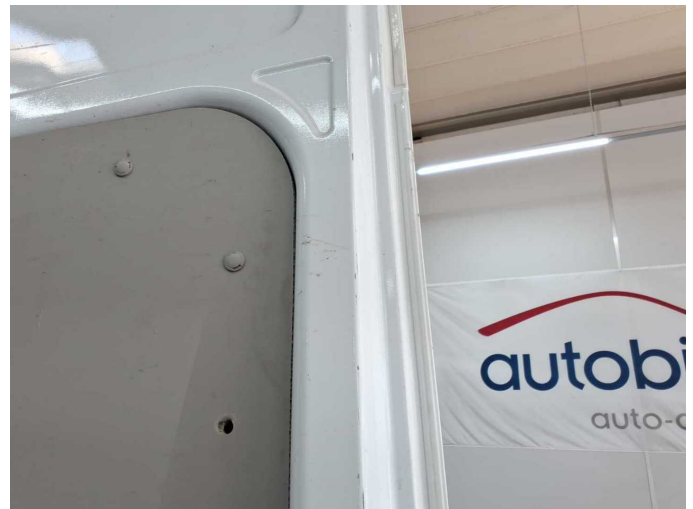
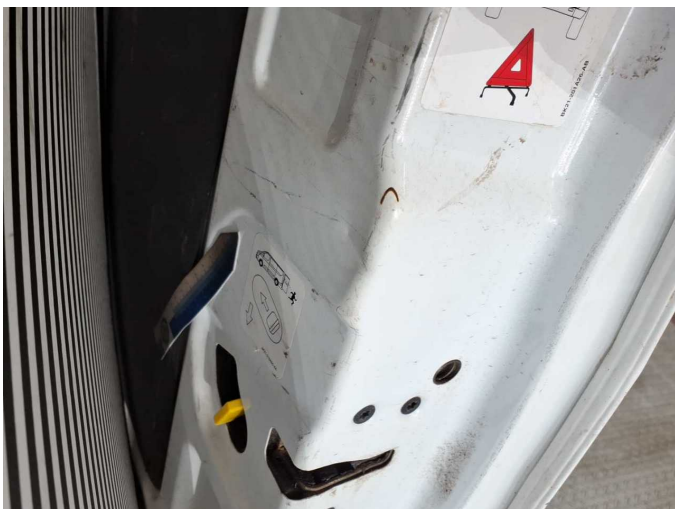
Damage 3: Boot lid / rear door: Rear door - right side - Dent / paintcoat
damage - Loss in value

Damage 3: Boot lid / rear door: Rear door - right side - Dent / paintcoat damage - Loss in value

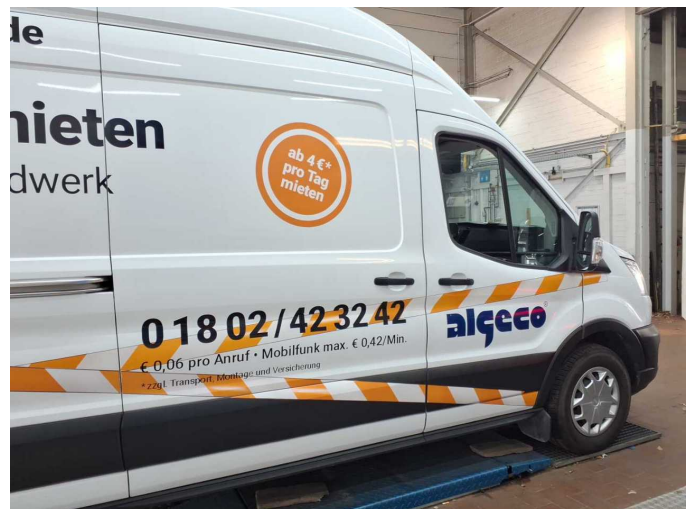
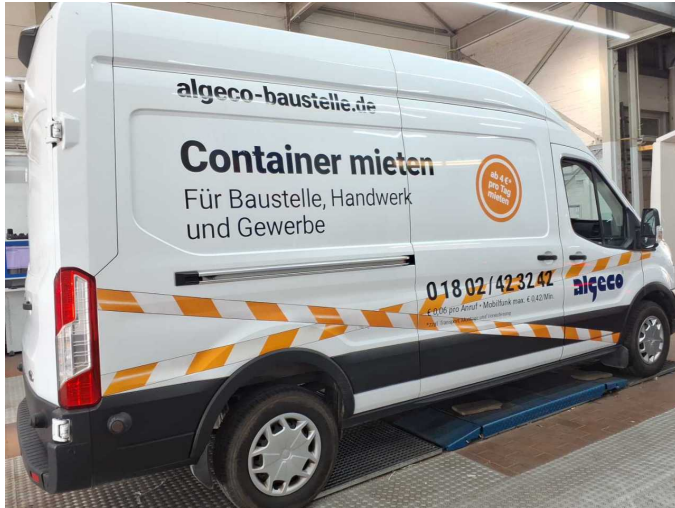
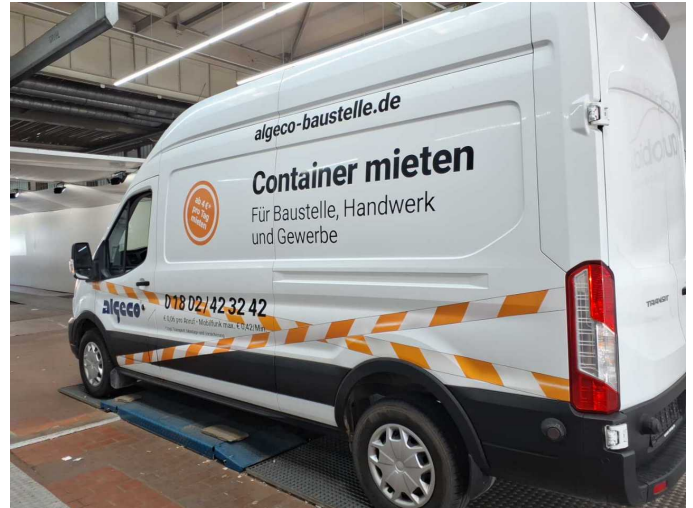
Damage 4: Body - Body - Glued / labelled - De-glue / neutralise

Damage 4: Body: Body - Glued / labelled - De-glue / neutralise
