## Expertise

Protocol number: 46374548  
Order No. / Reference: 26470477  
Inspection date: 6 Jul 2026

Manufacturer: Ford

Model: Transit Custom 280 L1H1 LKW VA Trend

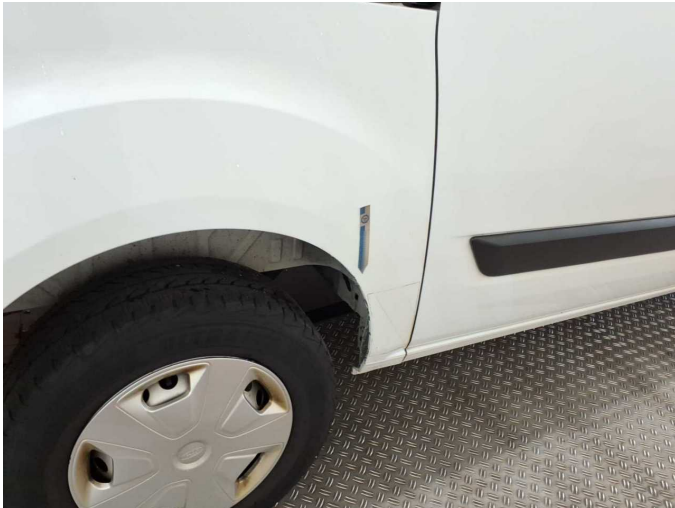
No.	Component group	Description
1	Side panel - rear right side	Side panel - Paint defect - Paint
2	Sliding door, right	Sliding door - Glued / labelled - De-glue / neutralise
3	Side panel - rear left side	Side panel - Glued / labelled - De-glue / neutralise
4	Door - front right side	Door - dent(s) - Smooth repair work
5	Boot lid / rear door	Boot lid - Dent / paintcoat damage - Smart repair

**Damage 1:** Side panel - rear right side: Side panel - Paint defect - Paint

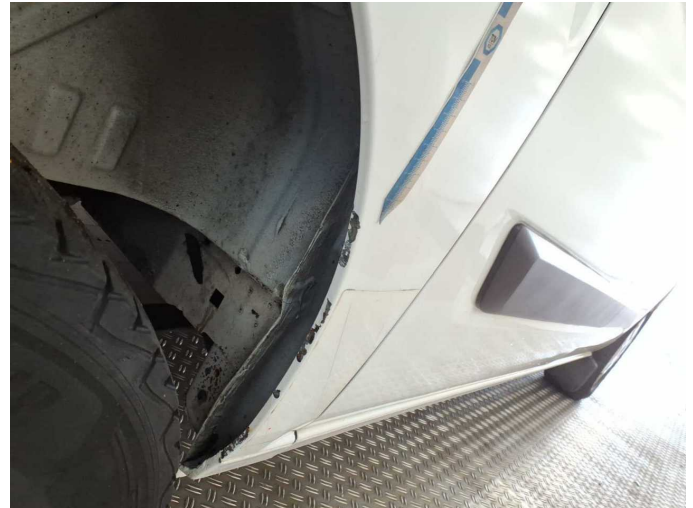
**Damage 1:** Side panel - rear right side: Side panel - Paint defect - Paint

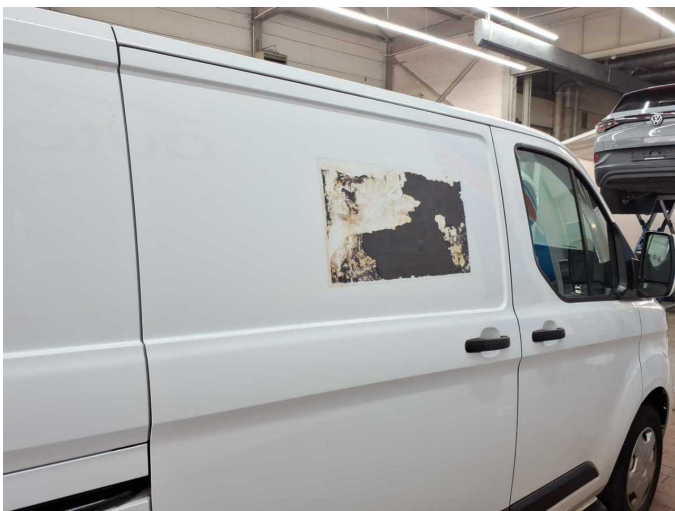
**Damage 2:** Sliding door, right: Sliding door - Glued / labelled - De-glove / neutralise

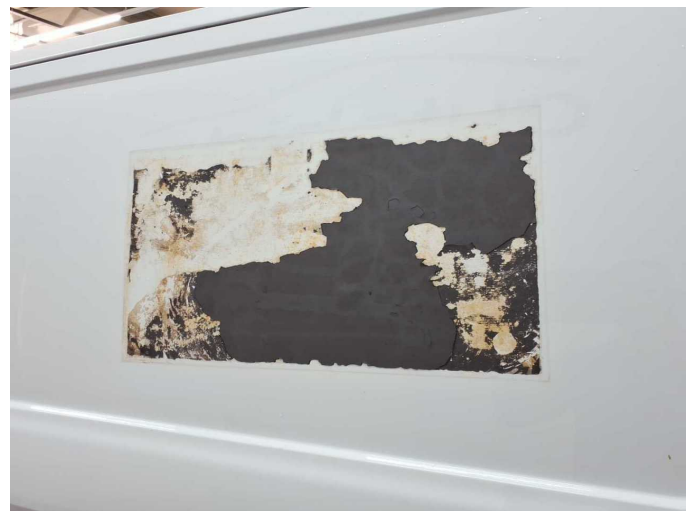
**Damage 2:** Sliding door, right: Sliding door - Glued / labelled - De-glove / neutralise

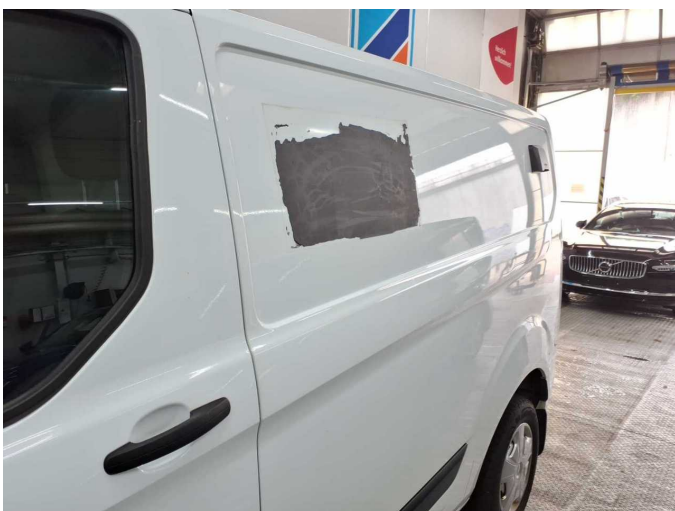
**Damage 3:** Side panel - rear left side: Side panel - Glued / labelled - De-glove / neutralise

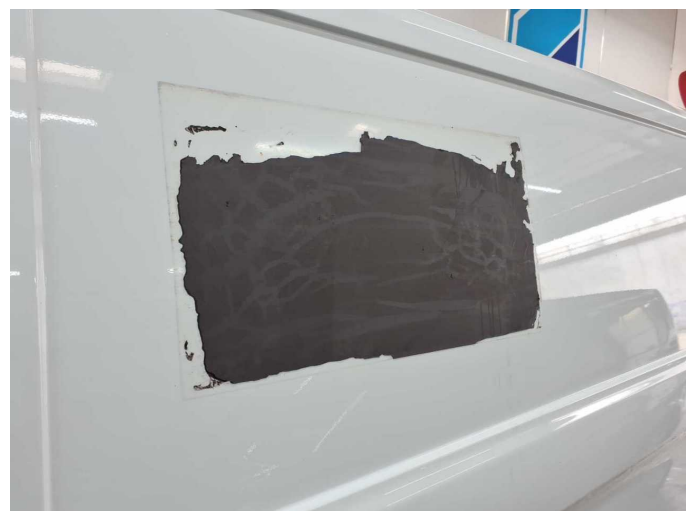
**Damage 3:** Side panel - rear left side: Side panel - Glued / labelled - De-glove / neutralise

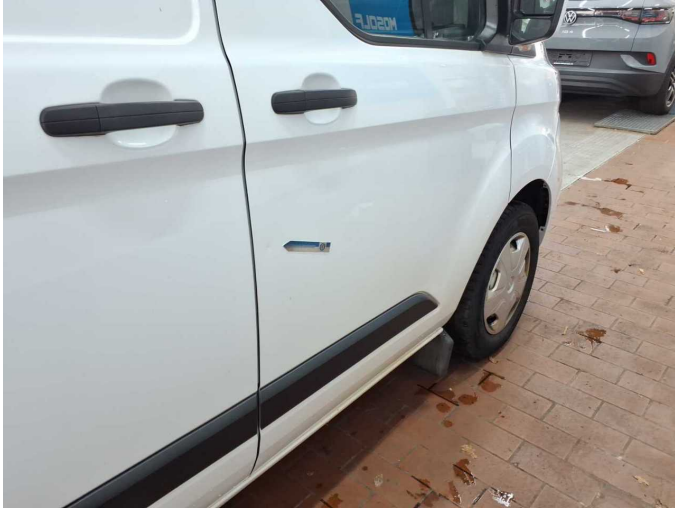
**Damage 4:** Door - front right side: Door - dent(s) - Smooth repair work

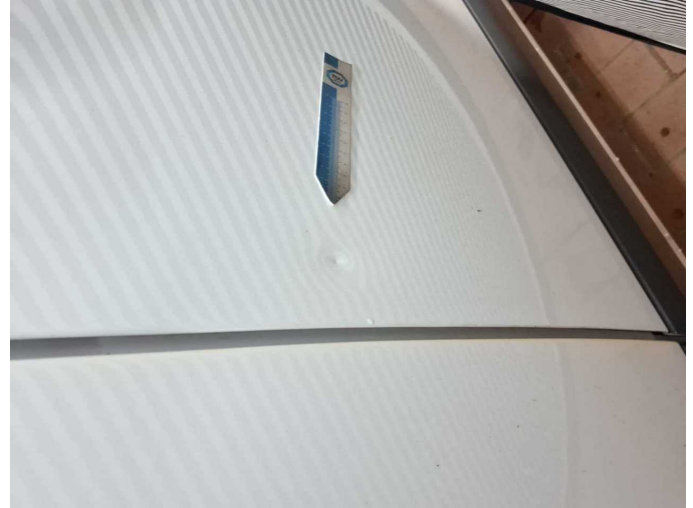
**Damage 4:** Door - front right side: Door - dent(s) - Smooth repair work

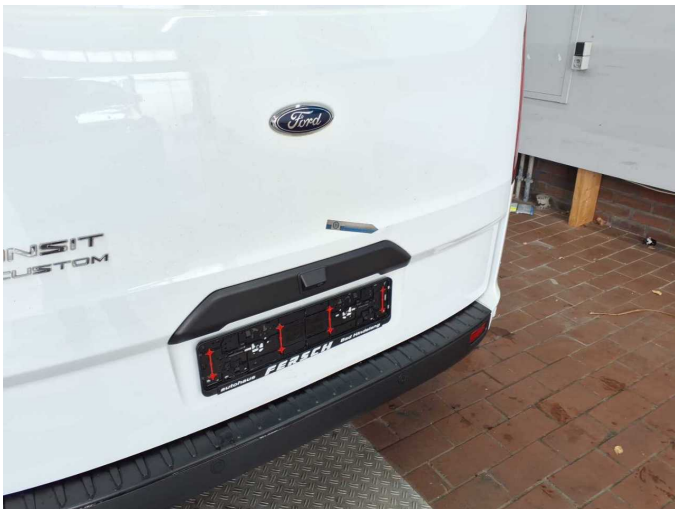
**Damage 5:** Boot lid / rear door: Boot lid - Dent / paintcoat damage - Smart repair

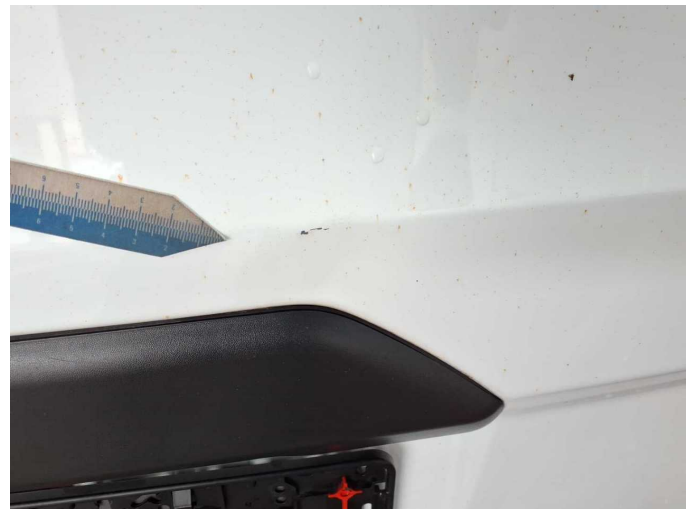
**Damage 5:** Boot lid / rear door: Boot lid - Dent / paintcoat damage - Smart repair

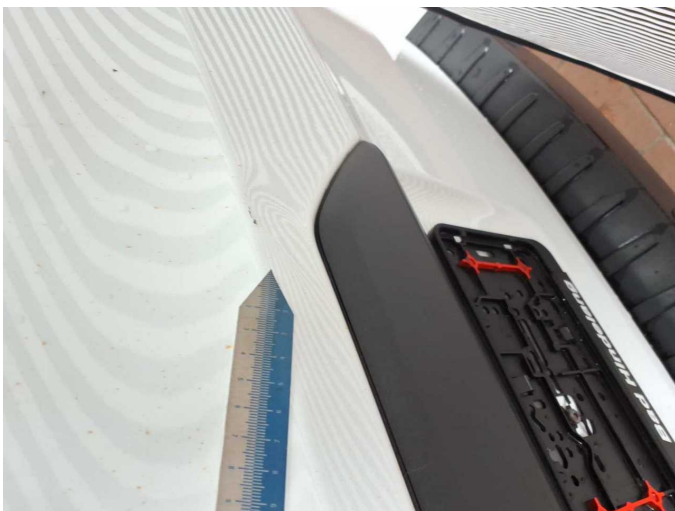
**Damage 5:** Boot lid / rear door: Boot lid - Dent / paintcoat damage - Smart repair
