Expertise

Protocol number: 45921730
Order No. / Reference: 26412781
Inspection date: 12 Jun 2026

Manufacturer: Ford

Model: Focus Turnier 1.5 EcoBlue Start-Stopp-System Aut. TITANIUM

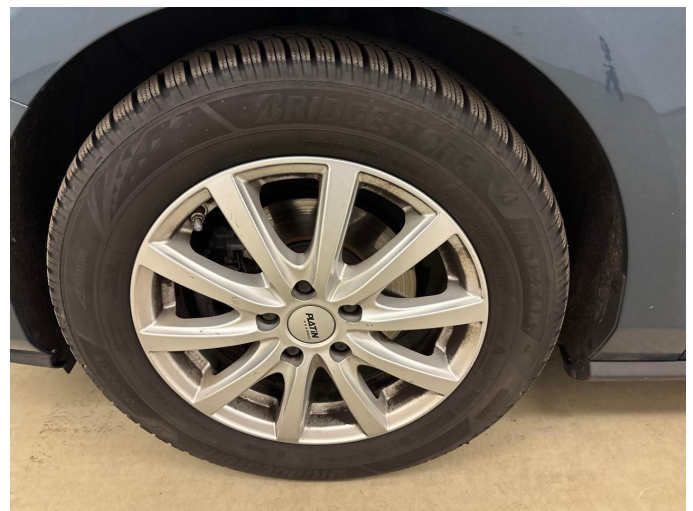
Figure 12: Mounted tyres

#	Tyre size	Type of tyre	Manufacturer	Tread depth
1)	205/60 R16 96H	Winter tyres on Light alloy	Bridgestone	5mm / 5mm
2)	205/60 R16 96H	Winter tyres on Light alloy	Bridgestone	5mm / 5mm

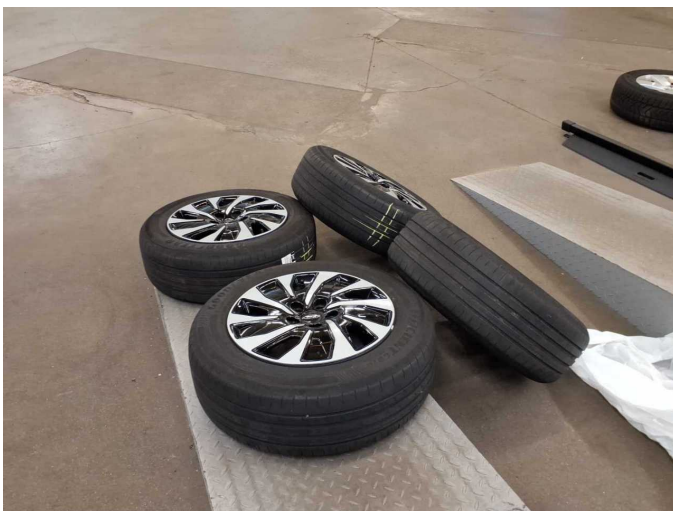
Figure 15: Additional tyres

#	Tyre size	Type of tyre	Manufacturer	Tread depth
1)	205/60 R16 92V	Summer tyres on Steel rim with wheel cover	Goodyear	5mm / 5mm
2)	205/60 R16 92V	Summer tyres on Steel rim with wheel cover	Goodyear	5mm / 5mm

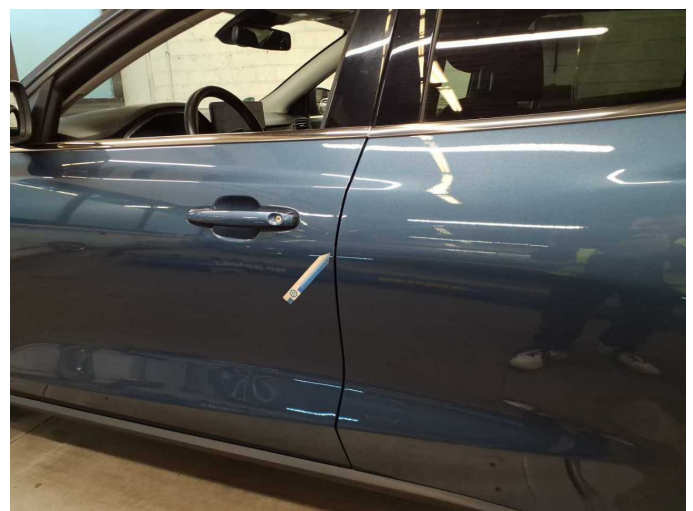
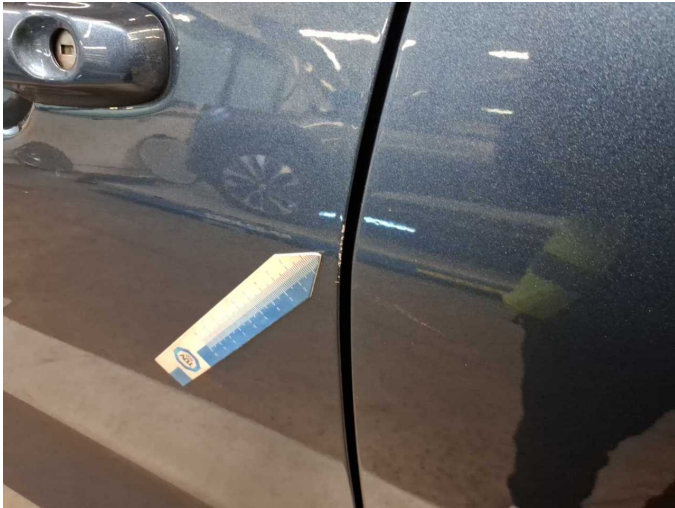
Damage 2: Door - front left side: Door edge - Scratch(es) - Smart repair

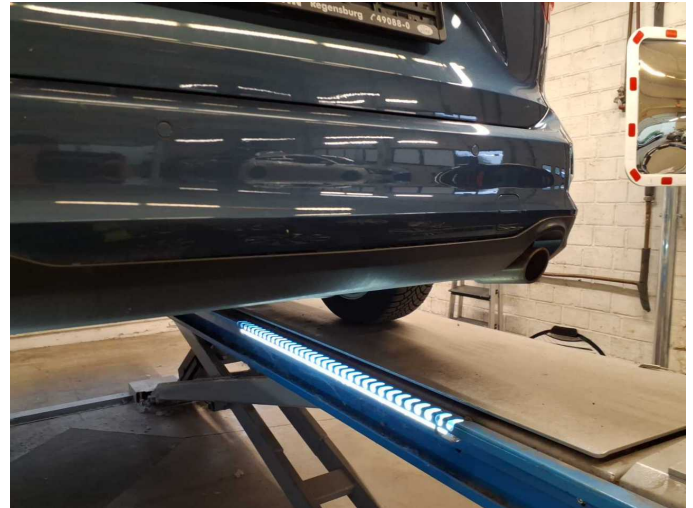
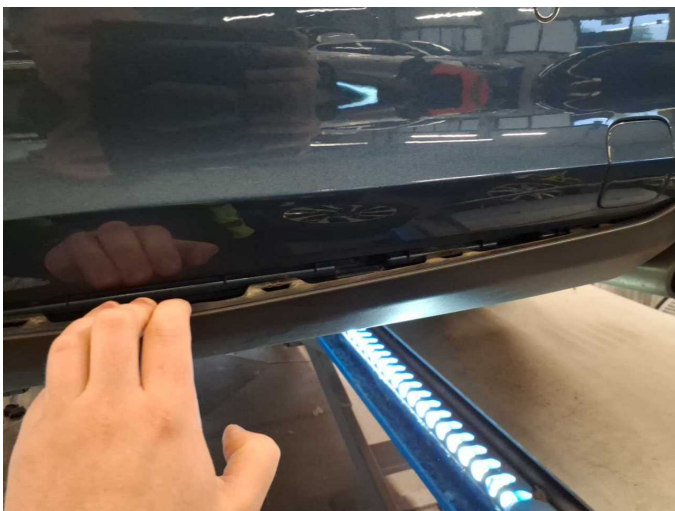
Damage 3: Rear bumper: Spoiler - Malposition - Repair

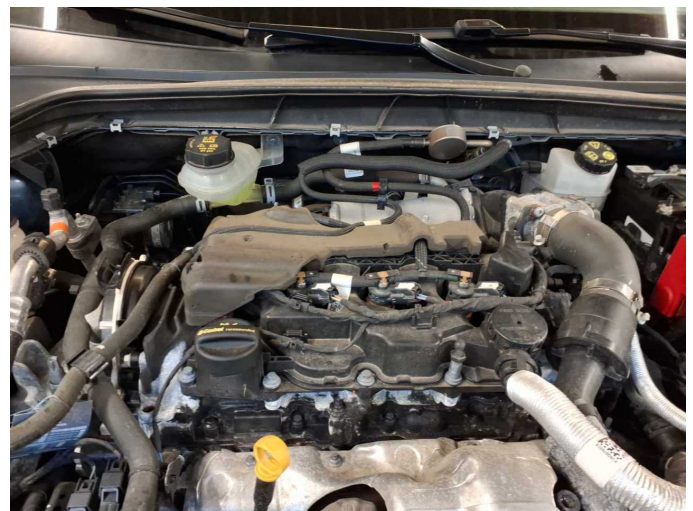
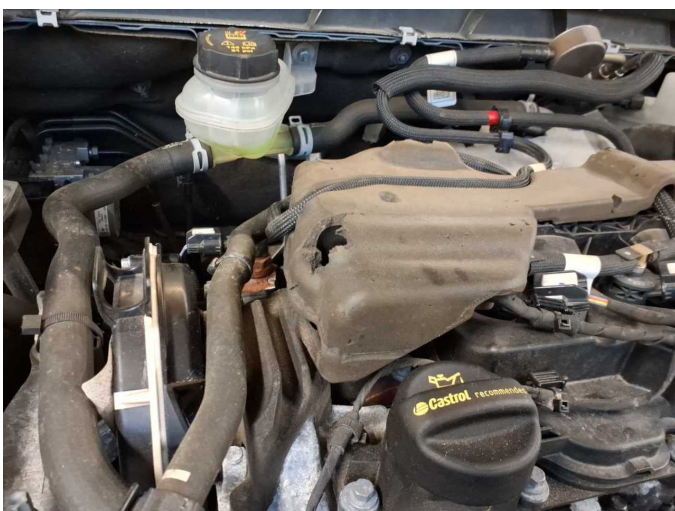
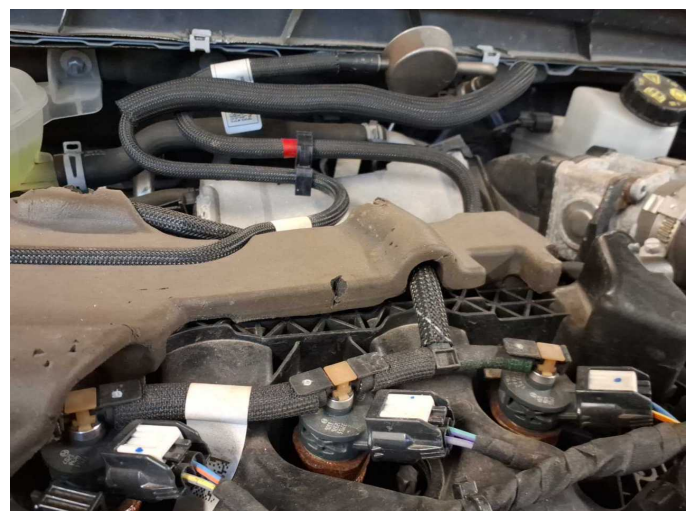
Damage 4: Engine: Engine cover - Damage caused by marten / rodent - Replace

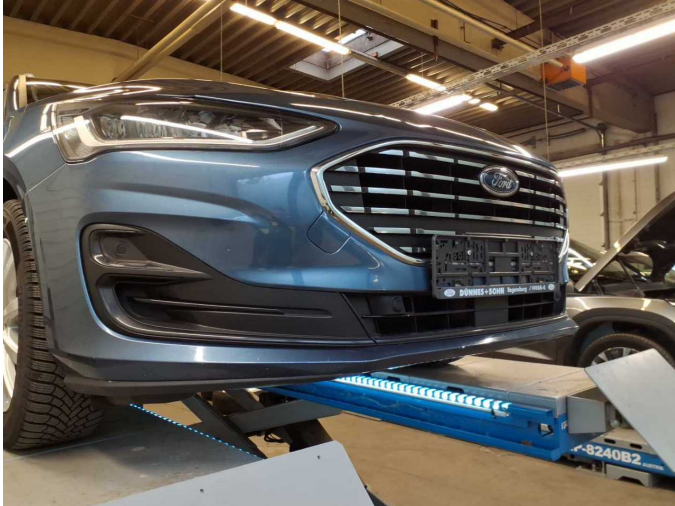
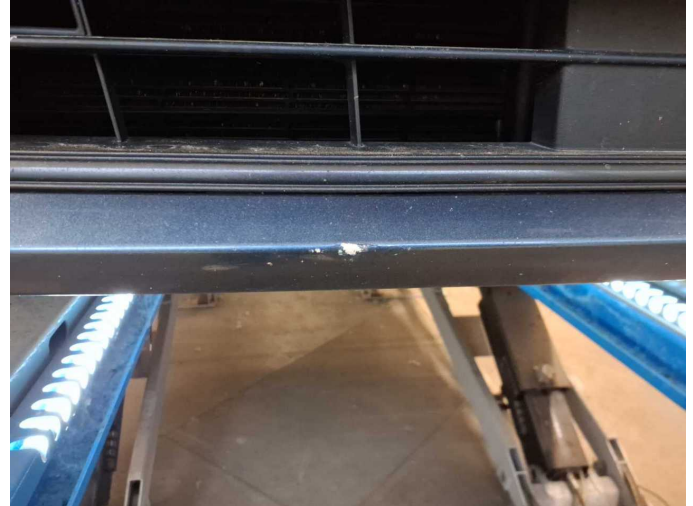
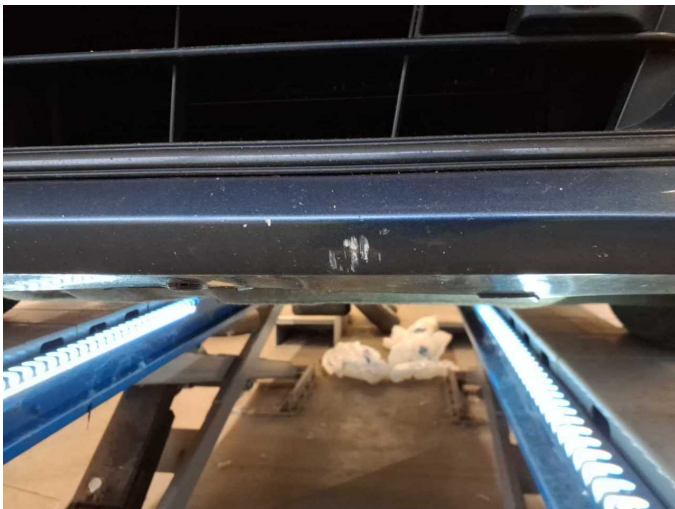
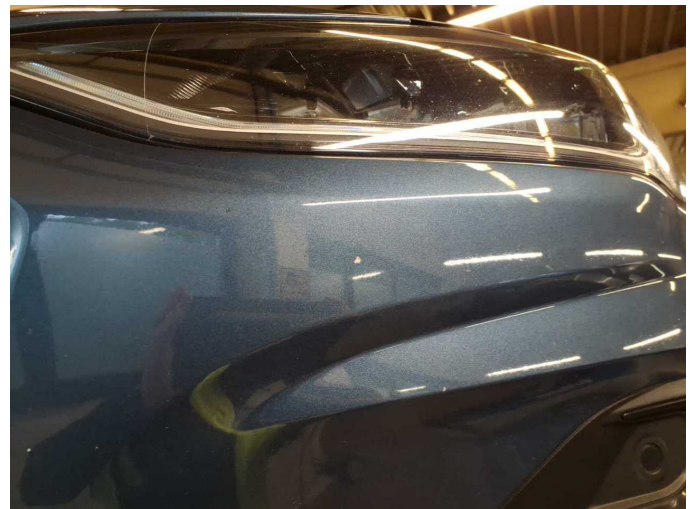
Damage 5: Front bumper: Front bumper - Scratch(es) - Paint

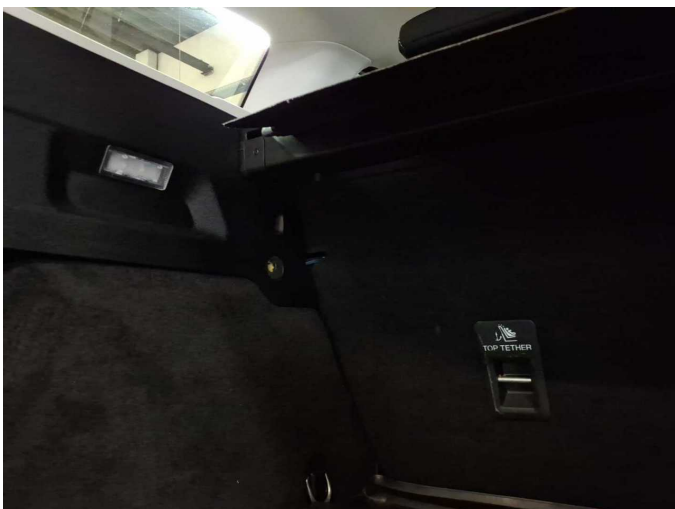
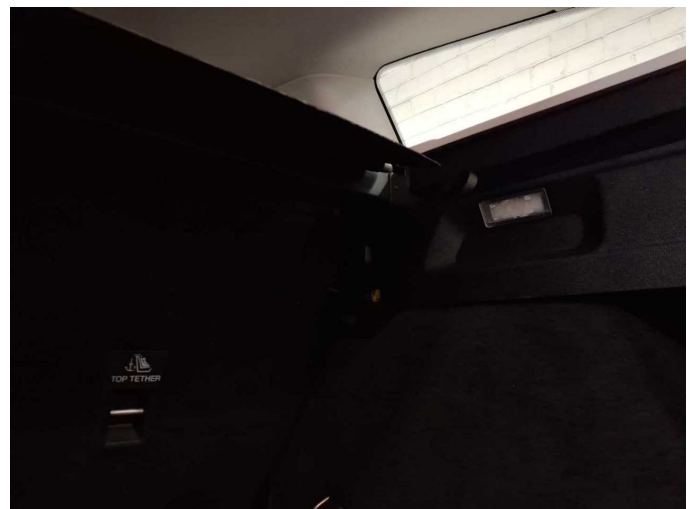
Missing part 1: Interior: Separation net - Missing - Replace
