Expertise

Protocol number: 47108463  
Order No. / Reference: 26787117  
Inspection date: 18 Aug 2026

Manufacturer: Skoda  
VIN: TMBLE9NY6PF058154

Model: Enyaq iV 80x

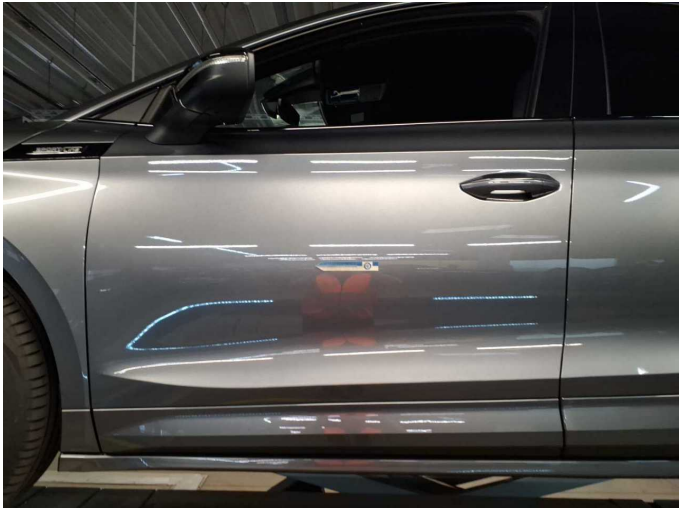
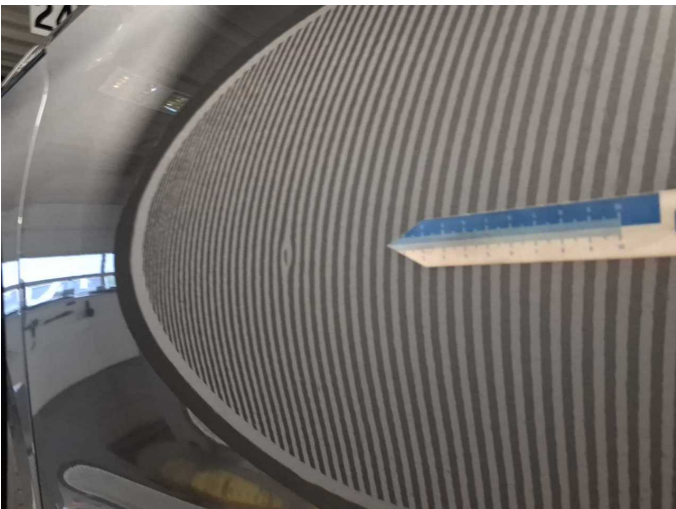
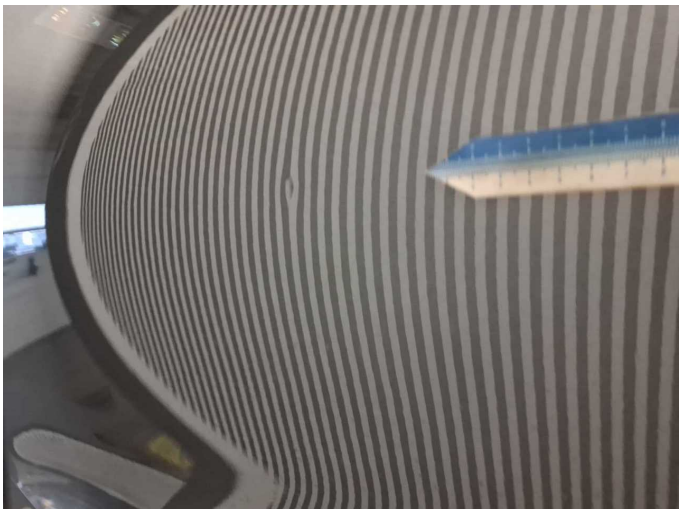
| No. | Component group | Description |
|---|---|---|
| 2 | Door - front left side | Door - dent(s) - Smooth repair work |

Damage 2: Door - front left side: Door - dent(s) - Smooth repair work

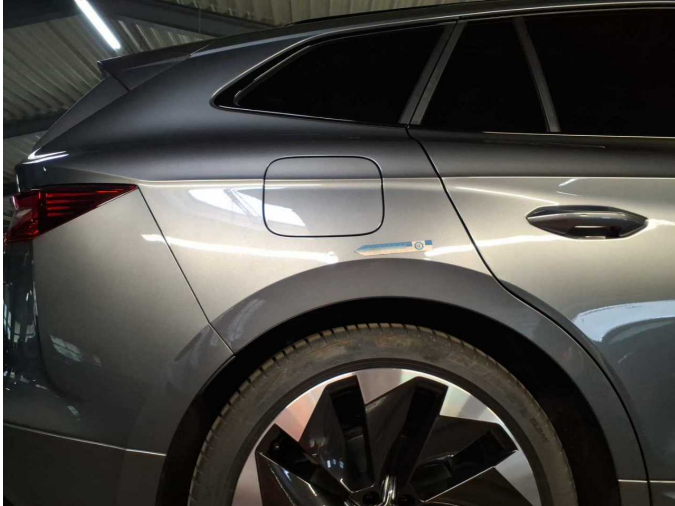
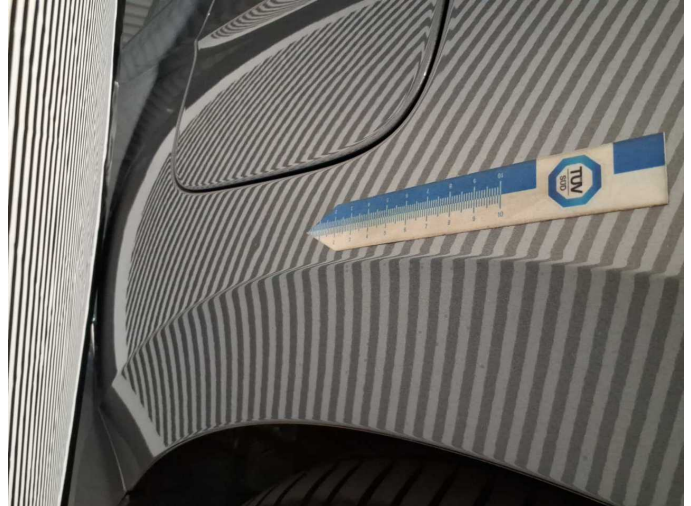
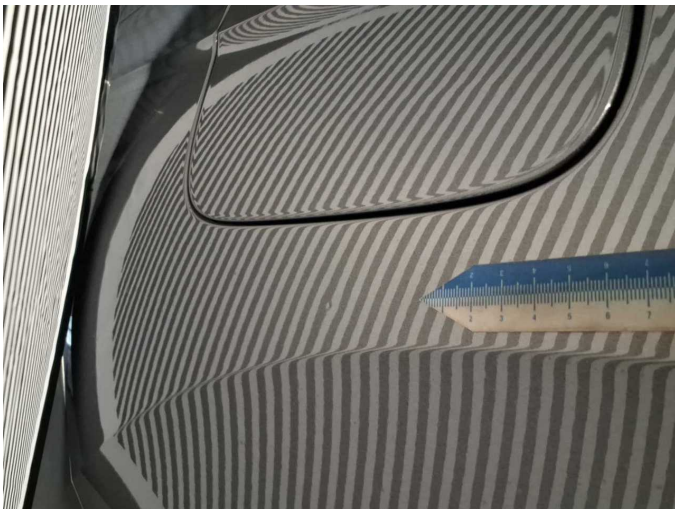
| No. | Component group | Description |
|---|---|---|
| 3 | Side panel - rear right side | Side panel - dent(s) - Smooth repair work |

**Damage 3:** Side panel - rear right side: Side panel - dent(s) - Smooth repair work

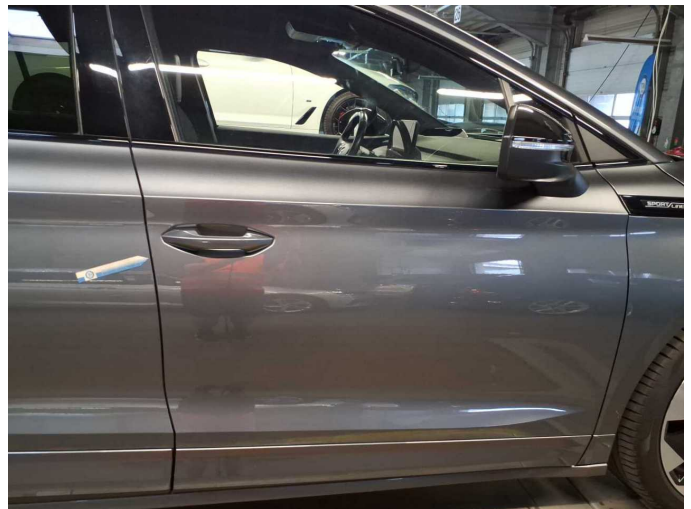
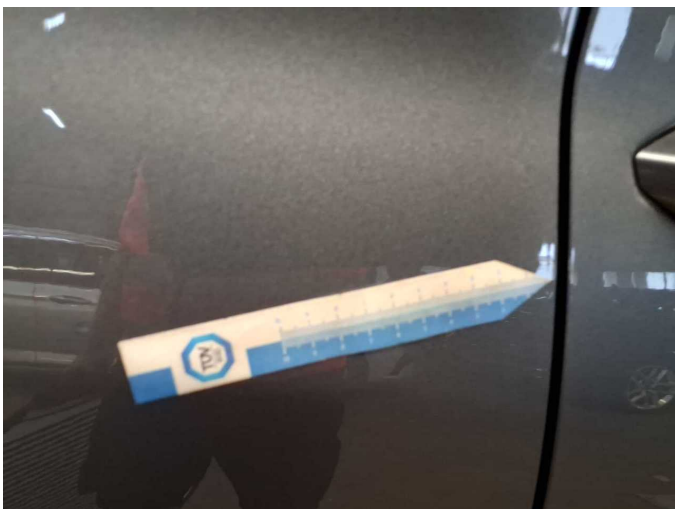
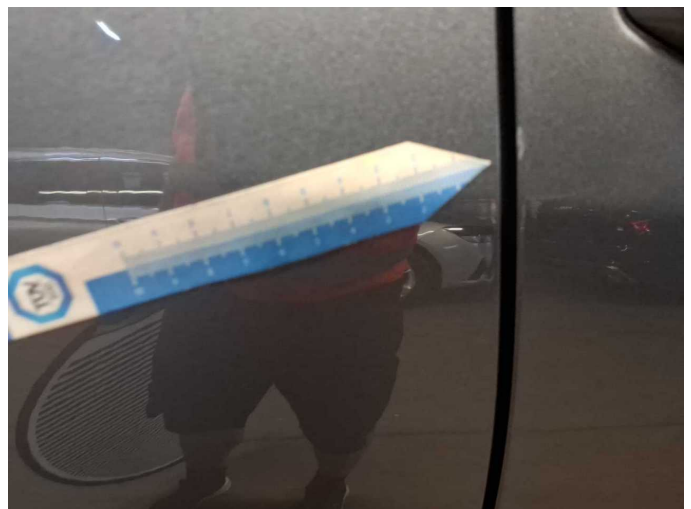
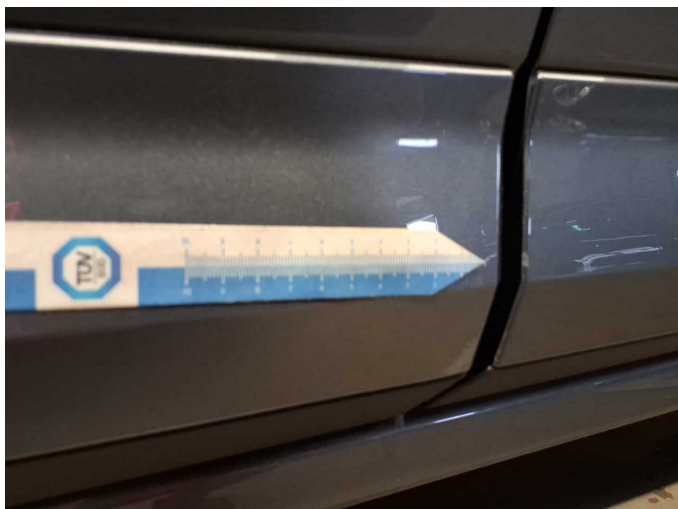
| No. | Component group | Description |
|---|---|---|
| 4 | Door - front right side | Door edge - Scratch(es) - Smart repair |

**Damage 4:** Door - front right side: Door edge - Scratch(es) - Smart repair

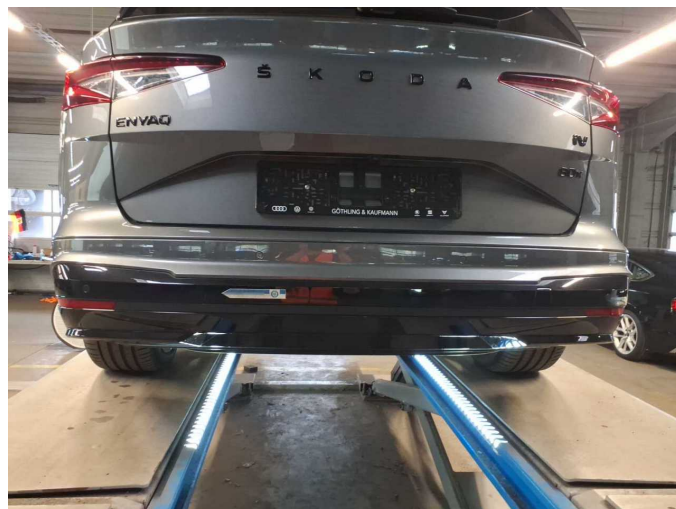
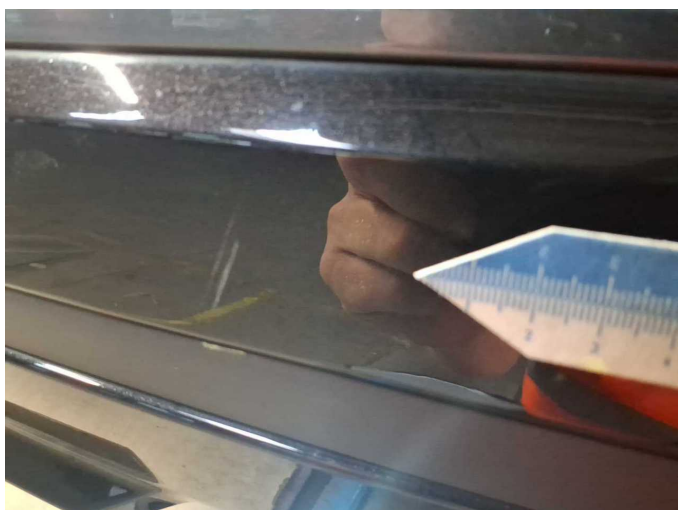
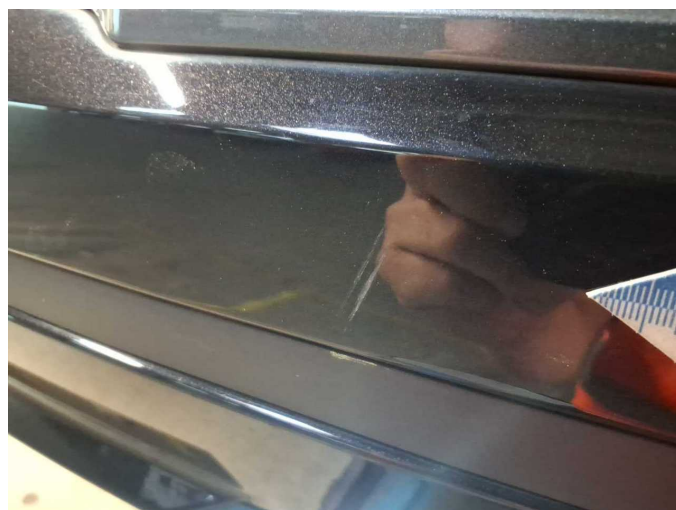
| No. | Component group | Description |
|---|---|---|
| 5 | Rear bumper | Spoiler - Scratch(es) - Smart repair |

**Damage 5:** Rear bumper: Spoiler - Scratch(es) - Smart repair

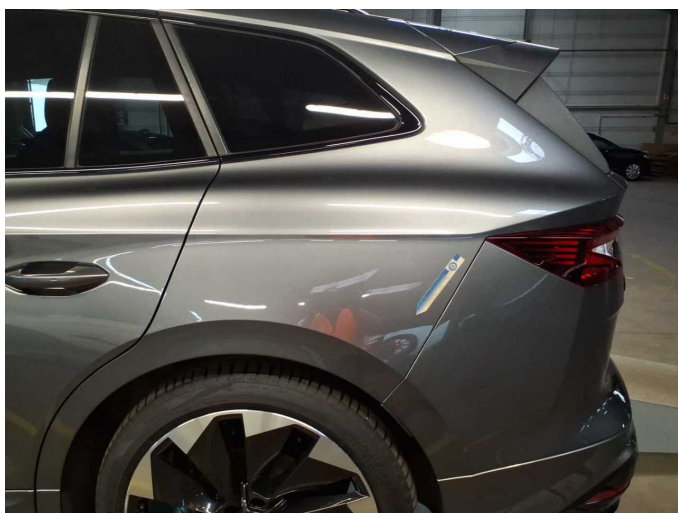
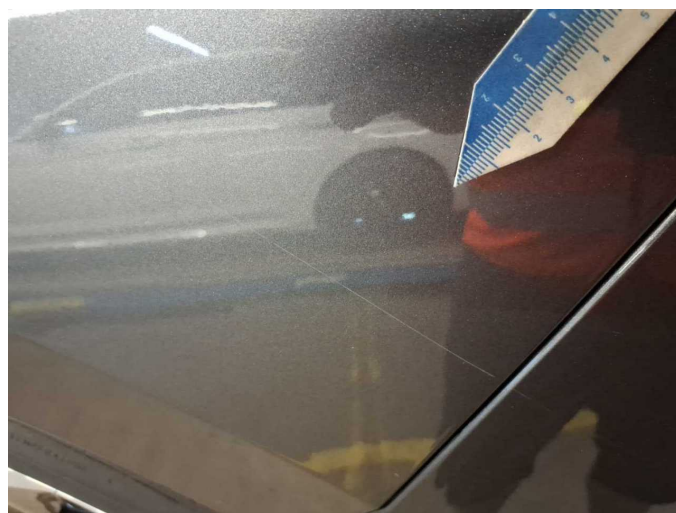
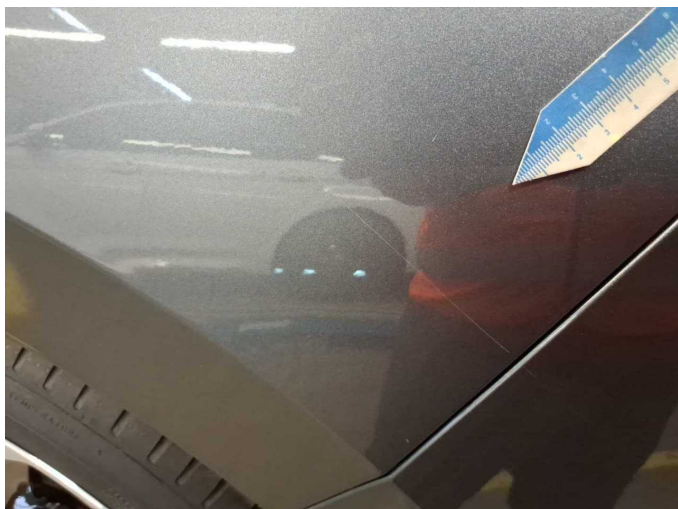
| No. | Component group | Description |
|---|---|---|
| 6 | Side panel - rear left side | Side panel - Scratch(es) - Smart repair |

**Damage 6:** Side panel - rear left side: Side panel - Scratch(es) - Smart repair

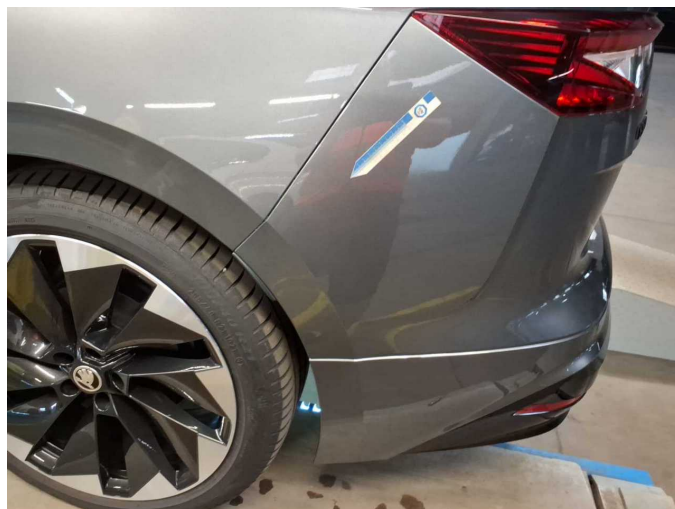
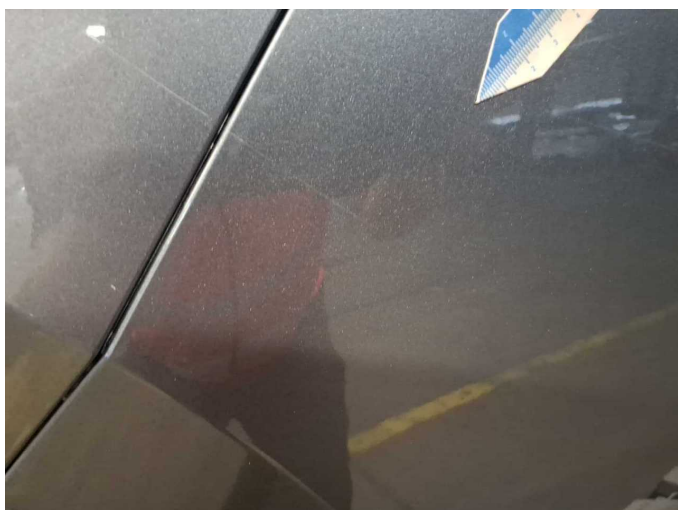
| No. | Component group | Description |
|---|---|---|
| 7 | Rear bumper | Rear bumper - Scratch(es) - Smart repair |

**Damage 7:** Rear bumper: Rear bumper - Scratch(es) - Smart repair

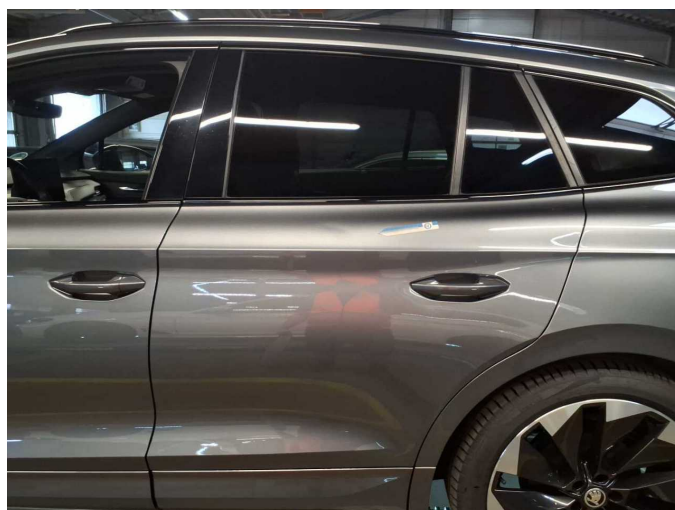
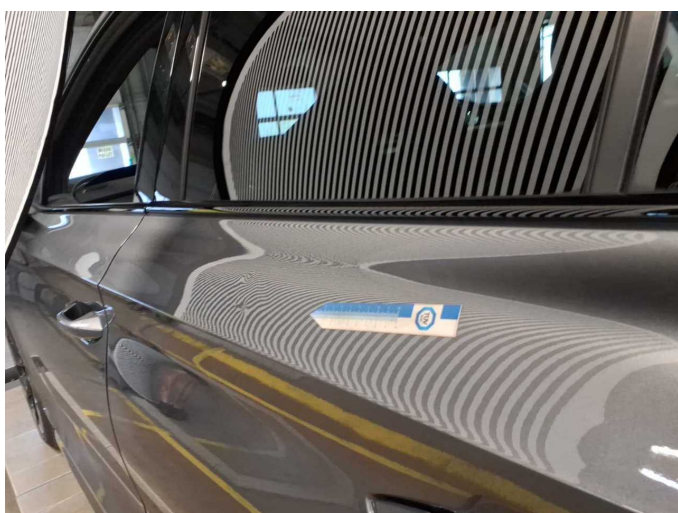
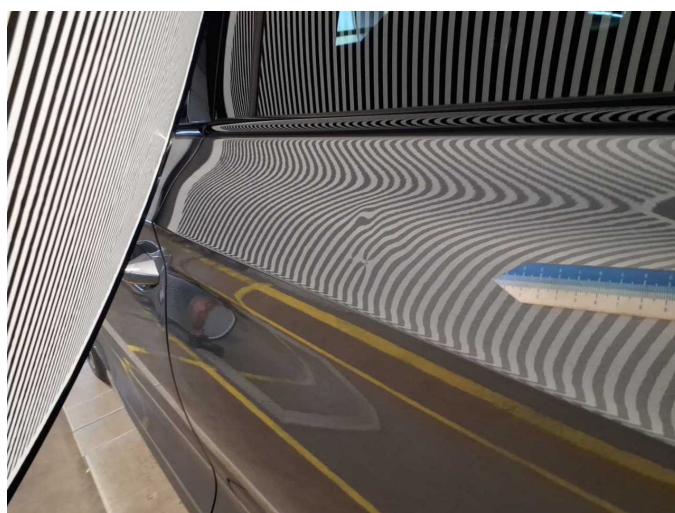
| No. | Component group | Description |
|---|---|---|
| 8 | Door - rear left side | Door - dent(s) - Smooth repair work |

**Damage 8:** Door - rear left side: Door - dent(s) - Smooth repair work
