Expertise

Protocol number: 46646308  
Order No. / Reference: 25858328  
Inspection date: 10 Jul 2026

Manufacturer: Mercedes-Benz

Model: Vito 116 CDI Extralang HA Aut. PRO

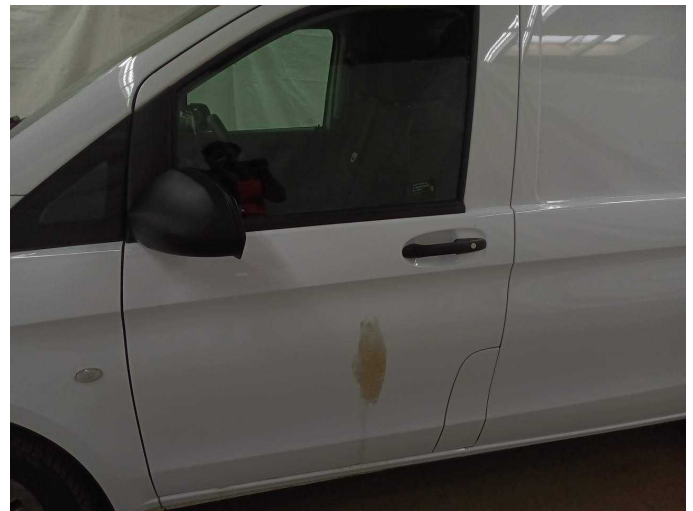
| No. | Component group | Description |
|---|---|---|
| 2 | Door - front left side | Door (Mehrkosten möglich) - Paint defect - Conditioning |

Damage 2: Door - front left side: Door (Mehrkosten möglich) - Paint defect - Conditioning

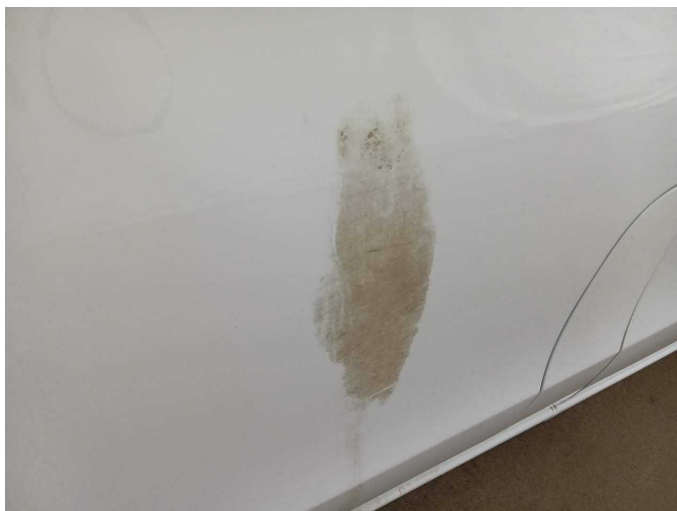
Damage 2: Door - front left side: Door (Mehrkosten möglich) - Paint defect - Conditioning

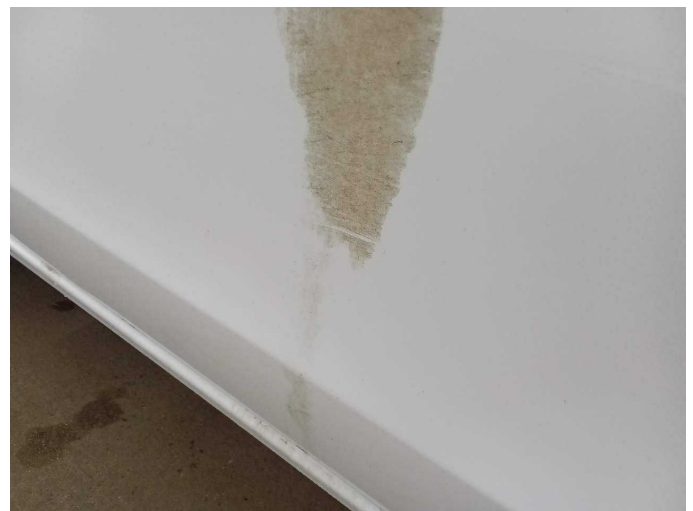
Damage 2: Door - front left side: Door (Mehrkosten möglich) - Paint defect - Conditioning

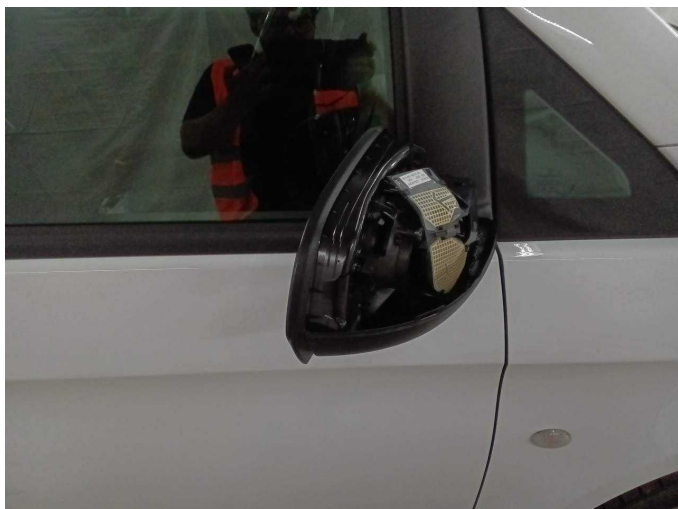
| No. | Component group | Description |
|---|---|---|
| 3 | Wing mirror - right side | Wing mirror - Damaged - Replace |

**Damage 3:** Wing mirror - right side: Wing mirror - Damaged - Replace

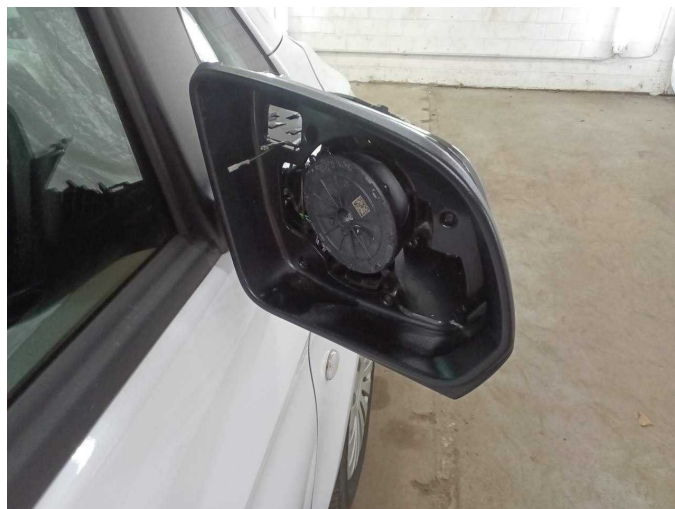
**Damage 3:** Wing mirror - right side: Wing mirror - Damaged - Replace

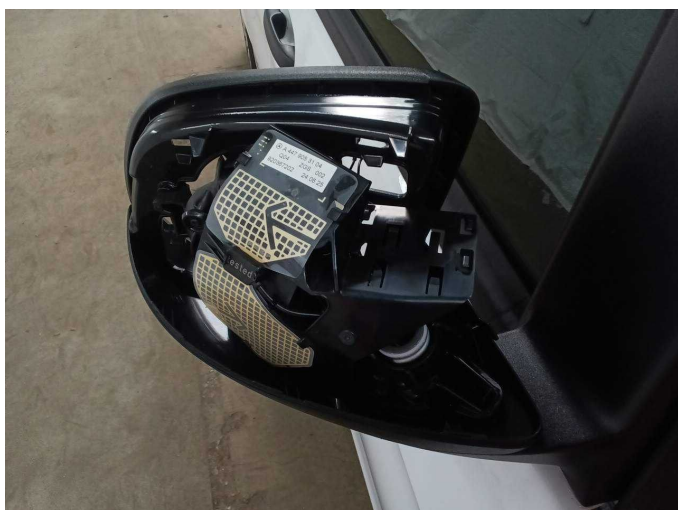
**Damage 3:** Wing mirror - right side: Wing mirror - Damaged - Replace

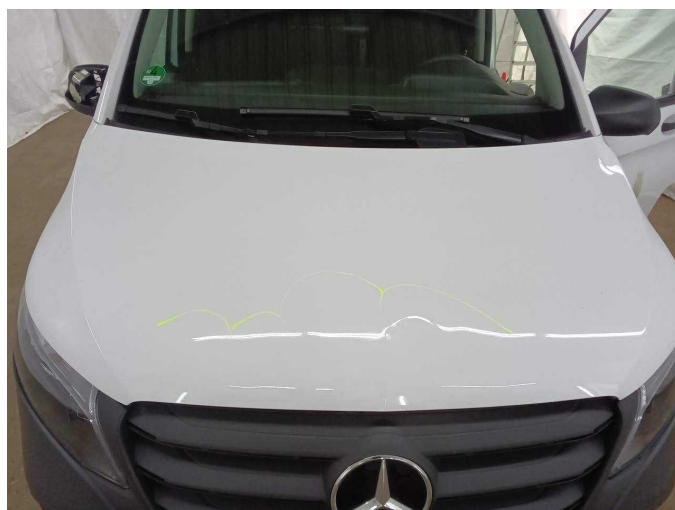
| No. | Component group | Description |
|---|---|---|
| 4 | Bonnet | Bonnet - dent(s) - Repair and paint |

**Damage 4:** Bonnet: Bonnet - dent(s) - Repair and paint

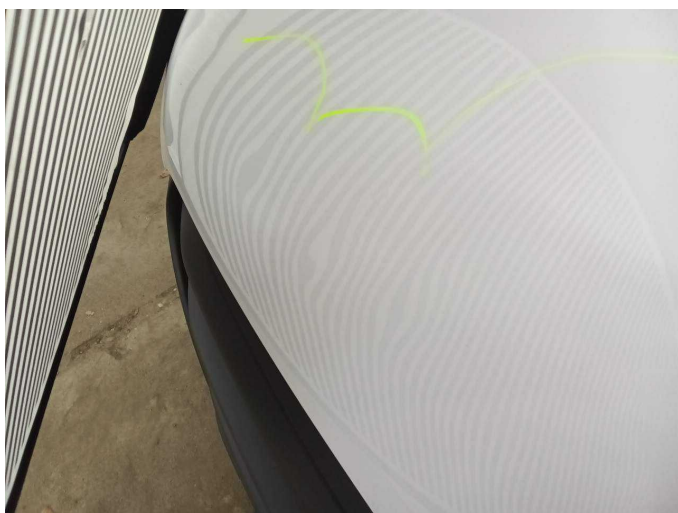
**Damage 4:** Bonnet: Bonnet - dent(s) - Repair and paint

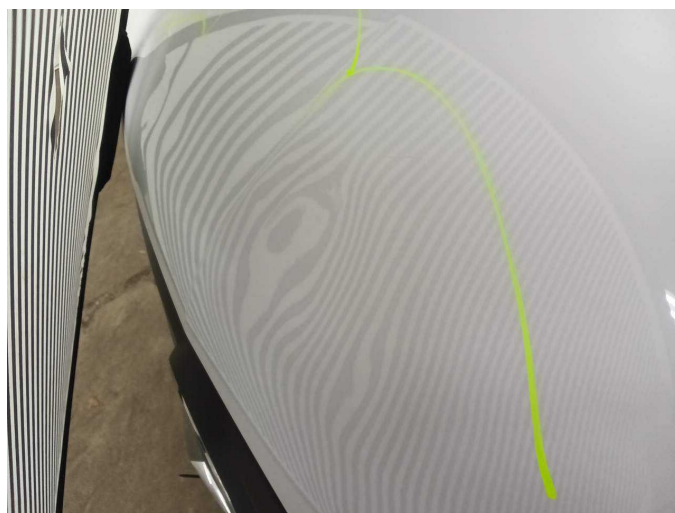
**Damage 4:** Bonnet: Bonnet - dent(s) - Repair and paint

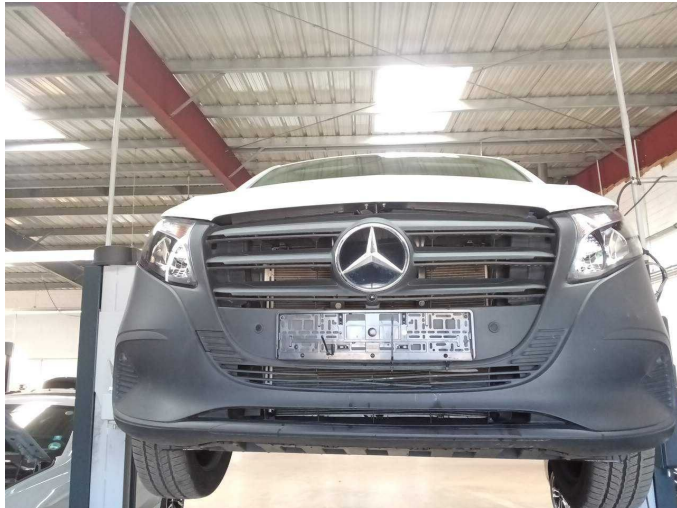
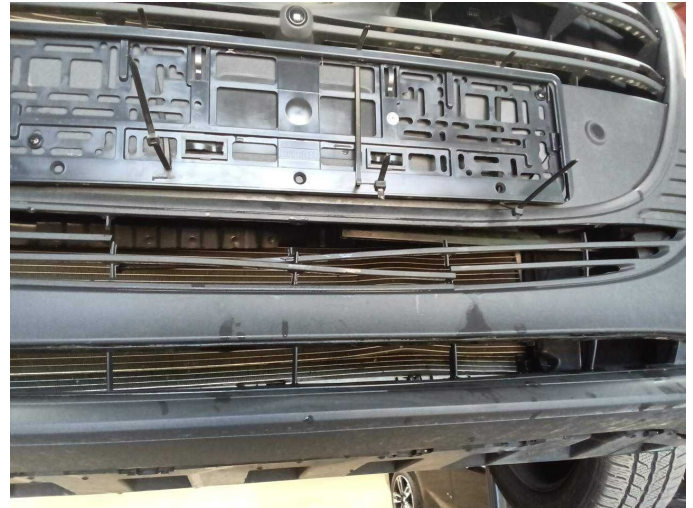
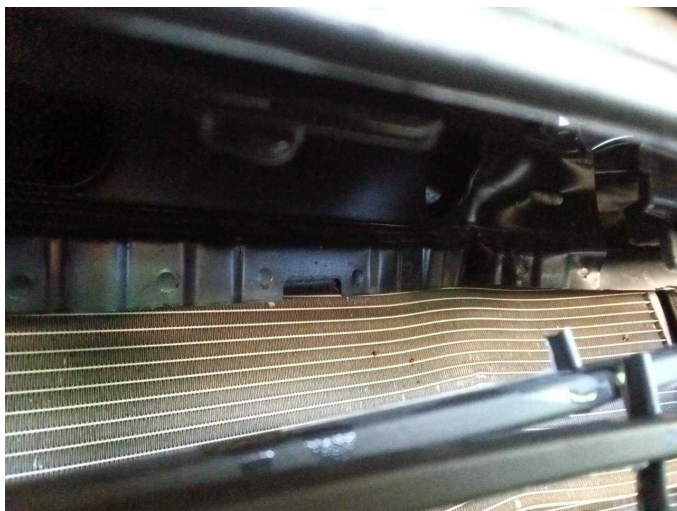
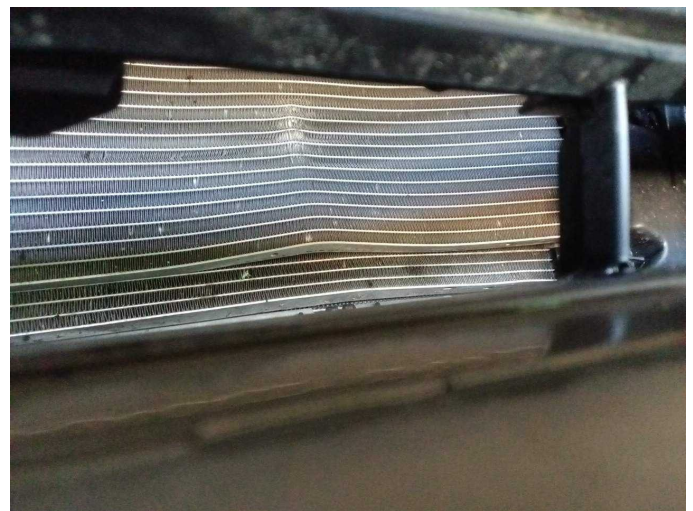
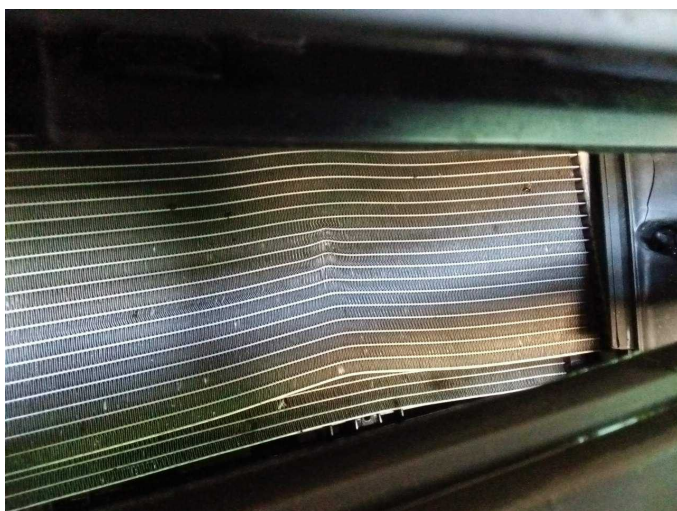
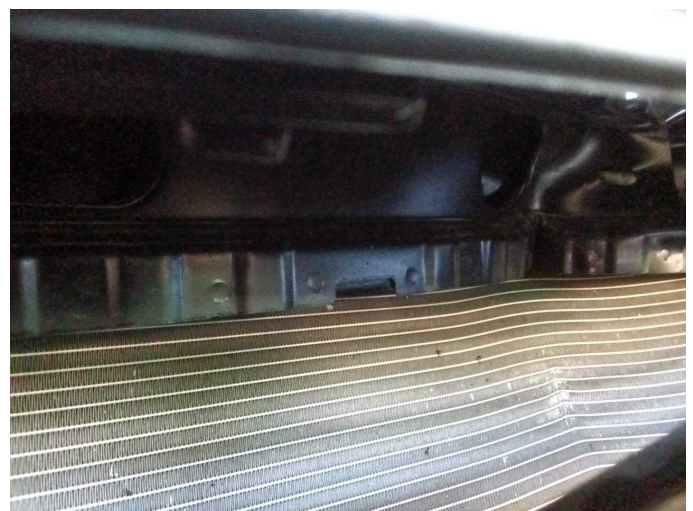
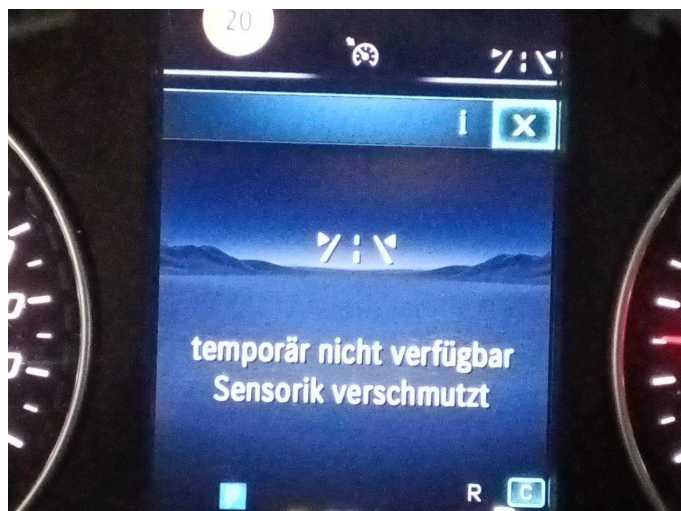
**Accident 1: Front**

Non-repaired previous damages were found at the vehicle. The necessary repair costs are listed in the expert report or if necessary, are listed in detail in a separately enclosed repair cost calculation.
